LANDSCAPE AND VISUAL ASSESSMENT VIEWPOINT 5

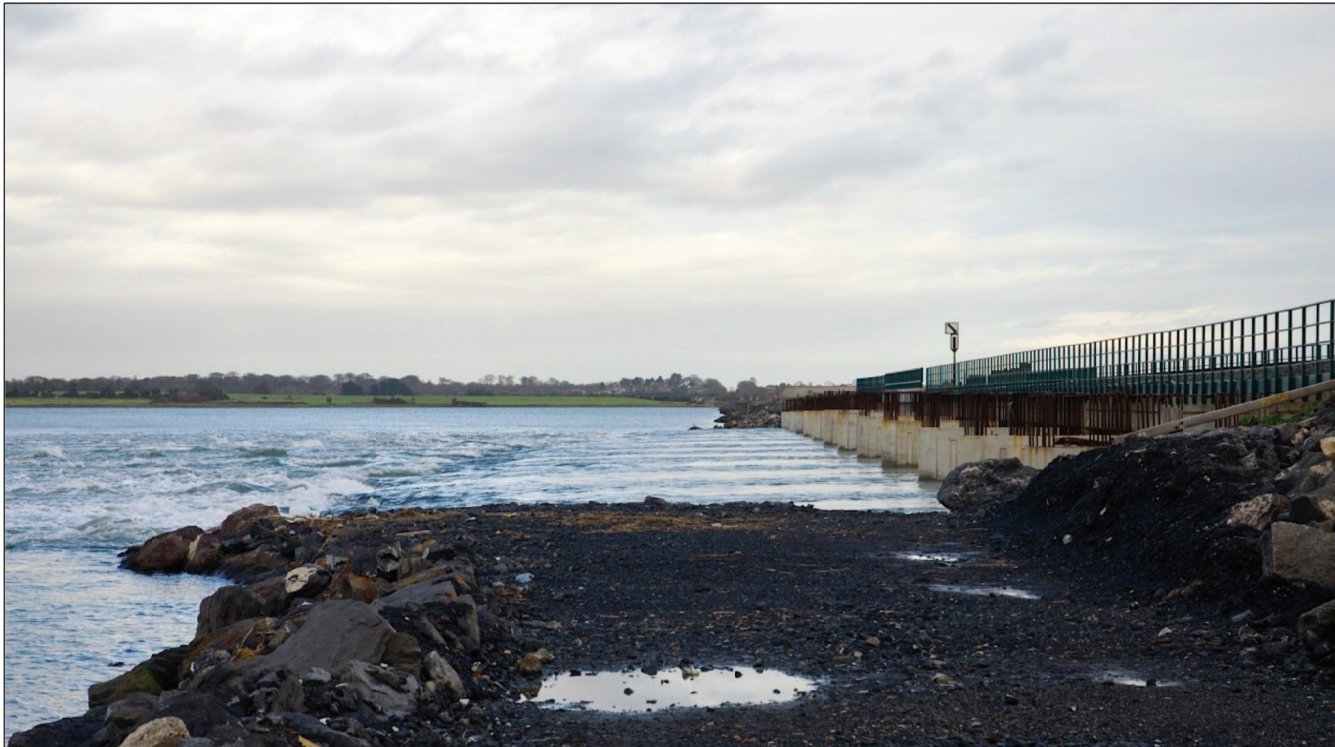
Viewpoint Location	On the railway causeway, immediately south of the weir.
Height AOD (approx)	
Distance from Route	0m

View Description	Northwards from the railway embankment maintenance track with the fields of Kilcrea Townlands visible ahead on the northern shore. The abutments to the proposed greenway bridge are to the right. The dramatic effects of the water coursing between the two parts of the estuary through the weir are apparent.
View during Construction	This view would not be obtained from this location during construction, as the causeway would remain closed to the public.
View on Completion	The maintenance track would be improved to form the greenway with a waist-high stone wall to the left. Views would be retained of the weir by the use of railings. The bridge would be completed to the right. The effects of the proposed lighting on the causeway would be clearly visible from this viewpoint, but would be in keeping with the engineered character of the rail embankment and railway infrastructure.
Mitigation Measures	The quality of robust detailing to the walls, railings and surfaces would enable the greenway to sit comfortably within the exposed estuarine environment.
