Newtown Drogheda

Factual Ground Investigation Report

Project Title	Newtown Drogheda
Engineer	Waterman - Moylan
Project No	8364-01-19
Document Title	Factual Ground Investigation Report

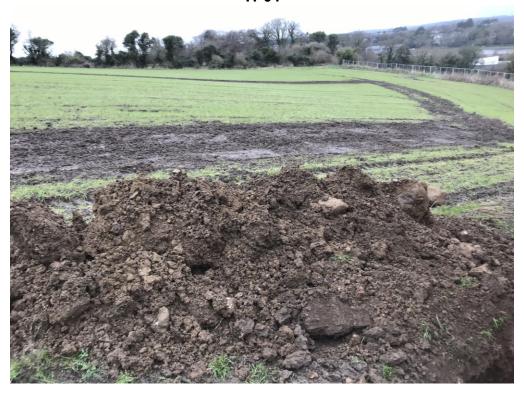
TP01

2.90	В				(0.30) - (0.40) - (0.40) - (1.10) - (1.10) - (1.10) - (2.90)	Soft brown slightly sandy s Soft to firm grey brown slig with rare rounded to subar Firm to stiff grey brown sa occasional rounded to sub boulders and occasional le	sandy slightly gravelly Clay was slightly gravelly CLAY. The sandy slightly gravelly Gravell	CLAY 6 - 6 - 6 - 6 - 6 - 6 - 6 - 6 - 6 - 6
Plan .					• •	No groundwater encountere Trial Pit sidewalls collasping Trial Pit backfilled upon com	d in Trial Pit. 2.0m BGL.

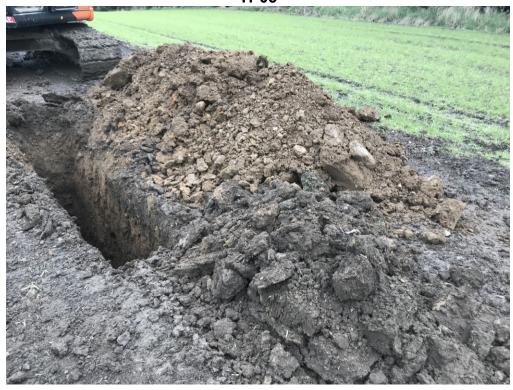
TP05

3.00	В				3.00	Complete at 3.00m		6 5 4	
Plan .						Remarks No groundwater in Trial Pit. Trial Pit sidewalls are stable Trial Pit backfilled upon com	ppletion.		
		·		-		Scale (approx)	Logged By CCostigan	Figure No. 8364-01-19.TP05
