Viewpoint 2 Southeast from R160. View Southeast from the R160 approximately 1.7km from the subject site. From this open section of regional road the temporary overburden tip is partially visible. The proposed extraction area would not be visible due to a combination of intervening vegetation, topography and distance.

Photo Viewpoint 2

Fig 9.5

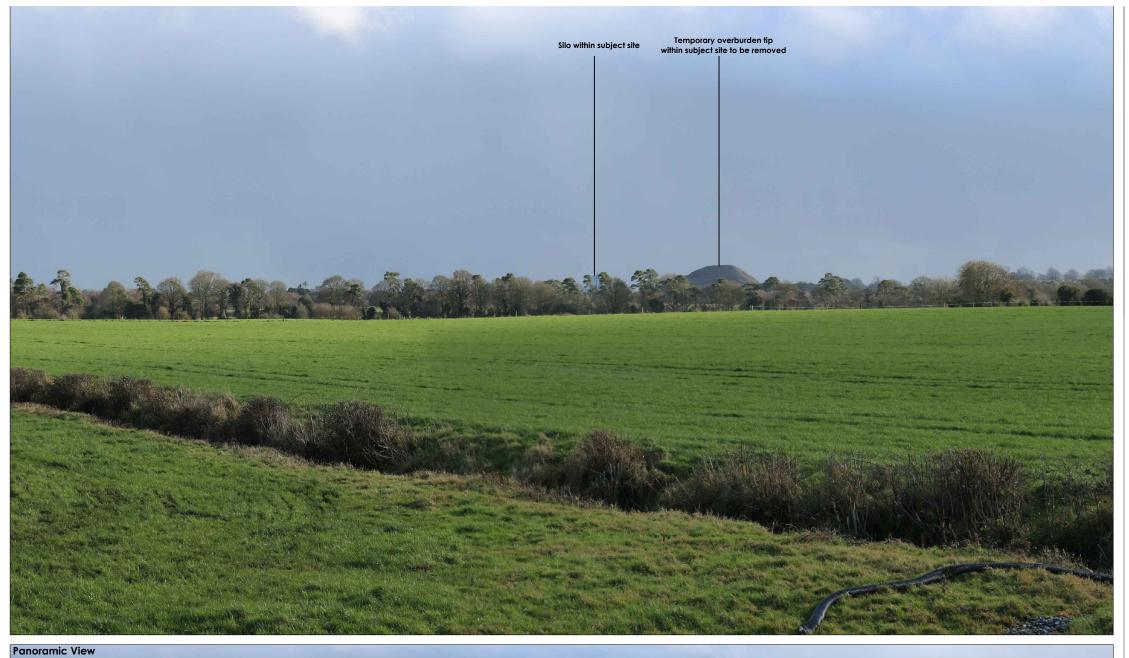
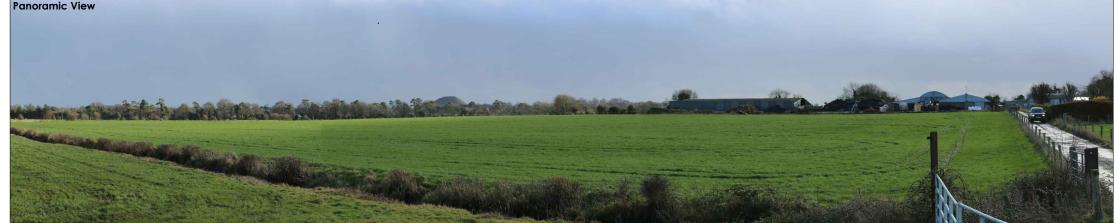
Viewpoint 2 73m AOD (Malin Head) 1750m 90 Degrees

Landscape & Visual Effects Baseline Landscape Viewpoint Duration Mitigation **Predicted Effect** & Visual Sensitivity Magnitude Considered sequence of extraction and phased restoration. Review all boundaries for Long Term Medium - Low (Landscape) Low Minor opportunities to improve screening through earthworks and planting. Gradual removal of Medium - Low (Visual) Low Negligible existing overburden stockpile. date July. 19 Keegan Quarries Ltd. NTS@A3 pjm
