## Selected site photographs

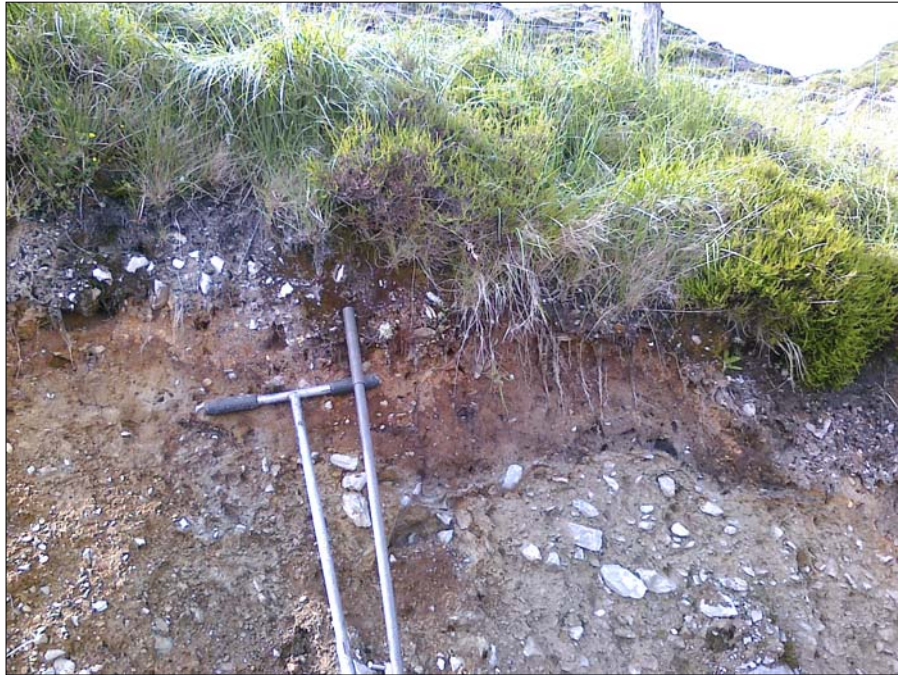
**Photo 1:** Mineral subsoil exposure on existing track north of T1 showing evidence of iron leaching.

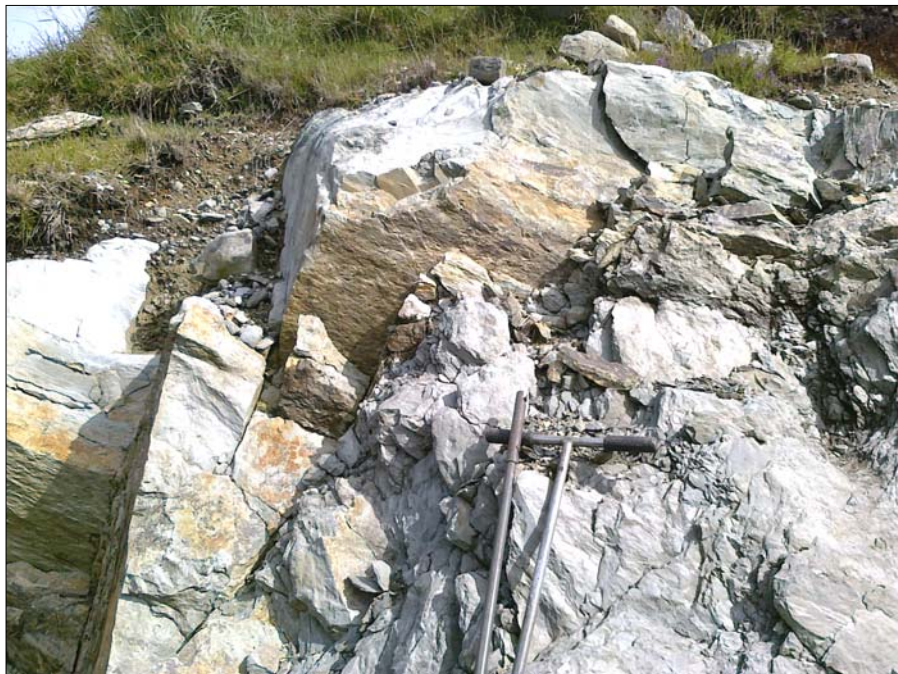
**Photo 2:** Exposed bedrock north of T1 / T2, typical of the Gun Point Formation, green/grey sandstone.

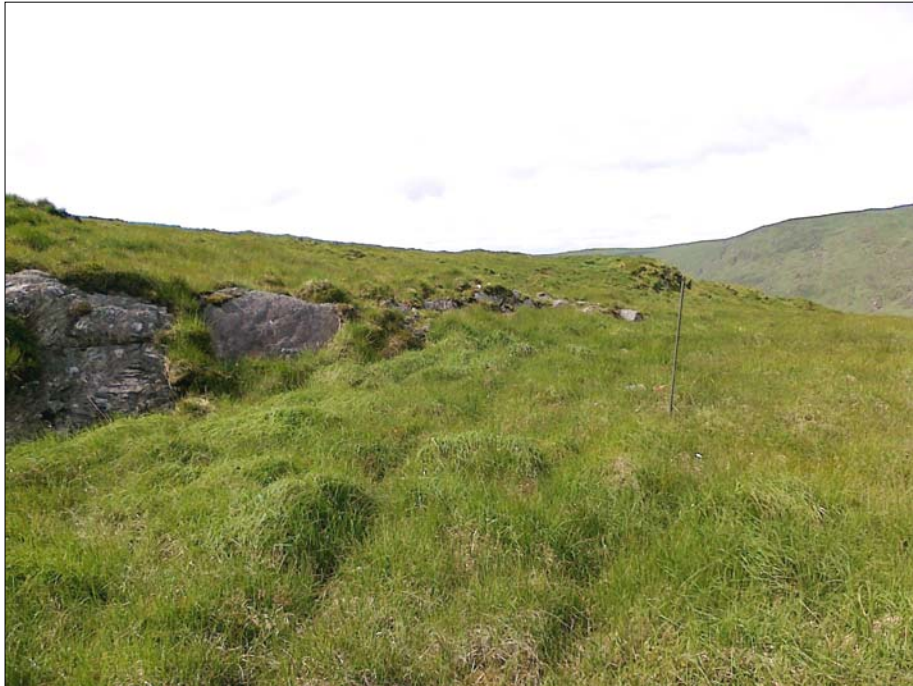
**Photo 3:** Looking west, trackway from T3 to T2 will be located on the high ground in left of photo on shallow peat/rock. Peat in centre of photo is 1-2.5m deep.

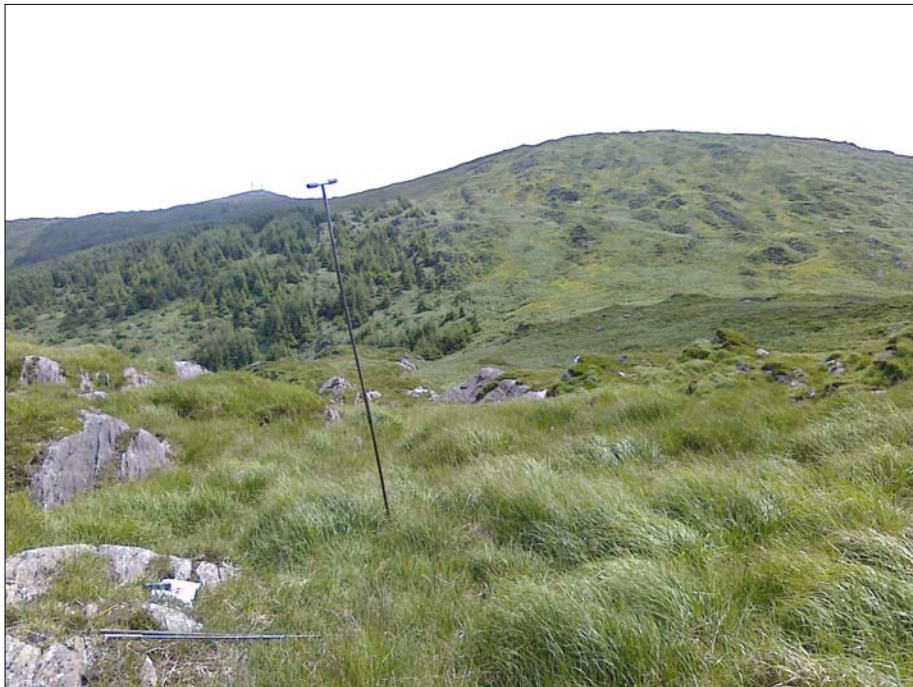
**Photo 4:** Looking east from location of T7, not bedrock at surface.

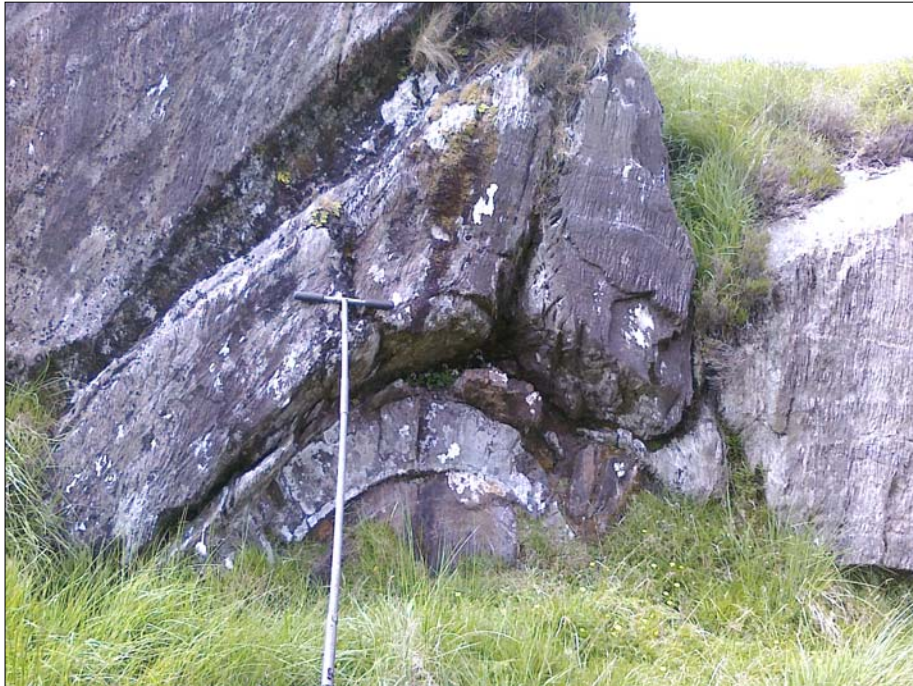
**Photo 5:** Looking west at exposed bedrock immediately downslope of T7 typical of purple siltstone of the Gun Point Formation.

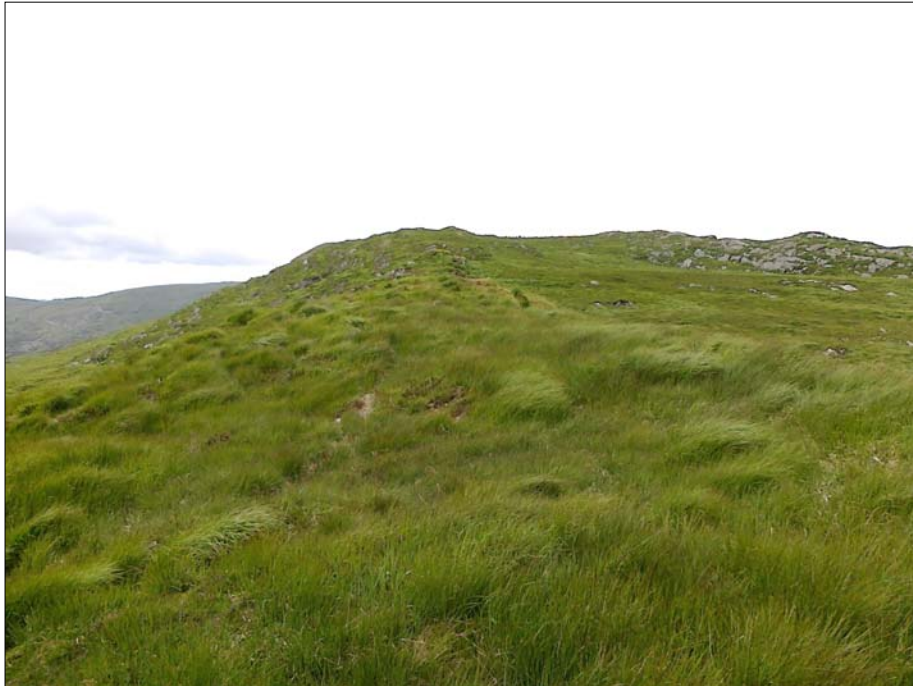
**Photo 7:** Looking east along proposed track route from T5 to T4, peat here is 0 – 0.3m deep along the higher ground.

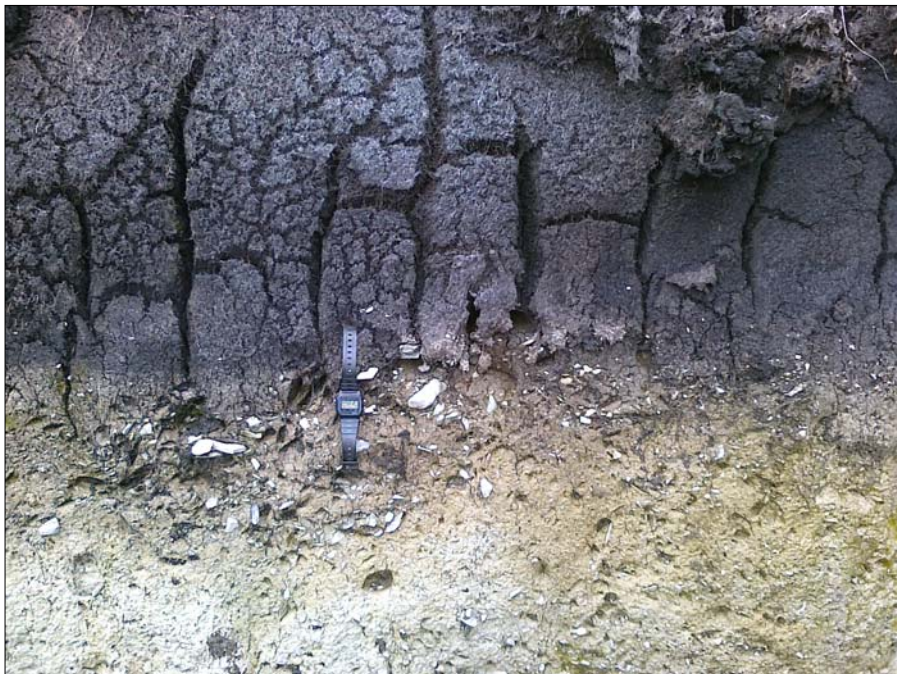
**Photo 8:** Peat-mineral subsoil interface at exposure on existing track north of T2.
