Title: **STAGE 1 ROAD SAFETY AUDIT**

**Proposed Mixed Use Development , Swords Road, Santry,
Dublin 9.**

Client: **DBFL Consulting Engineers.**

Report reference: **1061R01**

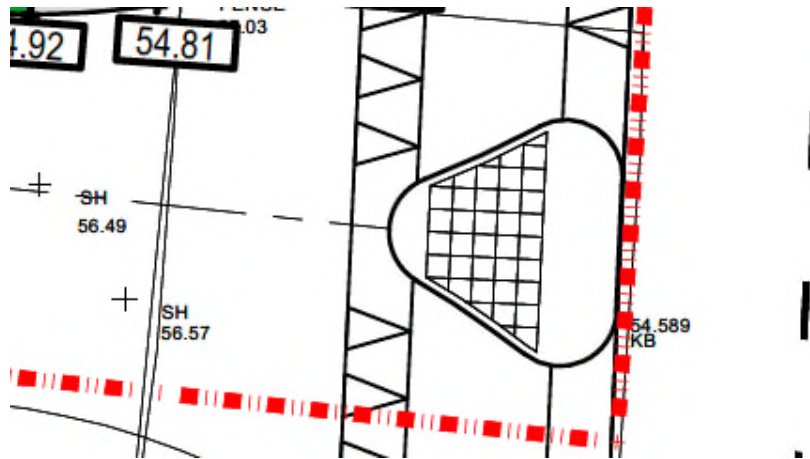
Drawing 200060-DBFL-RD-ST-DR-C-1001 Rev P02.

The junction of the access road to the South of the site appears to be a left in-left out junction (confirmed in the Traffic & transport Assessment provided by way of background information). It was observed during the site visit that the junction is not signed as such and drivers are turning right into it. The shape of the splitter island could lead to drivers entering the access road on the wrong side of the splitter island resulting in head-on collisions.

It is recommended that the signage and road markings relating to the left-in left-out only junction be provided or that the splitter island be reconfigured to allow all movements at the junction.

3.1	Yes	No	This junction has already received planning permission under Planning Ref.:2713/17 and is under construction. 'No Right Turn' signs can be facilitated within site boundary. The turn from Swords Road is under the control of the Local Authority and they will be made aware of the potential issue.	Yes

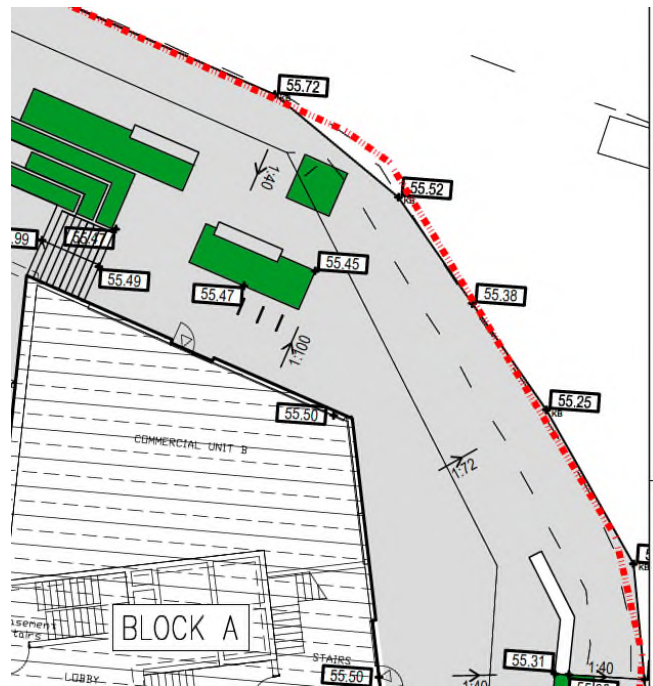
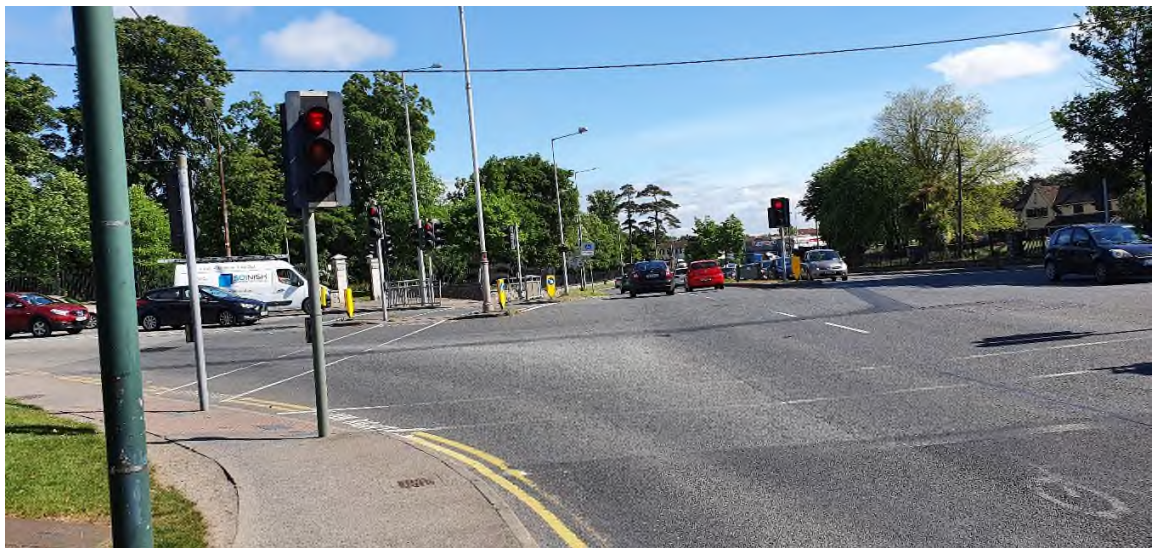
Drawing 200060-DBFL-RD-ST-DR-C-1001 Rev P02.

The corner radius of the R132/Santry Avenue junction is very large. This leads to high turning speeds and higher injury severities if pedestrians or cyclists are struck. There will be an increase in pedestrian activity at this junction as a result of the proposed development and there will be a corresponding reduction in heavy goods vehicles due to the replacement of the hardware premises. There is an existing issue with pedestrian collisions in that area as observed from the RSA data.

It is recommended that the corner radius is reduced at the junction.

3.2	Yes	No	This area is outside the site boundary and under the control of the Local Authority. The current footpath layout and radius is under review as part of the "BusConnects" scheme. The "BusConnects" DRAFT plans show a reduction of the radius and a more pedestrian friendly junction.	Yes

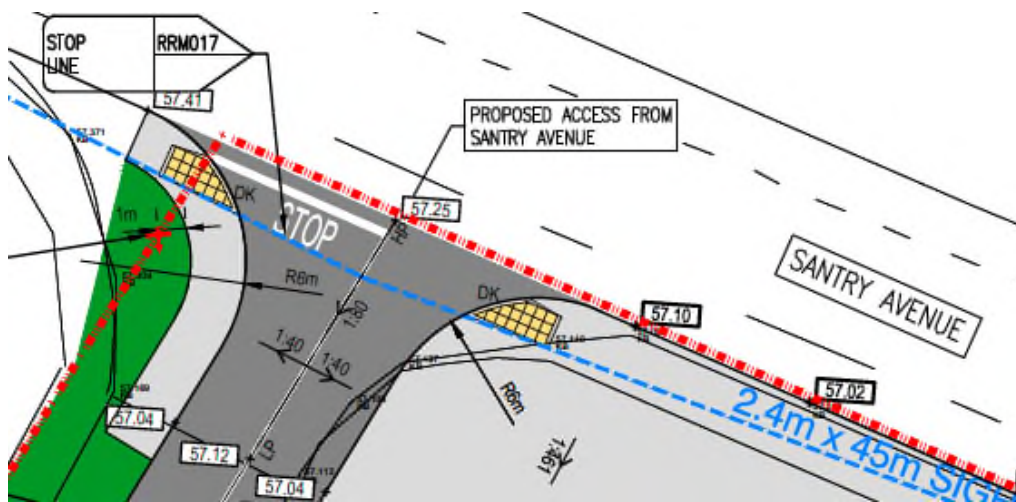
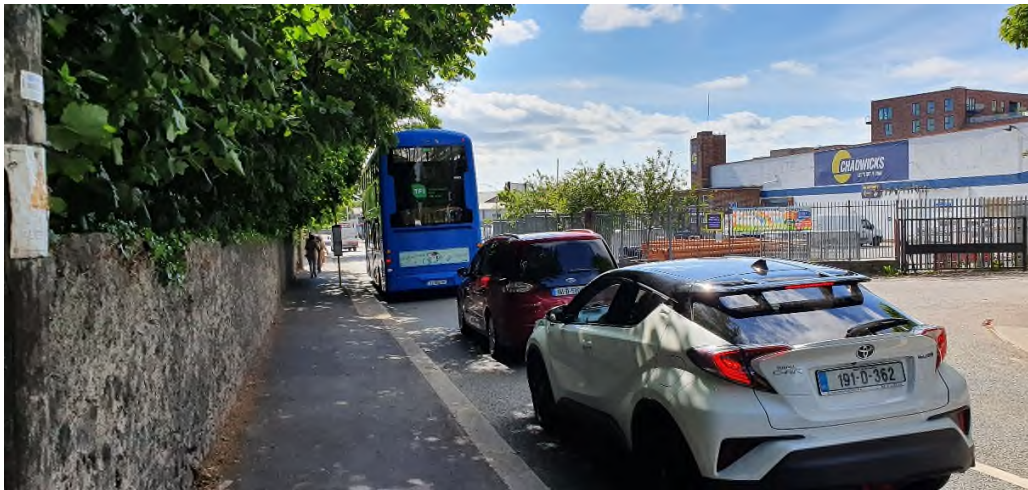
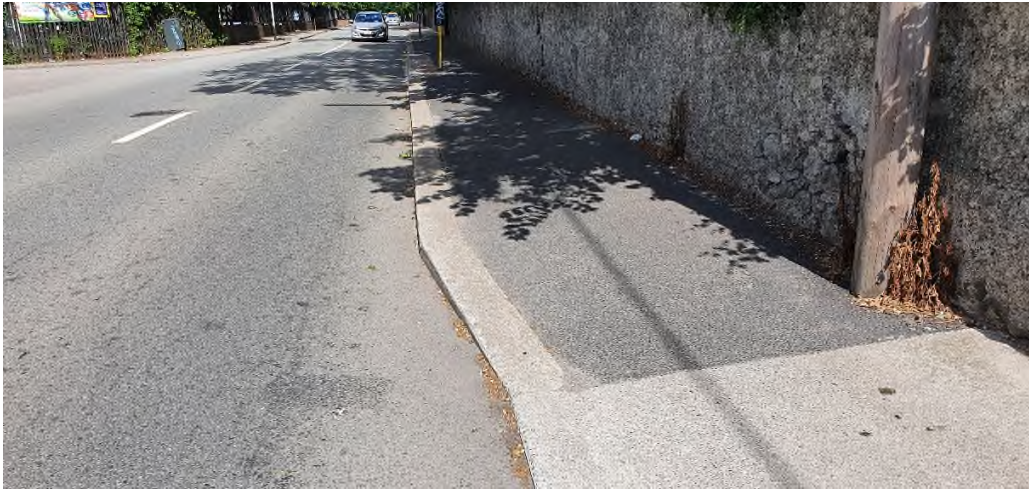
Drawing 200060-DBFL-RD-ST-DR-C-1001 Rev P02.

The proposed vehicular access off Santry Avenue is opposite an on-road bus stop (Route 17A) which is currently slightly built-out from the through kerb line. Drivers may exit from the proposed development when other drivers are overtaking parked buses which could lead to head on-or side swipe collisions.

Ensure that the proposed access does not compromise the safety of road users when busses are stopped on Santry Avenue. This may require the relocation of the bus stop.

3.3	Yes	No	Relocation of the bus stop is outside the site boundary and under the control of the Local Authority.	Yes
3.4	Yes	Yes	The recommendation will be incorporated during detailed design stage.

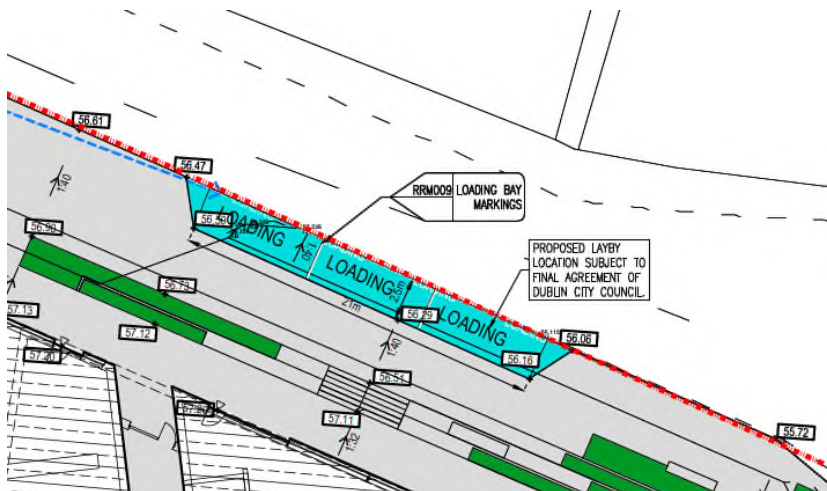
Drawing 200060-DBFL-RD-ST-DR-C-1001 Rev P02.

It is proposed to provide 3no. loading bays on Santry Avenue. It is unclear if there are routes for deliveries to the development that do not include steps or excessively long journeys. If the loading bays are not conveniently located there is a risk that delivery drivers may park on the footpaths and be hazards for pedestrians.

It is recommended that the loading bays be placed at convenient at grade locations for deliveries to/from the proposed development.

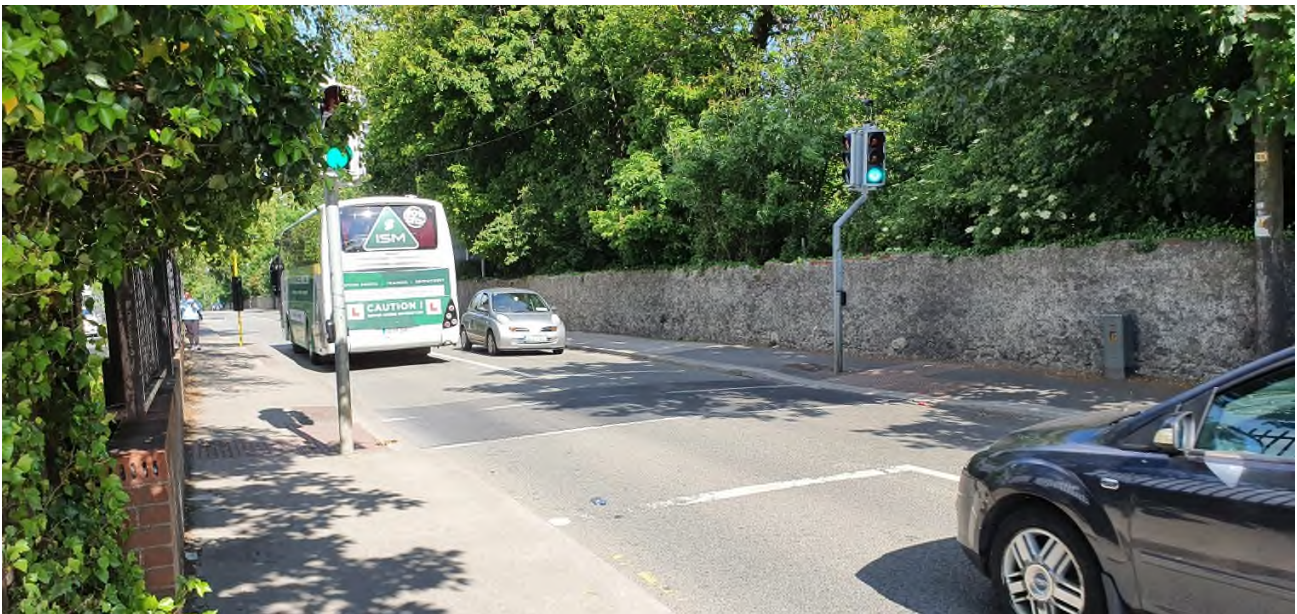
Drawing 200060-DBFL-RD-ST-DR-C-1001 Rev P02.

There is an existing controlled pedestrian crossing on Santry Avenue immediately west of the proposed vehicular access to the development. There is a risk that drivers exiting the development and turning left might not see the red signals and may turn at the same time as a pedestrian starts to cross the carriageway leading to a possible collision.

It is recommended that the existing crossing and signals be assessed for visibility by exiting drivers. If insufficient visibility is not provided then the crossing or the access should be relocated.

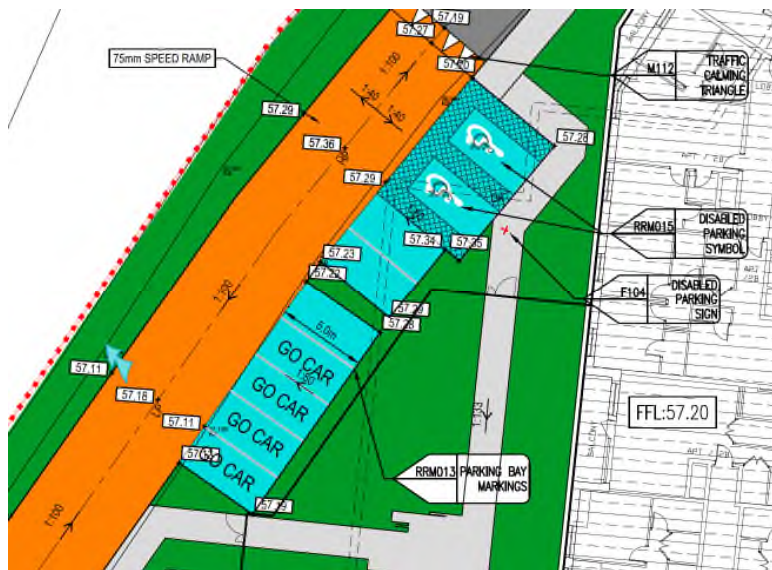
Drawing 200060-DBFL-RD-ST-DR-C-1001 Rev P02.

Occupants of the Go-Car parking spaces and one of the disabled spaces do not have an area of footpath to enter when they leave their vehicle. Those road users would have to enter the carriageway of the access road where they would have a greater likelihood of being struck by a passing vehicles.

It is recommended that a footpath be provided along the parking spaces and that dropped kerbs be provided at the disabled parking spaces to facilitate universal access. Although only indicative at this stage, signs should not be placed in the footways.

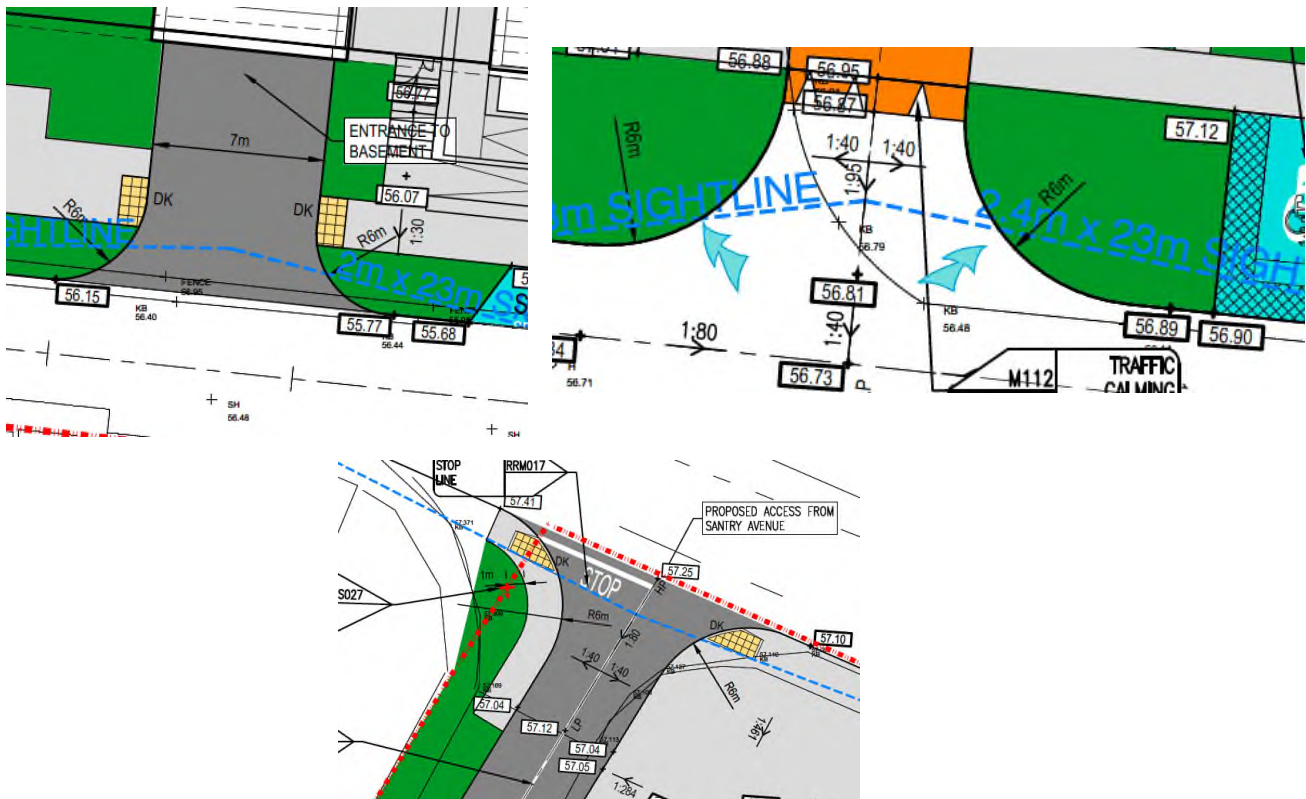
Drawing 200060-DBFL-RD-ST-DR-C-1001 Rev P02.

It is proposed to have 6m corner radii at all the vehicular accesses including the basement access. Larger corner radii can lead to higher turning speeds, greater distances for pedestrians to cross and greater likelihood of turning drivers not being able to see cyclists. Larger radii therefore lead to higher likelihoods and severity of collisions with vulnerable road users.

It is recommended that suitable corner radii be provided.

3.5	Yes	Yes		
3.6	Yes	Yes	The recommendation will be incorporated during detailed design stage.	
3.7	Yes	No	These radii are to accommodate larger vehicle (refuse/Fire Tender)	Yes

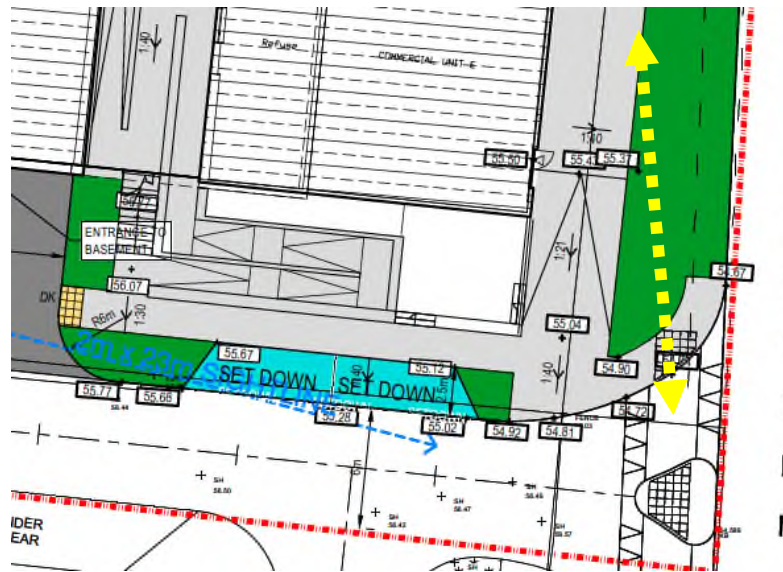
Drawing 200060-DBFL-RD-ST-DR-C-1001 Rev P02.

The proposed footpath along the R132 is set back from the kerb line due to the widened grassed verge. The proposed footpath does not align with the crossing at the southern access and is not along the desire line. This could lead to pedestrians not associated with the development travelling on the grassed verge which could lead to slips and falls.

It is recommended that a footpath be provided that caters for the desire line and crossing of the access.

Paragraph No. in Safety Audit Report	Problem accepted (yes/no)	Recommended measure accepted (yes/no)	Alternative measures (describe)	Alternative measures accepted by Auditors (Yes/No)
			maneuverability and in line with DMURS.	
3.8	Yes	Yes	The recommendation will be incorporated during detailed design stage.
