<b>CMK</b> Horticulture & Arboriculture Ltd		PROJECT: MILLTOWN PARK, SANDFORD ROAD, DUBLIN 6		JOB NO. TSAN001
Client: SANDFORD LIVING LIMITED	DRAWING: Tree Protection (Keyplan)	DATE: 13-08-21	SCALE: 1:750 @ A1 (Reference)	DRAWING NO. 107
NOTES: Do Not Cut, Use Flared Shovel, Do Not Compress, Exercise Care Quarterly Water	DRAWN BY: Neil McElroy	DATE: 13-08-21	SCALE: 1:750 @ A1 (Reference)	REVISION: G
STATUS: PLANNING

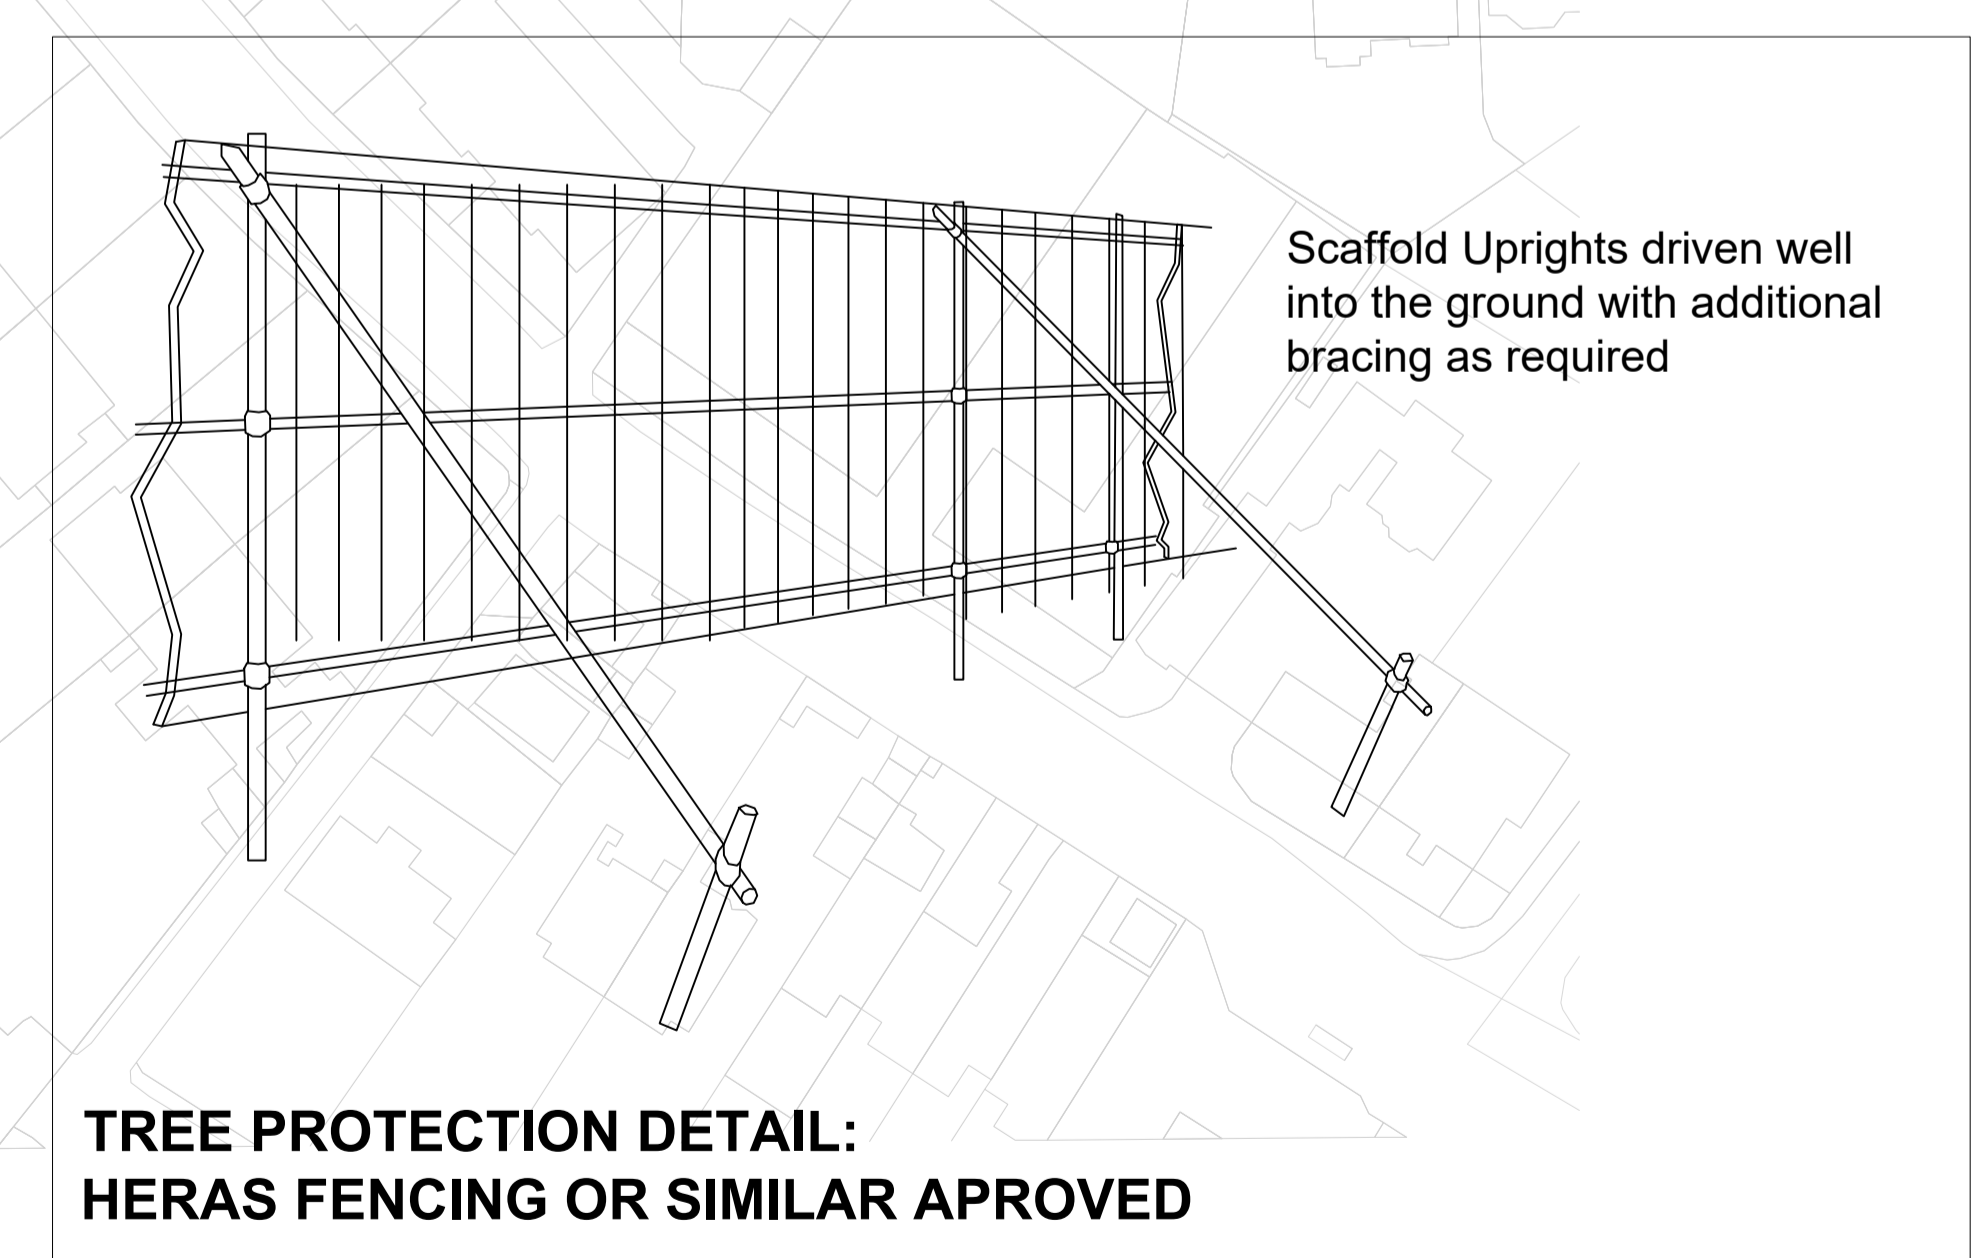
**AREA 1**

**AREA 3 (Refer to appendix report TSAN001 EGLINTON ROAD 110)**

**AREA 2**

Proposed wall bridging sections  
After preliminary investigation using hand tools/AirSpade will be undertaken to identify root systems extents

TREE PROTECTION TO REMAIN IN PLACE UNTIL PRIMARY CONSTRUCTION PHASE IS COMPLETED AND REMOVED AS NECESSARY FOR LANDSCAPING PHASE.  
Drawing to be interpreted with reference to the Arboricultural Assessment, Impact & Tree Protection document.
