**Volume III**

**EIAR Appendices**

**Milltown Park, Sandford Road, Dublin 6**

**Submitted on Behalf of  
Sandford Living Limited**

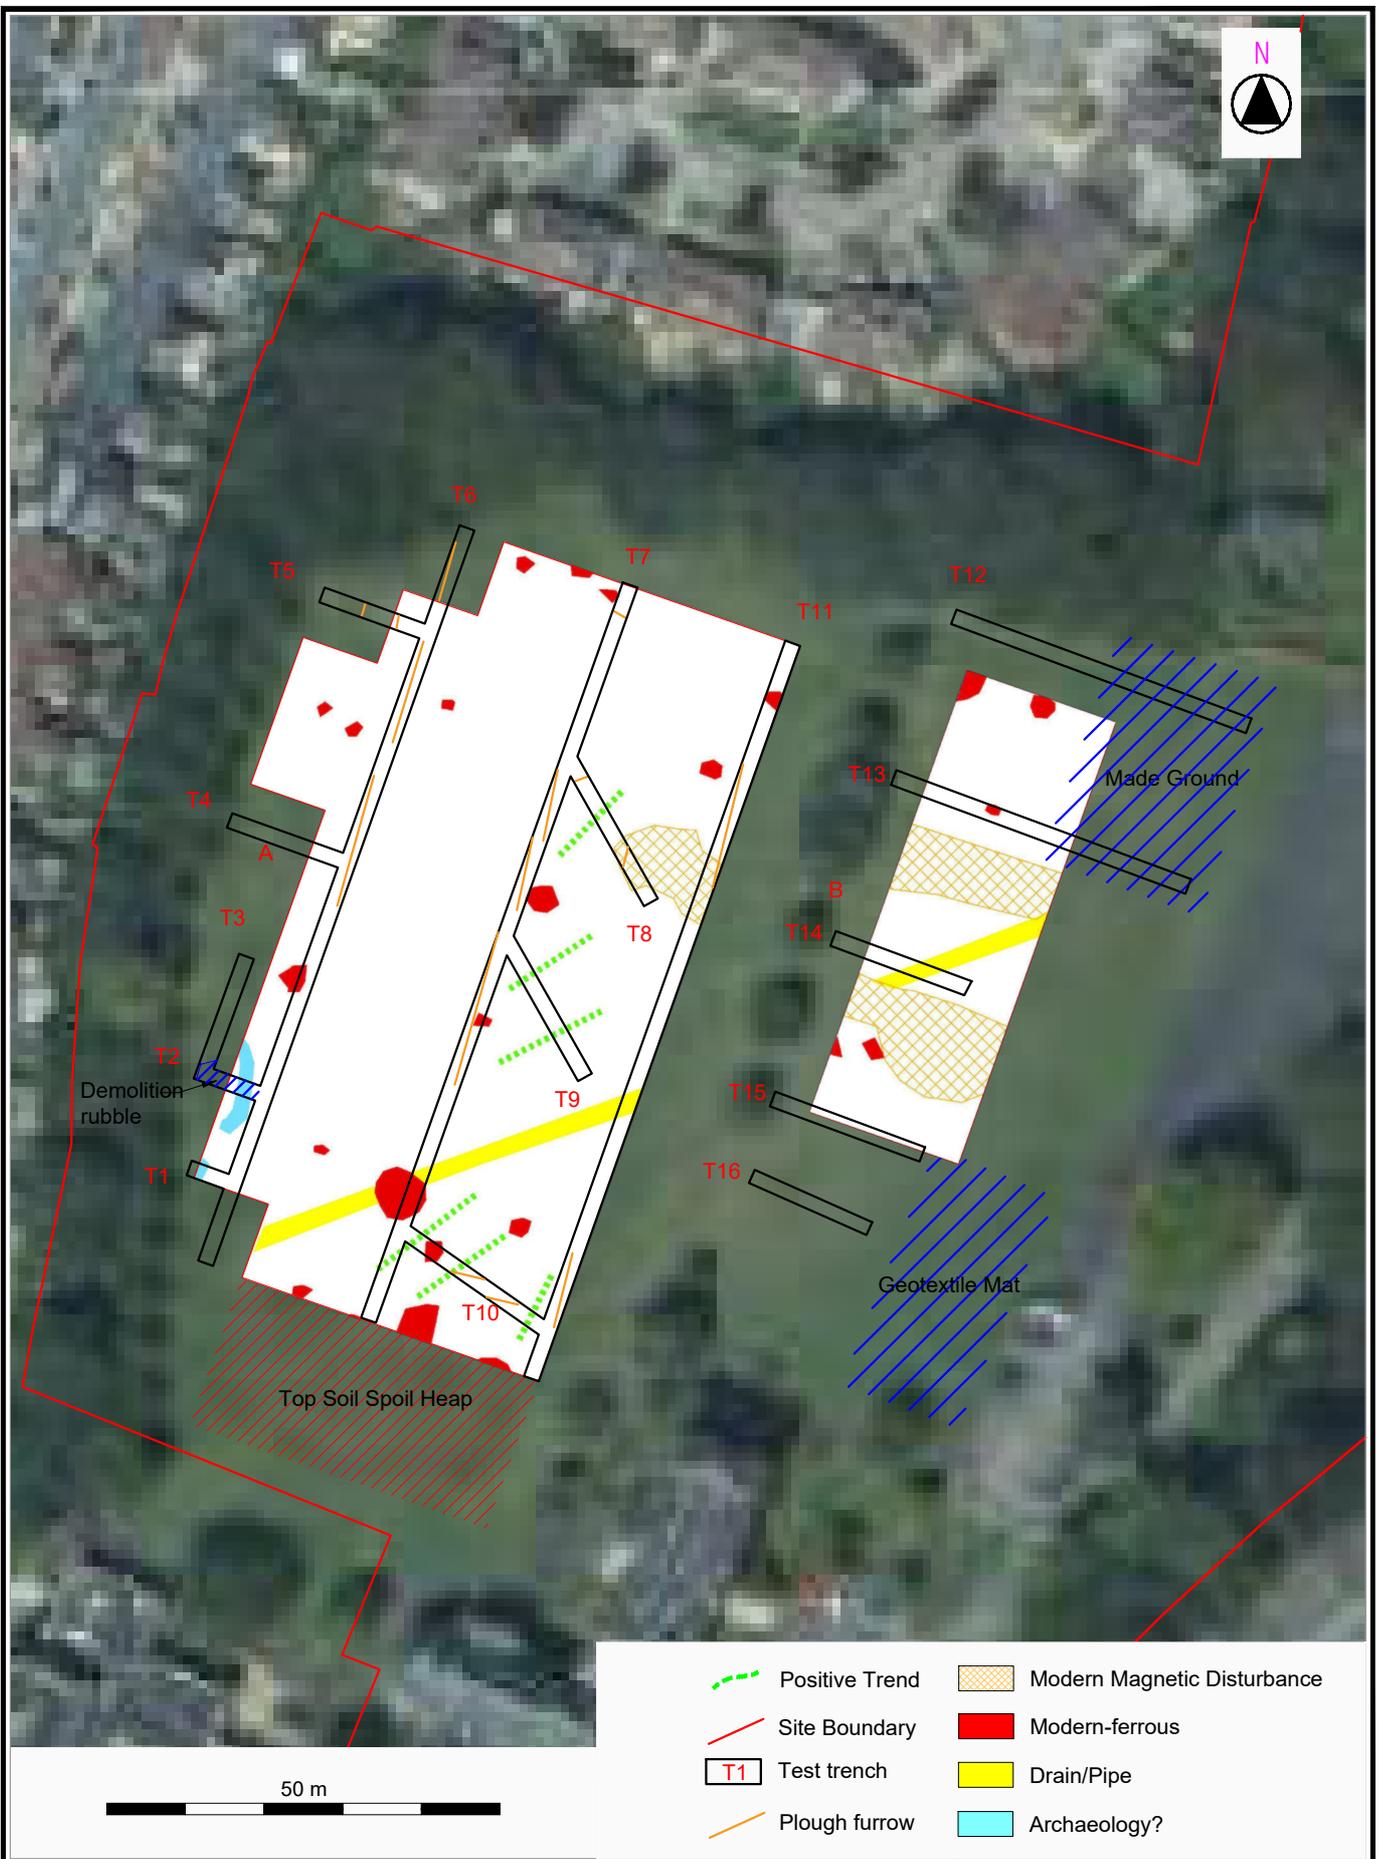
Figure 6.7: Test trench location

- Positive Trend
- Site Boundary
- Test trench
- Plough furrow
- Modern Magnetic Disturbance
- Modern-ferrous
- Drain/Pipe
- Archaeology?

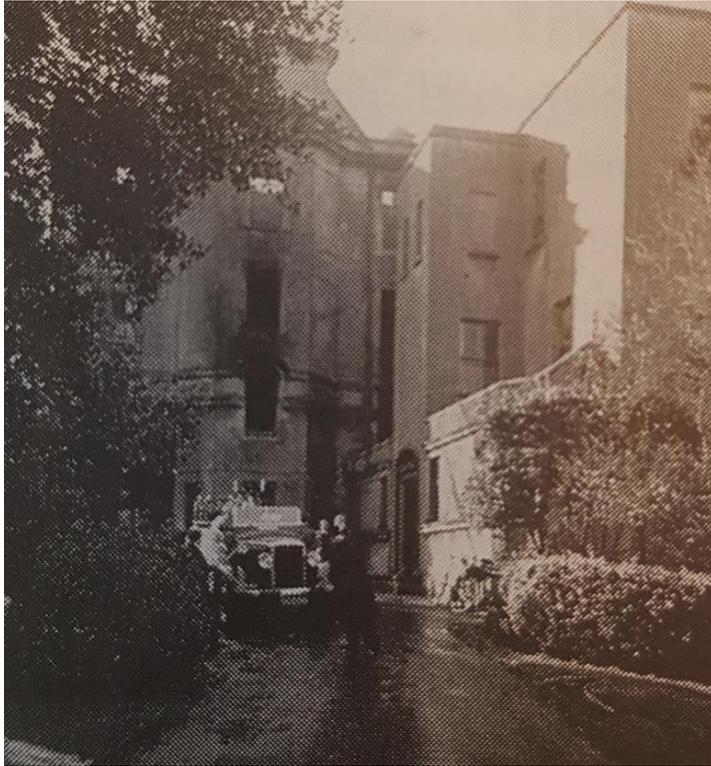
**Fig.13** The fire damaged exterior of the Finlay Wing, indicating its original height of three storey over basement with pitched roof over.

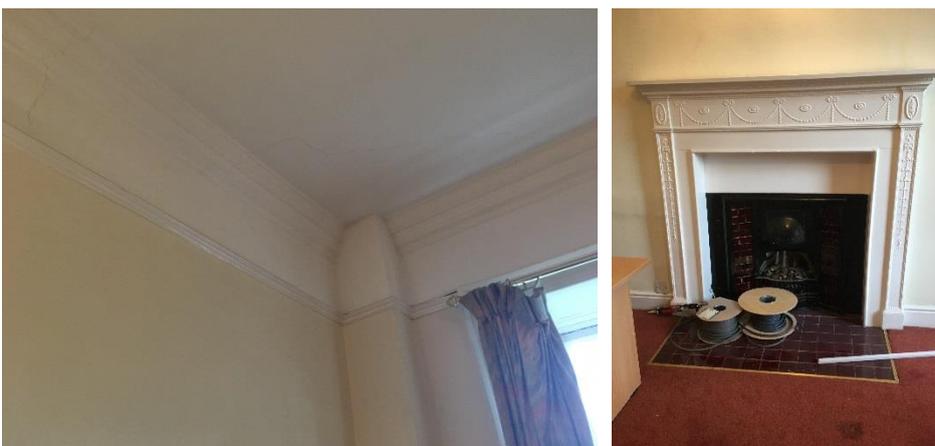
**Fig.27** Overpainted stucco cornice, with services riser in corner.

**Fig.28** Early chimney piece with later tiled inset and hearth, in same room.

Much of the plasterwork and joinery throughout the house has been replaced, with a single original, excessively overpainted stucco cornice surviving at entrance level in the former reception room to the northeast. Surviving chimney pieces originate from the late 19<sup>th</sup> century, and may comprise relocated original pieces, given the later origin of some tiled insets.

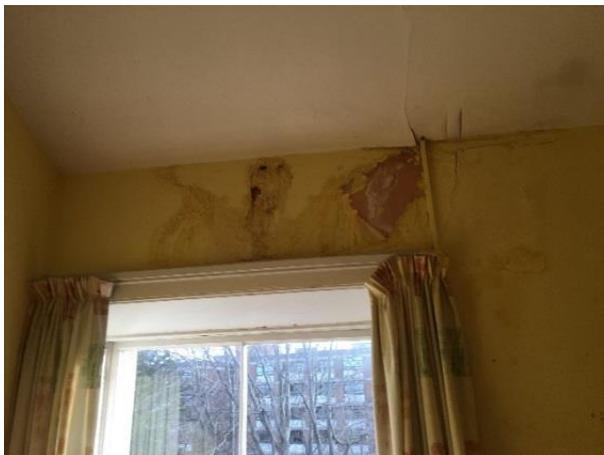
**Fig.31** Example of decay due to water ingress from breaches in roof coverings, at 2<sup>nd</sup> floor (later intervention) level

The property is in poor condition, with extensive roof breaches causing significance decay internally, extending from 2<sup>nd</sup> floor level down through the building.

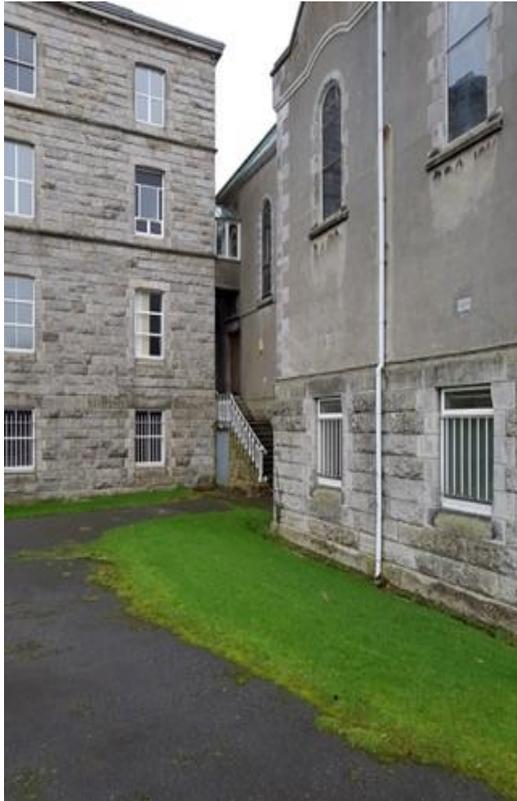
*Plate 27: Connection of Tabor House to the later Chapel: comprising a set of stone steps to first floor level, and a glazed link at second floor to the mezzanine at the rear of the Chapel*

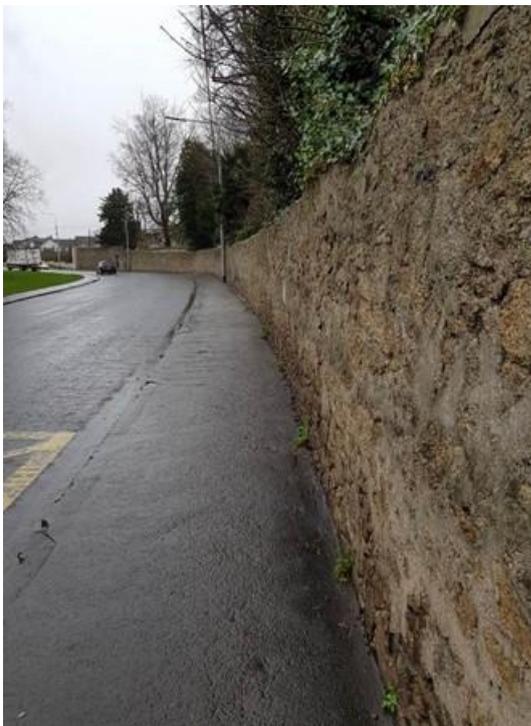
*Plate 75: Curve of wall looking up Milltown Road towards new entrance, note multiple pointing types cement repairs to rubble wall*

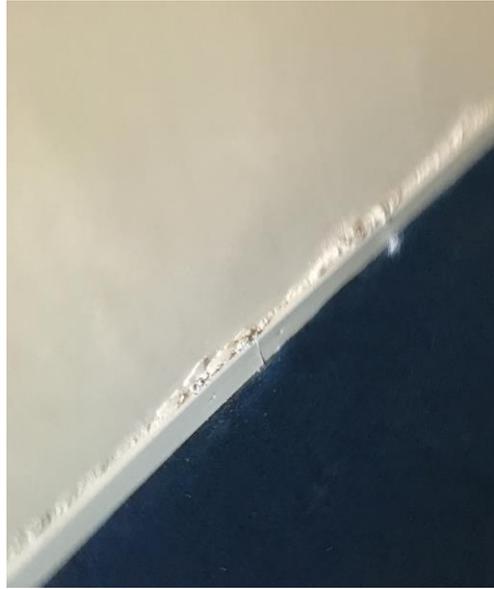
*Plate 103: decay of skirting boards within corridor*

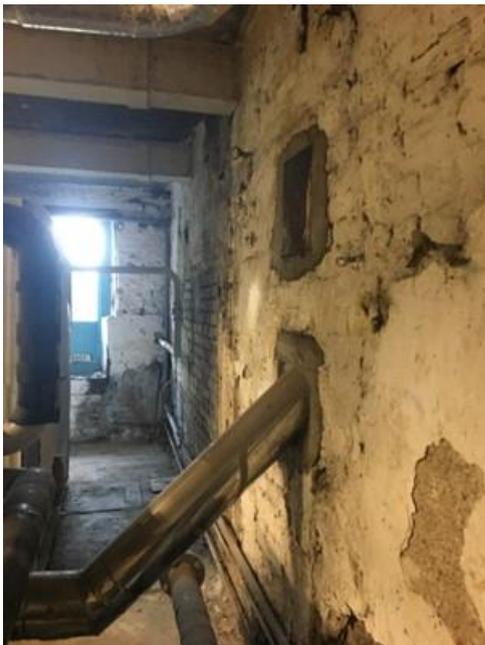
*Plate 104: Former kitchen to northwest at basement level, with original masonry and floor flags evident. Note concrete downstands for concrete floor plate supporting entrance level above*

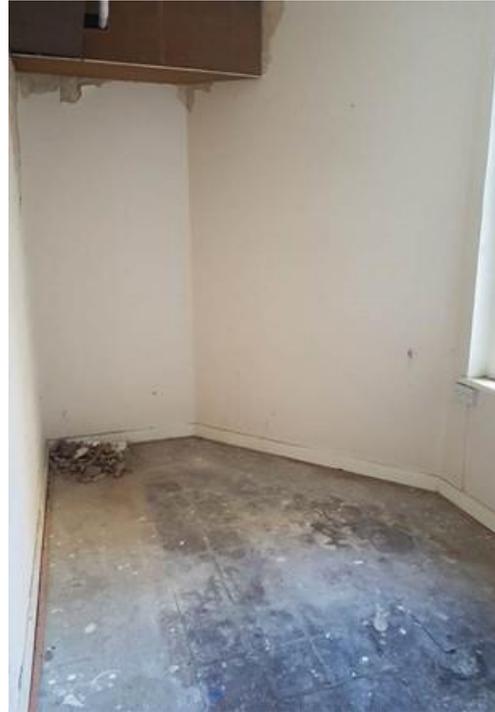
*Plate 134: Small room with partitioned wall showing signs of water damage*

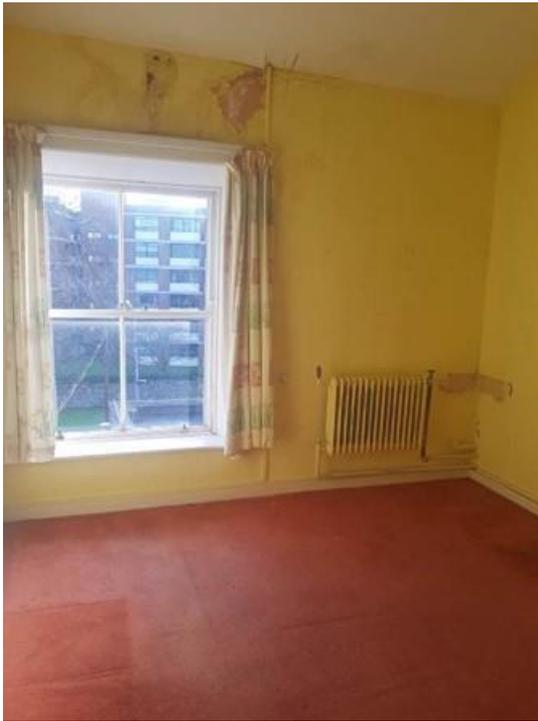
*Plate 158: 2<sup>nd</sup> floor level typical study room to front (east) on first floor with signs of water damage*

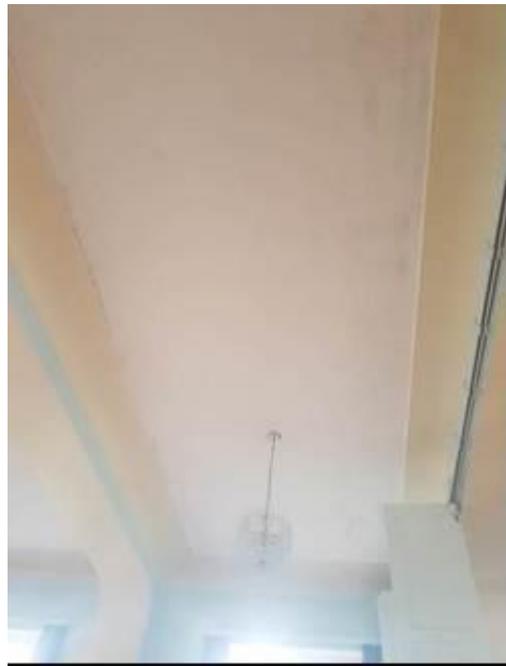
*Plate 250: Ceiling showing some signs of water damage*
