# Environmental Impact Assessment Report

## **Development of 220kV GIS 'Mooretown' Substation and Ancillary Structures**

## **Volume 3 – EIA Appendix**

**COMAH LAND USE  
PLANNING ASSESSMENT  
FOR PROPOSED  
SUBSTATION AND  
UNDERGROUND CABLE  
ROUTES, CO. DUBLIN**

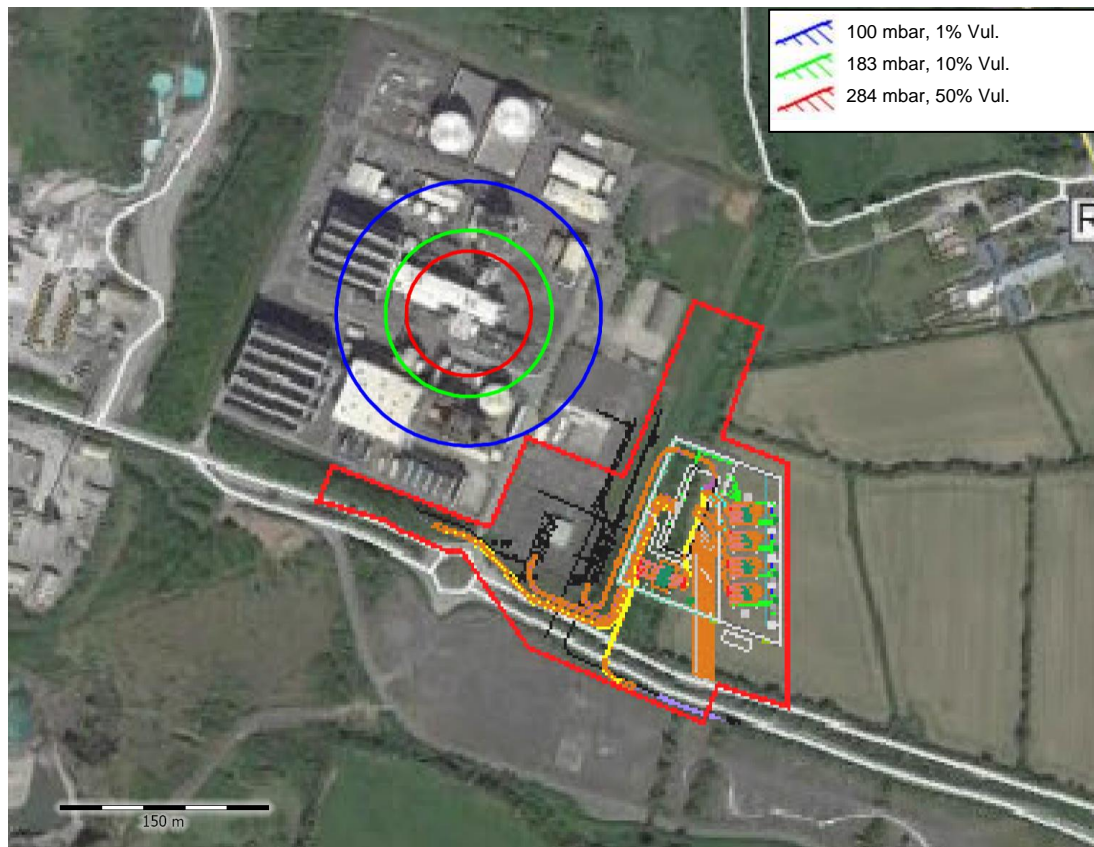
**Figure 8** Natural Gas VCE in Turbine Enclosure: Blast Damage Contours

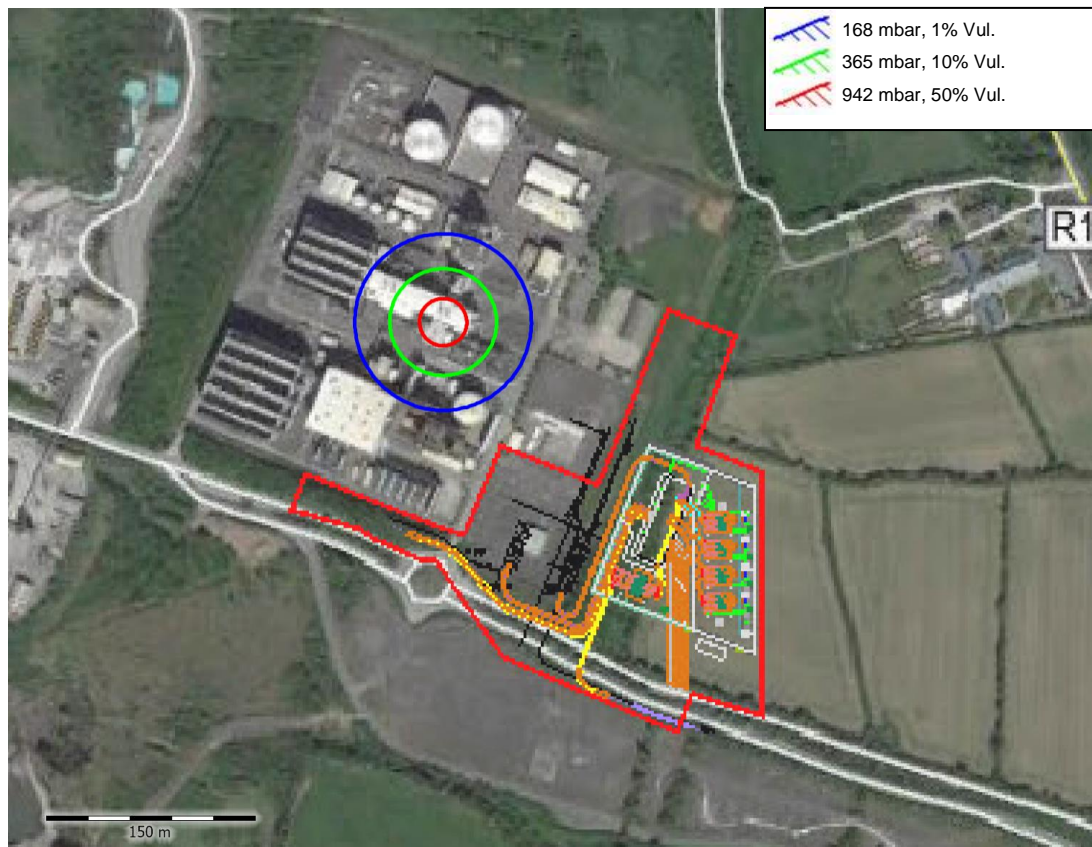
**Figure 9** Natural Gas VCE in Turbine Enclosure: Outdoor Mortality Contours

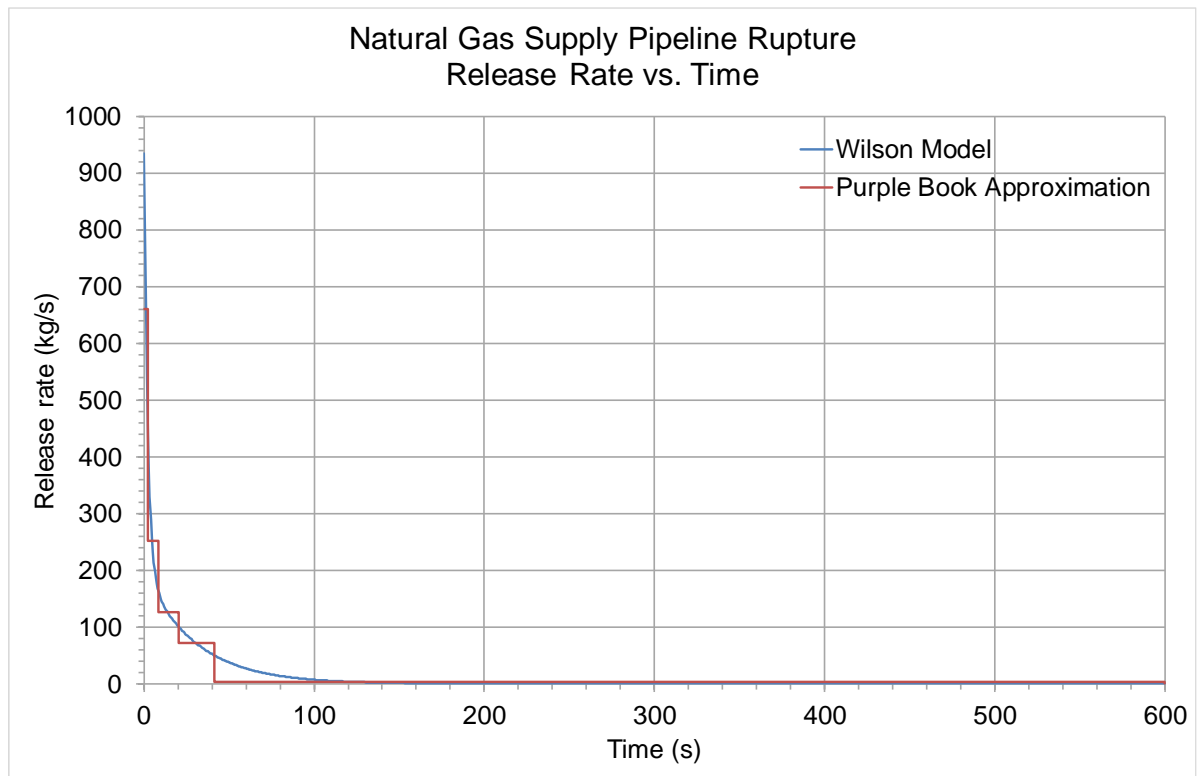
The long pipeline model calculates the drop off in release rate with time, and also the “Purple Book” representative release rate over time in 5 steps, as illustrated on Figure 10.

**Figure 10** High Pressure Natural Gas Supply Pipeline Rupture: Release Rate vs. Time

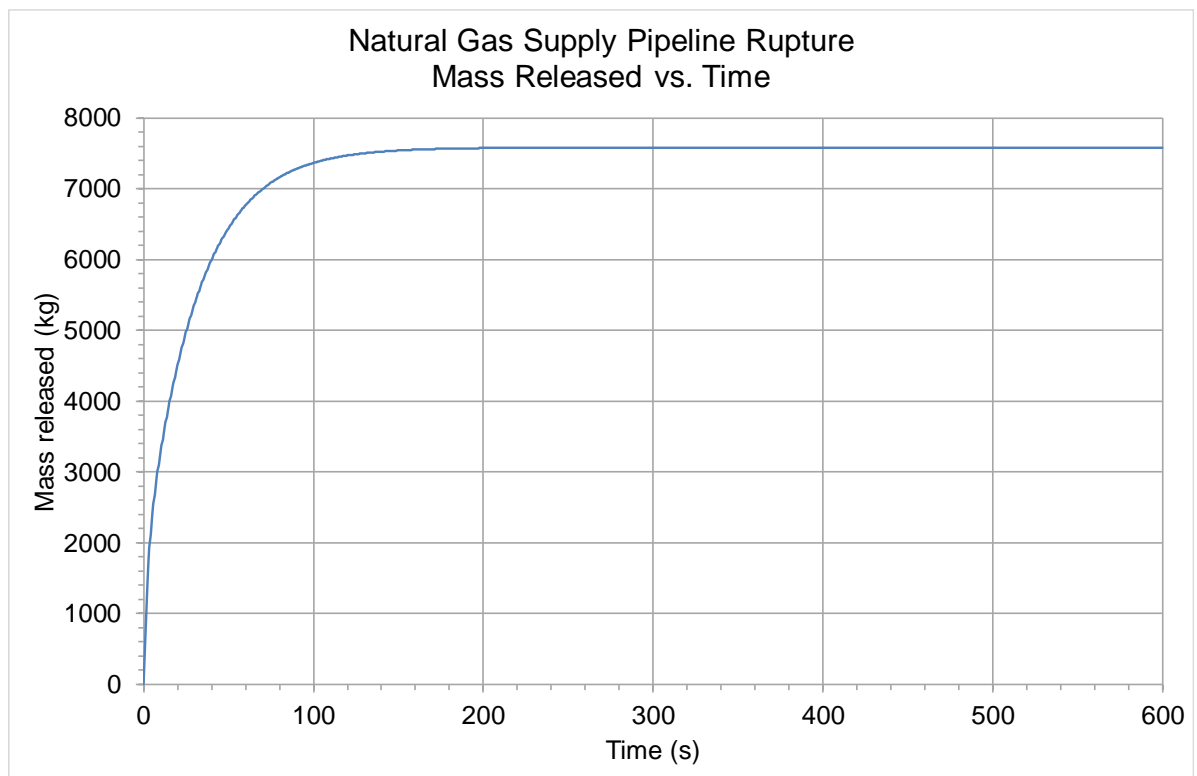
**Figure 11** High Pressure Natural Gas Supply Pipeline Rupture: Mass Released vs. Time

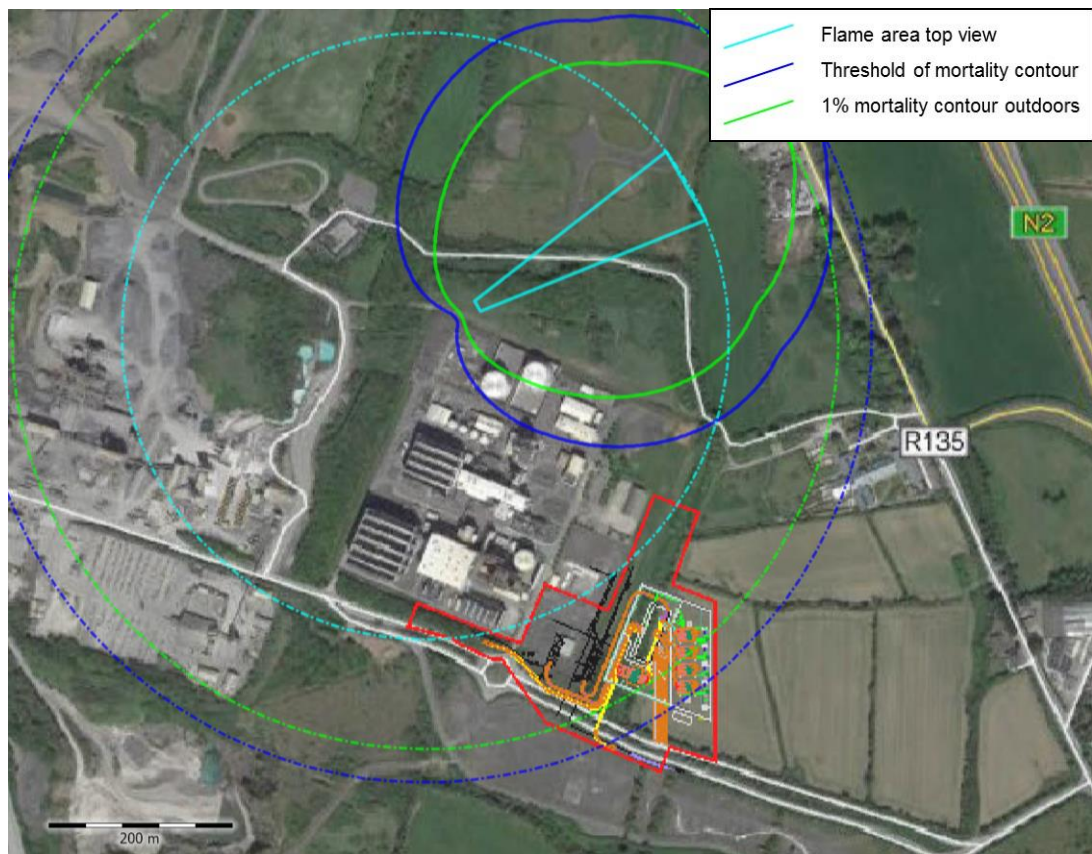
**Figure 16** Natural Gas Jet Fire at GNI AGI: Outdoor Mortality Contours

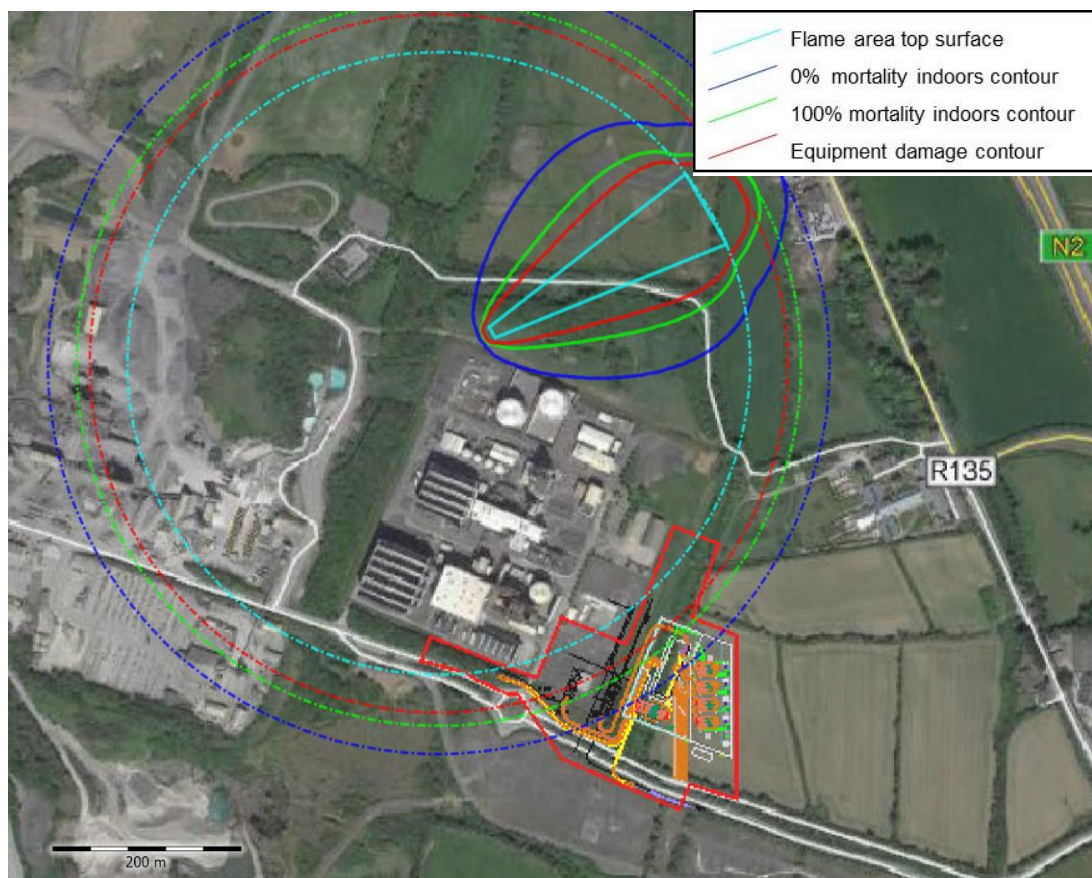
**Figure 17** Natural Gas Jet Fire at GNI AGI: Indoor Mortality and Equipment Damage Contours

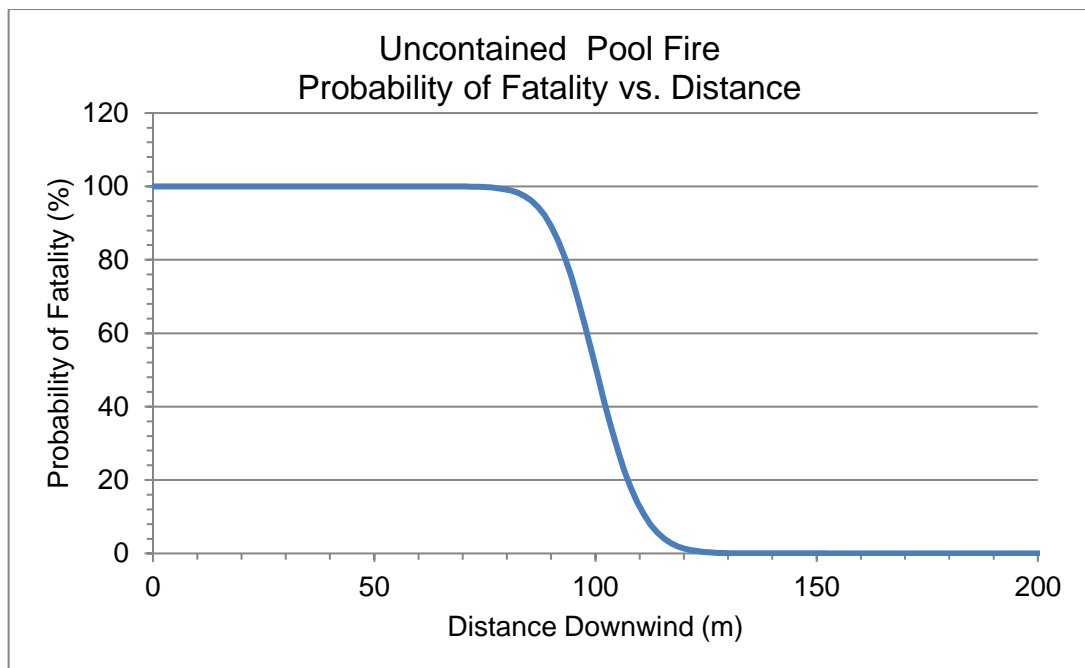
**Figure 21** Fuel Oil Uncontained Pool Fire: Probability of Fatality Outdoors vs Distance

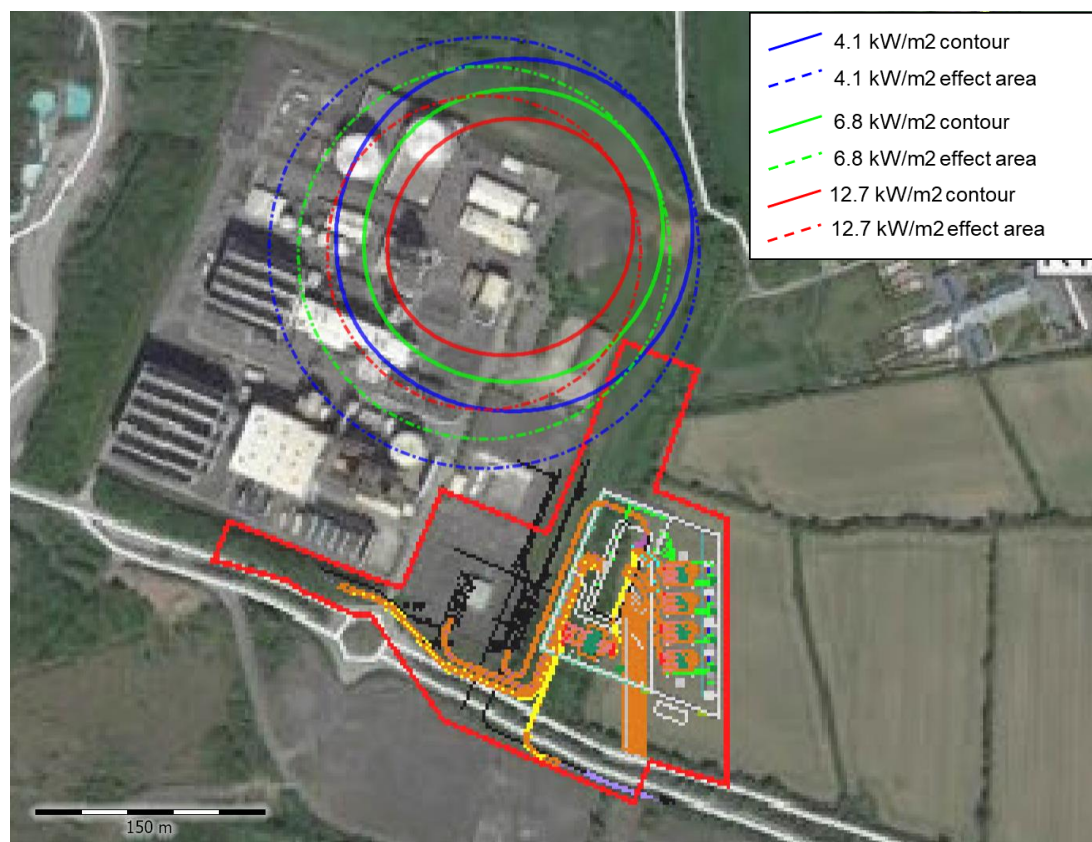
Thermal radiation contours and effect areas corresponding to the threshold of fatality ( $4.1 \text{ kW/m}^2$ ), 1% fatality ( $6.8 \text{ kW/m}^2$ ) and person protected indoors ( $12.7 \text{ kW/m}^2$ ) for an uncontained fuel oil pool fire are illustrated on Figure 22.

**Figure 22** Uncontained Pool Fire: Thermal radiation contours

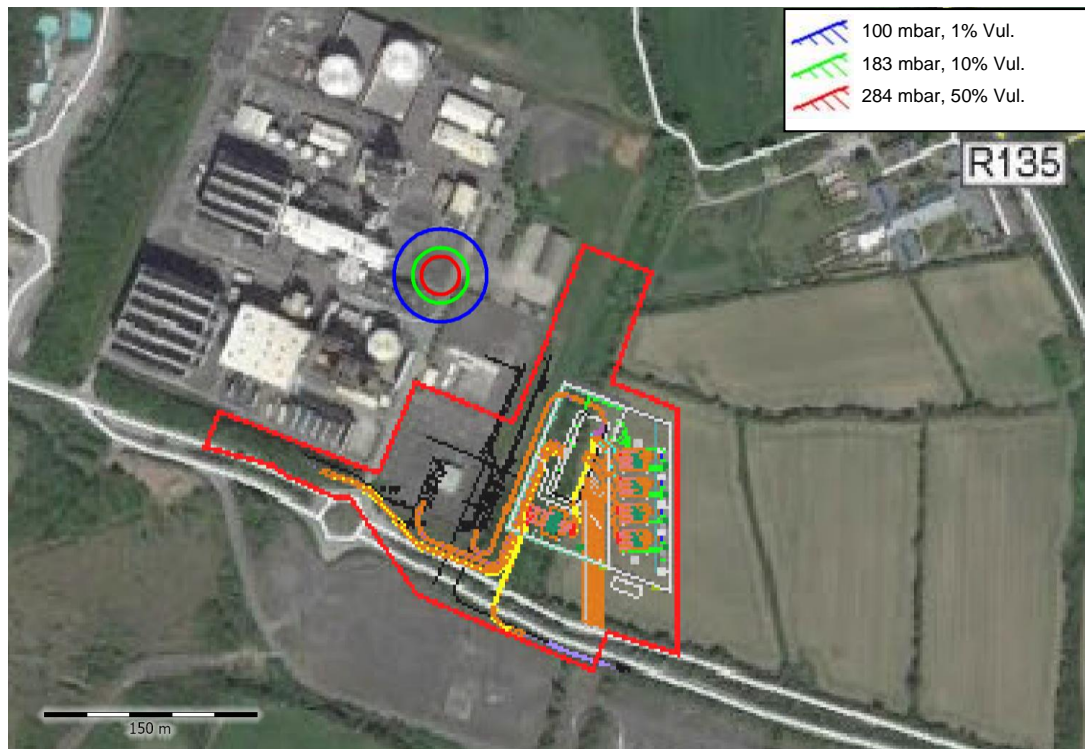
**Figure 26** LPG BLEVE: Indoor Mortality Contours (Category 2)

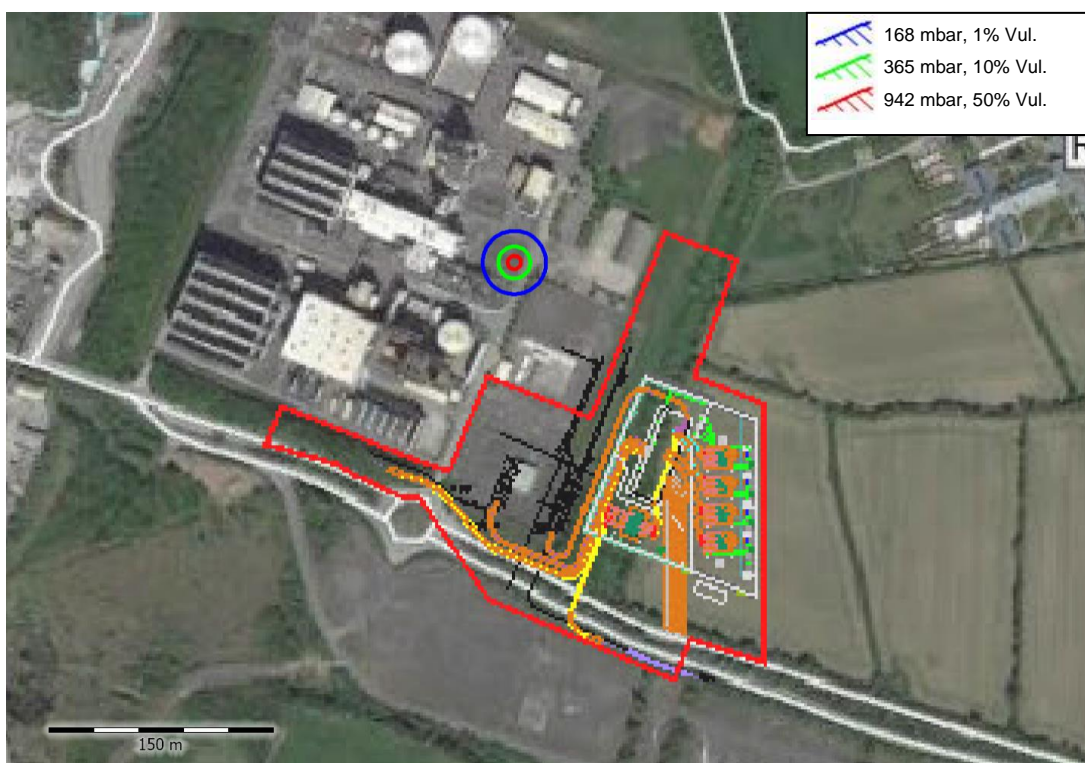
**Figure 27** LPG BLEVE: Outdoor Mortality Contours

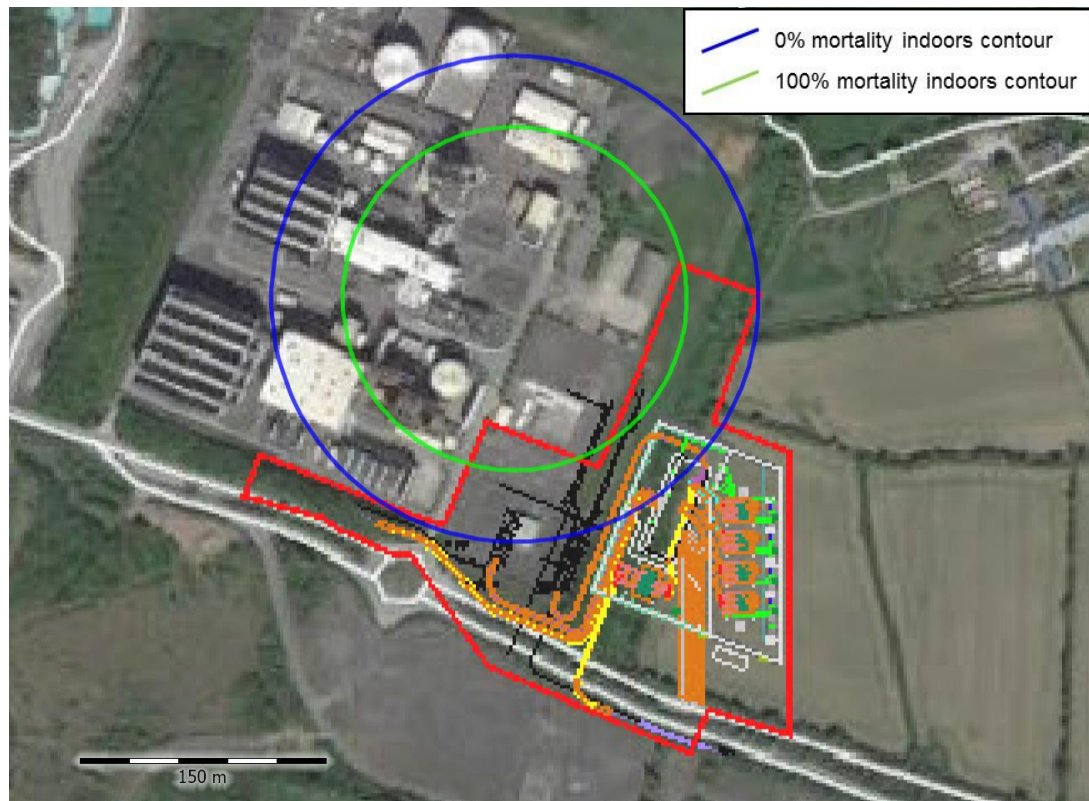
The thermal radiation levels corresponding to indoor mortality is illustrated on Figure 29.

**Figure 29** LPG Fireball: Indoor Mortality

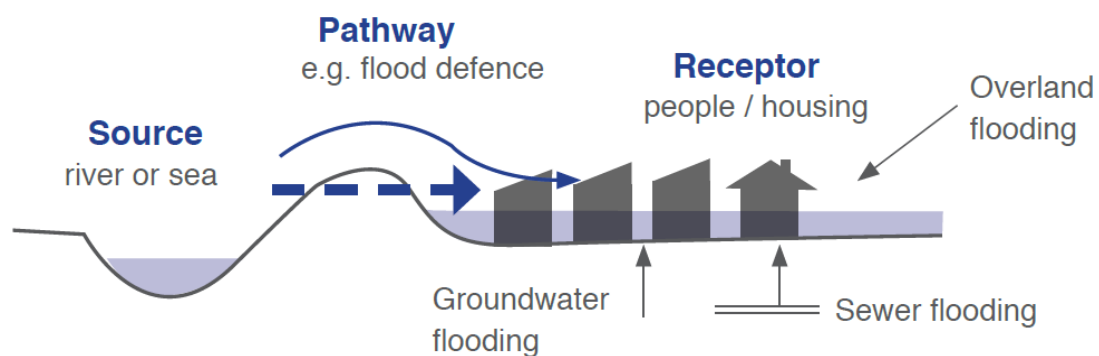
For carrying out a Site-specific Flood Risk Assessment (SSFRA), the OPW Guidelines recommend using Source-Path-Receptor (S-P-R) concept model to identify where the flood originates from, what is the floodwaters path and the areas in which assets and people might be affected by such flooding (section 2.18 of the OPW Guidelines, 2009). Figure 1.1 below shows a schematic representation of S-P-R model.

**Figure 1.1** Source-Pathway-Receptor Model (OPW, 2019)

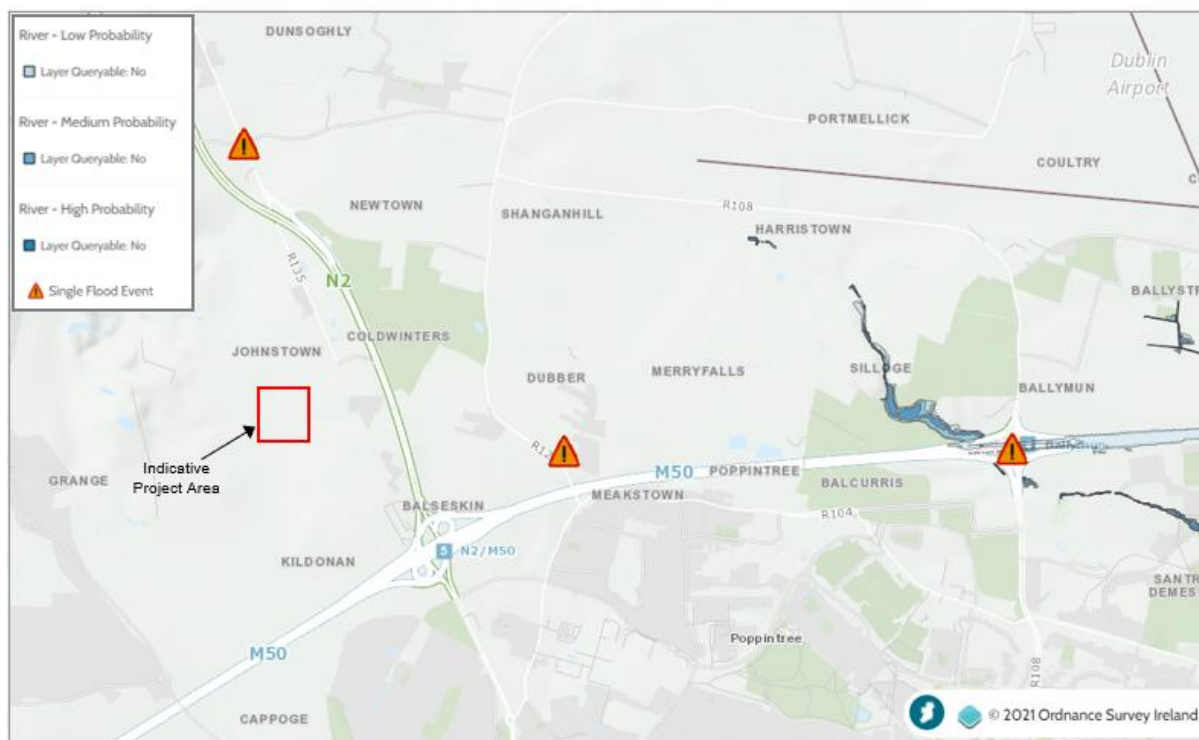
There is no history of flood on the site. The two closest historical events where at Kilshane Cross circa 1.3 km to the north (caused by overland flow from agricultural land) and at Dubber Cross circa 1.4 km to the east (caused by a ditch overflowing into a pumping station). Both of these events occurred in 2002.

Figure 4.1 Extract from OPW Flood Map for the Site Area (OPW, 2021)

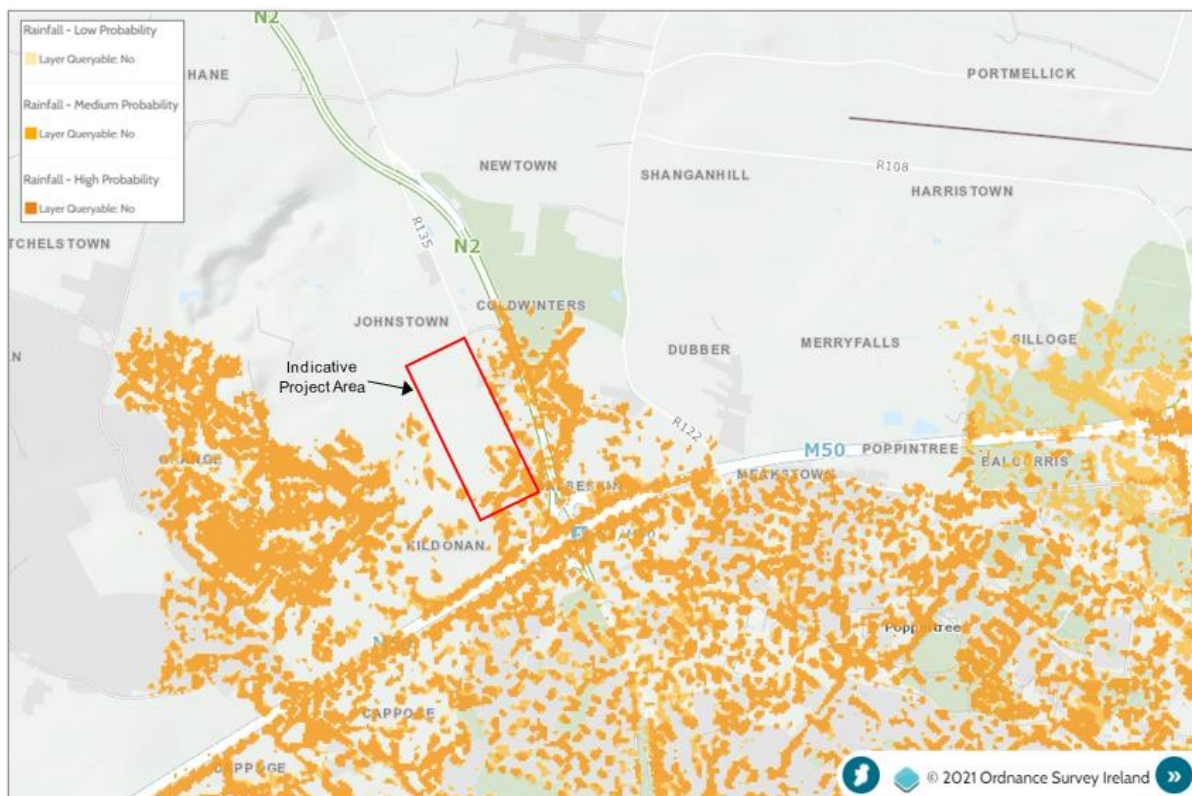
CFRAM Final Pluvial Flood Maps for the catchment were available as referred to in Figure 4.3 below. As it can be seen, punctual zones to the south of the subject area would be at risk of pluvial flooding. However, the area surrounding the site is not listed as one of the areas at risk from indicative pluvial flooding included in FCC’s SFRA.

**Figure 4.3** OPW CFRAM Pluvial Flood Risk Extent (site location shown)

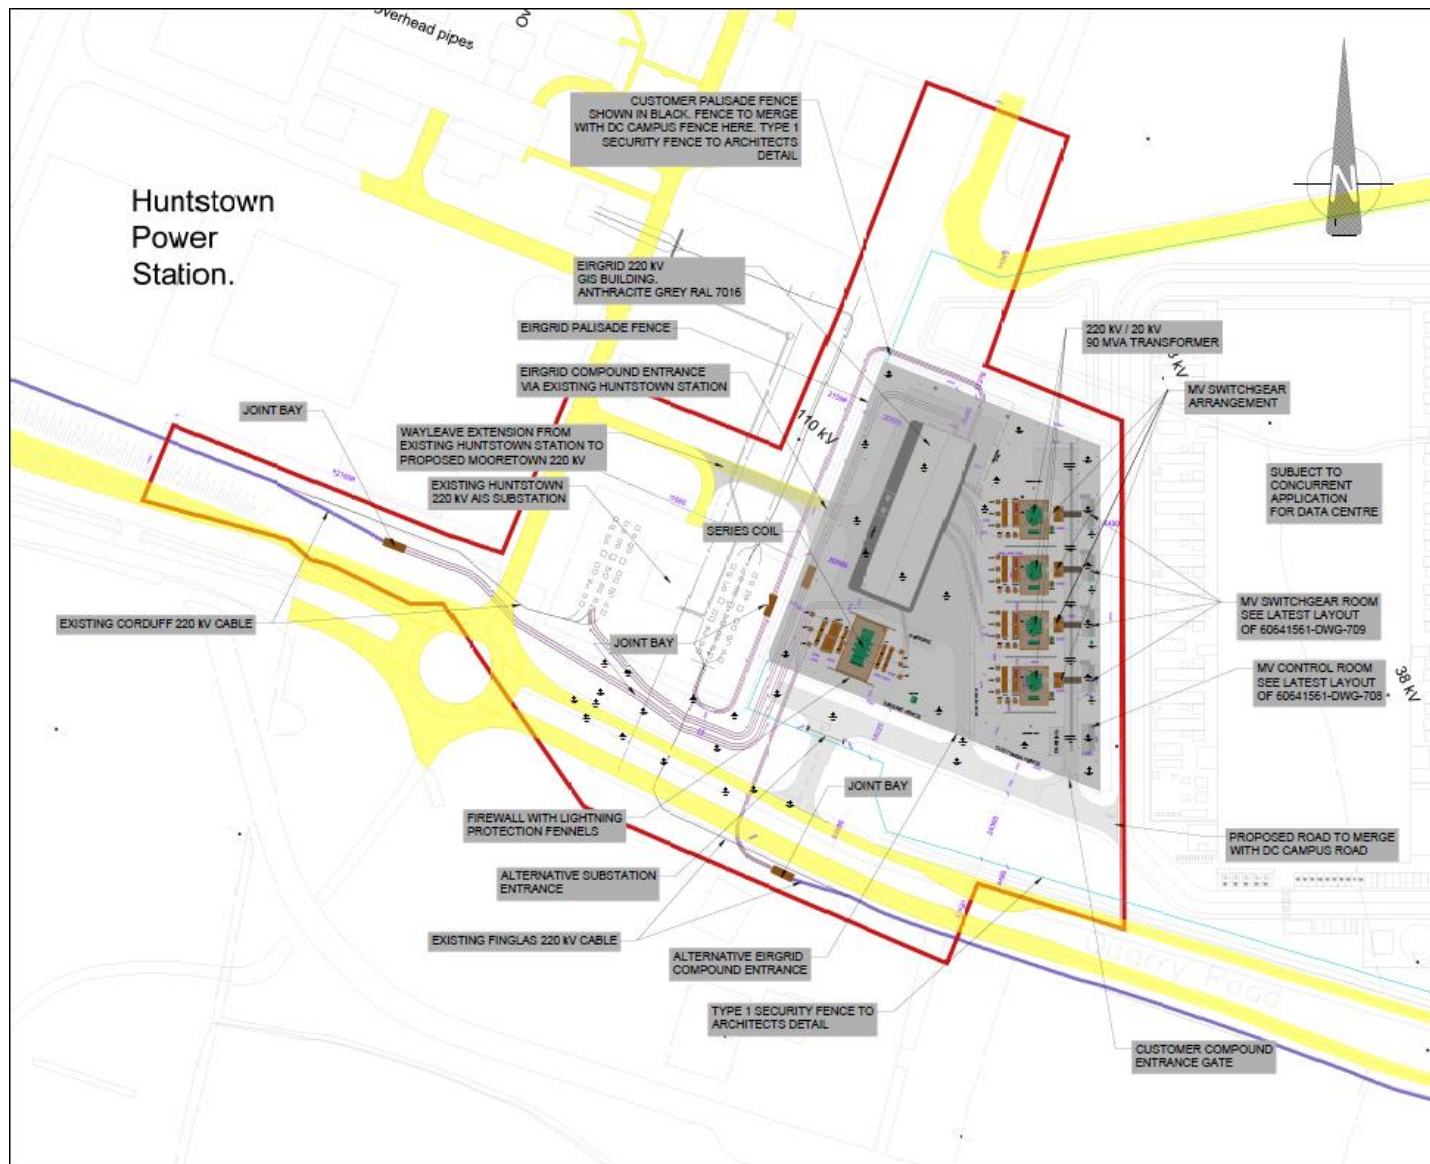
Figure 3. Plan of the Proposed Development.

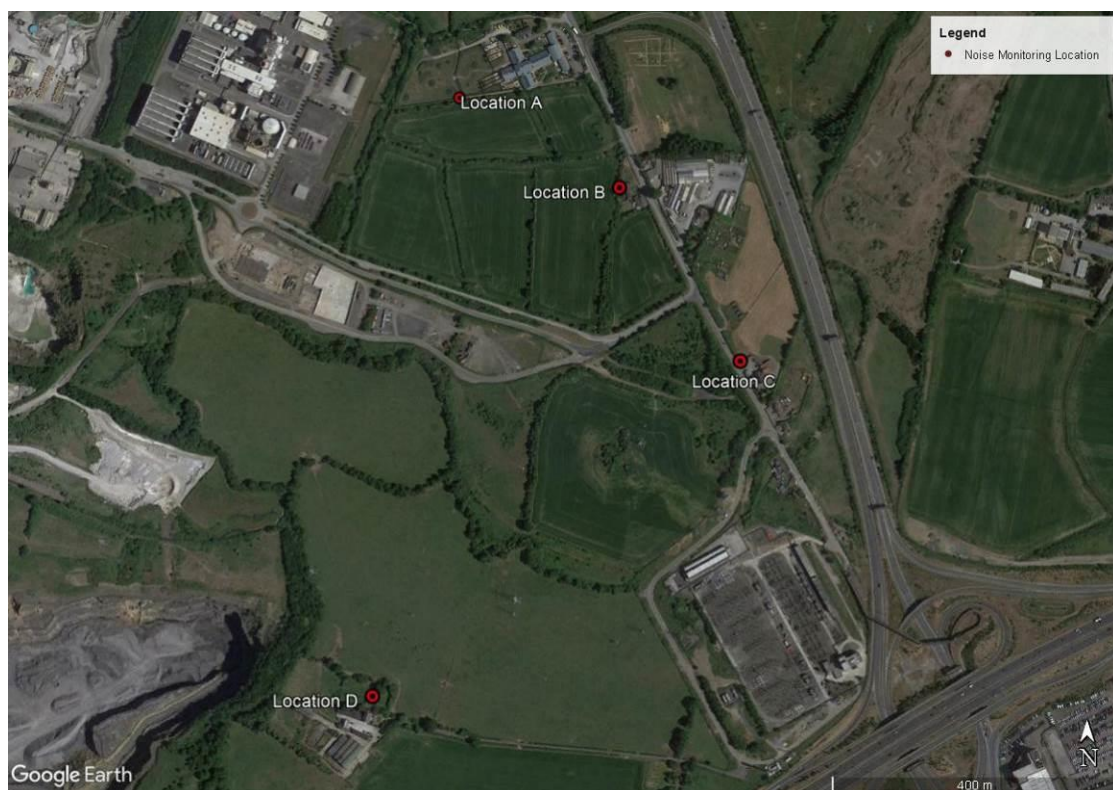
Measurements were conducted at the boundary location noted above. Sample periods for the noise measurements were typically 15 minutes. The results were noted onto a Survey Record Sheet immediately following each sample and were also saved to the instrument memory for later analysis if required. Survey personnel noted the primary noise sources contributing to noise build-up.

**Figure 10.2.1** Noise Survey Locations (Source: Google Maps)

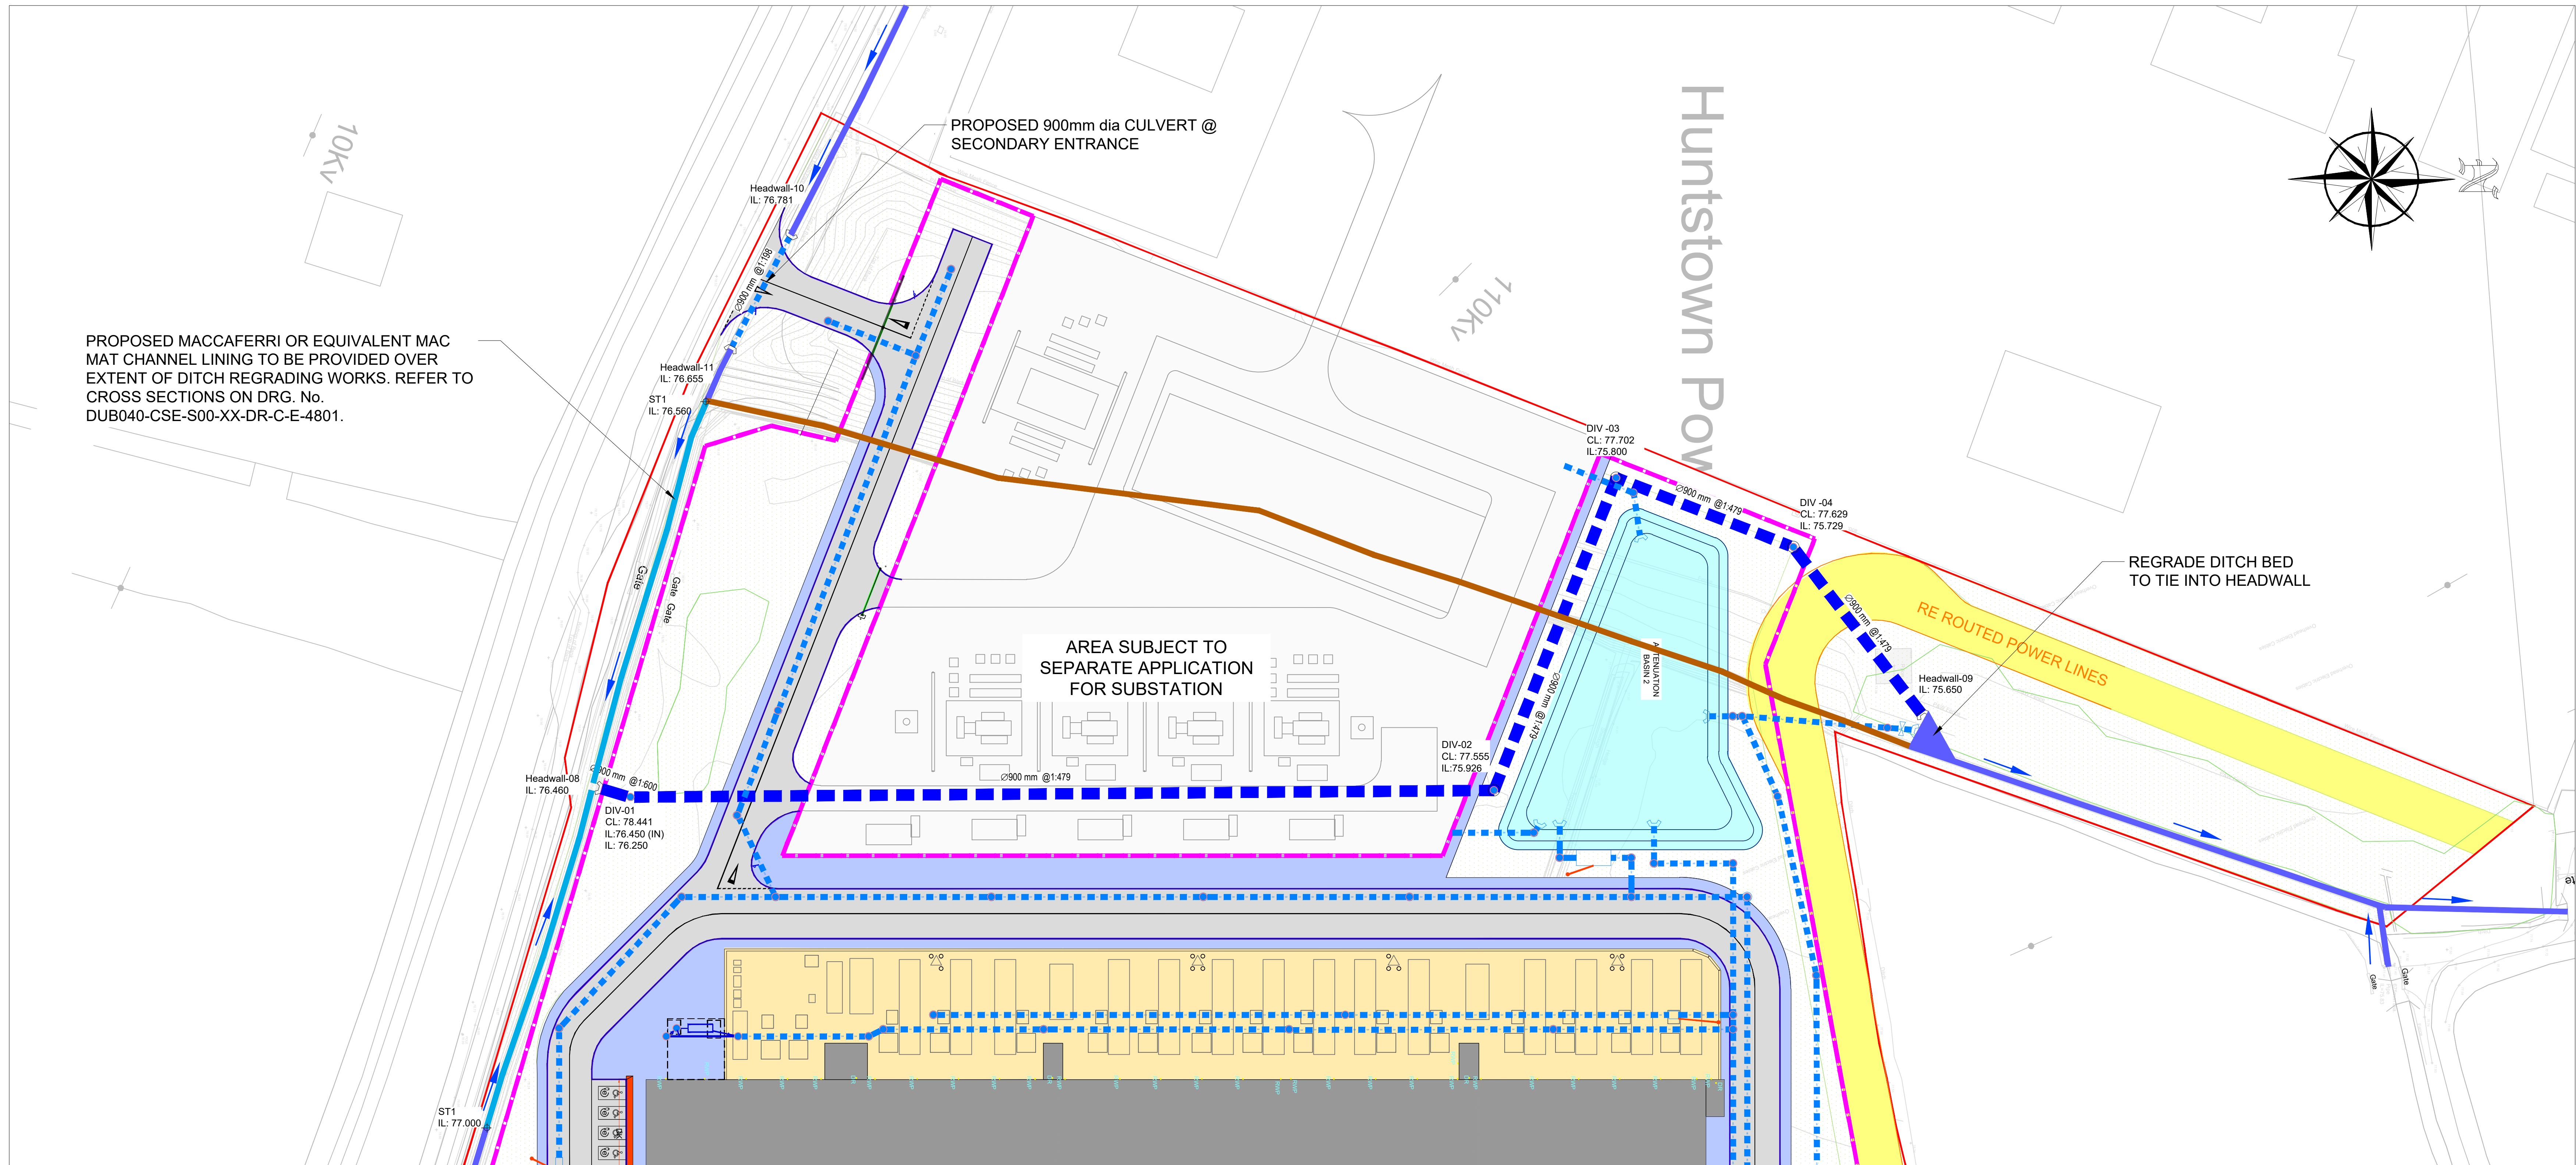
PROPOSED DITCH DIVERSION - LAYOUT PLAN  
Scale: 1:500

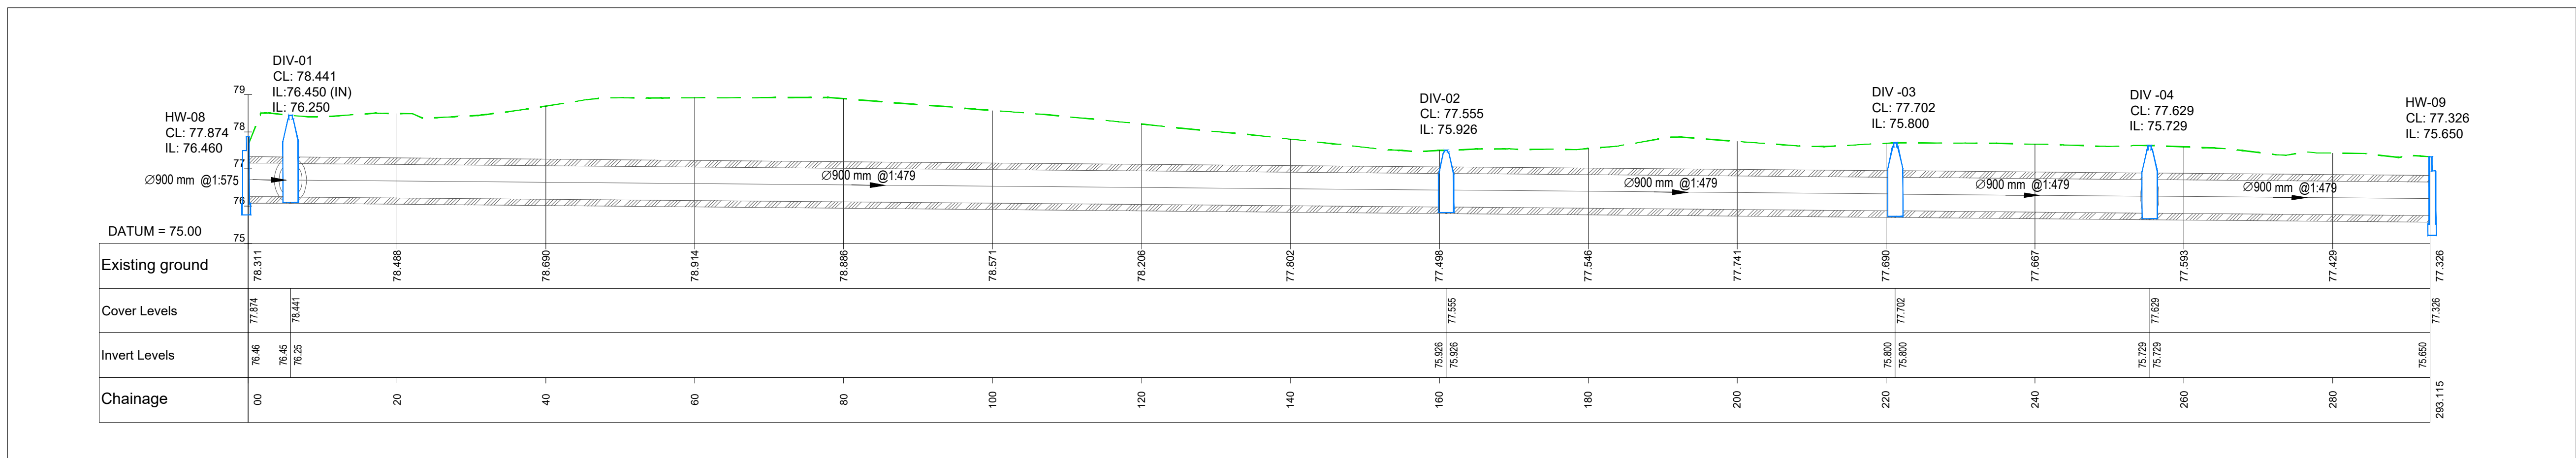
PROPOSED DITCH DIVERSION - PROFILE  
Scale: H 1:500, V 1:100

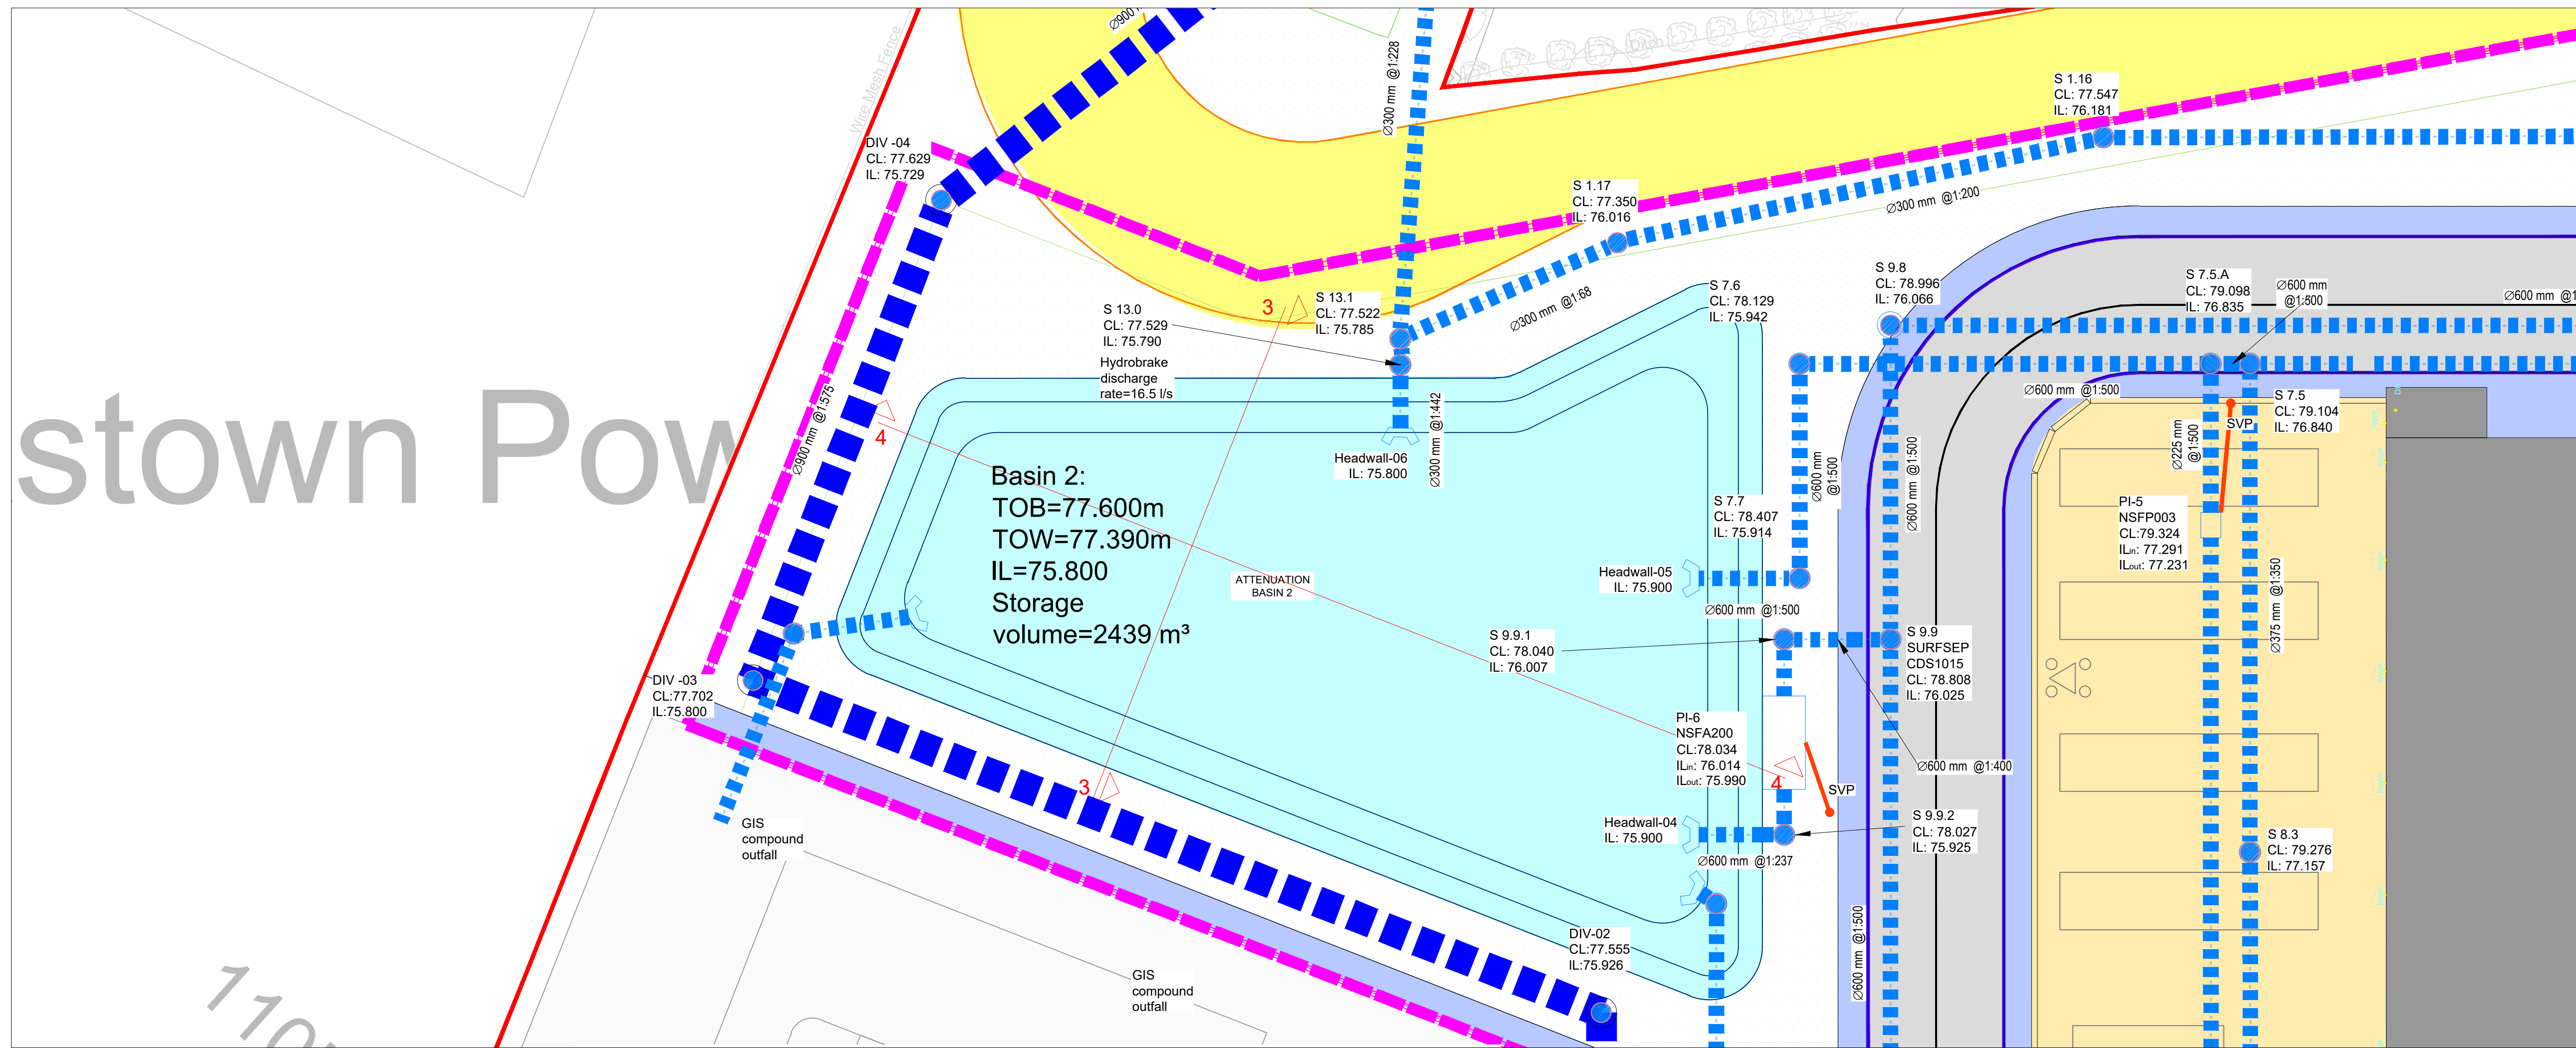
ATTENUATION BASIN 2 LAYOUT PLAN  
SCALE 1:250
