# Environmental Impact Assessment Report

## **Development of 220kV GIS 'Mooretown' Substation and Ancillary Structures**

## **Volume 3 – EIA Appendix**

**COMAH LAND USE  
PLANNING ASSESSMENT  
FOR PROPOSED  
SUBSTATION AND  
UNDERGROUND CABLE  
ROUTES, CO. DUBLIN**

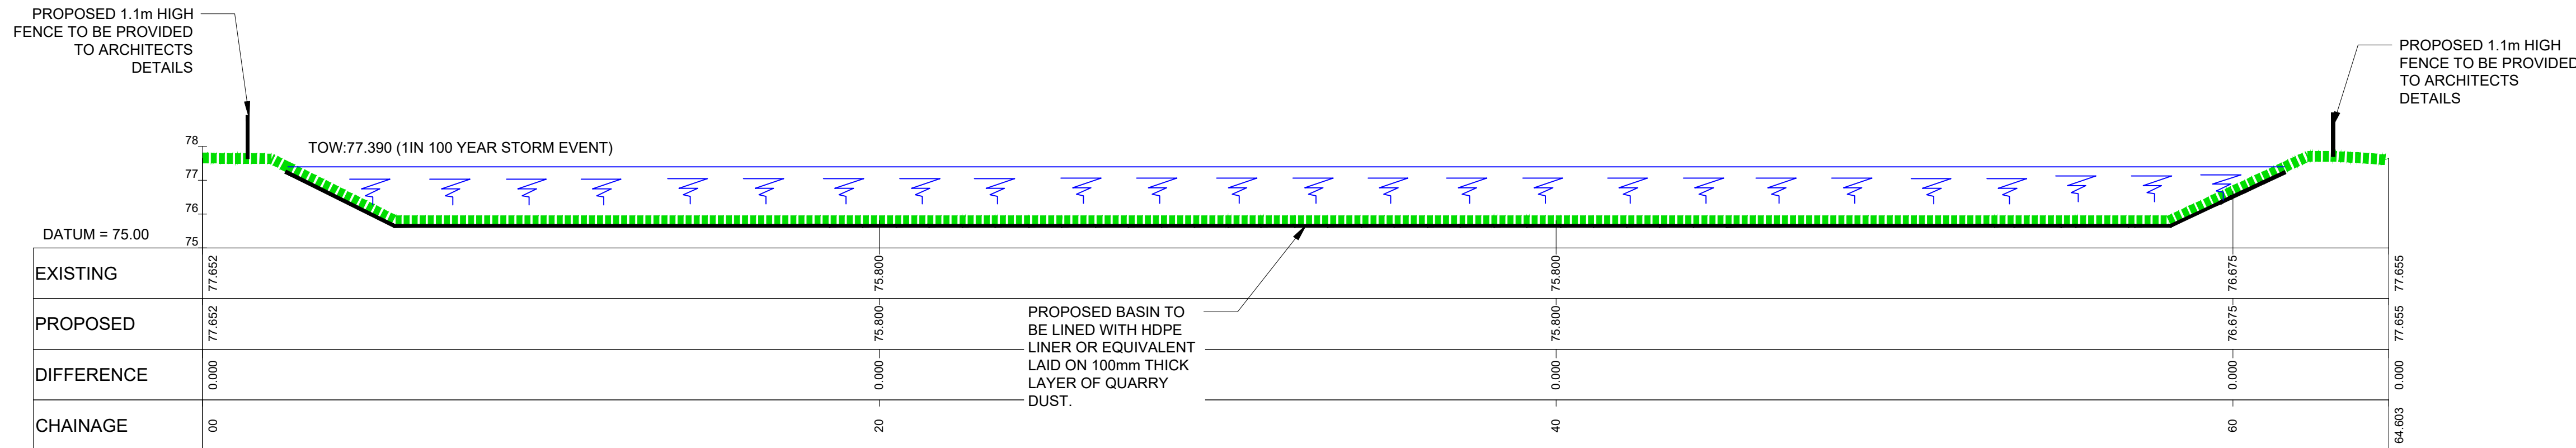
BASIN 2(3-3) - PROFILE  
SCALE: H 1:125,V 1:125

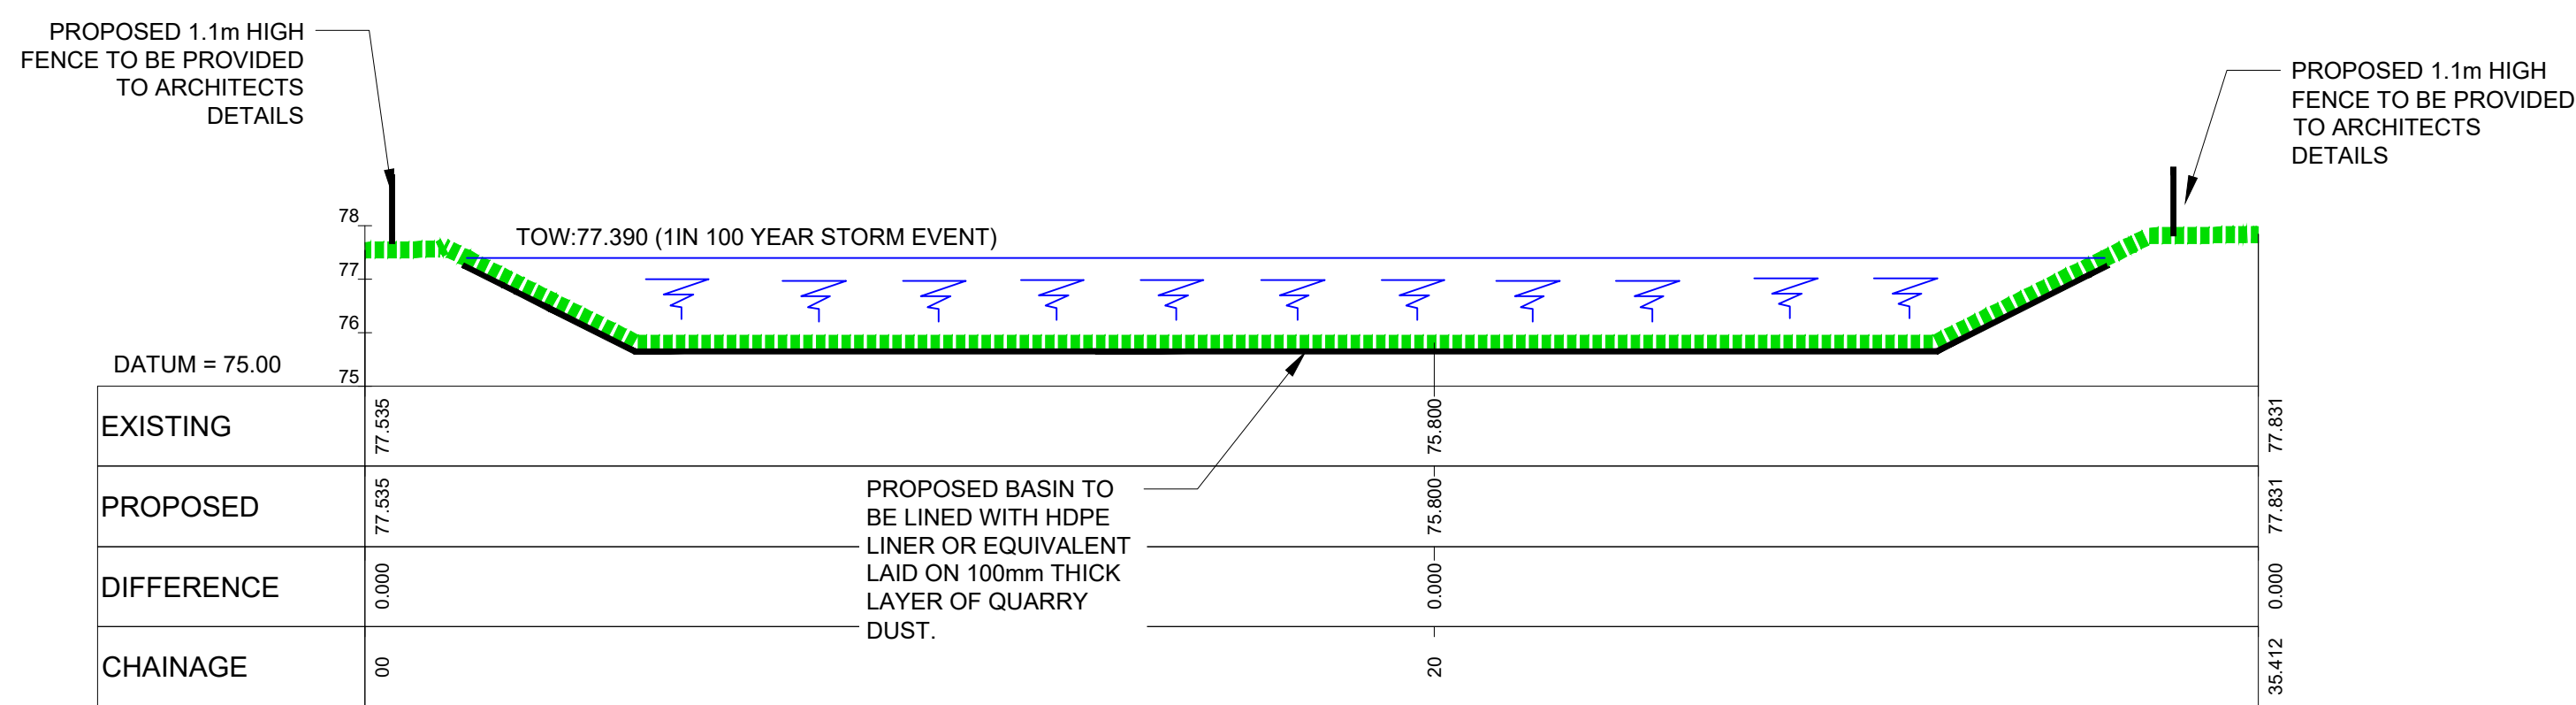
BASIN 2(4-4) - PROFILE  
SCALE: H 1:125,V 1:125
