BusConnects Infrastructure Dublin, Clongriffin to City Centre

Arboricultural Impact Assessment Report

National Transport Authority

January 2022

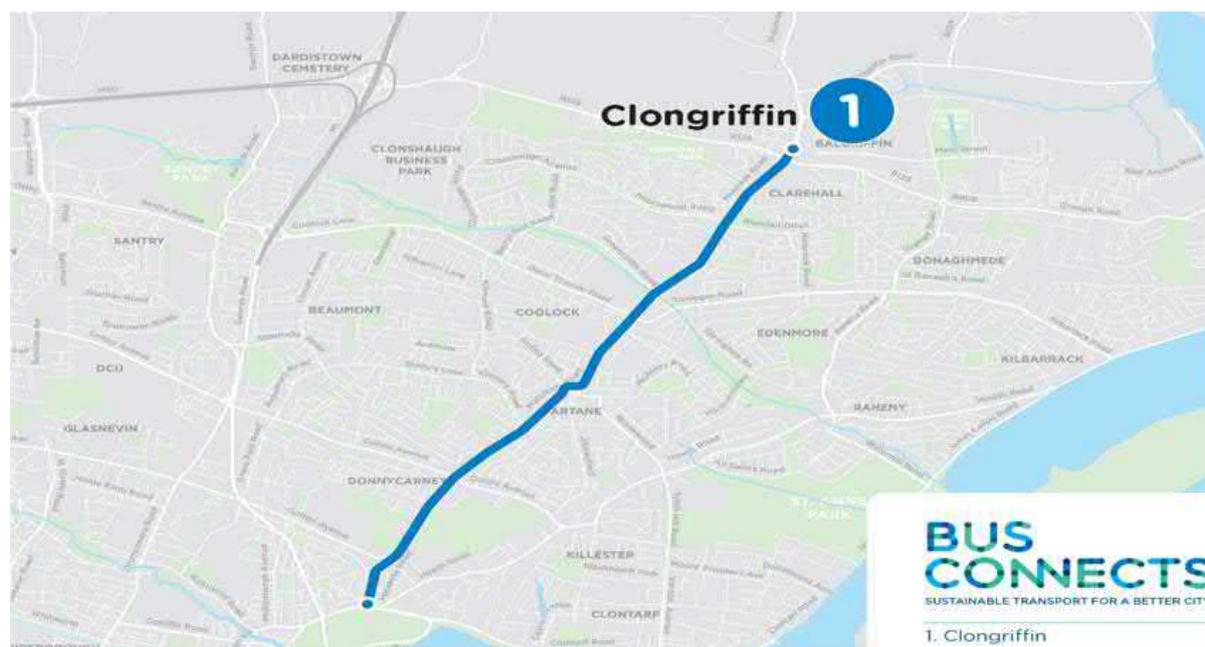
Figure 1 Clongriffin Overview Plan. BusConnects 2021.

The design has subsequently been amended to exclude the section between Clongriffin DART Station, along Clongriffin Main Street to Malahide Road (sheets 1 to 5 in figure 1 below).

The route extends through Balgriffin, Clarehall, Coolock, Artane and Donnycarney passing through a number of industrial and commercial zones but also residential areas both directly on the route and beyond.

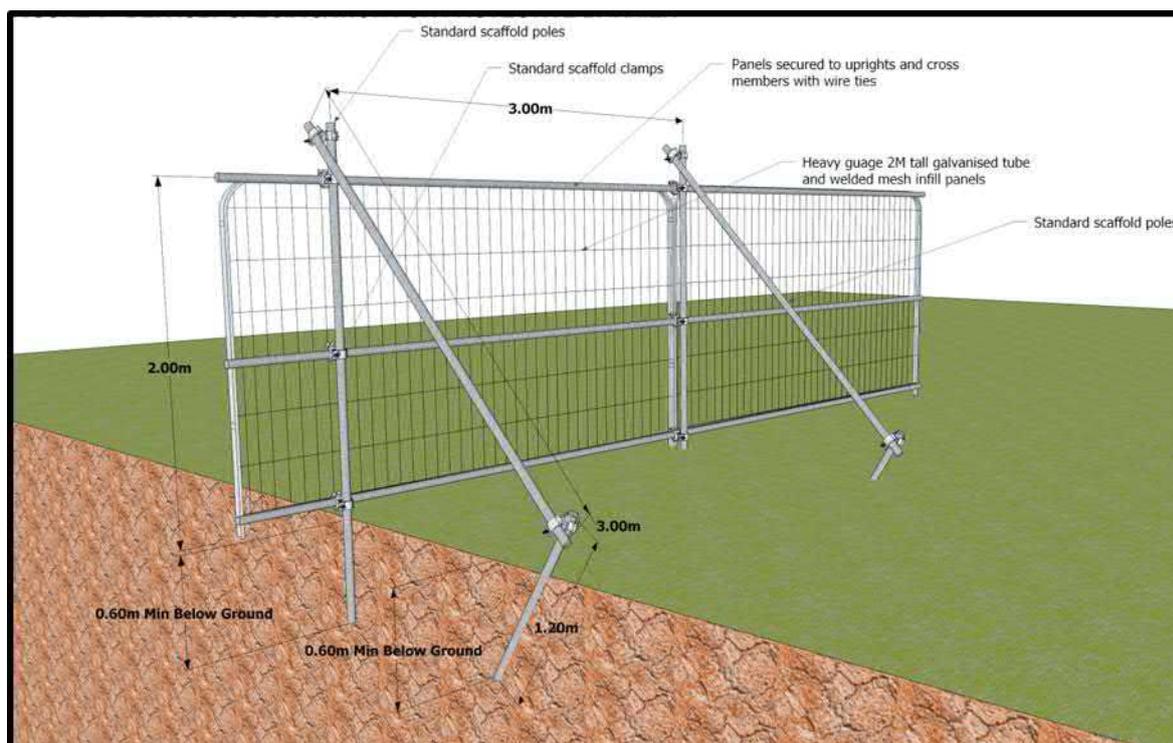
Figure 2: Default specification for tree protection barrier in accordance with BS5837:2012 figure 2.

Fencing shall be constructed with robust vertical and horizontal scaffold framework with weldmesh panels firmly attached in accordance with BS 5837:2012 Figure 2. Vertical support poles and bracing poles must be located with care to avoid underground utility services and will be sited to avoid the structural roots of retained trees. Where driven supports are not feasible due to the presence of roots or underground utilities block trays, counterweights or equivalent can be utilised.

Alternative equivalent robust and immovable fencing specification including site hoarding will also be appropriate.
