# Mixed Use Development at Chadwicks, Santry Avenue, Dublin 9

Foundation Appraisal

200060-X-10-Z-F01-RP-DBFL-SE-0001

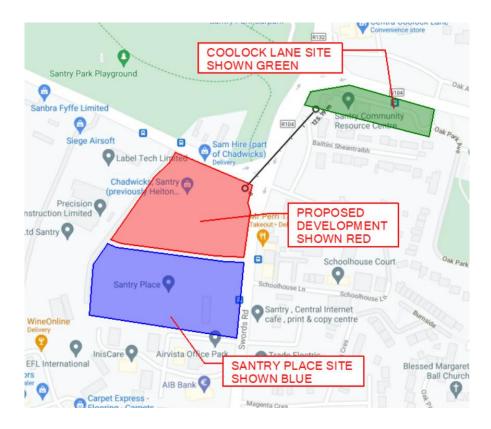
Figure 2.1 Location of Ground Investigations

No ground investigations have been carried out on the proposed site at the time of writing this report. However, the proposed development is located between the sites, where these investigations were carried out, as shown in figure 2.1 below. Due to the uniformity of ground conditions described in the 2 No. reports, it is envisaged that the ground conditions on the proposed site will be consistent with Santry Place and Coolock Lane. However, it is recommended that extensive ground investigations are carried out to confirm the ground conditions prior to carrying out any detailed design. This ground investigation should include a combination of trial pits, boreholes, and dynamic probes.

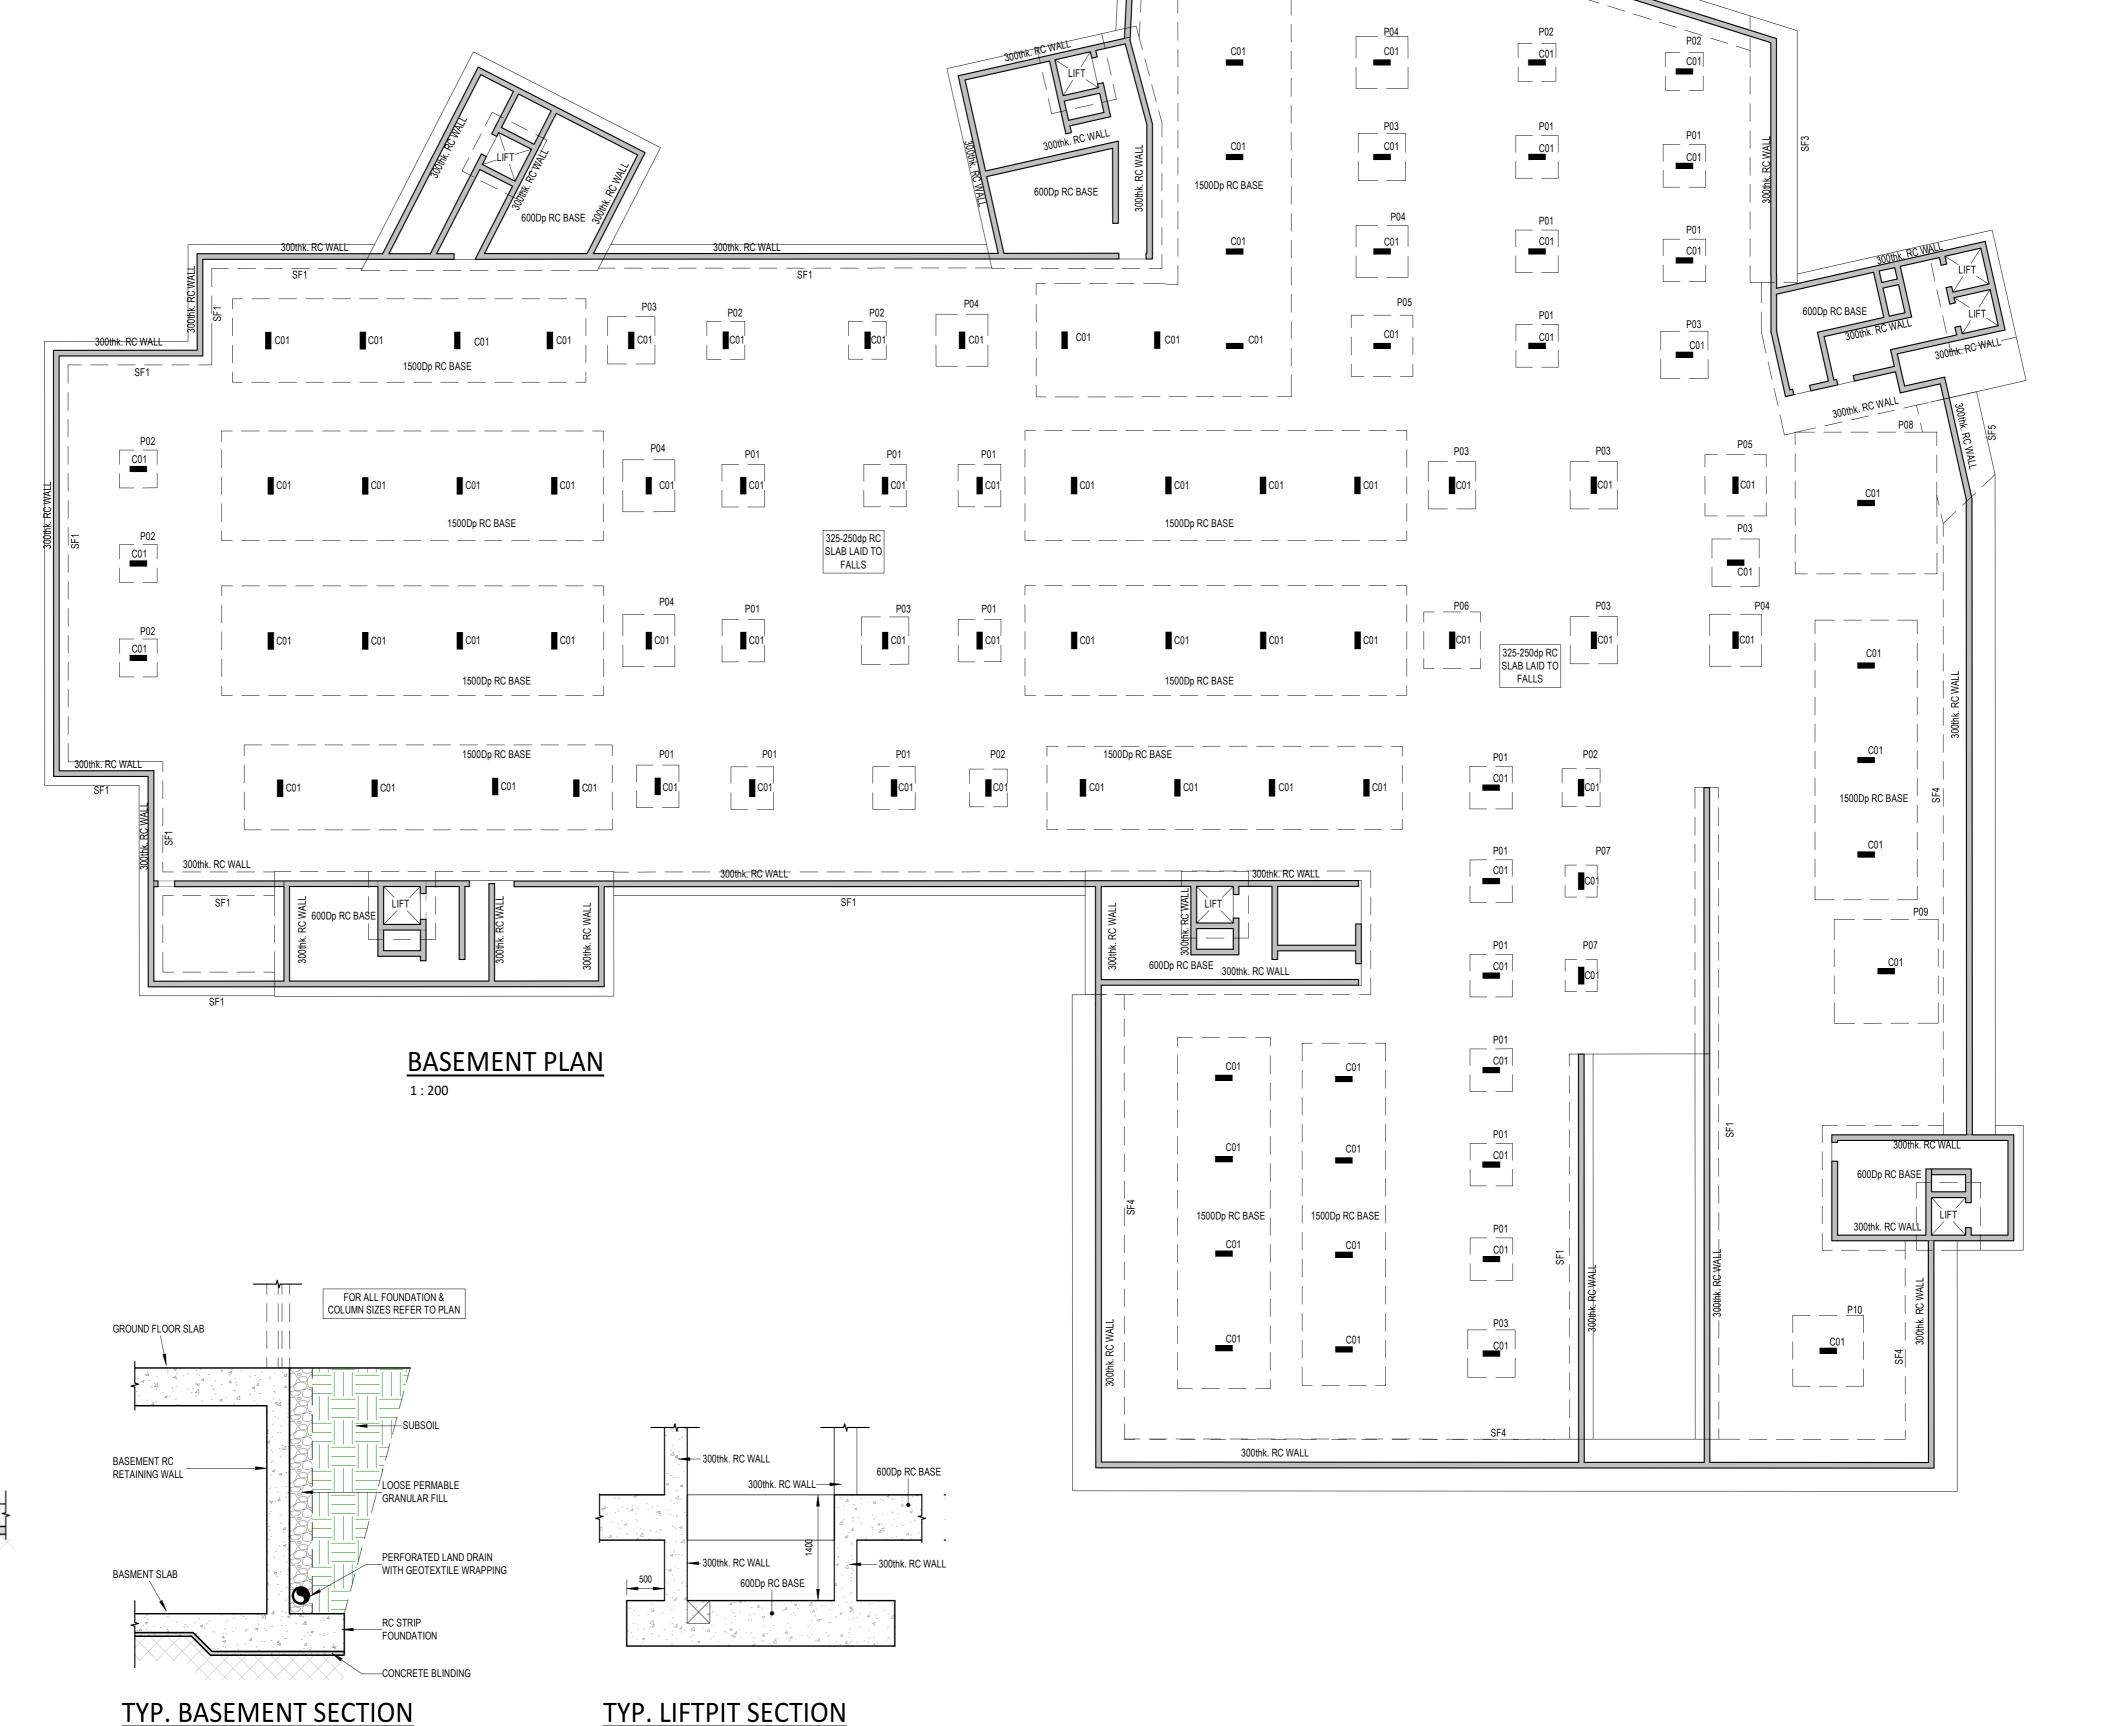
AS SHOWN drawing no. 200060-X-10-Z-B01-DR-DBFL-SE-1001

SIZING/POSITIONING OF STRUCTURAL ELEMENT SHOWN, INCLUDING FOUNDATIONS, ARE PRELIMINARY ONLY AND ARE SUBJECT TO CHANGE BASED ON FURTHER GEOTECHNICAL IN-SITU TESTING AND AT DETAILED DESIGN PHASE

This report is intended to accompany the DBFL structural layouts of basement and ground floor level of the proposed mixed-use development on the Swords Road, Santry. These drawings are presented in appendix A of this report. The choice of conventional strip footings and pad foundations is presented and the reason for the selection of this foundation configuration.

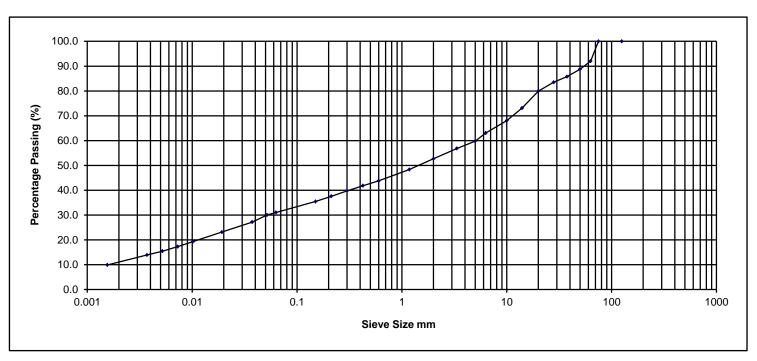
# **Determination of Particle Size Distribution**

Clay	Fine Medium Coars	Fine Medium Coarse	Fine Medium Coarse	Cobbles	Boulder
	Silt	Sand	Gravel		
9.9	21.1	21.7	39.3	8.0	0.0

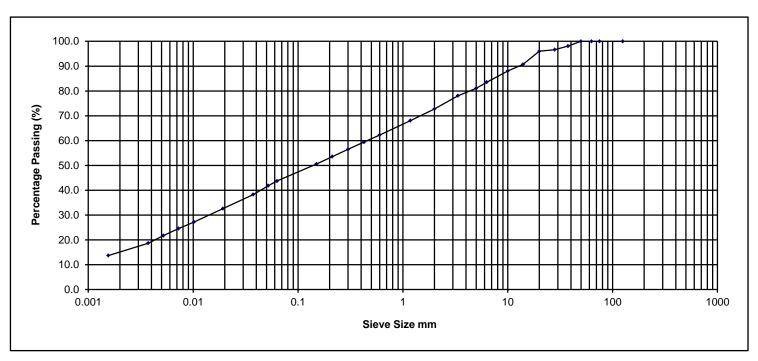
# **Determination of Particle Size Distribution**

Clay	Fine	Medium Coarse	Fine Medium	Coarse	Fine	Medium Coarse	Cobbles	Boulder	
			Silt	Sand			Gravel			
l	13.7		30.0	29.1			27.2	0.0	0.0

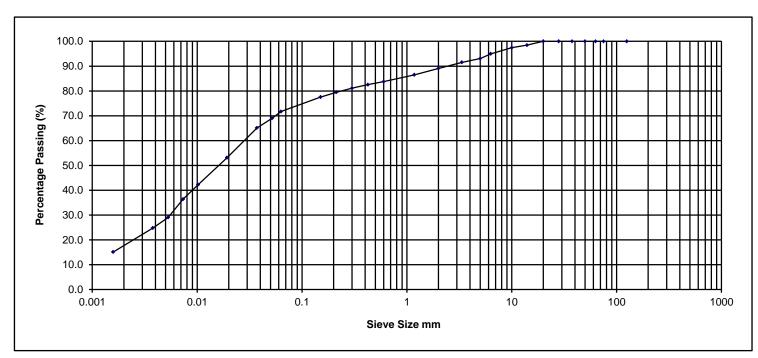
# **Determination of Particle Size Distribution**

C	Clay	Fine	Medium Coarse	Fine Medium Coar	se	Fine	Medium Coarse	Cobbles	Boulder
			Silt	Sand			Gravel		
1	5.1		56.6	17.4			10.9	0.0	0.0

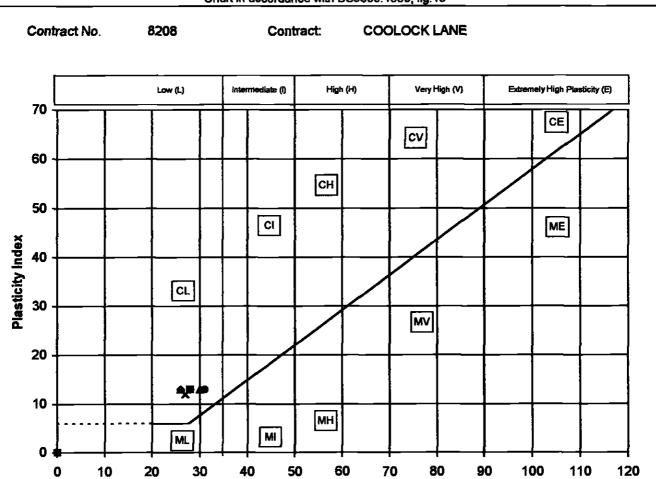
#### Plasticity Chart - Summary of Liquid & Plastic Limit Tests BS1377:Part 2:1990, clauses 3.2, 4 & 5 Chart in accordance with BS5930:1999, fig.18

Code	вн/тр	Sample	Depth (m)	MC%	LL%	PL%	P1%	%<425µm	Description
Δ	BH 1	3697	2.00	6.2	30	17	13	63.4	Grey brown alightly sandy stightly gravelly CLAY
	BH 2	3604	2.80	7.9	28	15	13	56.4	Dark grey elightly sandy slightly gravelly CLAY
•	BH 3	3683	1.00	13.2	31	18	13	62	Grey brown slightly sandy slightly gravelly CLAY
•	BH 4	3690	2.00	9.3	26	13	13	59.1	Dark grey slightly sandy slightly gravelly CLAY
×	BH 4	3692	2.90	11.4	27	15	12	58.5	Grey brown slightly sandy slightly gravelly CLAY
+	BH 5	3671	2.00	12.3	28	15	13	61	Gney brown slightly sandy slightly gravelly CLAY
Δ	BH 5	3673	4.00	12.7	26	13	13	60.1	Dark grey slightly sandy slightly gravelly CLAY
							_		
0									
<b>\rightarrow</b>									
lack									
•									
•									
×									
+						Ī			
Δ							_
