**Appendix D**  
Arboricultural Impact  
Assessment Report

# **TREE SURVEY AND REPORT**

**BUSCONNECTS CORE BUS CORRIDOR – LIFFEY VALLEY TO CITY CENTRE**

September 2020

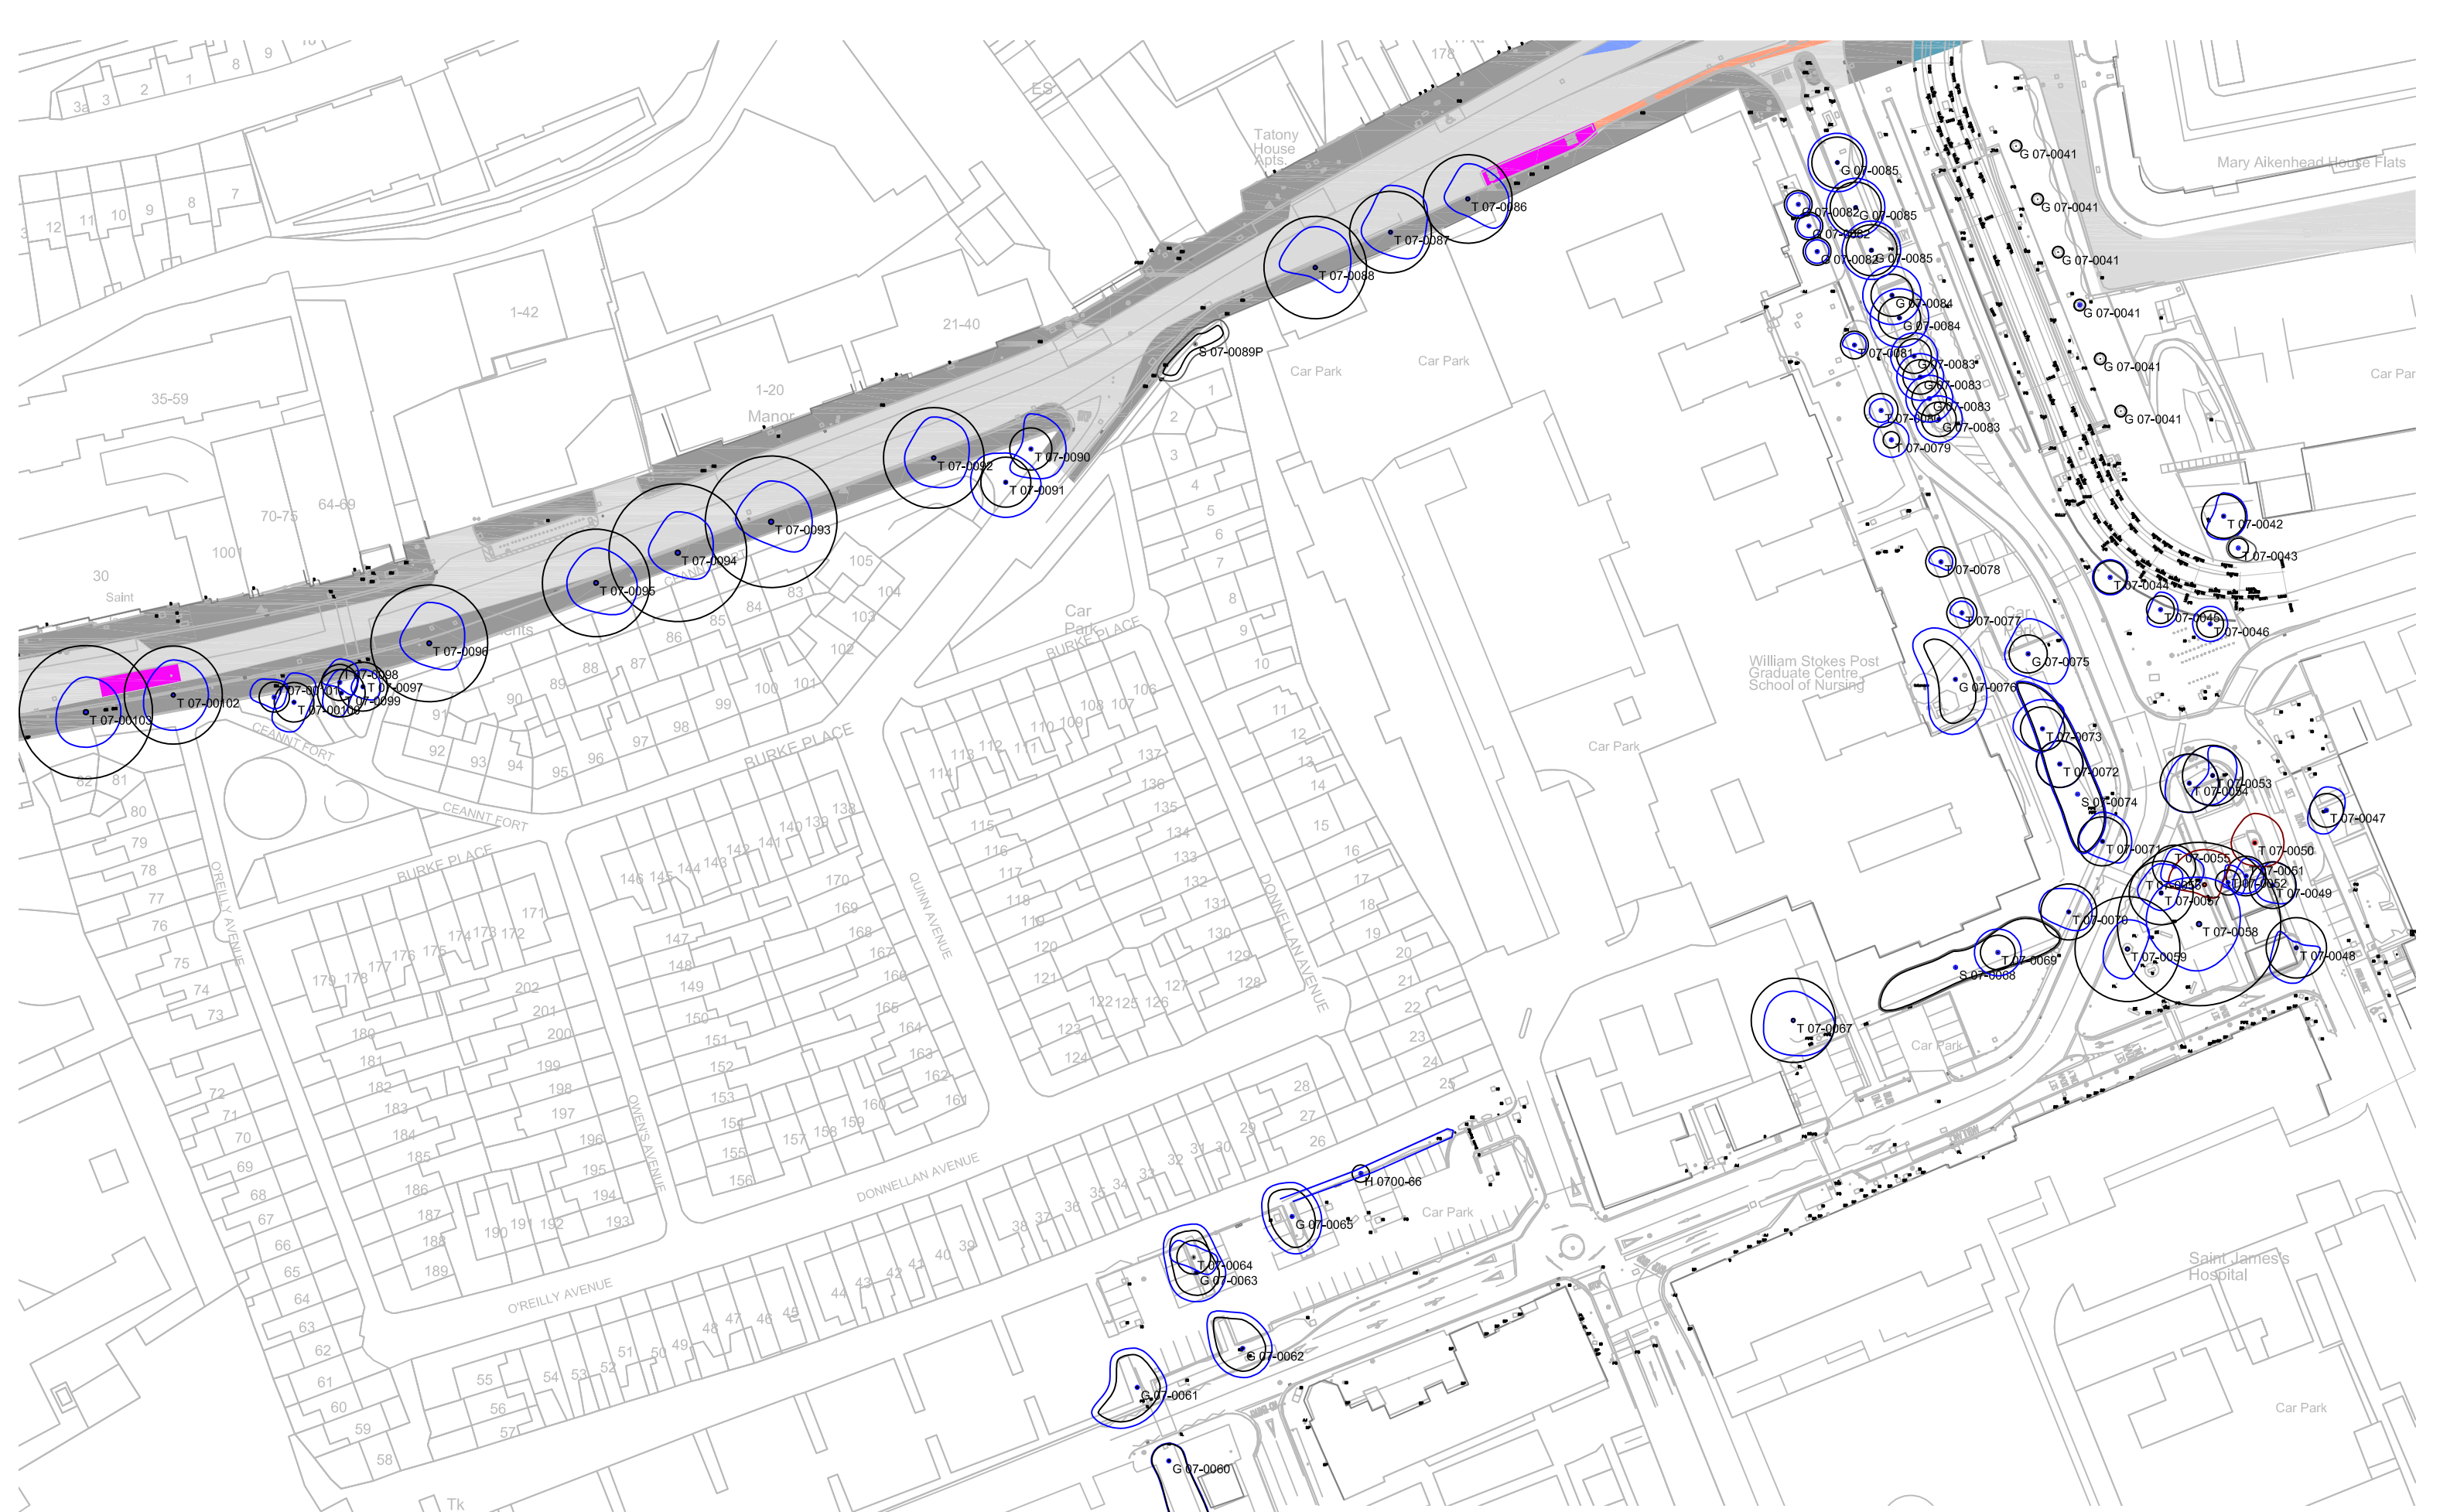
Area of Tree Protection Zone (if described as a perfect circle)
	Title: <b>TREE CONSTRAINTS PLAN</b> Plan indicating position, actual crown spread of trees and notional tree protection zones (based on a map produced by the client)

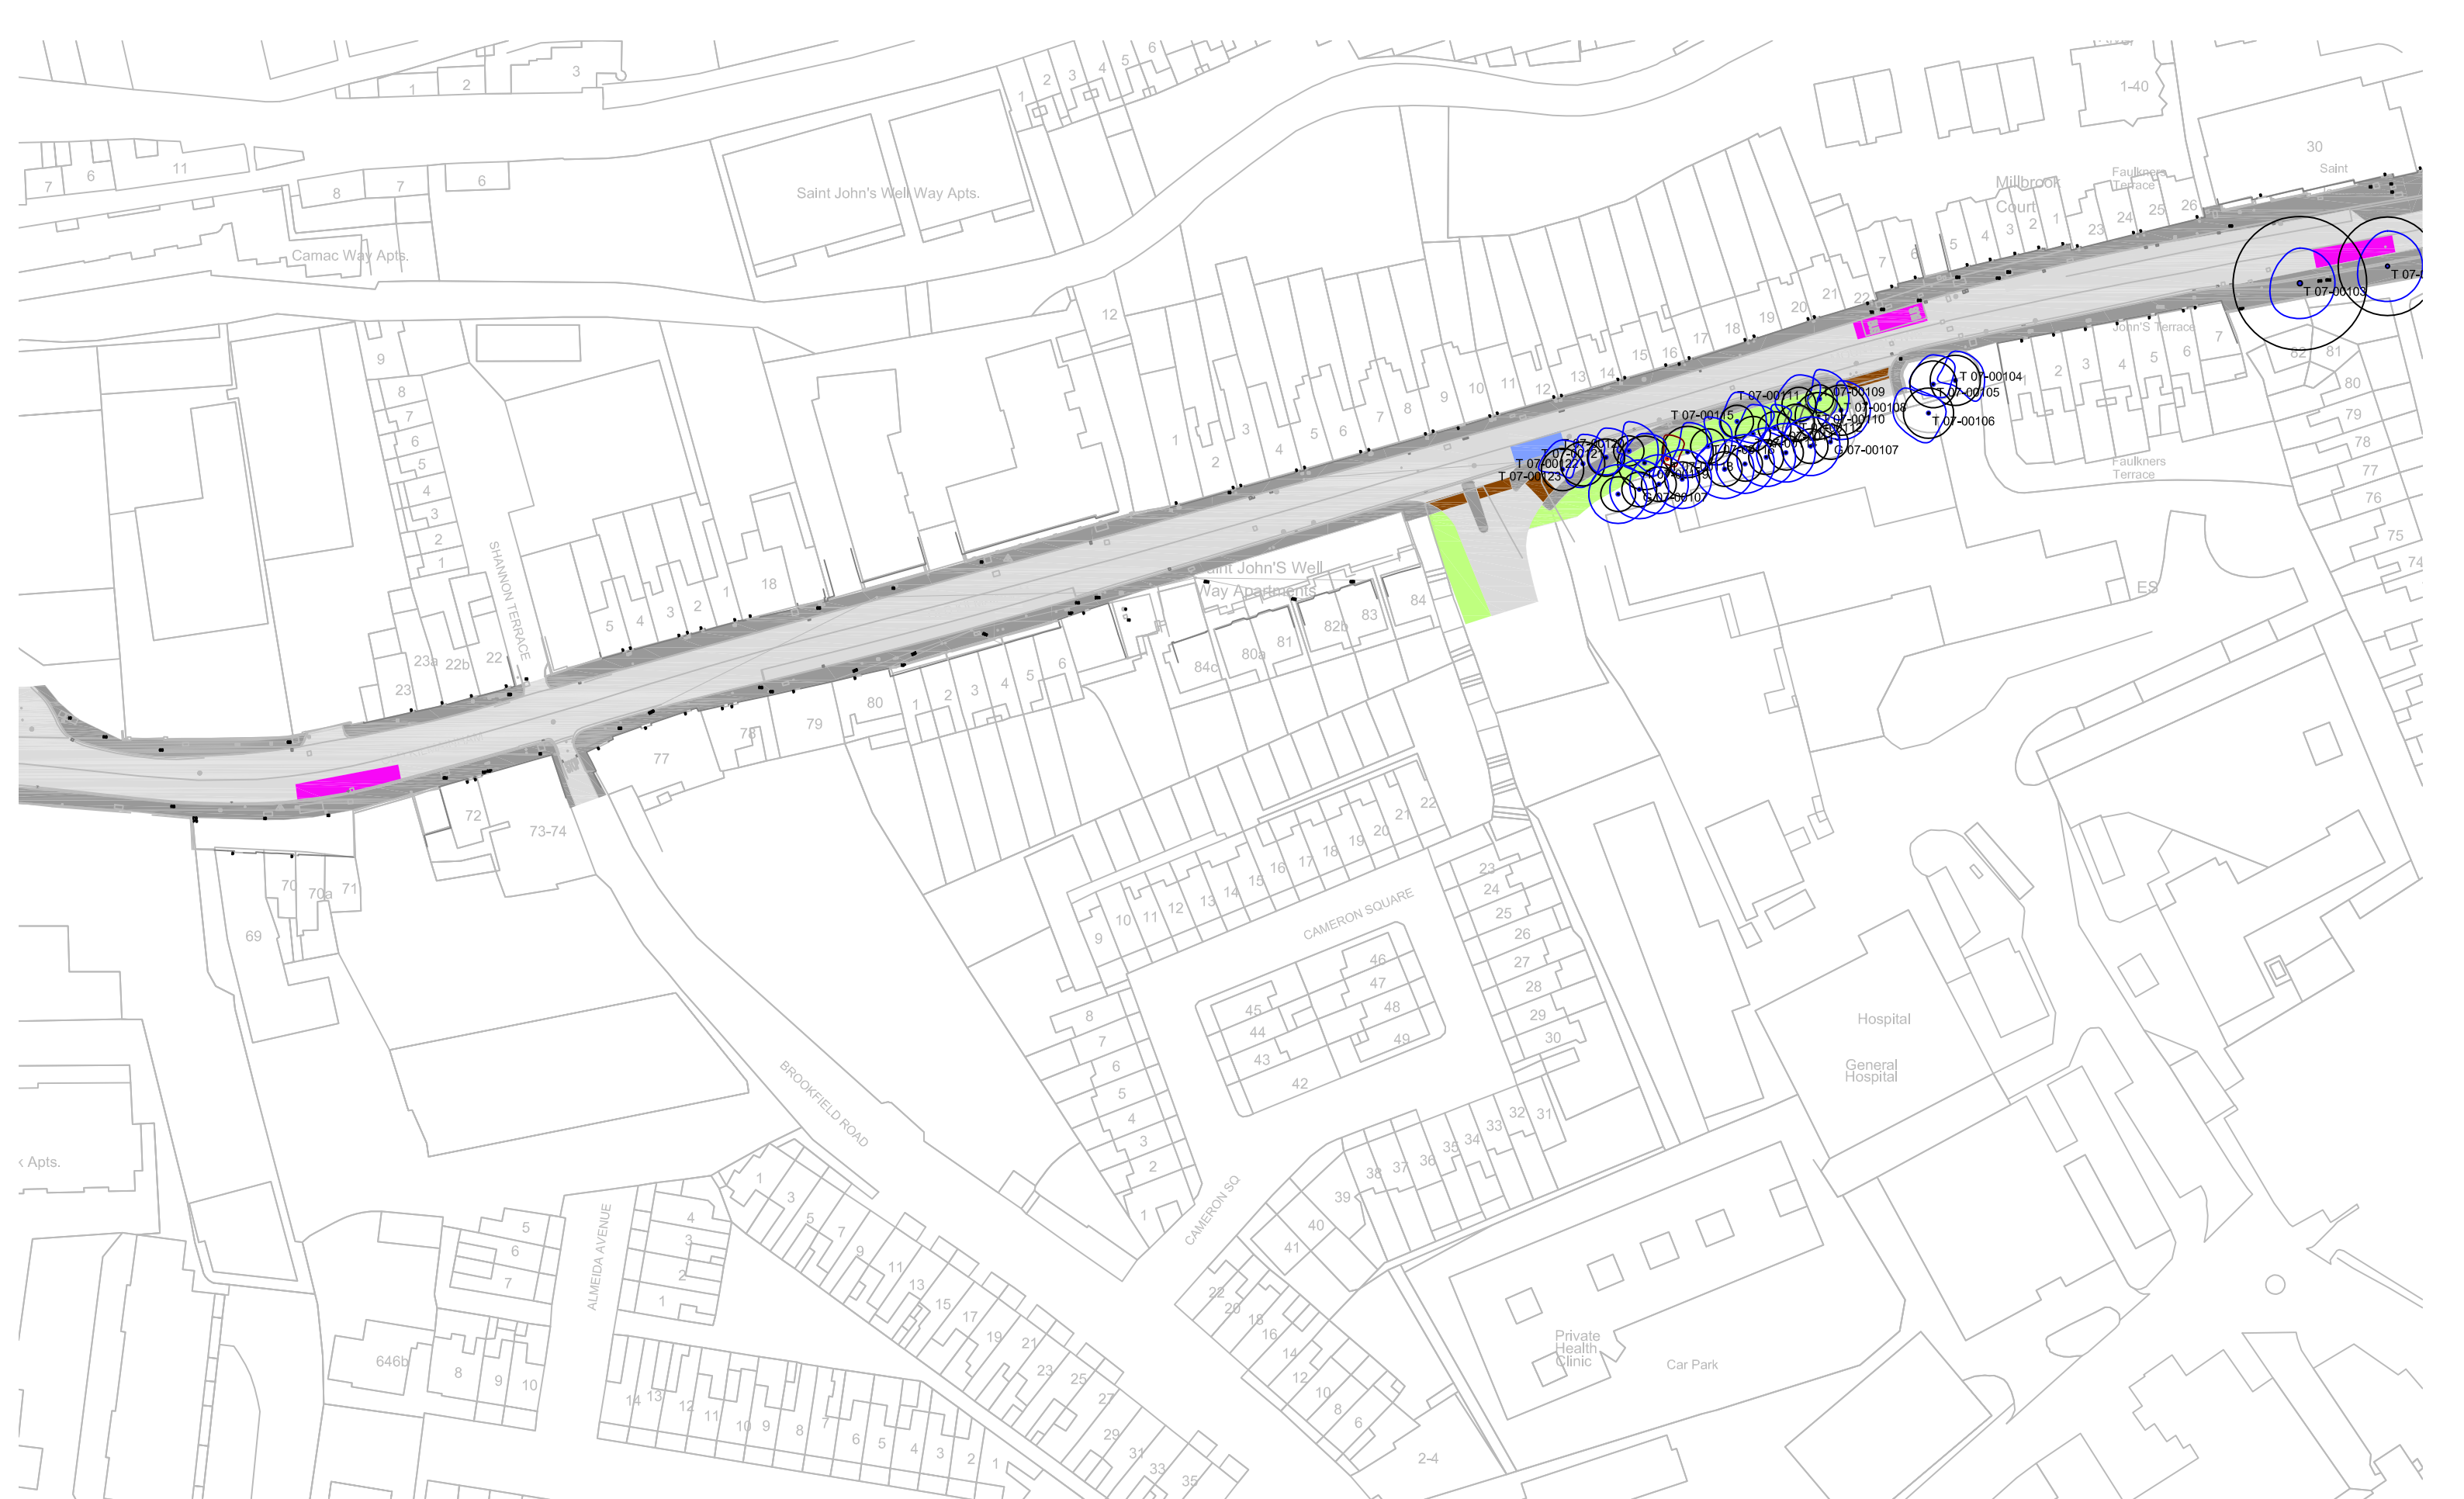
Area of Tree Protection Zone (if described as a perfect circle)
	<b>Title:</b> TREE CONSTRAINTS PLAN Plan indicating position, actual crown spread of trees and notional tree protection zones (based on a map produced by the client)		
<b>Scale:</b> 1:1000		<b>Drawn By:</b> Philip	<b>Date:</b> 14.08.2021

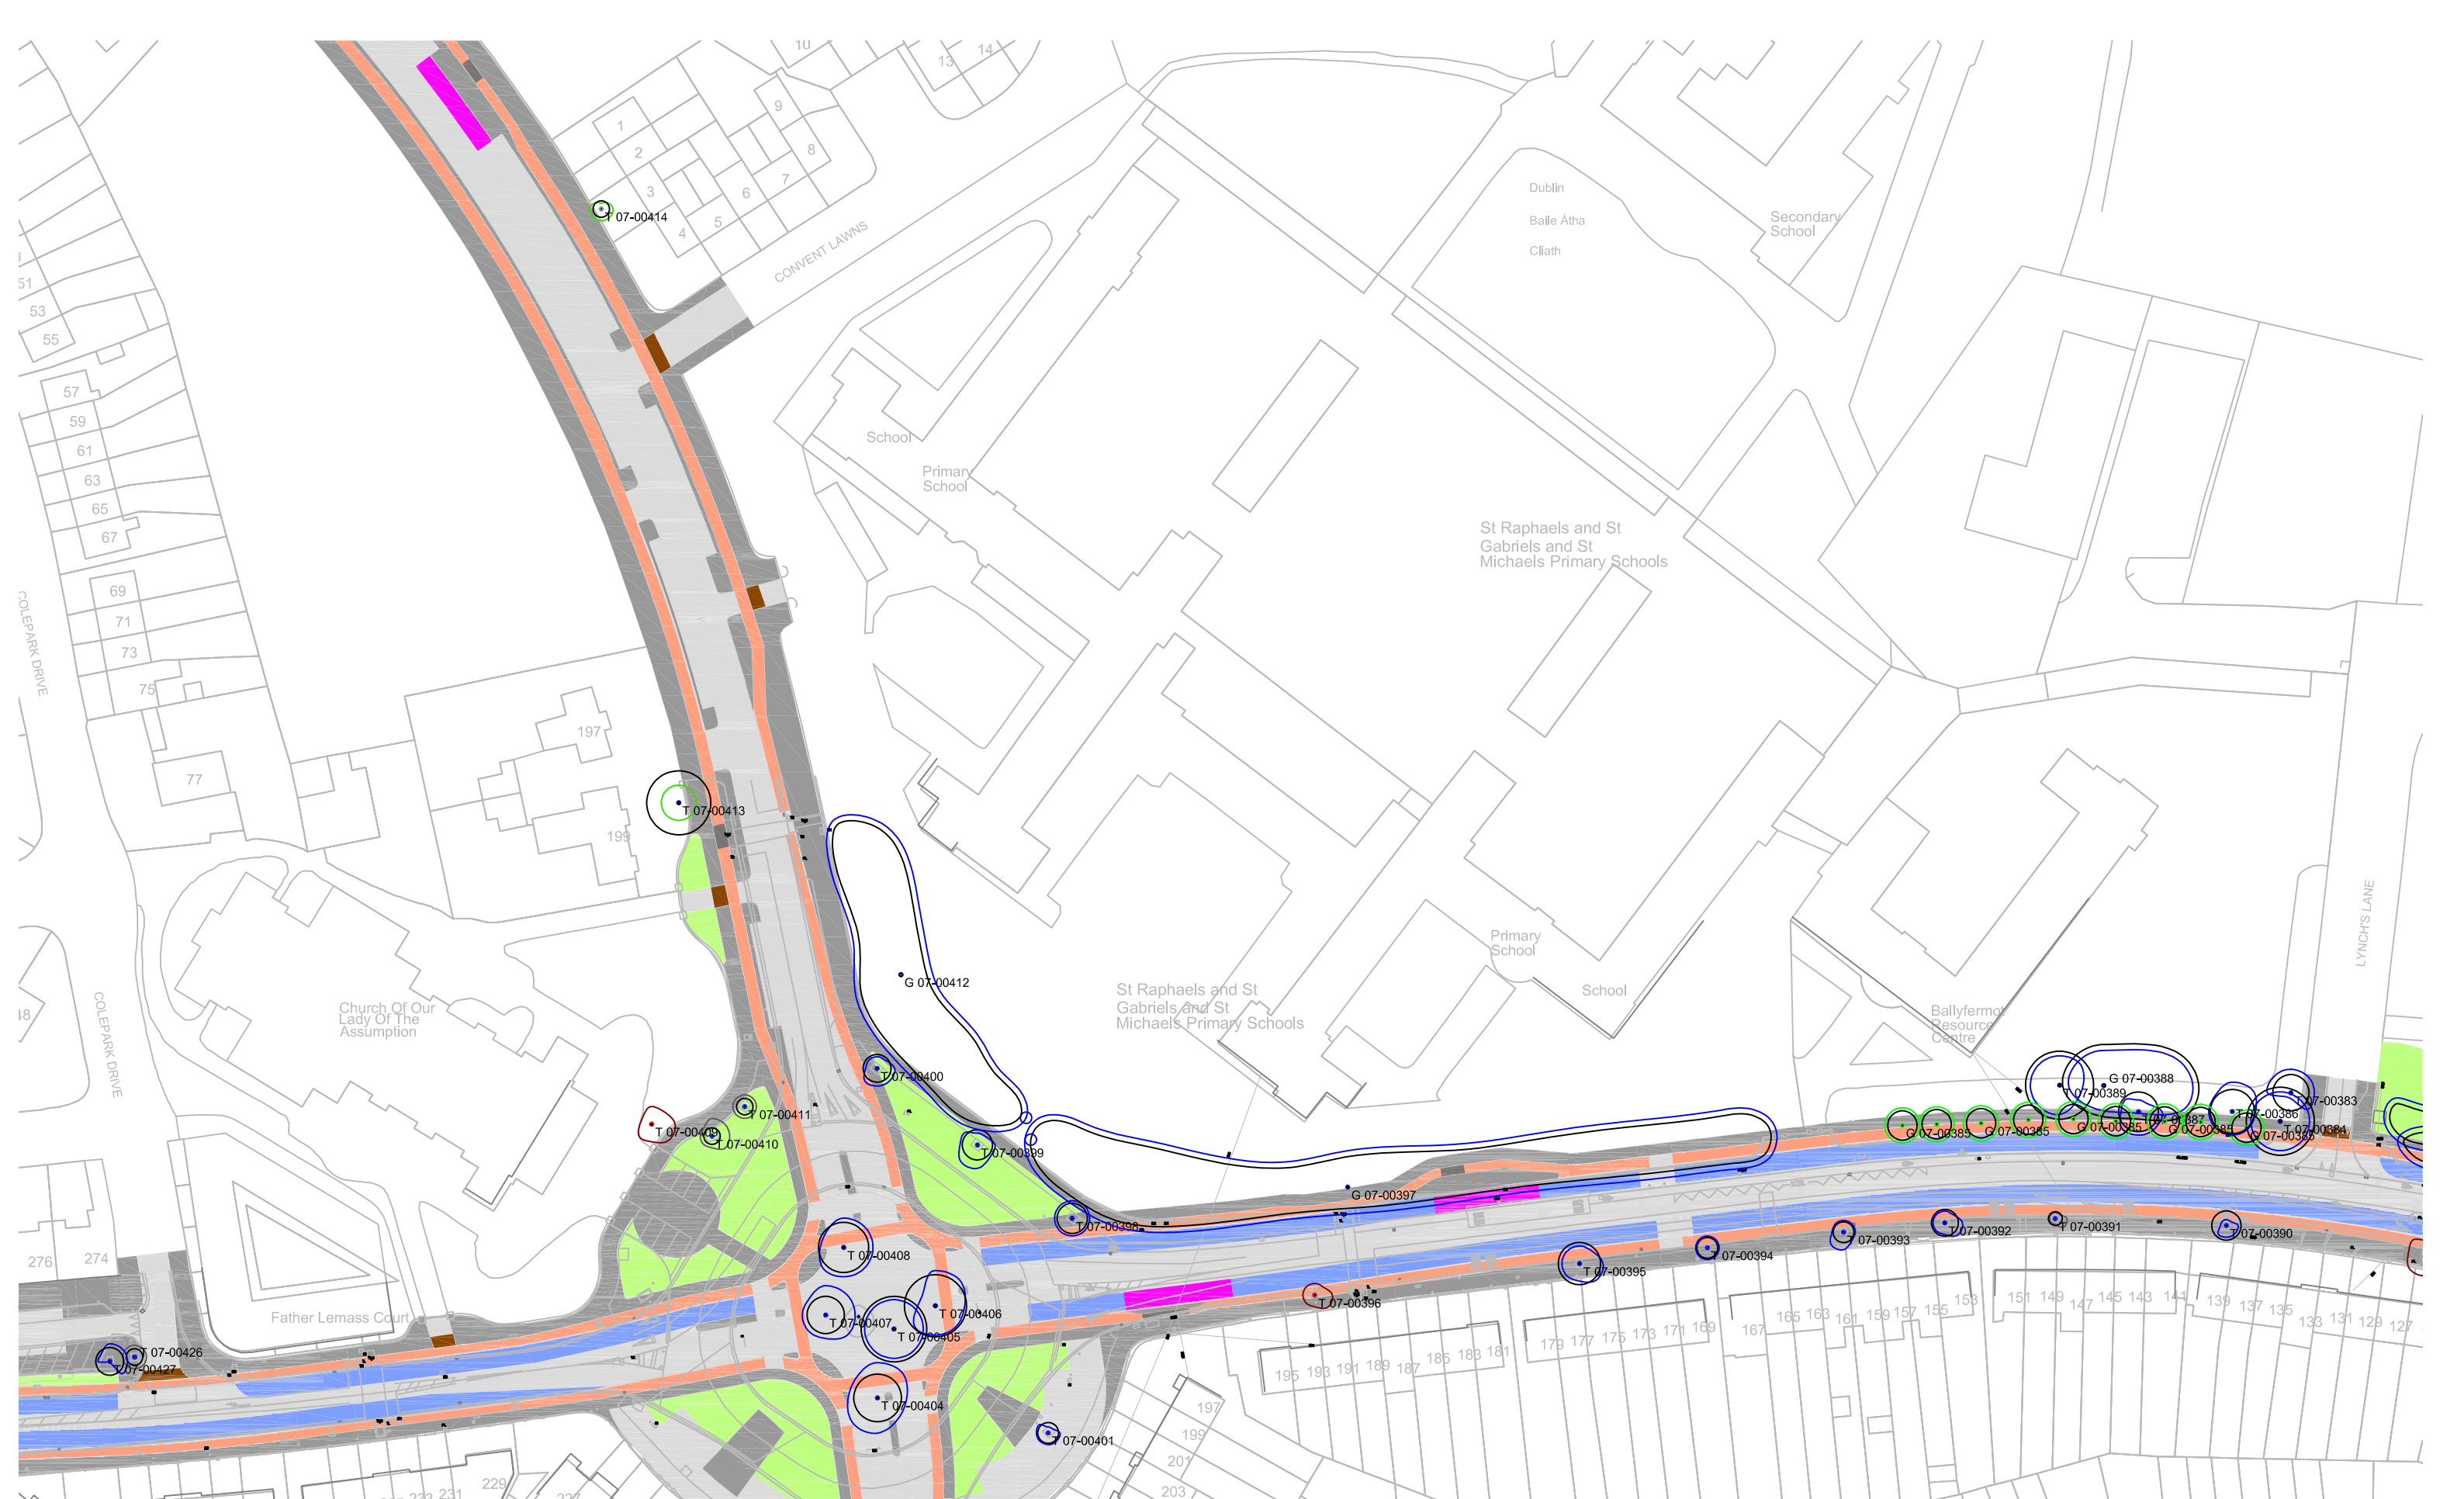
Area of Tree Protection Zone (if described as a perfect circle)
	Title: <b>TREE CONSTRAINTS PLAN</b> Plan indicating position, actual crown spread of trees and notional tree protection zones (based on a map produced by the client)		
Scale: <b>1:1000</b>		Drawn By: <b>Philip</b>	Date: <b>14.08.2021</b>

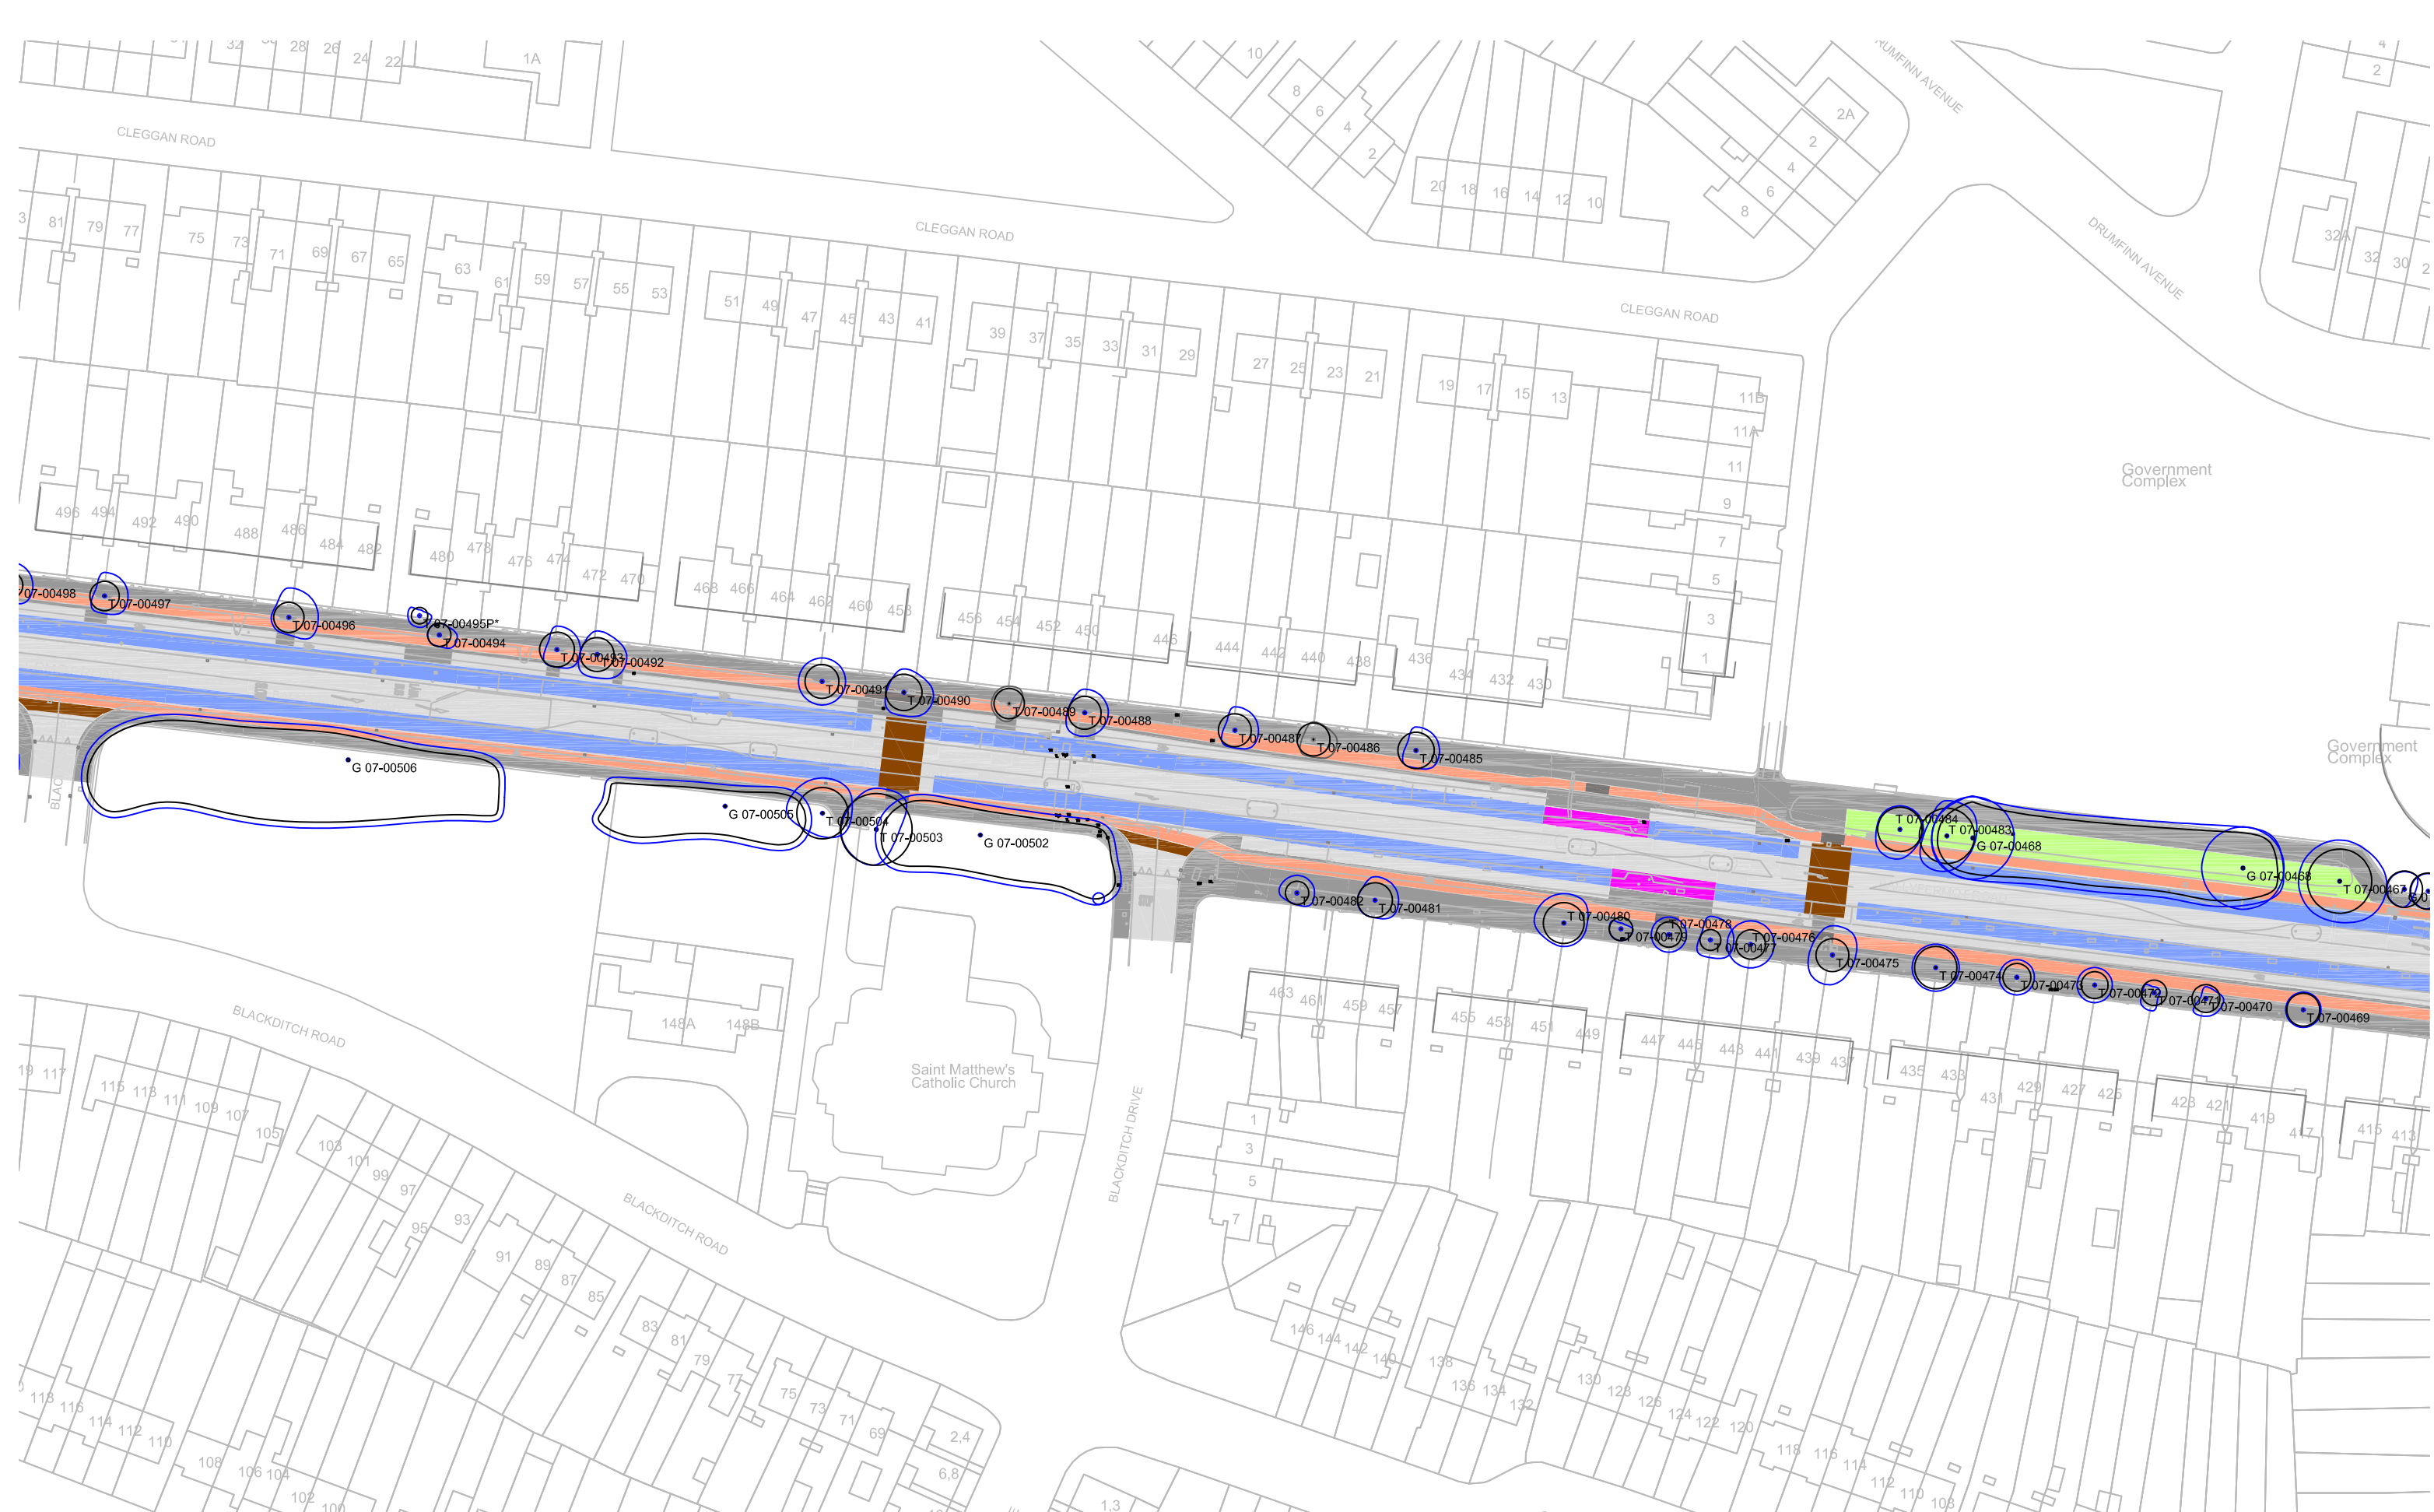
Area of Tree Protection Zone (if described as a perfect circle)
	Title: <b>TREE CONSTRAINTS PLAN</b> Plan indicating position, actual crown spread of trees and notional tree protection zones (based on a map produced by the client)		
Scale: <b>1:1000</b>	Drawn By: <b>Philip</b>	Date: <b>14.08.2021</b>

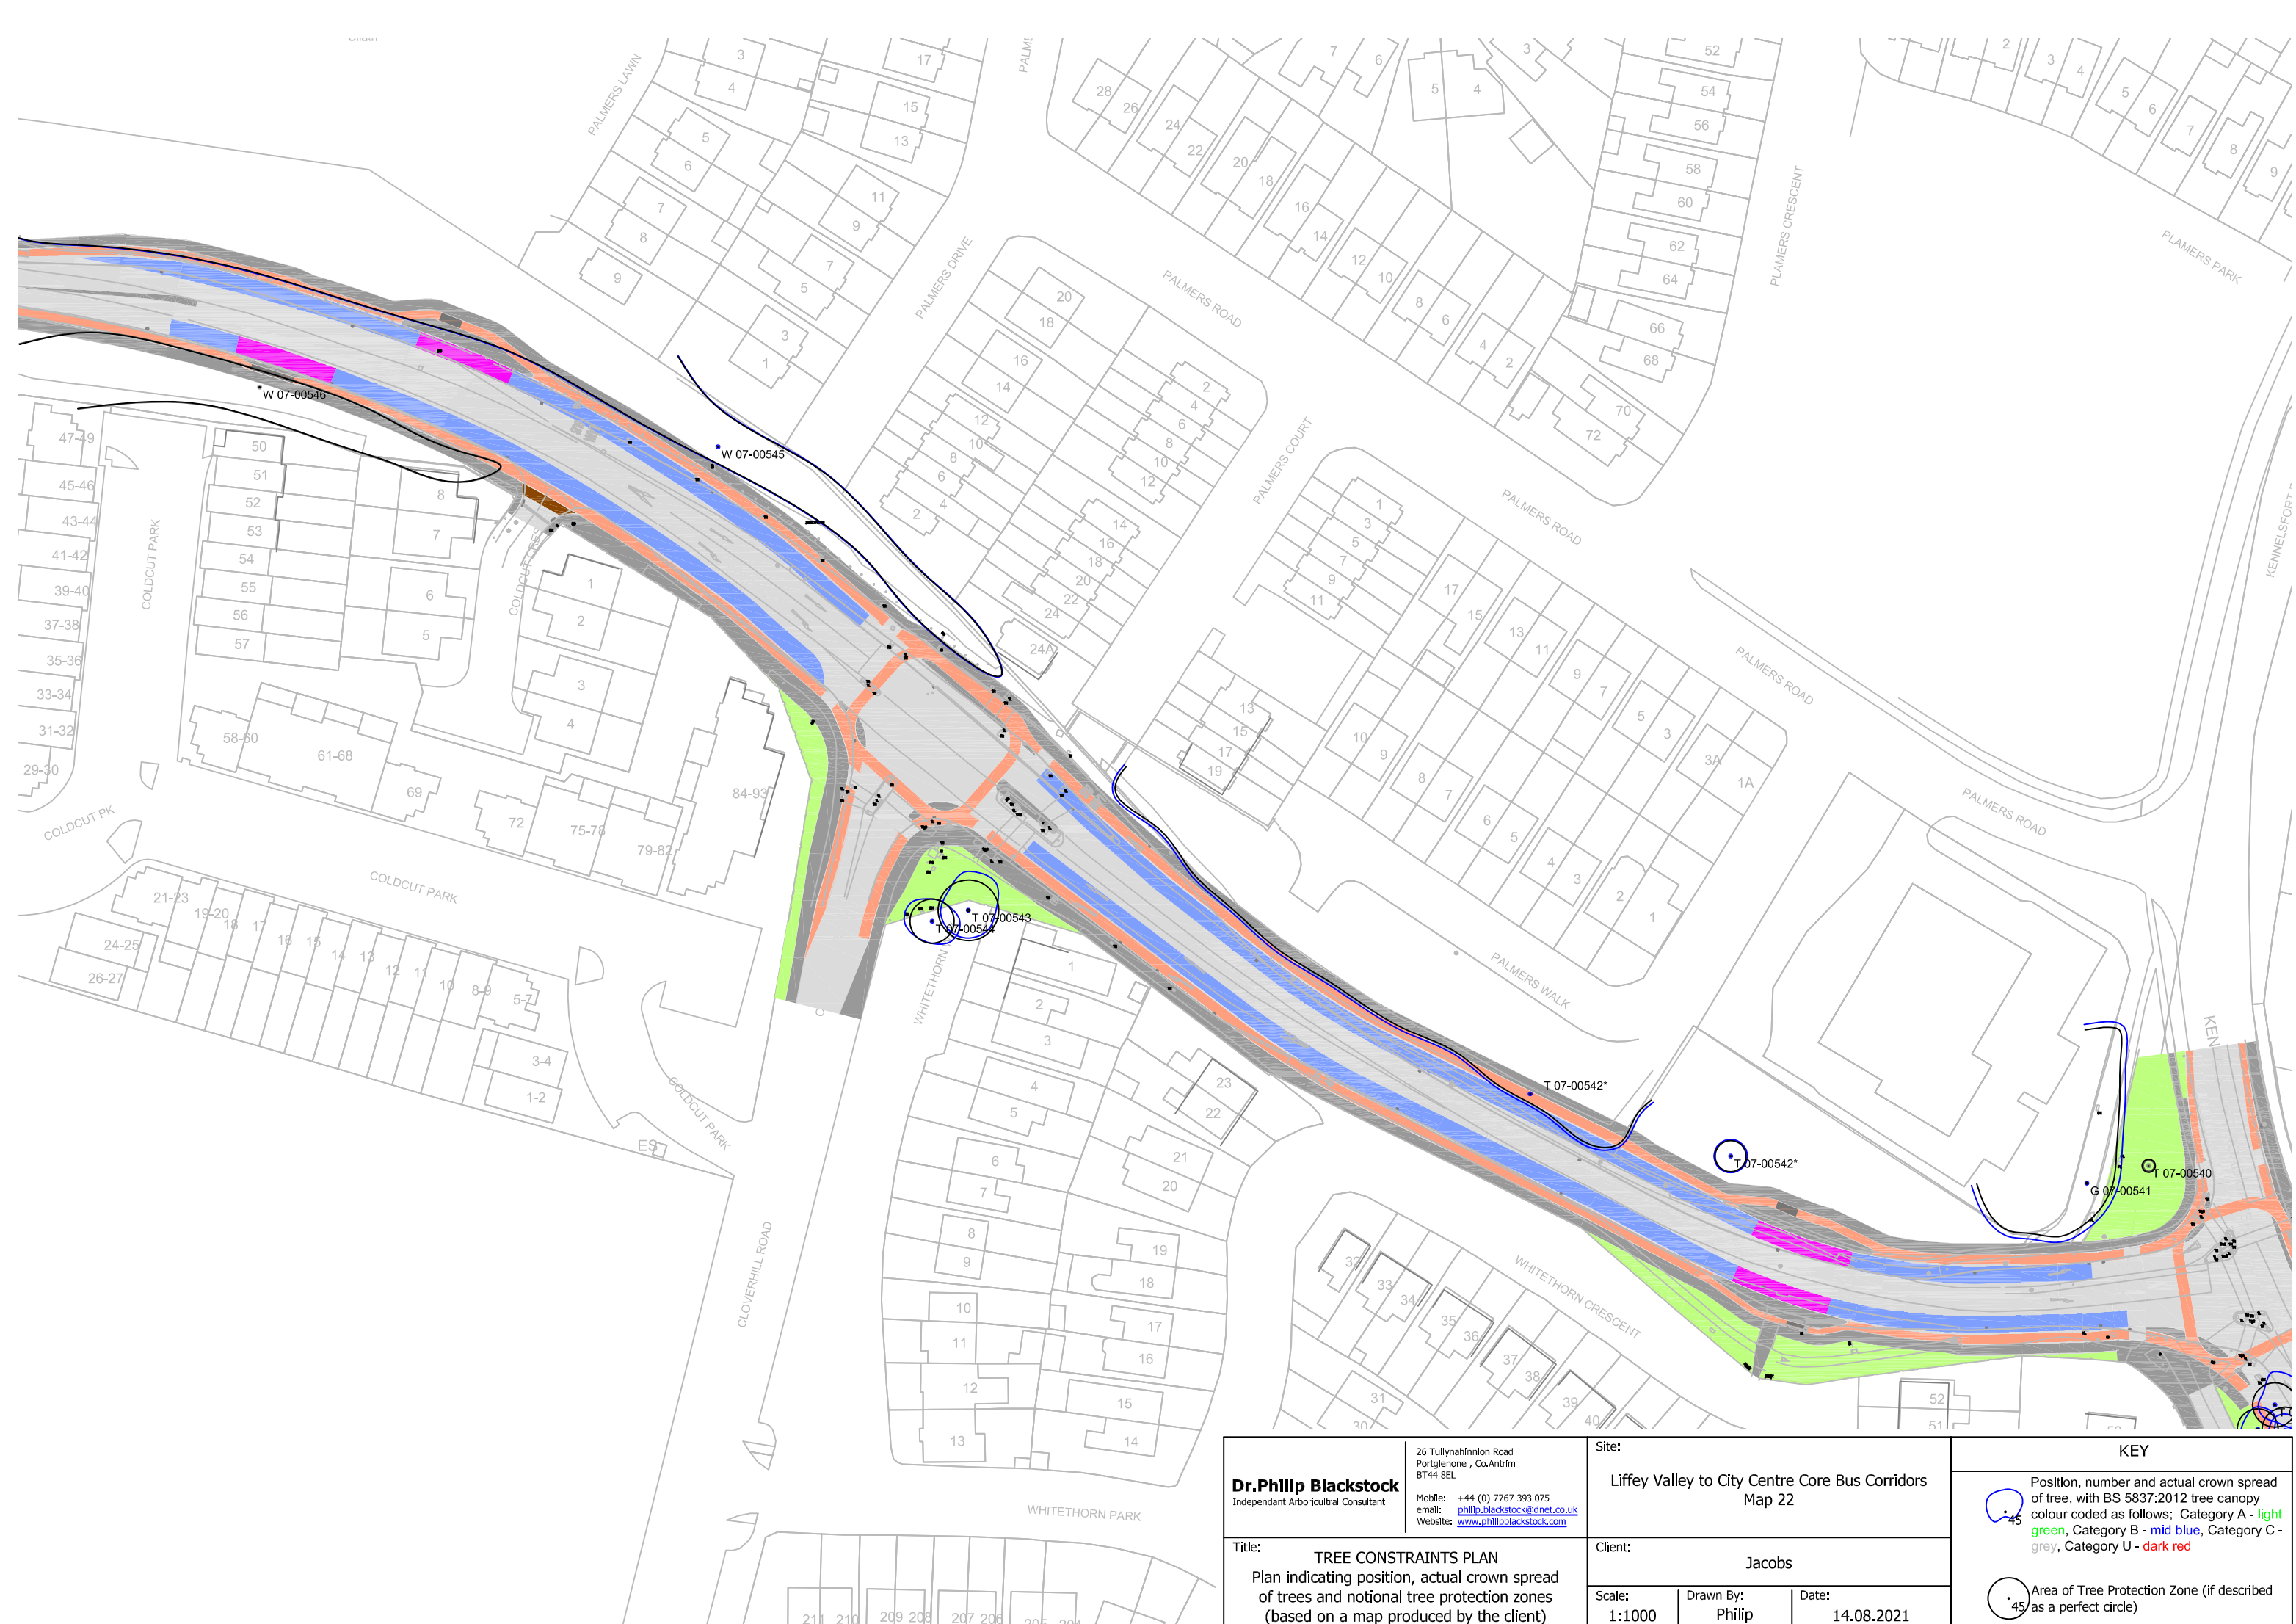
KEY	
	Position, number and actual crown spread of tree, with BS 5837:2012 tree canopy colour coded as follows; Category A - light green, Category B - mid blue, Category C - grey, Category U - dark red
	Area of Tree Protection Zone (if described as a perfect circle)

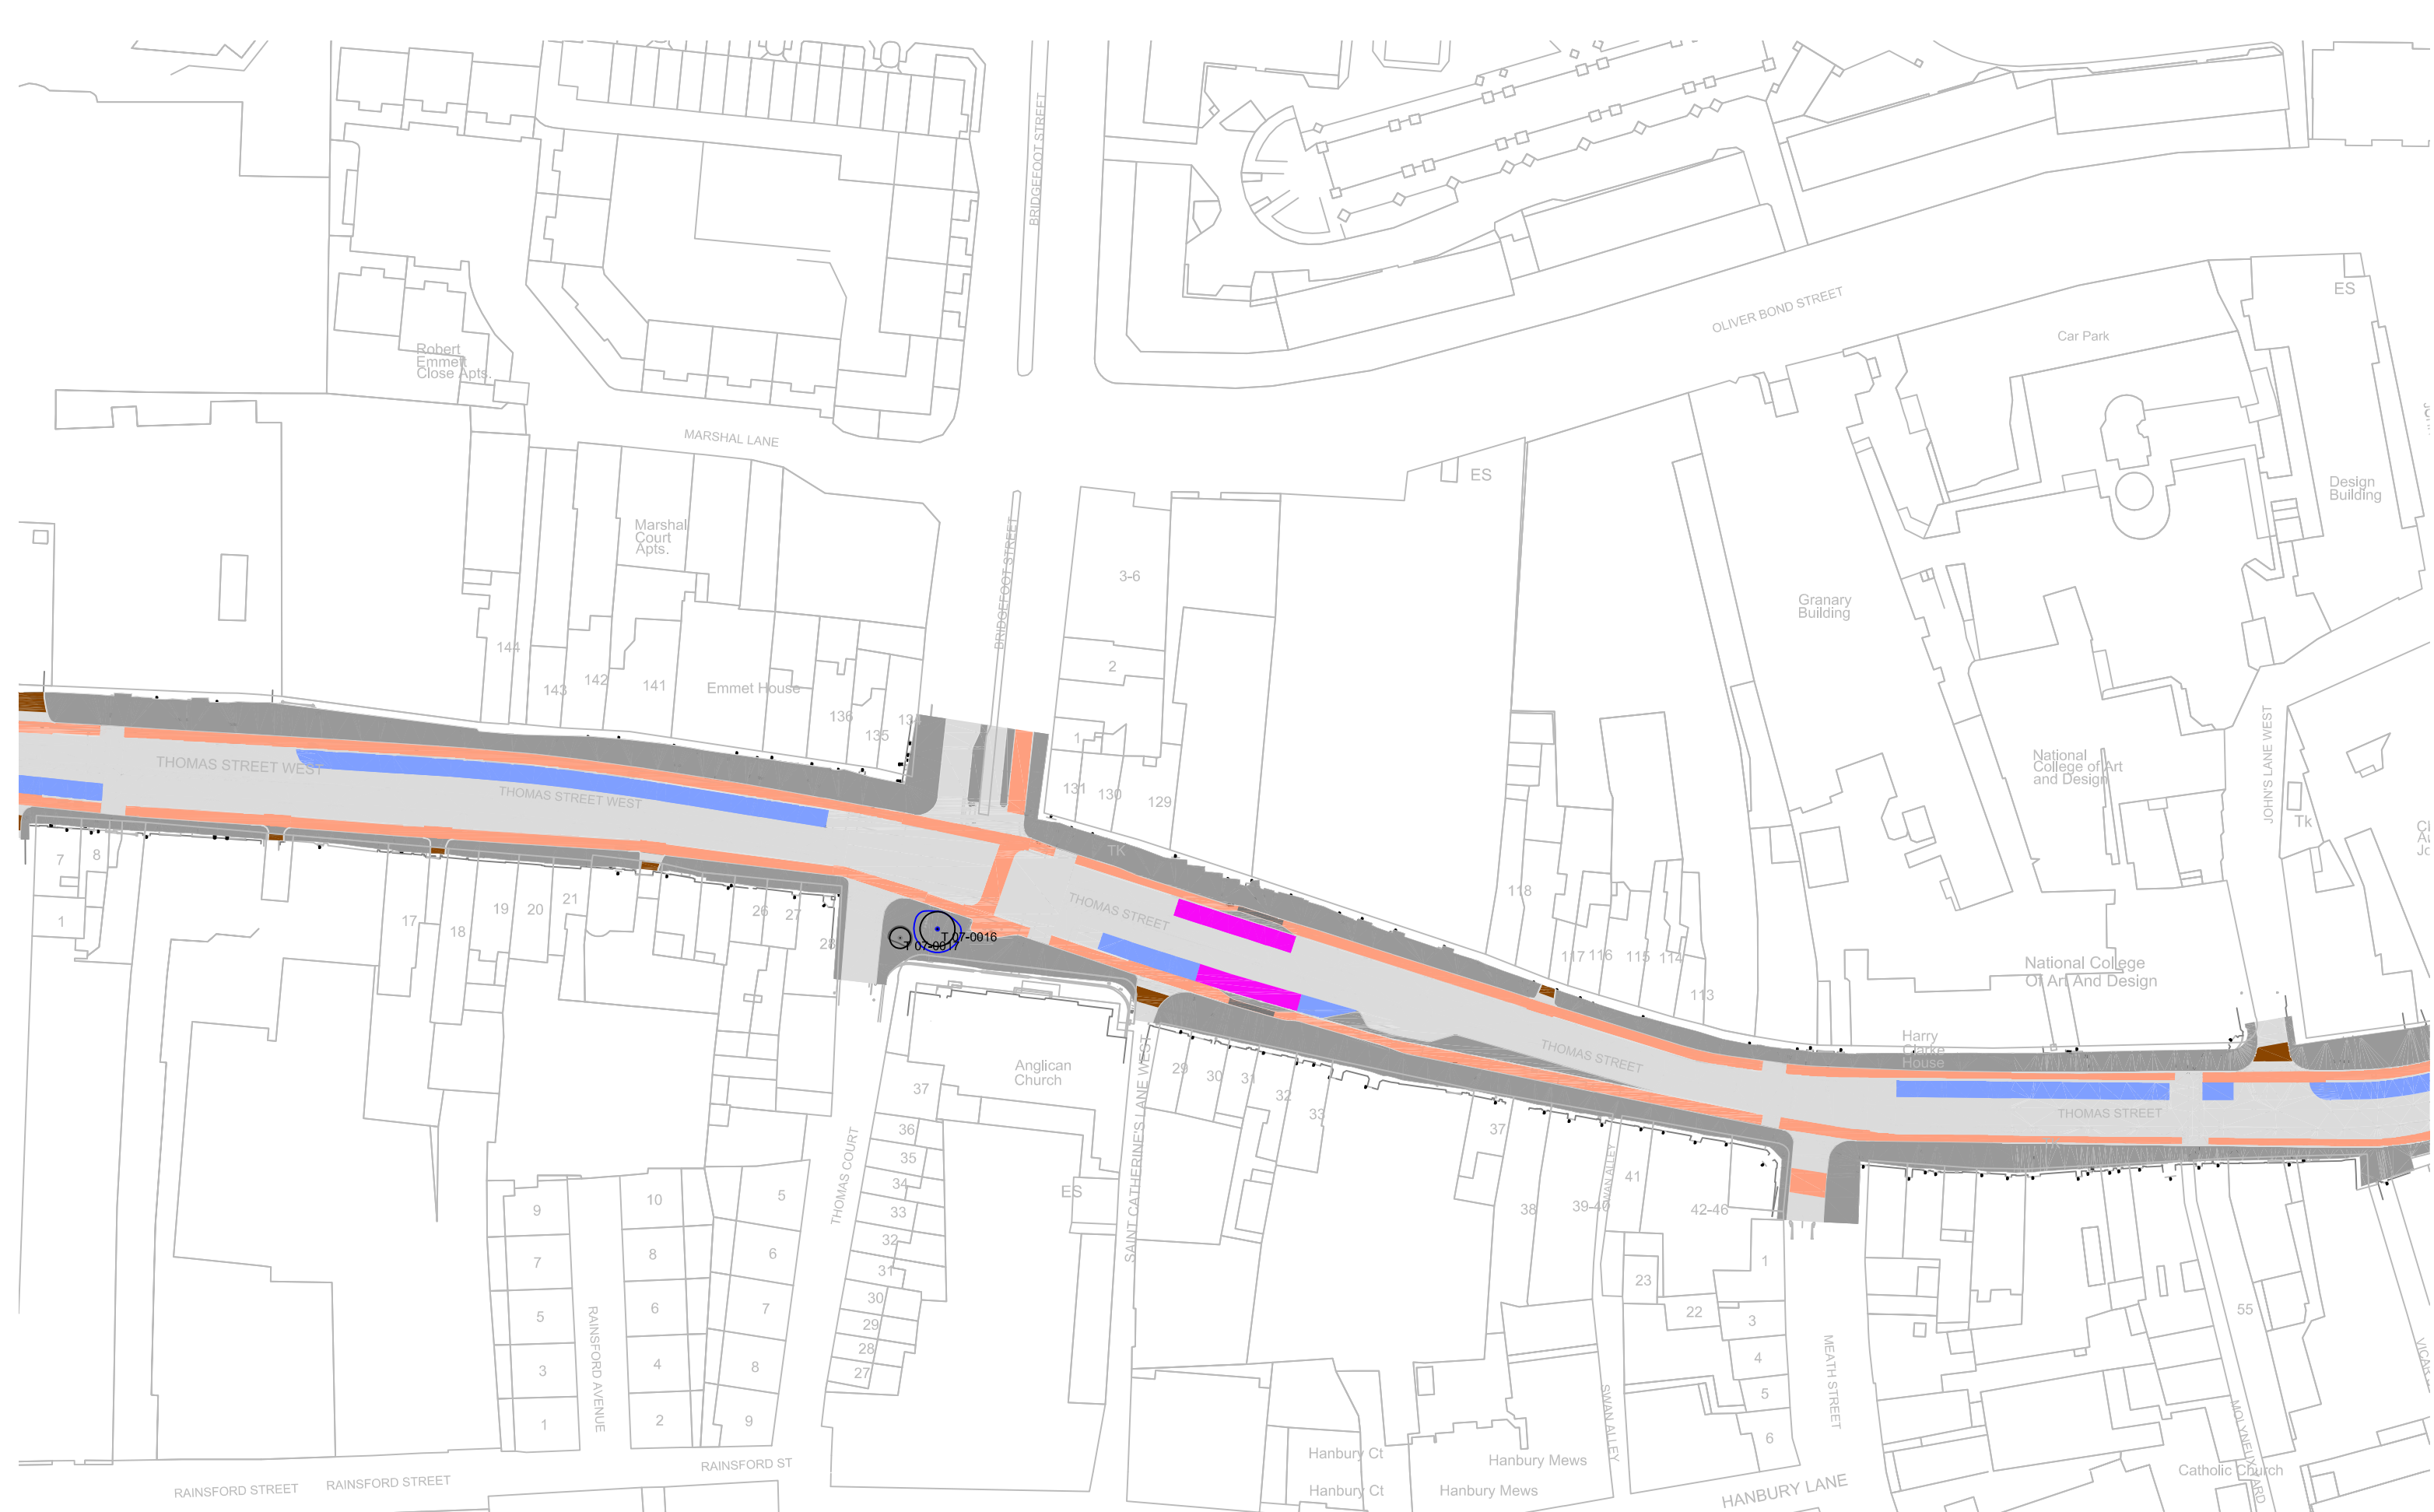
Area of Tree Protection Zone (if described as a perfect circle)
	<b>Title:</b> TREE IMPACT PLAN Plan indicating position, actual crown spread of trees and notional tree protection zones (based on a map produced by the client)		
<b>Scale:</b> 1:1000		<b>Drawn By:</b> Philip	<b>Date:</b> 14.08.2021
