**Appendix D**  
Arboricultural Impact  
Assessment Report

# **TREE SURVEY AND REPORT**

**BUSCONNECTS CORE BUS CORRIDOR – LIFFEY VALLEY TO CITY CENTRE**

September 2020

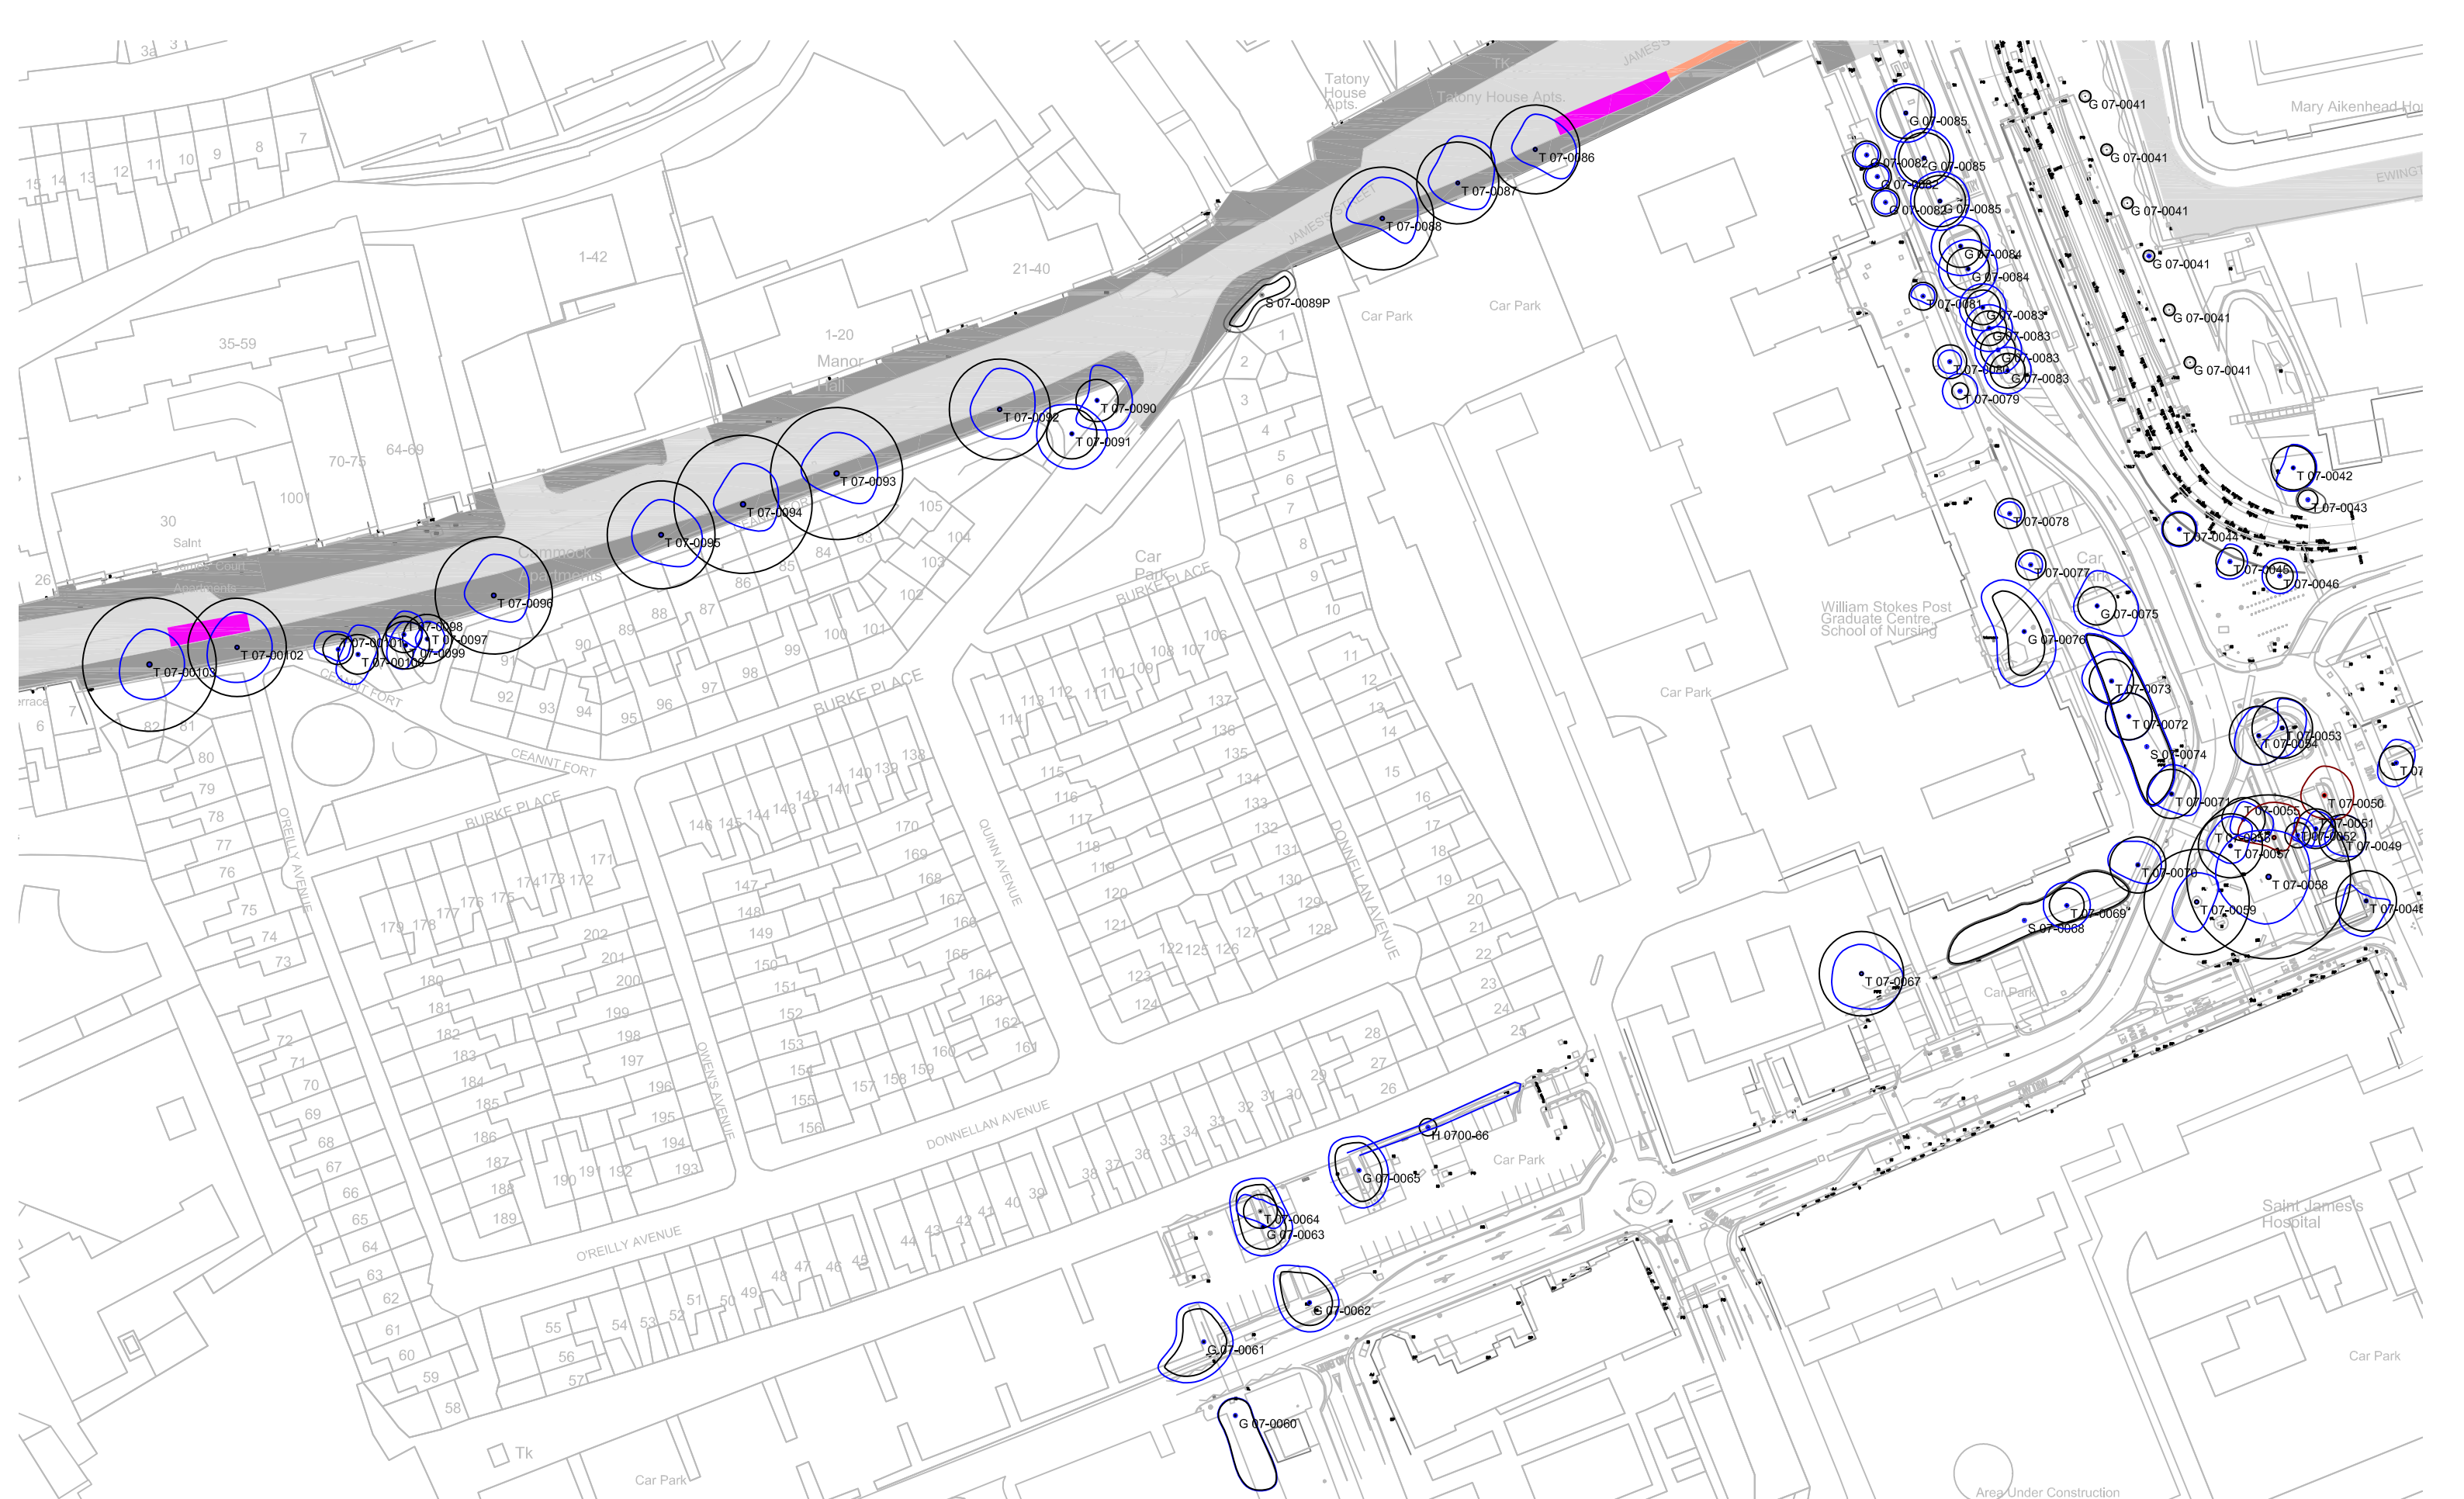
KEY	
	Position, number and actual crown spread of tree, with BS 5837:2012 tree canopy colour coded as follows; Category A - light green, Category B - mid blue, Category C - grey, Category U (or to be removed) - dark red, retained trees affected by proposals - magenta
	Area of Tree Protection Zone (if described as a perfect circle)

**Title:** TREE IMPACT PLAN  
 Plan indicating position, actual crown spread  
 of trees and notional tree protection zones  
 (based on a map produced by the client)

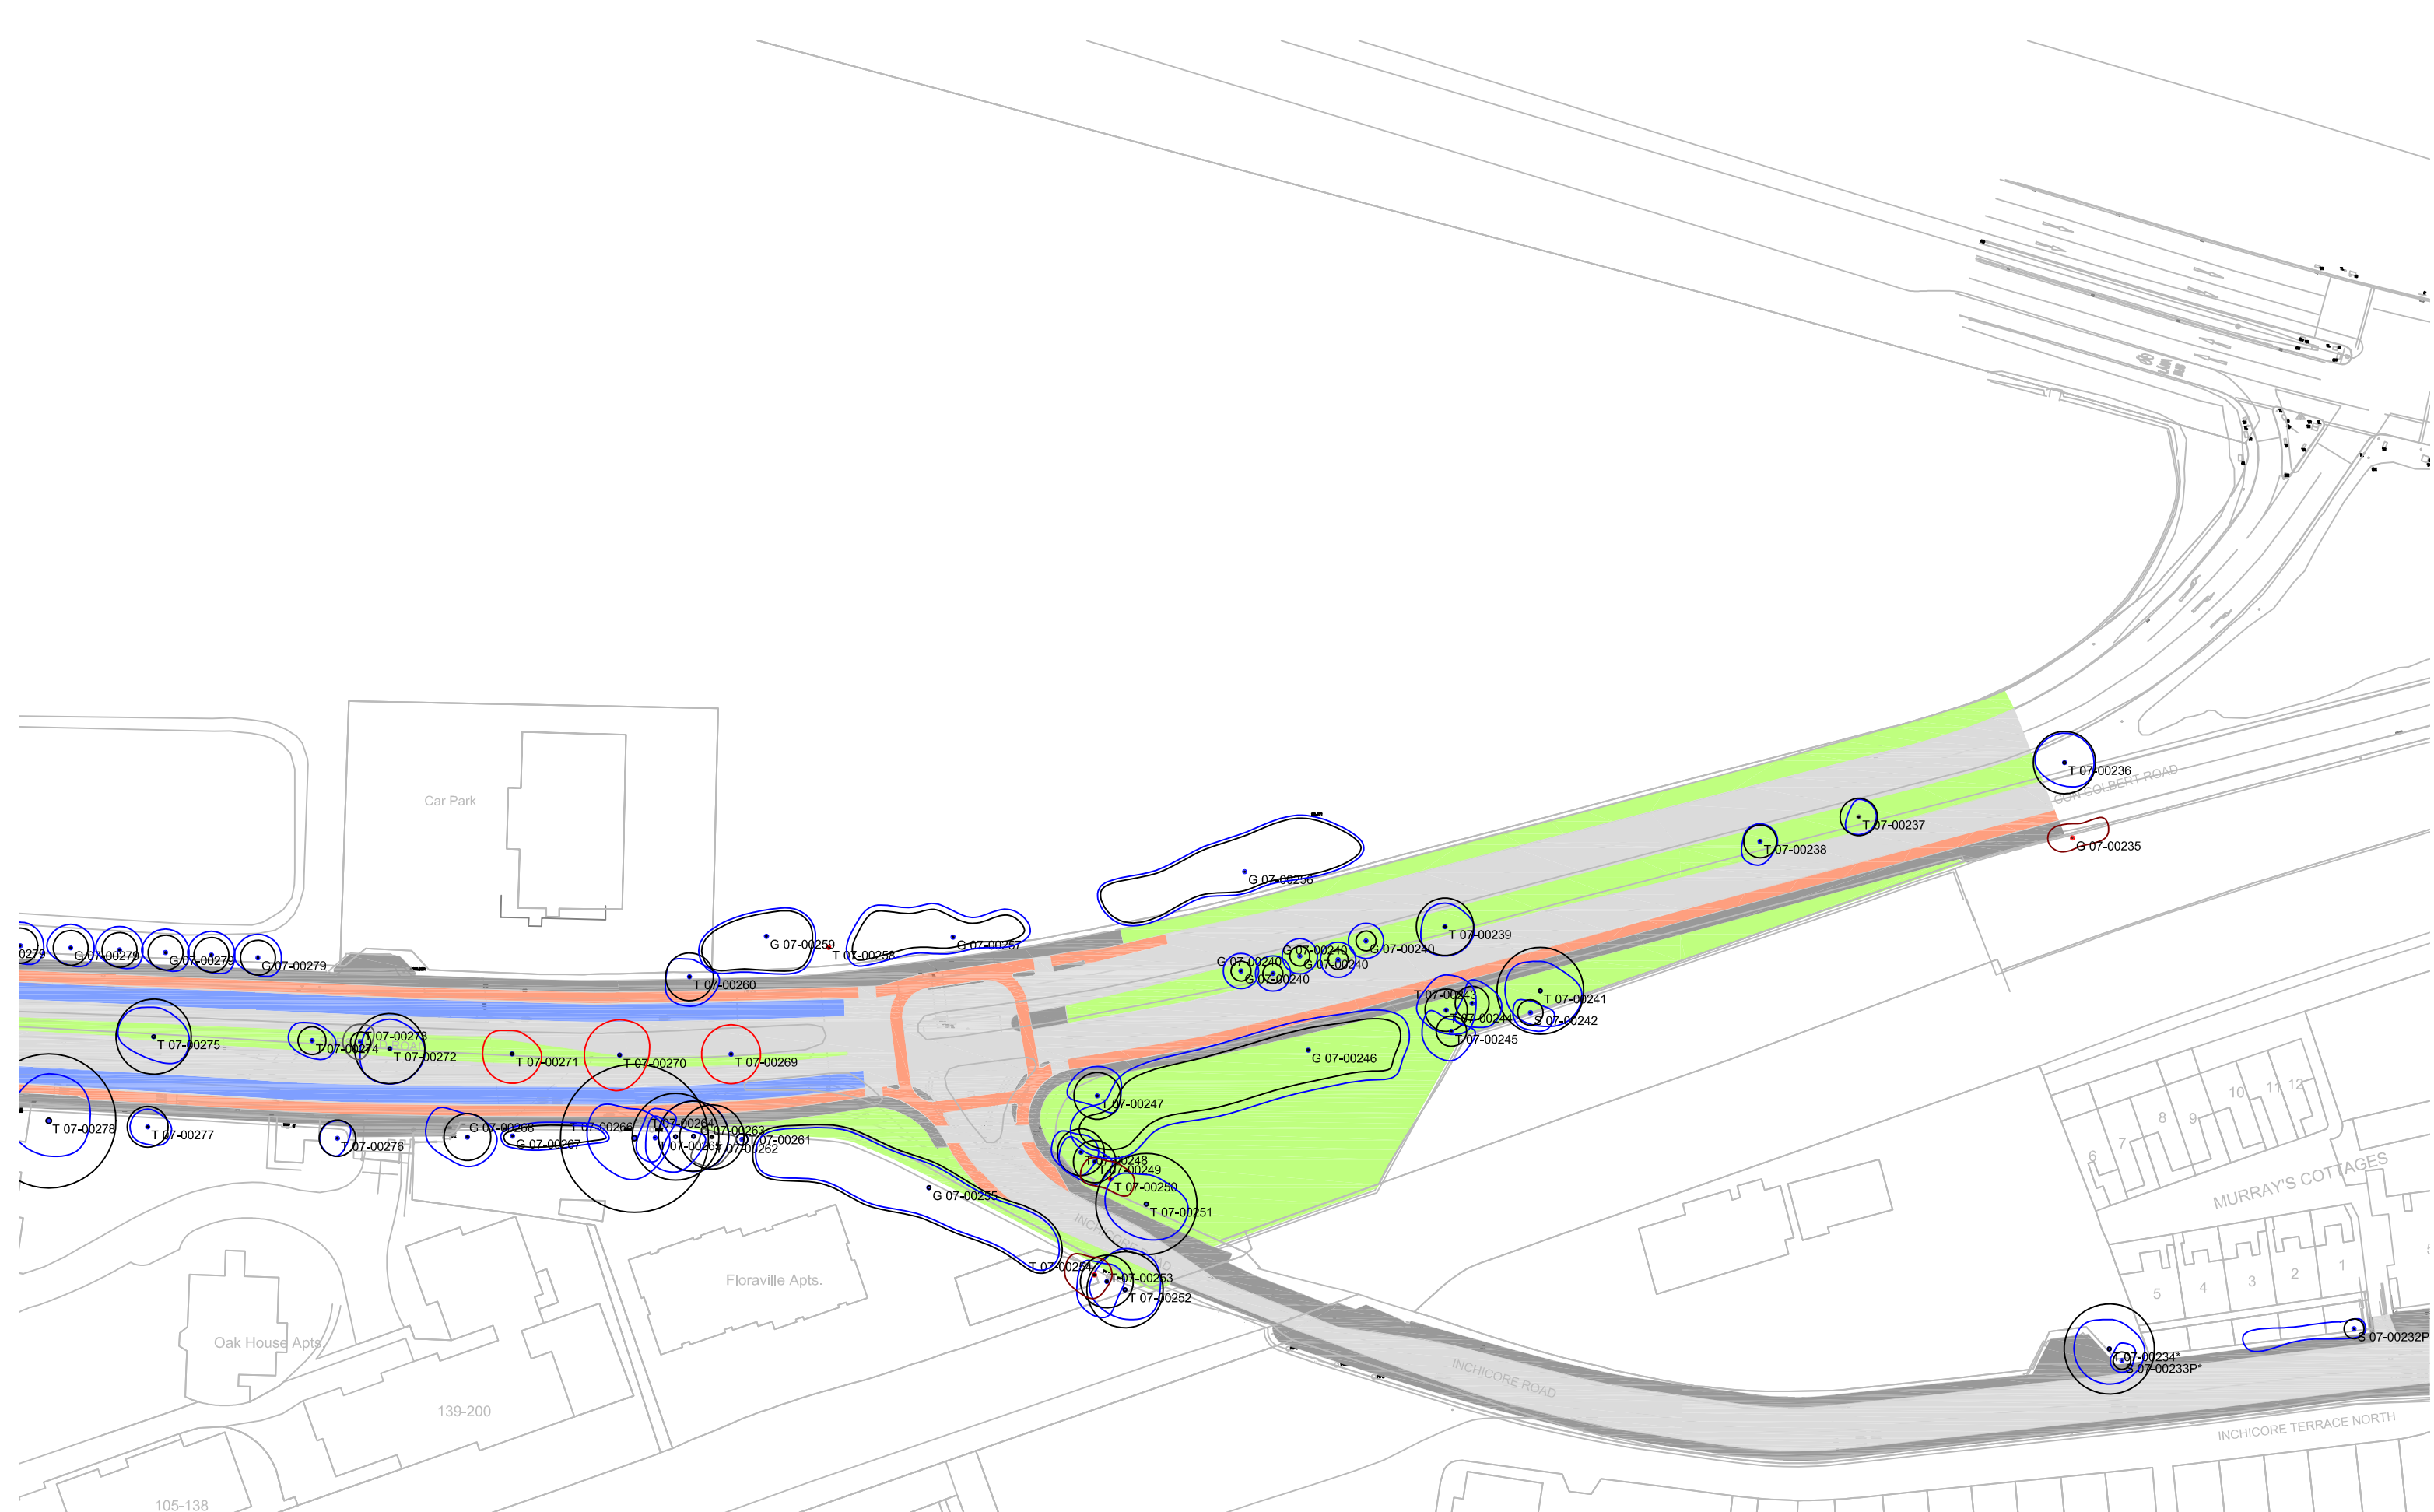
Site:  
**Liffey Valley to City Centre Core Bus Corridors**  
 Map 11

KEY	
	Position, number and actual crown spread of tree, with BS 5837:2012 tree canopy colour coded as follows; Category A - light green, Category B - mid blue, Category C - grey, Category U (or to be removed) - dark red, retained trees affected by proposals - magenta
	Area of Tree Protection Zone (if described as a perfect circle)

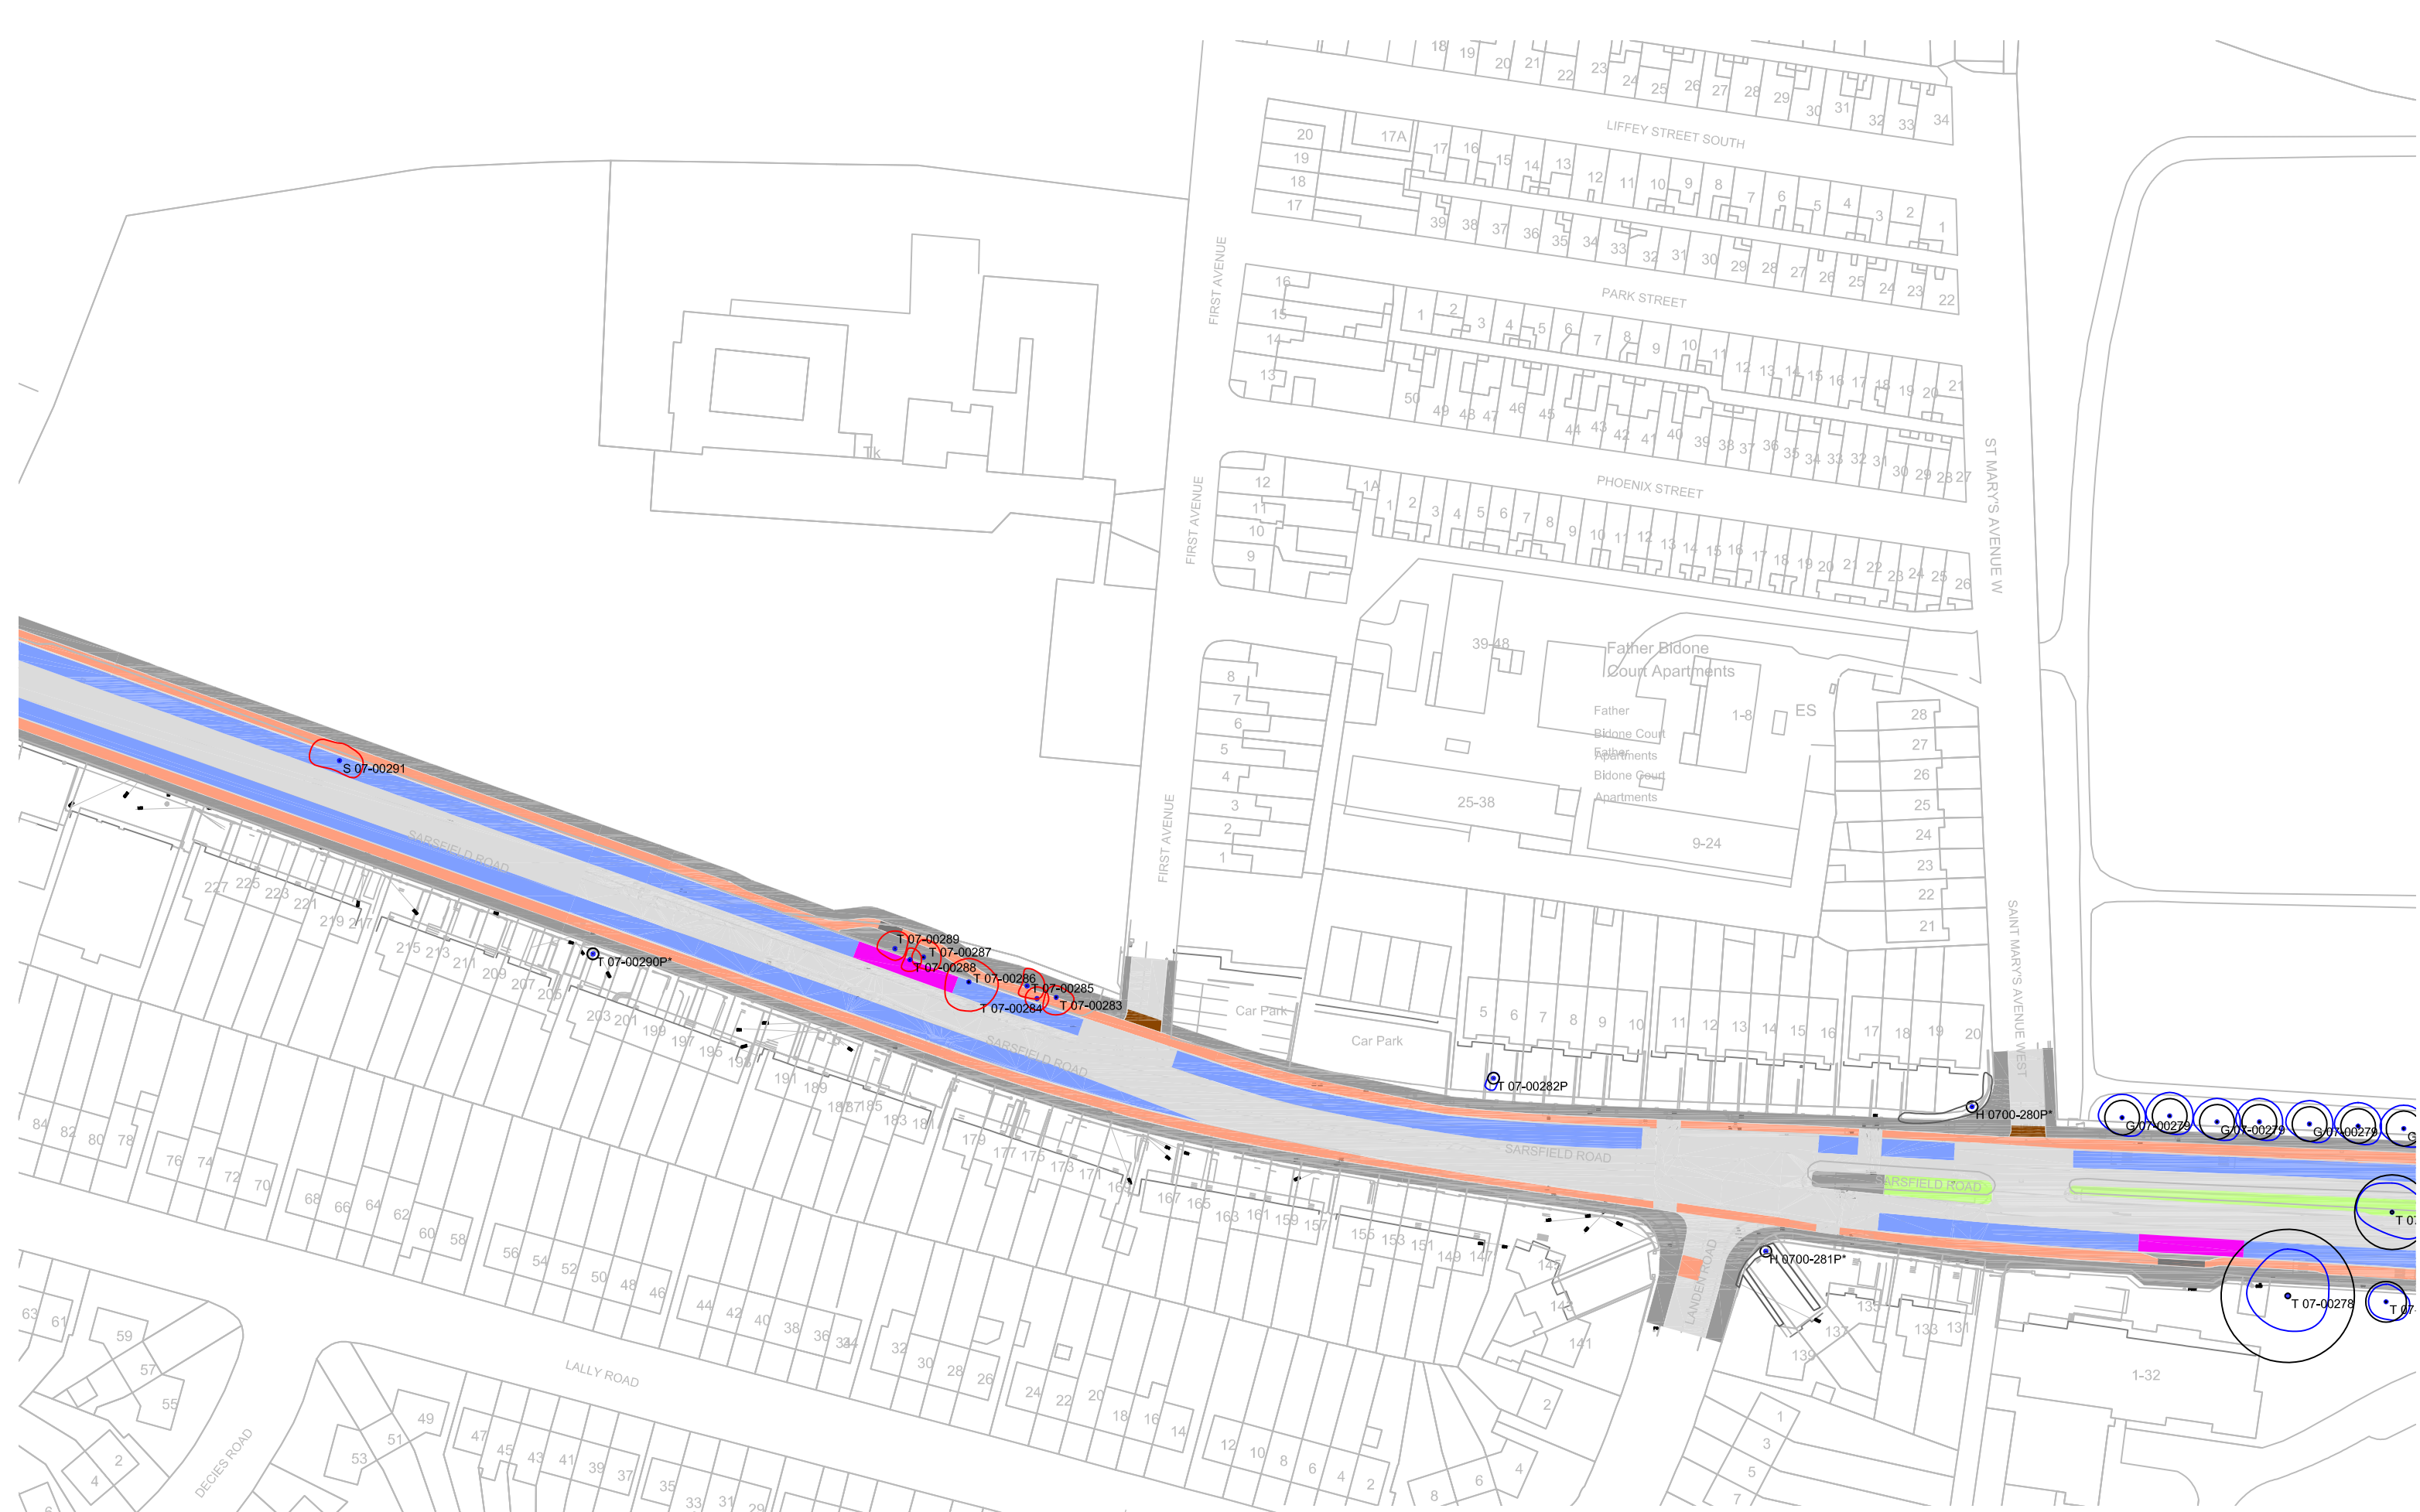
KEY	
	Position, number and actual crown spread of tree, with BS 5837:2012 tree canopy colour coded as follows; Category A - light green, Category B - mid blue, Category C - grey, Category U (or to be removed) - dark red, retained trees affected by proposals - magenta
	Area of Tree Protection Zone (if described as a perfect circle)

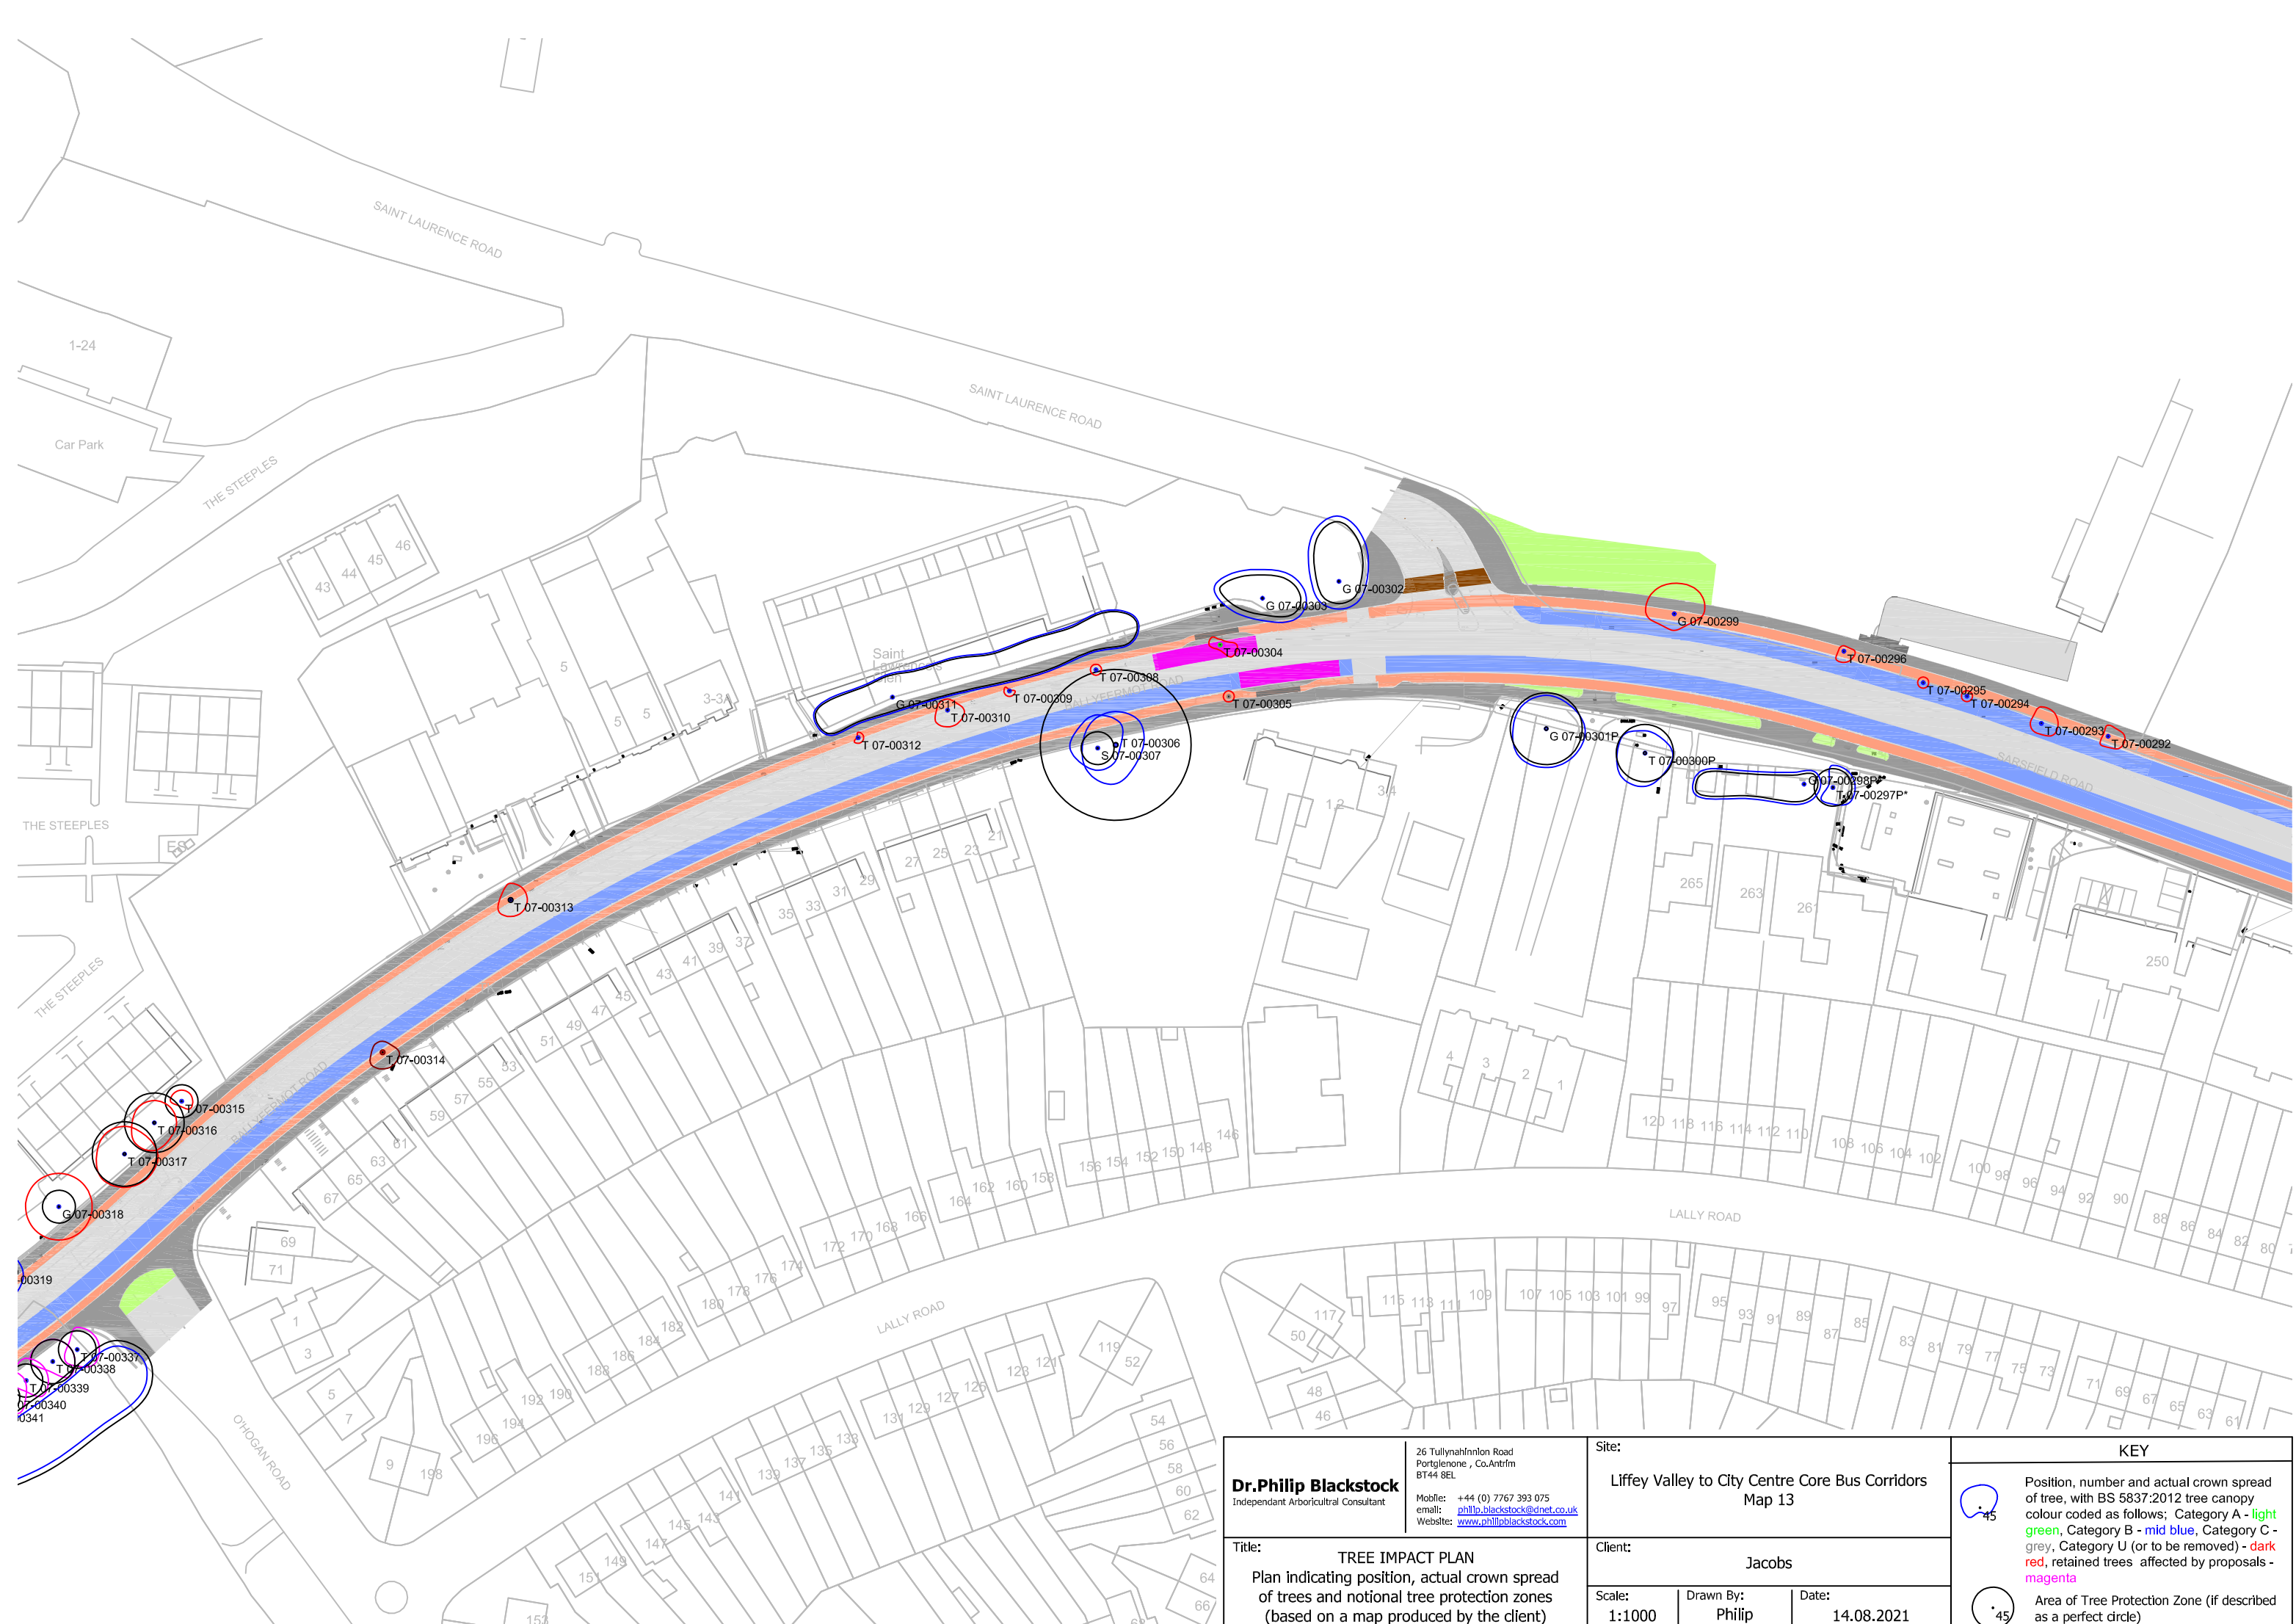
Area of Tree Protection Zone (if described as a perfect circle)
	<b>Title:</b> TREE IMPACT PLAN Plan indicating position, actual crown spread of trees and notional tree protection zones (based on a map produced by the client)		
<b>Scale:</b> 1:1000		<b>Drawn By:</b> Philip	<b>Date:</b> 14.08.2021

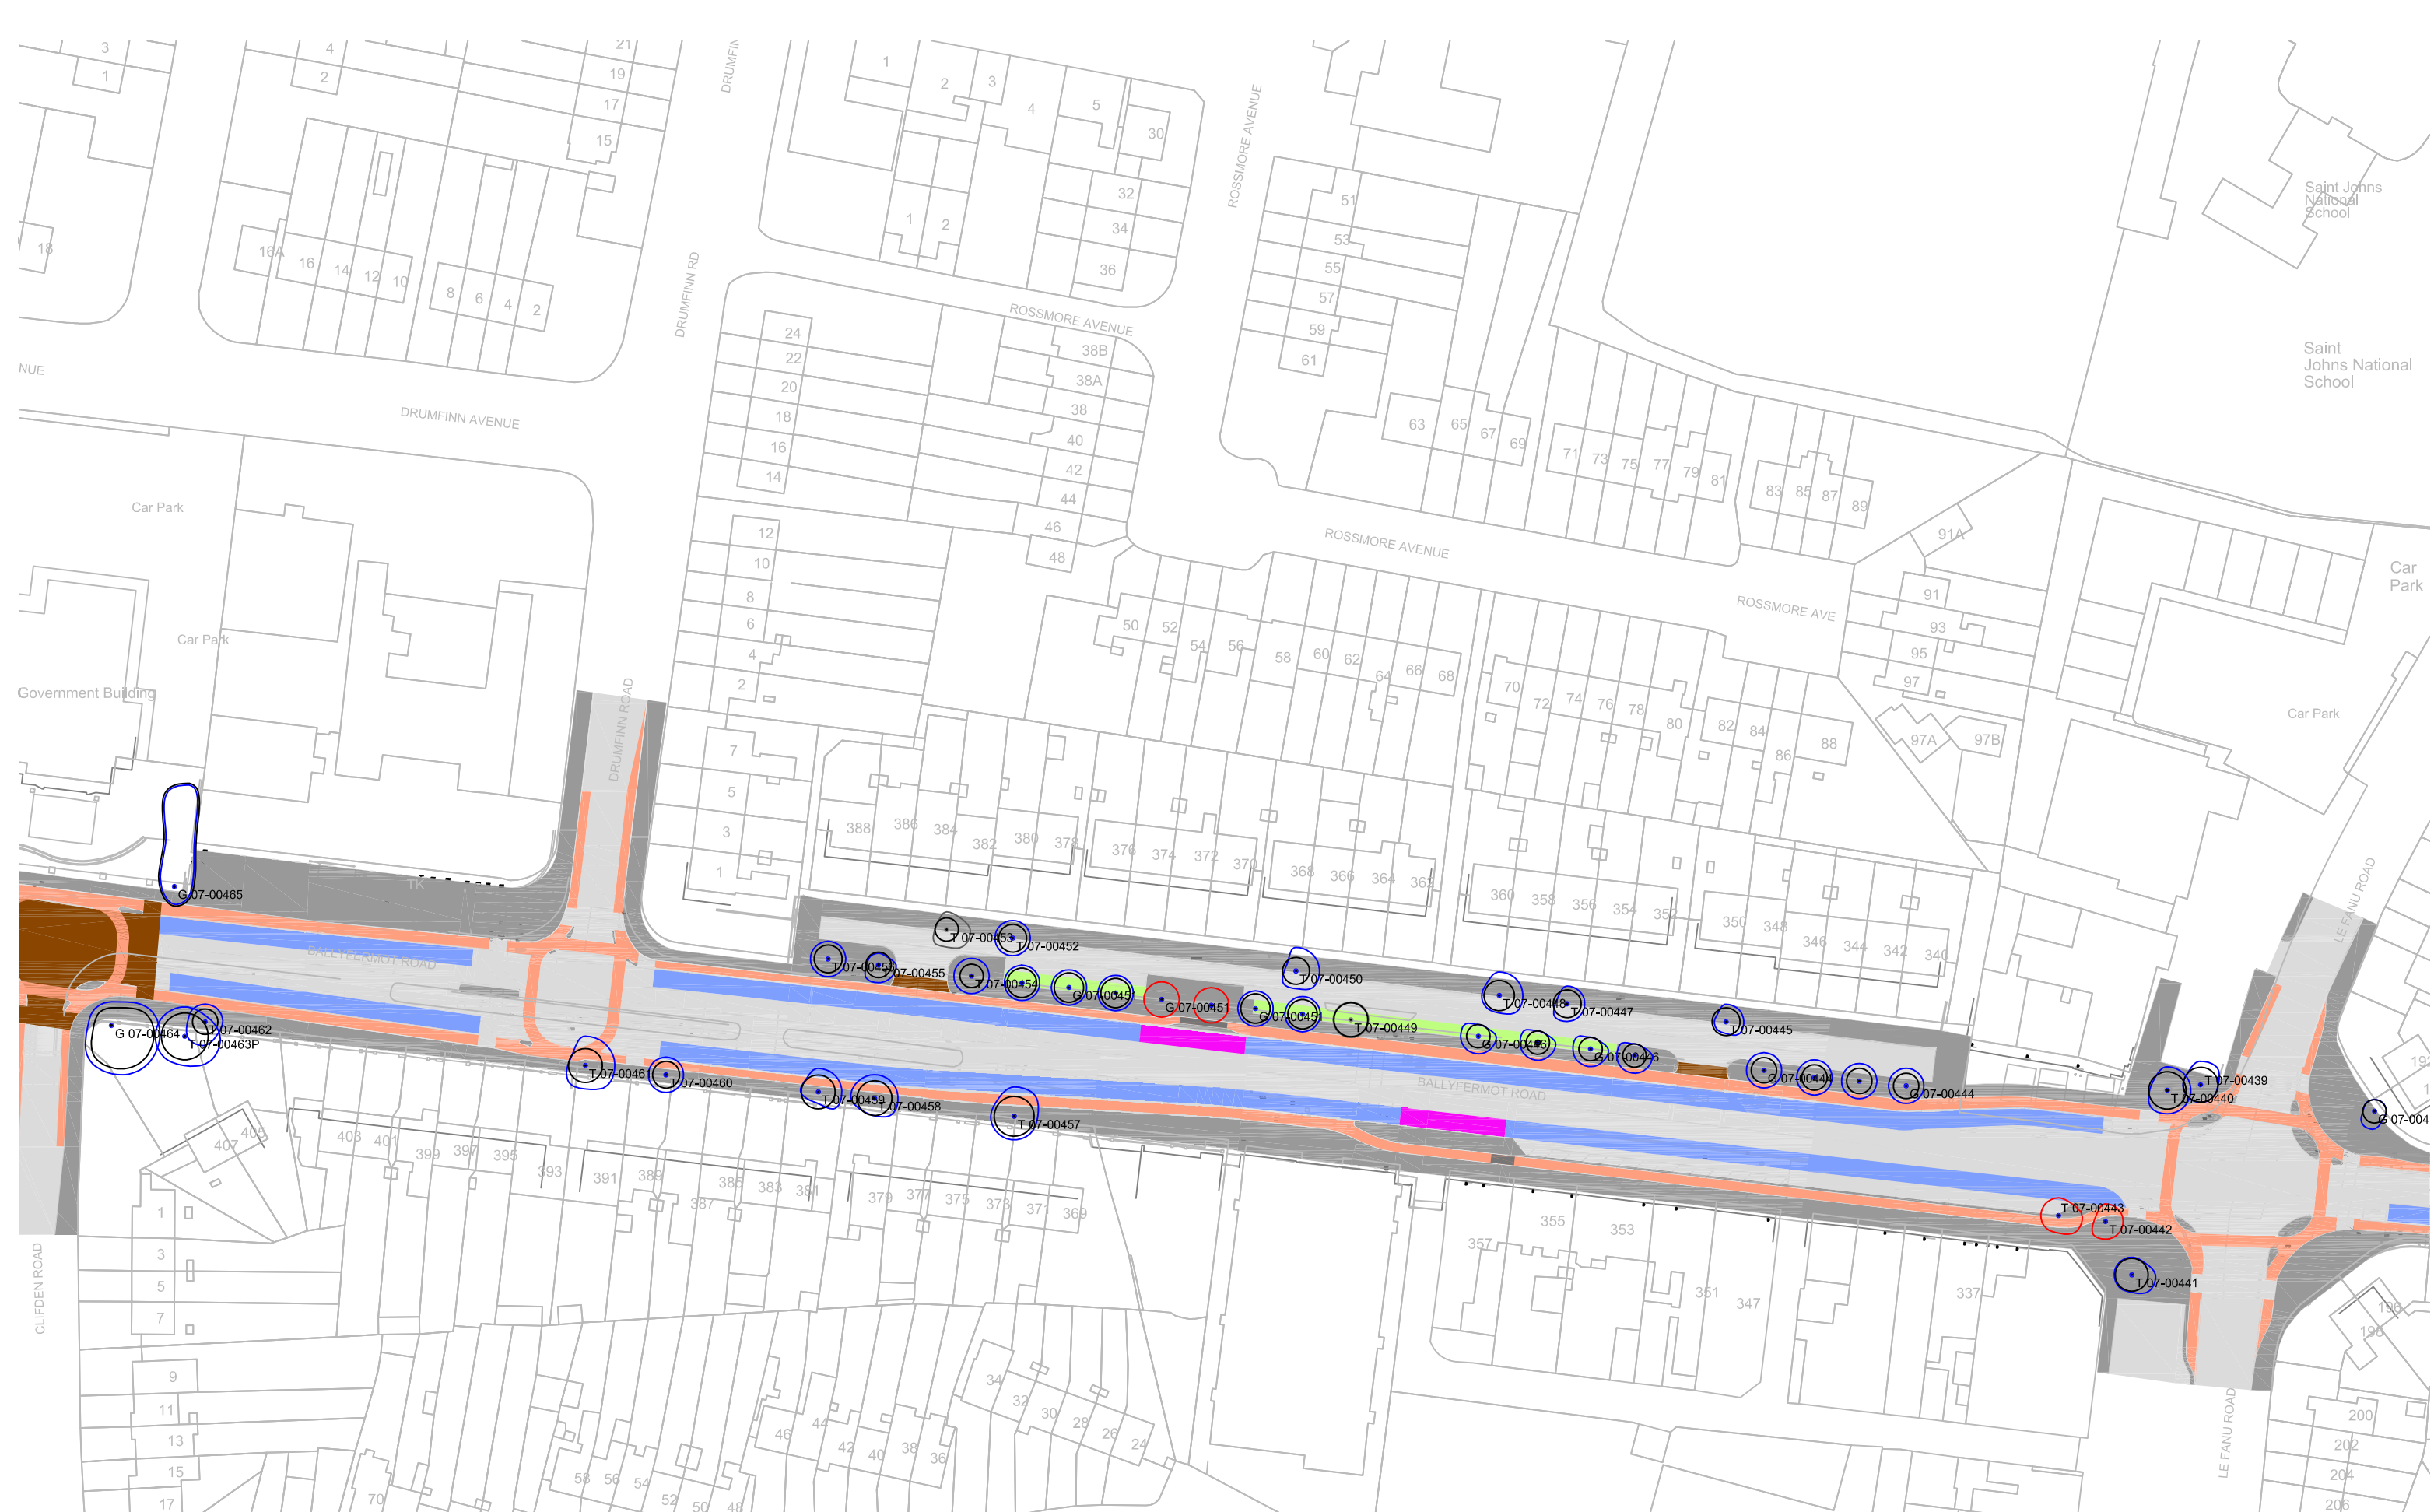
Area of Tree Protection Zone (if described as a perfect circle)

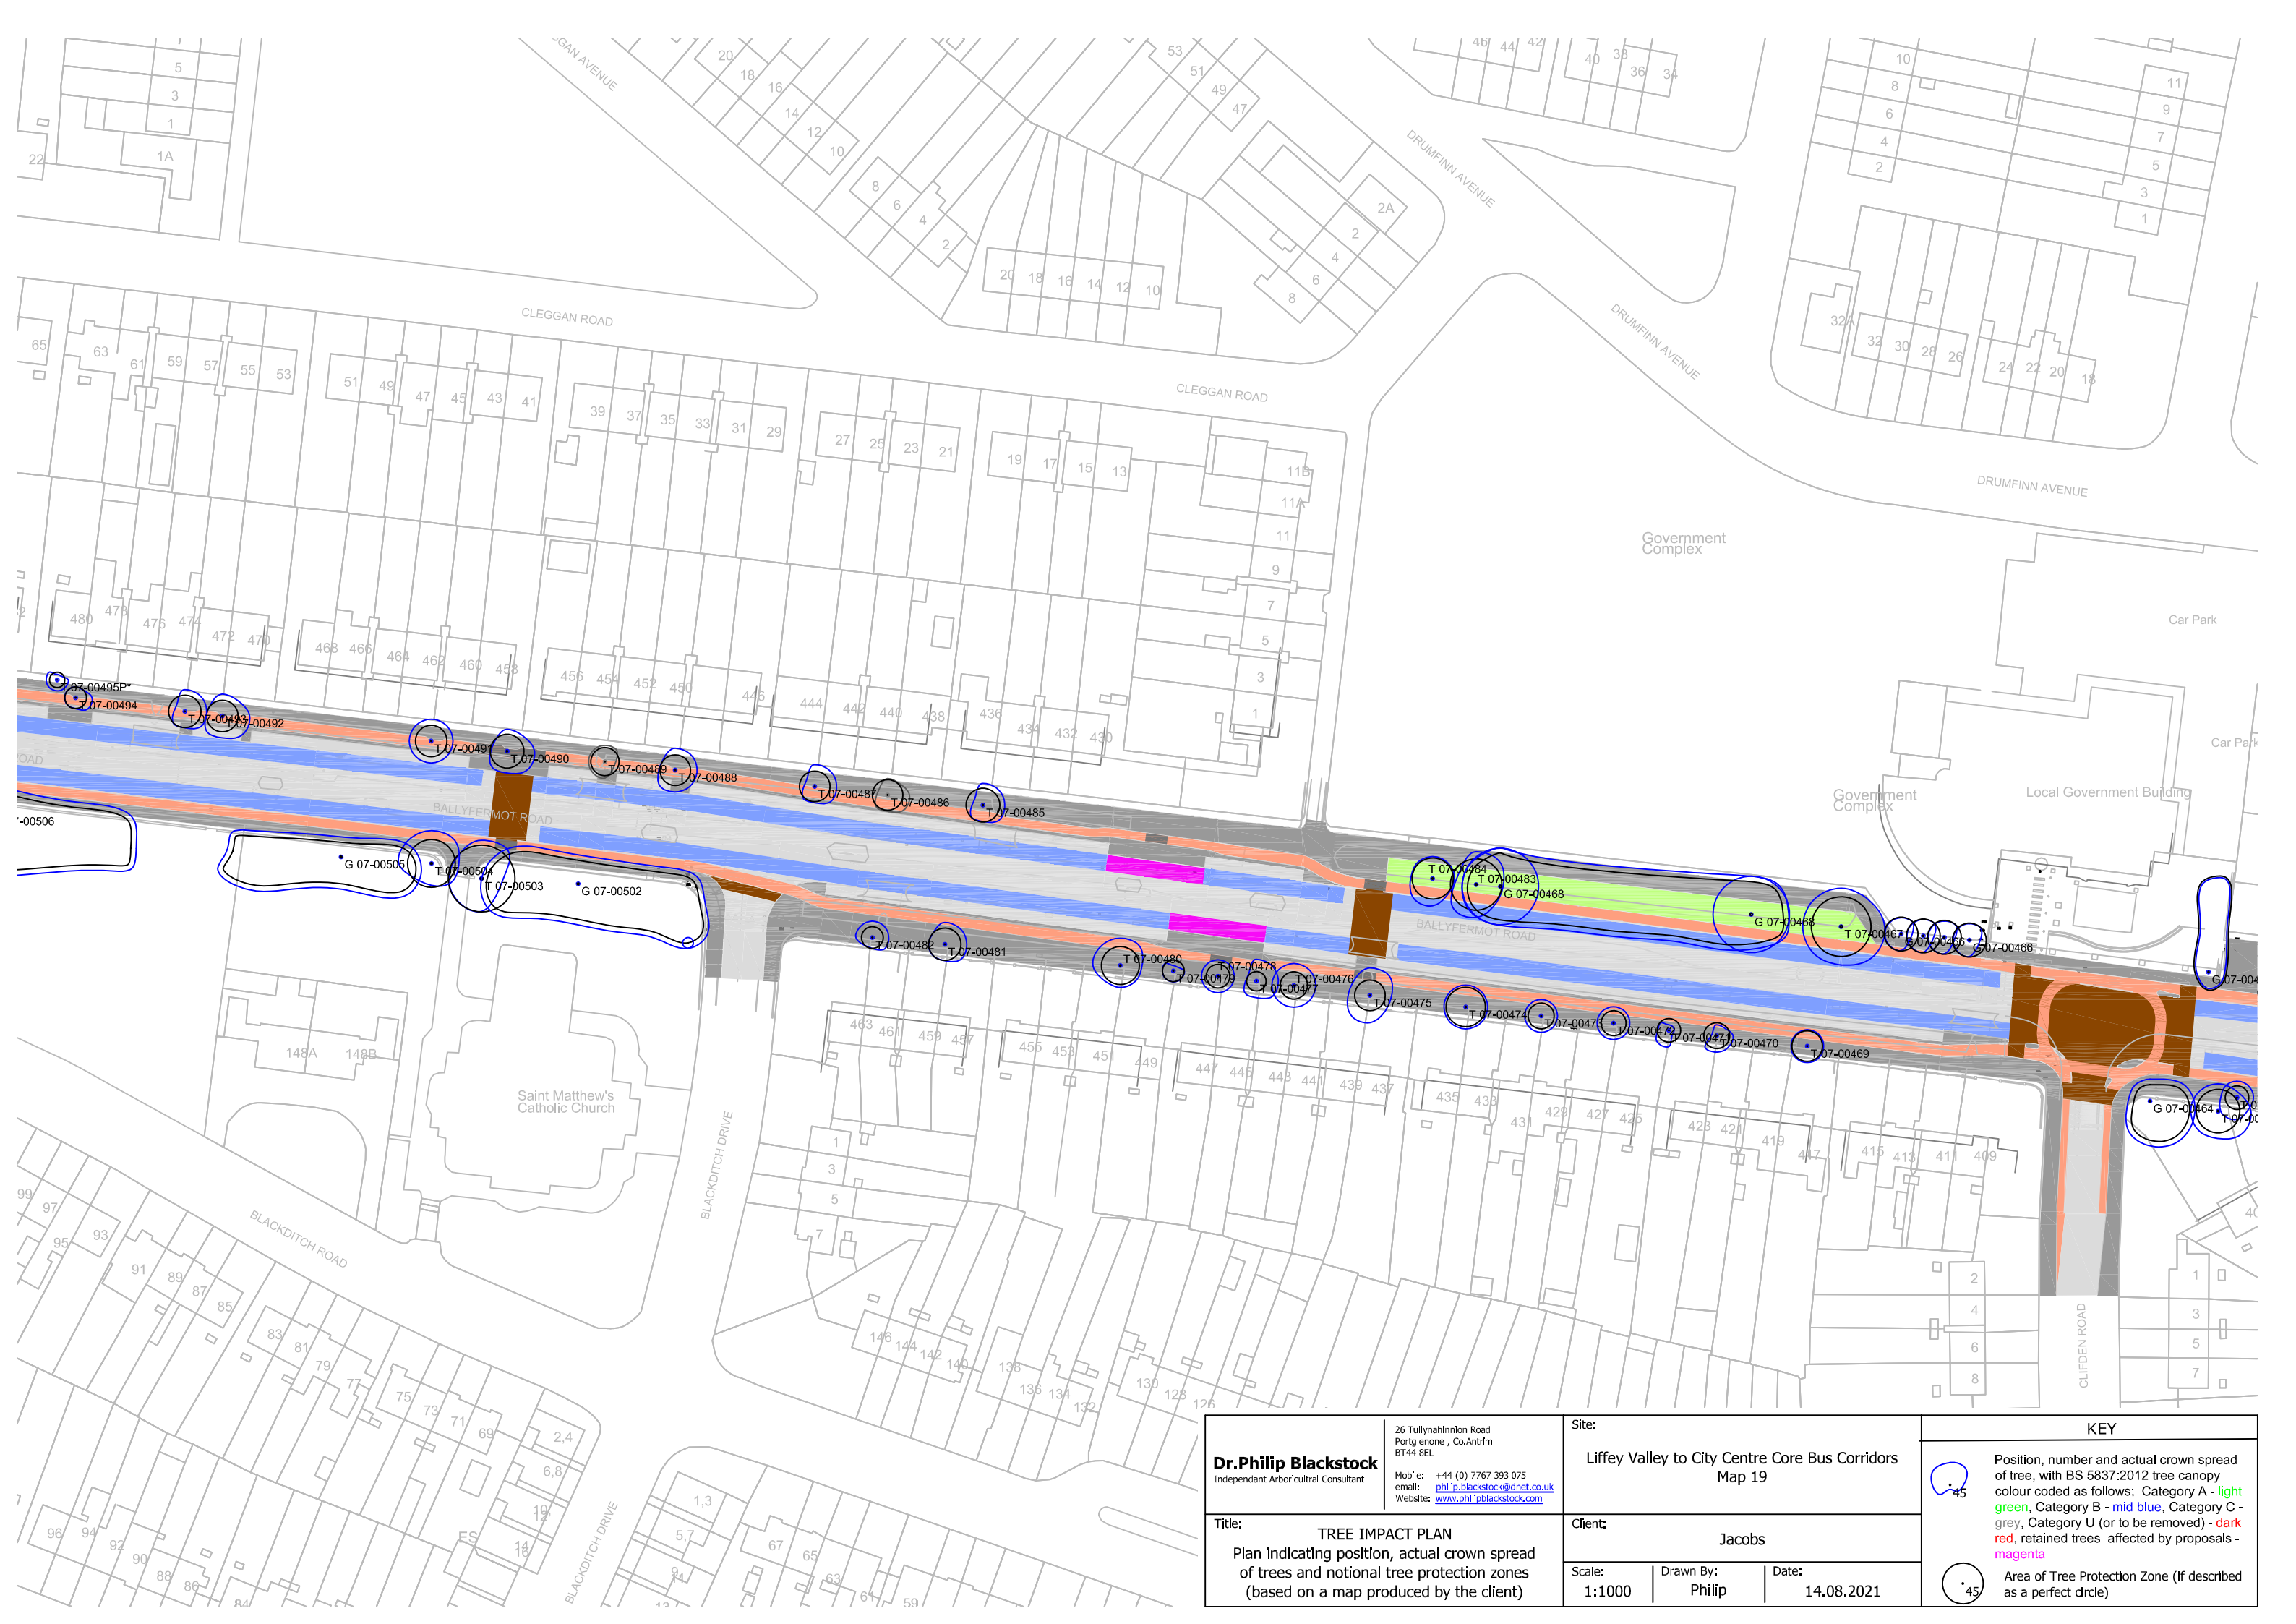
Area of Tree Protection Zone (if described as a perfect circle)
	<b>Title:</b> TREE IMPACT PLAN Plan indicating position, actual crown spread of trees and notional tree protection zones (based on a map produced by the client)		
<b>Scale:</b> 1:1000		<b>Drawn By:</b> Philip	<b>Date:</b> 14.08.2021
