SECTION 13: MATERIAL ASSETS - SITE SERVICES

13 MATERIAL ASSETS – SITE SERVICES

This section of the remedial Environmental Impact Assessment Report (rEIAR) evaluates the impact of the proposal on Material Assets – Site Services. They may be of either human or natural origin and the value may arise for either economic or cultural reasons.

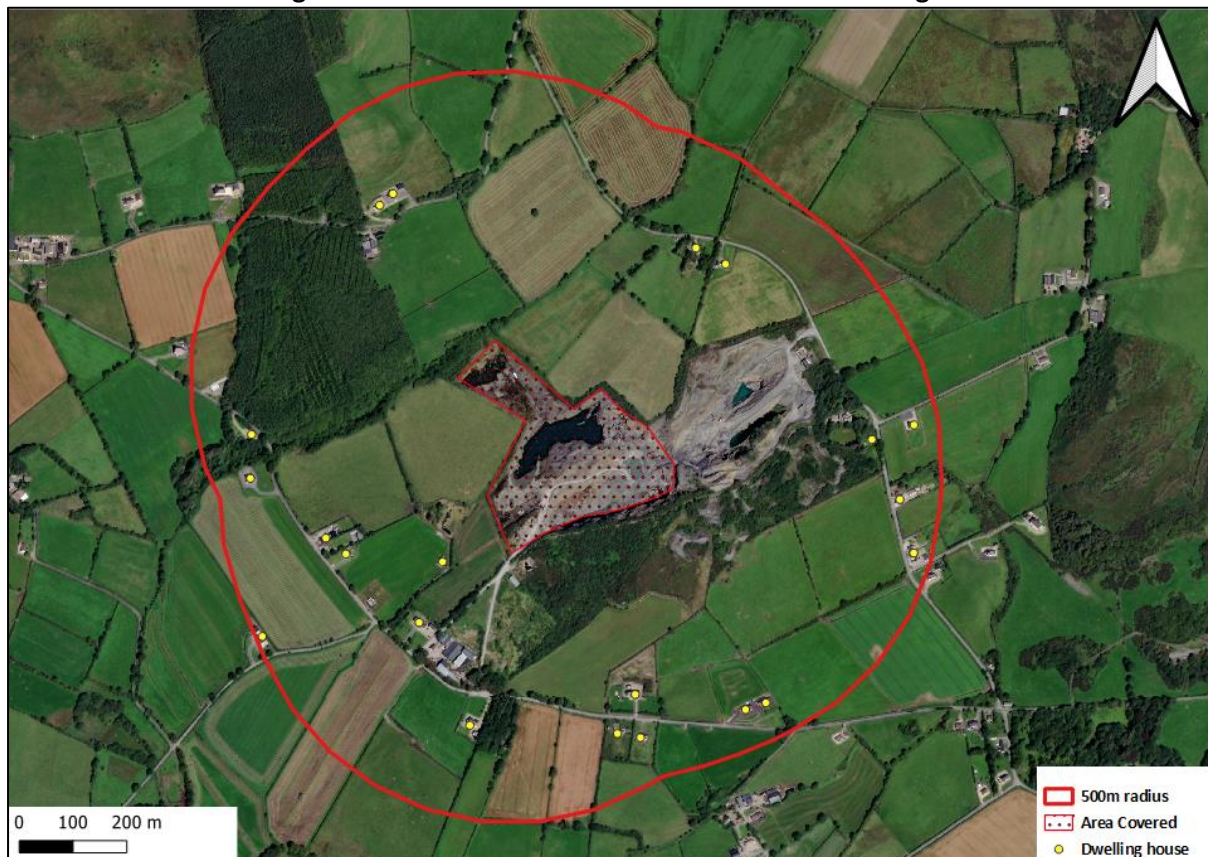
Figure 13.1: Site Location in Relation to Local Dwellings

The quarry is situated in a sparsely populated rural area with sporadic once off housing, the closest occupied dwelling is approximately 120m Southwest of the subject site. There is also a dwelling situated approximately 190m from the subject site on the L-5414-1 local secondary road on the approach to the quarry. Figure 13.1 shows the site location in relation to local dwellings within 500m radius.
