Appendix A9.1
Noise & Vibration
Survey

Appendix A9.1: Noise and Vibration Survey

This report includes the relevant survey details and results associated with baseline noise monitoring undertaken as part of the Lucan to City Centre Core Bus Corridor (hereafter referred to as the Proposed Scheme). The survey has been undertaken to inform the noise and vibration chapter of the Proposed Scheme EIAR.

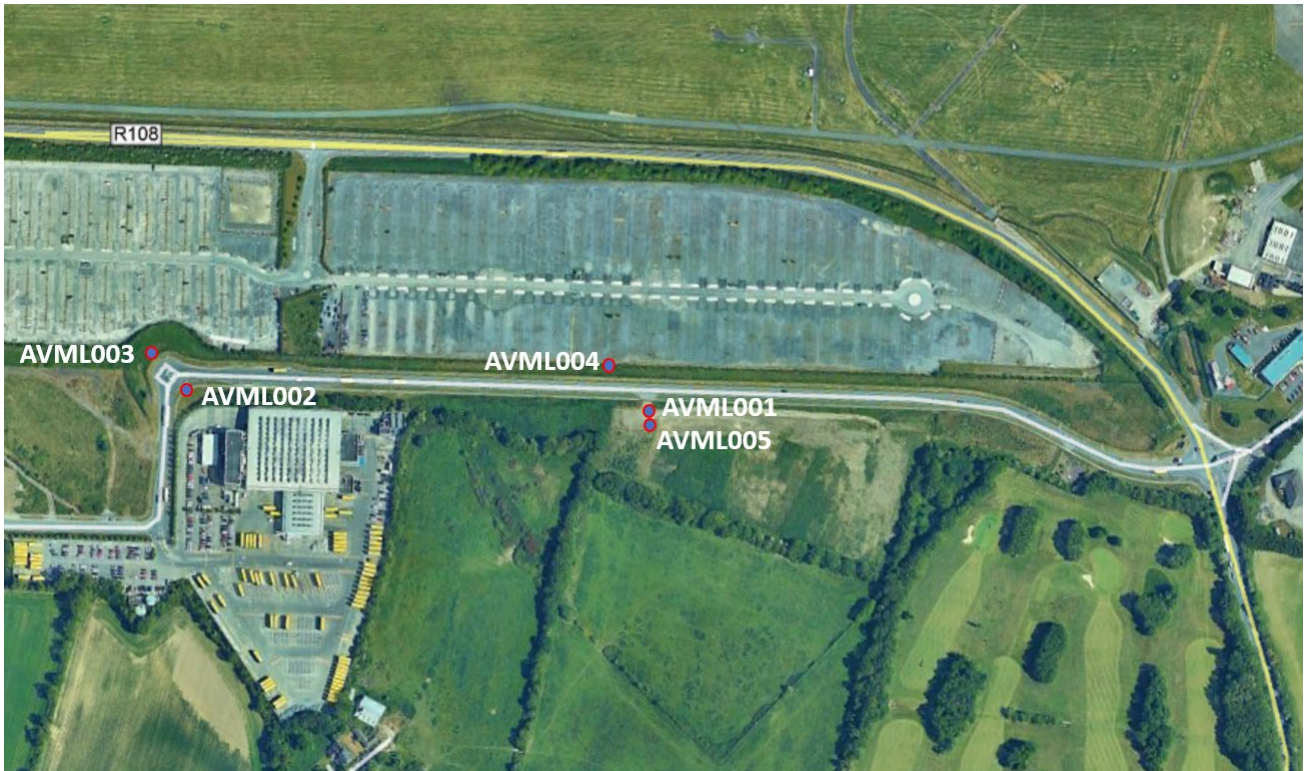
Figure 1: Vibration Monitoring Locations Harristown Bus Depot (source Google Earth)

Vibration Monitoring Locations	Description of Survey Location
AVML001	Harristown – Entrance Road to Bus Depot, midway along inbound road, 5m from road edge
AVML002	Harristown – Roundabout at Bus Depot entrance, buses entering depot, 5m from road edge
AVML003	Harristown – Roundabout at Bus Depot entrance, buses exiting depot, 5m from road edge
AVML004	Harristown – Entrance Road to Bus Depot, midway along outbound road, 5m from road edge
AVML005	Harristown – Entrance Road to Bus Depot, midway along inbound road, 7m from road edge
AVML006	Malahide Road / St. Johns Court – 5m from edge of Inbound Bus Lane
AVML007	Malahide Road / St. Johns Court – 10m from edge of Inbound Bus Lane
AVML008	Malahide Road / Donnycarney Church – 2.5m from edge of Inbound Bus Lane
AVML009	Malahide Road– 2.5m from edge of outbound Bus Lane

The survey locations undertaken along the Harristown Bus Depot entrance are illustrated in Figure 1. The survey locations undertaken along the Malahide Road are illustrated in Figure 2.

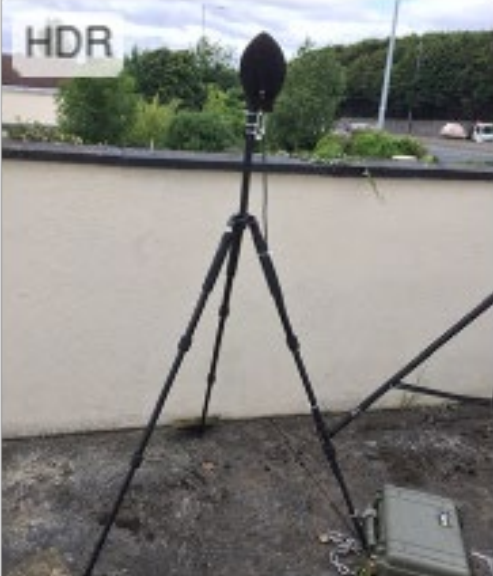
Location	Equipment Set up
<p>CBC0006UNML001</p> <p>On driveway in residential front garden to northwest of Mount Andrew Court, to south of N4. In line with closest residential facades to west in Hermitage Way estate, approximately 12m from N4 road edge.</p>

<p>The photograph shows a black tripod-mounted monitoring device, likely a noise or vibration sensor, positioned on a paved driveway. The device has a dark, spherical sensor head. In the background, a light-colored wall with a sign that reads 'HDR' is visible. The setting appears to be a residential area with trees and a road in the distance.</p>

For the unattended survey, a Rion WS-15 Outdoor Microphone Protection System with microphone extension cable and outdoor peli-case was used. An image of the equipment installed at the unattended monitoring location is included in this report. The surveys were conducted by Jack Brennan and Alex Ryan, acoustic technicians, AWN Consulting.

For the unattended noise survey, the monitoring equipment was installed within the private grounds of a residential property. The microphone was extended to a height of approximately 1.5m above ground. The equipment was set to log for 15 minute intervals on a continual basis over a one-week period.
