## **Botanical Study Appendix 6-1**

Botanical Survey,  
Renewable Energy  
Development Curraglass,  
Co. Cork

Project Title: **Botanical Survey, Renewable Energy Development Curraglass, Co. Cork**

Document Title: **Botanical Study Appendix 6-1**

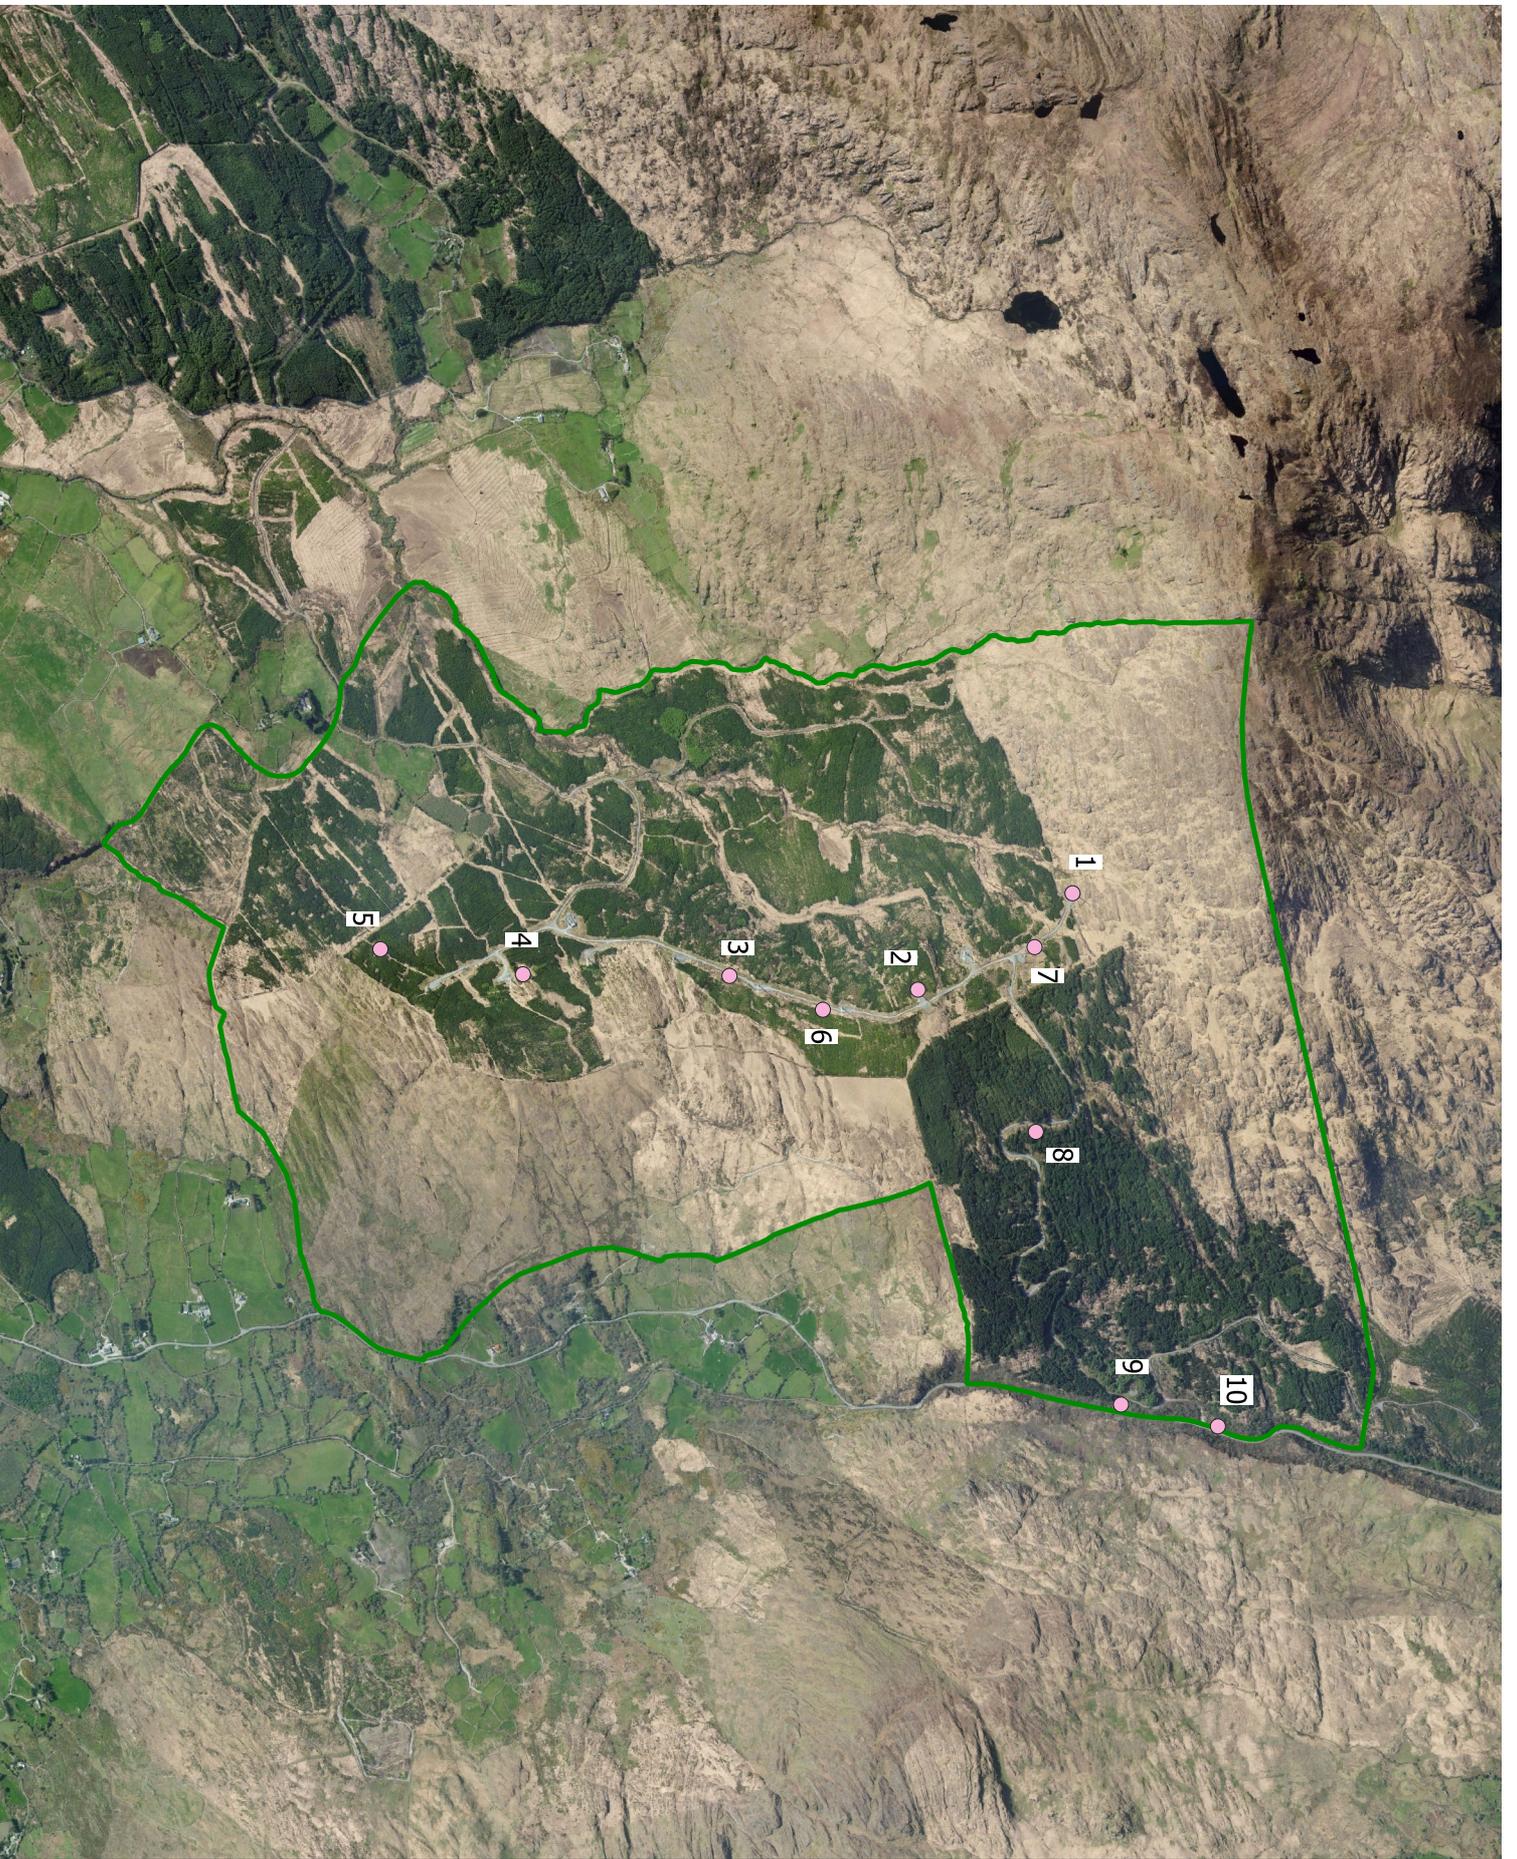
Project Title Curraglass Renewable Energy Development, Co. Cork	
Drawn By Laoise Kelly	Checked By John Hynes
Project No. 190301	Drawng No. Figure 6-1-1
Scale 1:22500	Date 07.05.2020

Drawing Title  
 Relevé Locations

A total of 10 relevés were undertaken within the proposed development footprint as shown on Figure 6-1-1. Additional relevés were also undertaken which have informed the Biodiversity chapter, however, these have not been described here as they are located outside of the proposed development footprint and will not be impacted by the proposed works.

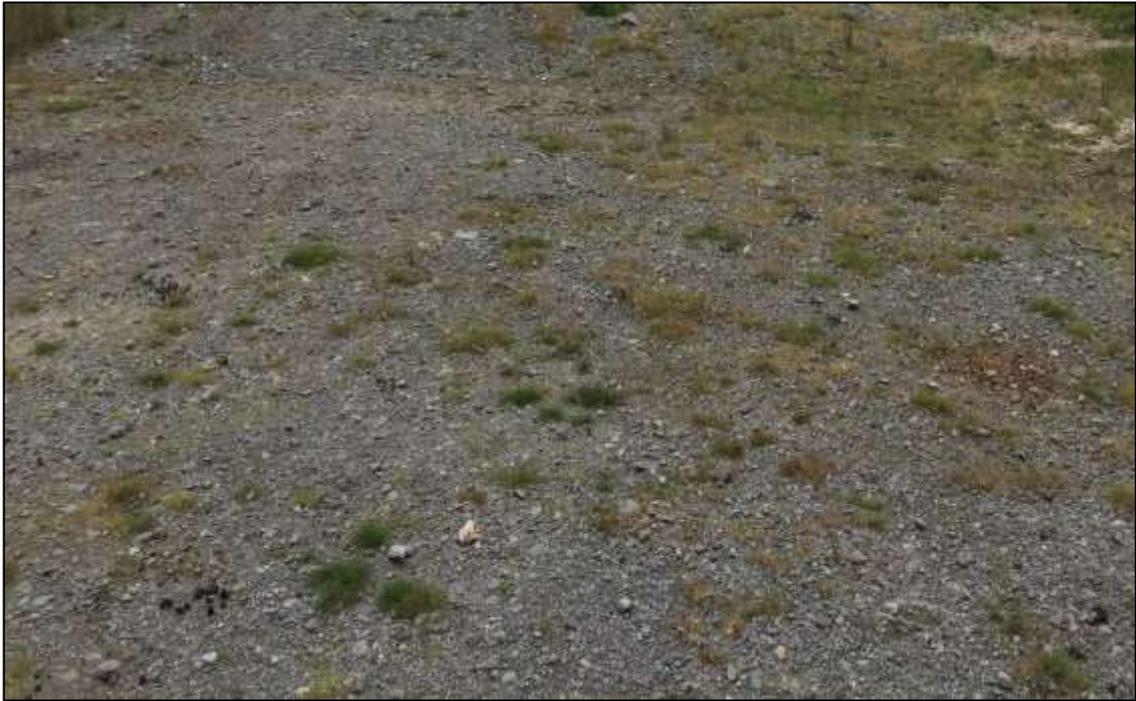
*Plate 3-1 Recolonising bare ground (ED3) at Turbine 1.*

The proposed turbine will be located at an existing turbine base categorised as Recolonising Bare Ground (ED3). The species recorded in this habitat are provided in Table 3-1 below.

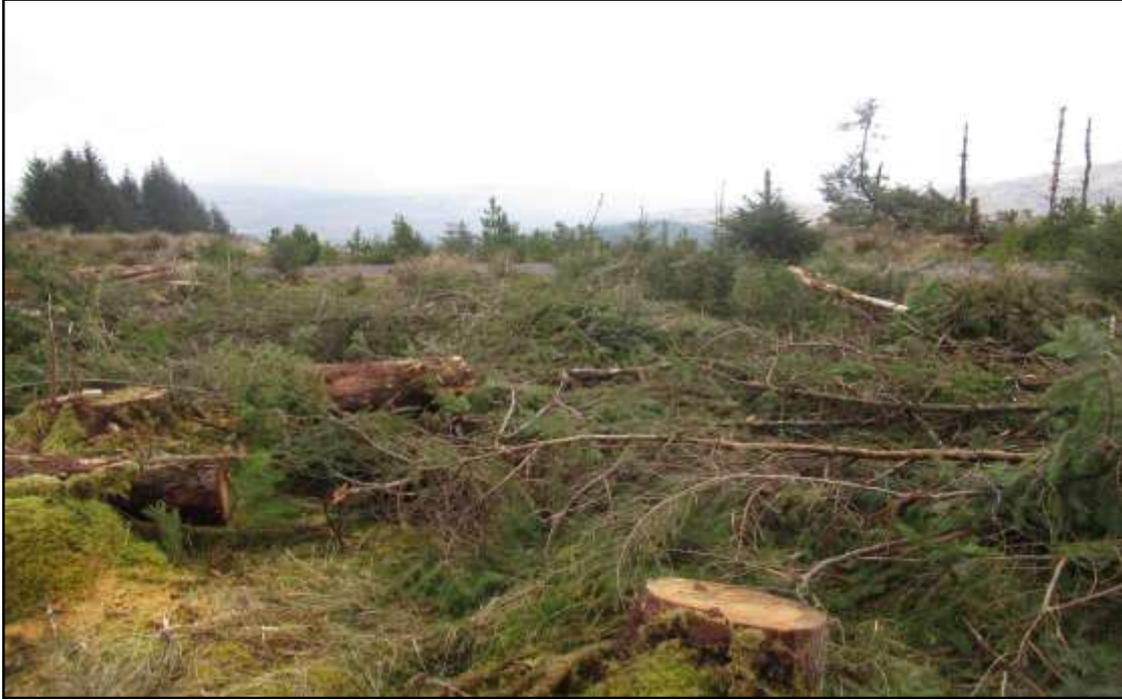
Plate 3-2 Example of conifer plantation recently felled at Turbine 2

Area dominated by conifer forestry with *Thuidium tamariscinum* ground flora. No table of vegetative composition provided here due to forestry dominated nature of the habitat within the proposed development footprint. Tree species comprised Sitka Spruce (*Picea sitchensis*) (Grid ref. E109462 N063558).

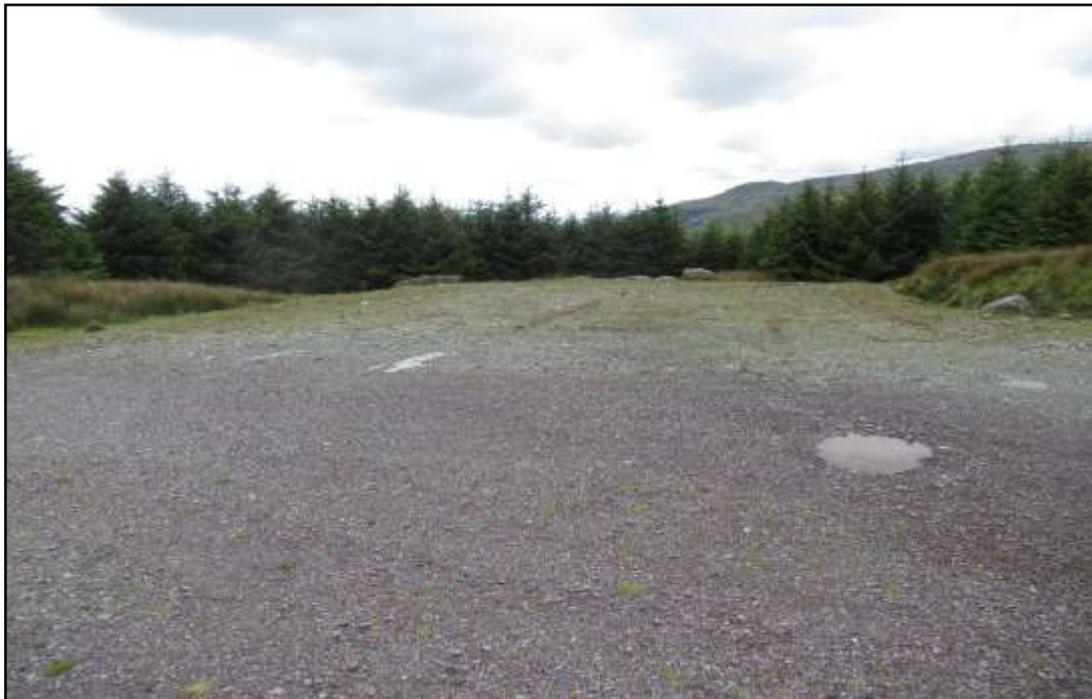
Plate 3-3 Recolonising Bare Ground (ED3) at Turbine 3.

Area comprised an existing hard standing associated with previous turbine infrastructure. The new turbine will be located within the footprint of the existing hardstanding area. The dominant habitat was described as Recolonising Bare Ground (ED3). The species recorded in this habitat are described in Table 3-2.

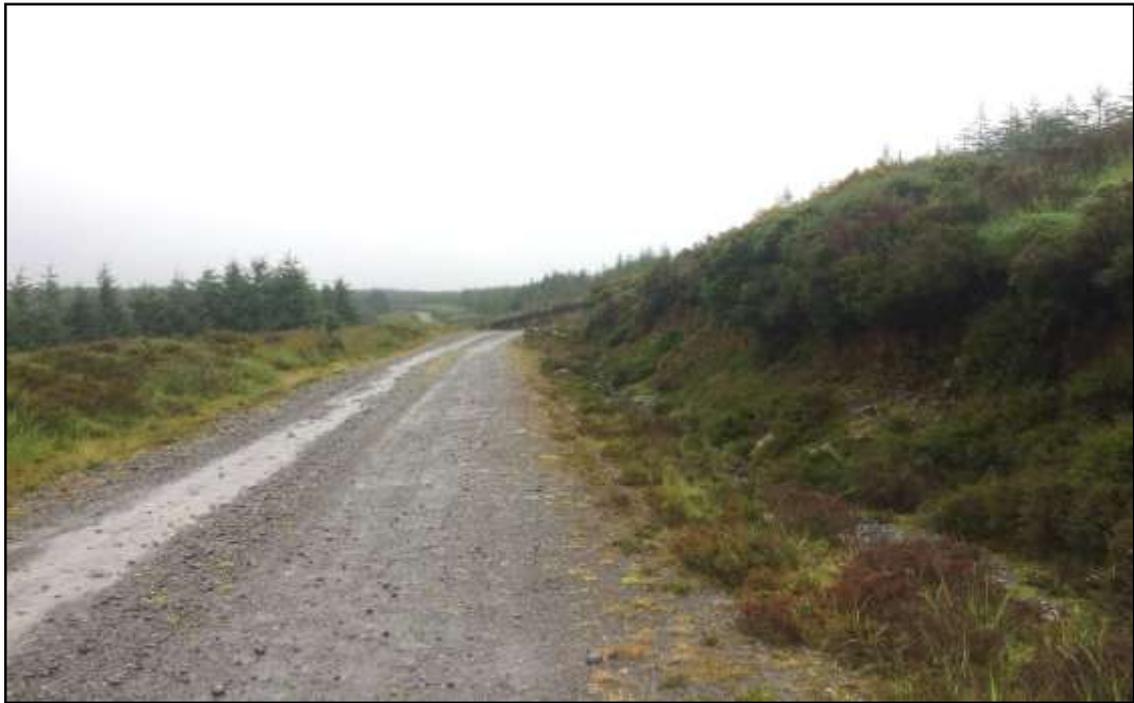
*Plate 3-4 Degraded Wet Heath (HH3) habitat located at Turbine 4*

Area comprised degraded Wet Heath (HH3) drained as a result of the existing adjacent road and conifer forestry. The species recorded in this habitat are described in Table 3.3.

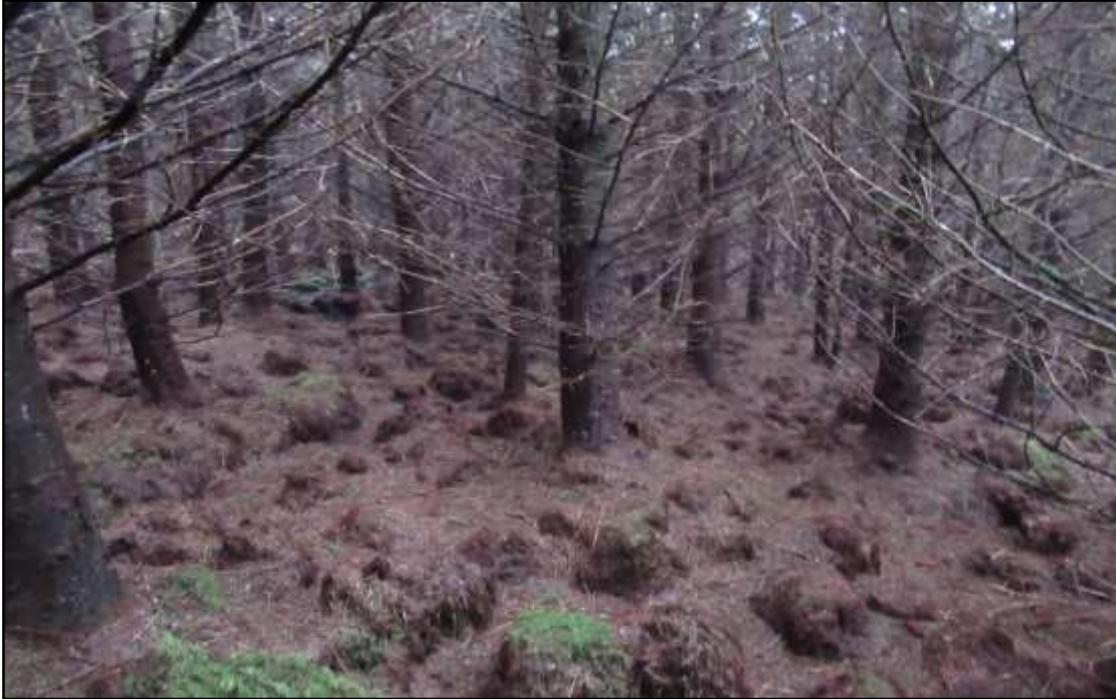
Plate 3-5 Conifer Forestry (WD4) located at Turbine 5

Area dominated by Sitka Spruce (*Picea sitchensis*). The forest floor was mostly bare and predominantly covered with pine needles with some small patches of *Thuidium tamariscinum* recorded throughout (Grid Ref. E108534 N062207).

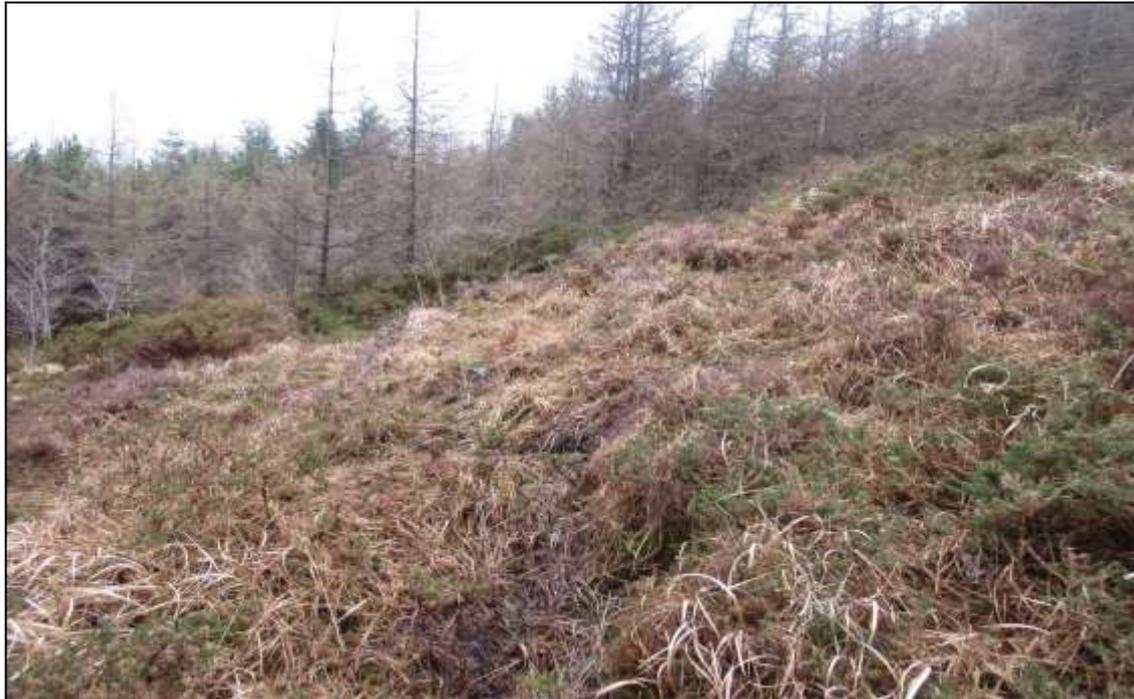
*Plate 3-6 Degraded Wet Heath (HH3) at Turbine 6*

Area of degraded Wet Heath (HH3) associated with conifer forestry supporting species Sitka Spruce (*Picea sitchensis*), Lodgepole Pine (*Pinus contorta*) and Larch (*Larix europaeus*). The ground was heavily poached and there was evidence of deer and sheep grazing. Rocky outcrops existed throughout the wider area. The species recorded in this habitat are described in Table 3-4.

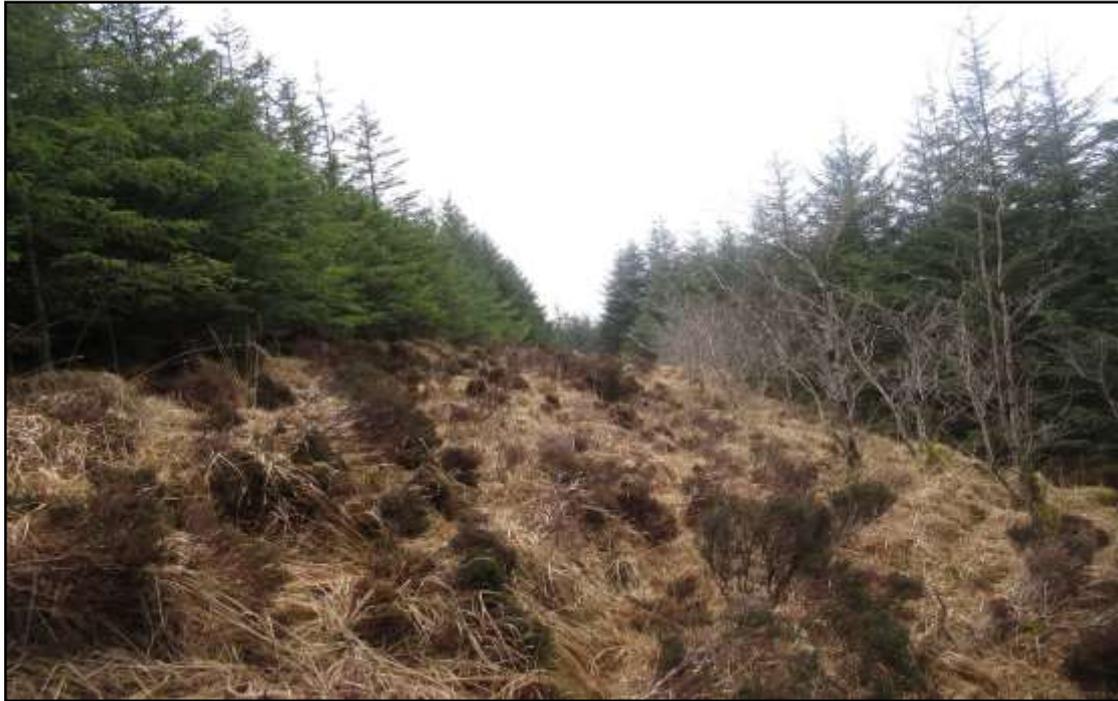
Plate 3-7 Forestry ride categorised as degraded Wet Heath (HH3), Turbine 7

Area of degraded Wet Heath (HH3) associated with forestry ride within Sitka Spruce (*Picea sitchensis*) forestry plantation. The species recorded in this habitat are described in Table 3-5.

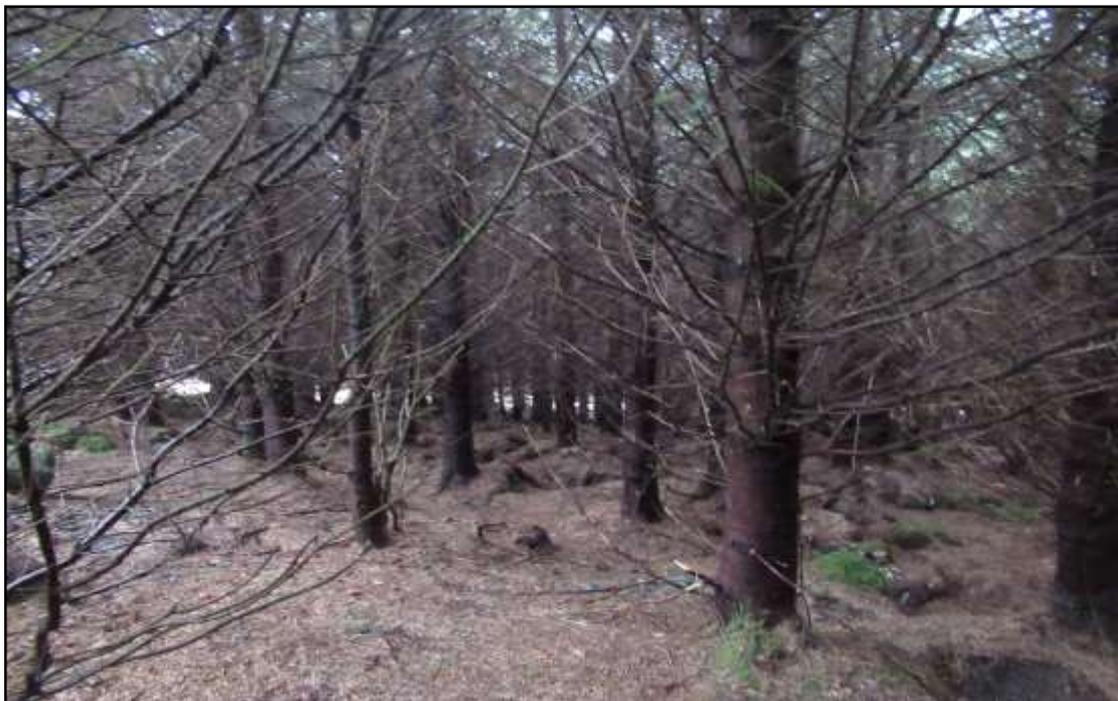
Plate 3-8-Location of substation and battery storage compound within Conifer Plantation (WD4)

Area comprised Sitka Spruce (*Picea sitchensis*) Conifer Plantation (WD4) adjacent to the existing substation. The forestry is mature and the forest floor heavily shaded with occasional patches of *Thuidium tamariscinum* moss and boulders present as shown in Plate 3-8

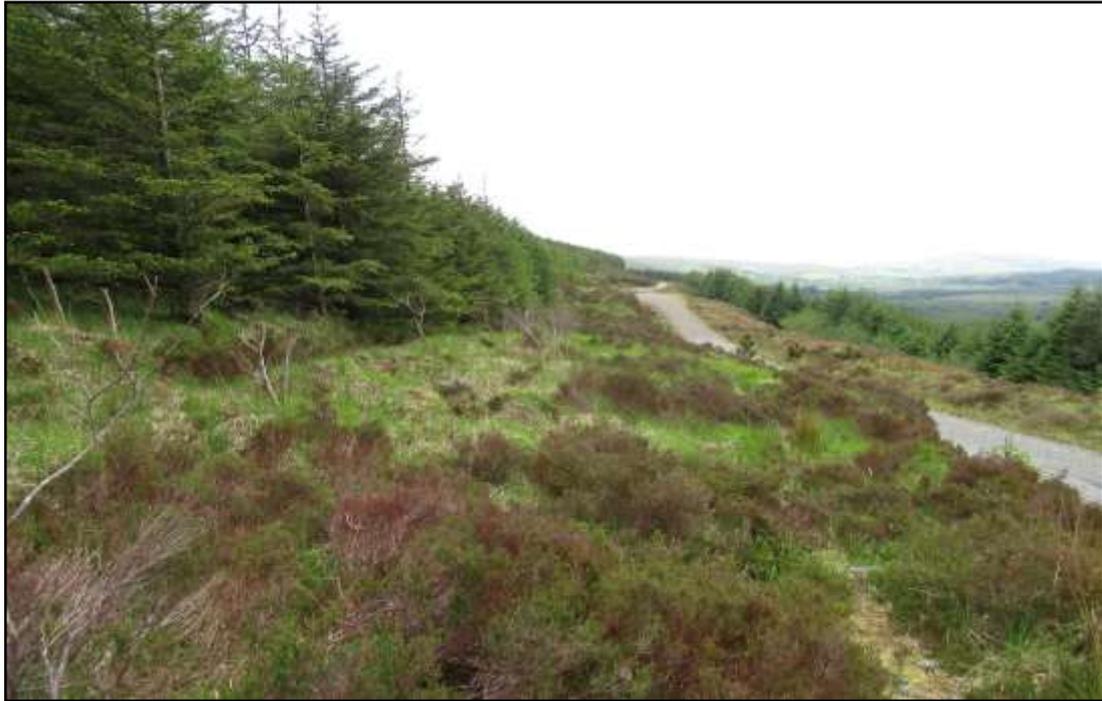
Plate 3-9 Location of proposed meteorological mast.

The location of the proposed meteorological mast comprised degraded wet heath that had been drained as a result of the road and forestry plantation. The species within this habitat are recorded in Table 3-6 below.

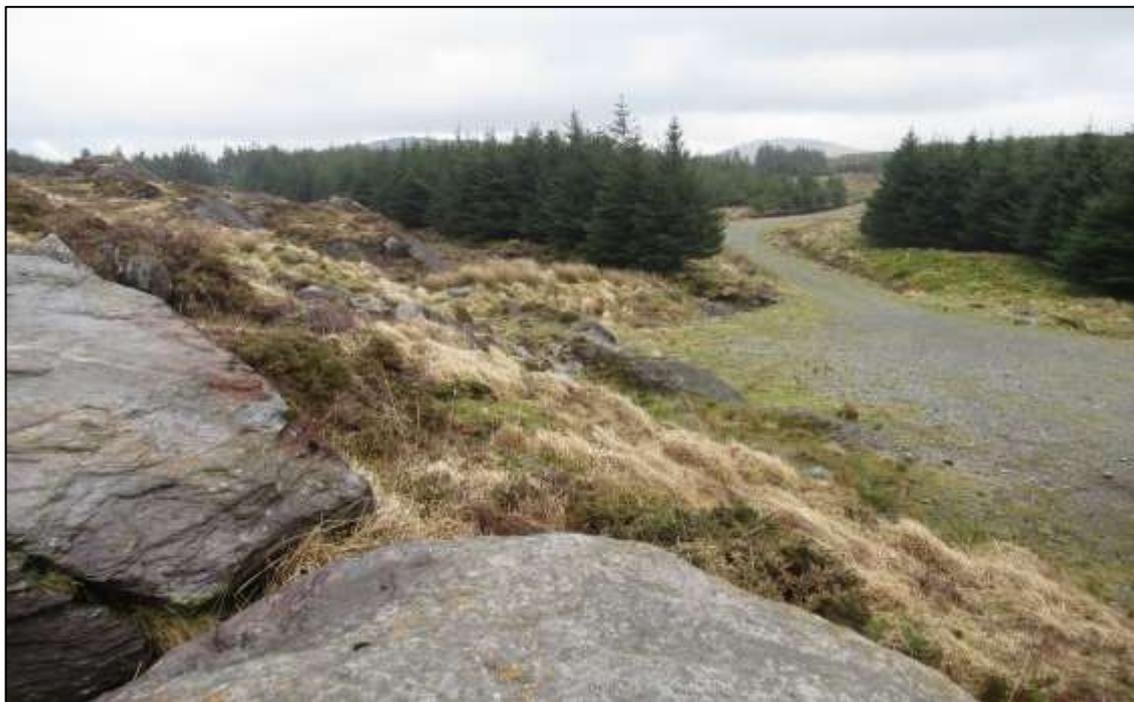
Plate 3-10 Borrow Pit near Turbine 3

It is proposed to develop 2 No. on-site borrow pits as part of the Proposed Development. Borrow Pit 1 is located approximately 70 metres northeast of Turbine No. 3 and measures approximately 7184.8 metres square. This borrow pit is located in an area categorised as Recolonising Bare Ground (ED3), Exposed Siliceous Rock (ER1), and Conifer Plantation (WD4) as shown below.

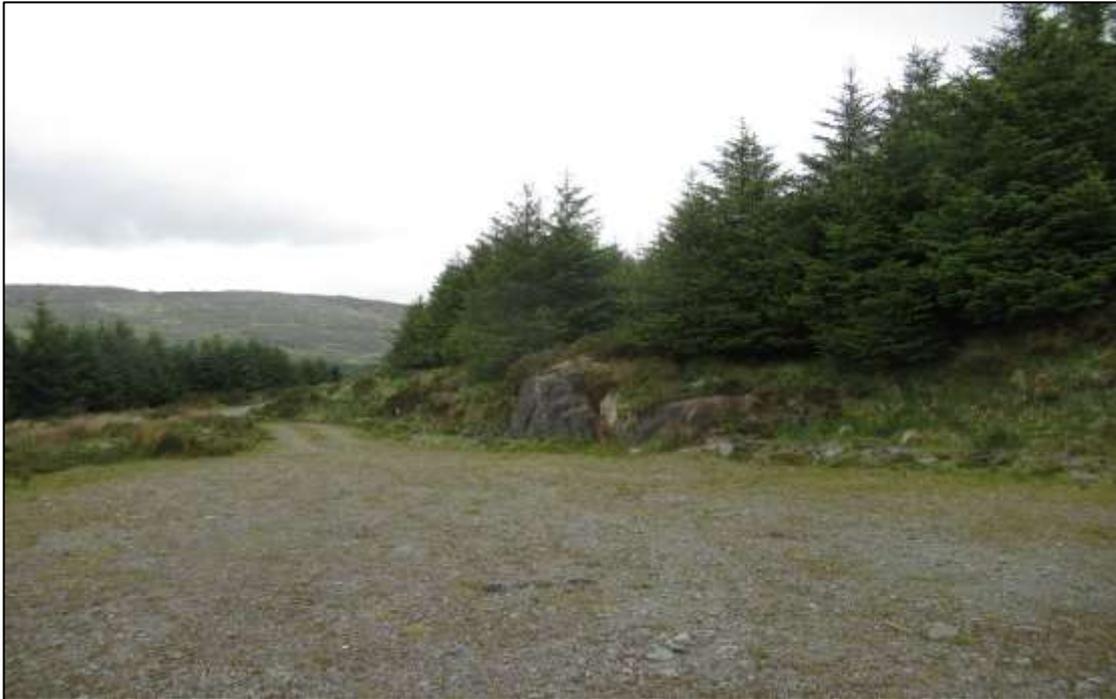
Plate 3-11 Conifer Plantation (WD4) in which Borrow Pit 2 will be constructed

Borrow Pit 2 is located further south within the site, approximately 180 metres north of Turbine No. 6, and measures approximately 2518 meters square (Grid Ref: E109002 N06211). This borrow pit is located in Conifer Plantation (WD4) as shown below. No table of vegetative composition is provided here due to the forestry dominated nature of the habitat within the proposed development footprint.

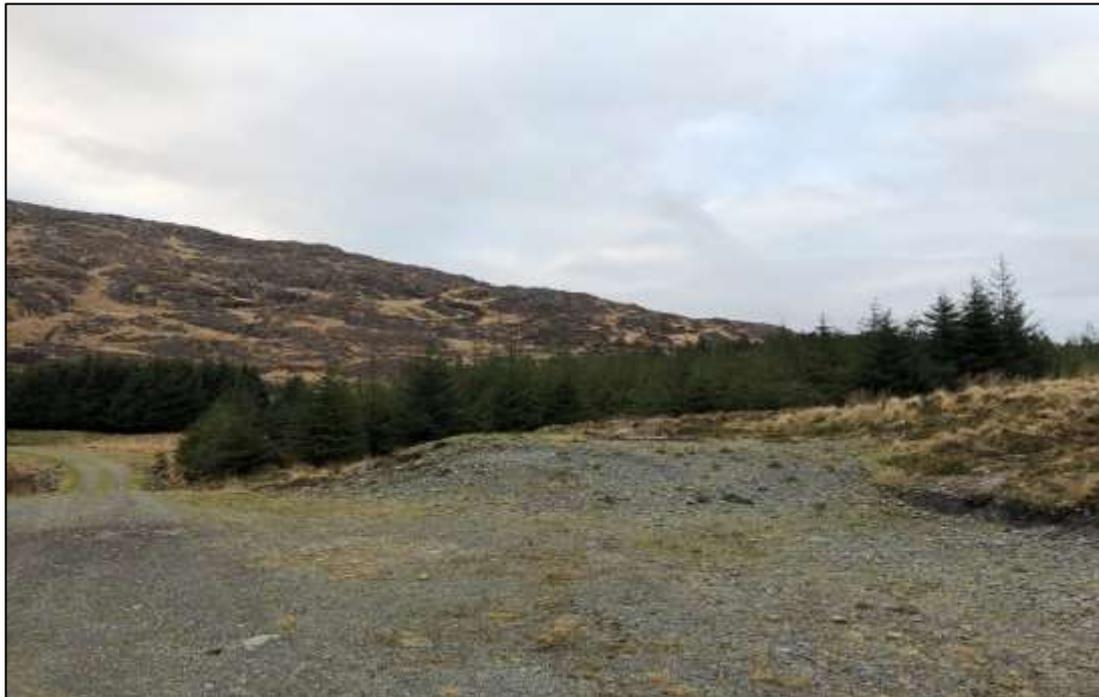
Plate 3-12 Temporary Construction Compound Relevé 7

The proposed temporary construction compound is predominantly located at a hardstanding area associated with a previous turbine and was categorised as Recolonising Bare Ground (ED3). The area to the east of this has been cut away and comprised degraded Wet Heath (HH3). The degraded heath habitat was being encroached by wet grassland species *Juncus* and was heavily poached by sheep grazing. A Relevé was taken within the footprint of the proposed compound as shown in Table 3-7 below.

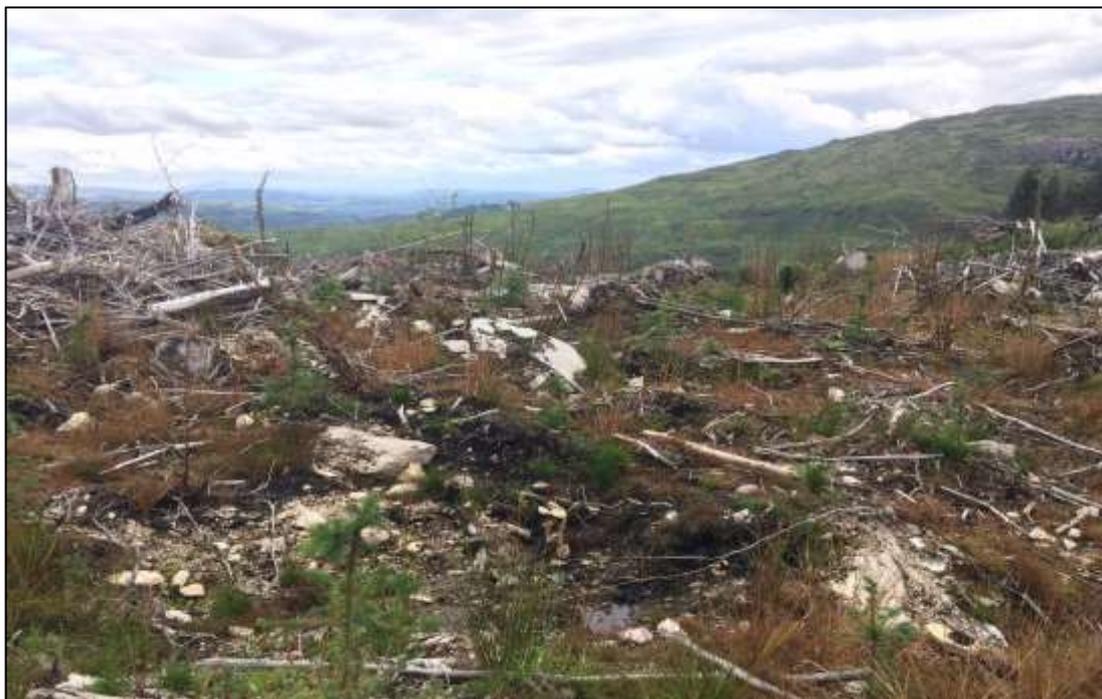
Plate 3-13 Recently felled and replanted Conifer Forestry (WD4) within new road realignment

The proposed new road realignment near Turbine 2 will go through existing Conifer Plantation (WD4) that has been recently felled and replanted. The species recorded within the footprint of the proposed road realignment are described in

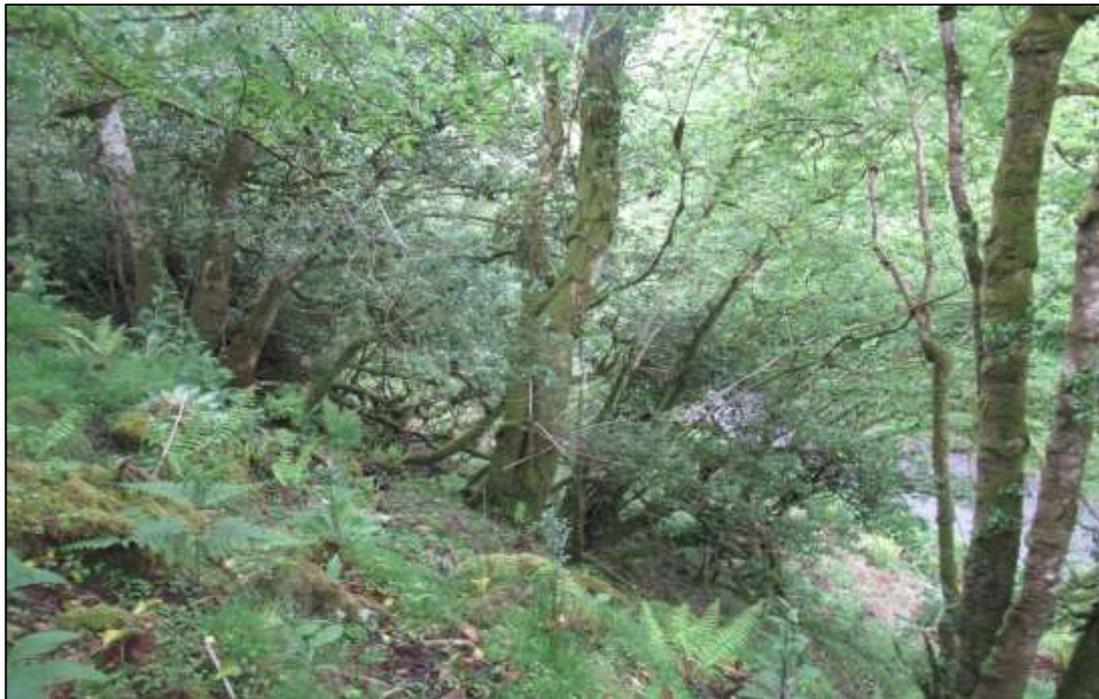
Plate 3-14 Sessile Oak- Hazel Woodland to south of the site entrance, Relevé 9

It is proposed to widen the existing access road at the entry to the site. The access track is bordered by Oak-Birch-Holly Woodland (WN1). A 20m x 20m relevé was conducted in one area to the north and one to the south of the existing access road. The results of these relevés are shown in Table 3-9 and Table 3-10

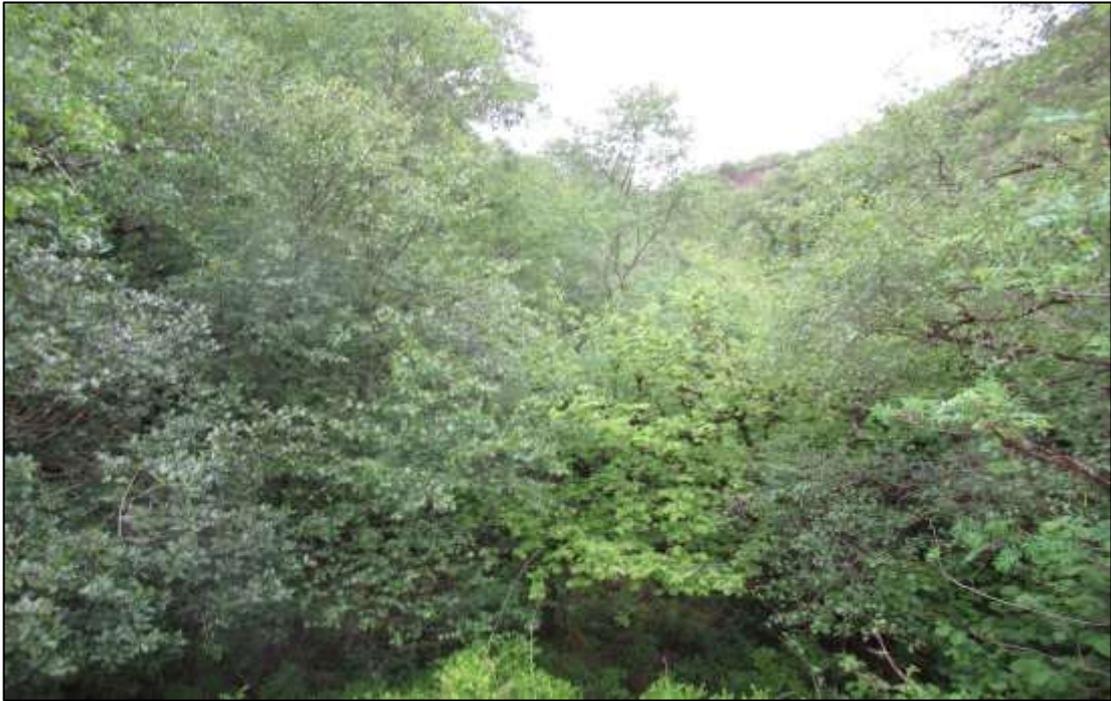
*Plate 3-15 Sessile Oak-Bilberry Woodland to north of the site entrance, Relevé 10*
