244 Airfield Surveys Phase 2

Ground Investigation Report

Project Title	244 Airfield Surveys Phase 2
Engineer	Kilwex
Client	DAA
Project No	7926-07-18
Document Title	Factual Ground Investigation Report

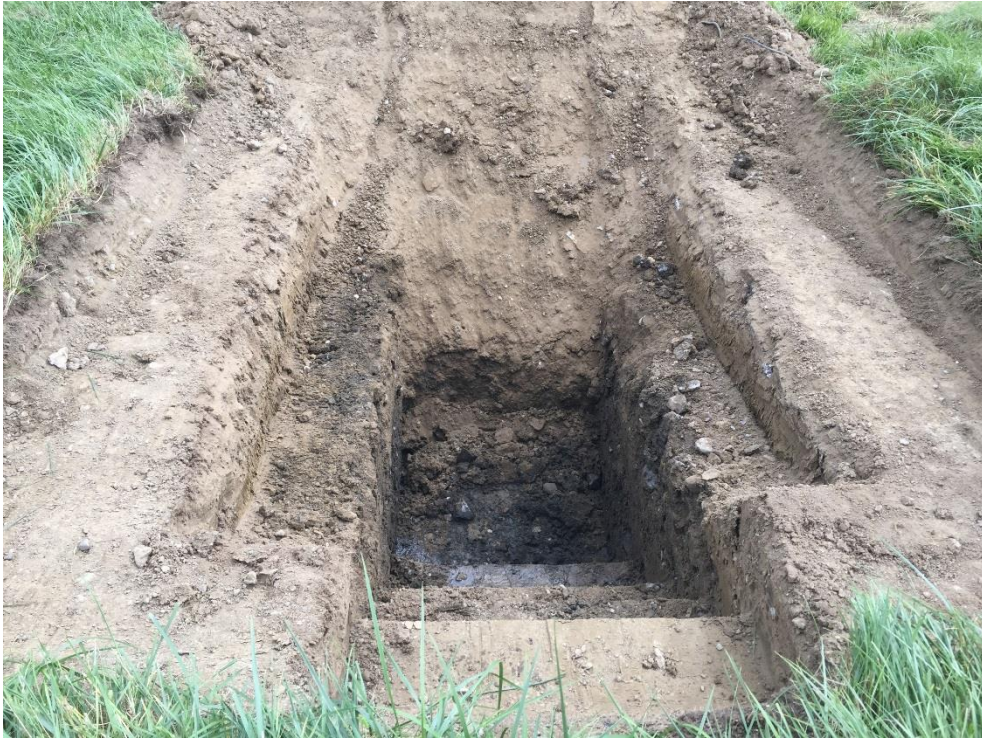
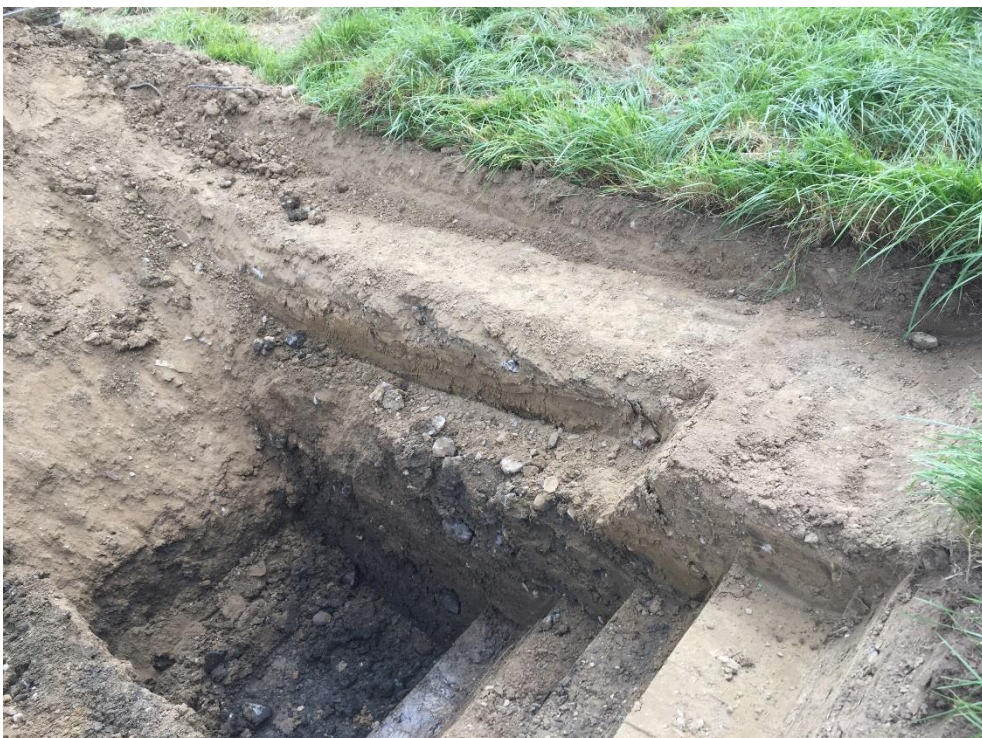
OP01

Plan .	Remarks No Groundwater encountered. Trial pit stable. TRL probe carried out at 0.50m, 1.0m 2.0m and 2.50m BGL. Plate test carried out at 1.0m BGL in trial pit. Trial pit backfilled on completion.			
	<table border="1" style="width: 100%; border-collapse: collapse;"> <tr> <td style="width: 33%;">Scale (approx) 1:25</td> <td style="width: 33%;">Logged By ROT</td> <td style="width: 33%;">Figure No. 7926-07-18.OP1</td> </tr> </table>	Scale (approx) 1:25	Logged By ROT	Figure No. 7926-07-18.OP1
Scale (approx) 1:25	Logged By ROT	Figure No. 7926-07-18.OP1

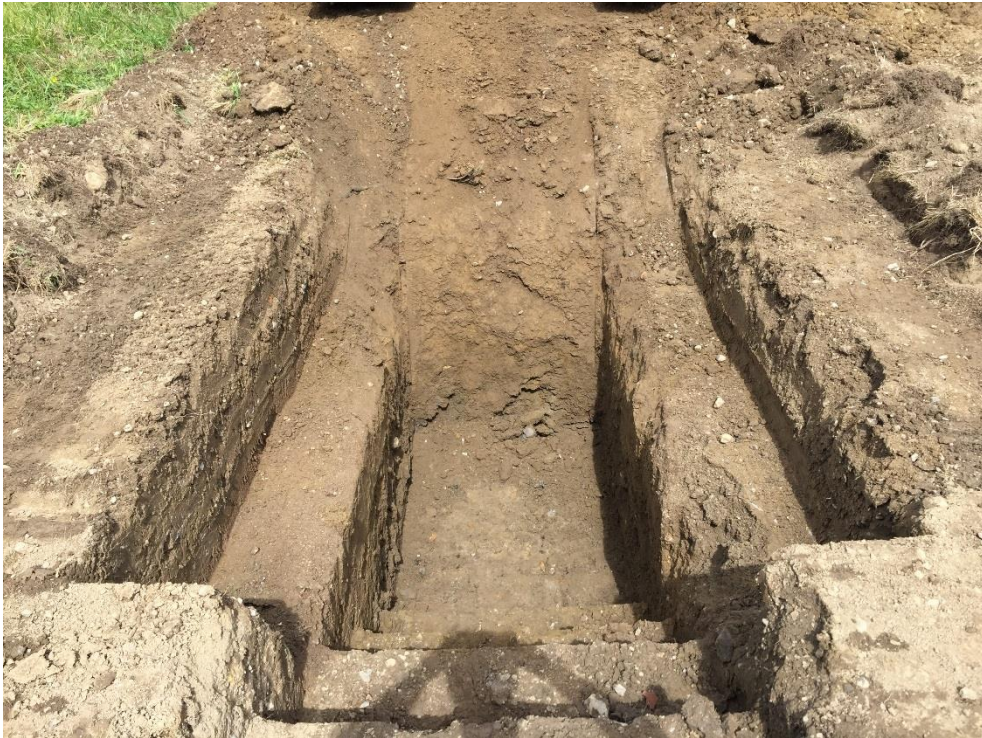
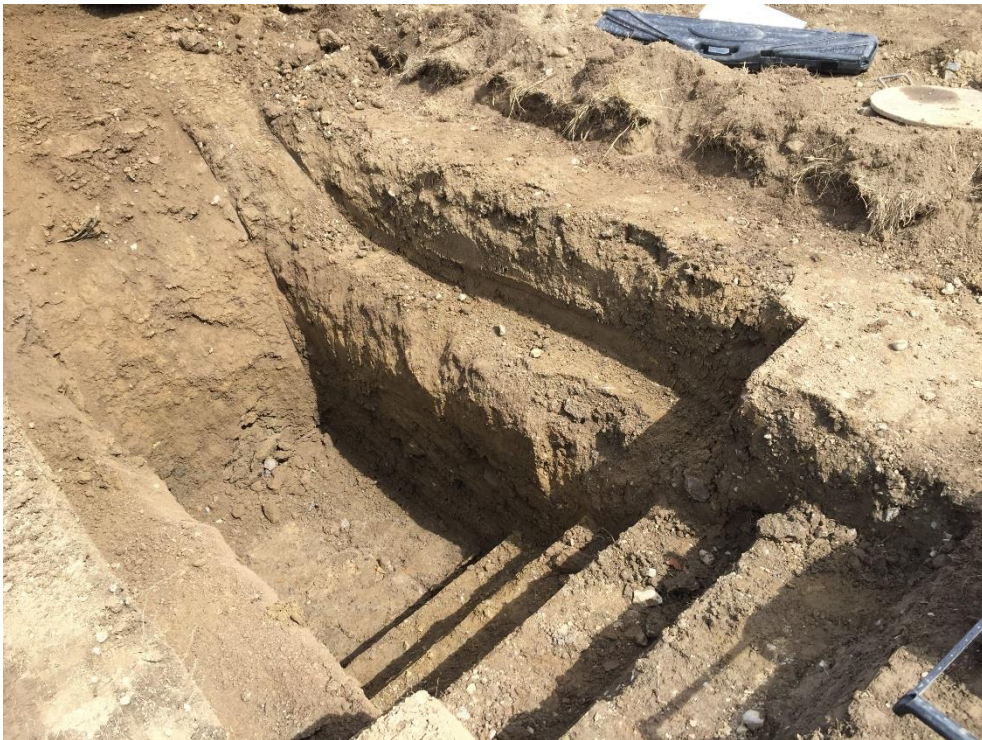
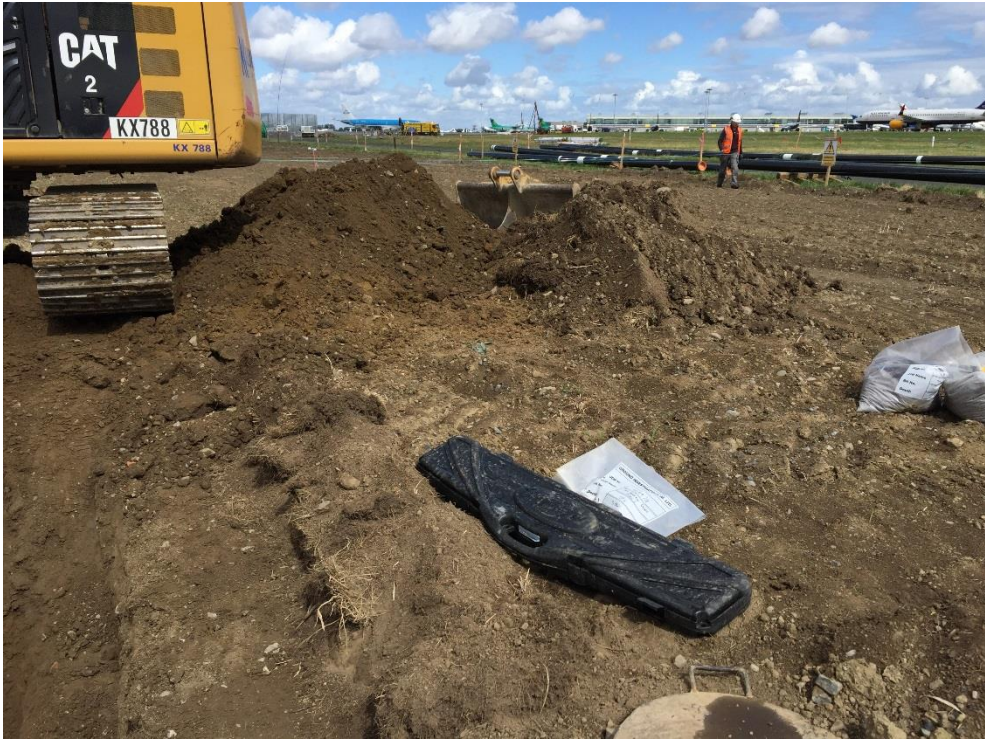
OP04

Scale (approx) 1:25	Logged By ROT	Figure No. 7926-07-18.OP04
-------------------------------	-------------------------	--------------------------------------

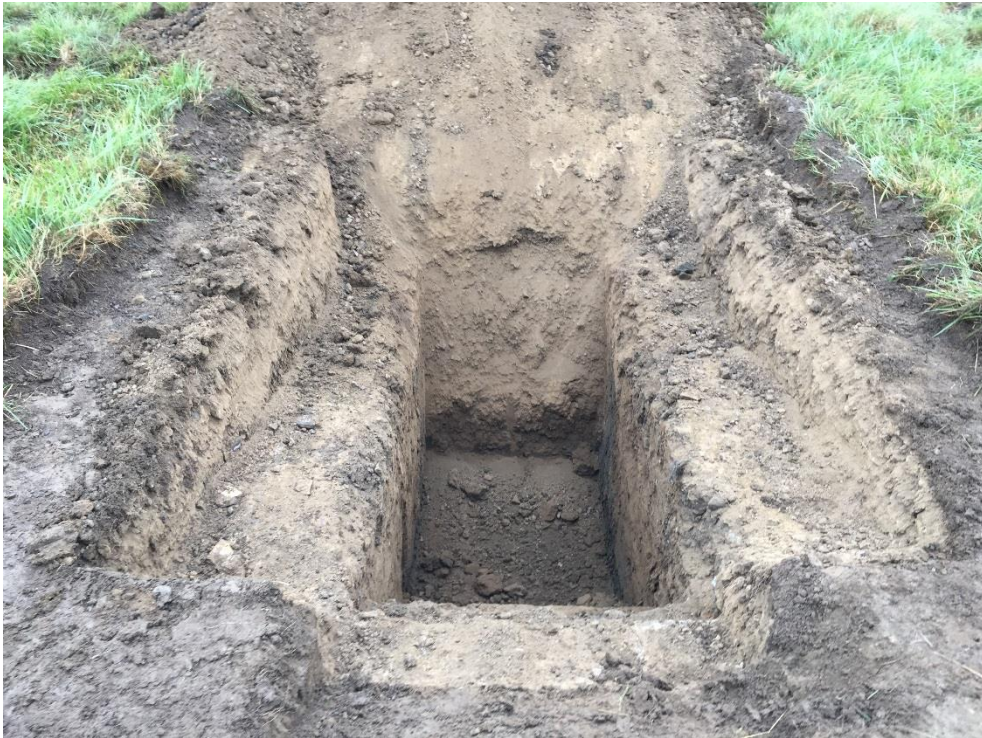
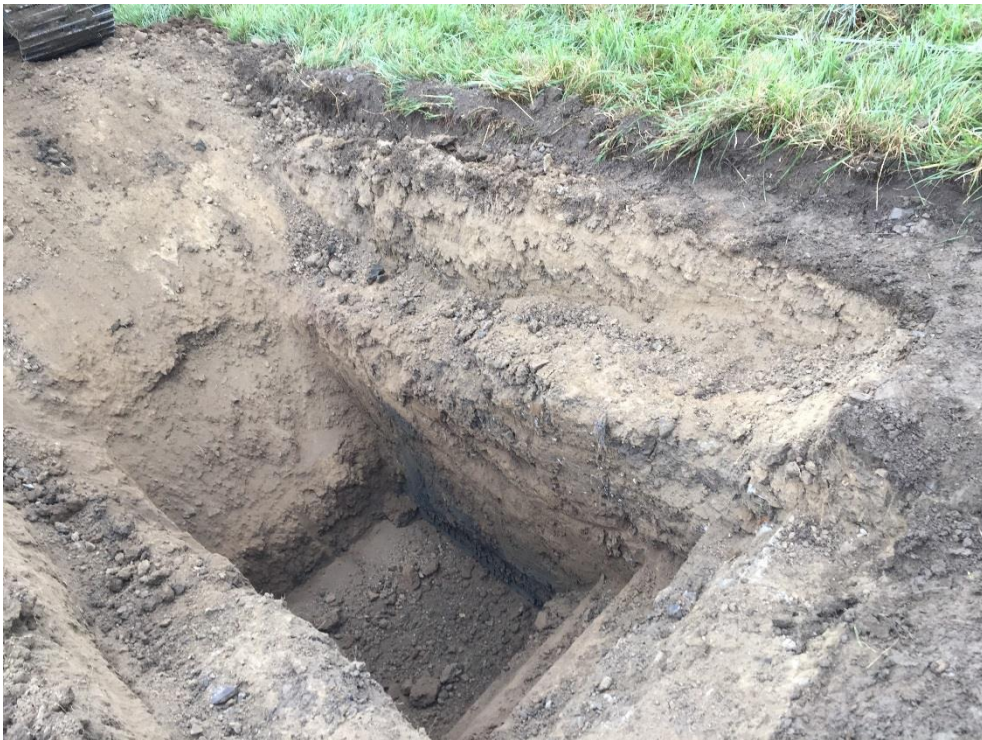
OP05

Plan	<p>Remarks</p> <p>No groundwater encountered. Trial pit stable. TRL Probe carried out at 0.50m, 1.00m 2.00m and 2.50m BGL. Plate test carried out at 1.0m BGL in Trial pit. Trial pit backfilled on completion.</p>								
	Scale (approx)	Logged By	Figure No.						
	1:25	ROT	7926-07-18.OP05

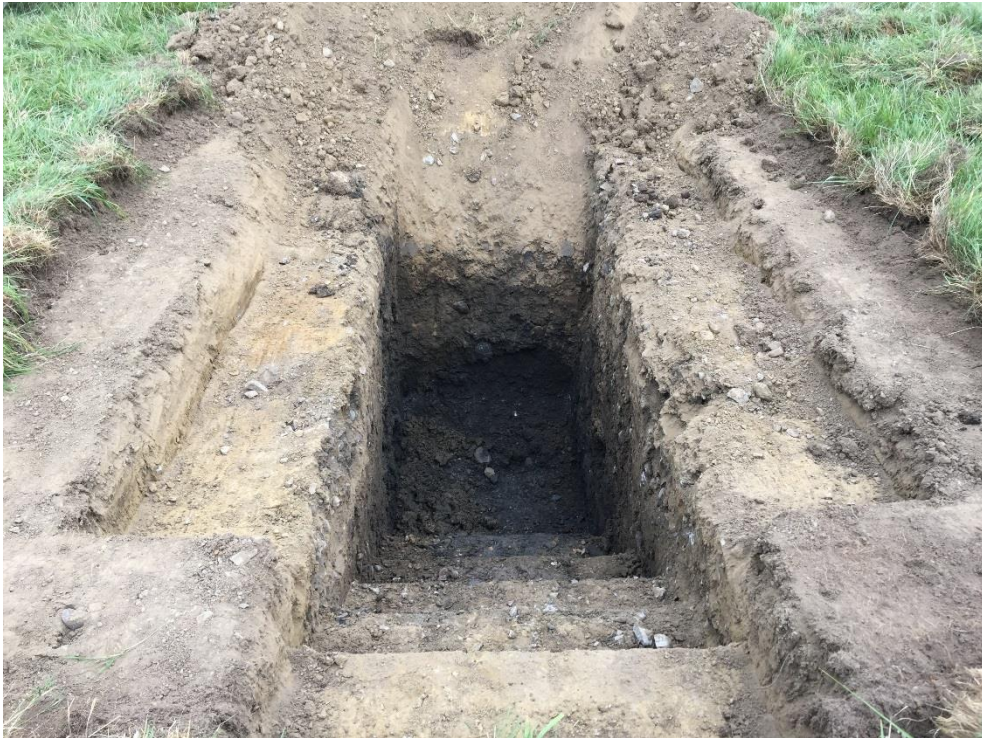
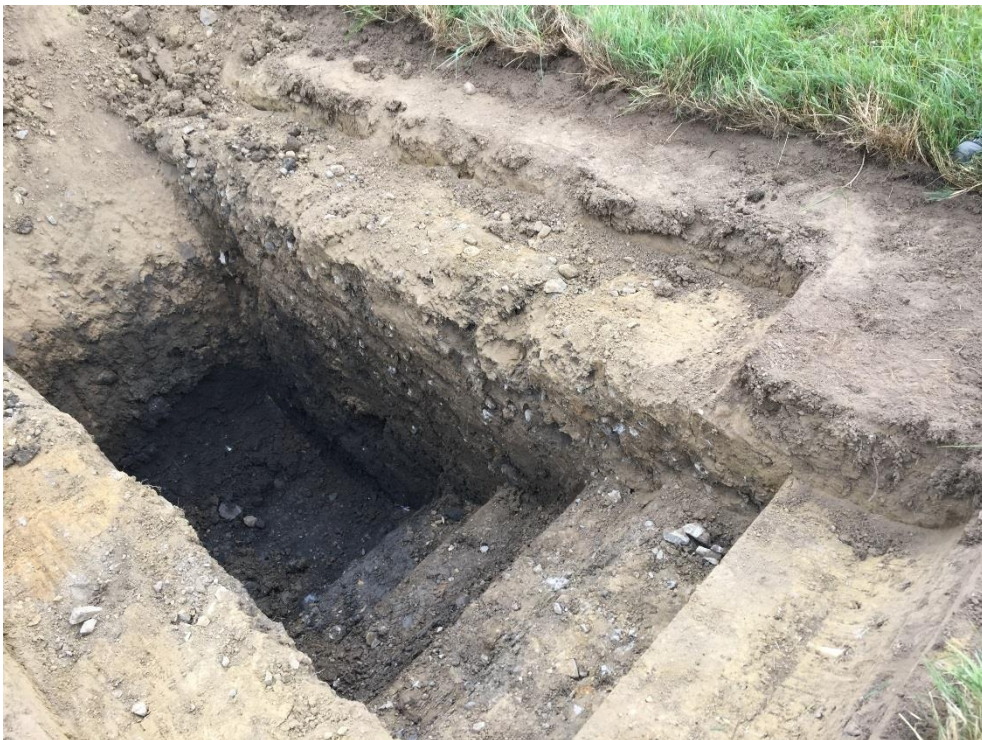
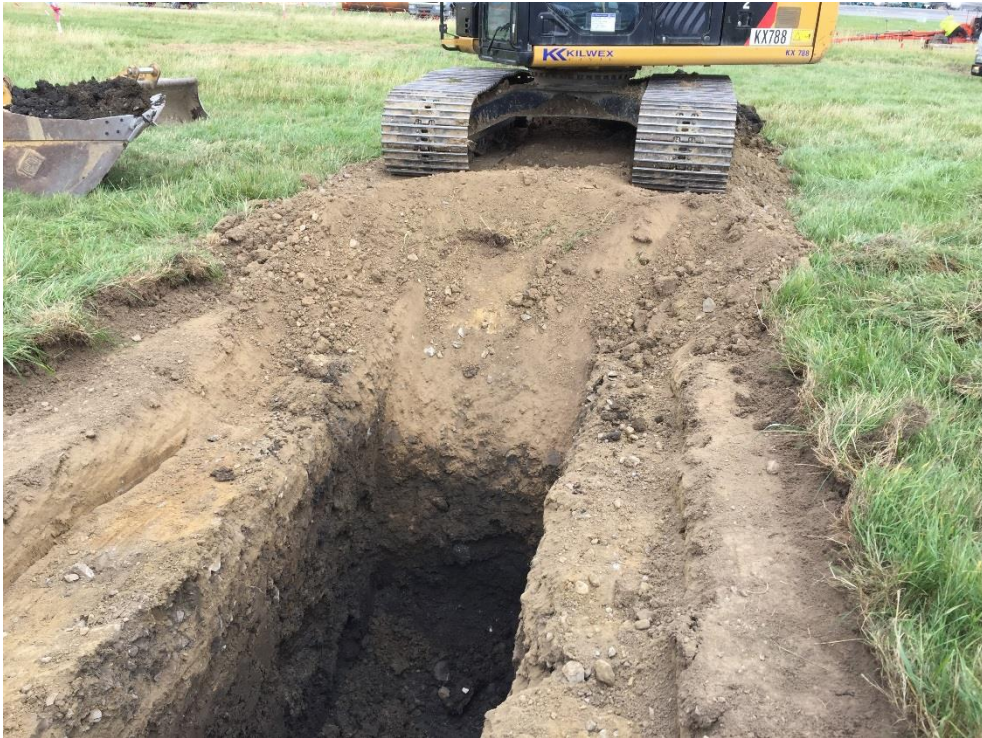
OP08 13/08/18

Scale (approx) 1:25	Logged By ROT	Figure No. 7926-07-18.OP08
-------------------------------	-------------------------	--------------------------------------

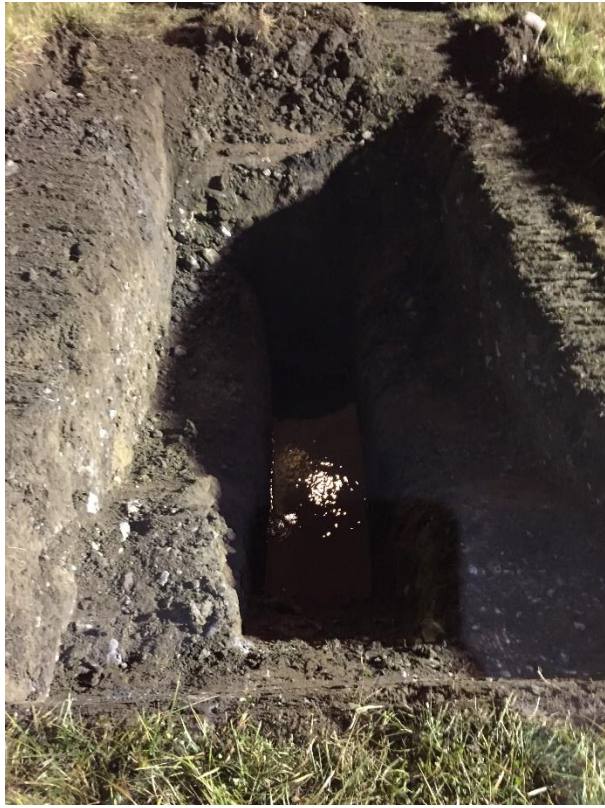
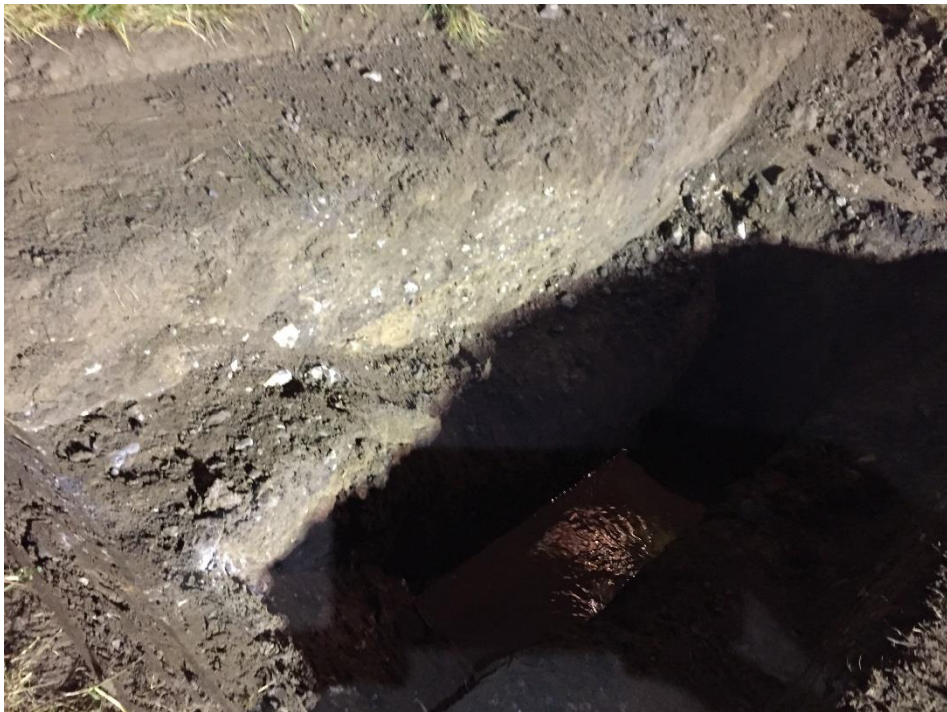
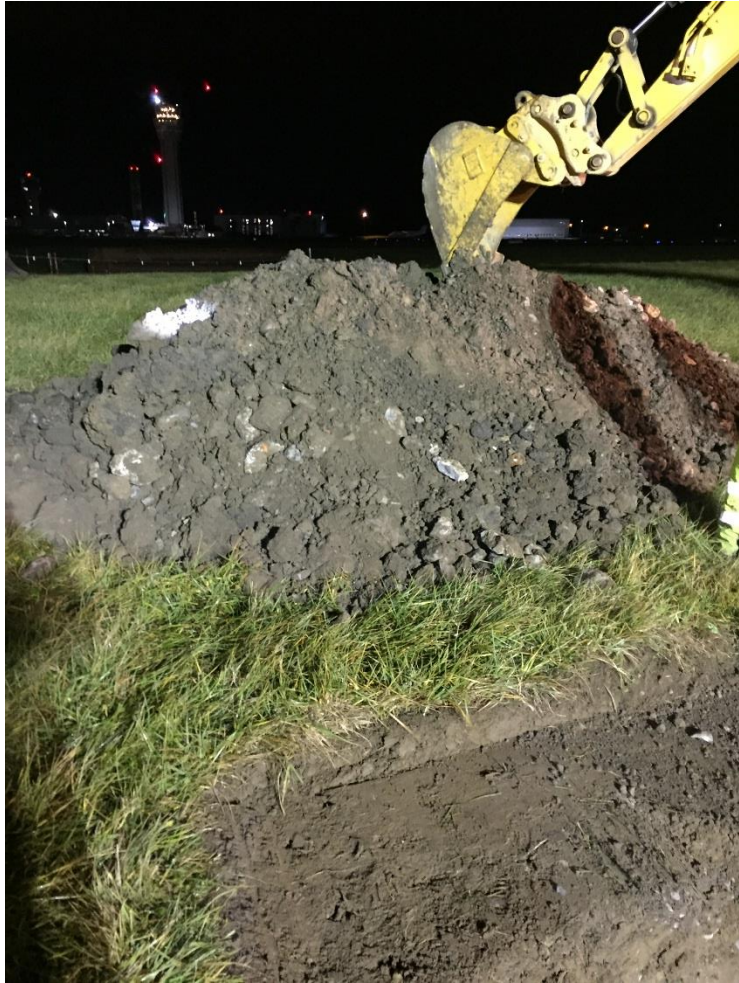
TP02

Plan .	Remarks Ground Water observed in TP at 2.20m BGL - Fast Flow Trial pit stable. Plate test carried out at 1.0m BGL in Trial pit. Trial pit backfilled on completion. Shear Vane tests attempted at 0.50 and 1.00m BGL - Too granular		
	<table border="1"> <tr> <td>Scale (approx) 1:25</td> <td>Logged By ROT</td> <td>Figure No. 7926-07-18.TP02</td> </tr> </table>	Scale (approx) 1:25	Logged By ROT
Scale (approx) 1:25	Logged By ROT	Figure No. 7926-07-18.TP02

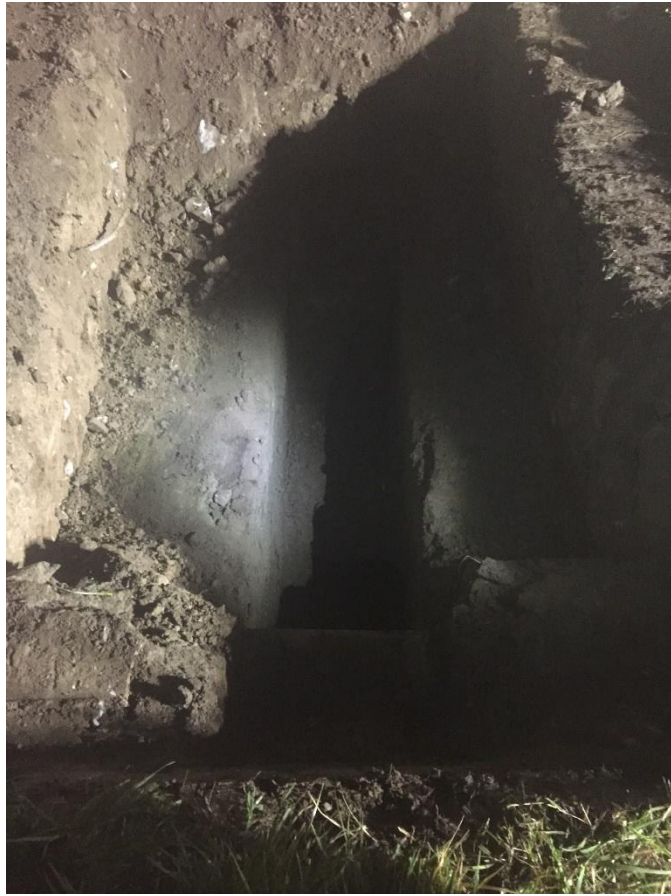
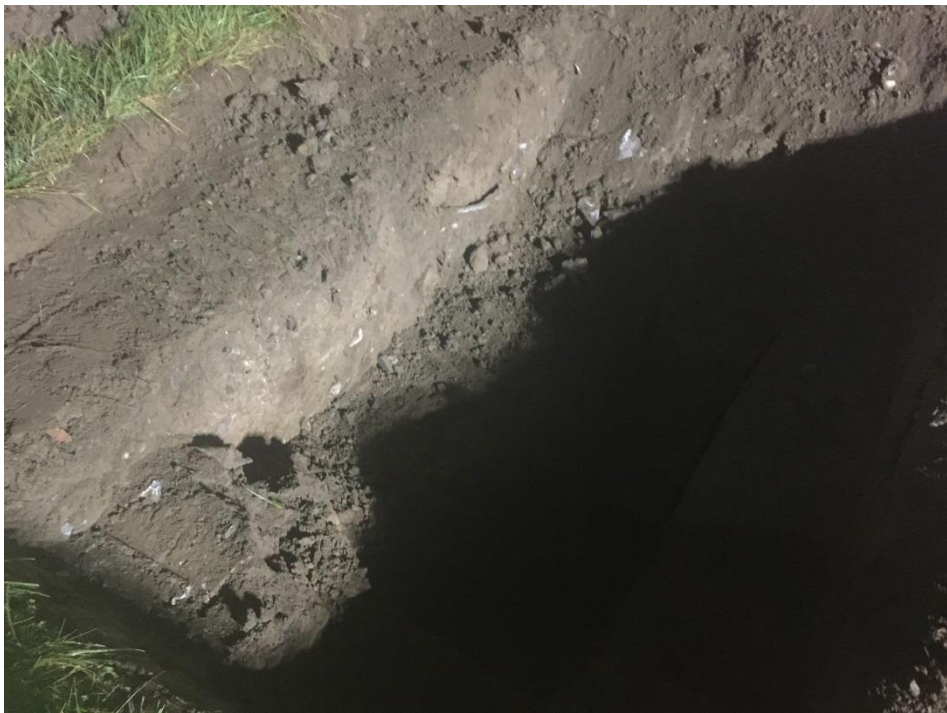
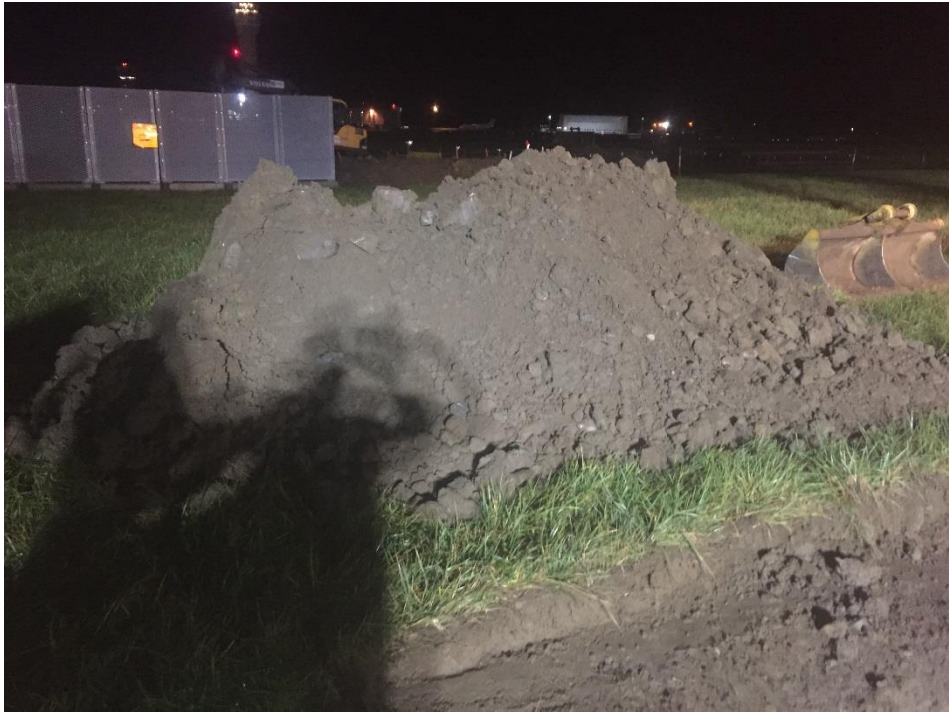
TP03

Plan	Remarks		
	No groundwater observed in TP Trial pit stable. Plate test carried out at 1.0m BGL in Trial pit. Trial pit backfilled on completion. Shear Vane tests attempted at 0.50 and 1.00m BGL - Too granular		
	Scale (approx)	Logged By	Figure No.
	1:25	ROT	7926-07-18.TP03

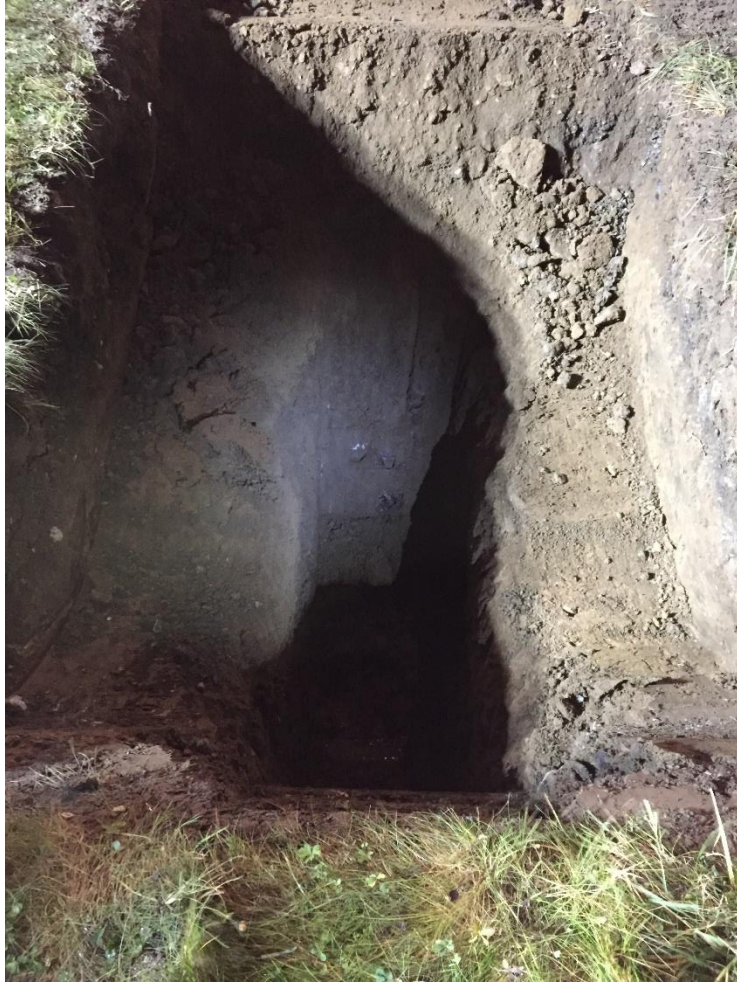
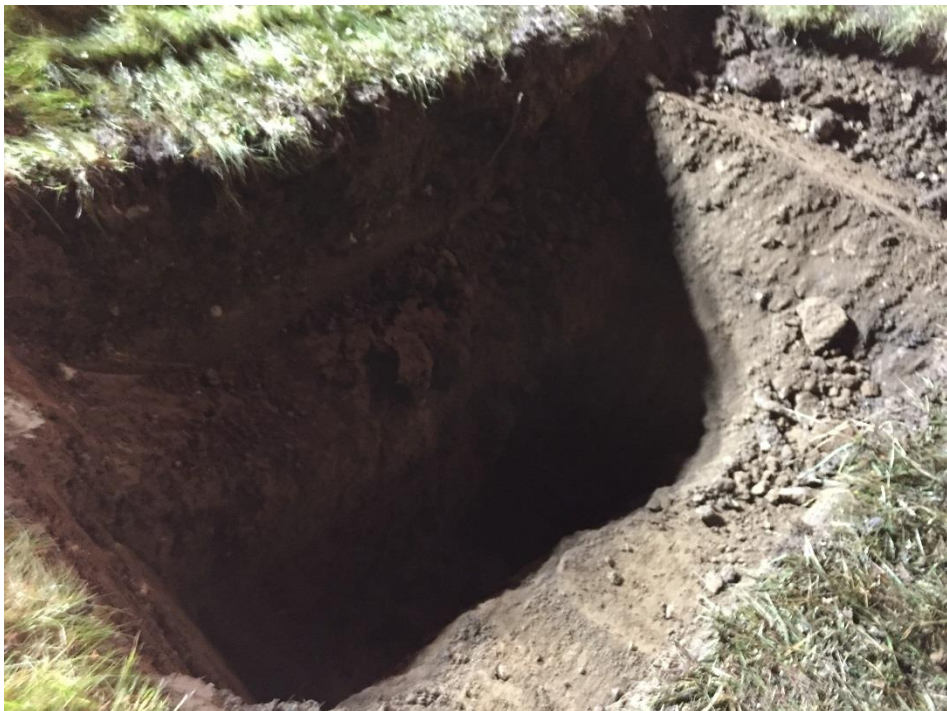
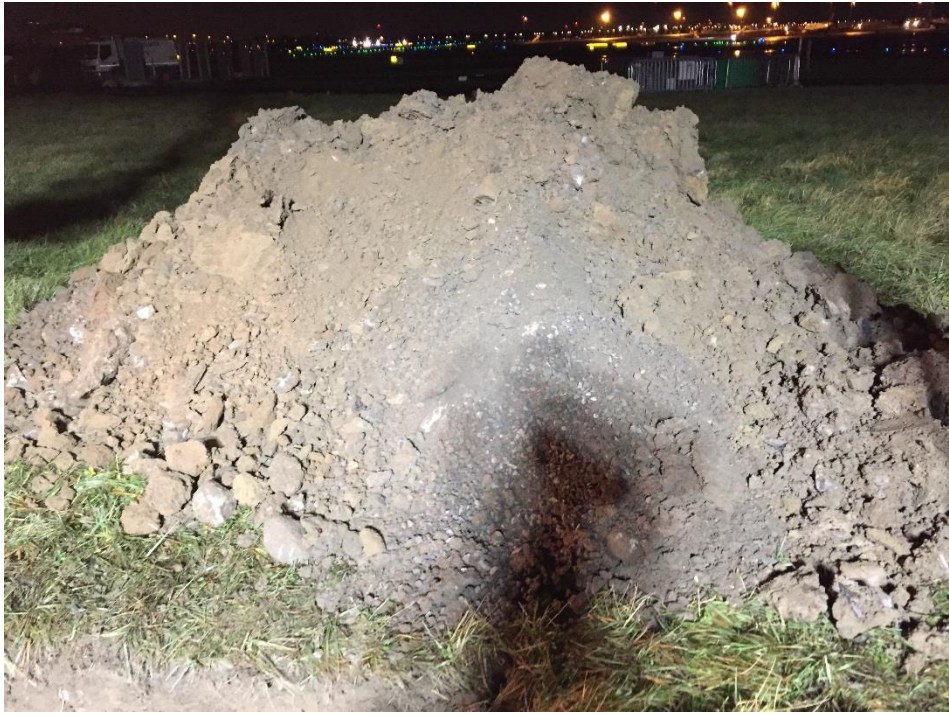
TP04

<p>Plan</p> <p style="text-align: center;">.</p> <p style="text-align: center;">.</p> <p style="text-align: center;">.</p> <p style="text-align: center;">.</p> <p style="text-align: center;">.</p> <p style="text-align: center;">.</p>	<p>Remarks</p> <p>No groundwater observed in TP Trial pit stable. Plate test carried out at 1.0m BGL in Trial pit. Trial pit backfilled on completion. Shear Vane tests attempted at 1.00m BGL - Too granular</p>			
<table border="1" style="width: 100%; border-collapse: collapse;"> <tr> <td style="width: 33%;">Scale (approx) 1:25</td> <td style="width: 33%;">Logged By ROT</td> <td style="width: 33%;">Figure No. 7926-07-18.TP04</td> </tr> </table>		Scale (approx) 1:25	Logged By ROT	Figure No. 7926-07-18.TP04
Scale (approx) 1:25	Logged By ROT	Figure No. 7926-07-18.TP04

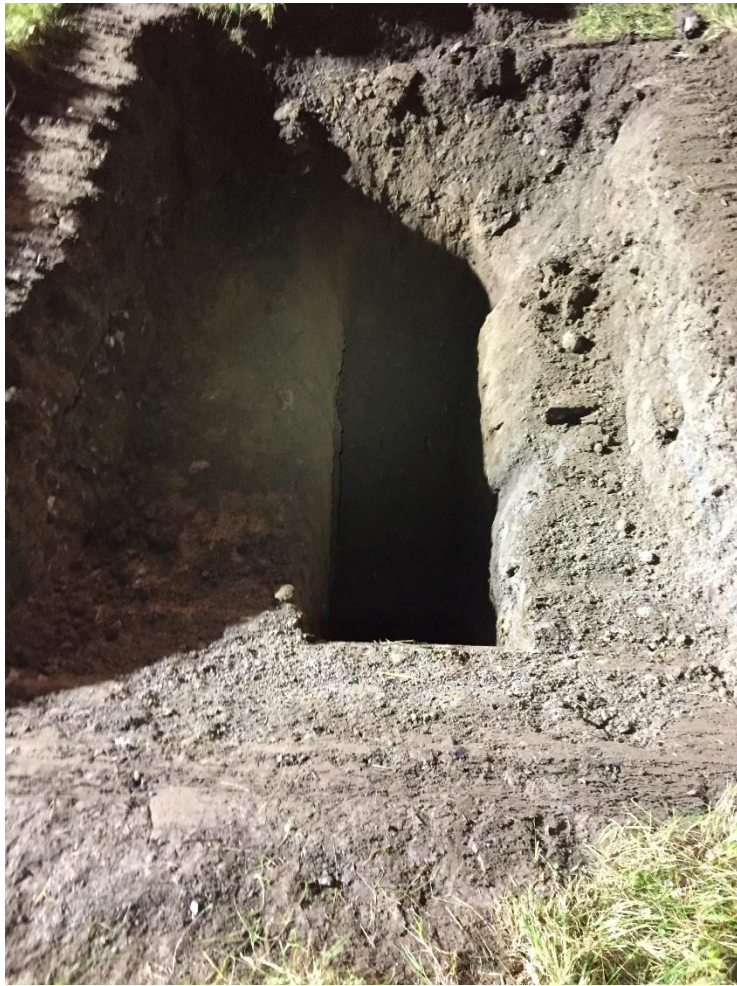
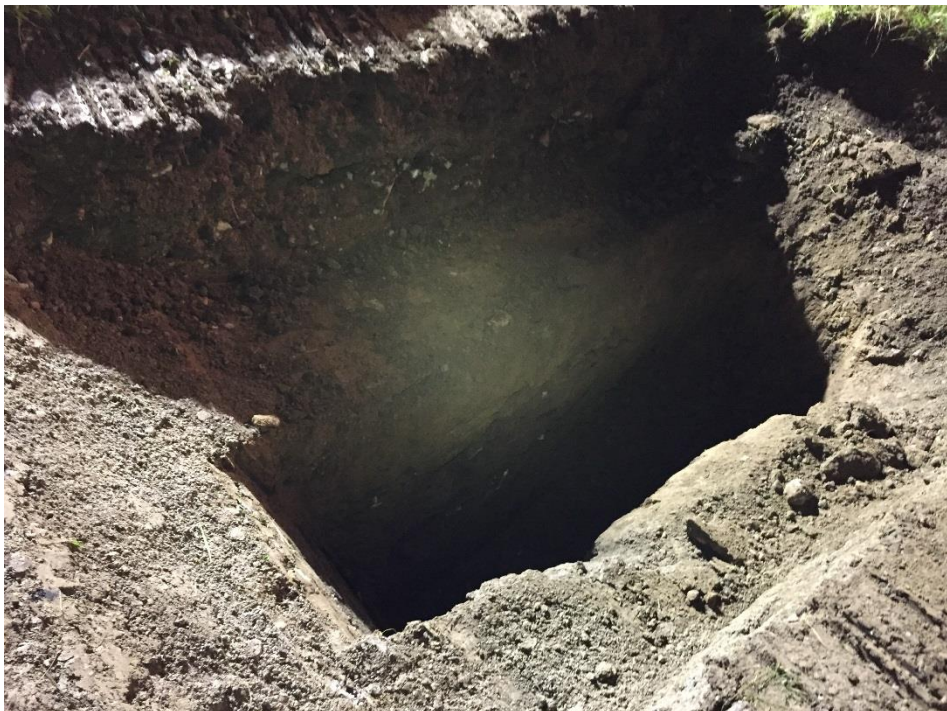
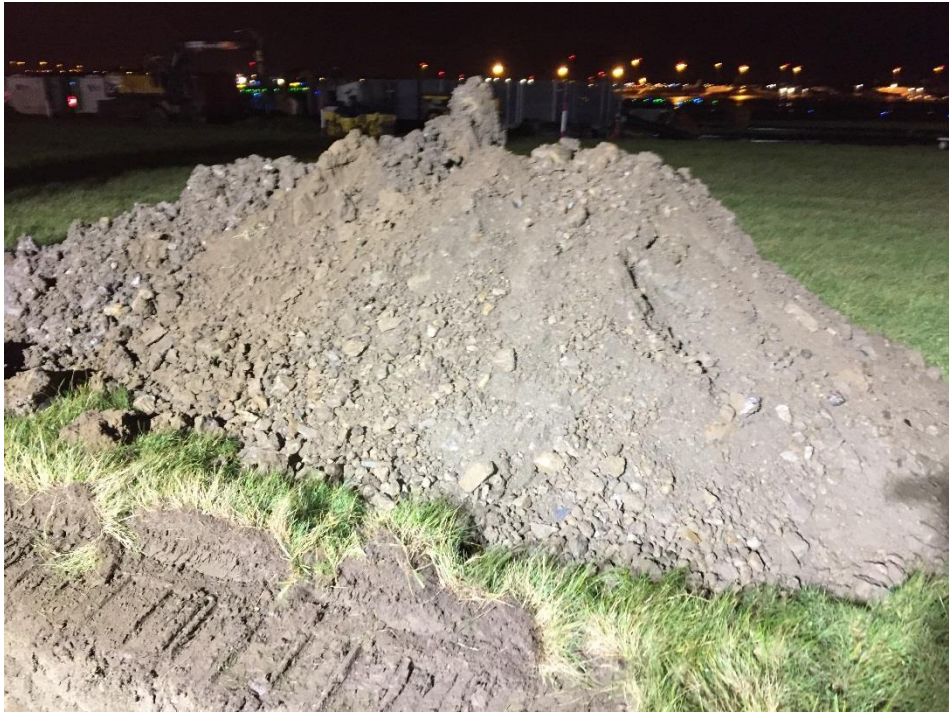
TP05

<p>Plan</p> <p style="text-align: center;">.</p> <p style="text-align: center;">.</p> <p style="text-align: center;">.</p> <p style="text-align: center;">.</p> <p style="text-align: center;">.</p> <p style="text-align: center;">.</p>	<p>Remarks</p> <p>No groundwater observed in TP Trial pit stable. Plate test carried out at 1.00m BGL in Trial pit. Trial pit backfilled on completion. Shear Vane tests attempted at 0.50m BGL and 1.00m BGL - Too granular</p>			
	<table border="1" style="width: 100%; border-collapse: collapse;"> <tr> <td style="width: 33%;">Scale (approx) 1:25</td> <td style="width: 33%;">Logged By ROT</td> <td style="width: 33%;">Figure No. 7926-07-18.TP05</td> </tr> </table>	Scale (approx) 1:25	Logged By ROT	Figure No. 7926-07-18.TP05
Scale (approx) 1:25	Logged By ROT	Figure No. 7926-07-18.TP05

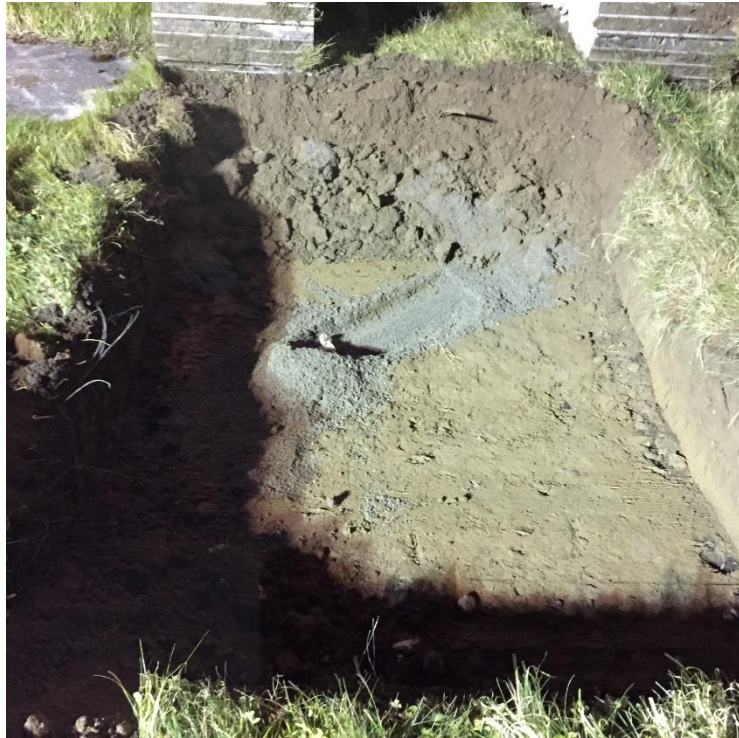
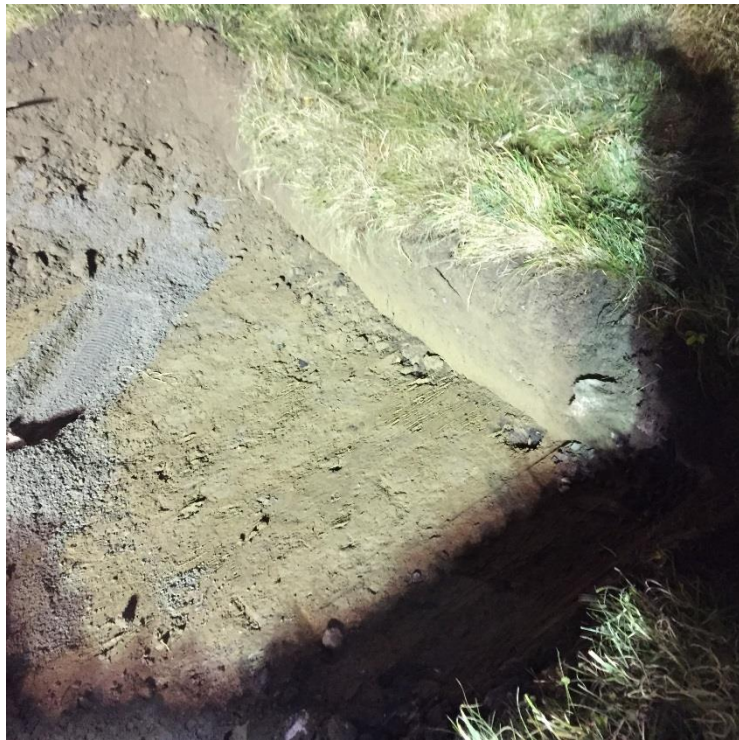
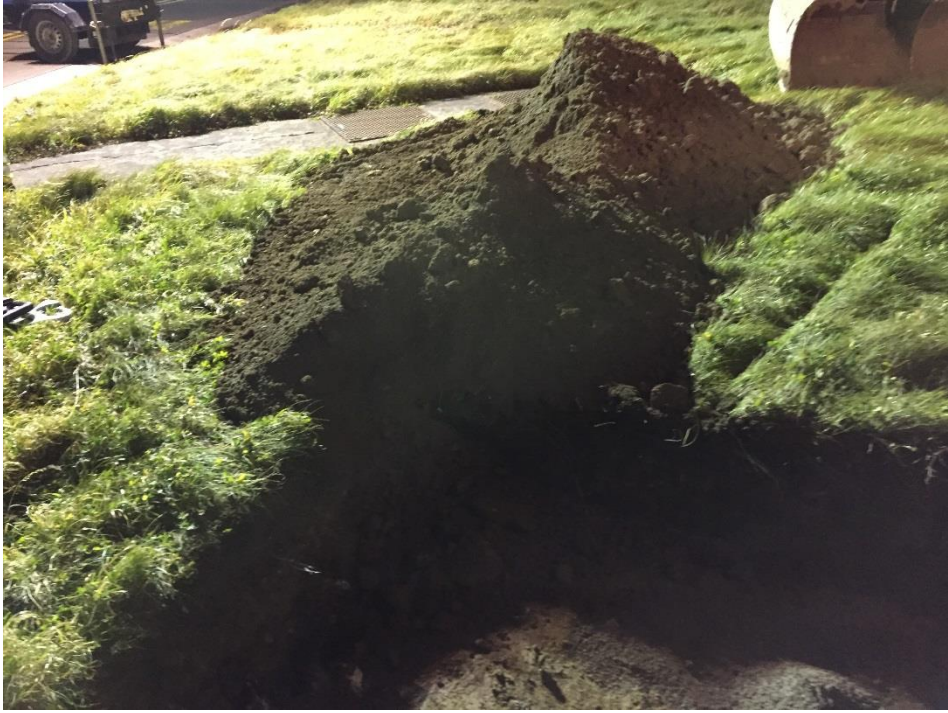
TP07

Plan	Remarks		
.	No groundwater observed in TP		
.	Trial pit stable.		
.	Trial pit backfilled on completion.		
.			
.			
.			
.			
.			
.			
	Scale (approx) 1:25	Logged By ROT	Figure No. 7926-07-18.TP07

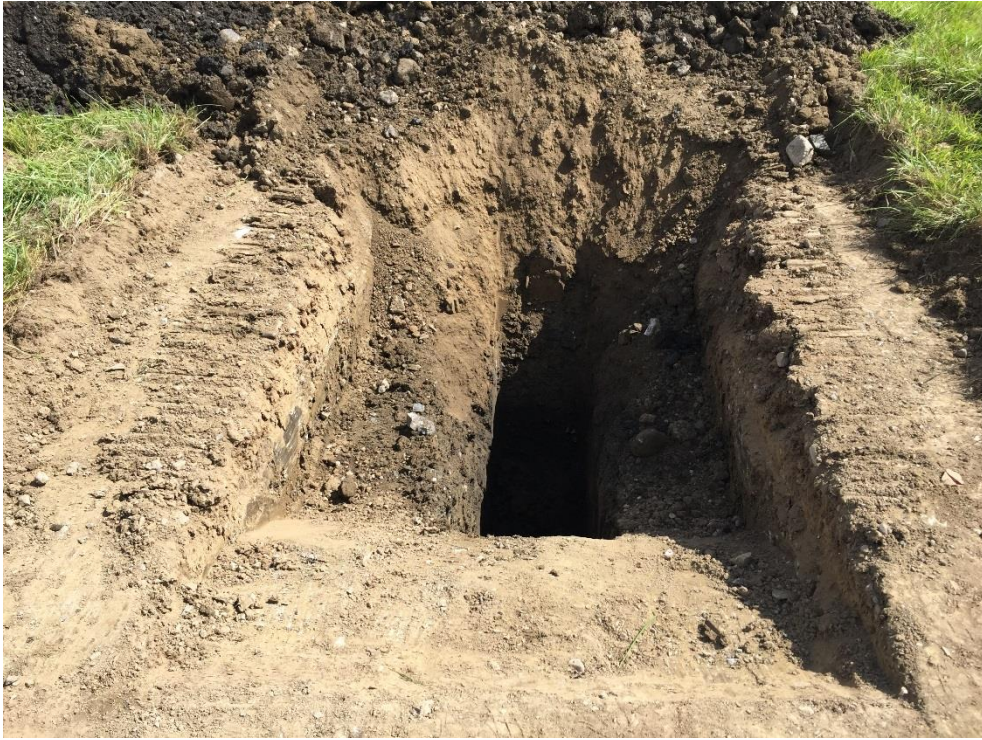
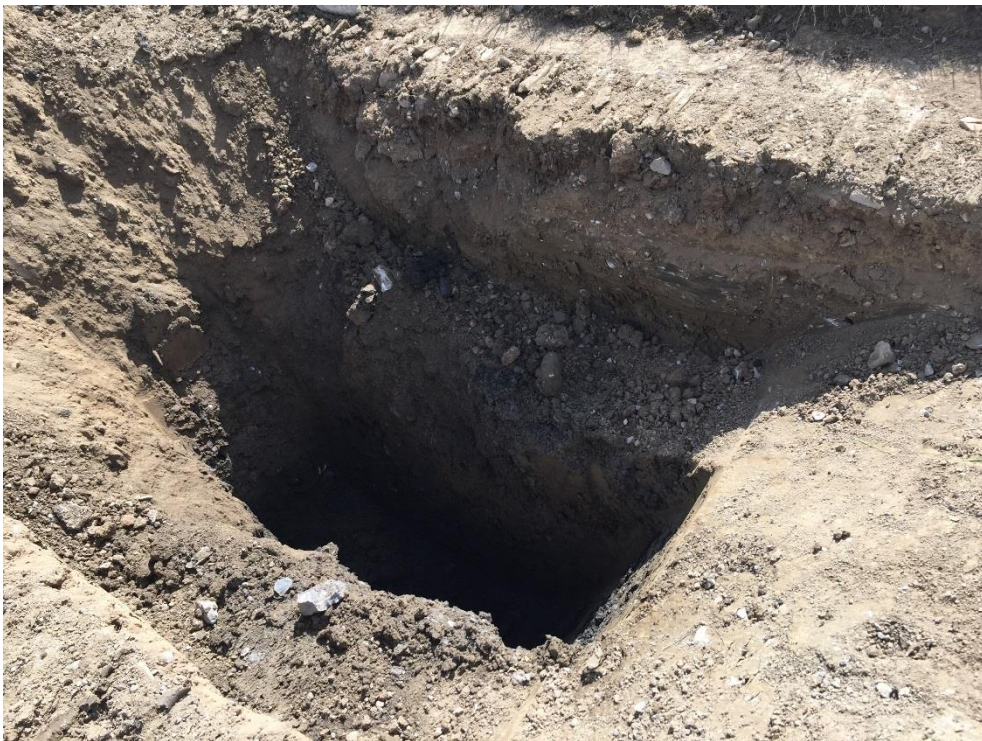
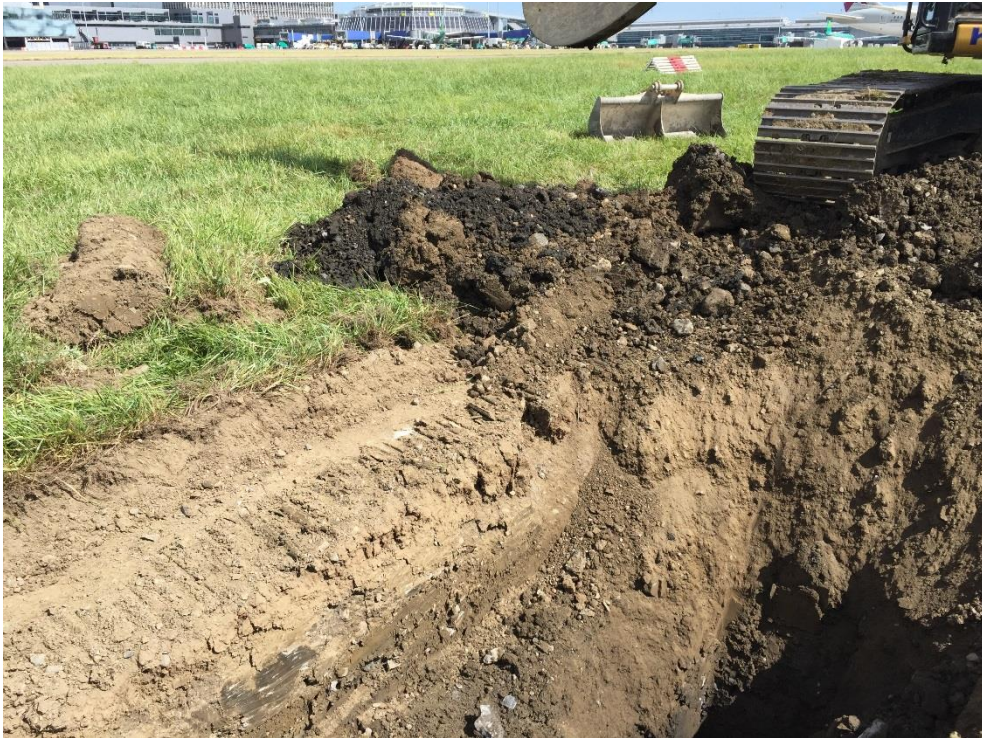
TP12

Plan								
Remarks								
No groundwater encountered. Trial pit stable. Plate test carried out at 1.0m BGL in Trial pit. Trial pit backfilled on completion. Shear Vane tests attempted at 0.50m and 1.00m BGL but strata too granular to complete tests.								
Scale (approx)						Logged By		Figure No.
1:25						ROT		7926-07-18.TP12

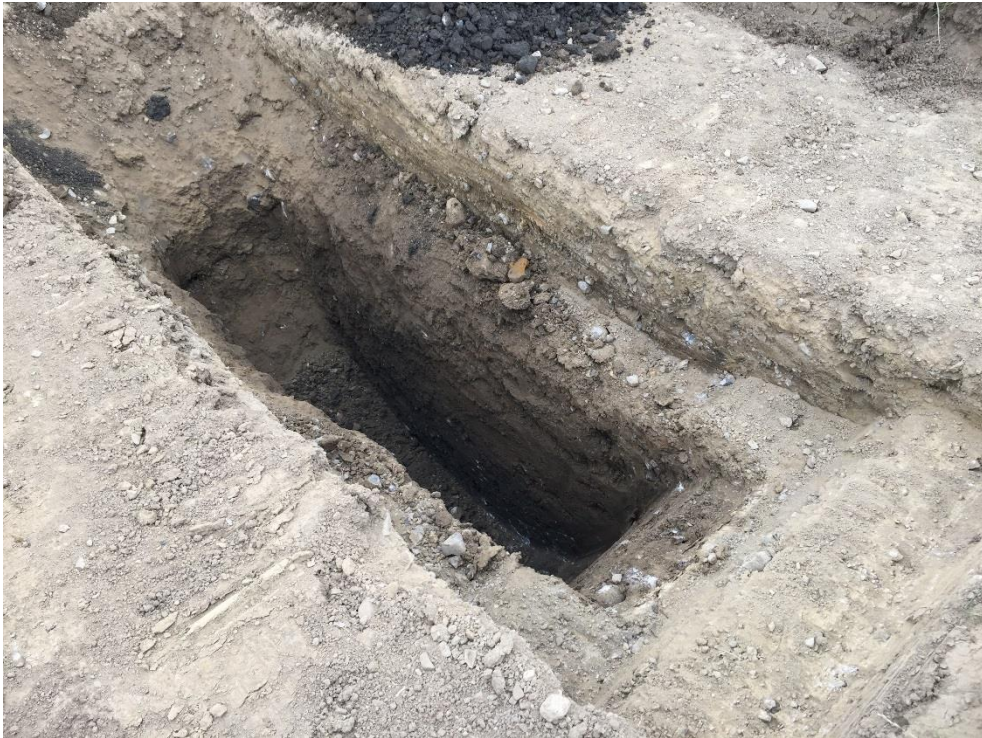
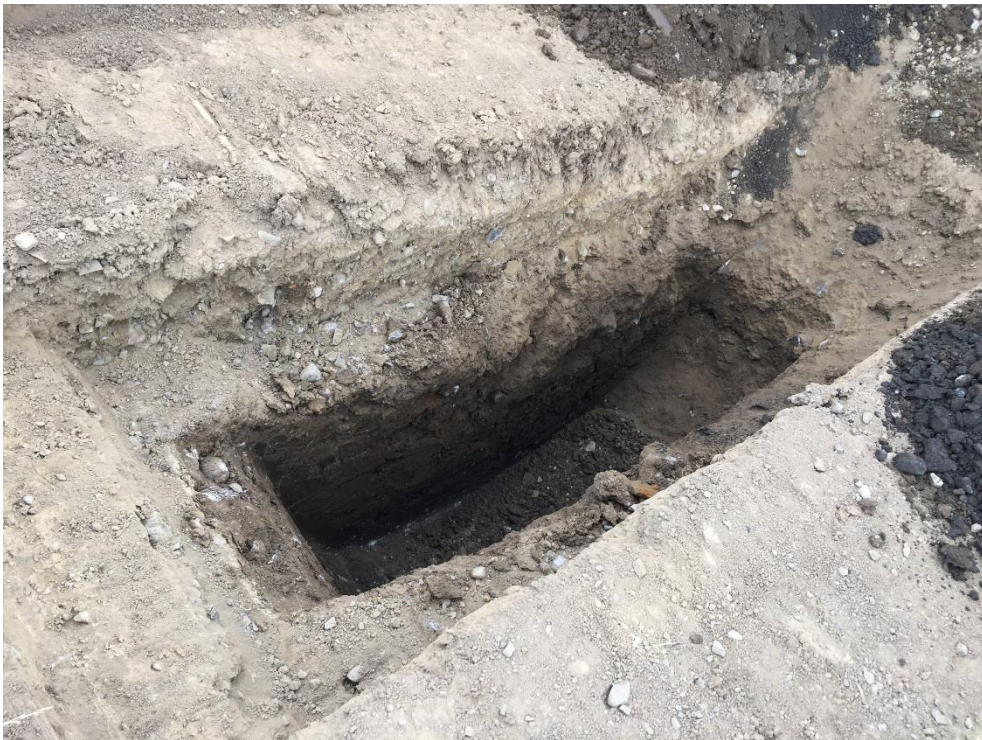
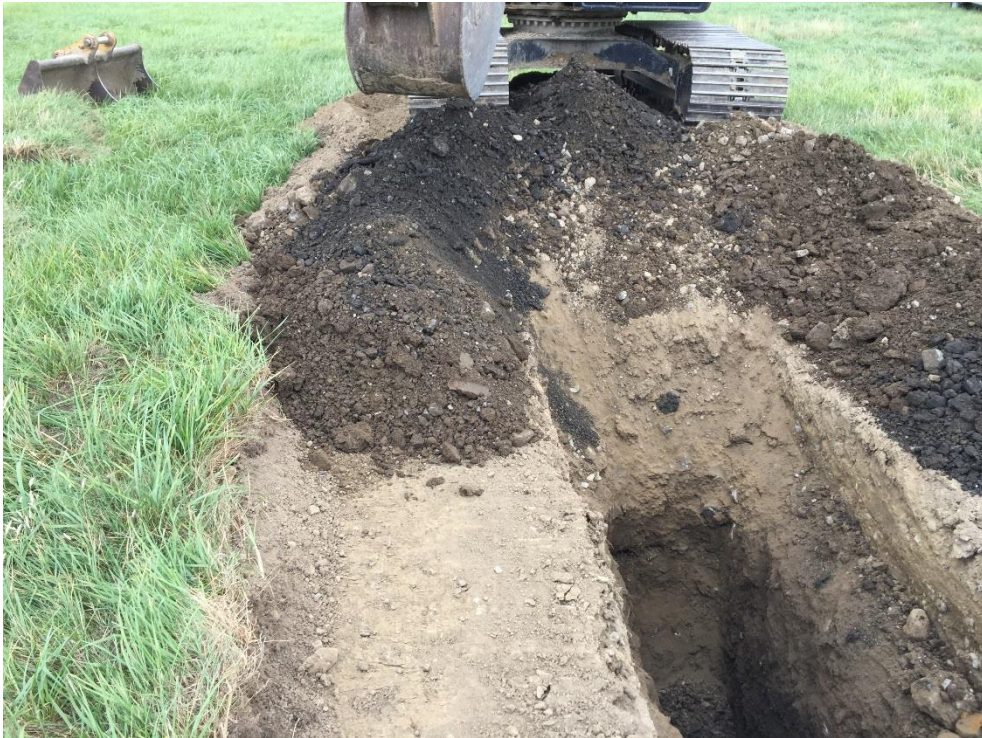
TP16

<p>Plan</p> <p style="text-align: center;">.</p> <p style="text-align: center;">.</p> <p style="text-align: center;">.</p> <p style="text-align: center;">.</p> <p style="text-align: center;">.</p> <p style="text-align: center;">.</p>	<p>Remarks</p> <p>No groundwater encountered. Trial pit stable. Plate test carried out at 1.0m BGL in Trial pit. Trial pit backfilled on completion.</p>
<p>Scale (approx)</p> <p>1:25</p>	<p>Logged By</p> <p>ROT</p>
<p>Figure No.</p> <p>7926-07-18.TP16</p>
