244 Airfield Surveys Phase 2

Ground Investigation Report

Project Title	244 Airfield Surveys Phase 2
Engineer	Kilwex
Client	DAA
Project No	7926-07-18
Document Title	Factual Ground Investigation Report

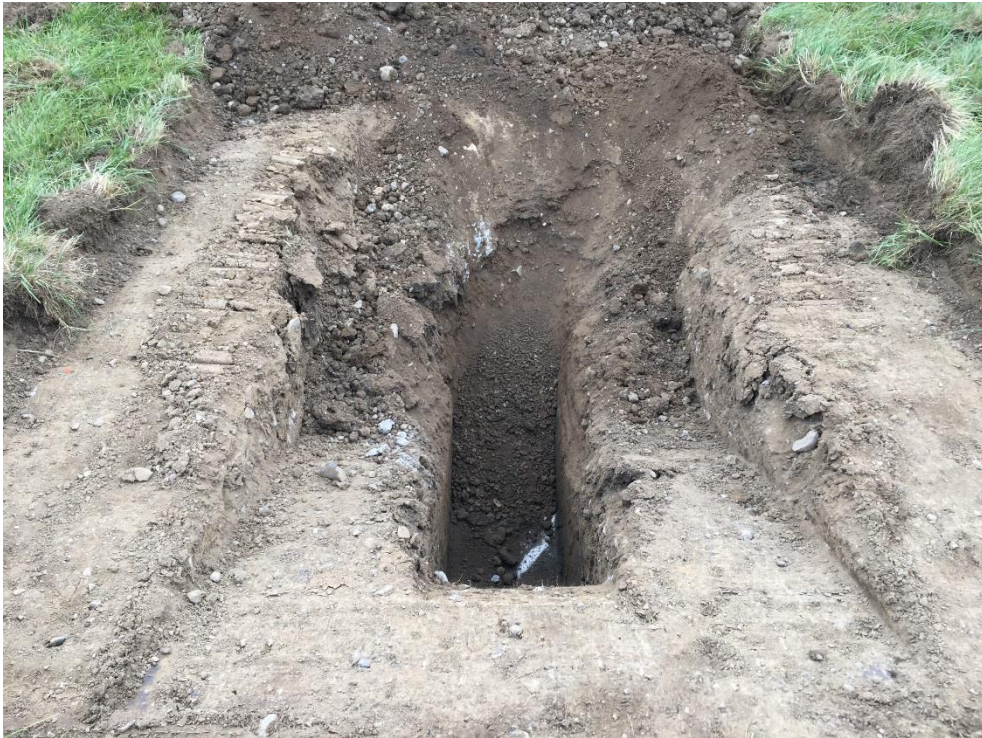
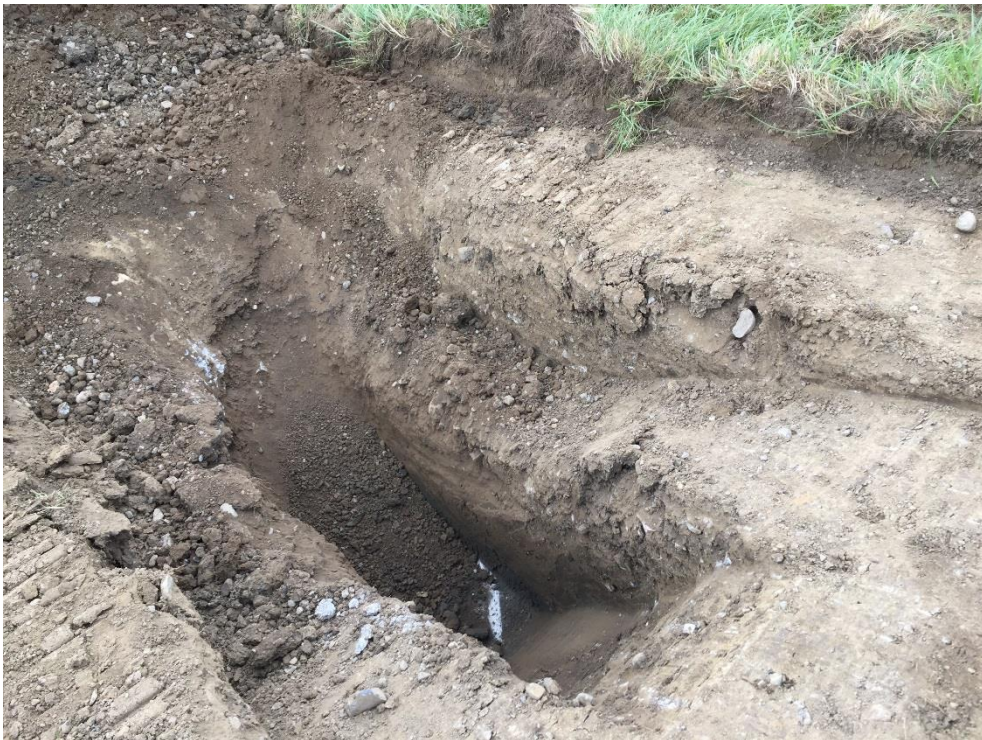
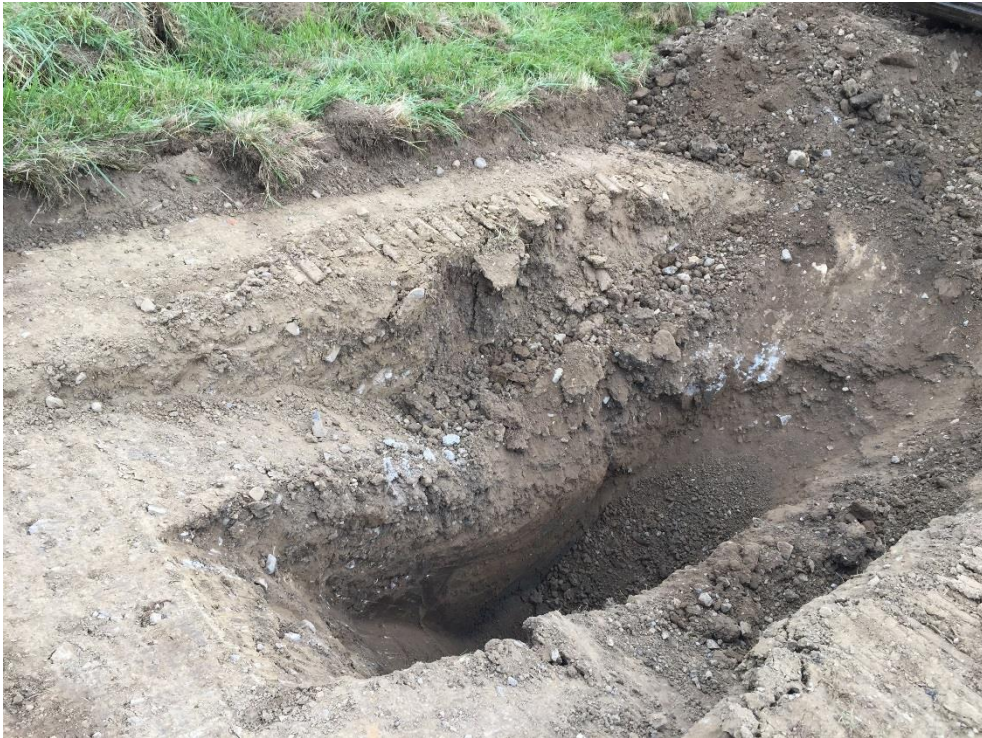
TP17

Plan	Remarks			
. .	No groundwater encountered. Trial pit stable. Plate test carried out at 1.0m BGL in Trial pit. Trial pit backfilled on completion.			
	<table border="1" style="width: 100%; border-collapse: collapse;"> <tr> <td style="width: 33%;">Scale (approx) 1:25</td> <td style="width: 33%;">Logged By ROT</td> <td style="width: 33%;">Figure No. 7926-07-18.TP17</td> </tr> </table>	Scale (approx) 1:25	Logged By ROT	Figure No. 7926-07-18.TP17
Scale (approx) 1:25	Logged By ROT	Figure No. 7926-07-18.TP17

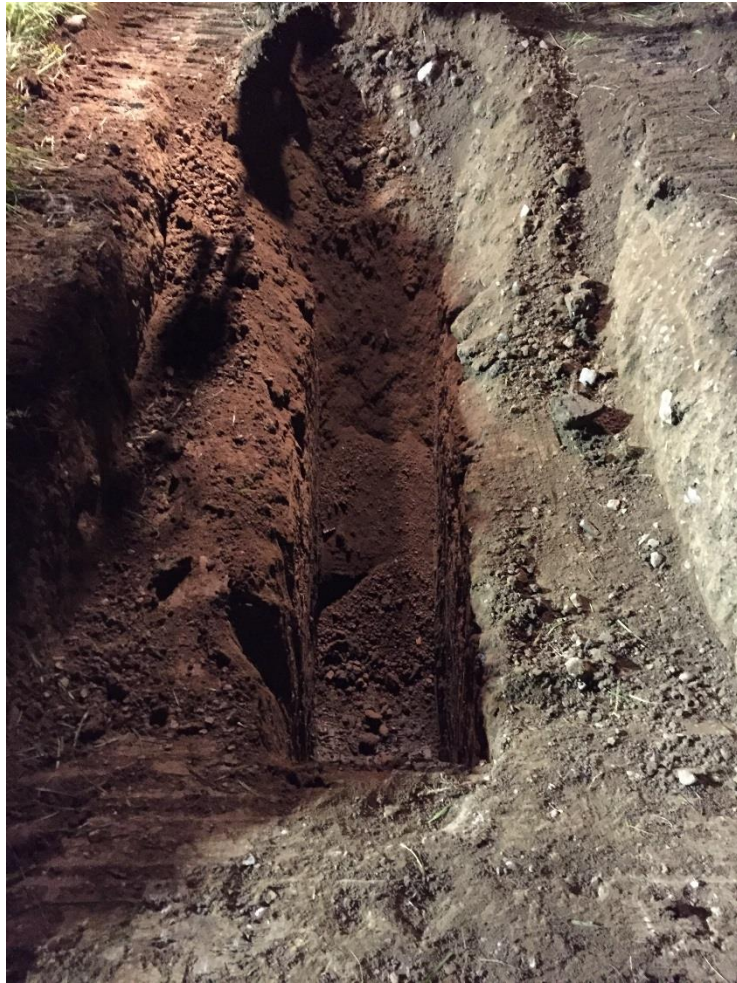
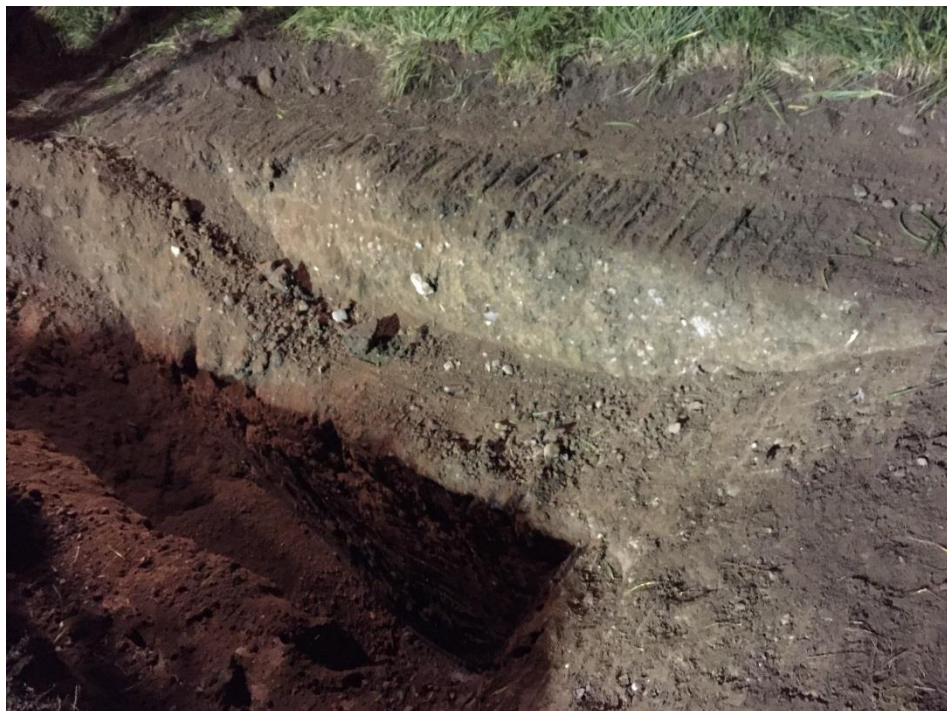
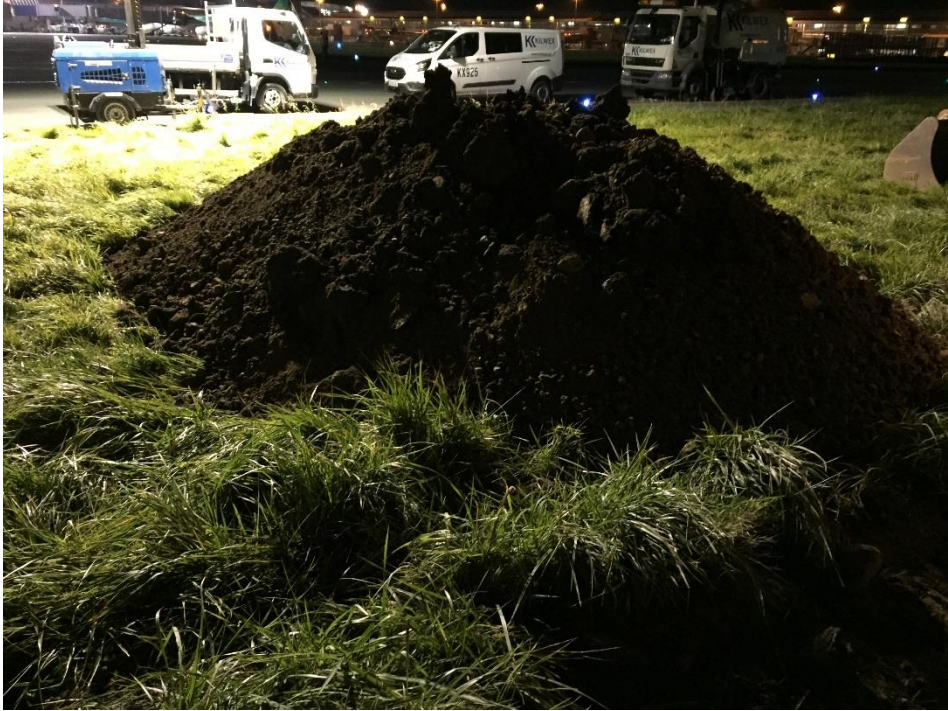
TP18

<p>Plan</p> <p style="text-align: center;">.</p> <p style="text-align: center;">.</p> <p style="text-align: center;">.</p> <p style="text-align: center;">.</p> <p style="text-align: center;">.</p> <p style="text-align: center;">.</p>	<p>Remarks</p> <p>No groundwater encountered. Trial pit stable. Plate test carried out at 1.0m BGL in Trial pit. Trial pit backfilled on completion. Shear Vane tests completed at 0.50m and 1.00m BGL</p>	
Scale (approx) 1:25	Logged By ROT	Figure No. 7926-07-18.TP18

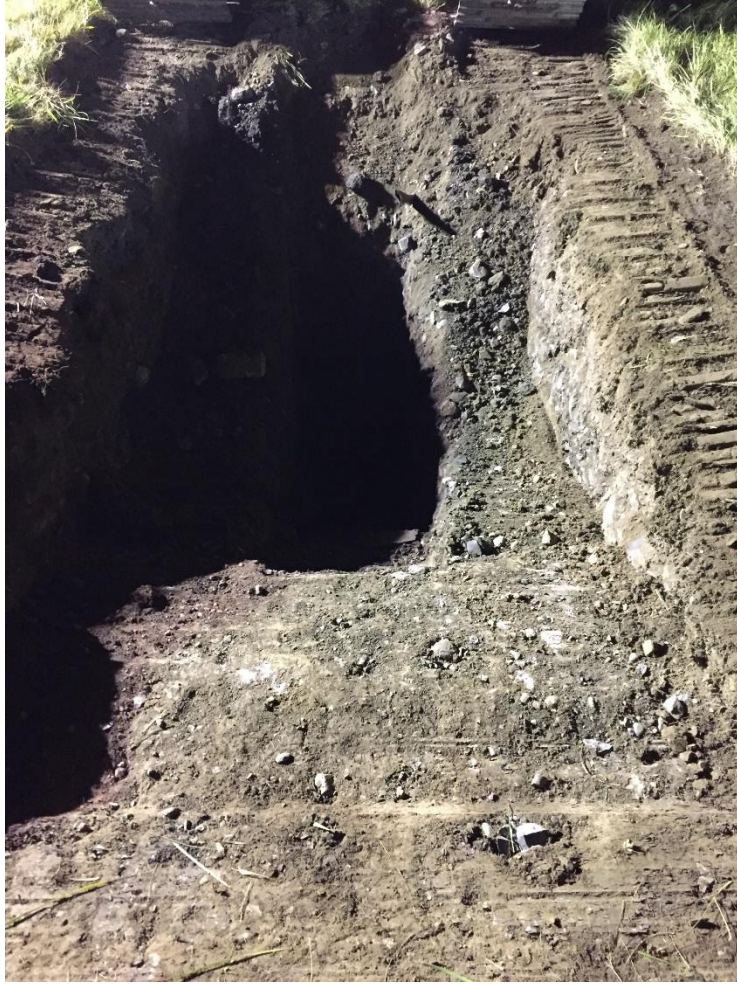
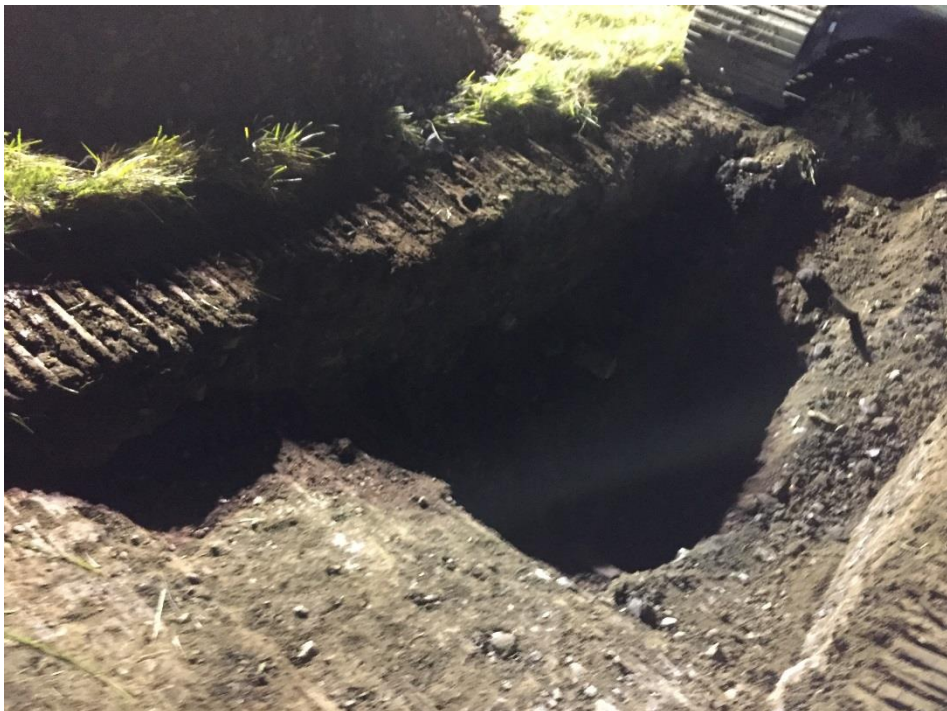
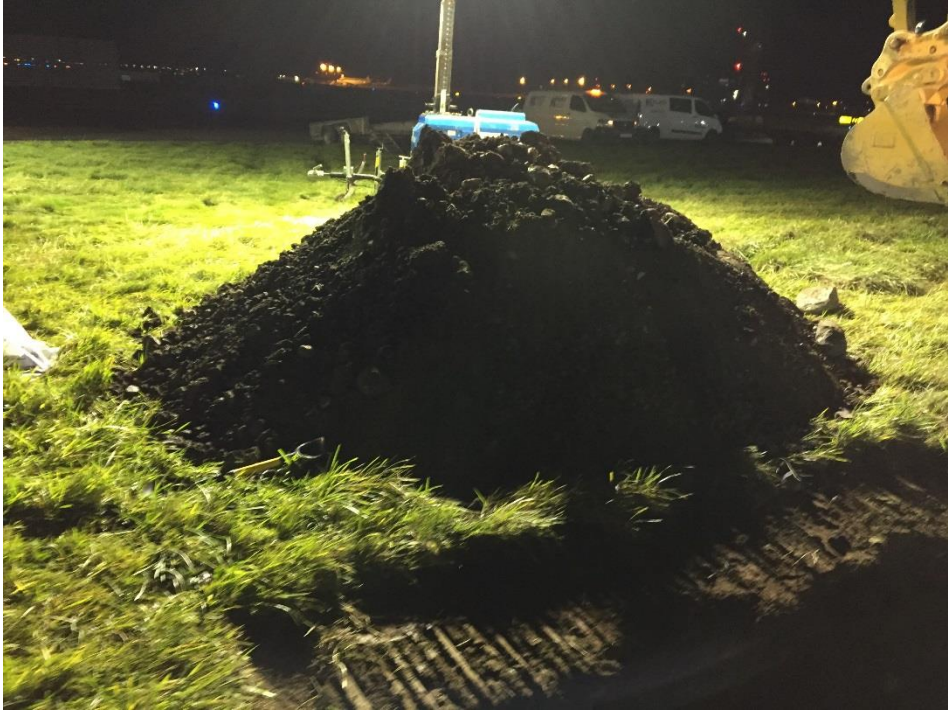
TP20

Plan									
						Remarks			
						No groundwater encountered. Trial pit stable. Plate test carried out at 1.0m BGL in Trial pit. Trial pit backfilled on completion. Shear Vane tests attempted at 0.50m and 1.00m BGL but strata too granular too complete test			
						Scale (approx)	Logged By	Figure No.	
						1:25	ROT	7926-07-18.TP20

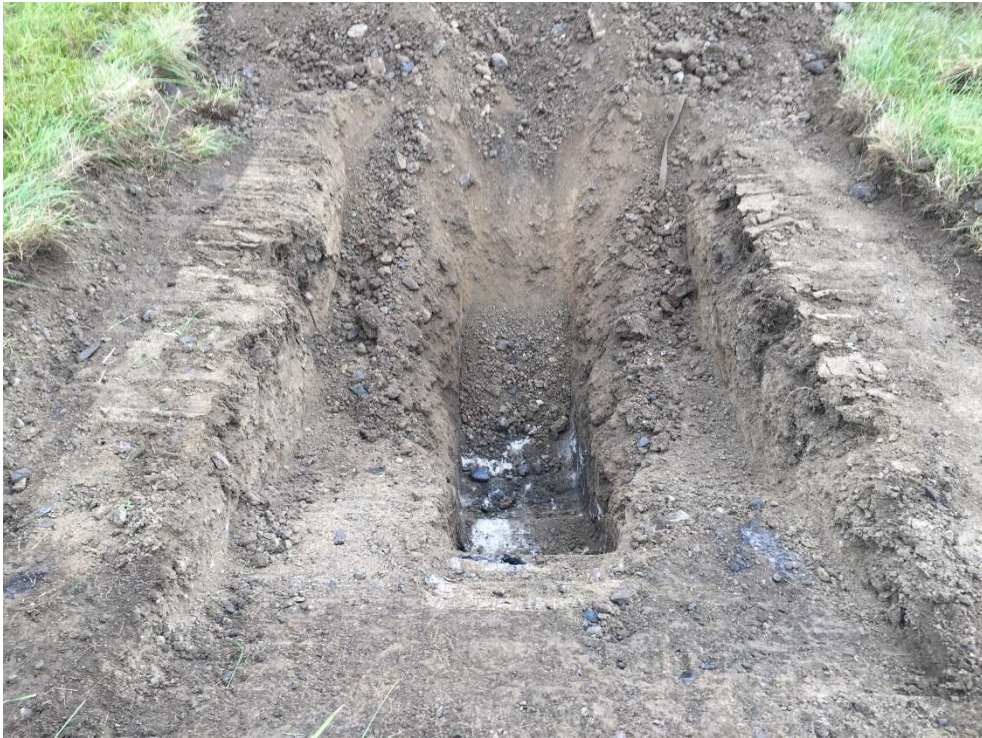
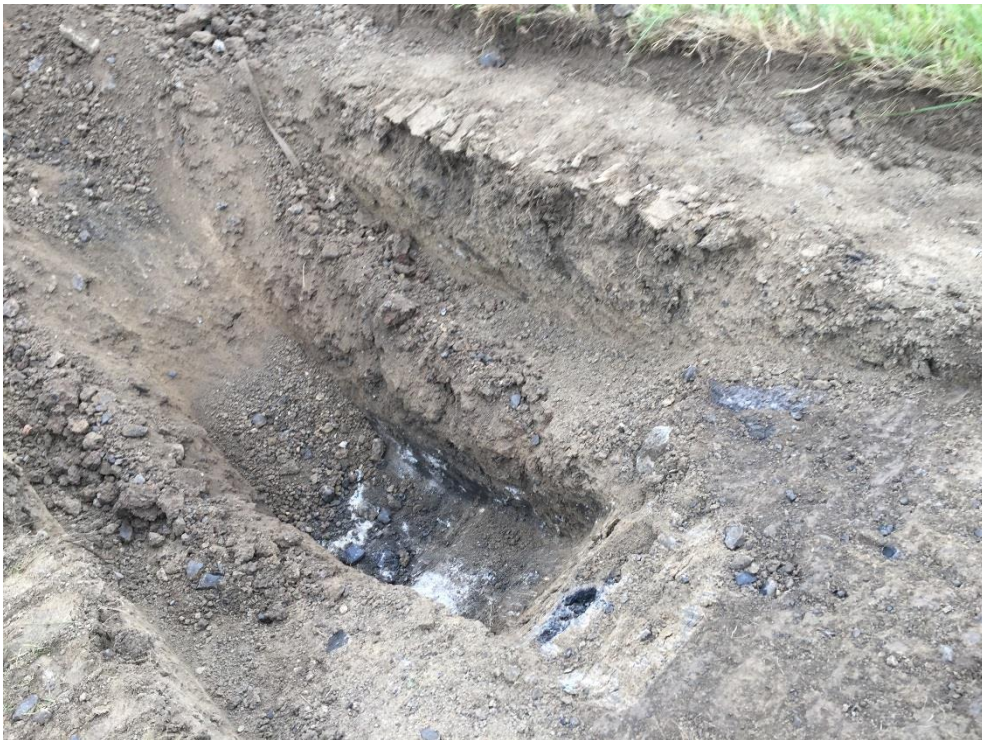
TP21

Plan	Remarks
.	No groundwater encountered.
.	Trial pit stable.
.	Plate test carried out at 1.0m BGL in Trial pit.
.	Trial pit backfilled on completion.
.	
.	
	Scale (approx) 1:25
	Logged By ROT
	Figure No. 7926-07-18.TP21

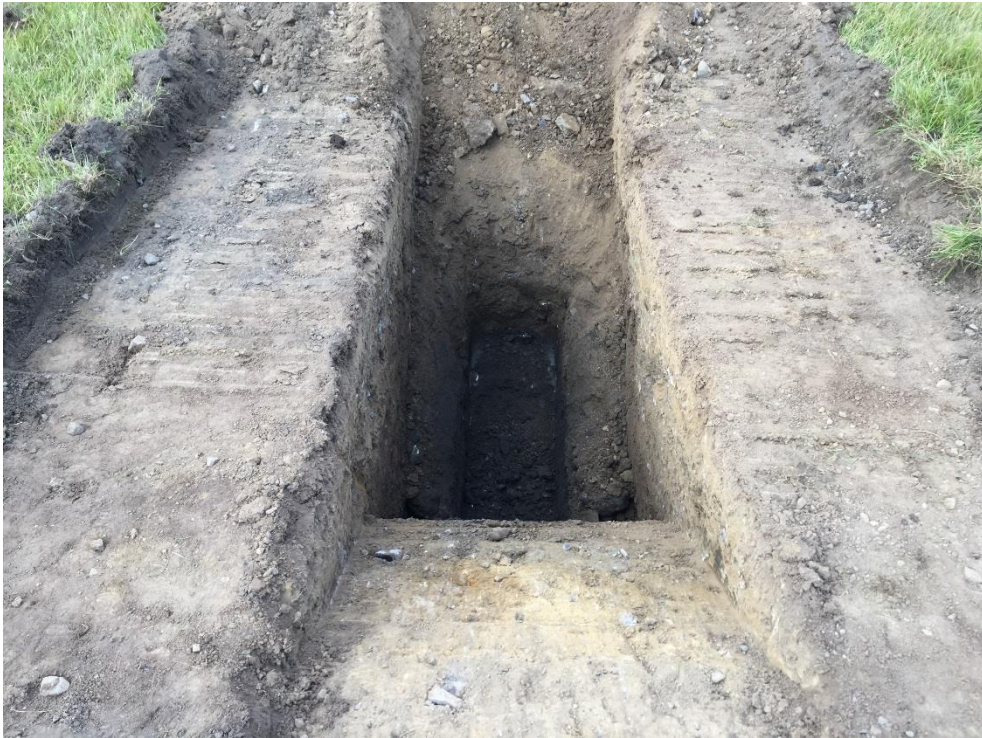
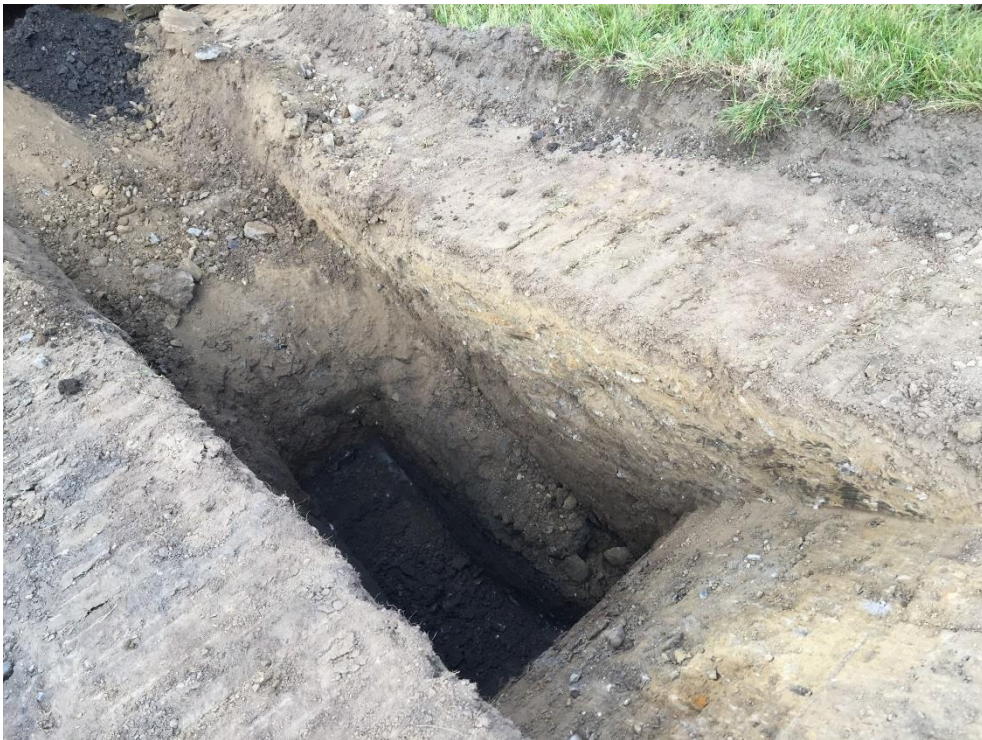
TP23

Plan									Remarks	
.	No groundwater encountered. Trial pit stable. Plate test carried out at 1.0m BGL in Trial pit. Trial pit backfilled on completion.	
.		
.		
.		
.		
								Scale (approx)	Logged By	Figure No.
								1:25	ROT	7926-07-18.TP23

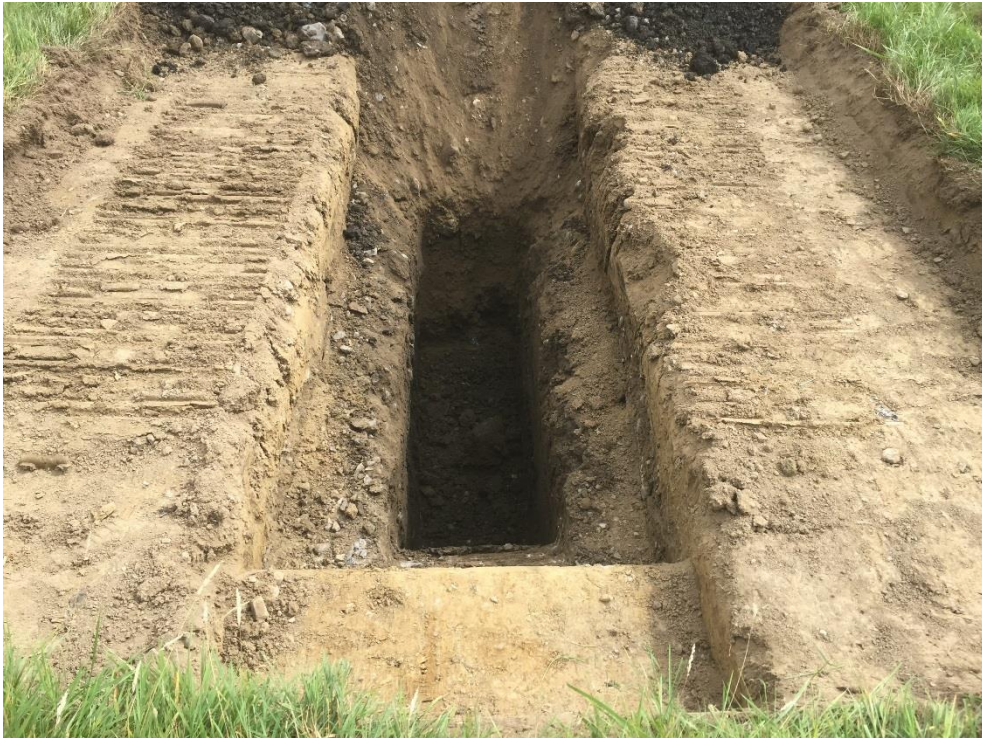
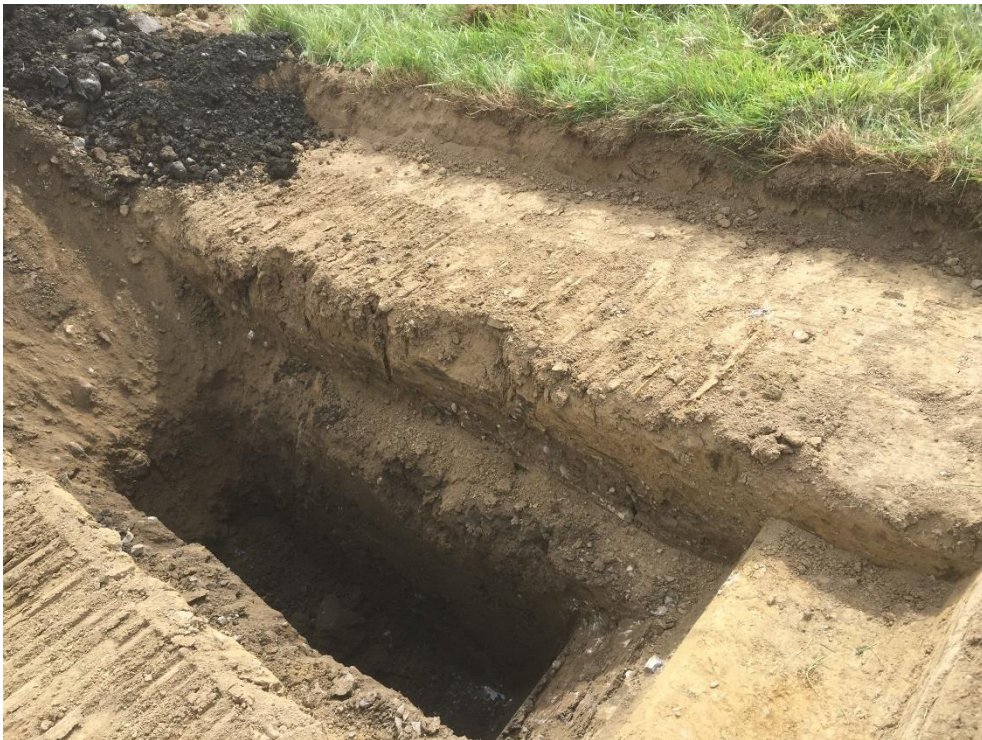
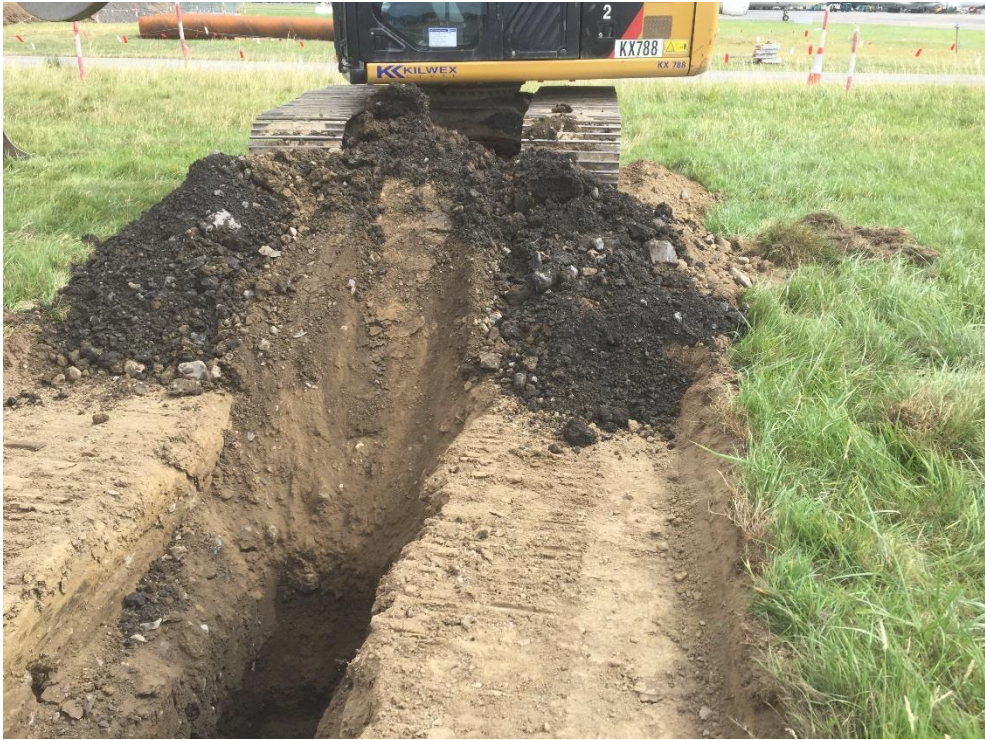
TP24

Plan	<p>Remarks</p> <p>No Groundwater encountered. Trial pit stable. Plate test carried out at 1.0m BGL in trial pit. Trial pit backfilled on completion.</p>		
	Scale (approx) 1:25	Logged By ROT	Figure No. 7926-07-18.TP24

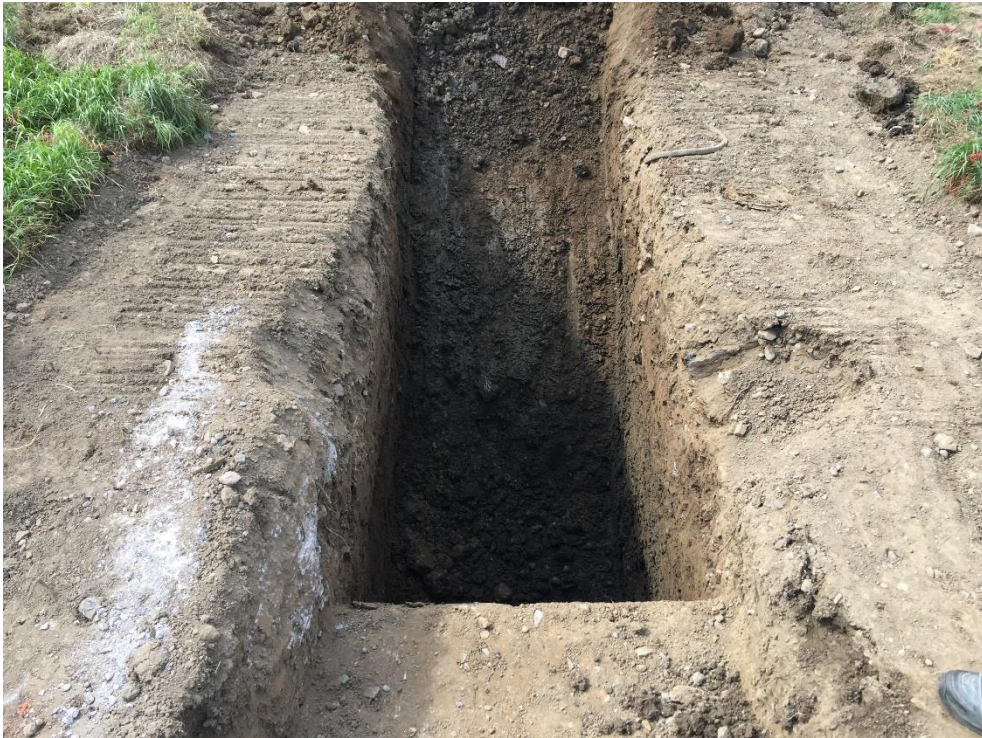
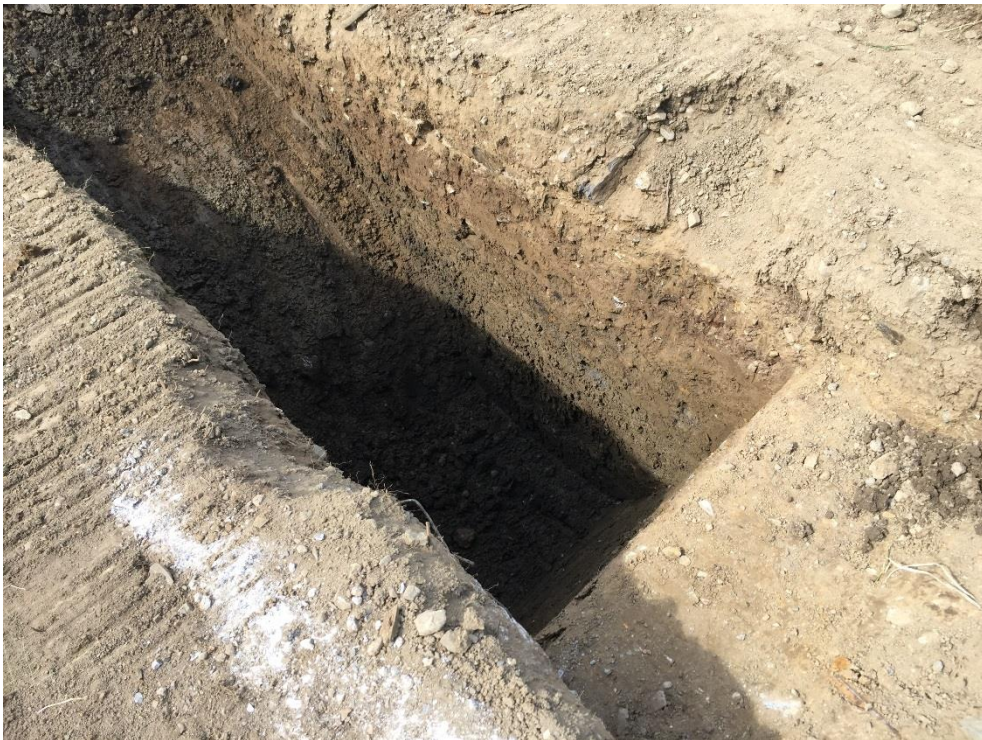
TP26

Plan				Remarks
				No Groundwater encountered. Trial pit stable. Plate test carried out at 1.0m BGL in trial pit. Trial pit backfilled on completion.
		Scale (approx)	Logged By	Figure No.
		1:25	ROT	7926-07-18.TP26

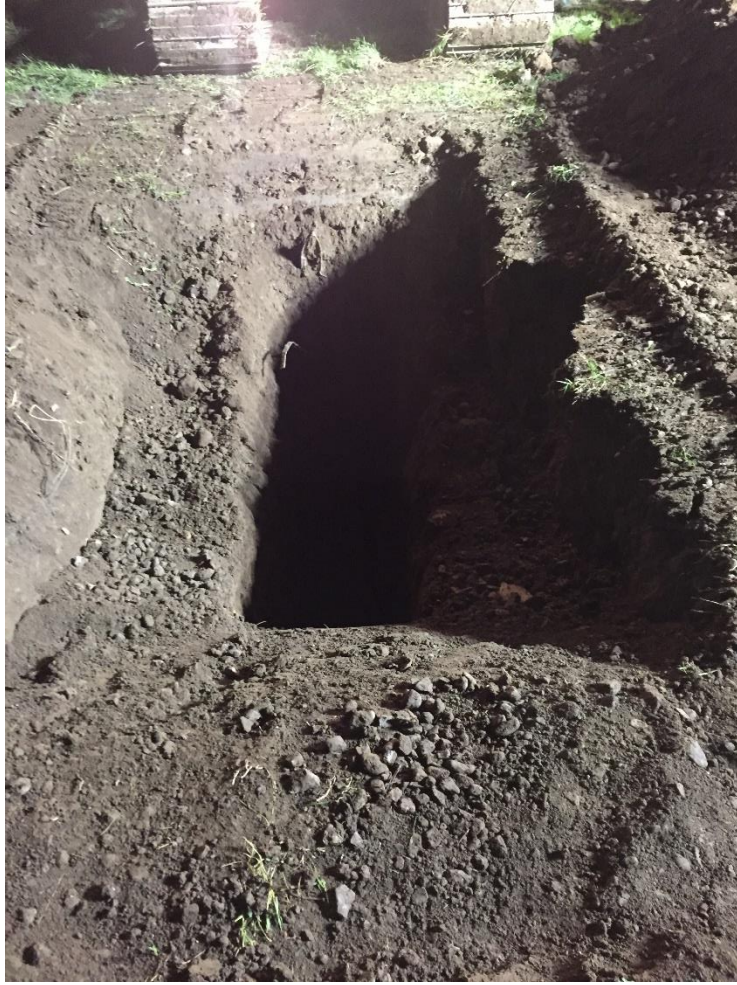
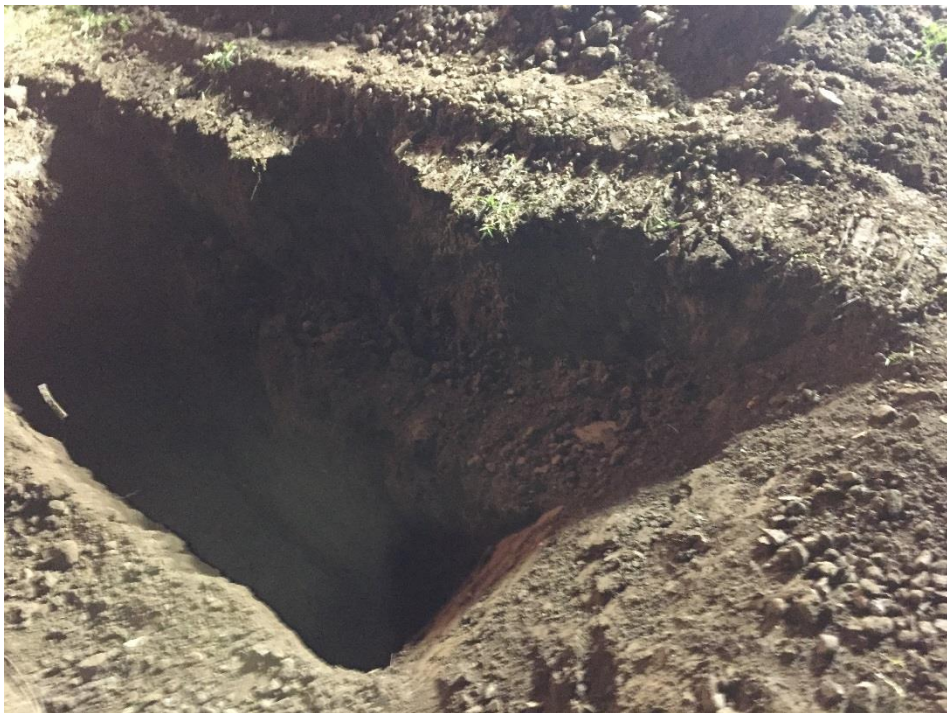
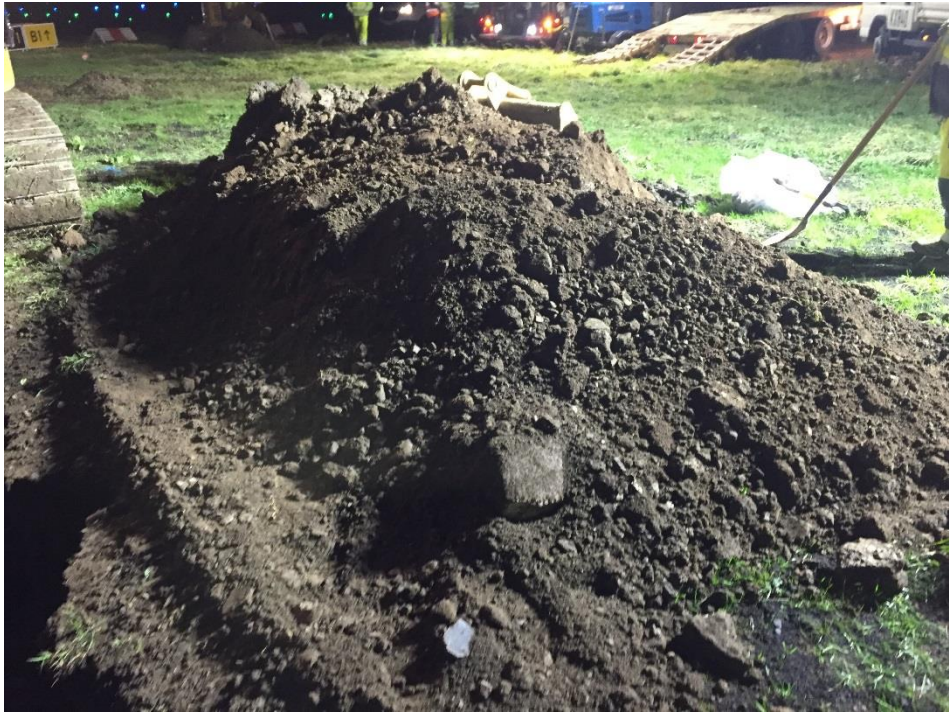
TP27

<p>Plan</p> <p style="text-align: center;">.</p> <p style="text-align: center;">.</p> <p style="text-align: center;">.</p> <p style="text-align: center;">.</p> <p style="text-align: center;">.</p> <p style="text-align: center;">.</p>	<p>Remarks</p> <p>No groundwater observed in TP Trial pit stable. Plate test carried out at 1.00m BGL in Trial pit. Trial pit backfilled on completion. Shear Vane tests completed at 0.50m BGL and 1.00m BGL</p>			
	<table border="1" style="width: 100%; border-collapse: collapse;"> <tr> <td style="width: 33%;">Scale (approx) 1:25</td> <td style="width: 33%;">Logged By ROT</td> <td style="width: 33%;">Figure No. 7926-07-18.TP27</td> </tr> </table>	Scale (approx) 1:25	Logged By ROT	Figure No. 7926-07-18.TP27
Scale (approx) 1:25	Logged By ROT	Figure No. 7926-07-18.TP27

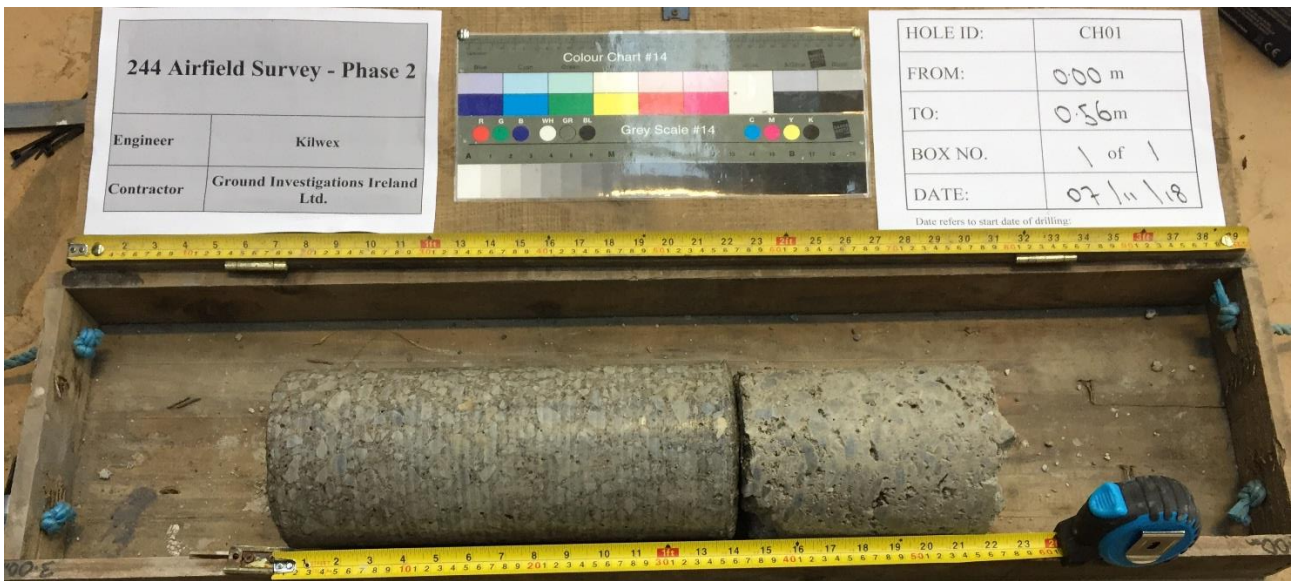
Vertical Core: CH01

Layer	From (m)	To	Thickness	Material
1	0.000	0.360	0.360	Concrete
2	0.360	0.560	0.200	Concrete Base
3	0.560	0.600	0.040	804 Hardcore Fill

- Core recovered 0.560m
- Diameter of core 140mm
- Separation of core at 0.36m caused during core extraction

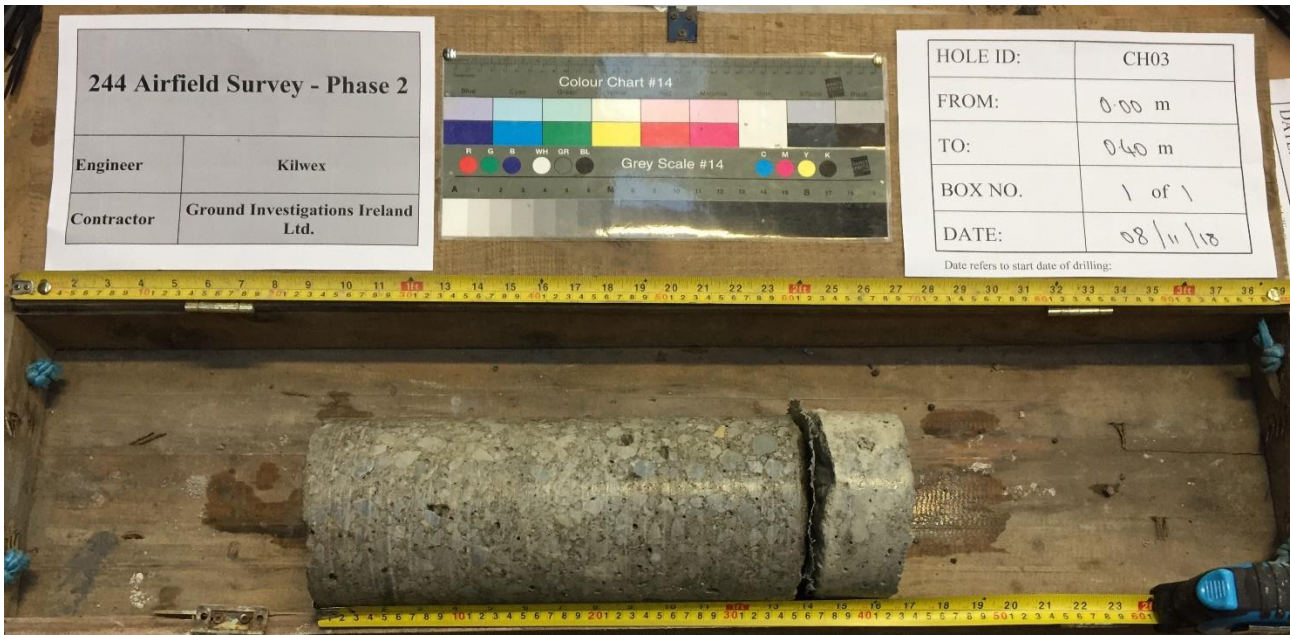
Vertical Core: CH03

Layer	From (m)	To	Thickness	Material
1	0.000	0.350	0.350	Concrete
2	0.350	0.400	0.050	Concrete Base
3	0.400	0.500	0.100	804 Hardcore Fill

- Core recovered 0.400m
- Diameter of core 140mm
- Separation of core at 0.35m caused during core extraction

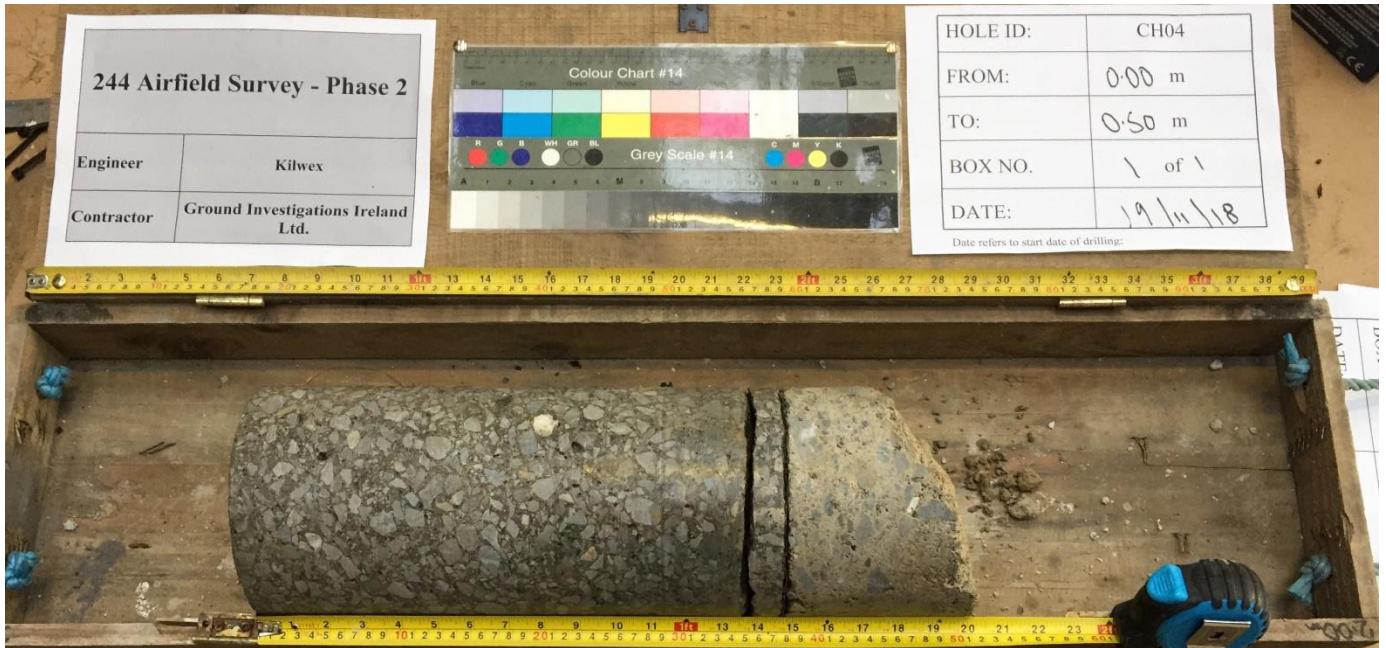
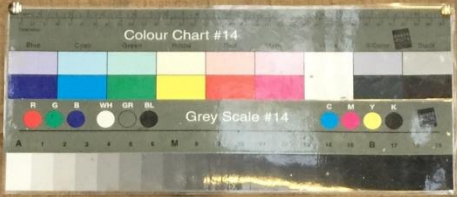
Vertical Core: CH04

HOLE ID:	CH04
FROM:	0.00 m
TO:	0.50 m
BOX NO.	1 of 1
DATE:	19/11/18

- Core recovered 0.500m
- Diameter of core 170mm
- Separation of core at 0.36m and 0.38m caused during core extraction
- 0.000 - 0.380 - Strong grey CONCRETE. 80% to 90% aggregate, angular to sub angular fine to coarse limestone gravels with 5 – 10% small voids.
- 0.380 - 0.500 - Strong light grey CONCRETE. 70% to 80% aggregate, sub rounded to sub angular fine to coarse limestone gravels with 5 – 10% small voids.
- 0.500 - 0.600 - Crushed Rock Fill
- No cracks in core
- No reinforcement in Concrete

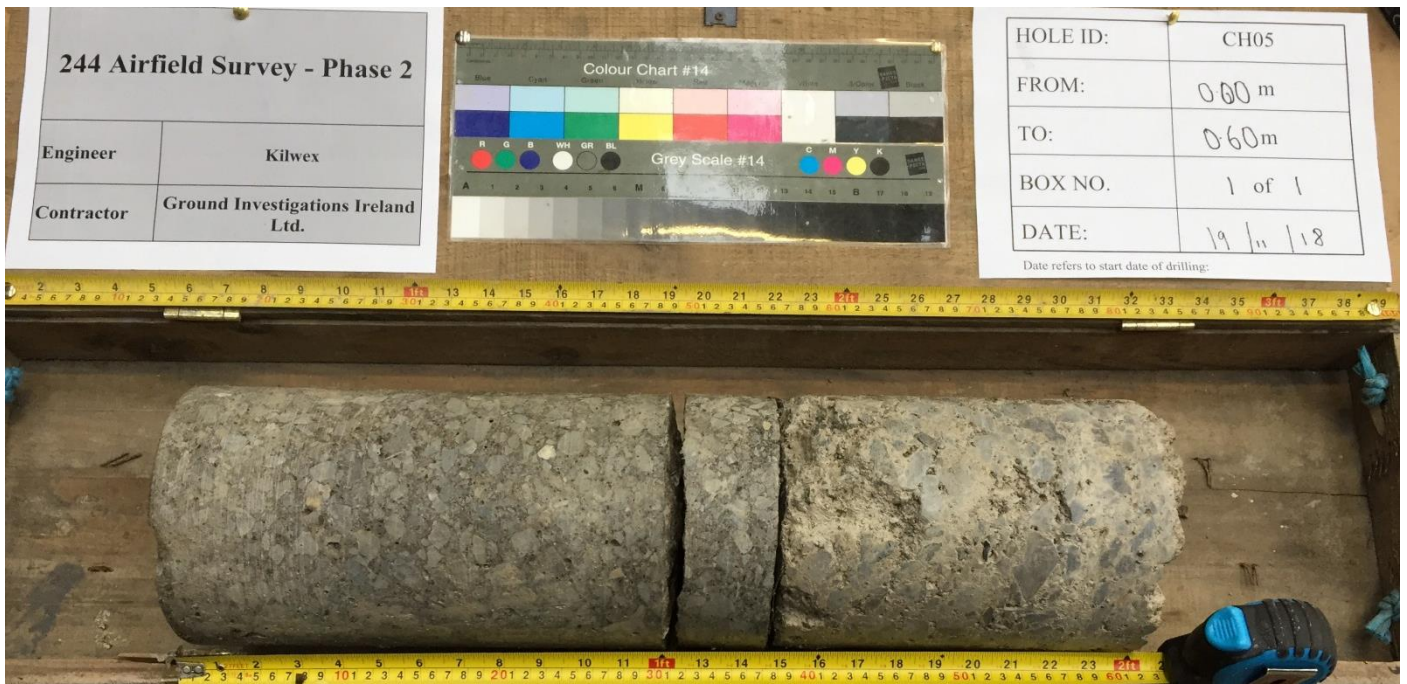
Vertical Core: CH05

Layer	From (m)	To	Thickness	Material
1	0.000	0.360	0.360	Concrete
2	0.360	0.600	0.240	Concrete
3	0.600	0.700	0.100	804 Hardcore Fill

- Core recovered 0.600m
- Diameter of core 170mm
- Separation of core at 0.30m and 0.36m caused during core extraction
- 0.000 - 0.360 - Strong light grey CONCRETE. 80% to 90% aggregate, angular to sub angular fine to coarse limestone gravels with 5% small voids.
- 0.360 - 0.600 - Strong light grey CONCRETE. 80% to 90% aggregate, sub rounded to sub angular fine to coarse limestone gravels with 10% small voids.
- 0.600 - 0.700 - Crushed Rock Fill
- No cracks in core
- No reinforcement in Concrete

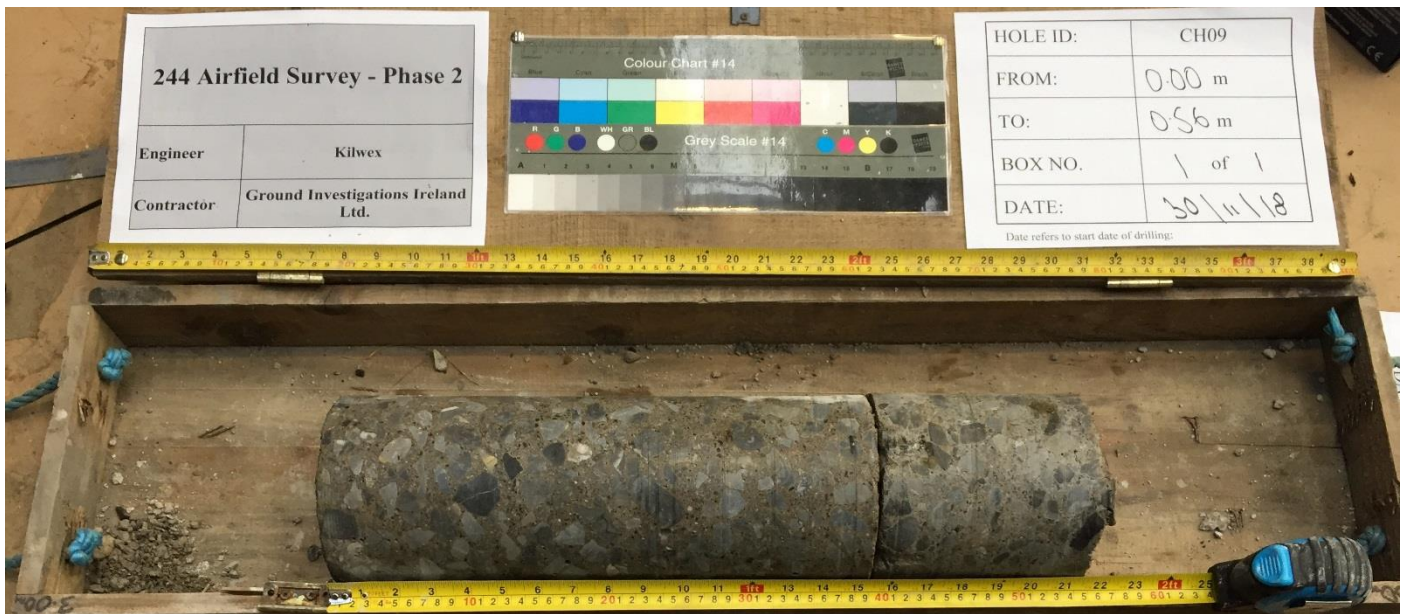
Vertical Core: CH09

Layer	From (m)	To	Thickness	Material
1	0.000	0.390	0.390	Concrete
2	0.390	0.560	0.170	Concrete Base
3	0.560	0.660	0.100	804 Hardcore Fill

- Core recovered 0.560m
- Diameter of core 140mm
- Separation of core at 0.39m caused during core extraction

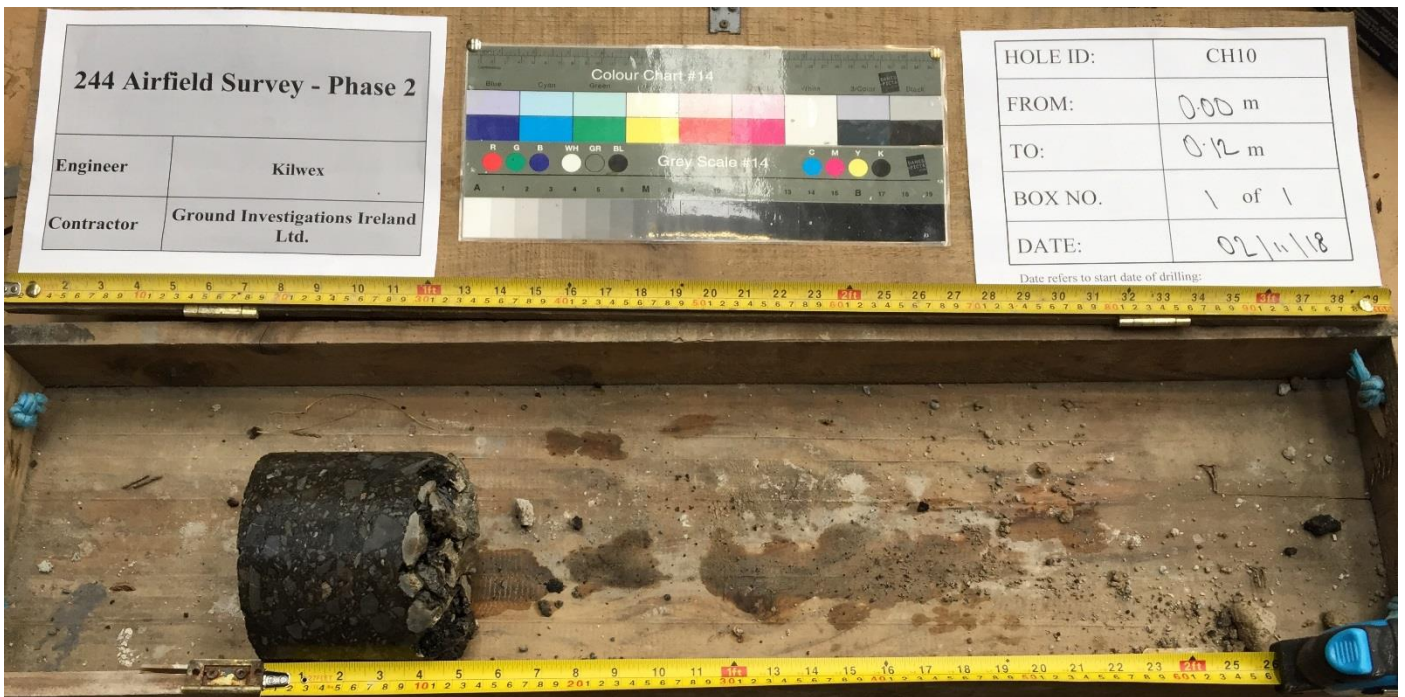
Vertical Core: CH10

Layer	From (m)	To	Thickness	Material
1	0.000	0.120	0.120	Tarmacadam
2	0.120	0.300	0.180	804 Hardcore Fill

- Core recovered 0.120m
- Diameter of core 140mm
- 0.000 - 0.120 - Strong black Tarmacadam. 80% to 90% aggregate, angular to sub angular fine to coarse limestone gravels with 20% small voids.
- 0.120 – 0.300 - Crushed Rock Fill
- No cracks in core
- No reinforcement in Tarmacadam

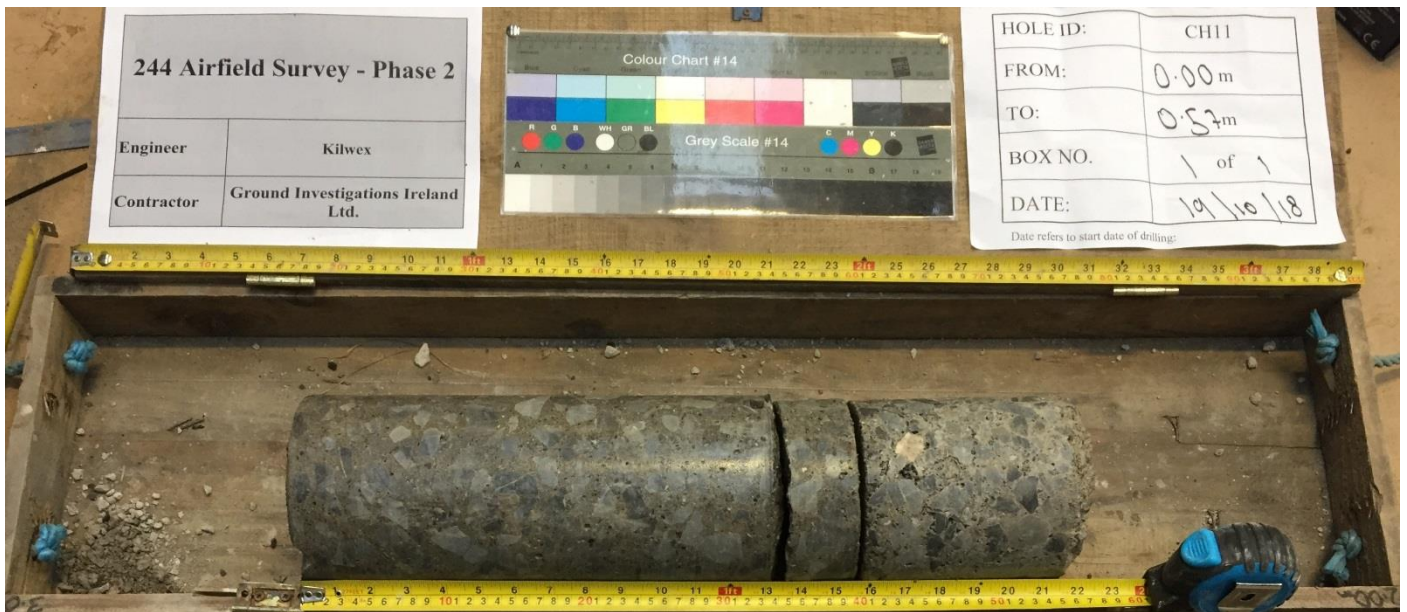
Vertical Core: CH11

Layer	From (m)	To	Thickness	Material
1	0.000	0.390	0.390	Concrete
2	0.390	0.570	0.180	Concrete Base
3	0.570	0.670	0.100	804 Hardcore Fill

- Core recovered 0.570m
- Diameter of core 140mm
- Separation of core at 0.34m and 0.39m caused during core extraction
