244 Airfield Surveys Phase 2

Ground Investigation Report

Project Title	244 Airfield Surveys Phase 2
Engineer	Kilwex
Client	DAA
Project No	7926-07-18
Document Title	Factual Ground Investigation Report

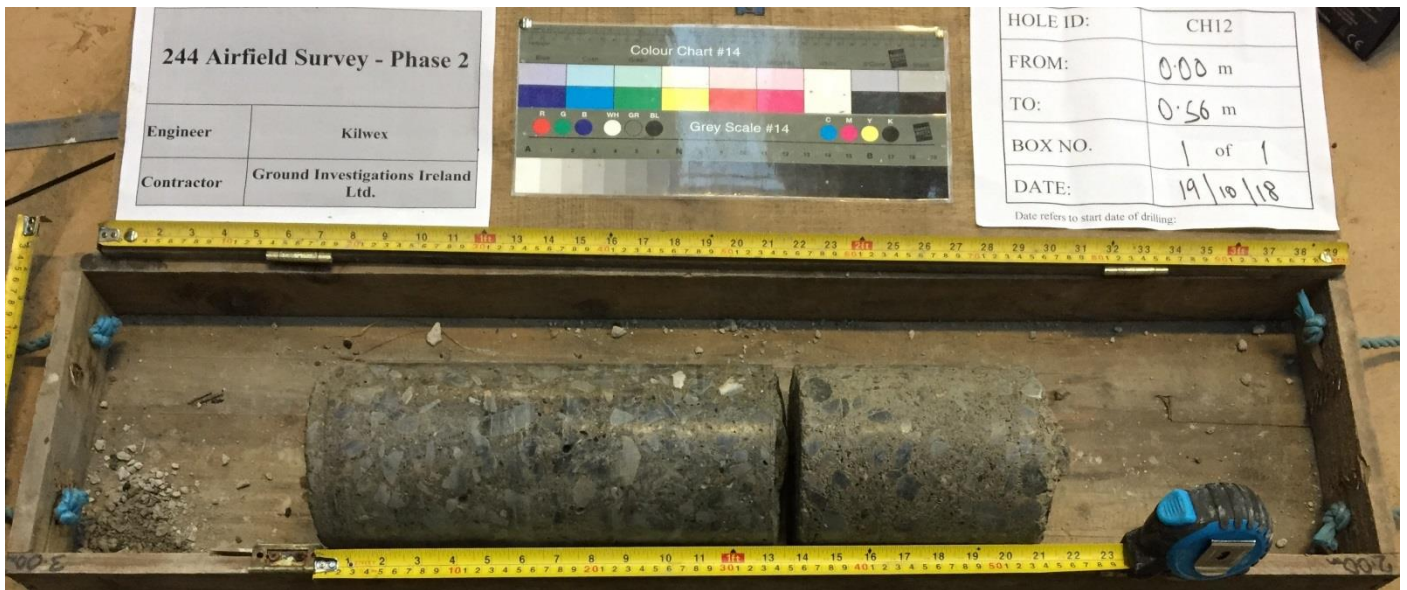
Vertical Core: CH12

Layer	From (m)	To	Thickness	Material
1	0.000	0.340	0.340	Concrete
2	0.340	0.560	0.220	Concrete Base
3	0.560	0.660	0.100	804 Hardcore Fill

- Core recovered 0.560m
- Diameter of core 140mm
- Separation of core at 0.34m caused during core extraction
- 0.000 - 0.340 - Strong grey CONCRETE. 70% to 80% aggregate, angular to sub angular fine to coarse limestone gravels with 10-20% small voids.
- 0.340 - 0.560 - Strong light grey CONCRETE. 70% to 80% aggregate, sub rounded to sub angular fine to coarse limestone gravels with 5-10% small voids.
- 0.560 - 0.660 - Crushed Rock Fill
- No cracks in core
- No reinforcement in Concrete

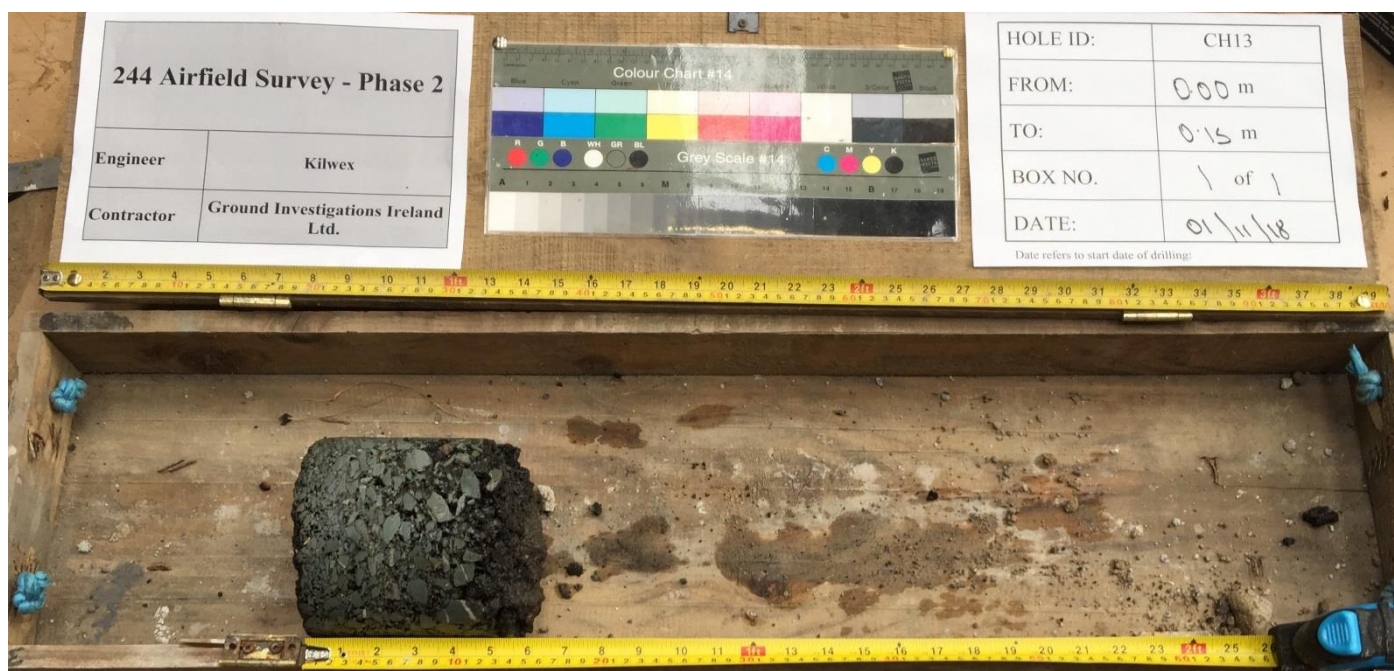
Vertical Core: CH13

Layer	From (m)	To	Thickness	Material
1	0.000	0.150	0.150	Tarmacadam
2	0.150	0.300	0.150	804 Hardcore Fill

- Core recovered 0.150m
- Diameter of core 140mm
- 0.000 - 0.150 - Strong black Tarmacadam. 80% to 90% aggregate, angular to sub angular fine to coarse limestone gravels with 20% small voids.
- 0.150 – 0.300 - Crushed Rock Fill
- No cracks in core
- No reinforcement in Tarmacadam

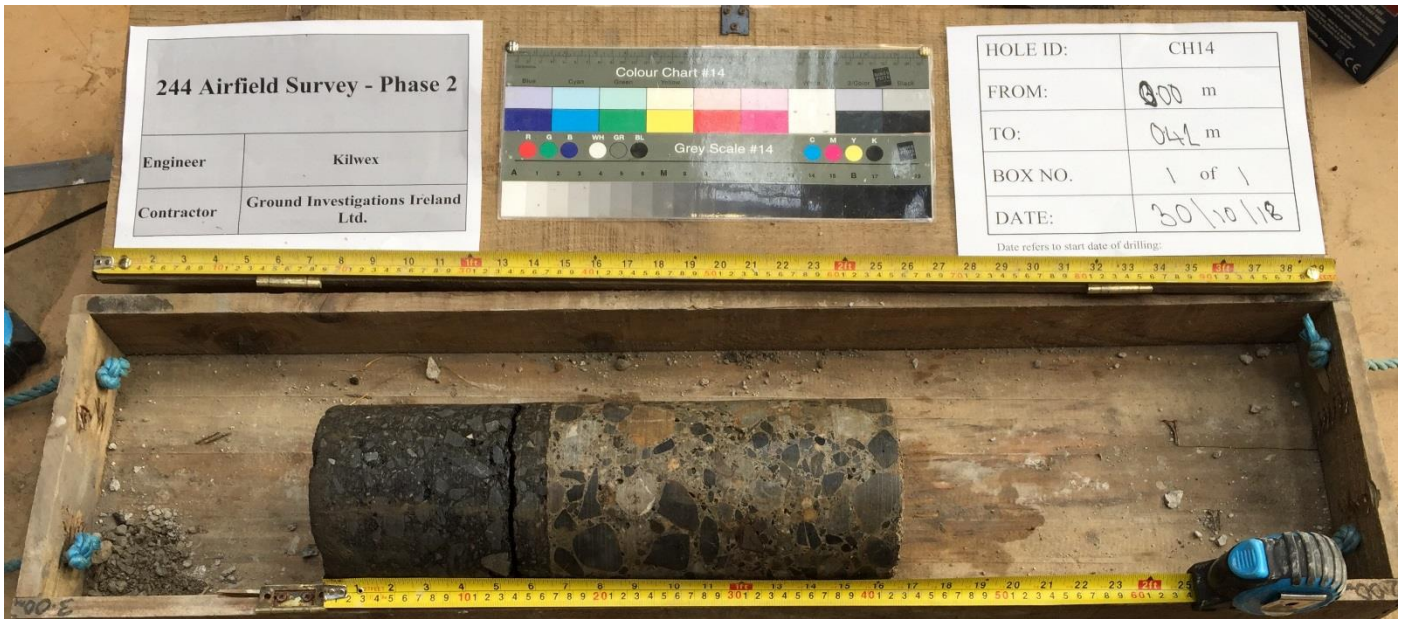
Vertical Core: CH14

Layer	From (m)	To	Thickness	Material
1	0.000	0.170	0.170	Tarmacadam
2	0.170	0.420	0.250	Concrete
3	0.420	0.520	0.100	804 Hardcore Fill

- Core recovered 0.420m
- Diameter of core 140mm
- Separation of core at 0.15m caused during core extraction
- 0.000 - 0.170 - Strong black Tarmacadam. 80% to 90% aggregate, angular to sub angular fine to coarse limestone gravels with 5-10% small voids.
- 0.170 - 0.420 - Strong grey CONCRETE. 70% to 80% aggregate, sub rounded to sub angular fine to coarse limestone gravels with 10-20% small voids.
- 0.420 - 0.520 - Crushed Rock Fill
- No cracks in core
- No reinforcement in Tarmacadam/Concrete

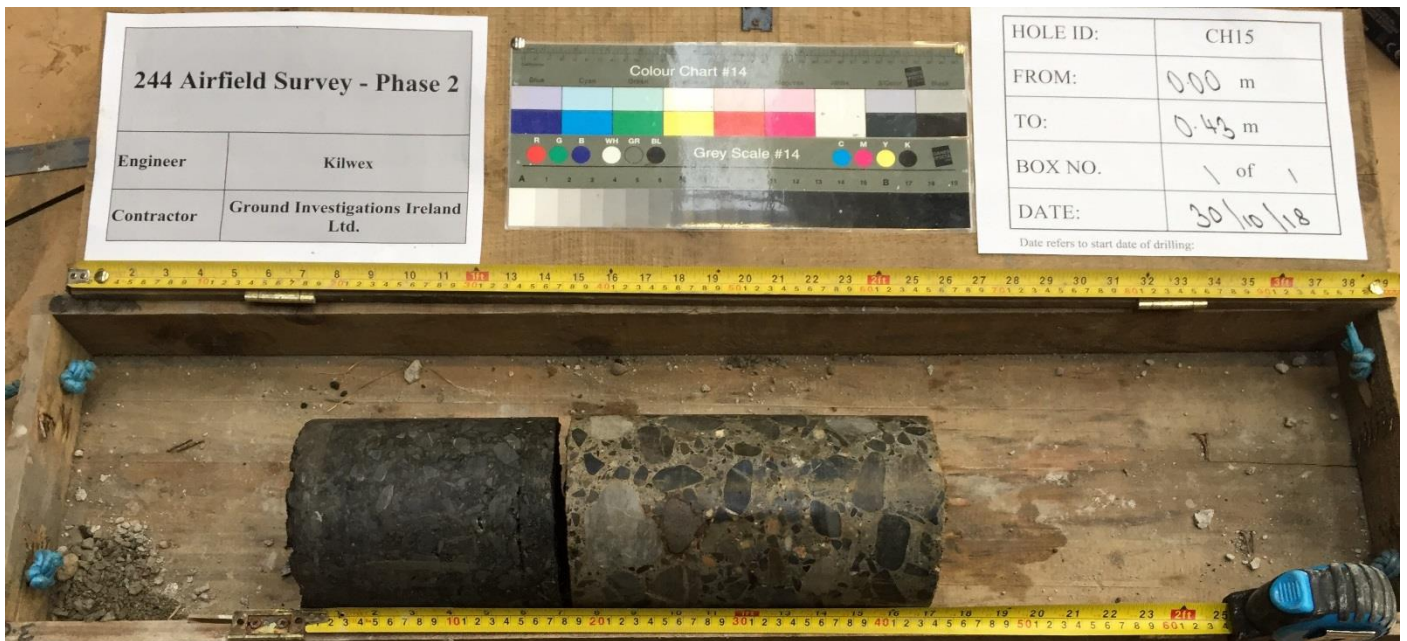
Vertical Core: CH15

Layer	From (m)	To	Thickness	Material
1	0.000	0.170	0.170	Tarmacadam
2	0.170	0.430	0.260	Concrete
3	0.430	0.530	0.100	804 Hardcore Fill

- Core recovered 0.430m
- Diameter of core 140mm
- Separation of core at 0.17m caused during core extraction
- 0.000 - 0.170 - Strong black Tarmacadam. 80% to 90% aggregate, angular to sub angular fine to coarse limestone gravels with 5-10% small voids.
- 0.170 - 0.430 - Strong grey CONCRETE. 70% to 80% aggregate, sub rounded to sub angular fine to coarse limestone gravels with 10-20% small voids.
- 0.430 - 0.530 - Crushed Rock Fill
- No cracks in core
- No reinforcement in Tarmacadam/Concrete

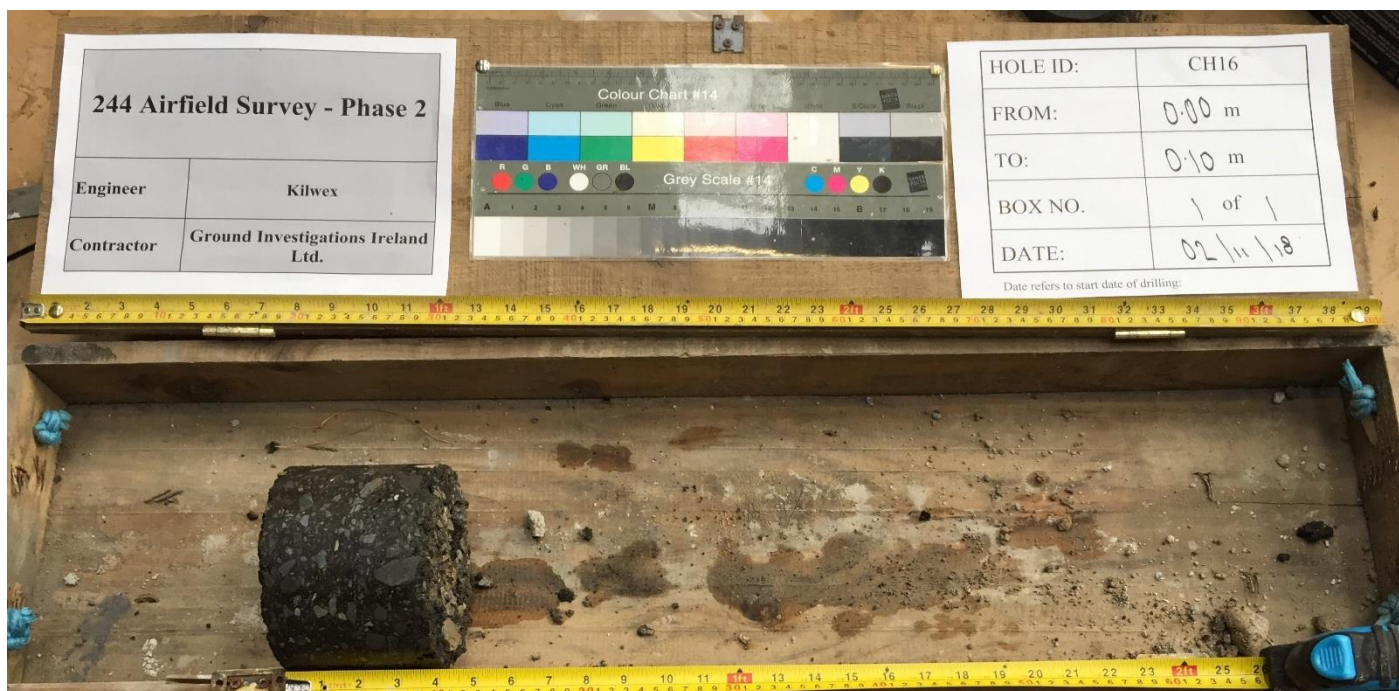
Vertical Core: CH16

Layer	From (m)	To	Thickness	Material
1	0.000	0.100	0.100	Tarmacadam
2	0.100	0.300	0.200	804 Hardcore Fill

- Core recovered 0.100m
- Diameter of core 140mm
- 0.000 - 0.100 - Strong black Tarmacadam. 80% to 90% aggregate, angular to sub angular fine to coarse limestone gravels with 20% small voids.
- 0.100 – 0.300 - Crushed Rock Fill
- No cracks in core
- No reinforcement in Tarmacadam

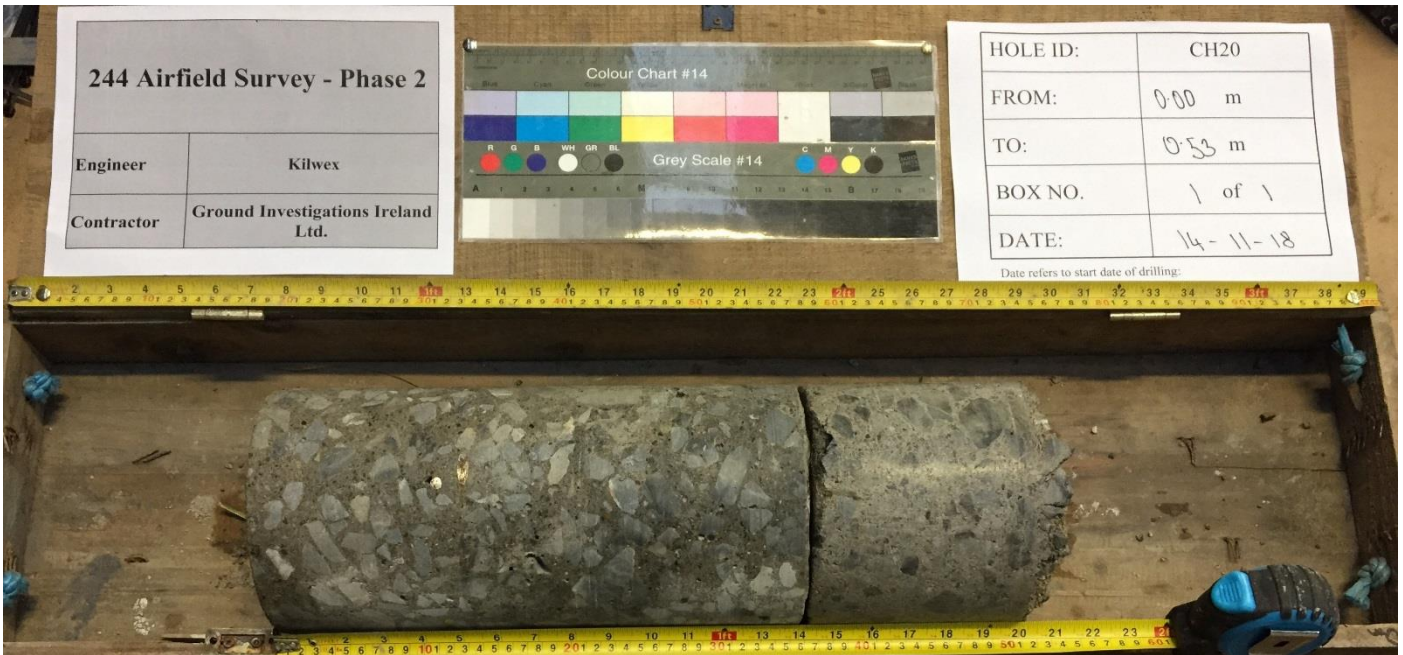
Vertical Core: CH20

Layer	From (m)	To	Thickness	Material
1	0.000	0.360	0.360	Concrete
2	0.360	0.530	0.170	Concrete base
3	0.530	0.630	0.100	804 Hardcore Fill

- Core recovered 0.530m
- Diameter of core 170mm
- Separation of core at 0.36m caused during core extraction
- 0.000 - 0.360 - Strong light grey CONCRETE. 70% to 80% aggregate, angular to sub angular fine to coarse limestone gravels with 5-10% small voids.
- 0.360 - 0.530 - Strong grey CONCRETE. 60% to 70% aggregate, sub rounded to sub angular fine to coarse limestone gravels with 5% small voids.
- 0.530 - 0.630 - Crushed Rock Fill
- No cracks in core
- 5mm and 10mm reinforcement bars of mesh at 100mm spacing in Concrete

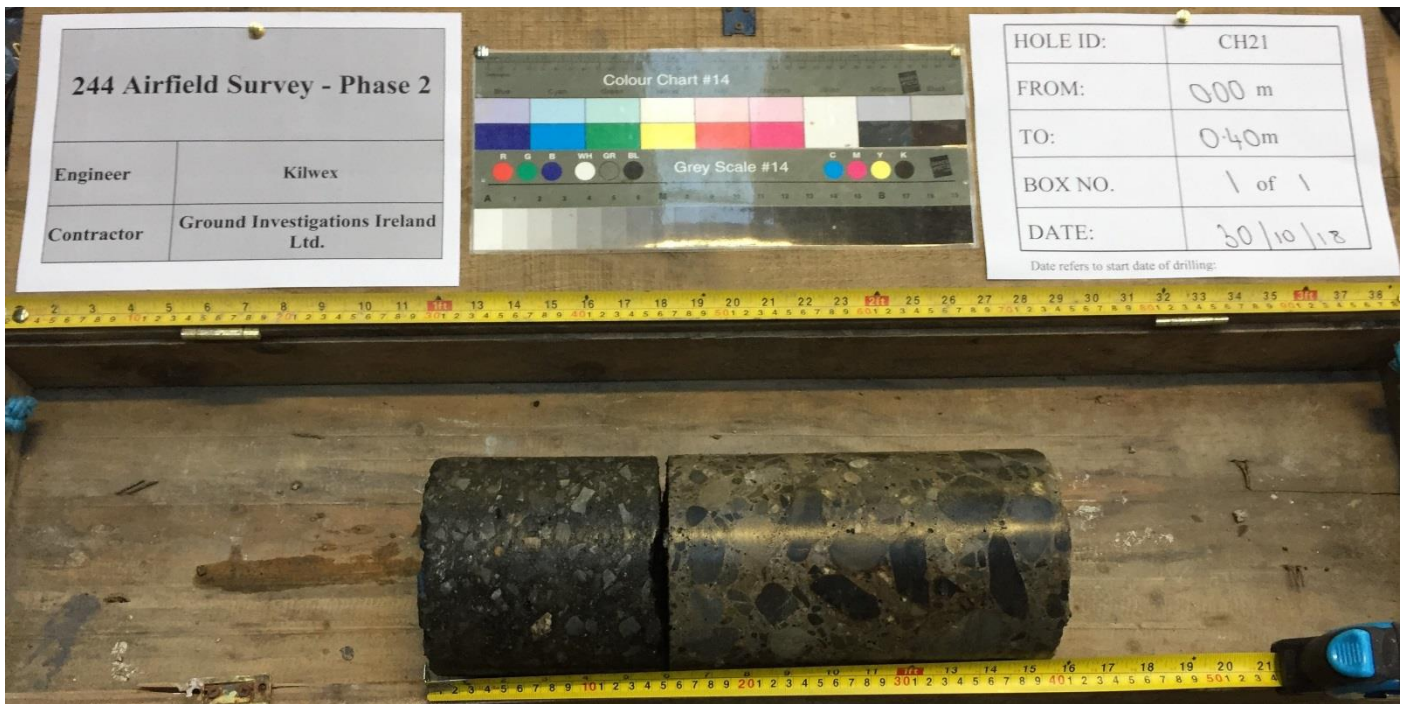
Vertical Core: CH21

Layer	From (m)	To	Thickness	Material
1	0.000	0.140	0.140	Concrete
2	0.140	0.400	0.260	Concrete Base
3	0.400	0.500	0.100	804 Hardcore Fill

- Core recovered 0.400m
 - Diameter of core 140mm
 - Separation of core at 0.14m caused during core extraction
- 0.000 - 0.140 - Strong black CONCRETE. 60% to 70% aggregate, angular to sub angular fine to coarse limestone gravels with 5% small voids.
- 0.140 - 0.400 - Strong light grey CONCRETE. 60% to 70% aggregate, sub rounded to sub angular fine to coarse limestone gravels with rare cobbles and with 5% small voids.
- 0.400 - 0.500 - Crushed Rock Fill
- No cracks in core
 - No reinforcement in Concrete

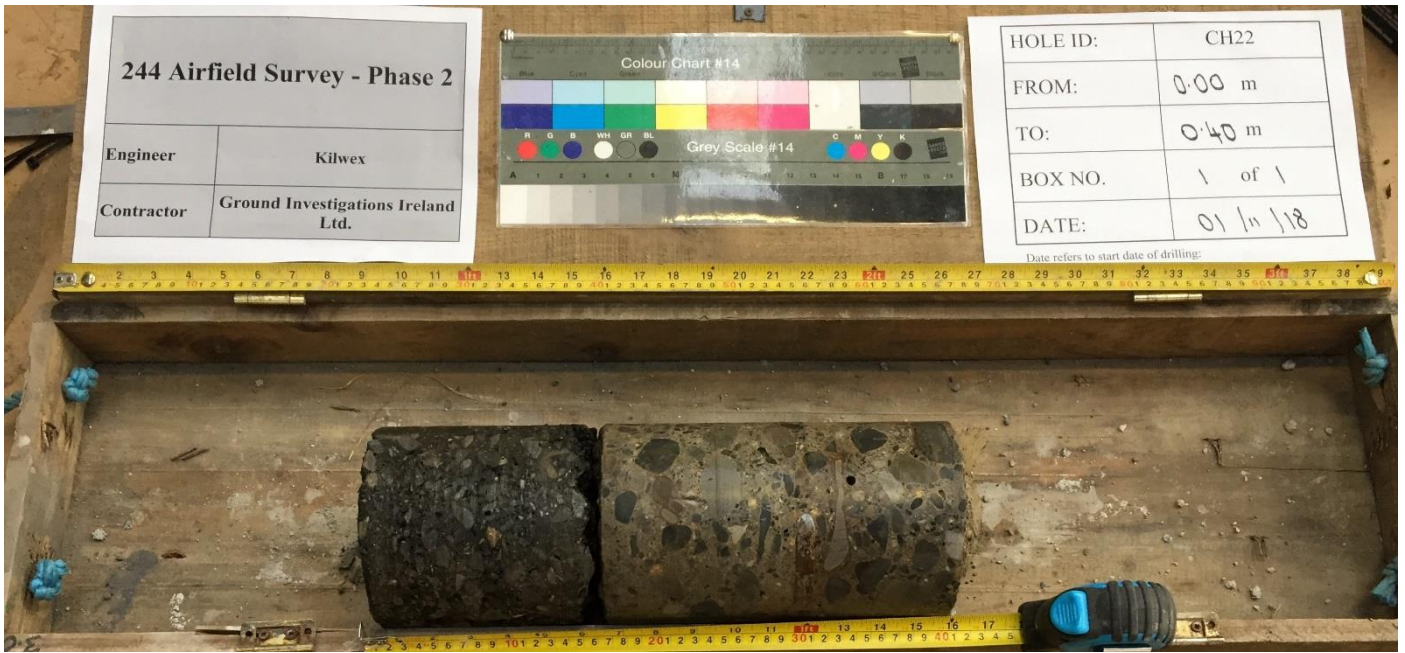
Vertical Core: CH22

Layer	From (m)	To	Thickness	Material
1	0.000	0.150	0.150	Tarmacadam
2	0.150	0.400	0.250	Concrete
3	0.400	0.500	0.100	804 Hardcore Fill

- Core recovered 0.400m
- Diameter of core 140mm
- Separation of core at 0.15m caused during core extraction
- 0.000 - 0.150 - Strong black Tarmacadam. 70% to 80% aggregate, angular to sub angular fine to coarse limestone gravels with 10-20% small voids.
- 0.150 - 0.400 - Strong grey CONCRETE. 70% to 80% aggregate, sub rounded to angular fine to coarse limestone gravels with 10-20% small voids.
- 0.400 - 0.500 - Crushed Rock Fill
- No cracks in core
- No reinforcement in Tarmacadam/Concrete

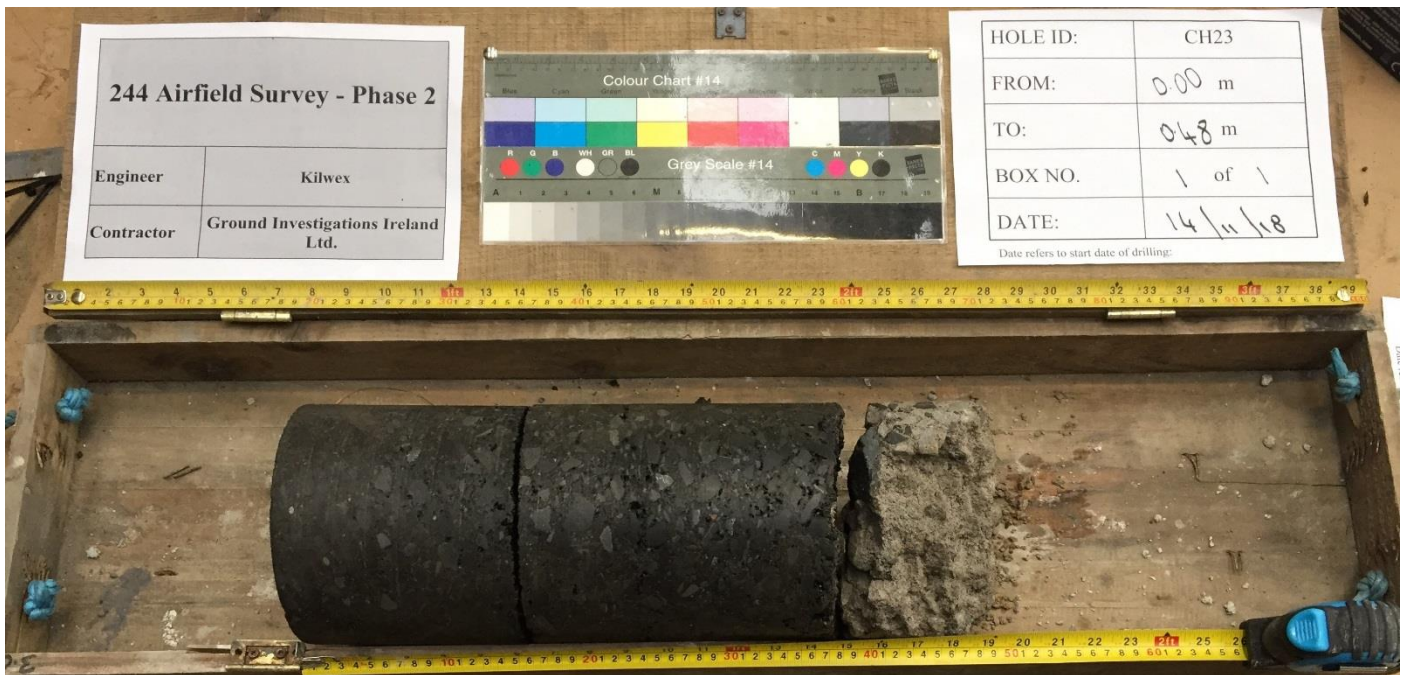
Vertical Core: CH23

Layer	From (m)	To	Thickness	Material
1	0.000	0.380	0.380	Tarmacadam
2	0.380	0.480	0.100	Concrete Base
3	0.480	0.580	0.100	804 Hardcore Fill

- Core recovered 0.480m
- Diameter of core 170mm
- Separation of core at 0.15m and 0.38m caused during core extraction
- 0.000 - 0.380 - Strong black Tarmacadam. 70% to 80% aggregate, angular to sub angular fine to coarse limestone gravels with 5-10% small voids.
- 0.380 - 0.480 - Strong light grey CONCRETE. 80% to 90% aggregate, angular to sub angular fine to coarse limestone gravels with 5% small voids.
- 0.480 - 0.580 - Crushed Rock Fill
- No cracks in core
- No reinforcement in Tarmacadam/Concrete

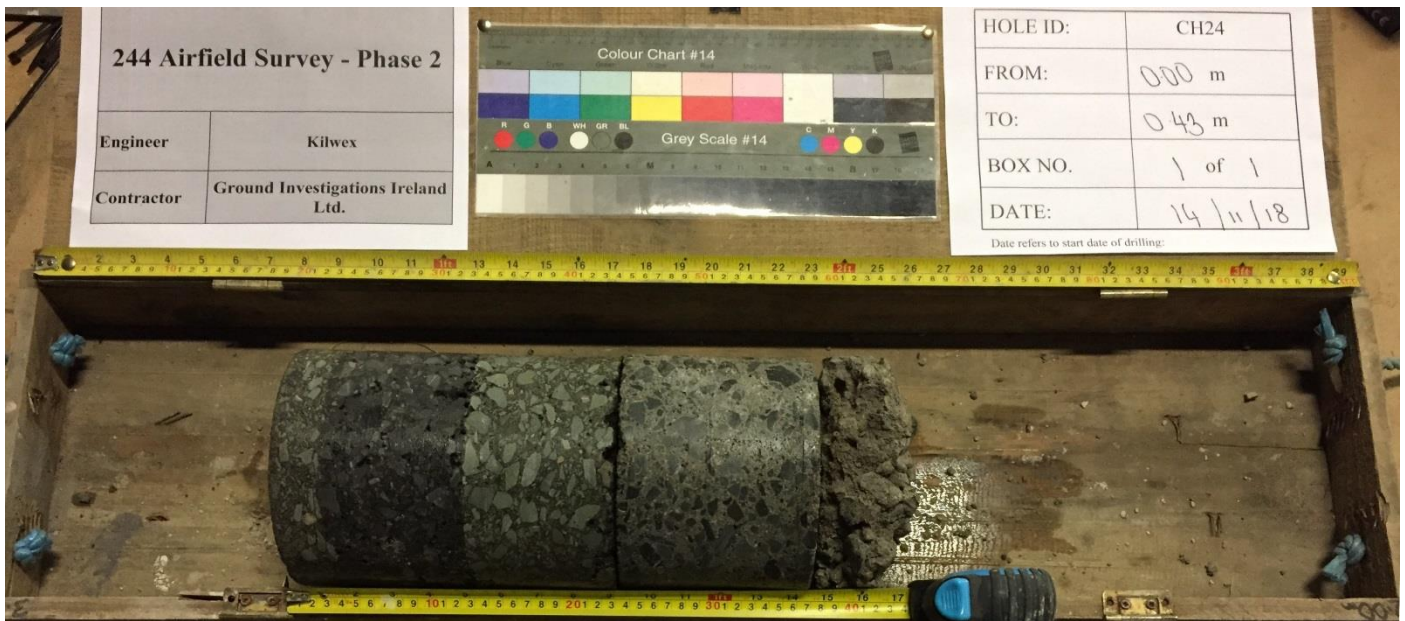
Vertical Core: CH24

Layer	From (m)	To	Thickness	Material
1	0.000	0.030	0.030	Tarmacadam
2	0.030	0.130	0.100	Tarmacadam
3	0.130	0.430	0.300	Concrete Base
4	0.430	0.530	0.100	804 Hardcore Fill

- Core recovered 0.430m
- Diameter of core 170mm
- Separation of core at 0.23m and 0.36m caused during core extraction
- 0.000 - 0.030 - Strong black Tarmacadam. 80% to 90% aggregate, angular to sub angular fine to coarse limestone gravels.
- 0.030 - 0.130 – Medium strong black Tarmacadam. 70% to 80% aggregate, angular to sub angular fine to coarse limestone gravels with 20% small and medium voids.
- 0.130 - 0.430 - Strong light grey CONCRETE. 80% to 90% aggregate, sub rounded to sub angular fine to coarse limestone gravels with 5% small voids.
- 0.430 - 0.530 - Crushed Rock Fill
- No cracks in core
- No reinforcement in Tarmacadam/Concrete
