Appendix A9.1
Noise & Vibration
Survey

Appendix A9.1: Noise & Vibration Surveys

This report includes the relevant survey details and results associated with baseline noise monitoring undertaken as part of the Templeogue / Rathfarnham to City Centre Core Bus Corridor Scheme (hereafter referred to as the Proposed Scheme). The survey has been undertaken to inform the noise and vibration chapter of the Proposed Scheme EIAR.

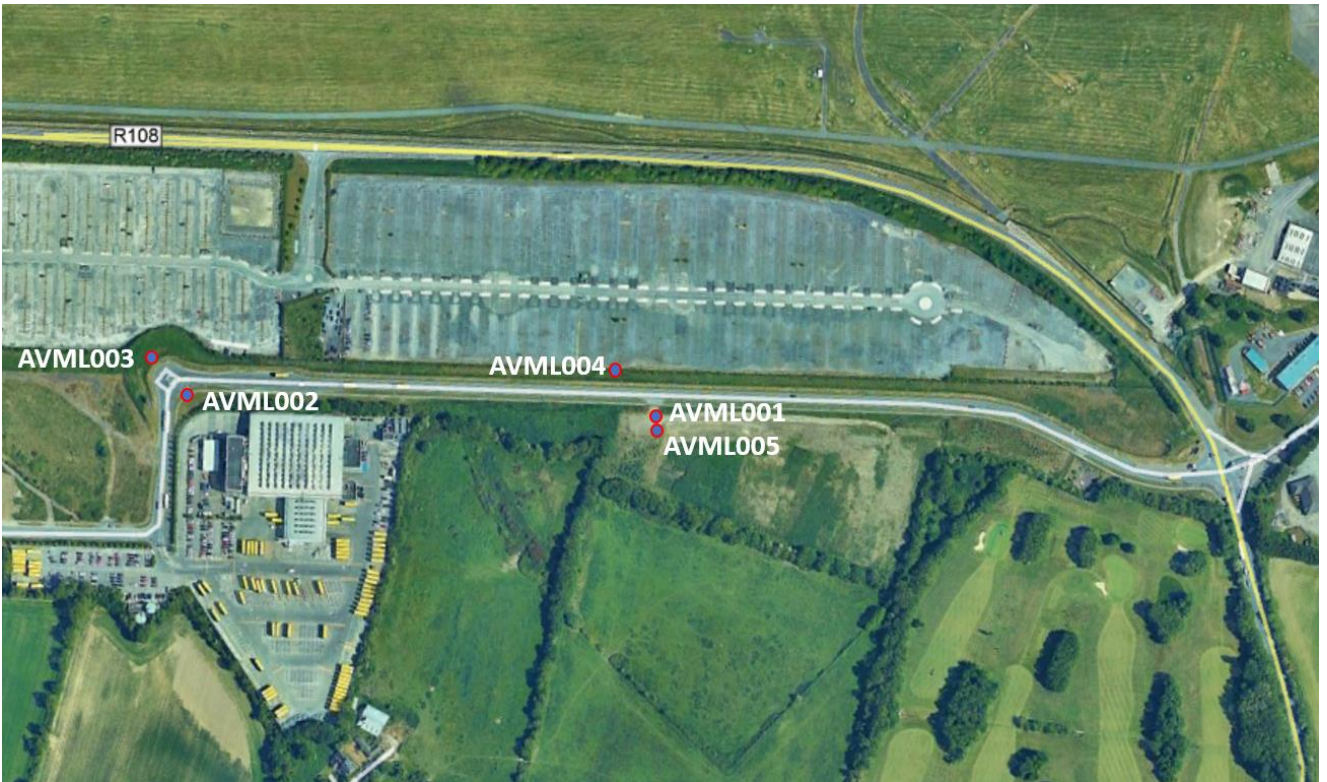
Figure 1: Vibration Monitoring Locations Harristown Bus Depot (source Google Earth)

The survey locations undertaken along the Harristown Bus Depot entrance are illustrated in Figure 1. The survey locations undertaken along the Malahide Road are illustrated in Figure 2.

Vibration Monitoring Locations	Description of Survey Location
AVML001	Harristown – Entrance Road to Bus Depot, midway along inbound road, 5m from road edge
AVML002	Harristown – Roundabout at Bus Depot entrance, buses entering depot, 5m from road edge
AVML003	Harristown – Roundabout at Bus Depot entrance, buses exiting depot, 5m from road edge
AVML004	Harristown – Entrance Road to Bus Depot, midway along outbound road, 5m from road edge
AVML005	Harristown – Entrance Road to Bus Depot, midway along inbound road, 7m from road edge
AVML006	Malahide Road / St. Johns Court – 5m from edge of Inbound Bus Lane
AVML007	Malahide Road / St. Johns Court – 10m from edge of Inbound Bus Lane
AVML008	Malahide Road / Donnycarney Church – 2.5m from edge of Inbound Bus Lane
AVML009	Malahide Road– 2.5m from edge of outbound Bus Lane

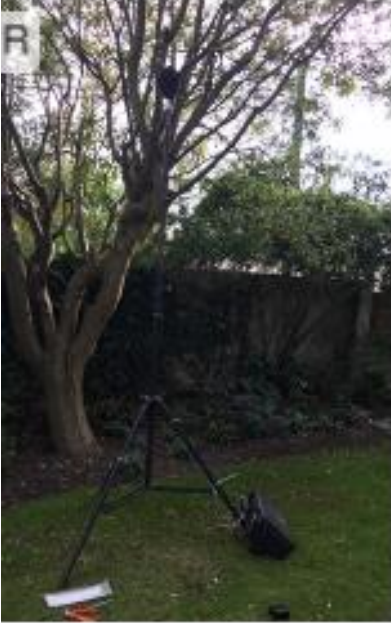
Location	Equipment Set up
<p>CBC1012UNML001</p> <p>In residential front garden located 130m to northeast of R137 Templeogue Road and R817 Cypress Grove Road. Located approximately 5m to R137 road edge. Residential NSLs along R137 Templeogue Road typically 15m to 20m from road edge.</p>

For unattended surveys, a Rion WS-15 Outdoor Microphone Protection System with microphone extension cable and outdoor peli-case was used. An image of the equipment install at each monitoring location is included in Section 5.
