Appendix A9.1
Noise & Vibration
Survey

Appendix A9.1: Noise and Vibration Survey

This Report includes the relevant survey details and results associated with baseline noise monitoring undertaken as part of the Tallaght / Clondalkin to City Centre Core Bus Corridor Scheme (hereafter referred to as the Proposed Scheme). The survey has been undertaken to inform the noise and vibration chapter of the Proposed Scheme EIAR.

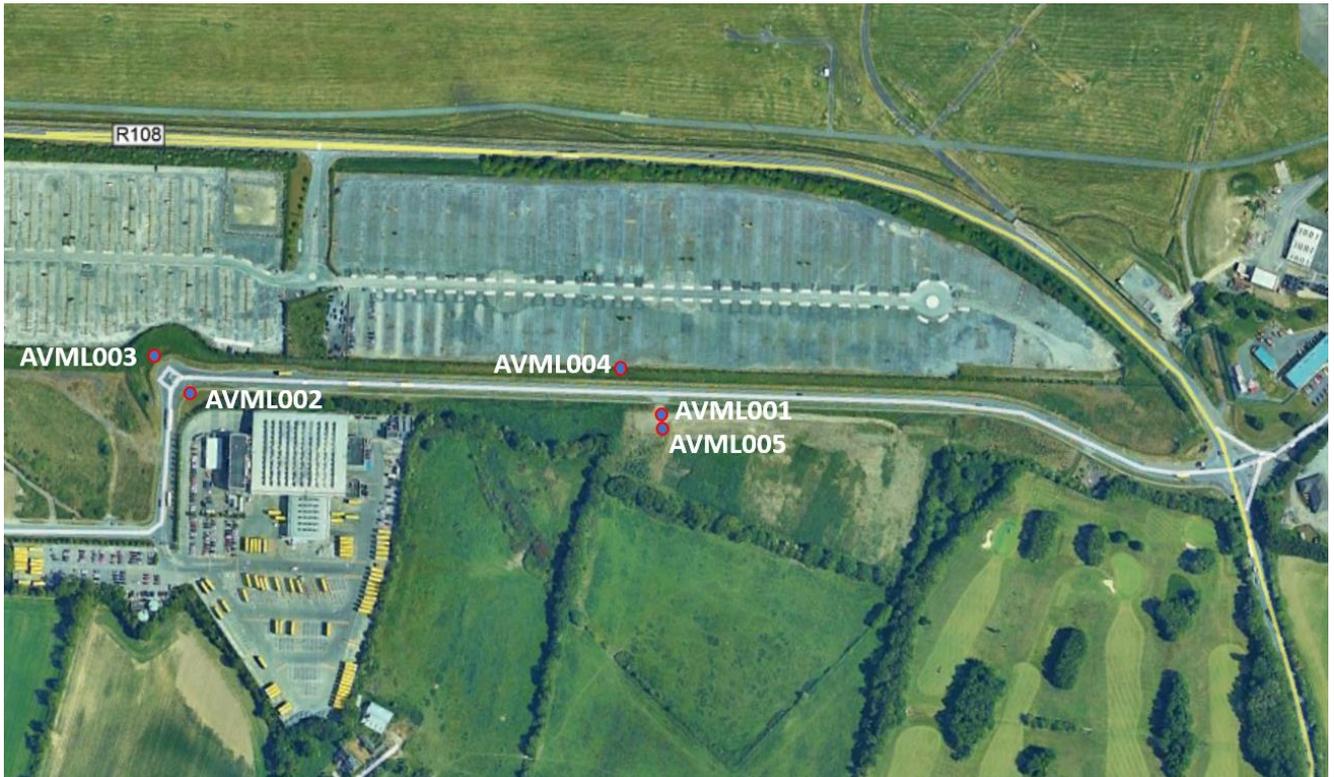
Figure 1: Vibration Monitoring Locations Harristown Bus Depot (source Google Earth)

Vibration Monitoring Locations	Description of Survey Location
AVML001	Harristown – Entrance Road to Bus Depot, midway along inbound road, 5m from road edge
AVML002	Harristown – Roundabout at Bus Depot entrance, buses entering depot, 5m from road edge
AVML003	Harristown – Roundabout at Bus Depot entrance, buses exiting depot, 5m from road edge
AVML004	Harristown – Entrance Road to Bus Depot, midway along outbound road, 5m from road edge
AVML005	Harristown – Entrance Road to Bus Depot, midway along inbound road, 7m from road edge
AVML006	Malahide Road / St. Johns Court – 5m from edge of Inbound Bus Lane
AVML007	Malahide Road / St. Johns Court – 10m from edge of Inbound Bus Lane
AVML008	Malahide Road / Donnycarney Church – 2.5m from edge of Inbound Bus Lane
AVML009	Malahide Road– 2.5m from edge of outbound Bus Lane

The survey locations undertaken along the Harristown Bus Depot entrance are illustrated in Figure 1. The survey locations undertaken along the Malahide Road are illustrated in Figure 2.

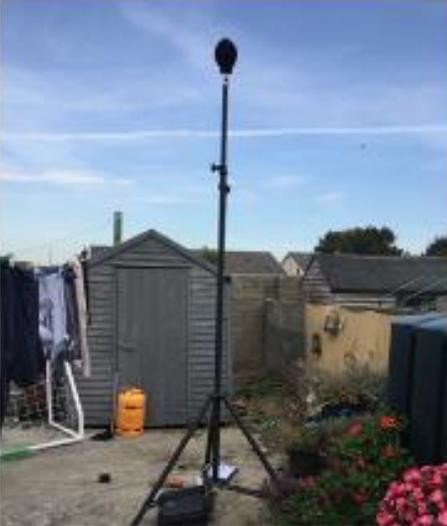
Location	Equipment Set Up
<p>CBC0809UNML001</p> <p>On hard ground in rear residential garden. Located approximately 35m to R819 Greenhills Road and 65m to Treepark Road edges.</p>

For unattended surveys, a Rion WS-15 Outdoor Microphone Protection System with microphone extension cable and outdoor peli-case was used. An image of the equipment install at each monitoring location is included in Section 5.

For unattended noise surveys, the monitoring equipment was installed within the private grounds of residential properties. For single story buildings, the microphone was installed at the height of ground floor windows (typically 1.5m above ground). For all other locations, the microphone was extended to a height of approximately 3.8m above ground. The equipment was set to log for 15 minute intervals on a continual basis over a one week period.

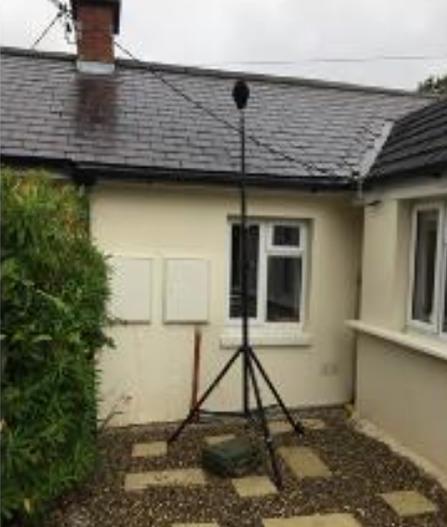
<p>CBC0809UNML002</p> <p>On hard ground in front residential garden, in line with façade of property. Located approximately 100 m from M50 and 100 m from R819 Greenhills Road.</p>
