Appendix 2-2 – Timahoe South Bog Decommissioning and Rehabilitation Plan 2022

Timahoe South Bog

Cutaway Bog Decommissioning and Rehabilitation Plan 2022

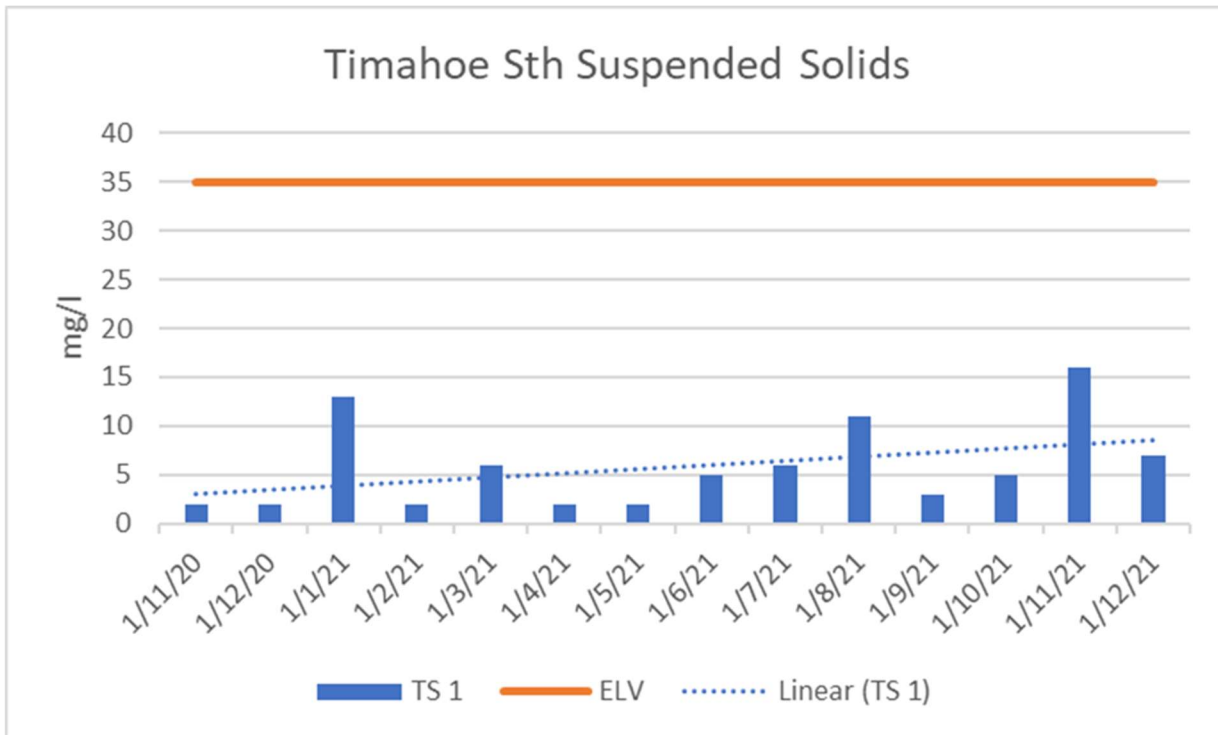
Figure AP13.1. Suspended solids in water sampling at Timahoe South from different discharge points. 35 mg/l is the emission limit value.
