ROAD SAFETY AUDIT

Title: STAGE 1 ROAD SAFETY AUDIT

Office Innovation Campus, Moygaddy, Co. Meath.

Report reference: 1388R01

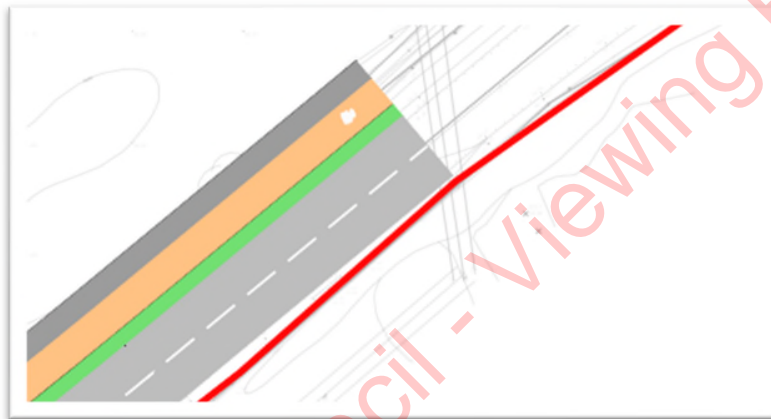
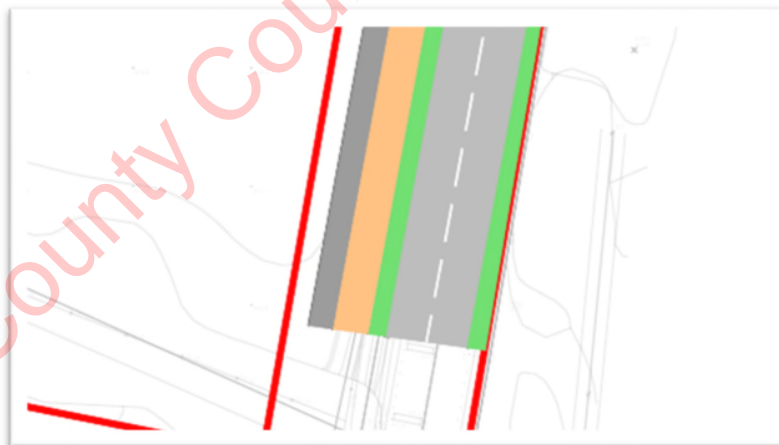
Examples only

LOCATION

General Comment tie-in points

Details have not been provided of how the cycle track and footpaths will tie in at the scheme extents. Cyclists and pedestrians will have to cross the carriageway to access the facilities. Without suitable transitions from off road to on road and suitable crossing facilities there is a risk that pedestrians and cyclists will be struck by passing traffic.

It is recommended that suitable transitions and crossing facilities be provided.

3.1	Y	Y	The proposed cycle lane along the R157 eastern arm will be updated to tie into the carriageway. A suitable Jug turn will be provided on the opposite side of the road to accommodate the cyclists' right turning movement towards the development	Yes

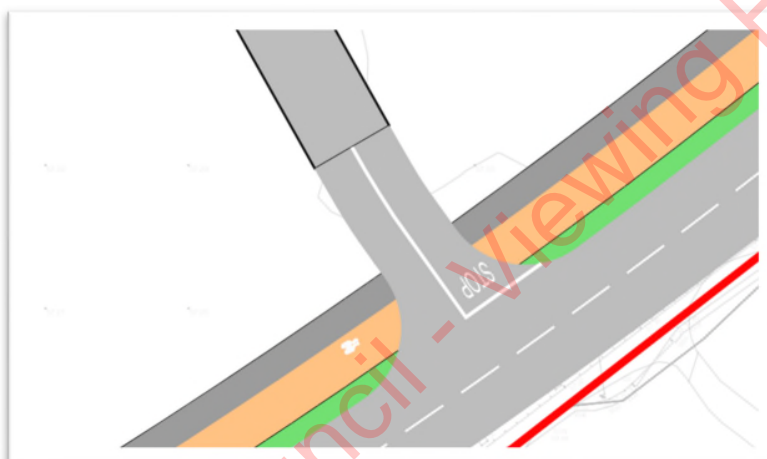
Drawing S665- OCSC-1A-MH-DR-C-0111 S2 P01 Sheet 2 of 3, cycle track across campus access road.

The proposed two way cycle track crosses the mouth of the campus access road. There is a risk that drivers exiting the campus may not expect two way cyclists as they approach the stop line.

It is recommended that a 'bend out crossing' be provided.

3.2	Y	N	It is proposed to provide a shared space and tactile for crossing before the cyclist and pedestrians approach the junction. A raised crossing will be provided to indicate priority for pedestrians and cyclists.	Yes

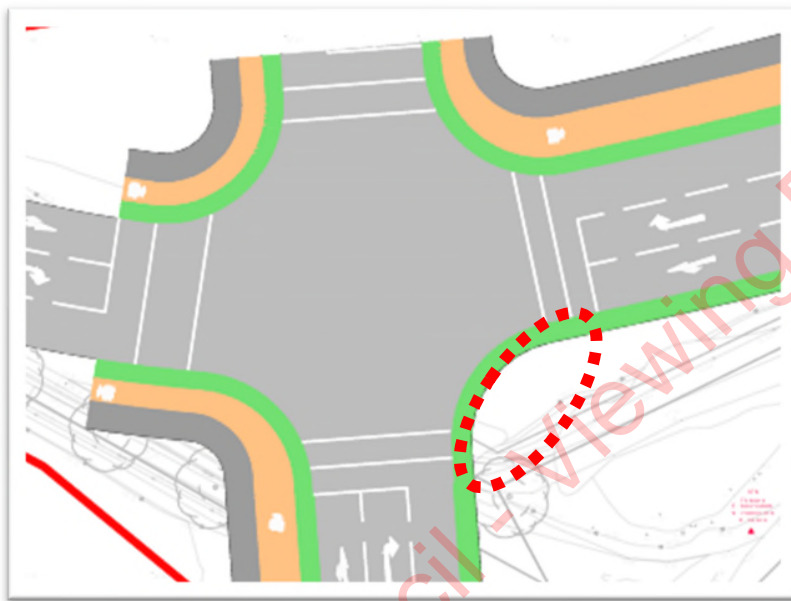
Drawing S665- OCSC-1A-MH-DR-C-0111 S2 P01 Sheet 2 of 3, campus access road.

There is a signalised pedestrian crossing of the R157 eastern section, however there is no footpath on that side. This could lead to slips and falls if pedestrians cross into the grassed verge.

It is recommended that a section of footpath be provided linking the north-south and east west pedestrian crossing areas. The crossing should be retained to be able to cater for potential future development.

3.3	Y	Y	A shared facility has been provided within the campus at required widths which ties into the external pedestrian and cyclist network.	Yes
3.4	Y	N	There are insufficient spaces to provide walkways and cycle lanes along the south-eastern parts of the design (boundary wall). As such, two way movements will take place on the opposite sides. Pedestrian crossing lines have been removed from the junction on the eastern and southern legs.	Yes

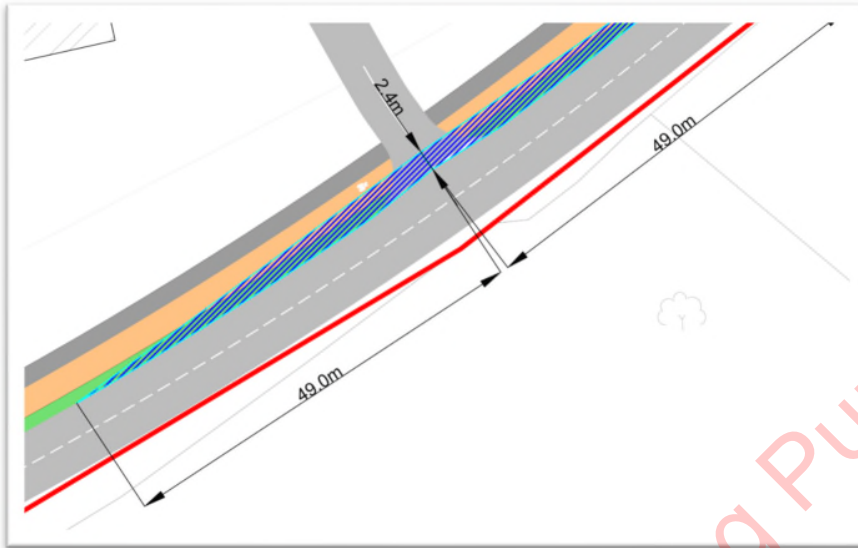
Drawing S665- OCSC-1A-MH-DR-C-0115 S2 P01, Visibility Splay at Campus junction.

The visibility splay is shown for a 50km/hr urban design speed. The posted speed is 80km/hr. There may be insufficient visibility to oncoming vehicles leading to side-impact or rear-end collisions.

It is recommended that visibility splays be provided to match the anticipated 85th percentile speed post opening.

3.5	N	N	The visibility splay is achieved for 50kph. The speed limited will be lowered to 50kph once the new	Yes

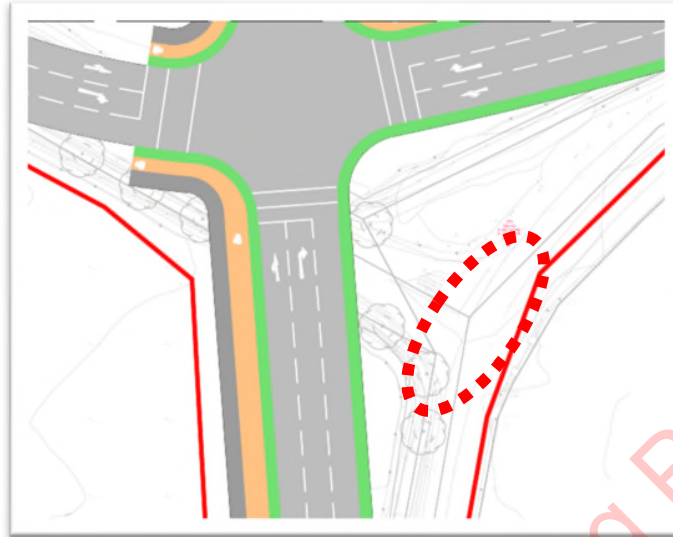
Drawing S665- OCSC-1A-MH-DR-C-0111 S2 P01 Sheet 2 of 3, Carton Estate gate.

There is an existing gate into the Carton estate close to the proposed signalised junction. It is unclear if this gate will be used in the future. If it is to be used movements into and out of it may lead to collisions at the junction.

It is recommended that the accommodation works relating to this gate be included in the design process.

distributor road and development is completed	
3.6	Y	Y	It is proposed to utilize the existing R157 road alignment as an off-road trail truck. The gate can be accessed via this trail in future once the development is completed.	Yes
3.7	Y	N	The proposed 1.5m verge separation is an improvement to the existing condition. As the section of road is fairly straight and the speed is being reduced, it is not anticipated that this would be a problem.	Yes

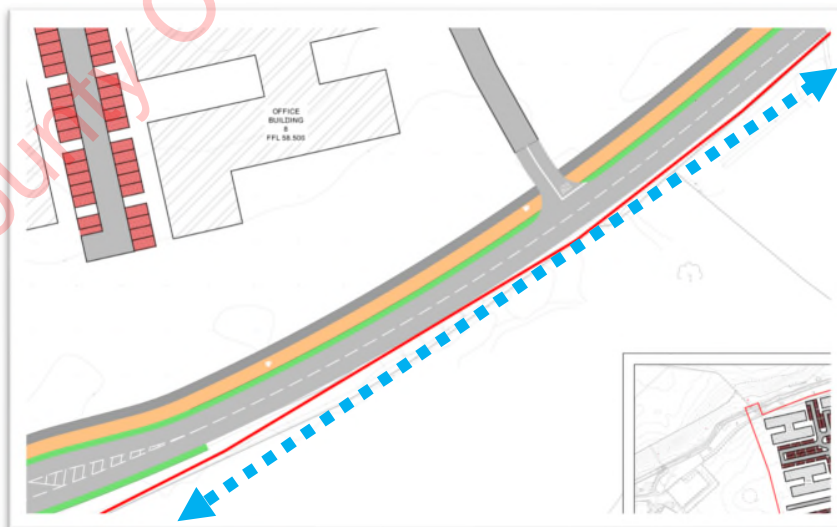
Drawing S665- OCSC-1A-MH-DR-C-0111 S2 P01 Sheet 2 of 3, Carton Estate boundary wall.

The realigned R157 eastern arm is very close to the stone wall of the Carton Estate. This is a hazard for an errant vehicle.

It is recommended that a suitable Clear Zone be provided between the boundary wall and the realigned carriageway.
