Title: **STAGE 1 ROAD SAFETY AUDIT**

**Primary Care Centre & Nursing Home, Moygaddy, Co. Meath.**

Report reference: **1388R02**

VERSION: **FINAL (April 2022)**

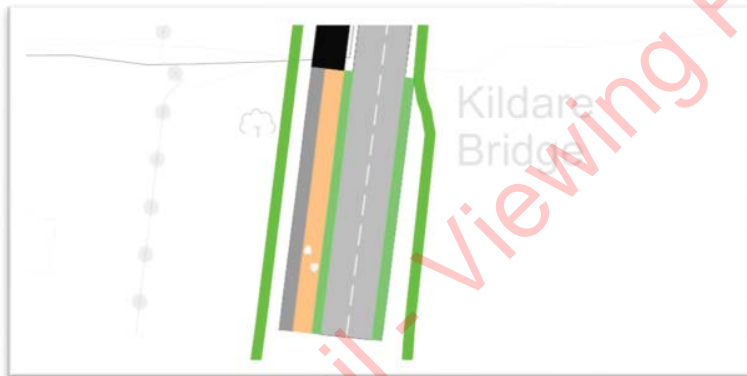
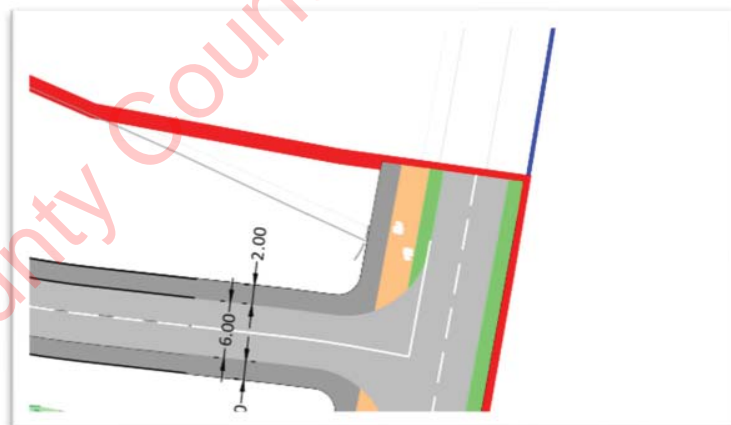
General Comment tie-in points

Details have not been provided of how the cycle track and footpaths will tie in at the scheme extents. Cyclists and pedestrians will have to cross the carriageway to access the facilities. Without suitable transitions from off road to on road and suitable crossing facilities there is a risk that pedestrians and cyclists will be struck by passing traffic.

It is recommended that suitable transitions and crossing facilities be provided. Where this scheme ties in with the other planned scheme to the north a transitional arrangement should be provided should construction of that scheme not proceed.

3.1	Y	Y	The proposed cycle lane across Kildare Bridge will be updated to tie in the existing carriageway R157 and at south cyclist will join carriageway

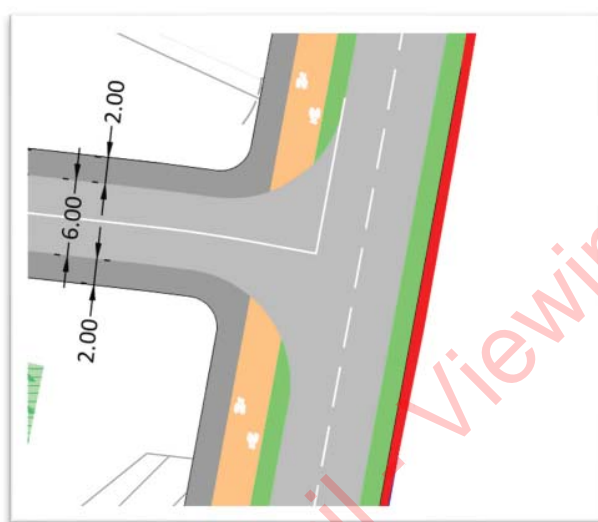
Drawing S665- OCSC-1B-MH-DR-C-0111 S2 P01 Sheet 2 of 3, cycle track across side road.

The proposed two way cycle track crosses the mouth of the proposed side road. There is a risk that drivers exiting the side road may not expect two way cyclists as they approach the stop line.

It is recommended that a 'bend out crossing' be provided.

3.2	Y	N	It is proposed to provide a shared space and tactile for crossing before the cyclist and pedestrian approach the junction. A raised crossing will be provided to indicate priority for pedestrians and cyclists.	Yes

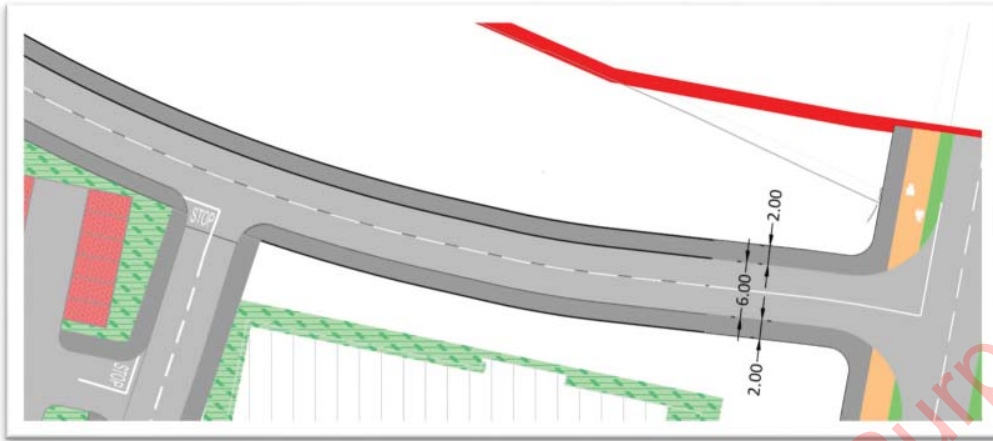
Drawing S665- OCSC-1B-MH-DR-C-0111 S2 P01 Sheet 2 of 3, Side road cross section.

There are no dedicated cycle facilities along the proposed side road. The side road will be a busy area with vehicular traffic when fully developed and this will increase the risk for cyclists.

It is recommended cycle tracks be provided on both sides of the side road.

3.3	Y	N	It is not anticipated to have high volume of pedestrian and cyclist traffic. 2m wide shared use will facilitate pedestrian and cyclist movement	Yes

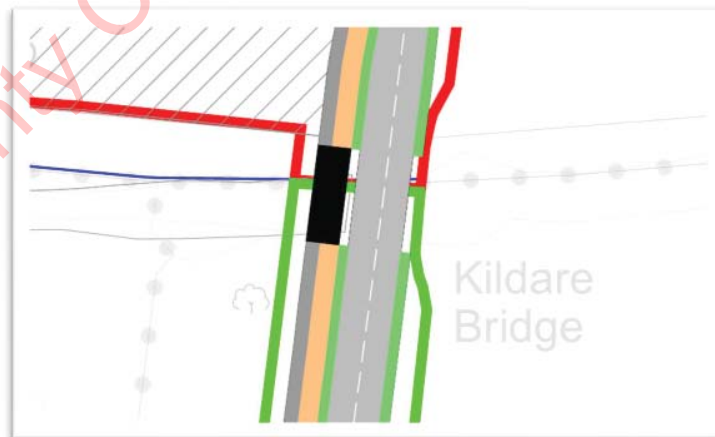
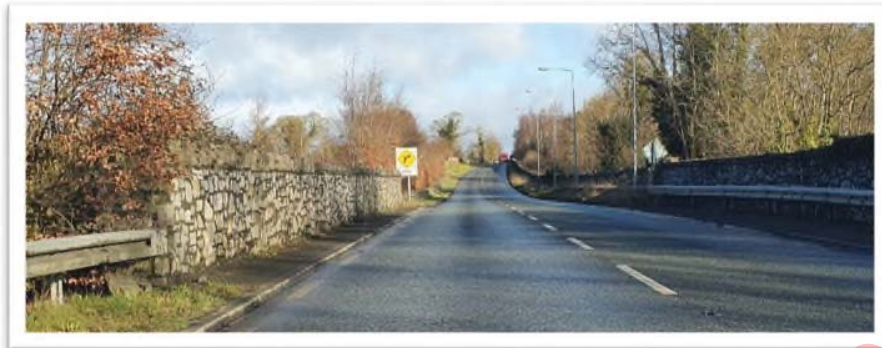
Drawing S665- OCSC-1B-MH-DR-C-0112 S2 P01 Sheet 3 of 3, Kildare Bridge Cross Section.

It is unclear if there is sufficient width at Kildare Bridge to accommodate a consistent cross section including the cycle track and footpath and the vehicle restraint systems (with correct setback to the front and working width to the rear). This could lead to a pinch point in the facilities for vulnerable road users which may result in cyclists opting to travel on the R157 carriageway where they would be at greater risk of being struck by passing vehicles.

It is recommended that the effective width of the cycle and pedestrian facilities be consistent all along the R157.

3.4	Y	N	The width of the cycle way and footway will stay consistent. A new pedestrian and cyclist bridge section will be constructed adjacent to the existing bridge to accommodate these modes.	Yes

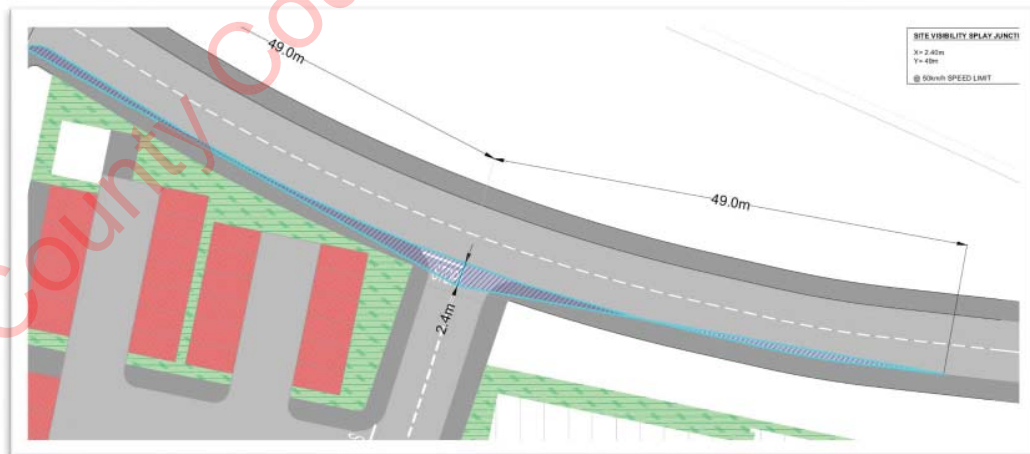
Drawing S665- OCSC-1B-MH-DR-C-0115 S2 P01 Visibility Splay at side road junction with the proposed units.

The visibility splay is shown for a 50km/hr urban design speed. It is unknown what the planned speed limit and design speed will be. The speed limit on the R157 is currently 80km/hr. There may be insufficient visibility to oncoming vehicles leading to side-impact or rear-end collisions.

It is recommended that visibility splays be provided to match the design speed of the side road.

3.5	N	N	The visibility splay is achieved for 50kmph. The new speed limit will be 50kmph once the new distributor road and development is completed.	Yes

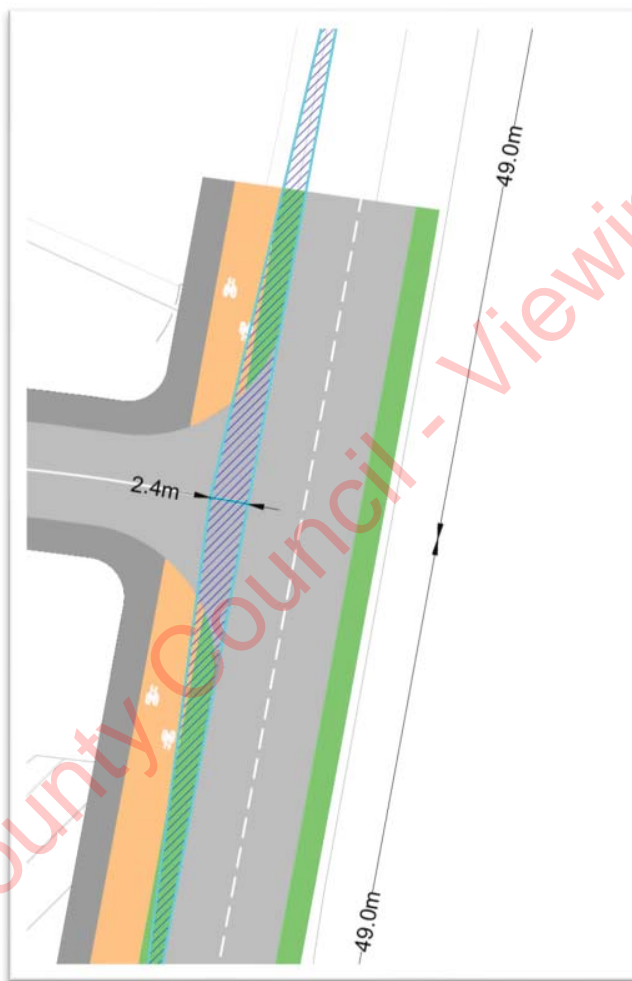
Drawing S665- OCSC-1B-MH-DR-C-0115 S2 P01 Visibility Splay at side road junction with R157.

The visibility splay is shown for a 50km/hr urban design speed. The speed limit on the R157 is currently 80km/hr. There may be insufficient visibility to oncoming vehicles leading to side-impact or rear-end collisions.

It is recommended that visibility splays to the posted speed/design speed be provided.

3.6	N	N	The visibility splay is achieved for 50kmph. The new speed limit will be 50kmph once the new distributor road and development is completed.	Yes

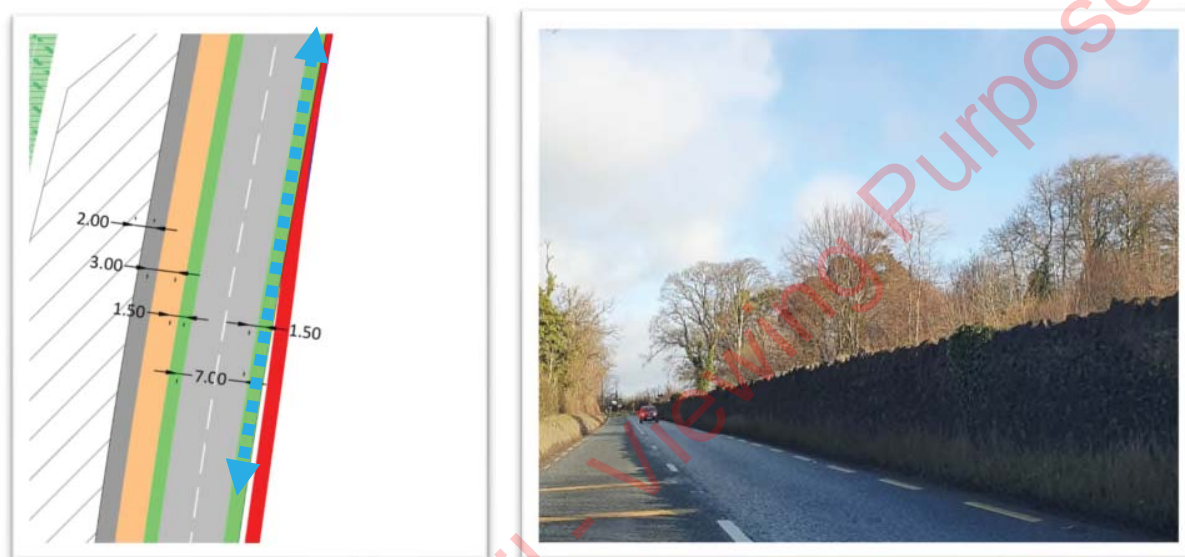
Drawing S665- OCSC-1B-MH-DR-C-0112 S2 P01 Sheet 3 of 3, Carton Estate boundary wall.

It is proposed to provide a 1.5m verge between the R157 and the Carton Estate boundary wall. The wall may be hazardous if struck by an errant vehicle.

It is recommended that a suitable Clear Zone be provided between the boundary wall and the R157 carriageway.

3.7	N	N	The proposed 1.5 m verge separation is an improvement to the existing condition, and the section of road is straight and the speed limit on the road will be reduced	Yes

once the new distributor road is completed.	
--	--	--	---	--
