Appendix H

Bus Stop Review Report

BusConnects – C11 Kimmage Corridor

Bus Stop Review

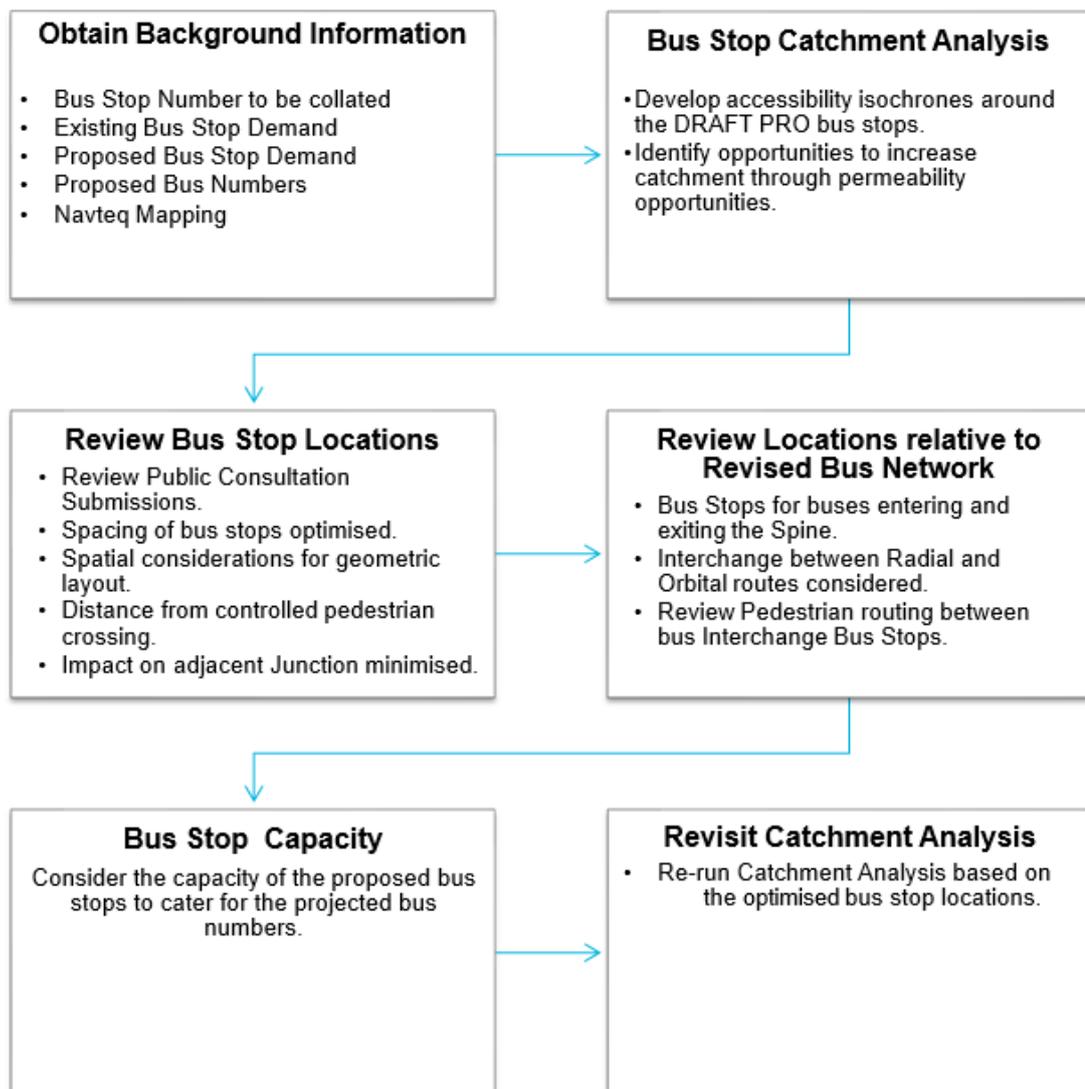
Figure 2.1 Bus Stop Review Flow Chart

Figure 2.1 below presents a flowchart which outlines the methodology proposed.

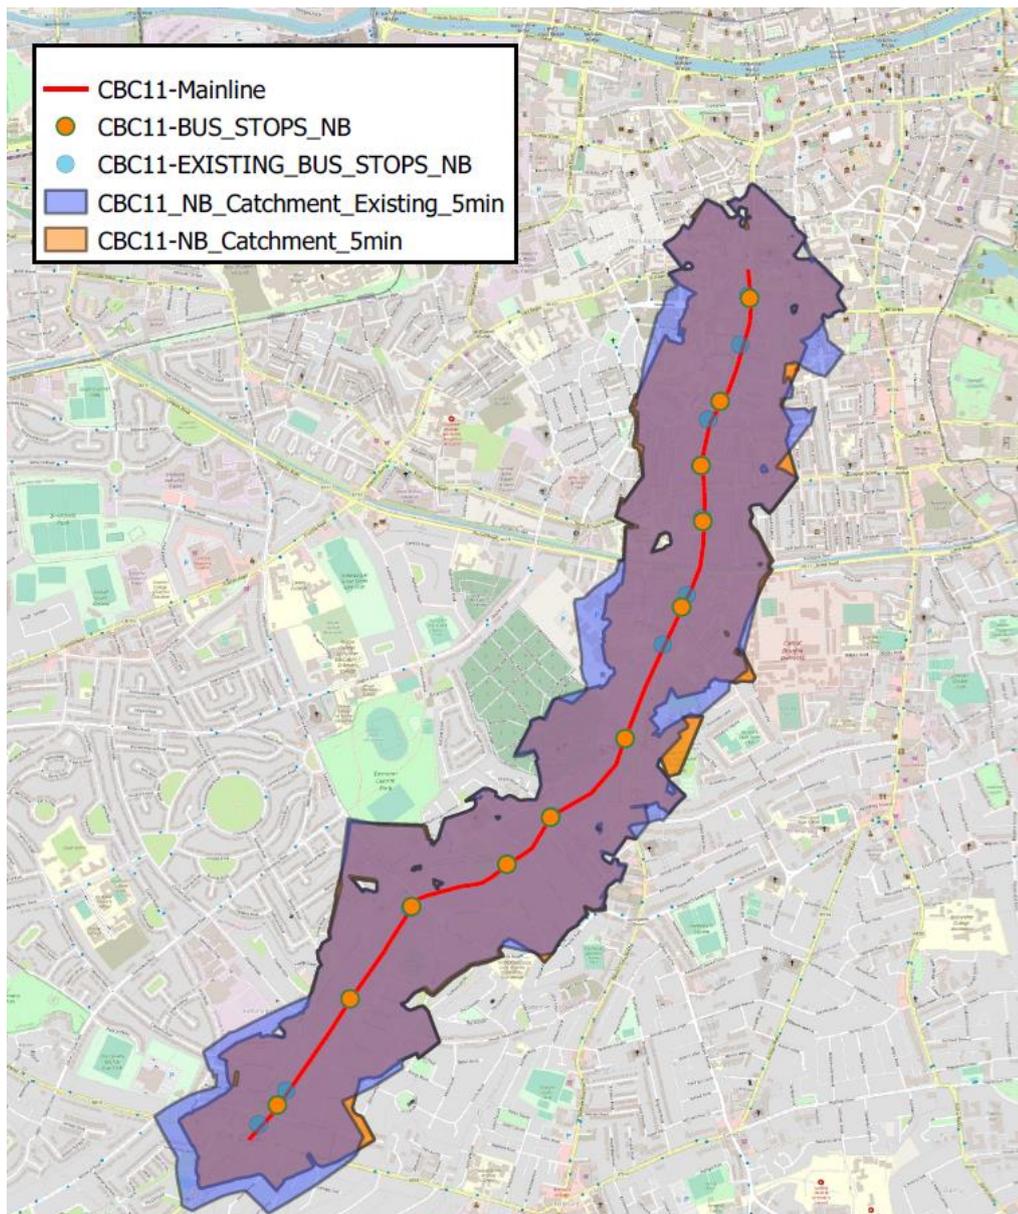
Figure 4.1 Existing Kimmage to City Centre Inbound Bus Stop Catchments

Figures 4.1, and 4.2 below show the catchments for the existing bus stop locations for the inbound and outbound directions in the Kimmage to City Centre section of the scheme.

A catchment analysis was carried out in GIS using Navteq mapping as the network dataset, along with the coordinates of the existing bus stop locations. The current catchment on both the inbound and the outbound bus stops at their existing locations are shown in 5-minute and 10-minute walking intervals.

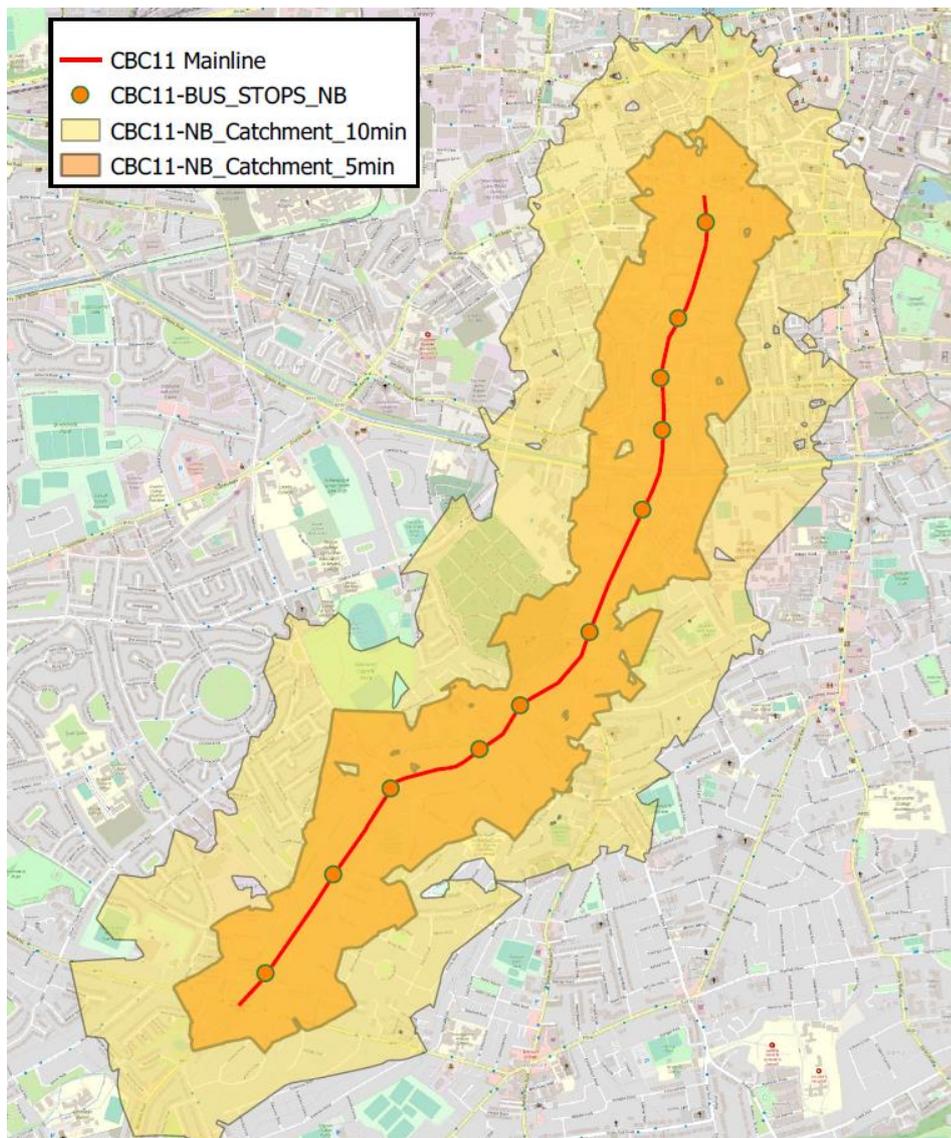
Figure 6.1 Proposed Kimmage inbound bus stop catchment – 5 & 10 minutes

Following the review of the bus stop locations, the catchment analysis was carried out again in order to understand the impact of the changes on the bus network. The results of the catchment analysis with the proposed bus stop locations for the Kimmage to City Centre route is presented below. The Figures below compare the catchments for 5minute and 10-minute walking distance for the existing and proposed bus stop locations.

On the Kimmage inbound direction there are 14 existing bus stops. One (1) existing bus stop will be moved, six (6) bus stop is to be removed from the route and three (3) stops will be added. The total proposed number of bus stops for the inbound direction is 11.

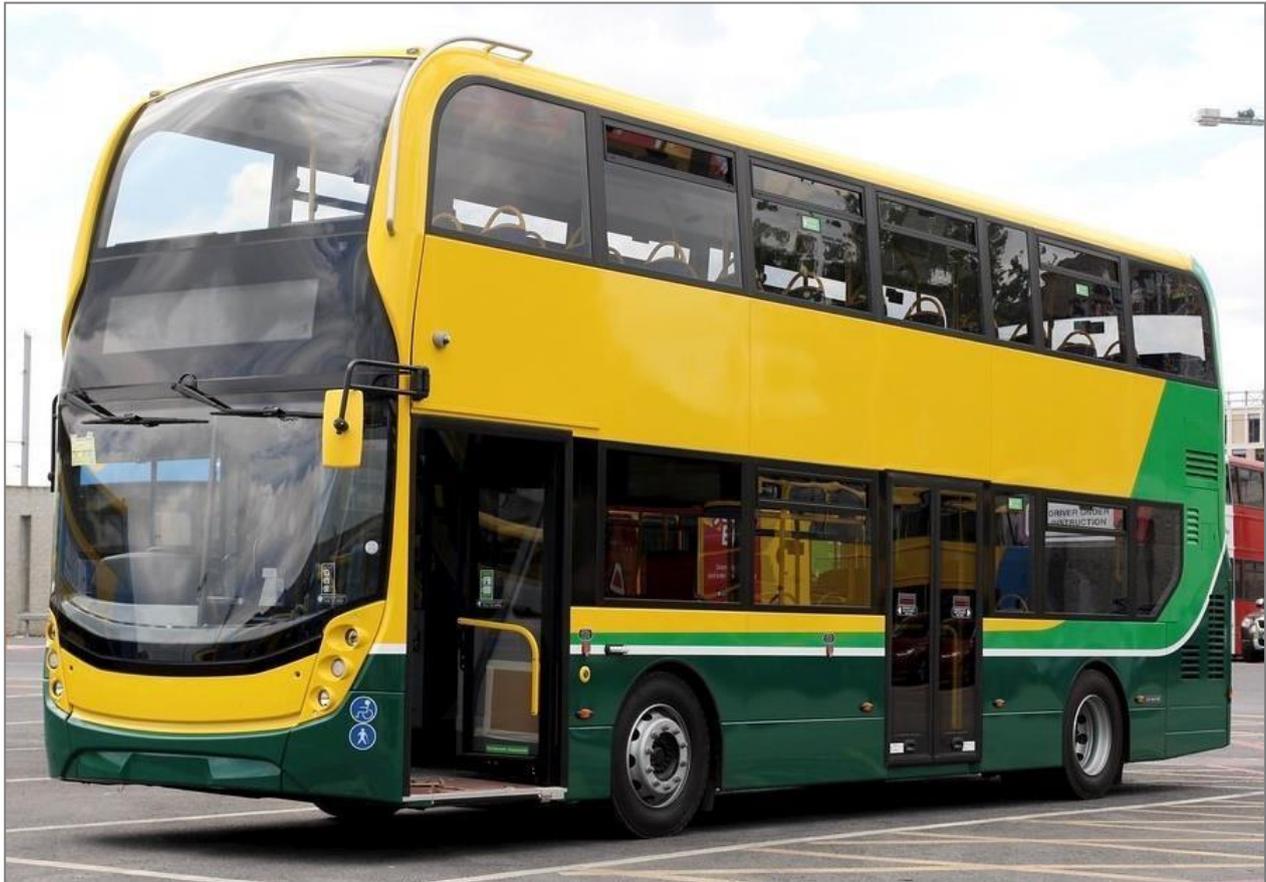
For avoidance of doubt this manual assumes the standard bus is a twin axle double decker bus (10 to 11m in length) with a front and middle doors. Other vehicles, such as 3-axle double decker, are in use by Dublin Bus and should be considered when undertaking the Geometric Design.

Figure 1.2 Standard Bus being used on the CBC's.

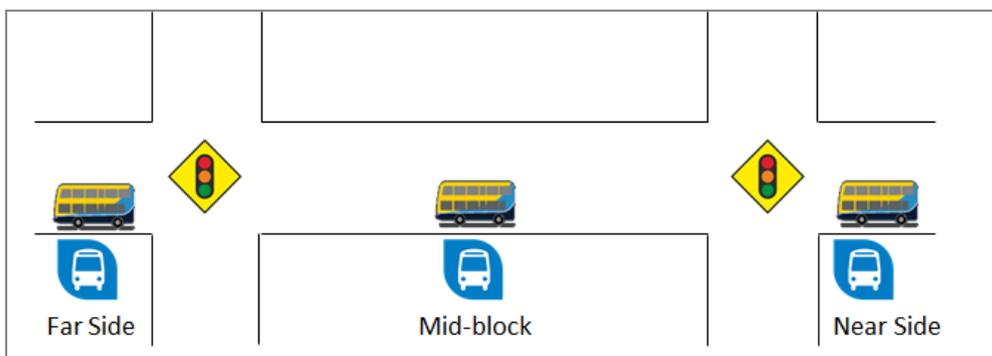
Figure 1.4 Typical Location of Bus Stops.

The proximity of a bus stop to signalised junctions has an impact on bus speeds with far-side stops having the least negative impact on speed and capacity, and also favored as passengers cross the road behind the bus which increases safety.

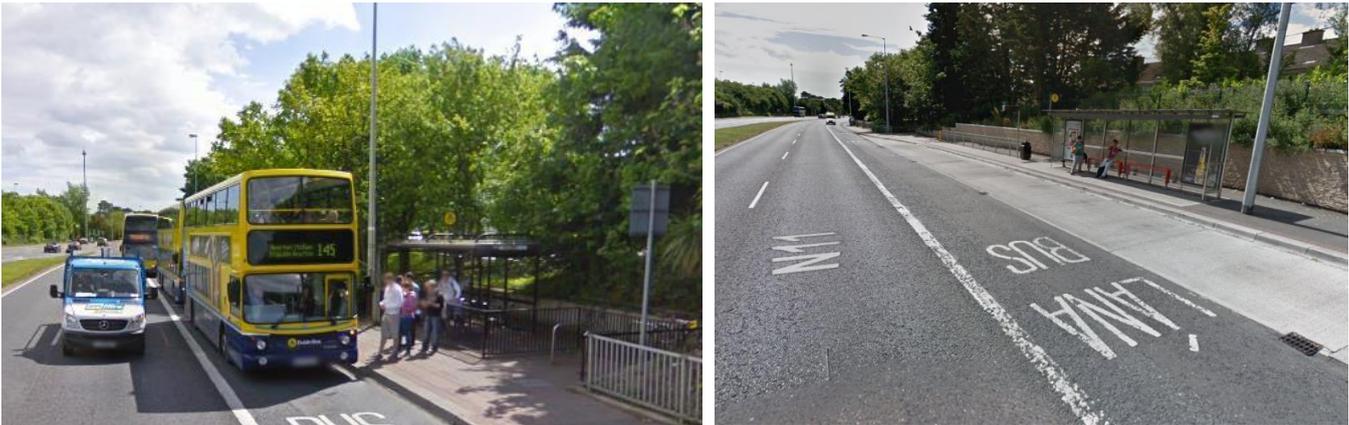
Figure 1.5 Stillorgan QBC with high bus flows and no bus laybys resulted in bus bunching/ platooning; bus lay-by's provided at key locations to allow express buses to pass slower buses. (Source: Google Maps)

Ability to overtake slower buses is an important parameter where the route is made up of both express (rarely stopping) and slower (stopping at all stops) buses. For example, on the N11 QBC lay-bys (or passing lanes) were introduced after the original QBC was built to increase the capacity and allow express buses to pass the slower vehicles. On some of the BusConnects schemes this will need to be considered particularly on those routes that include regional and intercity services.

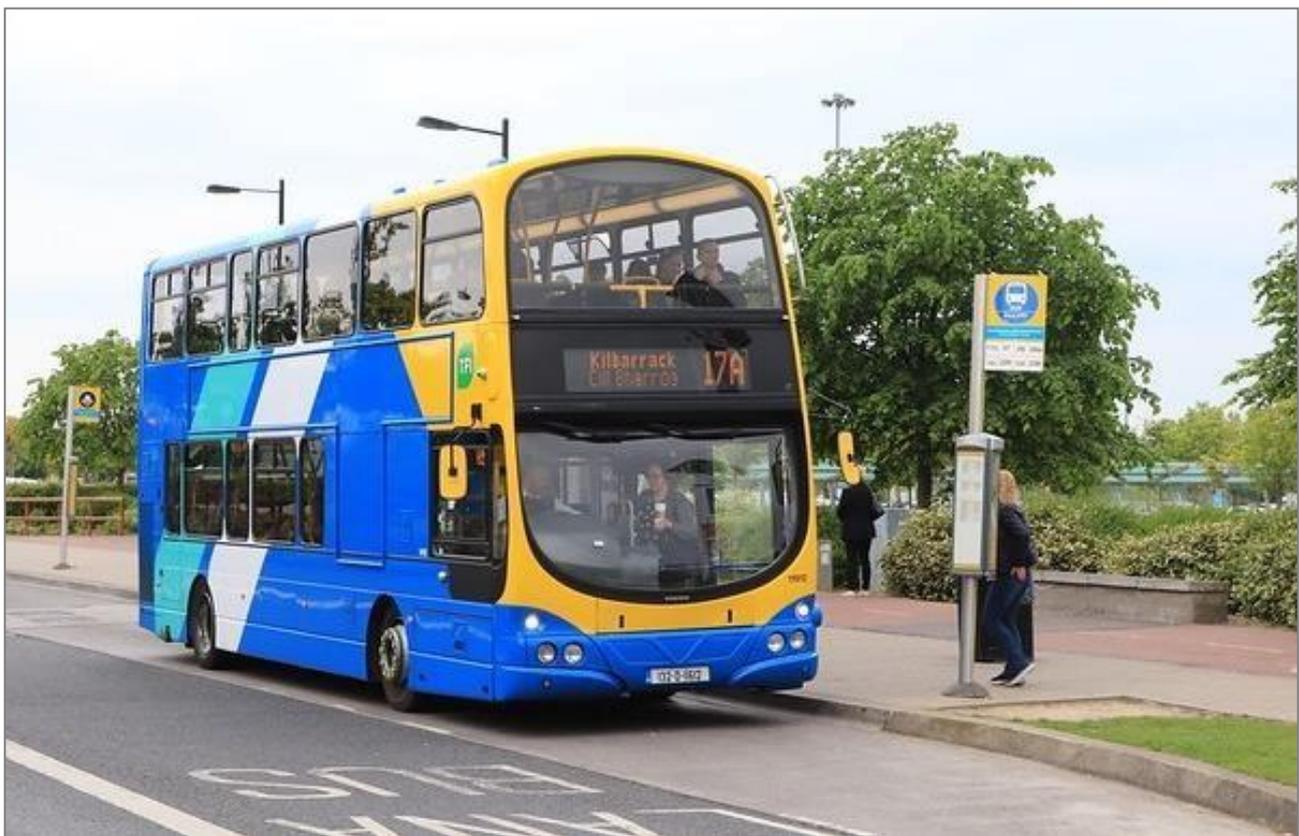
Figure 1.6 A typical bus lay-by adjacent to a bus lane; note concrete surface for additional durability.

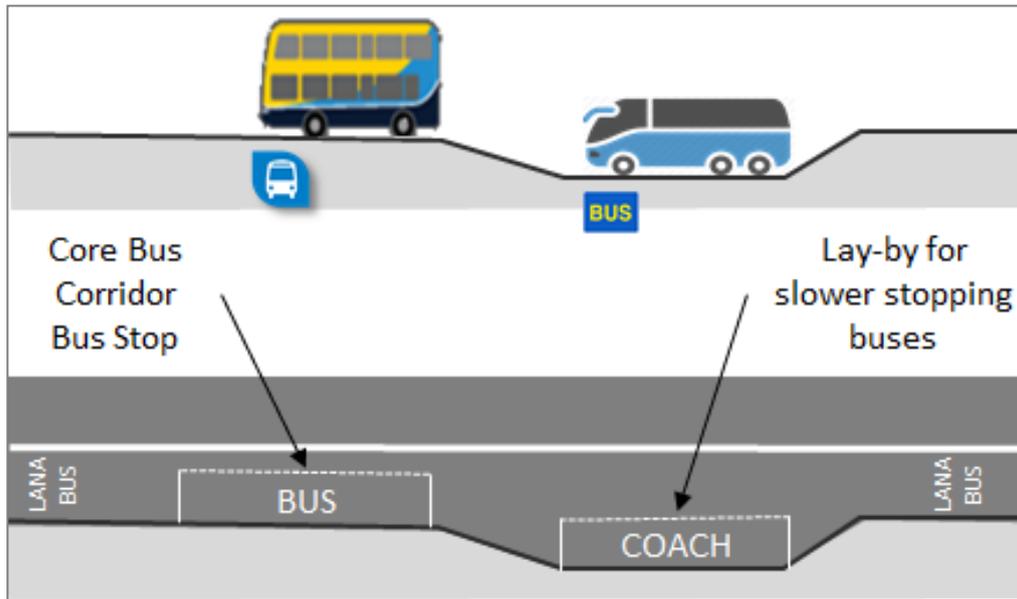
Consideration should also be given to locations where coaches stop along the Corridors, particularly those serving the airport which could require longer dwell time to allow passengers to load/unload their luggage. In these cases, a layby separate to the CBC Bus Stop maybe desirable (Figure 1.7).

Figure 1.7 Double Bus Stop (in-line for BusConnects routes) concept for locations with buses requiring different dwell times.

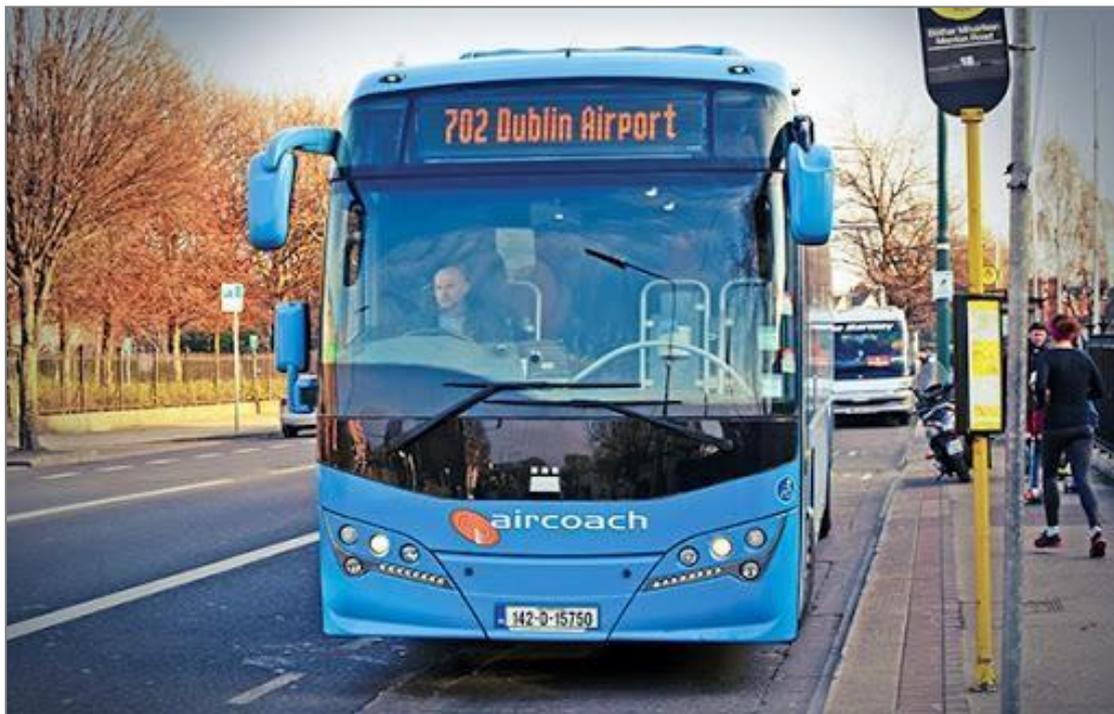
Figure 1.8 Multiple bus operators may be using bus stops along the Corridors.

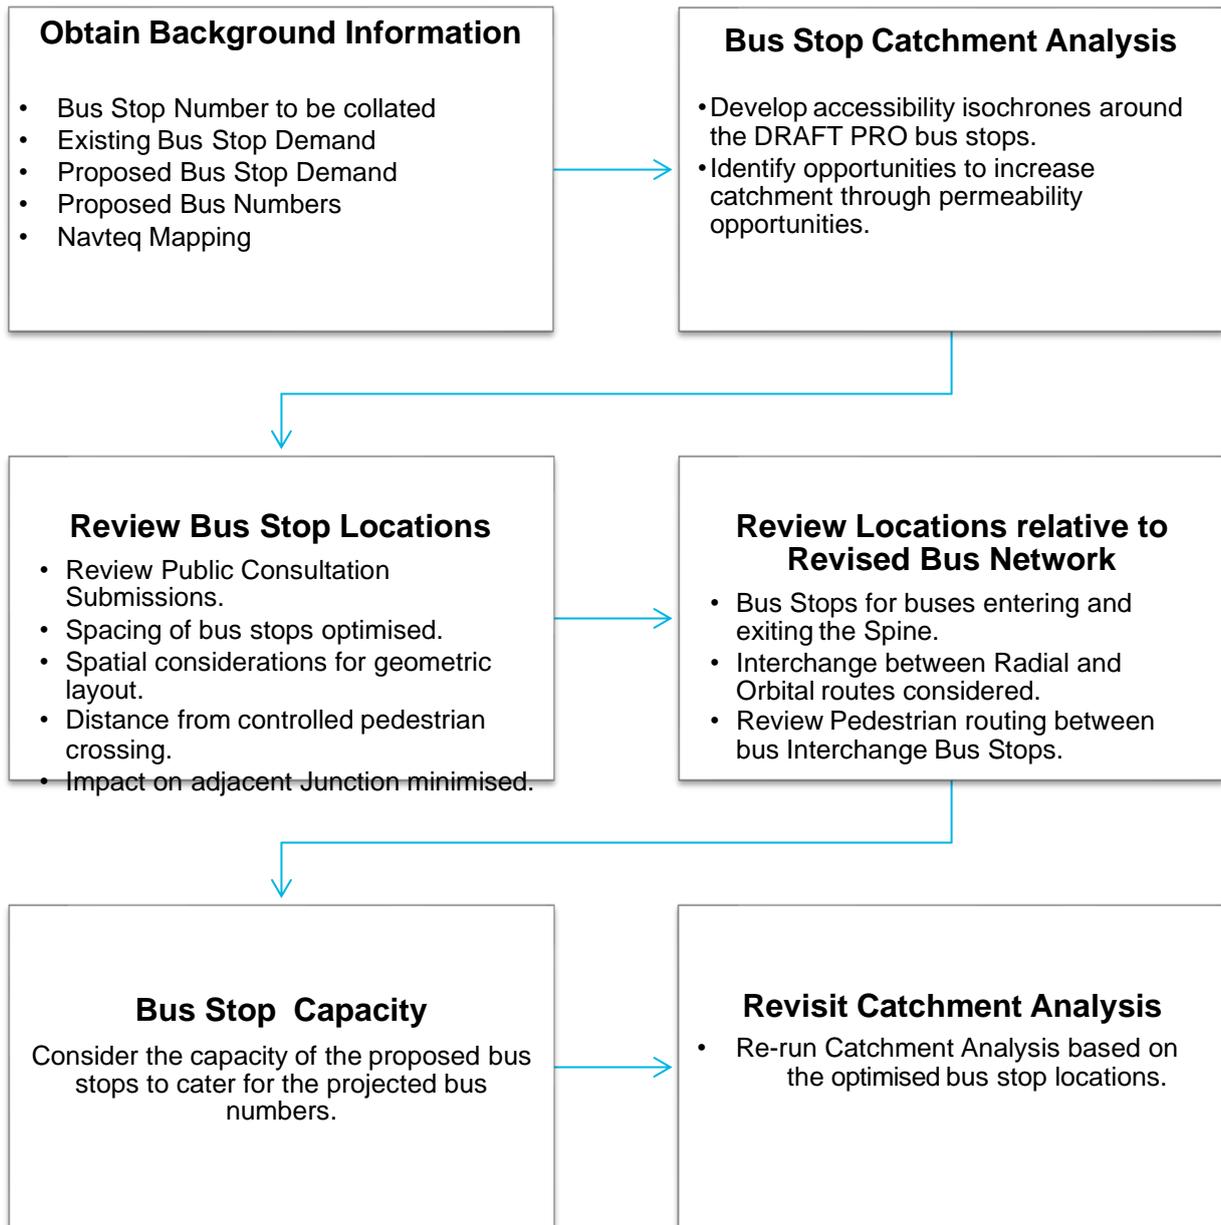
Figure 2.1 Flow Chart for proposed Bus Stop Review.

This section outlines the process for examining each BusConnects Corridor and assessing and reporting on the bus stops along each route. The flow chart summarises the process and this is followed by a more detailed description of the tasks to be undertaken.

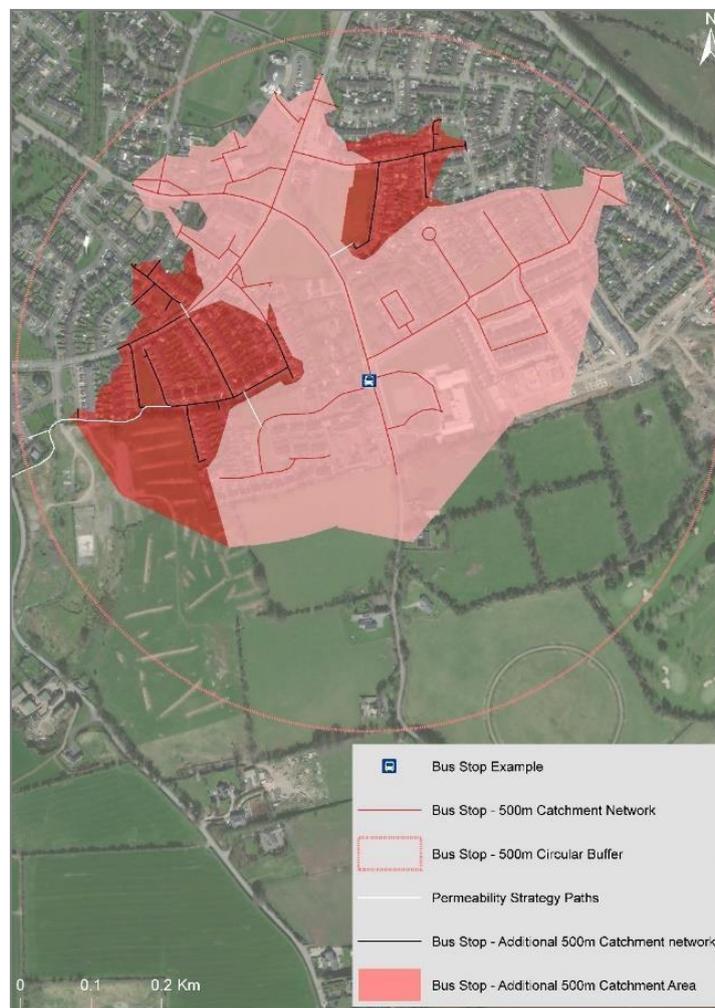
Figure 4.1 Passenger catchment analysis for a bus stop indicating the existing and possible catchment areas assuming permeability improvements can be undertaken.

Figure 4.1 indicates the area that is within a standard walking distance of a bus stop (400m for BusConnects CBC's) based on the actual walking distance rather than "as crow flies" analysis which can be misleading particularly where there are long sections of blank, inaccessible, wall along

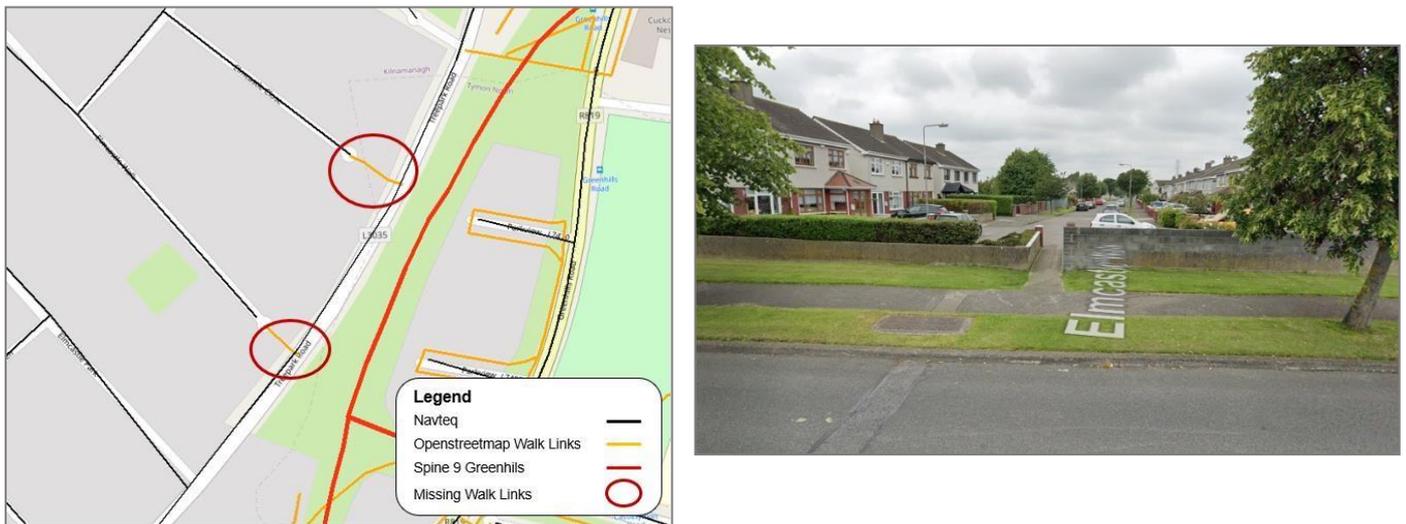
To do this you will add walk links extracted from OpenStreetMap's data clearly coding these into the Navteq supplied by the NTA. Google Streetview should be used as a check to ensure any link added to the Navteq exist on the ground and are accessible to all. Informal walk links should not be added at this stage.

Figure 4.2 Example of permeability link missing from Navteq mapping on Tallaght/Clondalkin Cor Bus Corridor.

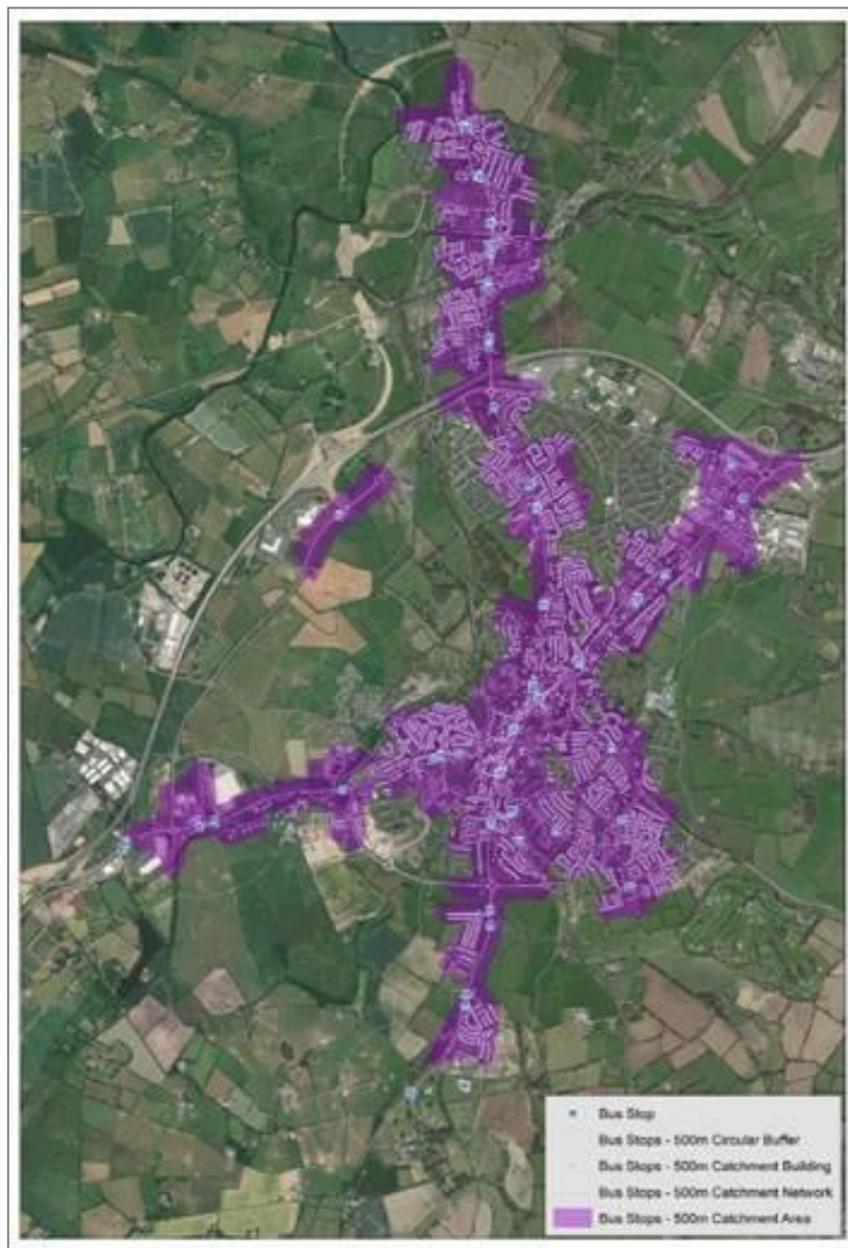
Task 2: Once the Navteq has been enhanced to the required level to capture all major pedestrian movement within bus stop catchment areas, catchment analysis shall be run for the proposed and existing bus stops. Using the Network Analyst Extension in ArcGIS generating 400m and 800m walking bands to reflect 5 and 10-minute walking catchments of bus stops.

Figure 4.3 Example of catchment analysis run for all bus stops in Naas

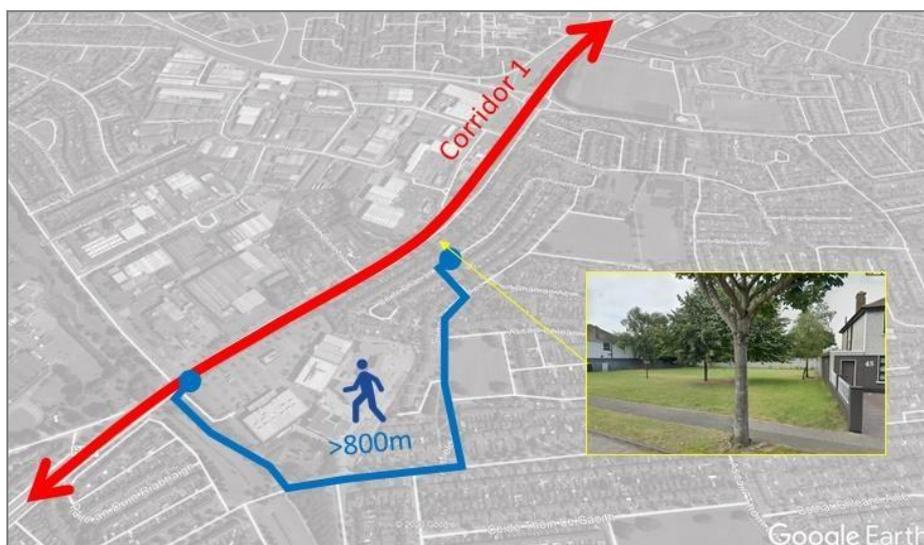
An example from the Clongriffin to City Centre CBC can be seen in Figure 4.4 where a very large housing estate which is located immediately adjacent to the proposed bus corridor has a continuous boundary wall that runs for over 800m preventing easy access to the bus routes and requiring a walk of almost 1km to access the bus routes. Opening a pedestrian access on the boundary wall could create a much shorter route to the buses and substantially increase the bus passenger catchment area.

Figure 4.4 Permeability option on the Malahide Road (Source: Google Maps).

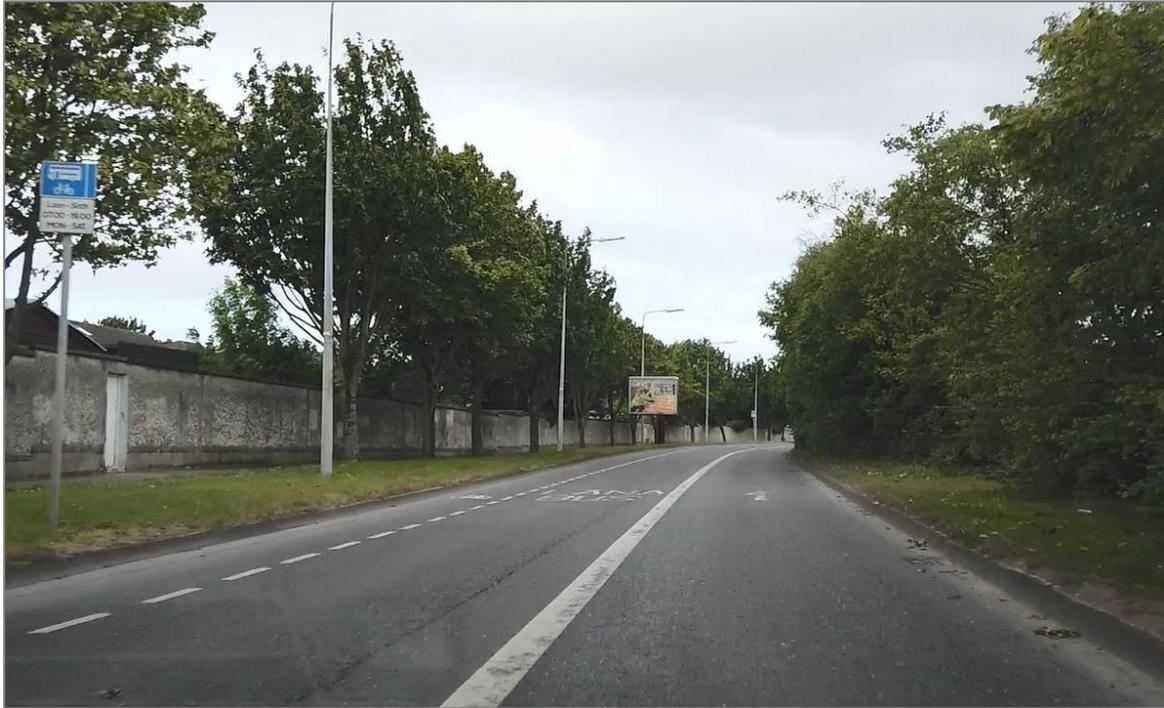
Figure 4.5 Boundary wall along Malahide Road (Corridor 1) where local residents have opened up individual doors to access the existing QBC route.

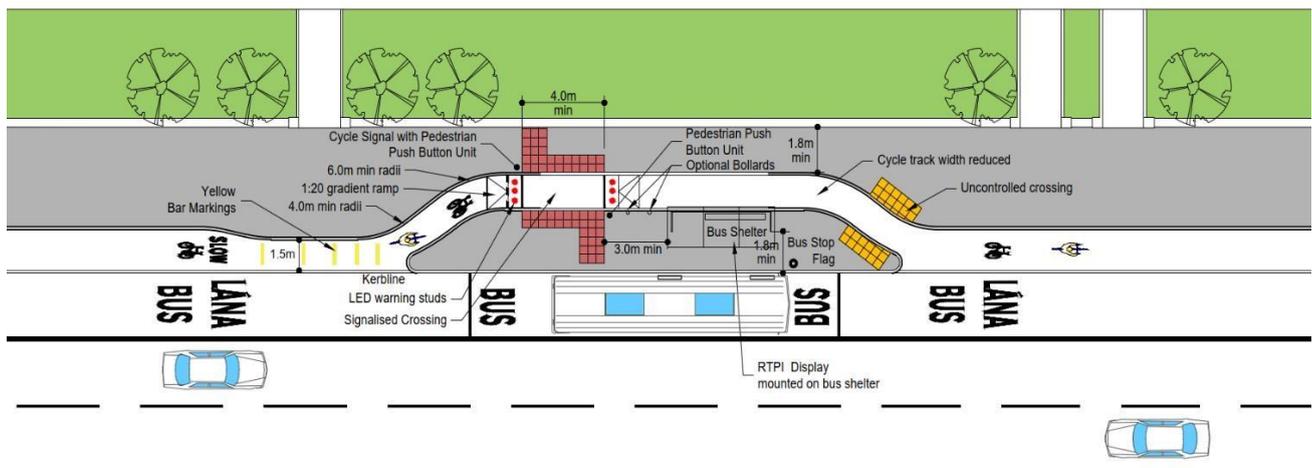
The BusConnects Design Guide suggests that an Island Bus Stop (Figure 5.1) is the preferred bus stop option to be used as standard on the CBC project where space constraints allow. The **minimum footpath width within which an island bus stop can be implemented is 5.4m** (1.8m footpath + 1.2m cycle track + 2.4m island with shelter). This option assumes a shelter with half bay end panels. Should full panels (as seen on Figure 5.2) be required the width requirement will increase to approximately 6.3m. [Standard Detail in Development (21/6/20) which may change these dimensions, Rev 4 will include updated information].

Figure 5.1 Typical Island Bus Stop Arrangement (Bus Connects Design Guideline).

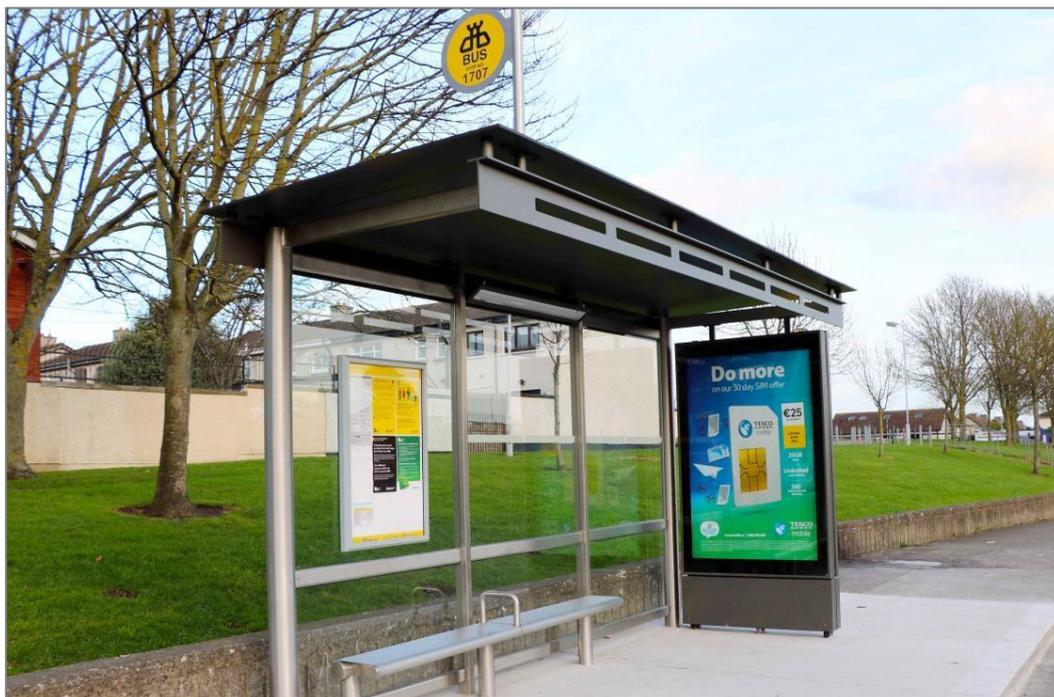
Figure 5.2 Standard 3 Bay Reliance Mark Shelter with full width advertising panel.

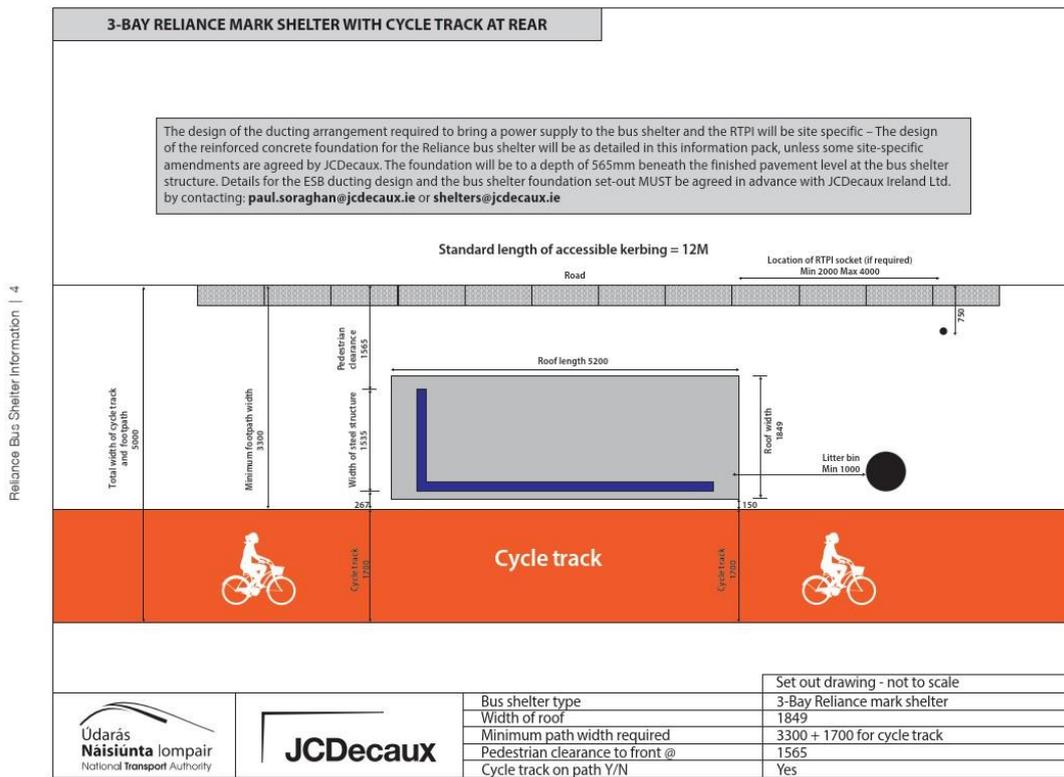
Figure 5.3 Standard layout for a 3 Bay Reliance Mark Shelter with full width advertising panel and cycle lane to the rear (note cycle lane width is to be determined by designers).

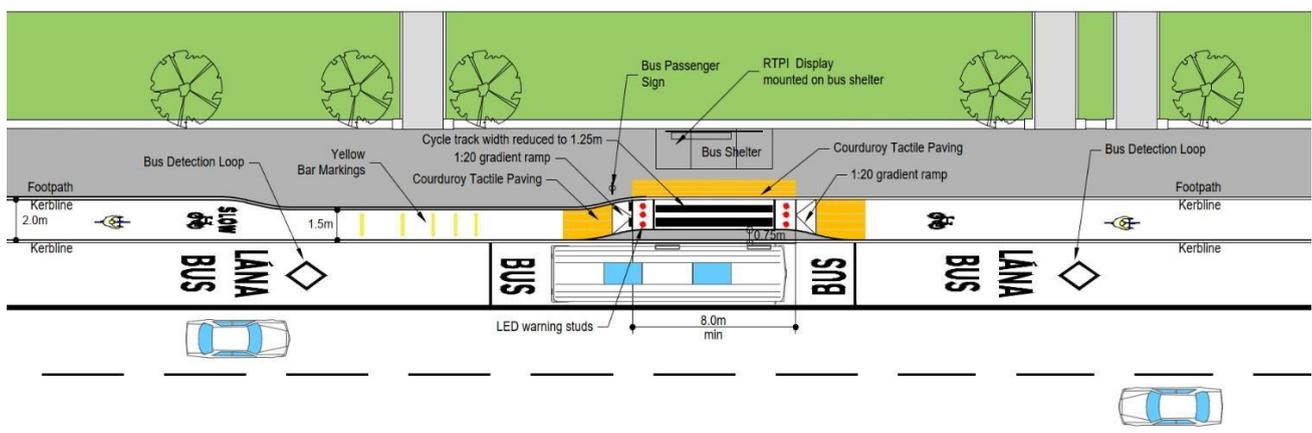
For locations where space is constrained an option consisting of a shared bus stop landing zone can be considered. This option is indicated in Figure 5.4 and should only be considered on a case-by-case basis to ensure suitability with particular attention paid to the volume of cyclists and volumes of boarding and alighting passengers. **Using the narrowest non-standard bus shelter this would require a minimum width of approximately 4.0m** (1.9m footpath with shelter + 1.2m cycle track + 0.75m island).

Figure 5.4 Shared Bus Stop Landing Zone Arrangement (Bus Connects Design Guideline).

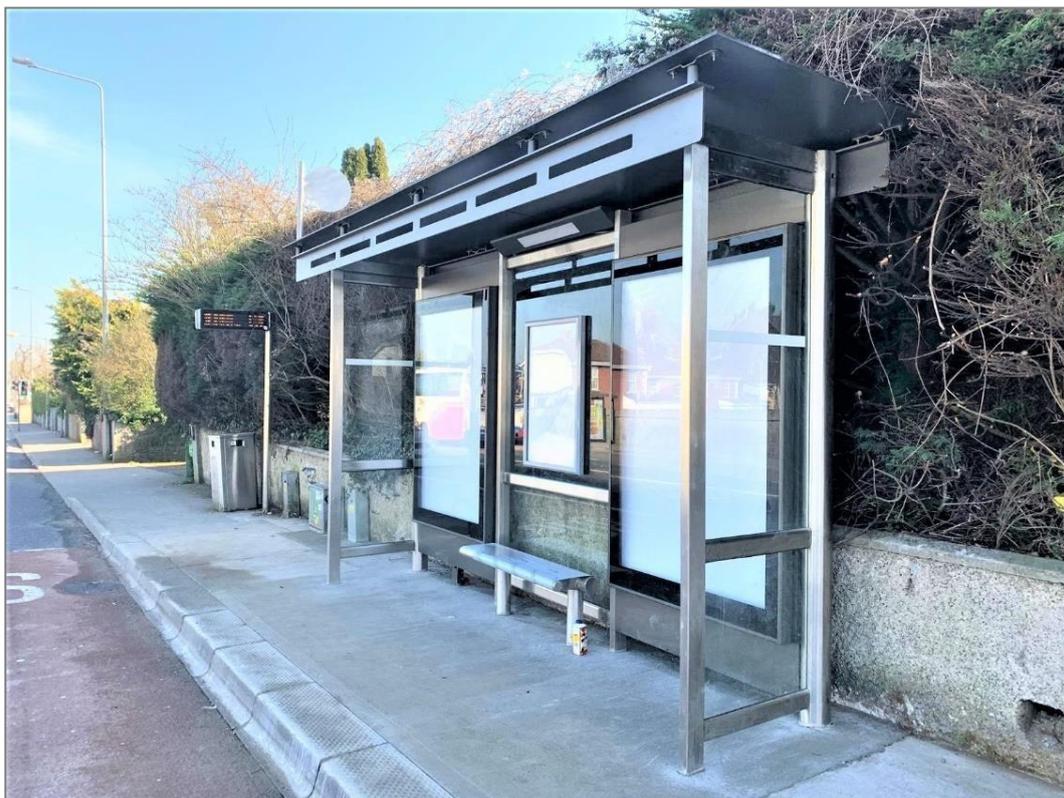
Figure 5.5 Cantilever narrow roof Bus Shelter

It is important that ED's do not immediately choose the minimum sized shelter as this will impact on the weather protection provided to bus passengers and potentially advertising revenue share received by the NTA. Where there are a substantial number of bus stops using the nonstandard bus shelter it is recommended that the NTA IPO are consulted prior to finalising the proposals.

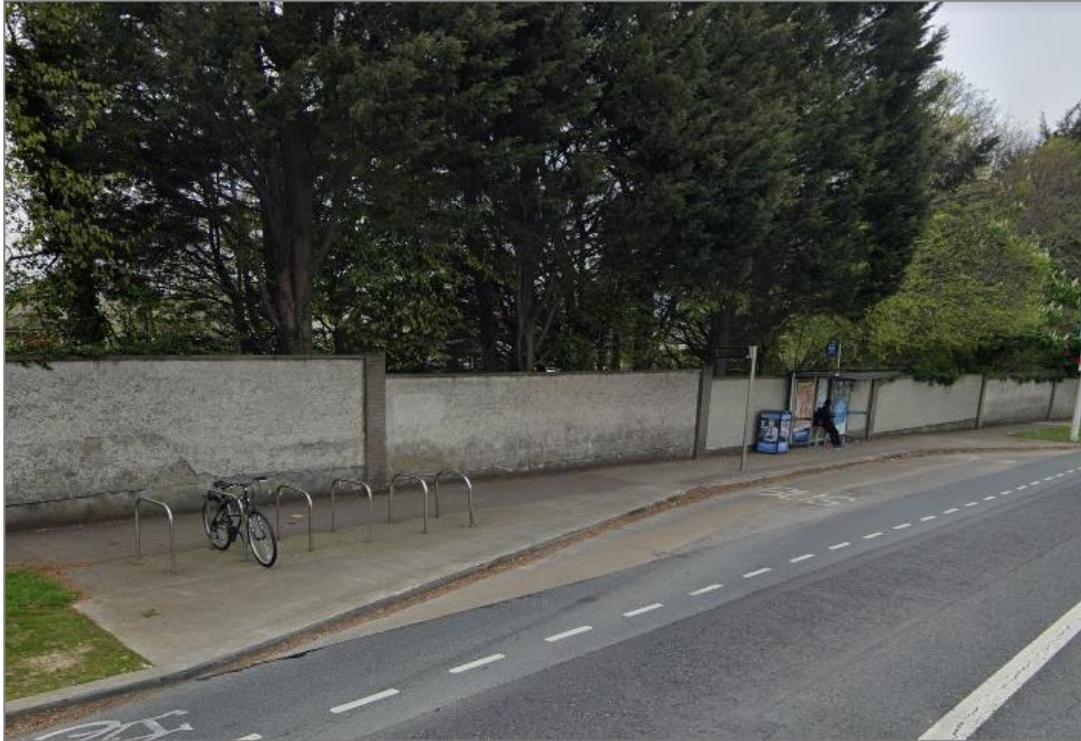
Figure 5.6 Sheffield Bicycle Stands provided at a Bus Stop on the N11.

Providing cycle parking at bus stops has the potential to increase the catchment area of a bus corridor by providing a safe place for cyclists to secure their bike for the duration of their trip. ED's should look to provide cycle parking at all bus stops along the BusConnects Corridors where space permits. The **minimum provision is 3 Sheffield Stands** (accommodating 6 bicycles) in the vicinity of a bus stop. Where larger numbers of cyclists can be expected consideration should be given to providing a larger covered area of approximately 10 Sheffield Stands (accommodating 20 bicycles).

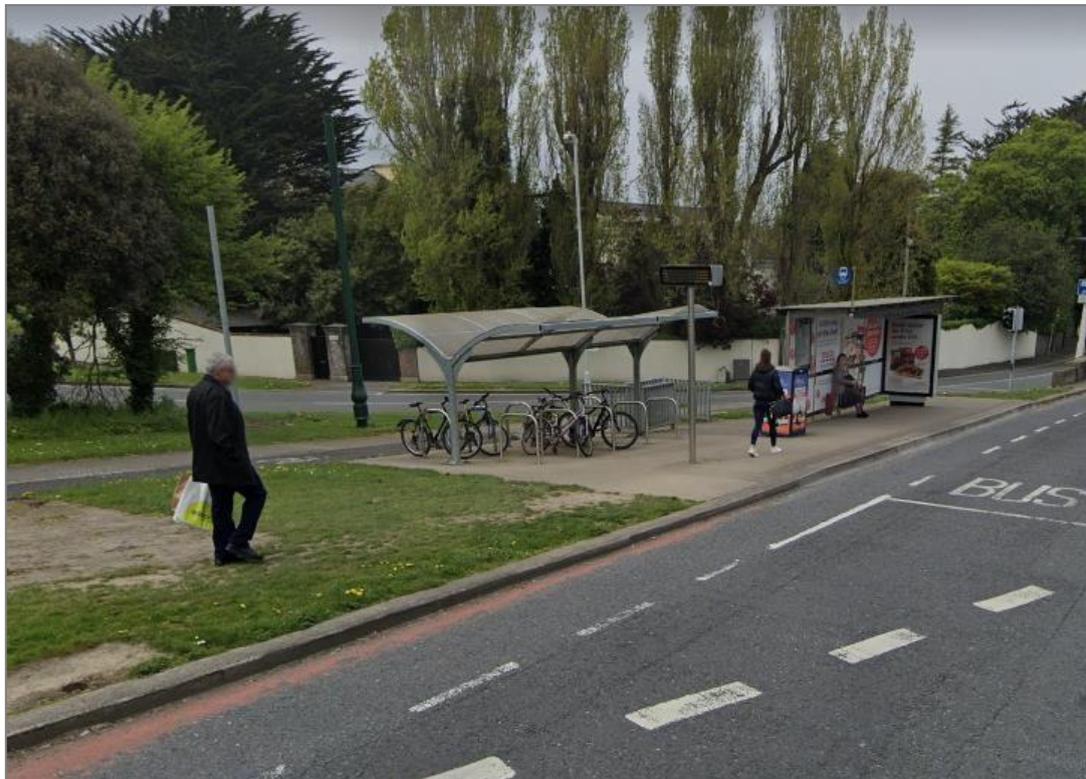
Figure 5.7 Covered Sheffield Bicycle Stands provided at a Bus Stop on the N11.

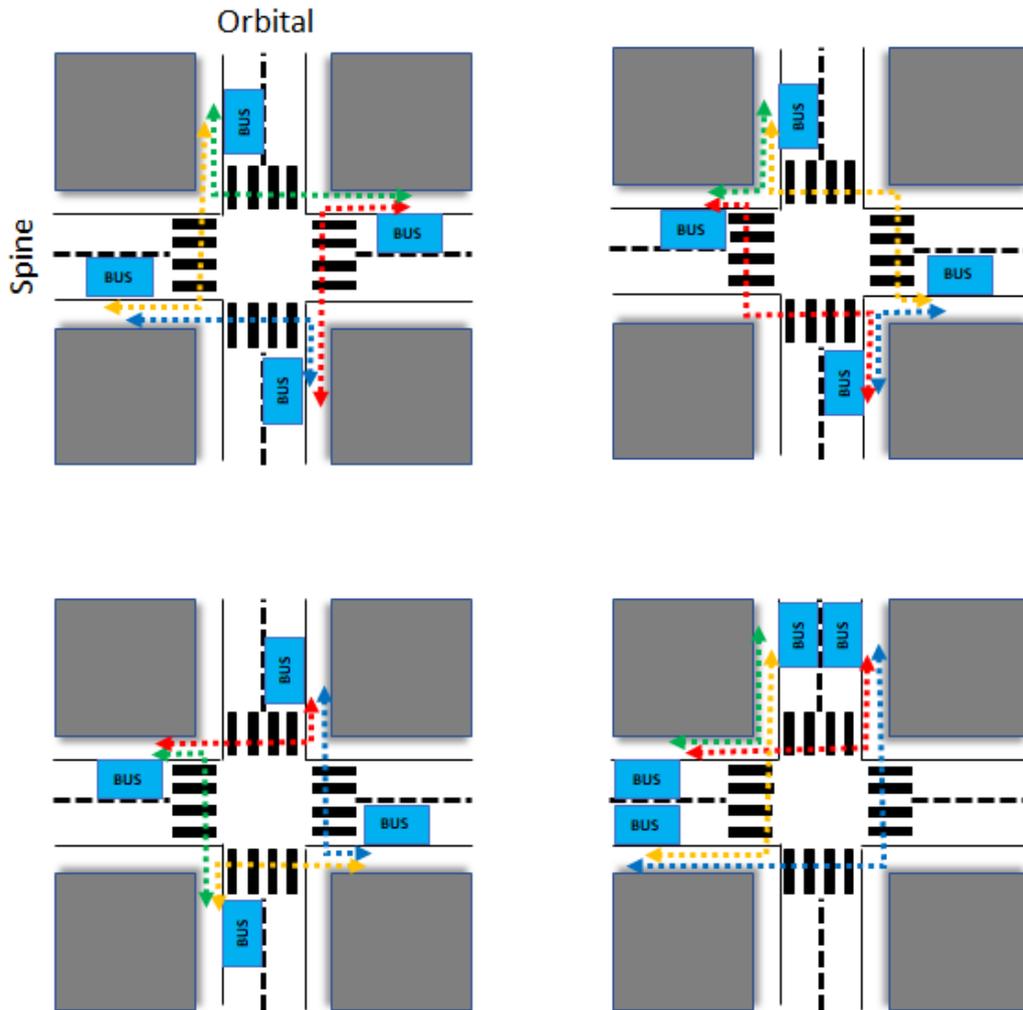
Figure 5.8 indicates various locations for bus stops at junctions with particular consideration for interchange between Spine and Orbital Core Bus Corridors. This indicates that all options which require passengers to interchange will require passengers to cross at least one arm of a junction (on average over both legs of their journey), emphasizing the importance of locating bus stops at junctions and providing controlled crossings on all desire lines between interchanging bus stops.

Figure 5.8 Bus stop locations and passenger interchange routes between them.

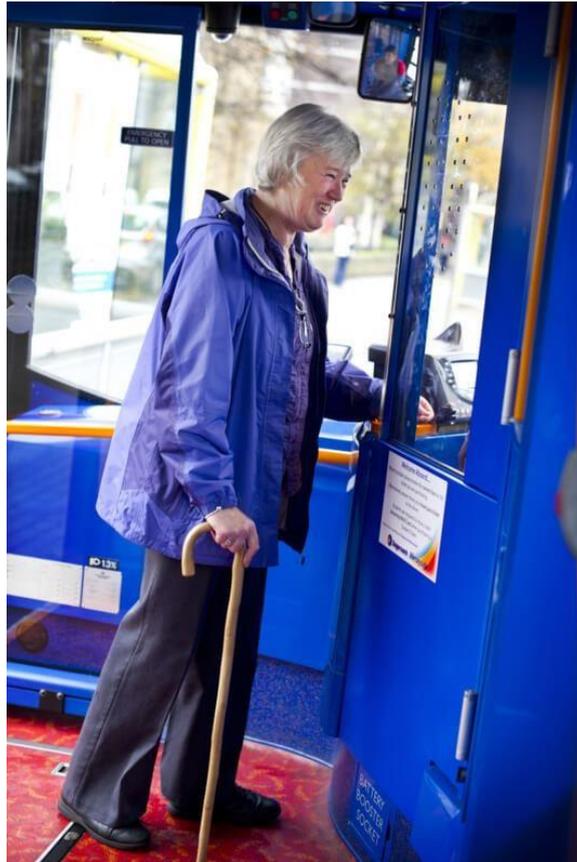
Figure 5.9 Pedestrians using sticks have a limited range of 50m before needing a rest.

The DfT document Inclusive Mobility (2005) suggests recommended distance limits without rest for various Mobility Impaired Groups that ranges from 50 to 150m, which limits the distance between interchanging bus stops significantly. It is therefore recommended that the distance between the key interchange bus stops is limited to approximately **100m walking distance** where possible to enable all impaired groups to be able to interchange, consideration must be given to providing a rest spots at approximately 50m between the bus stops to cater for those that will not make this distance without a rest.
