Appendix H

Bus Stop Review Report

BusConnects – C11 Kimmage Corridor

Bus Stop Review

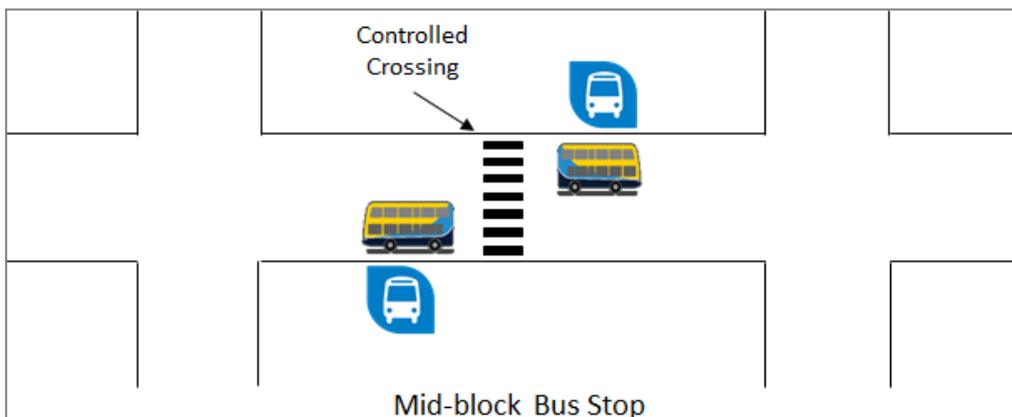
For mid-block (between junctions) bus stops it is important that consideration is given to the location of a safe crossing point. It is recommended that a signalised crossing is located in close proximity to these stops to allow all passengers to cross the road safely. It is also recommended that bus stops are positioned upstream of this crossing to avoid buses blocking visibility to the crossing and that passengers walk to the back of the bus where they are more visible to oncoming traffic.

Figure 5.10 Mid-block bus stop optimum layout.

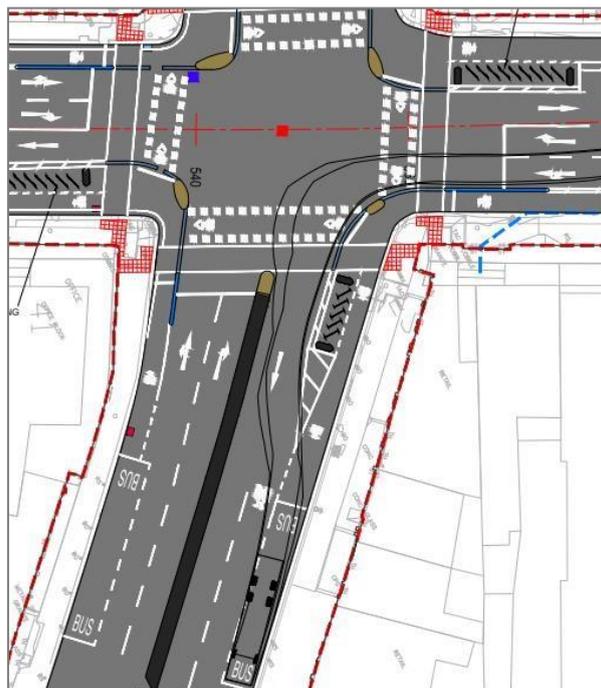
- Where a bus is joining a Spine from a side road it is important that the bus stops are fully accessible by the turning vehicle and sufficient space is provided to allow the bus to pull in flush with the bus stop so as the gap between the kerb and the bus is minimised (both doors). It is also important to ensure that the manoeuvring bus does not require the bus to sweep over the kerb line.

Figure 5.11 Tracking of a turning bus entering a bus stop.

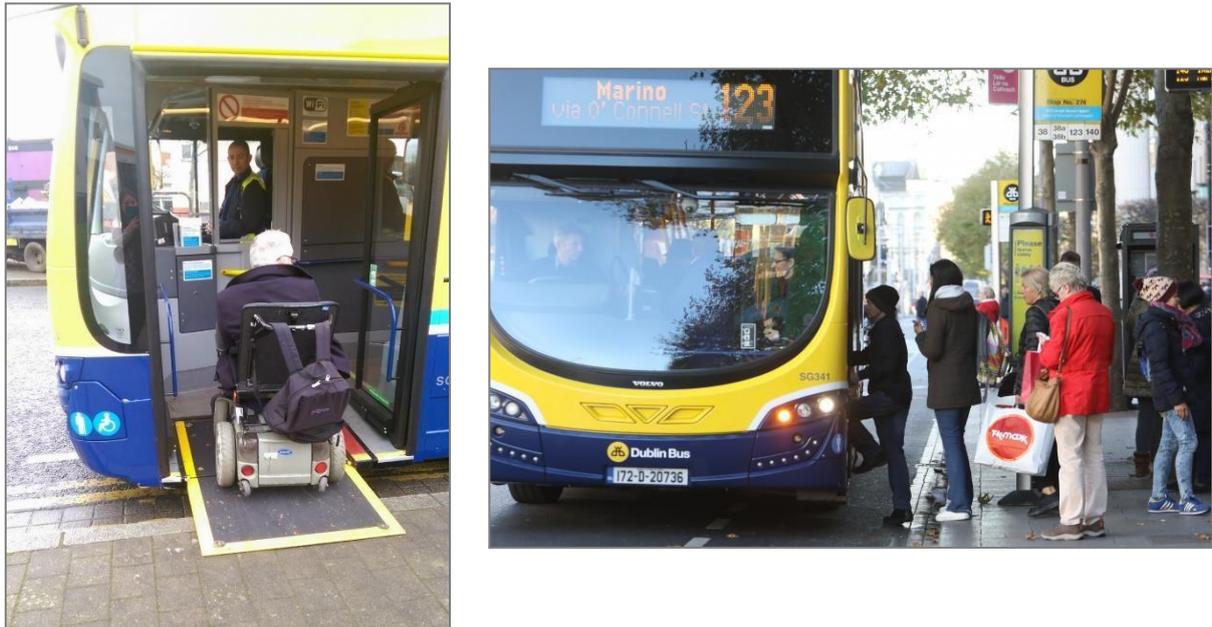
Figure 5.12 Having buses flush with the bus stop is important to allow the ramp to lower correctly, but also to speed up the boarding and alighting of all passengers as gaps slow this down.

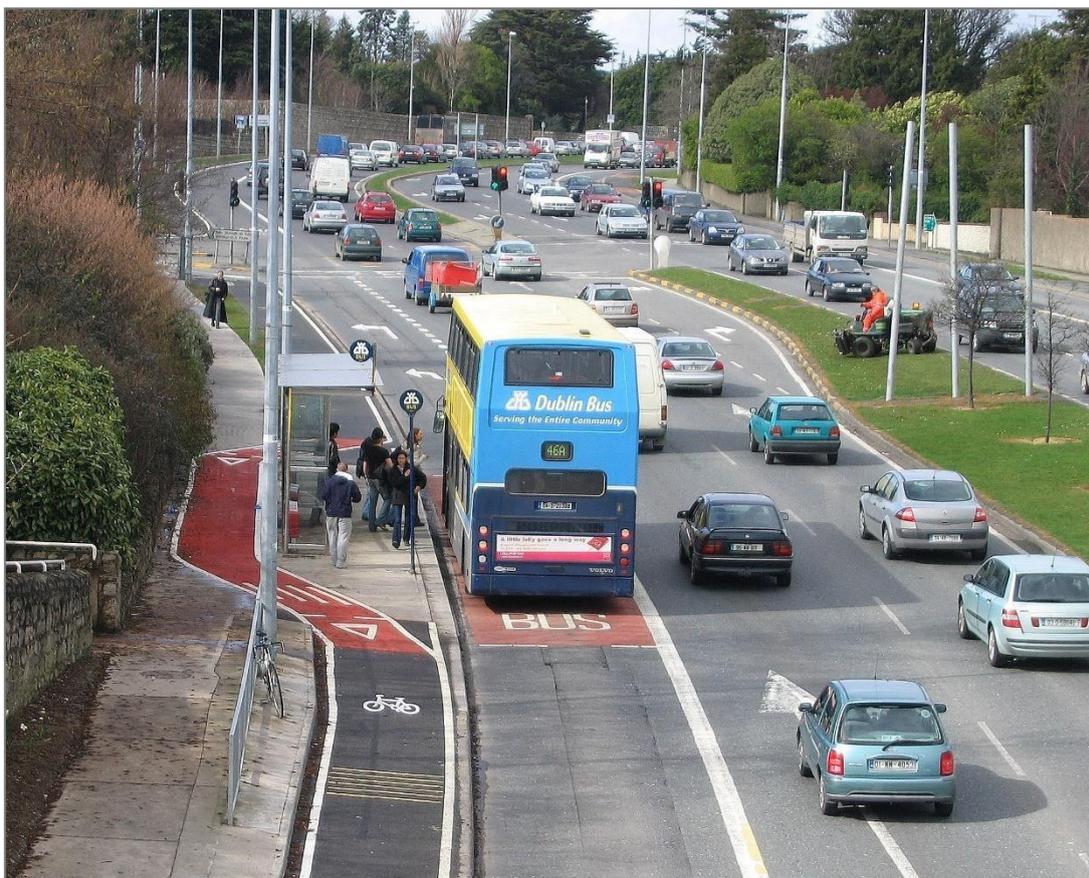
Figure 6.2 Foxrock Church Bus Stop on the N11 QBC

For buses entering and exiting the Spine, consideration should be given to how passengers may switch from one branch to another branch route. While this can happen anywhere along the Spine it will most regularly occur at the last stop before the branch route peels off the Spine. An existing example of this can be seen at Foxrock Church where two high frequency routes (46A/145) deviate at this point. At the last stop before the 46A deviates to Kill Avenue significant numbers switch from one route to the other.

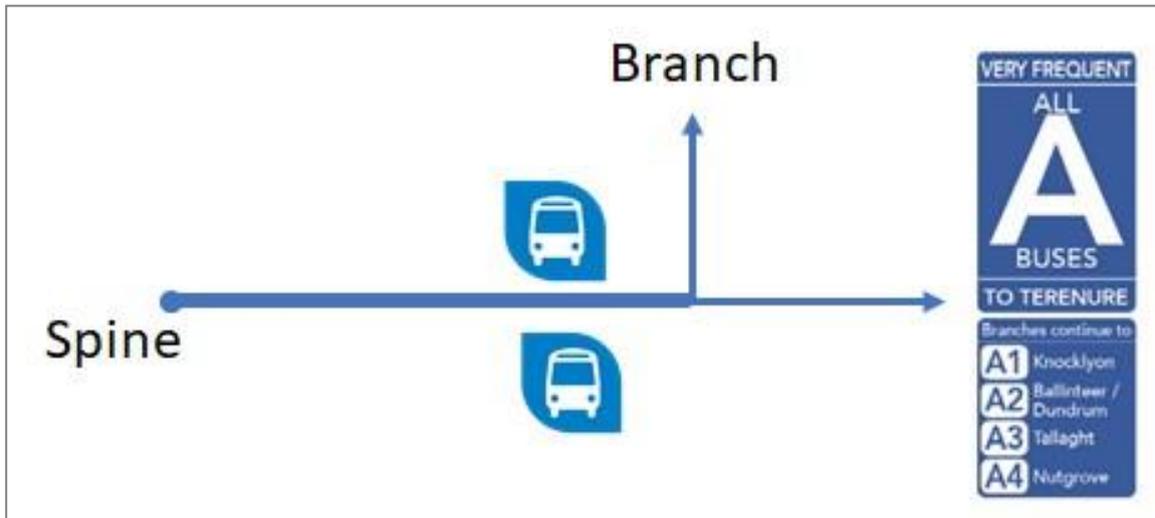
For the Core Bus Corridors consideration should be given to the size and location of the stops before branch routes leave the main Spine. The optimum location of stops at this location will allow all routes to overlap prior to the junction thus removing the necessity for passengers to walk to another bus stop.

Figure 6.3 Location of Bus Stops Immediately before Branch Route Peels Off Spine

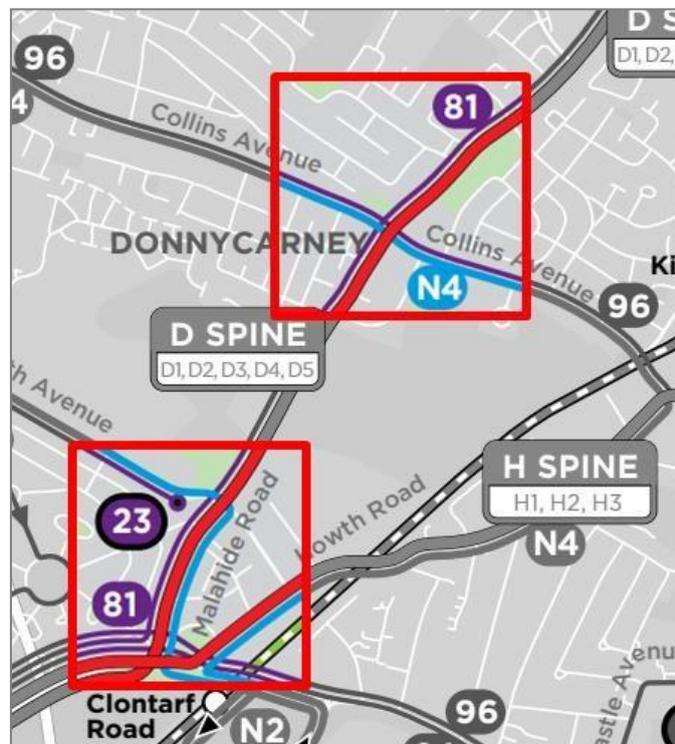
The movement of passengers from one corridor to another is critically important to make Dublin more accessible by public transport. Making this interchange as easy as possible is thus critical to the successful delivery of the BusConnects Programme. Figure 3.4 indicates two typical scenarios that will arise on this project; the crossing movement (D/N4) and the overlapping movement (D/N2).

Figure 6.4 Two Different Scenarios for Interchange between orbital and radial corridors.

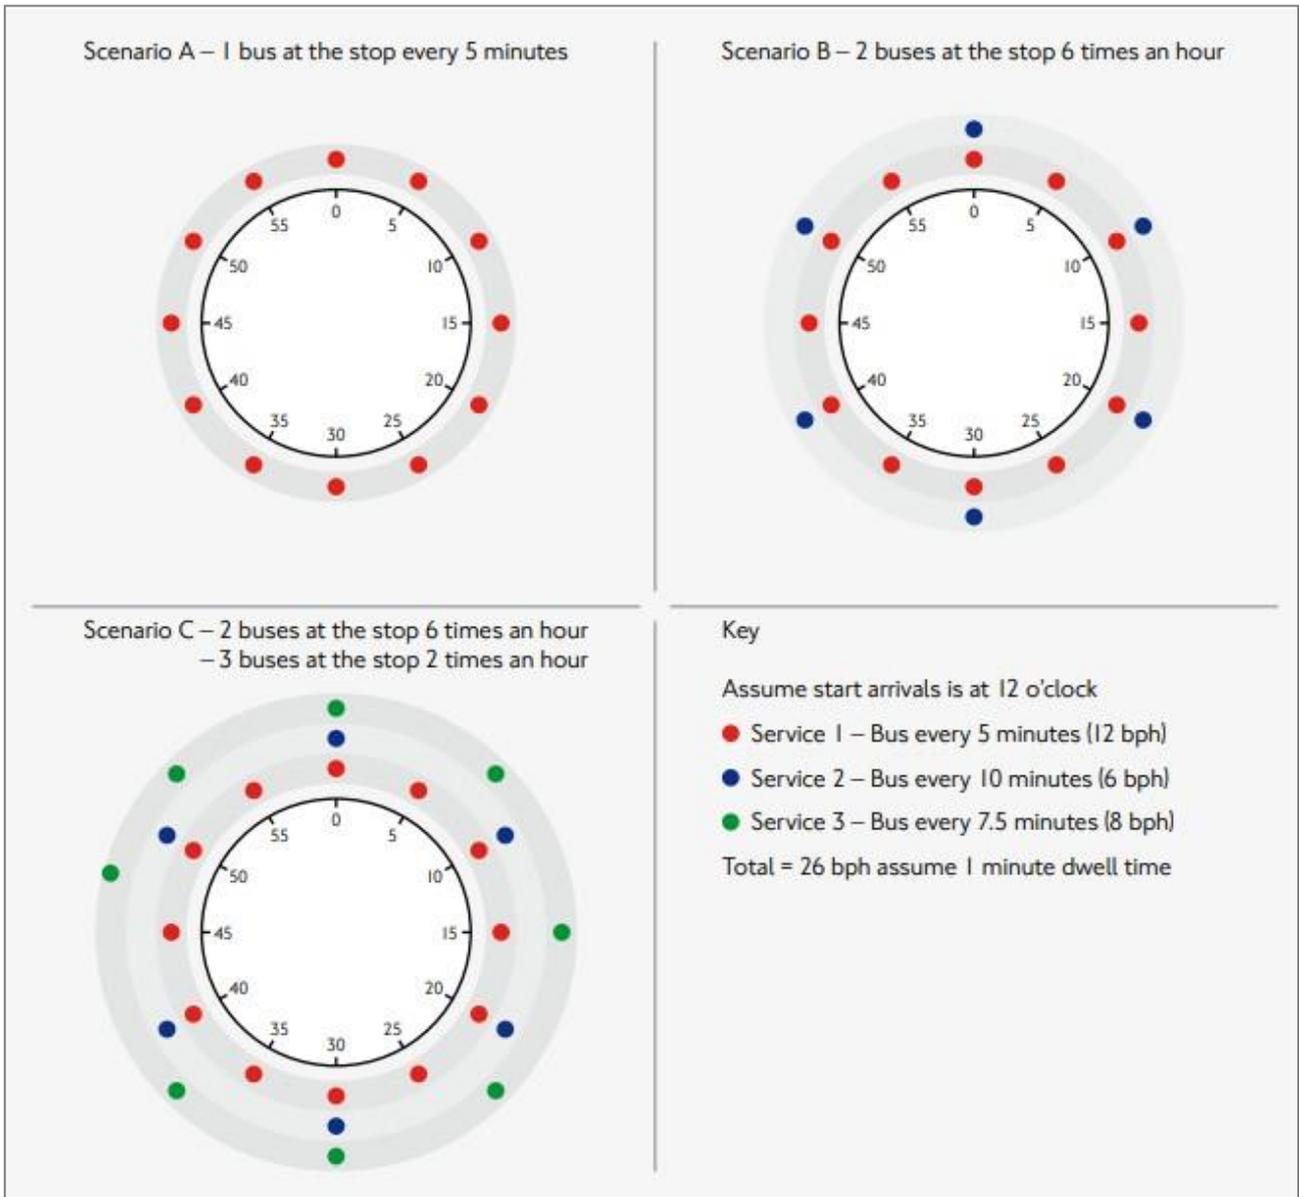
The TFL Bus Stop Design Guidance states that bus stop capacity is a function of bus length, service frequency, the number of serving routes and their average dwell time. The BusConnects Dublin Corridors will generally carry between 15 to 20 buses per hour at peak times, which equates to a bus every 3 minutes. Assuming a maximum dwell time of 1 minute it could be assumed that one bus stop will be sufficient in most cases. However, the spine corridors will have multiple branches joining at different points with buses running at different frequencies resulting in buses not running at a constant headway. Figure 7.1 below indicates a bus arrival scenario from the TFL Bus Stop Design Guideline which shows how buses may arrive at a stop. This shows the estimated volume of buses at a single bus stop, depending on the frequency of the respective services. For example, Scenario C shows that although there is a frequency of 26 buses per hour, the stop, would theoretically operate well below capacity, however the arrival pattern of buses means that at times more than one bus will be on the stop. For this reason, it would be recommended that this bus stop should have sufficient space to board and alight two buses at once.

Figure 7.1 Bus Arrival Pattern at a Bus Stop (Source: TFL Bus Stop Design Guidance)

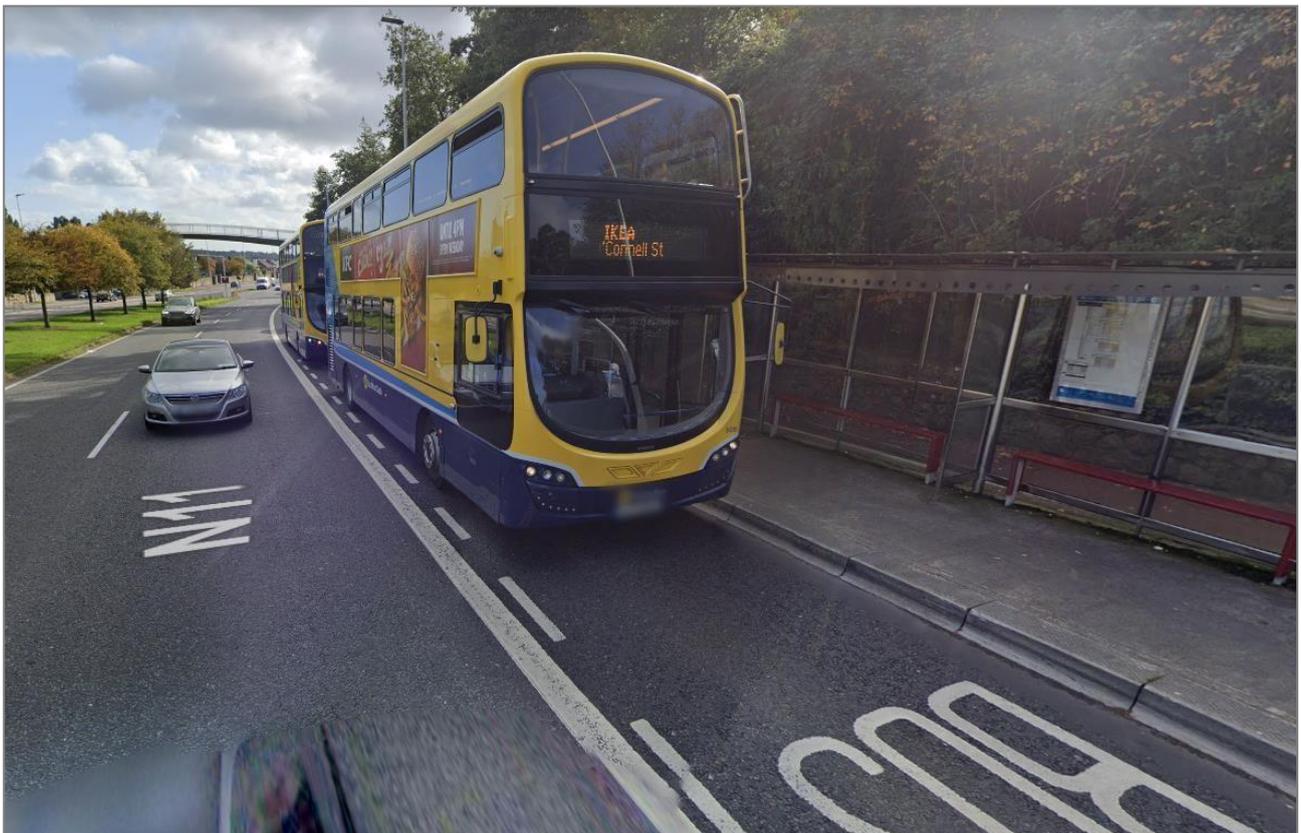
<p>Number of Bays at a Bus Stop</p>	<p>Where a Corridor is carrying approximately 25 to 30 buses or more per hour, consideration be given to lengthened the bus stop cage and kerbing to provide space for 2 buses stopping simultaneously. Independent arrival and departure is not required.</p>
--	---

Figure 7.2 Where space permits double bus bay should be provided where more than one bus is expected to arrive at a bus stop simultaneously (source: Google)

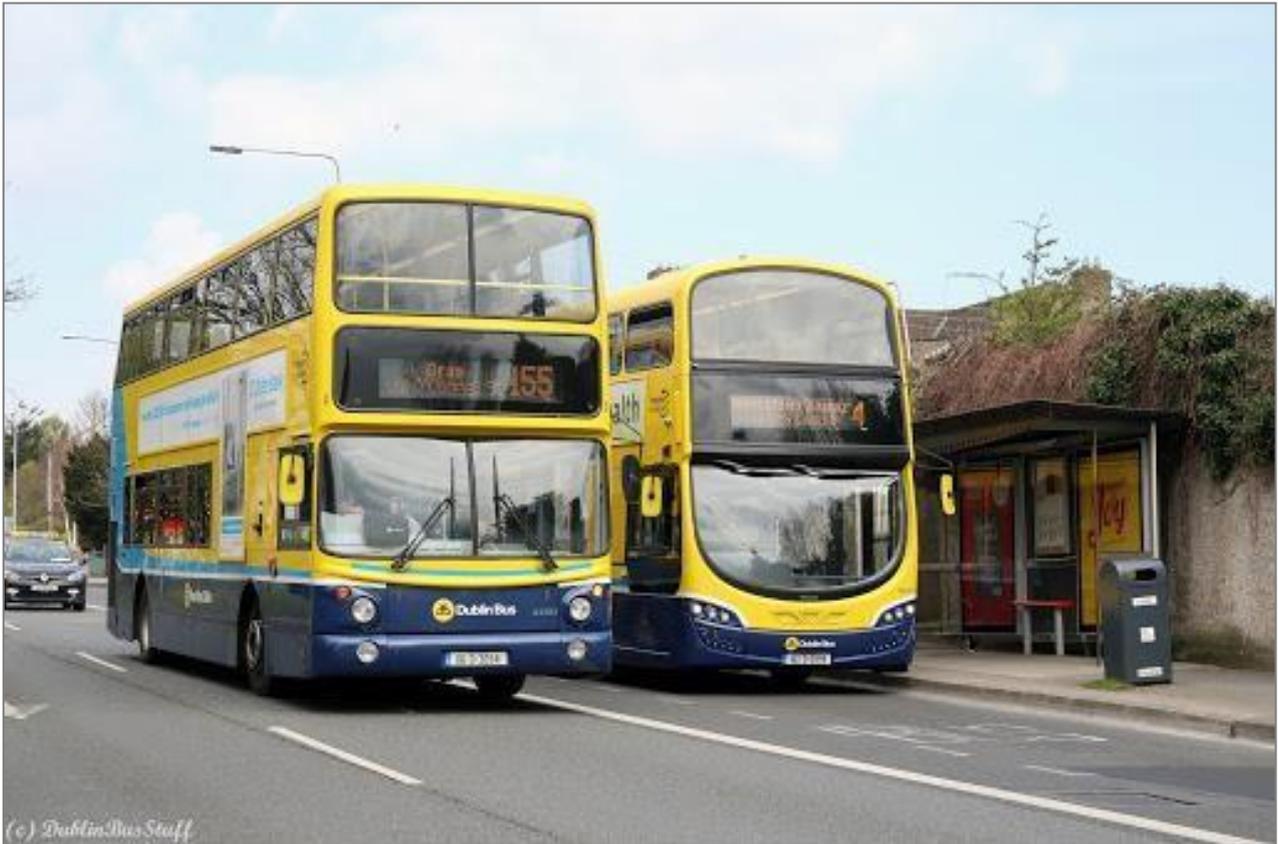
Requirements for passing Lanes	Where a section of corridor is carrying approximately 40 to 50 buses or more an hour, consideration should be given to providing passing lanes at bus stops.
---------------------------------------	---

Figure 7.3 In-line bus stops on a heavily used bus corridor can lead to express, or non-stopping buses, being delayed or making overtaking manoeuvres. (source: Dublin Bus Stuff).

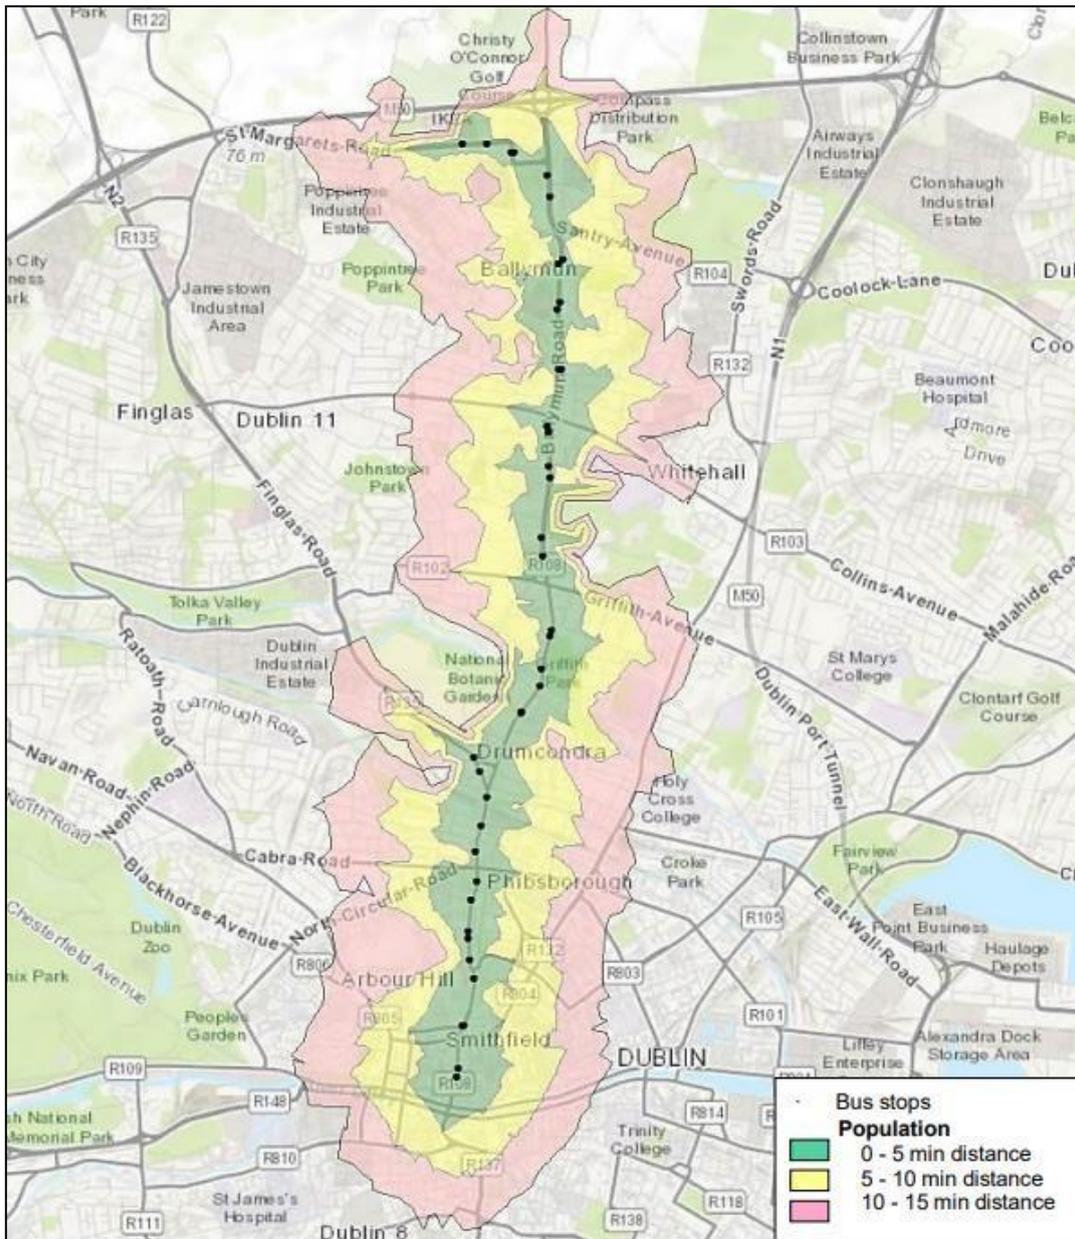
On completion of the review of bus stops along each corridor the catchment analysis for each corridor should be undertaken. The process was detailed in Section 4.0. The analysis should be undertaken and presented on a corridor basis with both Residential and Employment/Education population within 5 and 10 minutes presented.

Figure 8.1 Typical map of bus corridor catchment areas
