Appendix A16.1-A16.4
Architectural Heritage
Appendices

Appendix A16.4: Photographic Survey of Woodbrook Side Lodge	306
1. Introduction.....	306
2. Woodbrook Side Lodge	306
2.1 Exterior	306
2.2 Interior	309
1.1 Vehicular Gate.....	310
1.2 Pedestrian Gate.....	311
1.3 Boundary Wall	312
1.4 Grounds.....	312
References	314

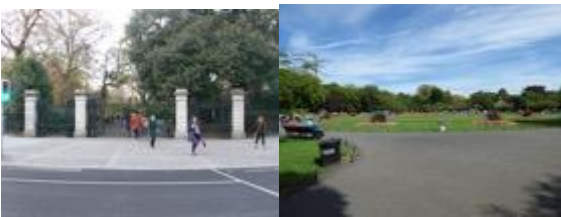
Identification No.	RMP DU018-020334
Additional Identifiers	DCC RPS 7751 NIAH 2375
Legal Status	National Monument, Recorded Monument and Protected Structure
Location	St. Stephen's Green
Date of Construction	1669
Original Use	Medieval Common
Description	Park. Originally a common in the medieval period. The plots around the green were laid out in 1664 but the green itself was not enclosed until 1669. The present landscaping dates to the 1870s and was instigated by Arthur E Guinness. Railings, gates and plinth walls of perimeter boundary on St. Stephen's Green. The boundary features date to 1818. The gates are late 19th century
Significance Rating	National
Categories of Special Interest	Architectural, Archaeological, Artistic Historical, Social, Technical
Sensitivity	High
Sources	DCC 2022, Dúchas 1998, NMS 2020a and 2020b, NMS 2009; NMS 2019, NIAH 2020a, NIAH 2020b, Speed 1610, Down Survey 1656 to 1658, Brooking 1728, Rocque 1756, Rocque 1760, Taylor & Skinner 1777, Taylor 1816, Duncan 1821, OSI 1837 to 1844, OSI 1847, OSI 1864, OSI 1876, OSI 1882, 1889 to 1892, OSI 1907 to 1911 and OSI 1937 to 1953, Archiseek 2020a, Ball 1903, Lewis, 1837, Clarke 2002, Lennon and Simms 2008, Goodbody 2014, M'Cready 1892, Bennett 2005, Casey 2005, Pearson 2000, Hone Craig and Fewer 2002, 2020, Joyce 1913, Field Survey

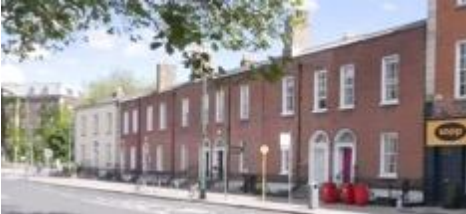
Identification No.	DCC RPS 4594, 4595, 4596, 4597, 4598, 4599
Legal Status	Protected Structure
Location	150 to 155 Leeson Street Upper
Date of Construction	Before 1821
Original Use	Houses
Description	Terrace of two bay two storey over basement red brick houses. Walls rendered at basement level. Brick stacks, sash windows Greek revival doorcases approached by granite steps. Sash windows to square headed window openings.
Significance Rating	Regional
Categories of Special Interest	Architectural, Artistic
Sensitivity	Medium
Sources	DCC 2022, Duncan 1821, OSI 1837 to 1844, OSI 1847, OSI 1864, OSI 1876, OSI 1882, 1889 to 1892, OSI 1907 to 1911 and OSI 1937 to 1953, Archiseek 2020a, Ball 1903, Bennett 2005, Galavan 2017, Daly et al.1998, Hone Craig and Fewer 2002, IAA 2020, Joyce 1913, Kelly 1996, Lewis, 1837, M'Cready 1892, Pearson 2000, Price 1942, Williams 1994, Field Survey
Photographs

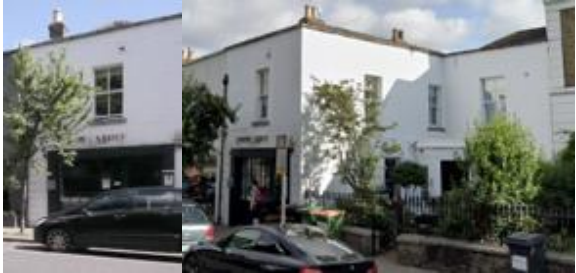
Identification No.	DCC RPS 4572
Legal Status	Protected Structure
Location	126 Leeson Street Upper
Date of Construction	Mid-19th century
Original Use	House
Description	Two bay two storey terraced building with recessed entrance bay. Rendered. Sash windows to the upper floor. Replacement shop front. Exterior, including front site, plinth wall and railings only are protected
Significance Rating	Regional
Categories of Special Interest	Architectural, Artistic, Social
Sensitivity	Medium
Sources	DCC 2022, Duncan 1821, OSI 1837 to 1844, OSI 1847, OSI 1864, OSI 1876, OSI 1882, 1889 to 1892, OSI 1907 to 1911 and OSI 1937 to 1953, Archiseek 2020a, Ball 1903, Bennett 2005, Galavan 2017, Daly et al.1998, Hone Craig and Fewer 2002, IAA 2020, Joyce 1913, Kelly 1996, Lewis, 1837, M'Cready 1892, Pearson 2000, Price 1942, Williams 1994, Field Survey
Photographs

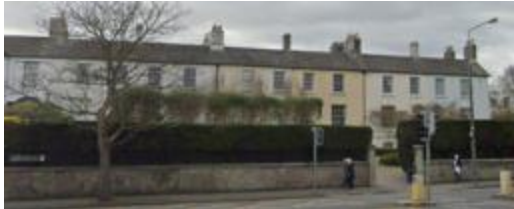
Identification No.	DCC RPS 451, 44515, 4516, 4517, 4518, 4519
Legal Status	Protected Structure
Location	65a to 69 Leeson Street Upper
Date of Construction	19th century
Original Use	Houses
Description	Terrace of two bay two story over raised basement rendered houses with granite steps leading up to the hall doors. Square headed sash windows and Greek revival door cases with plain glazed fanlights and sidelights. Rusticated finish and segmental arched openings to basements
Significance Rating	Regional
Categories of Special Interest	Architectural, Artistic
Sensitivity	Medium
Sources	DCC 2022, Duncan 1821, OSI 1837 to 1844, OSI 1847, OSI 1864, OSI 1876, OSI 1882, 1889 to 1892, OSI 1907 to 1911 and OSI 1937 to 1953, Archiseek 2020a, Ball 1903, Bennett 2005, Galavan 2017, Daly et al.1998, Hone Craig and Fewer 2002, IAA 2020, Joyce 1913, Kelly 1996, Lewis, 1837, M'Cready 1892, Pearson 2000, Price 1942, Williams 1994, Field Survey

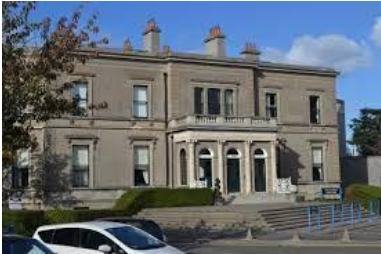
Identification No.	DLR RPS 19
Legal Status	Protected Structure
Location	Ardmore / Belview House University College Dublin, Stillorgan Road, Belfield .
Date of Construction	Circa 1806. Extant 1837
Original Use	House
Description	Ardmore House designed by William Dunlevy is a typical example of a 19th century country villa. It was described in 1832 as being two stories high consisting of parlour, drawing room and two bed chambers, basement story with kitchen and servants apartments, stabling for five horses, coach house and garden. An extension in the late 1800s incorporated a balustraded Corinthian porch and bow ends. The associated landscape is assessed in Section 2.5.
Significance Rating	Regional
Categories of Special Interest	Architectural, Artistic, Historical, Social
Sensitivity	Medium
Sources	DLR 2022, NIAH 2020b, Taylor 1816, Duncan 1821, OSI 1837 to 1844, OSI 1847, OSI 1864, OSI 1876, OSI 1882, 1889 to 1892, OSI 1907 to 1911 and OSI 1937 to 1953, Archiseek 2020a, Ball 1903, Bennett 2005, Bence Jones 1988, Dean 2016, Galavan 2017, Daly et al.1998, Hone Craig and Fewer 2002, IAA 2020, Joyce 1913, Kelly 1996, Lewis, 1837, M'Cready 1892, Corlett 1999, Pearson 1998, Price 1942, Williams 1994, Field Survey

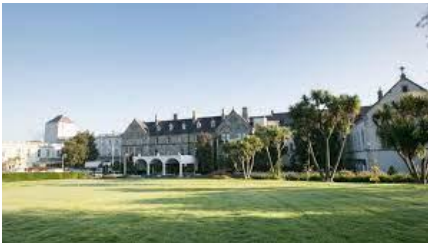
Identification No.	RMP DU023-071
Additional Identifiers	NIAH 2485
Legal Status	Recorded Monument
Location	Stillorgan Castle, St John Of Gods, Stillorgan Rd
Date of Construction	Present buildings are 19 th century but are built on the site of a 14 th century castle
Original Use	Castle
Description	A castle is depicted on the First Edition of the Ordnance Survey maps this house is titled ' Stillorgan Castle'. This holding may relate to the manor of Stillorgan owned by John De Clahill, Raymond de Carew and by 1360 by Sir John Cruise. It would appear that the manor house may have been sited 355 m to the N at 'Stillorgan House'. A house was built c 1820.In 1836 it was described as a first rate residence with four reception rooms, a library and billiard room with six bedrooms. There were water closets and servants accommodation in the basement. It was purchased in 1882 by the Brothers of St John of God as a "House of Retreat for the old and the Invalid" and enlarged including the construction of gothic institutional buildings using granite from the Dublin mountains. A cemetery was opened in 1884.It was further enlarged in 1890 when a community wing and chapel were added. On the 25th November 1908 it burned to the ground. By 1911 a new building was constructed followed by a chapel in 1913.Present buildings are 19th century of granite construction. The associated landscape is assessed in Section 2.5.

Significance Rating	Regional
Categories of Special Interest	Architectural, Archaeological, Artistic, Historical, Social
Sensitivity	Medium
Sources	Dúchas 1995, Dúchas 1998, NMS 2020a and 2020b, DLR 2022, NIAH 2020b, IAA 2020, Archiseek 2020a, Lewis, 1837, Ball 1903, Joyce 1913, Price 1942, Hone Craig and Fewer 2002, Bennett 2005, Bence Jones 1988, Dean 2016, Williams 1994, Kelly 1996, Galavan 2017, Daly et al.1998,Corlett 1999, Pearson 1998, Speed 1610, Down Survey 1656-1658,Rocque 1760,Taylor & Skinner 1777, Taylor 1816, Duncan 1821, OSI 1837 to 1843, OSI 1847, OSI 1864, OSI 1877, OSI 1889-90, OSI 1908 to 1911, OSI 1940 to 1944,Field Survey
Photographs

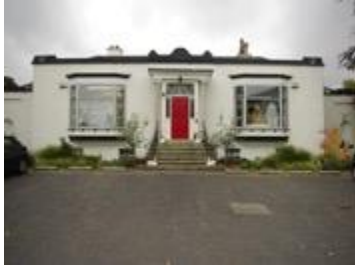
Identification No.	DLR RPS 2005
Additional Identifiers	NIAH 60230074
Legal Status	Protected Structure recognised by the NIAH
Location	Eversham / Disciples of the Divine Master Liturgical Centre, Stillorgan Rd
Date of Construction	Extant 1837
Original Use	Eversham House
Description	Detached three-bay single-storey over part raised basement house, erected by William Minchin extant 1837, on a T-shaped plan with single-bay full-height return abutting two- or four-bay full-height parallel block. The associated landscape is assessed in Section 2.5.
Significance Rating	Regional
Categories of Special Interest	Architectural, Artistic, Historical, Social
Sensitivity	Medium
Sources	DLR 2022, NIAH 2020a, OSI 1837 to 1844, OSI 1847, OSI 1864, OSI 1876, OSI 1882, 1889 to 1892, OSI 1907 to 1911 and OSI 1937 to 1953, Archiseek 2020a, Ball 1903, Bennett 2005, Bence Jones 1988, Dean 2016, Galavan 2017, Daly et al.1998, Hone Craig and Fewer 2002, IAA 2020, Joyce 1913, Kelly 1996, Lewis, 1837, M'Cready 1892, Corlett 1999, Pearson 1998 Turner 1983, Price 1942, Williams 1994, Field Survey

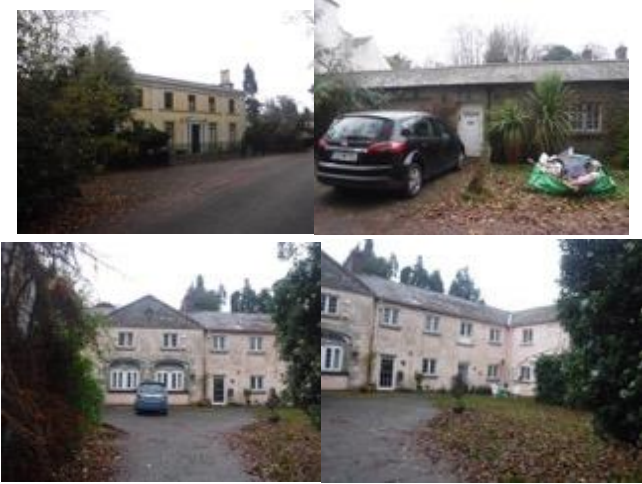
Identification No.	DLR RPS 1869
Additional Identifiers	NIAH 60260155, 60260156
Legal Status	Protected Structure
Location	Corke Lodge / Wood Lawn Dublin Road, Bray
Date of Construction	Early 19 th century house extant 1816
Original Use	House and Stable Block
Description	Originally called Wood Lawn, this early 19 th century house was built for William Henry Magan (1790-1840) to a design attributed to William Farrell (d. 1851). Pearson refers to it as the regency style Stewart's house which was associated with Woodbrook as were the stables to the east. It is thought to occupy the site of an earlier house annotated as "Little Cork of Gerard Esquire" by Taylor and Skinner. The building has changed use over time as different uses are given in 1901 and 1911. It was restored, 1980, and is currently in private residential use. The building has historic connections with Augusta Elizabeth Magan (c.1825-1905), allegedly the inspiration for Miss Havisham in "Great Expectations" (1860-1) by Charles Dickens (1812-70). The house is a detached five-bay two-storey double fronted house, built on a rectangular plan. Front elevation features rendered and panelled supporting a moulded cornice on blind frieze below the parapet. A Stable block is located to the rear. The buildings were renovated to accommodate residential use. Stable complex, U-shaped in plan and arranged around a courtyard with a detached ten-bay two-storey coach House/stable outbuilding. Set in landscaped grounds shared with Corke Lodge and Woodbrook and approached from the same lane. There is a row of outbuildings to the east and farm buildings to the north. The associated landscape is assessed in Section 2.5.

Significance Rating	Regional
Categories of Special Interest	Architectural, Historical, Social, Artistic
Sensitivity	Medium
Sources	DLR 2022, NIAH 2020a and 2020b, Taylor & Skinner 1777, Taylor 1816, Duncan 1821, OSI 1837 to 1844, OSI 1847, OSI 1864, OSI 1876, OSI 1882, 1889 to 1892, OSI 1907 to 1911 and OSI 1937 to 1953, Archiseek 2020a, Ball 1903, Bennett 2005, Bence Jones 1988, Dean 2016, Galavan 2017, Daly et al. 1998, Hone Craig and Fewer 2002, IAA 2020, Joyce 1913, Kelly 1996, Lewis, 1837, M'Cready 1892, Corlett 1999, Pearson 1998 Turner 1983, Price 1942, Williams 1994, Field Survey
Photographs

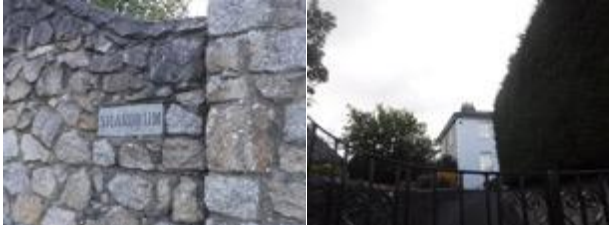
Identification No.	NIAH 60230060
Legal Status	Not protected but recognised by the NIAH
Location	Shandrum - Stillorgan Rd / Victoria House
Date of Construction	1844 - 1894
Description	Double fronted villa
Significance Rating	Local
Categories of Special Interest	Architectural
Sensitivity	Low
Sources	NIAH 2020a, IAA 2020a, OSI 1837 to 1844, OSI 1907 to 1911 and OSI 1937 to 1953, Archiseek 2020a, Ball 1903, Bennett 2005, Galavan 2017, Daly et al.1998, Hone Craig and Fewer 2002, IAA 2020, Joyce 1913, Kelly 1996, Lewis, 1837, M'Cready 1892, Corlett 1999, Pearson 1998 Turner 1983, Price 1942, Williams 1994, Field Survey
Photographs

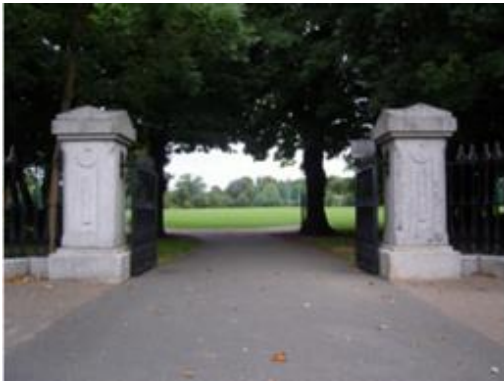
Identification No.	NIAH 60260149
Legal Status	Curtilage of a protected structure and recognised by the NIAH
Location	Shanganagh Park Gates and Railings, Dublin Road Shankill
Date of Construction	1870 – 1894
Original Use	Gate Piers
Description	Originally part of Shanganagh Park (NIAH 60260120), the gates were repositioned here in 1987. The southern entrance gates to the Shanganagh Castle Estate, located on the corner of a junction. Not to be confused with the gates described above. The gateway consists of a pair of cut-granite panelled piers on stepped plinths topped with stepped stringcourses below gabled capping. Between are cast-iron double gates there is a similar outer pair of piers with cut-granite panelled outer piers. Running between the entrance piers and the outer piers are curved or bowed cast-iron serpentine railings set in a cut granite plinth. The gates are in the grounds of Shanganagh Castle, a protected structure (RPS Reg. #: 1845) It is therefore also protected as it is within the curtilage. The NIAH stated that the gateway makes a pleasing visual statement in a sylvan street scene, but also survives as a repurposed relic of the Shanganagh park estate. The associated landscape is assessed in Section 2.5.

Significance Rating	Regional
Categories of Special Interest	Architectural, Artistic, Historical, Social, Technical
Sensitivity	Medium
Sources	NIAH 2020a, IAA 2020a, OSI 1837 to 1844, OSI 1907 to 1911 and OSI 1937 to 1953, Archiseek 2020a, Ball 1903, Bennett 2005, Galavan 2017, Daly et al.1998, Hone Craig and Fewer 2002, IAA 2020, Joyce 1913, Kelly 1996, Lewis, 1837, M'Cready 1892, Corlett 1999, Pearson 1998 Turner 1983, Price 1942, Williams 1994, Field Survey
Photographs

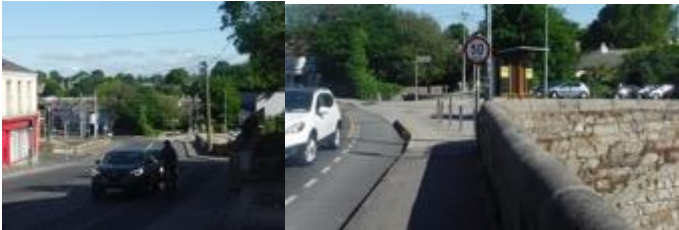
Identification No.	NIAH 16301267
Legal Status	Not protected but recognised by the NIAH
Location	Fran O'Toole Bridge Little Bray
Date of Construction	Built in 1855-56
Description	Three-arch stone built road bridge over the Dargle or Bray River. The bridge is in dressed granite, with round-ended piers rising into panelled pilasters and a string course just above the level of the arches. The arches themselves are segmental, whilst the parapets have rounded coping.
Significance Rating	Regional
Categories of Special Interest	Architectural, Artistic, Historical, Social, Technical
Sensitivity	Medium
Sources	NIAH 2020a, IAA 2020a, OSI 1907 to 1911 and OSI 1937 to 1953, Archiseek 2020a, Ball 1903, Bennett 2005, Galavan 2017, Daly et al.1998, Hone Craig and Fewer 2002, IAA 2020, Joyce 1913, Kelly 1996, Lewis, 1837, M'Cready 1892, Corlett 1999, Pearson 1998 Turner 1983, Price 1942, Garner 1980, Scott 1984, Field Survey

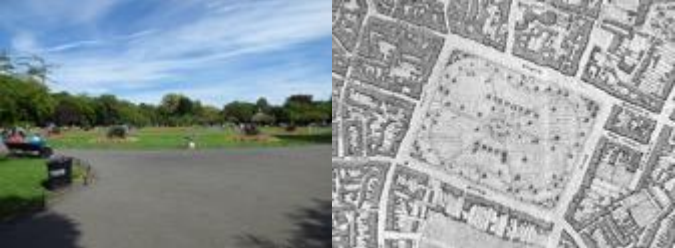
Identification No.	NIAH 2375
Additional Identifiers	RMP DU018-020334, DCC RPS 7751, NIAH 50100259, 50100148
Legal Status	National Monument and Protected Structure within St. Stephen's Green Conservation Area. Protected under Policy BHA9 of the Dublin City Development Plan (DCC 2022) as it is within a Conservation Area, indicated as an area hatched in red
Location	St Stephen's Green
Date of Construction	1669
Original Use	Medieval common
Description	Park. Originally a common in the medieval period. The plots around the green were laid out in 1664 but the green itself was not enclosed until 1669. The present landscaping dates to the 1870s and was instigated by Arthur E Guinness. Main features substantially present: - no loss of integrity
Significance Rating	National
Categories of Special Interest	Architectural, Archaeological, Artistic, Historical, Social, Technical
Sensitivity	High
Sources	Dúchas 1995, Dúchas 1998, NMS 2020a and 2020b, DCC 2003 to 2009, DCC 2022, NIAH 2020a, NIAH 2020b, Speed 1610, Down Survey 1656-1658, Brooking 1728, Rocque 1756, Rocque 1760, Taylor & Skinner 1777, Taylor 1816, Duncan 1821, OSI 1843 to 1844, OSI 1847, OSI 1864, OSI 1876, OSI 1882, 1889 to 1892, OSI 1910 to 1911 and OSI 1940 to 1953, Archiseek 2020a, Ball 1901, Ball 1902, Ball 1903, Ball 1907, Bence Jones 1988, Bennett 2005, Casey 2005, Clarke 2002, Dean 2016, Galavan 2017, Daly et al. 1998, Goodbody 2014, Hone Craig and Fewer 2002, IAA 2020, Joyce 1913, Kelly 1996, Lennon and Simms 2008, Lewis, 1837, M'Cready 1892, O'Maitiu 2003, Corlett 1999, Pearson 1998, Pearson 2000, Price 1942, Williams 1994, Field Survey

<p>The photograph on the left shows a modern-day view of St Stephen's Green, a large open park area with trees and a paved walkway. The map on the right is a historical 1843 Ordnance Survey map showing the layout of the park and surrounding buildings.</p>

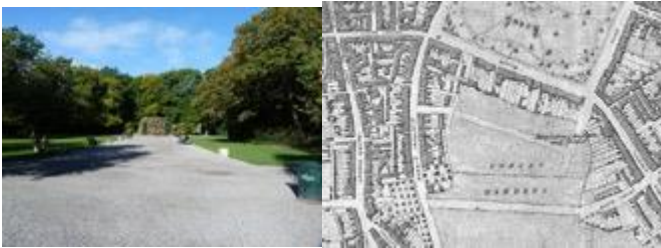
Identification No.	DLR RPS 2426
Additional Identifiers	NIAH 2373
Legal Status	Protected Structure
Location	Iveagh Gardens Earlsfort Terrace
Date of Construction	1865
Description	Developed as part of the pleasure grounds of the 1865 Dublin Exhibition and later functioned as the gardens of Iveagh House. The perimeter of site covered by buildings. Main features substantially present: - no loss of integrity
Significance Rating	Regional
Categories of Special Interest	Architectural, Artistic, Historical, Social, Technical
Sensitivity	Medium
Sources	DCC 2003 to 2009, DCC 2022, NIAH 2020a, NIAH 2020b, OSI 1864, OSI 1876, OSI 1882, 1889 to 1892, OSI 1910 to 1911 and OSI 1940 to 1953, Archiseek 2020a, Ball 1901, Ball 1902, Ball 1903, Ball 1907, Bence Jones 1988, Bennett 2005, Casey 2005, Clarke 2002, Dean 2016, Goodbody 2014, Hone Craig and Fewer 2002, IAA 2020, Lennon and Simms 2008, M'Cready 1892, Pearson 2000, Williams 1994, Field Survey

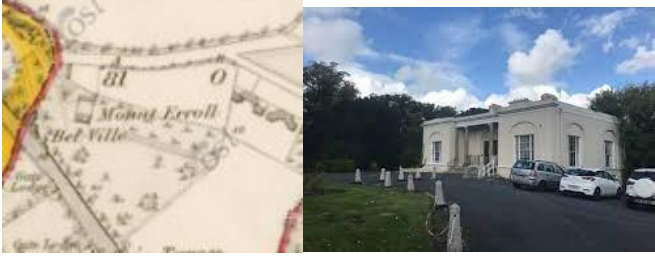
Identification No.	DCC RPS 7846
Legal Status	Protected Structure
Location	Mount Errol House, Stillorgan Road
Date of Construction	Early 19th century Extant 1837
Original Use	Home of Sir Richard Baker (1780- 1853) House and landscaped grounds shown on the 1837 OS map. House survives but the grounds have been altered as it was previously formed part of the Radio Telifis Eireann campus. The drive survives as do the sables to the rear and the walls to the walled garden. The lodge and original boundary treatment have been removed.
Description	House
Significance Rating	Regional
Categories of Special Interest	Architectural, Artistic
Sensitivity	Medium
Sources	DCC 2022, IAA 2020, Archiseek 2020a, Lewis, 1837, Ball 1903, Joyce 1913, Price 1942, Hone Craig and Fewer 2002, Bennett 2005, Bence Jones 1988, Dean 2016, Williams 1994, Kelly 1996, Galavan 2017, Daly et al.1998,OSI 1837 to 1844, OSI 1847, OSI 1864, OSI 1876, OSI 1882, 1889 to 1892, OSI 1907 to 1911 and OSI 1937 to 1953, Field Survey

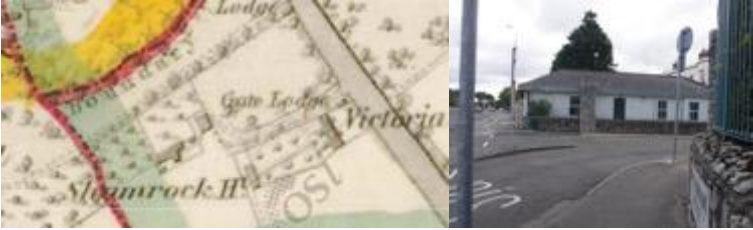
Identification No.	CBC0013BTH226
Legal Status	Not Protected
Location	Shamrock Hill Stillorgan Road
Date of Construction	Extant 1837
Description	House and landscaped grounds shown on the 1837 OS map as consisting of a house and a large complex of attached out buildings within a park with avenues and a gate lodge. Only gate lodge survives
Significance Rating	Local
Categories of Special Interest	Historical
Sensitivity	Low
Sources	IAA 2020, Archiseek 2020a, Lewis, 1837, Ball 1903, Joyce 1913, Price 1942, Hone Craig and Fewer 2002, Bennett 2005, Bence Jones 1988, Dean 2016, Williams 1994, Kelly 1996, Galavan 2017, Daly et al.1998,OSI 1837 to 1843, OSI 1847, OSI 1864, OSI 1877, OSI 1889-90, OSI 1908 to 1911, OSI 1940 to 1944, Field Survey
Photographs

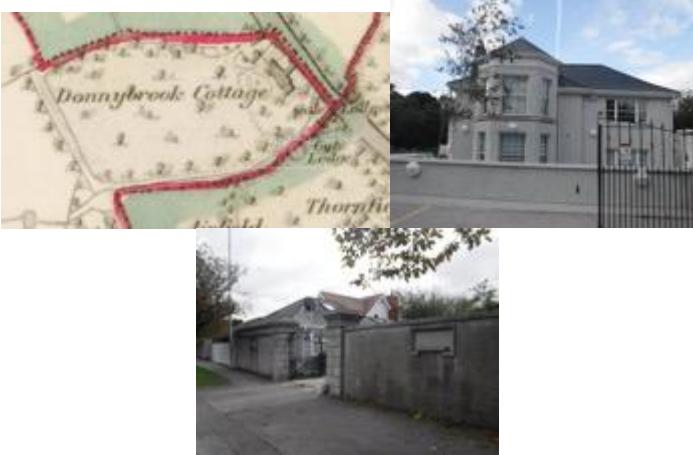
Identification No.	CBC0013BTH108
Legal Status	Not Protected
Location	Donnybrook Cottage St Teresians School Stillorgan Road
Date of Construction	Extant 1821
Description	House and landscaped grounds shown on Duncan's 1821 map. Also known as Donnybrook Cottage and St Margaret's. House and grounds now part of St Teresians School
Significance Rating	Regional
Categories of Special Interest	Architectural, Artistic, Historical, Social
Sensitivity	Medium
Sources	IAA 2020, Archiseek 2020a, Lewis, 1837, Ball 1903, Joyce 1913, Price 1942, Hone Craig and Fewer 2002, Bennett 2005, Bence Jones 1988, Dean 2016, Williams 1994, Kelly 1996, Galavan 2017, Daly et al.1998,Duncan 1821, OSI 1837 to 1843, OSI 1847, OSI 1864, OSI 1877, OSI 1889-90, OSI 1908 to 1911, OSI 1940 to 1944, Field Survey
Photographs

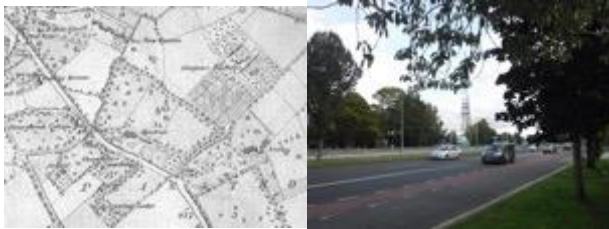
Identification No.	NIAH 2427
Additional Identifiers	DLR RPS 7847
Legal Status	Protected Structure
Location	Montrose, Stillorgan Road
Date of Construction	Extant 1816
Description	House and landscaped grounds shown on the 1837 OS map. Much of the site is covered by development. Montrose House: detached stucco house / offices. Main features substantially present: - peripheral features unrecognizable
Significance Rating	Regional
Categories of Special Interest	Architectural, Artistic, Historical, Social
Sensitivity	Medium
Sources	DLR 2022, NIAH 2020b, IAA 2020, Archiseek 2020a, Lewis, 1837, Ball 1903, Joyce 1913, Price 1942, Hone Craig and Fewer 2002, Bennett 2005, Bence Jones 1988, Dean 2016, Williams 1994, Kelly 1996, Galavan 2017, Daly et al.1998, Corlett 1999, Pearson 1998 Taylor 1816, Duncan 1821, OSI 1837 to 1843, OSI 1847, OSI 1864, OSI 1877, OSI 1889-90, OSI 1908 to 1911, OSI 1940 to 1944, Field Survey

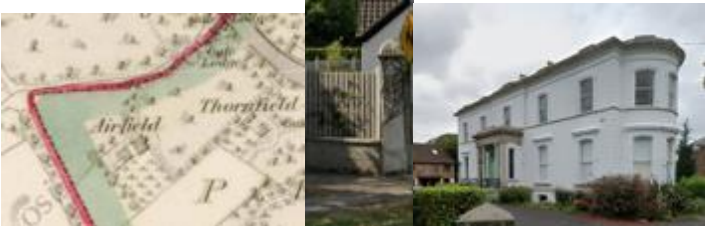
Identification No.	CBC0013BTH106
Legal Status	Not Protected
Location	Airfield, Stillorgan Road
Date of Construction	Extant 1837
Description	House and landscaped grounds shown on the 1837 OS map. Site redeveloped with housing but house, rusticated granite piers and rendered curtain wall remains
Significance Rating	Local
Categories of Special Interest	Architectural, Historic
Sensitivity	Low
Sources	IAA 2020, Archiseek 2020a, Lewis, 1837, Ball 1903, Joyce 1913, Price 1942, Hone Craig and Fewer 2002, Bennett 2005, Bence Jones 1988, Dean 2016, Williams 1994, Kelly 1996, Galavan 2017, Daly et al.1998, Corlett 1999, Pearson 1998, OSI 1837 to 1843, OSI 1847, OSI 1864, OSI 1877, OSI 1889-90, OSI 1908 to 1911, OSI 1940 to 1944, Field Survey
Photographs

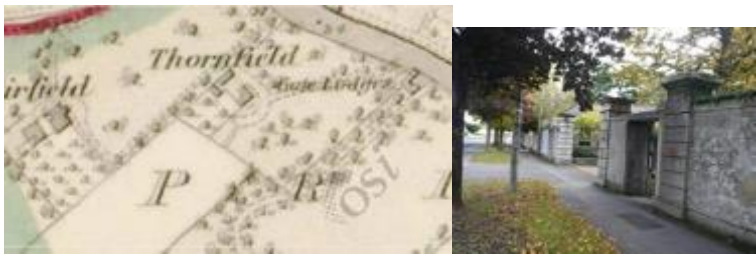
Identification No.	CBC0013BTH105
Legal Status	Not Protected
Location	Thornfield, Stillorgan Road
Date of Construction	Extant 1837
Description	House and landscaped grounds shown on the 1837 OS map. Site redeveloped with housing, but gate piers and gate lodge remain. Rusticated granite piers and rendered curtain wall to former house and landscaped grounds. Two sets of gate piers. Gate lodge is a single story five bay double fronted lodge Site redeveloped with housing but piers remain
Significance Rating	Local
Categories of Special Interest	Architectural, Historic
Sensitivity	Low
Sources	IAA 2020, Archiseek 2020a, Lewis, 1837, Ball 1903, Joyce 1913, Price 1942, Hone Craig and Fewer 2002, Bennett 2005, Bence Jones 1988, Dean 2016, Williams 1994, Kelly 1996, Galavan 2017, Daly et al.1998,Corlett 1999, Pearson 1998, OSI 1837 to 1843, OSI 1847, OSI 1864, OSI 1877, OSI 1889-90, OSI 1908 to 1911, OSI 1940 to 1944, Field Survey

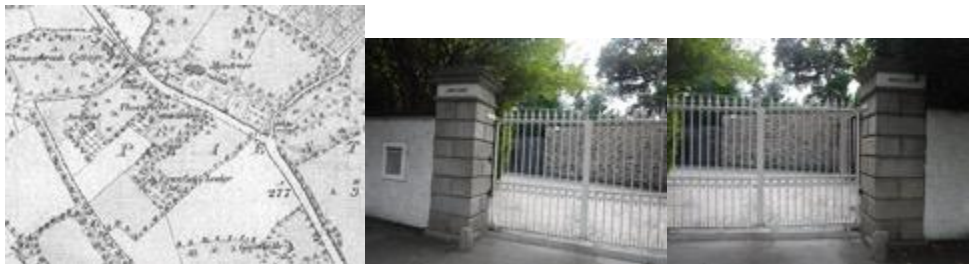
Identification No.	NIAH 2425
Legal Status	Not Protected
Location	Moylurgh Stillorgan Road
Date of Construction	1836 to 1846
Description	Known initially as Greenfield Lodge. House and landscaped grounds shown on the 1837 OS map. Site completely covered by residential development. Rusticated granite piers and rendered curtain wall survive
Significance Rating	Local
Categories of Special Interest	Architectural, Historic
Sensitivity	Low
Sources	NIAH 2020b, IAA 2020, Archiseek 2020a, Lewis, 1837, Ball 1903, Joyce 1913, Price 1942, Hone Craig and Fewer 2002, Bennett 2005, Bence Jones 1988, Dean 2016, Williams 1994, Kelly 1996, Galavan 2017, Daly et al.1998,Corlett 1999, Pearson 1998, OSI 1837 to 1843, OSI 1847, OSI 1864, OSI 1877, OSI 1889-90, OSI 1908 to 1911, OSI 1940 to 1944, Field Survey
Photographs

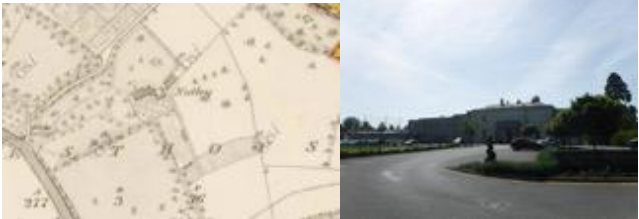
Identification No.	NIAH 2440
Legal Status	Not protected
Location	Nutley House, Elm Park Golf Club
Date of Construction	Early 19th century extant 1837
Description	Nutley House, a three bay two storey detached house with breakfront to entrance porch to central bay. Hipped slate roof with central valley, rendered stacks. Moulded parapet to rendered walls. Square headed openings containing sash windows. Demesne, now part of Elm Park Golf Club.
Significance Rating	Regional
Categories of Special Interest	Architectural, Historical
Sensitivity	Medium
Sources	NIAH 2020b, IAA 2020, Archiseek 2020a, Lewis, 1837, Ball 1903, Joyce 1913, Price 1942, Hone Craig and Fewer 2002, Bennett 2005, Bence Jones 1988, Dean 2016, Williams 1994, Kelly 1996, Galavan 2017, Daly et al.1998,OSI 1837 to 1843, OSI 1847, OSI 1864, OSI 1877, OSI 1889-90, OSI 1908 to 1911, OSI 1940 to 1944,Field Survey
Photographs

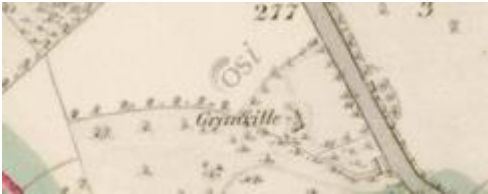
Identification No.	Record only
Legal Status	Not protected
Location	Granville Stillorgan Road
Date of Construction	Extant 1837
Description	Also known as Glenville and Naobh Bridgid. Shown on the 1837 OS map as consisting of a house and a large complex of attached out buildings within a park with avenues and a gate lodge. All since demolished. Virtually no recognizable features.
Significance Rating	Record only
Categories of Special Interest	Historical
Sensitivity	Negligible Sensitivity
Sources	IAA 2020, Archiseek 2020a, Lewis, 1837, Ball 1903, Joyce 1913, Price 1942, Hone Craig and Fewer 2002, Bennett 2005, Bence Jones 1988, Dean 2016, Williams 1994, Kelly 1996, Galavan 2017, Daly et al.1998, , Taylor 1816, Duncan 1821, OSI 1837 to 1843, OSI 1847, OSI 1864, OSI 1877, OSI 1889-90, OSI 1908 to 1911, OSI 1940 to 1944, Field Survey
Photographs

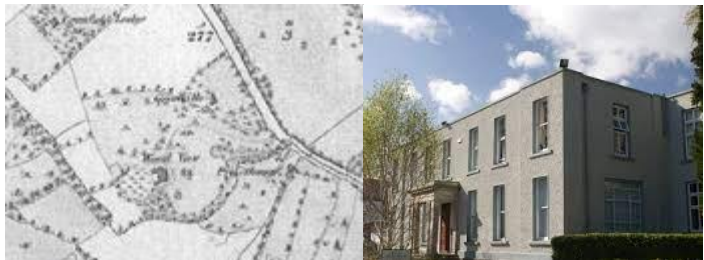
Identification No.	NIAH 2432
Additional Identifiers	DLR RPS 9
Legal Status	Protected Structure
Location	Woodview House University College Dublin, Belfield, Stillorgan Road
Date of Construction	Circa 1820. Extant 1837
Description	House and landscaped grounds shown on the 1837 OS map. originally approached by a long tree lined avenue and gate lodge opposite to what is now Nutley Park. Set in a parkland with ornamental streams, footbridge and a large hexagonal walled garden to the southwest with outline still visible on map of 1938. Some demesne features such as the House, and walks have been retained within the university campus
Significance Rating	Regional
Categories of Special Interest	Architectural, Artistic, Historical, Social
Sensitivity	Medium
Sources	DLR 2022, NIAH 2020b, IAA 2020, Archiseek 2020a, Lewis, 1837, Ball 1903, Joyce 1913, Price 1942, Hone Craig and Fewer 2002, Bennett 2005, Bence Jones 1988, Dean 2016, Williams 1994, Kelly 1996, Galavan 2017, Daly et al.1998, Corlett 1999, Pearson 1998, OSI 1837 to 1843, OSI 1847, OSI 1864, OSI 1877, OSI 1889-90, OSI 1908 to 1911, OSI 1940 to 1944, Field Survey

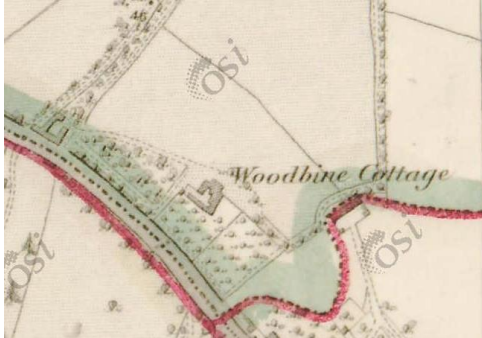
Identification No.	Record only
	CBC0013BTH228
Legal Status	Not protected
Location	Woodbine Cottage
Date of Construction	Extant 1837
Description	House and landscaped grounds including a drive and turning circle are shown on the 1837 OS map. All since demolished except some remnants of the boundary wall (CBC0013BTH228) and the name, which is retained as a local placename
Significance Rating	Record only
Categories of Special Interest	Historical
Sensitivity	Negligible Sensitivity
Sources	DLR 2022, NIAH 2020b, IAA 2020, Archiseek 2020a, Lewis, 1837, Ball 1903, Joyce 1913, Price 1942, Hone Craig and Fewer 2002, Bennett 2005, Bence Jones 1988, Dean 2016, Williams 1994, Kelly 1996, Galavan 2017, Daly et al.1998, Corlett 1999, Pearson 1998, OSI 1837 to 1843, OSI 1847, OSI 1864, OSI 1877, OSI 1889-90, OSI 1908 to 1911, OSI 1940 to 1944, Field Survey
Photographs

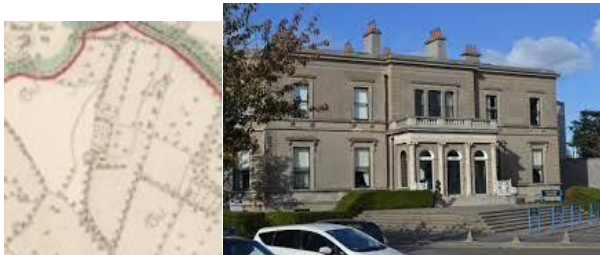
Identification No.	DLR RPS 19
Legal Status	Protected Structure
Location	Ardmore, University College Dublin, Stillorgan Road
Date of Construction	Circa 1806. Extant 1837
Description	Also known as Belview. House and landscaped grounds shown on the 1837 OS map. It had a gate lodge, and stables which went on fire in 1897. Some demesne features such as the House have been retained within the university campus
Significance Rating	Regional
Categories of Special Interest	Architectural, Artistic, Historical, Social
Sensitivity	Medium
Sources	DLR 2022, NIAH 2020b, IAA 2020, Archiseek 2020a, Lewis, 1837, Ball 1903, Joyce 1913, Price 1942, Hone Craig and Fewer 2002, Bennett 2005, Bence Jones 1988, Dean 2016, Williams 1994, Kelly 1996, Galavan 2017, Daly et al. 1998, Corlett 1999, Pearson 1998, OSI 1837 to 1843, OSI 1847, OSI 1864, OSI 1877, OSI 1889-90, OSI 1908 to 1911, OSI 1940 to 1944, Field Survey
Photographs

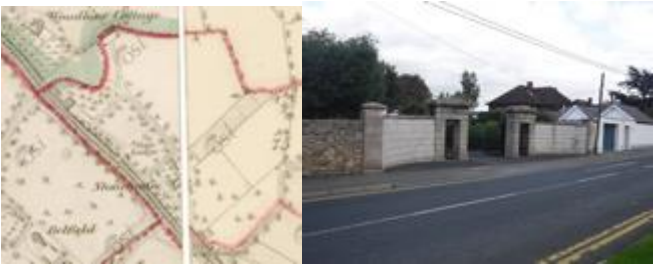
Identification No.	CBC0013BTH101
Legal Status	Not protected
Location	Stonehouse, Stillorgan Road
Date of Construction	19th century, extant 1837
Description	House and landscaped grounds. House has since been demolished and grounds redeveloped with housing. Lodge and entrance gates survive
Significance Rating	Local
Categories of Special Interest	Historical
Sensitivity	Low
Sources	IAA 2020, Archiseek 2020a, Lewis, 1837, Ball 1903, Joyce 1913, Price 1942, Hone Craig and Fewer 2002, Bennett 2005, Bence Jones 1988, Dean 2016, Williams 1994, Kelly 1996, Galavan 2017, Daly et al. 1998, Corlett 1999, Pearson 1998, OSI 1837 to 1843, OSI 1847, OSI 1864, OSI 1877, OSI 1889-90, OSI 1908 to 1911, OSI 1940 to 1944, Field Survey
Photographs

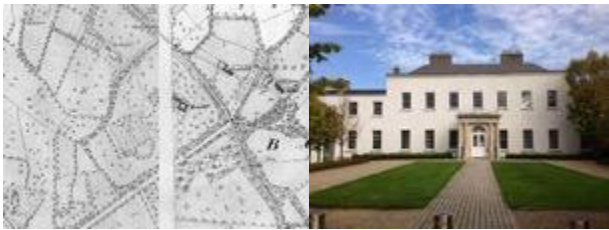
Identification No.	NIAH 2444
Additional Identifiers	DLR RPS 94
Legal Status	Protected Structure
Location	Merville House University College Dublin, Stillorgan Road, Belfield
Date of Construction	Circa 1770. Extant 1837
Description	House and landscaped grounds shown on the 1837 OS map. The gardens contained an old Mulberry tree in 1908, thought to be one of only 4 in the locality. It also had some specimen Banksia roses. Some demesne features such as the House, Stable Yard, Entrance Gate and Piers have been retained within the university campus
Significance Rating	Regional
Categories of Special Interest	Architectural, Artistic, Historical, Social
Sensitivity	Medium
Sources	DLR 2022, NIAH 2020b, IAA 2020, Archiseek 2020a, Lewis, 1837, Ball 1903, Joyce 1913, Price 1942, Hone Craig and Fewer 2002, Bennett 2005, Bence Jones 1988, Dean 2016, Williams 1994, Kelly 1996, Galavan 2017, Daly et al. 1998, Corlett 1999, Pearson 1998, Rocque, 1760, Taylor & Skinner 1777, Taylor 1816, Duncan 1821, OSI 1837 to 1843, OSI 1847, OSI 1864, OSI 1877, OSI 1889-90, OSI 1908 to 1911, OSI 1940 to 1944, Field Survey

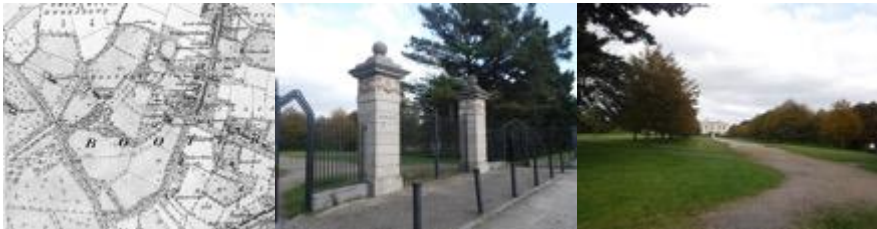
Identification No.	NIAH 2460
Additional Identifiers	RMP DU023-067 DLR RPS 89
Legal Status	Protected Structure
Location	St Helens, Stillorgan Rd
Date of Construction	1750
Description	House in a designed landscape. It had four gate lodges, one of which was opposite St Thomas's Church and another which as on Booterstown Avenue. The garden is thought to have been originally designed by Nivian Nevin (the Victorian age landscaper).The 1st Viscount Gough renamed the House St Helen's during his tenure and employed John McCurdy to makes extensive alterations and additions. A beech tree planted in the garden had a circular iron seat which was slowly subsumed by the tree. The garden also contained one of the few old Mulberry trees in the locality. Site has been partially covered by residential development but the House and entrance gates along with the remaining parkland to the west survive
Significance Rating	Regional

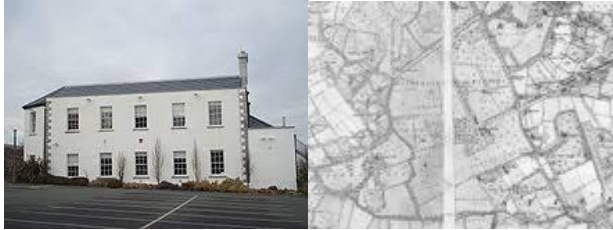
Identification No.	NIAH 2451
Additional Identifiers	DLR RPS 598
Legal Status	Protected Structure
Location	Mount Merrion House North Avenue, Mount Merrion, Co. Dublin
Date of Construction	House built 1710.
Description	Mount Merrion Lodge was built circa 1711 by Richard Fitzwilliam. The demesne consisted of about 300 acres. It was surrounded by an eight foot high granite wall, parts of which still survive particularly on the Lower Kilmacud Road. Being built on what was then known as Owenstown Hill it had a beautiful aspect was considered to be one of the best situated houses in Dublin with its unrivalled views of Dublin Bay and the Wicklow Mountains. The main house was converted to use as a chapel in the 1930's and little of the 1767 house survived. Much of the site is covered by residential development. With just a house, now a community centre, and avenue remaining as greenspace between the housing.

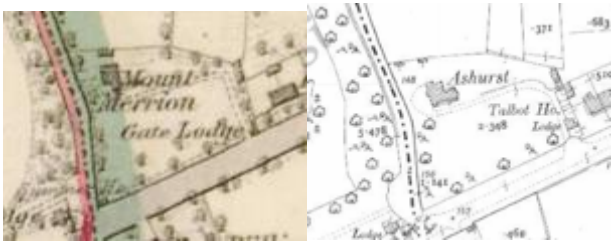
Identification No.	Record only
Legal Status	Not protected
Location	Ash Hurst Mount Merrion Stillorgan Rd
Date of Construction	Extant 1837
Description	Shown on the 1837 OS map as consisting of a house then known as Mount Merrion and out buildings within ground ds with a gate lodge. Renamed Ashurst c 1911. All since demolished. Name survives locally
Significance Rating	Record only
Categories of Special Interest	Historical
Sensitivity	Negligible Sensitivity
Sources	IAA 2020, Archiseek 2020a, Lewis, 1837, Ball 1903, Joyce 1913, Price 1942, Hone Craig and Fewer 2002, Bennett 2005, Bence Jones 1988, Dean 2016, Williams 1994, Kelly 1996, Galavan 2017, Daly et al.1998, Corlett 1999, Pearson 1998, OSI 1837 to 1843, OSI 1847, OSI 1864, OSI 1877, OSI 1889-90, OSI 1908 to 1911, OSI 1940 to 1944, Field Survey
Photographs

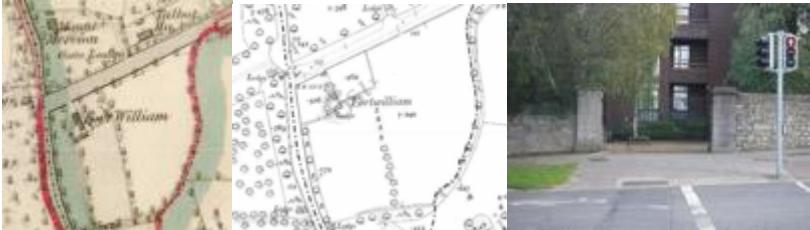
<p>Image Credit: The Ordnance Survey of Ireland 1843 and 1911</p>

Identification No.	CBC0013BTH230
Legal Status	Not protected
Location	Fort William Mount Merrion Stillorgan Rd
Date of Construction	Extant 1837
Description	Shown on the 1837 OS map as consisting of a house and a large complex of attached out buildings within a park with avenues and a gate lodge. Only the entrance gates remain
Significance Rating	Local
Categories of Special Interest	Historical
Sensitivity	Low Sensitivity
Sources	IAA 2020, Archiseek 2020a, Lewis, 1837, Ball 1903, Joyce 1913, Price 1942, Hone Craig and Fewer 2002, Bennett 2005, Bence Jones 1988, Dean 2016, Williams 1994, Kelly 1996, Galavan 2017, Daly et al.1998, Corlett 1999, Pearson 1998, OSI 1837 to 1843, OSI 1847, OSI 1864, OSI 1877, OSI 1889-90, OSI 1908 to 1911, OSI 1940 to 1944, Field Survey
Photographs

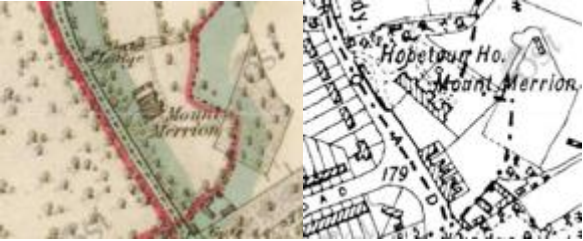
<p>Image Credit: The Ordnance Survey of Ireland 1843 and 1943</p>

Identification No.	Record only
Legal Status	Not protected
Location	Hopetoun House / Mount Merrion House, Stillorgan Rd
Date of Construction	Extant 1837
Description	Shown on the 1837 OS map as consisting of a house and a large complex of attached out buildings within a park with avenues and a gate lodge. All since demolished. Virtually no recognizable features.
Significance Rating	Record only
Categories of Special Interest	Historical
Sensitivity	Negligible Sensitivity
Sources	IAA 2020, Archiseek 2020a, Lewis, 1837, Ball 1903, Joyce 1913, Price 1942, Hone Craig and Fewer 2002, Bennett 2005, Bence Jones 1988, Dean 2016, Williams 1994, Kelly 1996, Galavan 2017, Daly et al.1998,Corlett 1999, Pearson 1998, OSI 1837 to 1843, OSI 1847, OSI 1864, OSI 1877, OSI 1889-90, OSI 1908 to 1911, OSI 1940 to 1944, Field Survey
Photographs

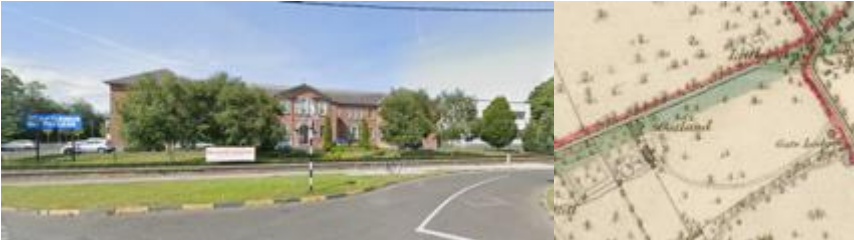
<p>Image Credit: The Ordnance Survey of Ireland 1843.</p>

Identification No.	CBC0013BTH100
Legal Status	Not protected
Location	Oatlands Stillorgan Rd
Date of Construction	Deed dated 1799
Description	Land formerly held by Robert Emmet now in the possession of Thomas Addis Emmet leased to William Fleming for 95 years (Total land 13A 1R 17.5P)" - Deed dated 1799. On Taylors map of 1816 it is shown as a small house called Oatland. It was a five bay, two storey over basement with an Ionic portico. Typically, Georgian with a central Wyatt window above the porch. Oatlands originally had two gate lodges, one is still extant and was for sale in 2015.An Arts & Crafts style lodge with tripartite oriel window and herringbone brick decorative panels. The house itself was described as having 5 bedrooms with a drawing room that led to a greenhouse in 1823 but by 1904 it had seven bedrooms, four drawing rooms plus servants quarters. In 1880 it was sold by the Landed Estate Court and purchased by Matthew Pollock, the tenant. It housed the telescope of John Ross. Although Lady Jane's address is listed at Oatlands up to 1947 the contents of the house were sold in 1937 so she may not have lived in the house after the House and demesne replaced by School of the same name but retains some demesne landscape features such as the grounds and avenue

Significance Rating	Local
Categories of Special Interest	Historical
Sensitivity	Low
Sources	IAA 2020, Archiseek 2020a, Lewis, 1837, Ball 1903, Joyce 1913, Price 1942, Hone Craig and Fewer 2002, Bennett 2005, Bence Jones 1988, Dean 2016, Williams 1994, Kelly 1996, Galavan 2017, Daly et al.1998,Corlett 1999, Pearson 1998, Taylor 1816, Duncan 1821, OSI 1837 to 1843, OSI 1847, OSI 1864, OSI 1877, OSI 1889-90, OSI 1908 to 1911, OSI 1940 to 1944, Field Survey
Photographs

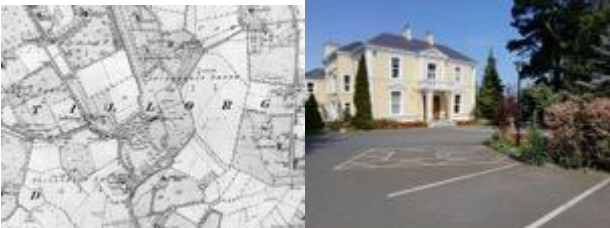
<p style="text-align: center;">Image Credit: The Ordnance Survey of Ireland 1843.</p>

Identification No.	NIAH 2483
Additional Identifiers	RMP DU023-012001 DLR RPS 1058
Legal Status	Recorded Monument and Protected Structure
Location	Stillorgan House / Park House (Polio Fellowship of Ireland) Training Centre, Stillorgan Grove, Stillorgan, Co. Dublin.
Date of Construction	Original House built 1695, new house built on site in 1887/8.
Description	Site marked as 'Stillorgan House' the site may mark the location of the original manor house, or main residence of the lord of the manor, which by 1360 was occupied by Sir John Cruise. The Wolverston family resided here between the dissolution of the monasteries and the Cromwellian period. Stillorgan House is mentioned in the Depositions of 1641. In 1695 the then owner Viscount John Allen replaced the fortified manor house with a large mansion. Demolished c. 1880. And the present 19th century house was built to the north. The estate stretched from Stillorgan village across to Newtownpark Avenue, down to Blackrock, and adjoined the Fitzwilliam estate at Mount Merrion Avenue, encompassing all of what is now Priory Park, Grove Avenue, Avoca Avenue, Stillorgan Grove and Carysfort Avenue. The soft water stream ran for two miles through the demesne and a grove of lime trees (also known as lindens) is shown on a map of the Allen estate dating from the 18 th century. A grotto and an obelisk were once part of the demesne, they were designed by Edward Lovett Pearce and are extant. In 1778 the park was closed by Lord Carysfort, citing damage done by trespassers and going forward a ticket would be required to access the park. Between 1777 and 1779, some 70 acres were sold off as building plots by Lord Carysfort. It had two lodges originally and a third lodge was added circa 1880 at Ulster Terrace. None of these survives completely covered by residential development. Present 19 th century house completely surrounded by residential development.

Significance Rating	Regional
Categories of Special Interest	Architectural, Archaeological, Artistic, Historical
Sensitivity	Medium
Sources	Dúchas 1995, Dúchas 1998, NMS 2020a and 2020b, DLR 2022, NIAH 2020b, IAA 2020, Archiseek 2020a, Lewis, 1837, Ball 1903, Joyce 1913, Price 1942, Hone Craig and Fewer 2002, Bennett 2005, Bence Jones 1988, Dean 2016, Williams 1994, Kelly 1996, Galavan 2017, Daly et al. 1998, Corlett 1999, Pearson 1998, Speed 1610, Down Survey 1656-1658, Rocque 1760, Taylor & Skinner 1777, Taylor 1816, Duncan 1821, OSI 1837 to 1844, OSI 1847, OSI 1864, OSI 1876, OSI 1882, 1889 to 1892, OSI 1907 to 1911 and OSI 1937 to 1953, Field Survey
Photographs

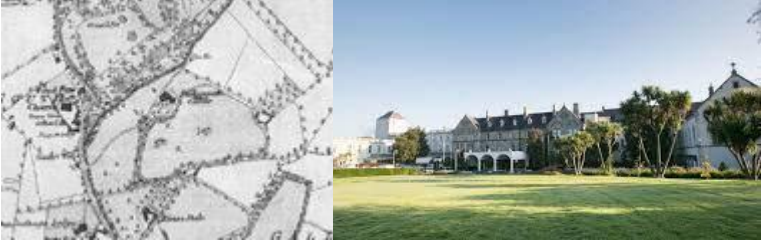
<p style="text-align: center;">Image Credit: The Ordnance Survey of Ireland 1843.</p>

Identification No.	NIAH 2485
Additional Identifiers	RMP DU023-071
Legal Status	Recorded Monument
Location	Stillorgan Castle / St John Of Gods, Stillorgan Rd
Date of Construction	Landscape extant 1837
Description	A castle is depicted on the 1837 OS and labelled 'Stillorgan Castle'. In 1836 it was to let or the interest in the lease sold on 20 acres. Present buildings are 19th century gothic institutional buildings of granite construction. Demesne landscape survives as part of the St John Of God Complex
Significance Rating	Regional
Categories of Special Interest	Architectural, Archaeological, Artistic, Historical, Social
Sensitivity	Medium
Sources	Dúchas 1995, Dúchas 1998, NMS 2020a and 2020b, DLR 2022, NIAH 2020b, IAA 2020, Archiseek 2020a, Lewis, 1837, Ball 1903, Joyce 1913, Price 1942, Hone Craig and Fewer 2002, Bennett 2005, Bence Jones 1988, Dean 2016, Williams 1994, Kelly 1996, Galavan 2017, Daly et al.1998,Corlett 1999, Pearson 1998, Speed 1610, Down Survey 1656-1658,Rocque 1760,Taylor & Skinner 1777, Taylor 1816, Duncan 1821,OSI 1837 to 1844, OSI 1847, OSI 1864, OSI 1876, OSI 1882, 1889 to 1892, OSI 1907 to 1911 and OSI 1937 to 1953, Field Survey

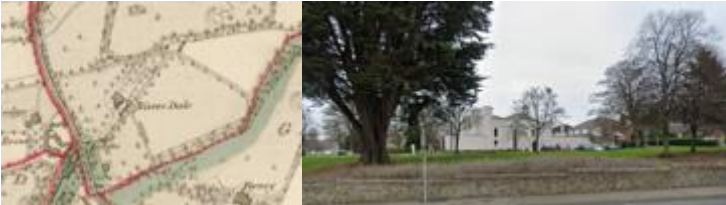
<p style="text-align: center;">Image Credit: The Ordnance Survey of Ireland 1843.</p>

Identification No.	DLR RPS 1420
Legal Status	Protected Structure
Location	Granada House, St John Of Gods, Stillorgan Rd
Date of Construction	Circa 1778
Description	House and demesne. Formerly Riversdale. It 1920 it was set on 14.5 acres. It was also noted that it had a new entrance with a gate lodge. Demesne landscape survives as part of the St John Of God Complex
Significance Rating	Regional
Categories of Special Interest	Architectural, Artistic, Historical
Sensitivity	Medium
Sources	DLR 2022, NIAH 2020b, IAA 2020, Archiseek 2020a, Lewis, 1837, Ball 1903, Joyce 1913, Price 1942, Hone Craig and Fewer 2002, Bennett 2005, Bence Jones 1988, Dean 2016, Williams 1994, Kelly 1996, Galavan 2017, Daly et al.1998,Corlett 1999, Pearson 1998, Taylor & Skinner 1777, Taylor 1816, Duncan 1821,OSI 1837 to 1844, OSI 1847, OSI 1864, OSI 1876, OSI 1882, 1889 to 1892, OSI 1907 to 1911 and OSI 1937 to 1953, Field Survey

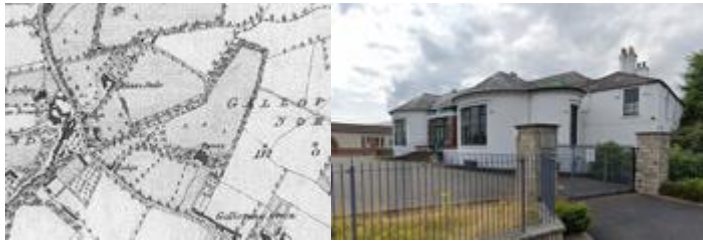
<p>Image Credit: The Ordnance Survey of Ireland 1843.</p>

Identification No.	NIAH 2489
Additional Identifiers	DLR RPS 2098
Legal Status	Protected Structure
Location	Beech Park / Ferney, Kill, Co. Dublin
Date of Construction	Circa 1790
Description	Single-storey over basement Georgian villa and two storey to the rear. Deceptively large, it has double bow projections to front and rear and original Wyatt windows. The hood moulds above each window are like graceful eyebrows and the bow projections with their conical slated roofs are most unusual. The coach house and stables were destroyed in a fire in 1866. In 1937 the name of the house was changed to Beech Park. Ferney, later Setanta School/Beech Park House is landlocked in the middle of Beechwood Court Estate. It still retains many beautiful trees including some Monterey Cypress. Demesne features such as a house, lodge, and landscaping. Building indicated labelled School. Complex of large buildings built around the site of the principal building. Now in use as a convent

Significance Rating	Regional
Categories of Special Interest	Architectural, Historical
Sensitivity	Medium
Sources	DLR 2022 NIAH 2020b, Lewis, 1837, Ball 1903, Joyce 1913, Price 1942, Hone Craig and Fewer 2002, Bennett 2005, Bence Jones 1988, Dean 2016, Williams 1994, Kelly 1996, Galavan 2017, Daly et al.1998,Corlett 1999, Pearson 1998, Speed 1610, Down Survey 1656-1658,Rocque 1760,Taylor & Skinner 1777, Taylor 1816, Duncan 1821, OSI 1837 to 1843, OSI 1847, OSI 1864, OSI 1877, OSI 1889-90, OSI 1908 to 1911, OSI 1940 to 1944, Field Survey
Photographs

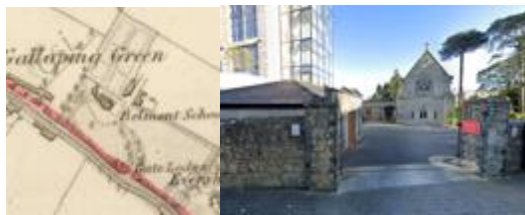
<p>Image Credit: The Ordnance Survey of Ireland 1843.</p>

Identification No.	DLR RPS 1451
Legal Status	Protected Structure
Location	Belmont House, Galloping Green, Blackrock, Co. Dublin.
Date of Construction	Circa 1790
Description	Consisting of a house and a large complex of attached out buildings within a park with avenues and a gate lodge. Only the House, chapel and entrance gates survive. Grounds redeveloped as a nursing home.
Significance Rating	Regional
Categories of Special Interest	Architectural, Artistic, Historical, Social
Sensitivity	Medium
Sources	DLR 2022, NIAH 2020b, IAA 2020, Archiseek 2020a, Lewis, 1837, Ball 1903, Joyce 1913, Price 1942, Hone Craig and Fewer 2002, Bennett 2005, Bence Jones 1988, Dean 2016, Williams 1994, Kelly 1996, Galavan 2017, Daly et al.1998, Corlett 1999, Pearson 1998, Taylor & Skinner 1777, Taylor 1816, Duncan 1821, OSI 1837 to 1843, OSI 1847, OSI 1864, OSI 1877, OSI 1889-90, OSI 1908 to 1911, OSI 1940 to 1944, Field Survey

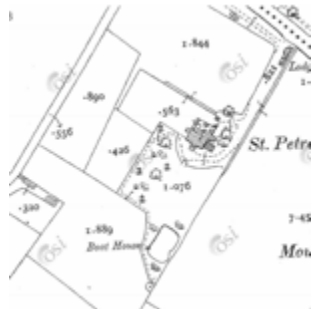
<p>Image Credit: The Ordnance Survey of Ireland 1911.</p>

Identification No.	Record only
Legal Status	Not protected
Location	St Petroc, Stillorgan Rd
Date of Construction	Built circa 1860. Shown on the 1911 OS map
Description	Plain house with gate lodge for Charles Fox Godwin. Consisting of a house out buildings within a park with avenue and a gate lodge. The name was changed to St Petroc circa 1888. In 1939 a CPO was issued to widen the road and some of the grounds were lost. All since demolished.
Significance Rating	Record only
Categories of Special Interest	Historical
Sensitivity	Negligible Sensitivity
Sources	DLR 2022, NIAH 2020b, IAA 2020, Archiseek 2020a, Lewis, 1837, Ball 1903, Joyce 1913, Price 1942, Hone Craig and Fewer 2002, Bennett 2005, Bence Jones 1988, Dean 2016, Williams 1994, Kelly 1996, Galavan 2017, Daly et al.1998, Corlett 1999, Pearson 1998, OSI 1908 to 1911, OSI 1940 to 1944, Field Survey
Photographs

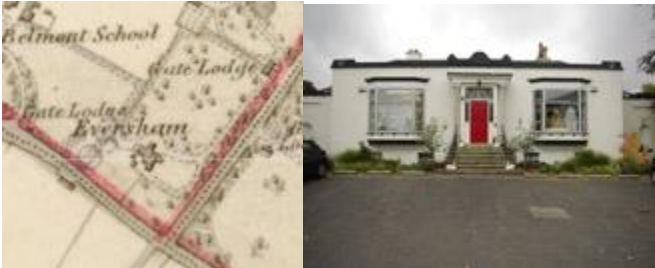
<p style="text-align: center;">Image Credit: The Ordnance Survey of Ireland 1843.</p>

Identification No.	DLR RPS 2005
Additional Identifiers	NIAH 60230074
Legal Status	Protected
Location	Eversham / Disciples Of The Divine Master Liturgical Centre, Stillorgan Rd
Date of Construction	Extant 1837
Description	Eversham House, erected by William Minchin Shown on the 1843 OS map as consisting of a house out buildings within a park with avenues and a gate lodge. In Use as a convent. Landscape reduced and has been relandscaped
Significance Rating	Regional
Categories of Special Interest	Architectural, Artistic, Historical, Social
Sensitivity	Medium
Sources	DLR 2022, NIAH 2020a, IAA 2020, Archiseek 2020a, Lewis, 1837, Ball 1903, Joyce 1913, Price 1942, Hone Craig and Fewer 2002, Bennett 2005, Bence Jones 1988, Dean 2016, Williams 1994, Kelly 1996, Galavan 2017, Daly et al.1998,Corlett 1999, Pearson 1998, OSI 1837 to 1843, OSI 1847, OSI 1864, OSI 1877, OSI 1889-90, OSI 1908 to 1911, OSI 1940 to 1944, Field Survey

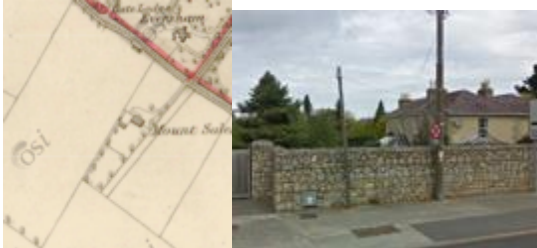
<p style="text-align: center;">Image Credit: The Ordnance Survey of Ireland 1843.</p>

Identification No.	DLR RPS 1496
Additional Identifiers	NIAH 60230014
Legal Status	Protected Structure
Location	Mount Salem Stillorgan Rd
Date of Construction	House extant 1837
Description	Shown on the 1837 to 43 OS map as consisting of a house out buildings within a park with avenues and a gate lodge. Originally on 3 acres, it was for sale on 1.5 acres in 1953, some of the original land, including the paddock was hived off for other developments including a house called White Cross. The coach house has been converted to a mews. Originally the entrance was from the Dublin road but after a CPO for road widening, the entrance is now from Leopardstown Road. In 2019 the site was split and the portion with the main house offered for sale
Significance Rating	Regional
Categories of Special Interest	Architectural, Artistic, Historical, Social
Sensitivity	Medium
Sources	DLR 2022, NIAH 2020a, IAA 2020, Archiseek 2020a, Lewis, 1837, Ball 1903, Joyce 1913, Price 1942, Hone Craig and Fewer 2002, Bennett 2005, Bence Jones 1988, Dean 2016, Williams 1994, Kelly 1996, Galavan 2017, Daly et al.1998,Corlett 1999, Pearson 1998, Speed 1610, Down Survey 1656-1658,Rocque 1760,Taylor & Skinner 1777, Taylor 1816, Duncan 1821, OSI 1837 to 1843, OSI 1847, OSI 1864, OSI 1877, OSI 1889-90, OSI 1908 to 1911, OSI 1940 to 1944, Field Survey

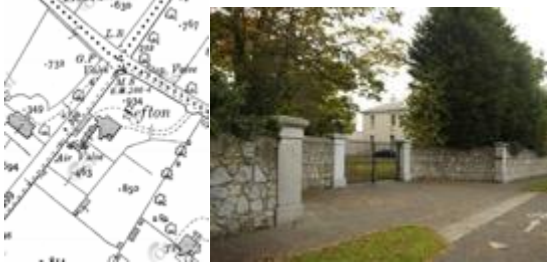
<p>Image Credit: The Ordnance Survey of Ireland 1911</p>

Identification No.	DLR RPS 1498
Additional Identifiers	NIAH 60230065
Legal Status	Protected Structure
Location	Sefton House, Stillorgan Rd
Date of Construction	Circa 1860
Description	Shown on the 1911 OS map as consisting of a house out buildings within a park with avenues and a gate lodge. It had a coach house and by 1922 had tennis courts. It was for sale on 1 acre in 1967. Although the original gates with their cut granite piers are still in situ on the Bray Road, access is via the Kelston Estate on Leopardstown Road.
Significance Rating	Regional
Categories of Special Interest	Architectural, Artistic, Historical, Social
Sensitivity	Medium
Sources	DLR 2022, NIAH 2020a, IAA 2020, Archiseek 2020a, Lewis, 1837, Ball 1903, Joyce 1913, Price 1942, Hone Craig and Fewer 2002, Bennett 2005, Bence Jones 1988, Dean 2016, Williams 1994, Kelly 1996, Galavan 2017, Daly et al.1998, Corlett 1999, Pearson 1998 OSI 1908 to 1911, OSI 1940 to 1944, Field Survey

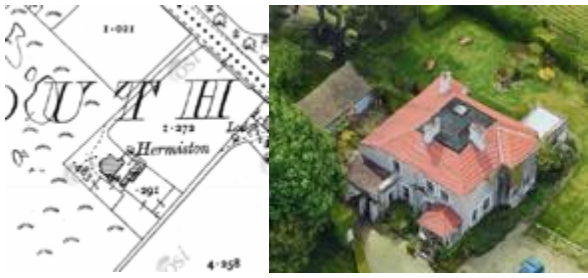
<p>Image Credit: The Ordnance Survey of Ireland 1911.</p>

Identification No.	DLR RPS 2041
Additional Identifiers	NIAH 60230063
Legal Status	Protected Structure recognised by the NIAH
Location	Hermiston, Stillorgan Rd
Date of Construction	Extant 1911
Description	House extant 1911. House retains its grounds and outbuildings including kitchen gardens
Significance Rating	Regional
Categories of Special Interest	Architectural, Artistic, Historical, Social
Sensitivity	Medium
Sources	DLR 2022, NIAH 2020a, IAA 2020, Archiseek 2020a, Lewis, 1837, Ball 1903, Joyce 1913, Price 1942, Hone Craig and Fewer 2002, Bennett 2005, Bence Jones 1988, Dean 2016, Williams 1994, Kelly 1996, Galavan 2017, Daly et al. 1998, Corlett 1999, Pearson 1998, OSI 1908 to 1911, OSI 1940 to 1944, Field Survey
Photographs

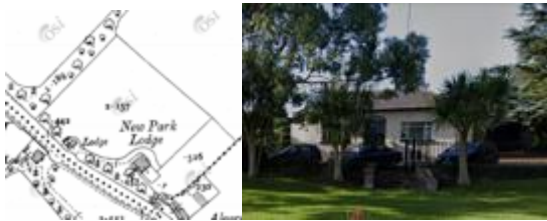
<p>Image Credit: The Ordnance Survey of Ireland 1911.</p>

Identification No.	NIAH 60230058
Legal Status	Not protected
Location	Newpark Lodge, Stillorgan Road
Date of Construction	Circa 1860
Description	Three bay single storey over raised basement double fronted villa with gate lodge It retains its grounds to the front but has lost some to the N11 to the west
Significance Rating	Local Importance
Categories of Special Interest	Architectural, Historical
Sensitivity	Low
Sources	NIAH 2020a, IAA 2020, Archiseek 2020a, Lewis, 1837, Ball 1903, Joyce 1913, Price 1942, Hone Craig and Fewer 2002, Bennett 2005, Bence Jones 1988, Dean 2016, Williams 1994, Kelly 1996, Galavan 2017, Daly et al. 1998, Corlett 1999, Pearson 1998, OSI 1908 to 1911, OSI 1940 to 1944, Field Survey,
Photographs

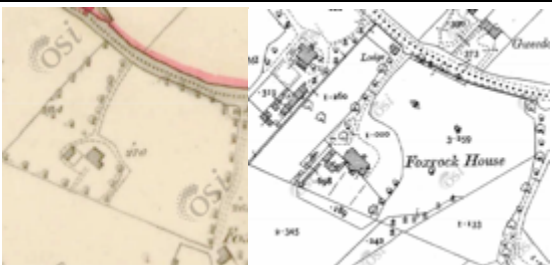
<p>Image Credit: The Ordnance Survey of Ireland 1843 and 1911.</p>

Identification No.	CBC0013BTH084
Legal Status	Not protected
Location	Foxrock House Stillorgan Rd
Date of Construction	Shown on the 1837 OS map as
Original Use	House and grounds.
Description	Consisting of a house and a large complex of attached out buildings within a park with avenues and a gate lodge. All since demolished. Site completely covered by residential development. Virtually no recognizable features. Site completely covered by residential development. No longer evident as housing built on site.
Significance Rating	Record only
Categories of Special Interest	Historical
Sensitivity	Negligible Sensitivity
Sources	AA 2020, Archiseek 2020a, Lewis, 1837, Ball 1903, Joyce 1913, Price 1942, Hone Craig and Fewer 2002, Bennett 2005, Bence Jones 1988, Dean 2016, Williams 1994, Kelly 1996, Galavan 2017, Daly et al.1998,Corlett 1999, Pearson 1998,OSI 1837 to 1843, OSI 1847, OSI 1864, OSI 1877, OSI 1889-90, OSI 1908 to 1911, OSI 1940 to 1944, Field Survey

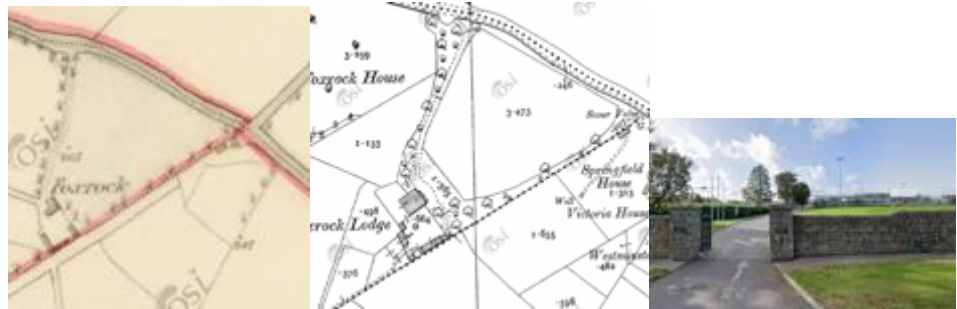
<p>Image Credit: The Ordnance Survey of Ireland 1843 and 1911.</p>

Identification No.	CBC0013BTH083
Legal Status	Not protected
Location	Foxrock Lodge Stillorgan Rd
Date of Construction	Shown on the 1837 OS map as
Original Use	House and grounds.
Description	Consisting of a house and a large complex of attached out buildings within a park with avenues and a gate lodge. Incorporated in to the present school. Some demesne features such as the house and avenues survive within the school grounds
Significance Rating	Regional
Categories of Special Interest	Architectural, Historical
Sensitivity	Medium
Sources	AA 2020, Archiseek 2020a, Lewis, 1837, Ball 1903, Joyce 1913, Price 1942, Hone Craig and Fewer 2002, Bennett 2005, Bence Jones 1988, Dean 2016, Williams 1994, Kelly 1996, Galavan 2017, Daly et al.1998,Corlett 1999, Pearson 1998,OSI 1837 to 1843, OSI 1847, OSI 1864, OSI 1877, OSI 1889-90, OSI 1908 to 1911, OSI 1940 to 1944, Field Survey
Photographs
