Appendix A16.1-A16.4
Architectural Heritage
Appendices

Appendix A16.4: Photographic Survey of Woodbrook Side Lodge	306
1. Introduction.....	306
2. Woodbrook Side Lodge	306
2.1 Exterior	306
2.2 Interior	309
1.1 Vehicular Gate.....	310
1.2 Pedestrian Gate.....	311
1.3 Boundary Wall	312
1.4 Grounds.....	312
References	314

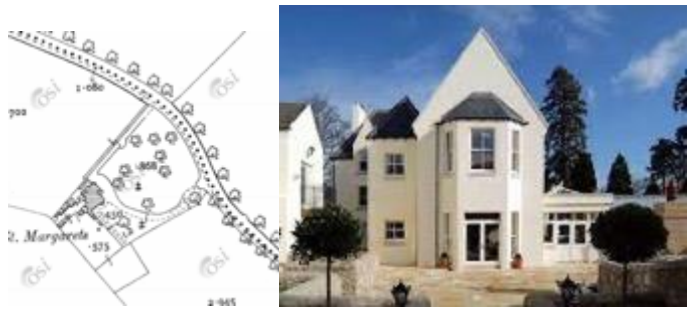
<p>Image Credit: The Ordnance Survey of Ireland 1911.</p>

Identification No.	DLR RPS 1621
Additional Identifiers	NIAH 60230059
Legal Status	Protected Structure
Location	Cornelscourt House, Stillorgan Rd / Old Bray Rd
Date of Construction	Extant 1866
Description	Also known as St Margaret's. Set in relandscaped grounds with rendered channelled piers to perimeter having ball finial-topped shallow pyramidal capping supporting crocketed cast-iron double gates
Significance Rating	Regional
Categories of Special Interest	Architectural, Artistic, Historical, Social
Sensitivity	Medium
Sources	DLR 2022, NIAH 2020a, IAA 2020, Archiseek 2020a, Lewis, 1837, Ball 1903, Joyce 1913, Price 1942, Hone Craig and Fewer 2002, Bennett 2005, Bence Jones 1988, Dean 2016, Williams 1994, Kelly 1996, Galavan 2017, Daly et al.1998,Corlett 1999, Pearson 1998, OSI 1908 to 1911, OSI 1940 to 1944, Field Survey
Photographs

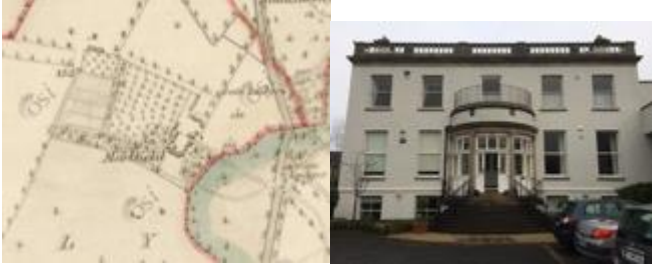
<p style="text-align: center;">Image Credit: The Ordnance Survey of Ireland 1843</p>

Identification No.	NIAH 2530
Additional Identifiers	DLR RPS 1654 NIAH 60230141
Legal Status	Protected Structure
Location	Marfield / Saint Gabriel's Hospital Kill, Co. Dublin
Date of Construction	Country house built 1794
Description	Demesne reduced and much of site covered by residential development. Set in relandscaped grounds.
Significance Rating	Regional
Categories of Special Interest	Architectural, Artistic, Historical, Social
Sensitivity	Medium
Sources	DLR 2022, NIAH 2020a and 2020b, IAA 2020, Archiseek 2020a, Lewis, 1837, Ball 1903, Joyce 1913, Price 1942, Hone Craig and Fewer 2002, Bennett 2005, Bence Jones 1988, Dean 2016, Williams 1994, Kelly 1996, Galavan 2017, Daly et al.1998,Corlett 1999, Pearson 1998 Taylor 1816, Duncan 1821, OSI 1837 to 1843, OSI 1847, OSI 1864, OSI 1877, OSI 1889-90, OSI 1908 to 1911, OSI 1940 to 1944, Field Survey
Photographs

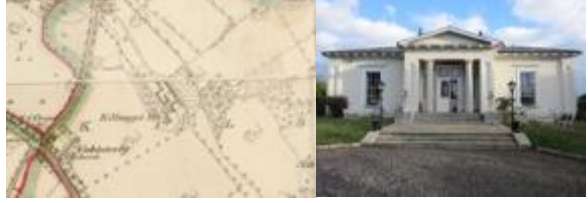
<p style="text-align: center;">Image Credit: The Ordnance Survey of Ireland 1843</p>

Identification No.	NIAH 2536
Additional Identifiers	DLR RPS 1671 NIAH 60260247
Legal Status	Protected Structure
Location	Kilbogget House Shrewsbury Wood, Cabinteely, Dublin 18
Date of Construction	House extant 1837
Description	Originally set in landscaped grounds. Much of the site is covered by residential and institutional development.
Significance Rating	Regional
Categories of Special Interest	Architectural, Artistic, Historical, Social
Sensitivity	Medium
Sources	DLR 2022, NIAH 2020a and 2020b, IAA 2020, Archiseek 2020a, Lewis, 1837, Ball 1903, Joyce 1913, Price 1942, Hone Craig and Fewer 2002, Bennett 2005, Bence Jones 1988, Dean 2016, Williams 1994, Kelly 1996, Galavan 2017, Daly et al.1998,Corlett 1999, Pearson 1998, OSI 1837 to 1843, OSI 1847, OSI 1864, OSI 1877, OSI 1889-90, OSI 1908 to 1911, OSI 1940 to 1944, Field Survey
Photographs

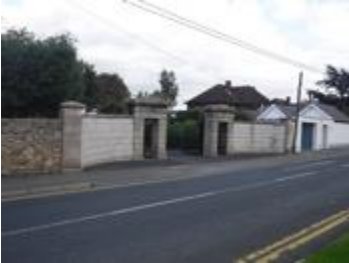
Identification No.	CBC0013BTH102
Location	Stonehouse Gate Piers
Legal Status	Not Protected
Date of Construction	19th century, extant 1837
Original Use	Granite gate piers
Description	Granite gate piers and lintels to since demolished house. House and landscaped grounds. Site redeveloped with housing. The associated landscape is assessed in Section 2.5.
Significance Rating	Regional
Categories of Special Interest	Historical, Architectural, Artistic
Sensitivity	Medium
Sources	IAA 2020, Archiseek 2020a, Lewis, 1837, Ball 1903, Joyce 1913, Price 1942, Hone Craig and Fewer 2002, Bennett 2005, Bence Jones 1988, Dean 2016, Williams 1994, Kelly 1996, Galavan 2017, Daly et al.1998,Corlett 1999, Pearson 1998, OSI 1837 to 1843, OSI 1847, OSI 1864, OSI 1877, OSI 1889-90, OSI 1908 to 1911, OSI 1940 to 1944, Field Survey
Photographs

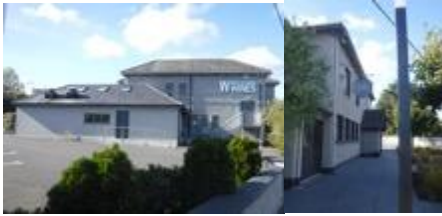
Identification No.	CBC0013BTH075
Location	The Silver Tassie
Legal Status	Not Protected
Date of Construction	Early 19th century
Original Use	School house
Description	Formerly Loughlinstown Bridge school house later the Silver Tassie Pub. Early 19th century but much altered, now a commercial premises. Seven bay two story building with a later entrance porch
Significance Rating	Local
Categories of Special Interest	Historical, Architectural, Social, Technical
Sensitivity	Low
Sources	IAA 2020a, Archiseek 2020a, Lewis, 1837, Ball 1903, Joyce 1913, Price 1942, Hone Craig and Fewer 2002, Turner 1983, Corlett 1999, Pearson 1998, Galavan 2017, Daly et al.1998, Taylor 1816, Duncan 1821, OSI 1837 to 1843, OSI 1847, OSI 1864, OSI 1877, OSI 1889-90, OSI 1908 to 1911, OSI 1940 to 1944, Field Survey
Photographs

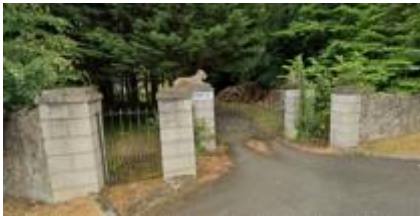
Identification No.	CBC0013BTH069
Location	Lurganbrae House Dublin Road Shankill
Legal Status	Not Protected
Date of Construction	19th century
Original Use	House
Description	Formerly known as New Brighton, House Still extant but largely obscured by trees. Gates visible. Aerial imagery suggests house is a tree bay double fronted house with step leading up to the entrance on the west elevation. Aerial and cartographic records indicate its similar to St. Brendan's (DLR RPS 1795) to the south
Significance Rating	Regional
Categories of Special Interest	Historical, Architectural, Artistic
Sensitivity	Medium
Sources	IAA 2020a, Archiseek 2020a, Lewis, 1837, Ball 1903, Joyce 1913, Price 1942, Hone Craig and Fewer 2002, Turner 1983, Corlett 1999, Pearson 1998, Galavan 2017, Daly et al.1998, Taylor 1816, Duncan 1821, OSI 1837 to 1843, OSI 1847, OSI 1864, OSI 1877, OSI 1889-90, OSI 1908 to 1911, OSI 1940 to 1944, Field Survey

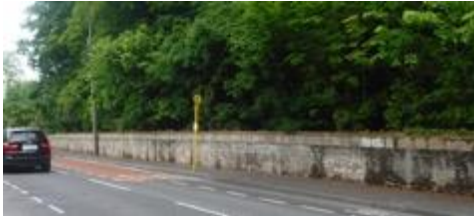
Identification No.	CBC0013BTH067	
Location	Lurganbrae Dublin Road Shankill	
Legal Status	Not Protected	
Date of Construction	19th century	
Original Use	Boundary Wall	
Description	Rendered granite wall with granite and brick cap	
Significance Rating	Regional	
Categories of Special Interest	Historical, Architectural, Artistic	
Sensitivity	Medium	
Sources	IAA 2020a, Archiseek 2020a, Lewis, 1837, Ball 1903, Joyce 1913, Price 1942, Hone Craig and Fewer 2002, Turner 1983, Corlett 1999, Pearson 1998, Galavan 2017, Daly et al.1998,Taylor 1816, Duncan 1821, OSI 1837 to 1843, OSI 1847, OSI 1864, OSI 1877, OSI 1889-90, OSI 1908 to 1911, OSI 1940 to 1944, Field Survey	
Photographs

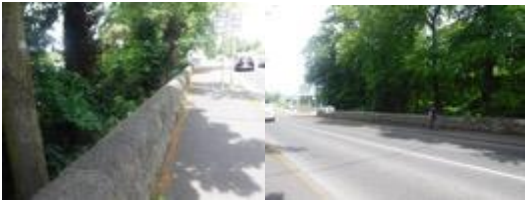
Identification No.	CBC0013BTH060
Location	North Of The Railway Bridge Dublin Road, Shankill
Legal Status	Not Protected
Date of Construction	19th century
Original Use	Boundary walls
Description	Low 19th century coursed granite rubble wall with bevelled granite cap, both sides of the road
Significance Rating	Regional
Categories of Special Interest	Historical, Architectural, Technical
Sensitivity	Medium
Sources	IAA 2020a, Archiseek 2020a, Lewis, 1837, Ball 1903, Joyce 1913, Price 1942, Hone Craig and Fewer 2002, Turner 1983, Corlett 1999, Pearson 1998, Galavan 2017, Daly et al.1998,OSI 1837 to 1843, OSI 1908 to 1911, OSI 1940 to 1944, Field Survey
Photographs

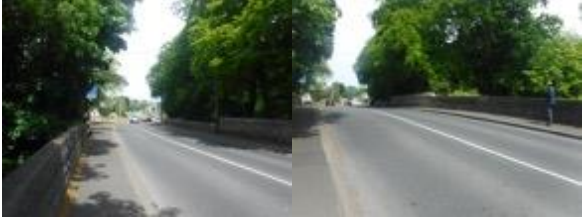
Identification No.	CBC0013BTH059
Location	Dublin Road, Shankill
Legal Status	Not Protected
Date of Construction	C. 1854
Original Use	Bridge
Description	Former railway bridge. The nearby Shankill railway station was opened by the Dublin, Wicklow and Wexford Railway (DW&WR) on 10 July 1854 as part of the Harcourt Street line, initially Dundrum to Bray Walls consist of tooled granite blocks and granite capping
Significance Rating	Regional
Categories of Special Interest	Historical, Architectural, Technical
Sensitivity	Medium
Sources	IAA 2020a, Archiseek 2020a, Lewis, 1837, Ball 1903, Joyce 1913, Price 1942, Hone Craig and Fewer 2002, Turner 1983, Corlett 1999, Pearson 1998, Galavan 2017, Daly et al.1998,OSI 1837 to 1843, OSI 1908 to 1911, OSI 1940 to 1944, Field Survey
Photographs

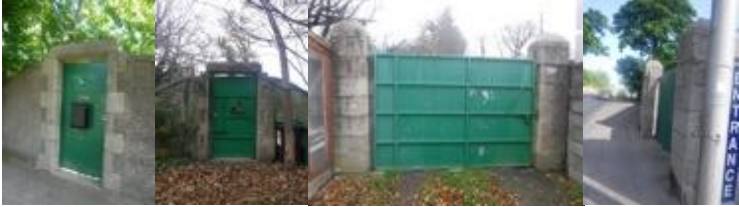
Identification No.	CBC0013BTH021
Location	Pedestrian Gate At Woodbrook Side Lodge
Legal Status	Within the curtilage of a Protected structure (DLR RPS 1874)
Date of Construction	c. 1909
Original Use	Pedestrian and vehicular gate
Description	Dressed granite dressings and lintel to gateway. Granite piers to vehicular entrance The gate has been moved in the past
Significance Rating	Regional
Categories of Special Interest	Historical, Architectural, Artistic
Sensitivity	Medium
Sources	IAA 2020a, Archiseek 2020a, Lewis, 1837, Ball 1903, Joyce 1913, Price 1942, Hone Craig and Fewer 2002, Turner 1983, Corlett 1999, Pearson 1998, Galavan 2017, Daly et al.1998,OSI 1837 to 1843, OSI 1908 to 1911, OSI 1940 to 1944, Field Survey
Photographs

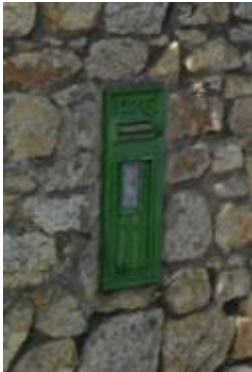
Identification No.	NIAH 60230075	
Additional Identifiers	CBC0013PB005, DLRIHS 1023	
Location	Newtownpark Avenue	
Legal Status	Not Protected	
Date of Construction	Between 1939-62	
Original Use	Post Box	
Description	Wall-mounted cast-iron "wall box" post box, with "P7T [Posts and Telegraphs]" monogram. Now disused. Set in coursed rubble granite boundary wall.	
Significance Rating	Regional Importance	
Categories of Special Interest	Architectural, Artistic, Social, Technical	
Sensitivity	Medium Sensitivity	
Sources	DLR 2022, NIAH 2020a, Dublin Civic Trust 2004, Corlett 1999, Pearson 1998, O'Connell 1975, Ferguson 2009, Field Survey	
Photographs

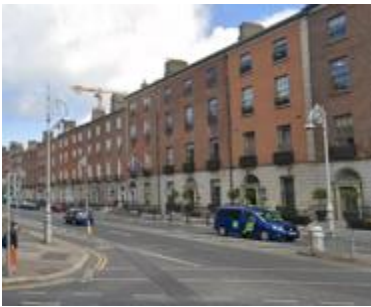
Identification No.	CBC0013LP053 to CBC0013LP051
Location	Fitzwilliam Place
Legal Status	Located within a Conservation Area so protected under Policy BHA9 of the Dublin City Development Plan (DCC 2022)
Date of Construction	Erected c.1903 or 1940s and 1950s
Original Use	Lamp posts
Description	3 No. Scotch Standard, erected c.1903 or 1940s and 1950s
Significance Rating	Regional
Categories of Special Interest	Artistic, Social, Technical
Sensitivity	Medium
Sources	DCC 2022, NIAH 2020a, Dublin Civic Trust 2004, Corcoran 2008, O'Connell 1975 p19, 20 and 25, Field Survey
Photographs

Lamp posts will be repaired and repositioned within the vicinity of its existing position, re-using all of the significant historic fabric and reinstating the fabric and function.

Where it is not possible to repair and reinstate the removed lamp posts, e.g., where the bases are in poor condition and not possible to salvage, the lamps will be replaced with replica historic lamps matching the existing material and detail of the historic lamps that they replace. Though this will constitute a loss of fabric, it is in line with the approach that has been taken by Local Authorities previously.

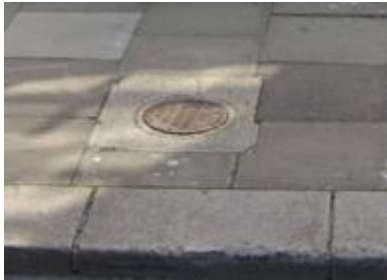
Identification No.	CBC0013BTH206
Location	97 Leeson Street Lower
Legal Status	Within a Conservation Area so protected under Policy BHA9 of the Dublin City Development Plan (DCC 2022)
Date of Construction	C.1800
Original Use	Coal hole
Description	Coal Hole
Significance Rating	Regional Importance
Categories of Special Interest	Historic, Technical, Social
Sensitivity	Medium Sensitivity
Sources	DCC 2022, DAHG 2015, Dublin Civic Trust 2004, OSI 1837 to 1843, OSI 1847, OSI 1864, OSI 1889-90, OSI 1908 to 1911, O'Connell 1975, Field Survey
Photographs

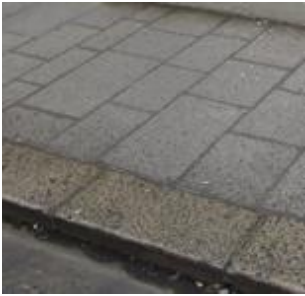
Identification No.	CBC0013BTH184	
Location	North side Pembroke Street Upper	
Legal Status	Within a Conservation Area so protected under Policy BHA9 of the Dublin City Development Plan (DCC 2022)	
Date of Construction	C. 1820	
Original Use	Granite paving	
Description	Granite paving	
Significance Rating	Regional Importance	
Categories of Special Interest	Historic, Technical, Social	
Sensitivity	Medium Sensitivity	
Sources	DCC 2022, DAHG 2015, Dublin Civic Trust 2004, OSI 1837 to 1843, OSI 1847, OSI 1864, OSI 1889-90, OSI 1908 to 1911, O'Connell 1975, Field Survey	
Photographs

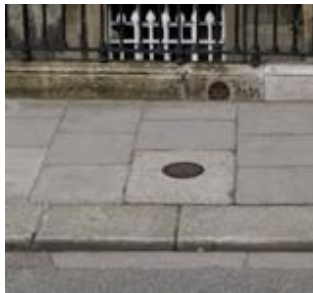
Identification No.	CBC0013BTH176	
Location	36 Leeson Street Lower	
Legal Status	Within a Conservation Area so protected under Policy BHA9 of the Dublin City Development Plan (DCC 2022)	
Date of Construction	C. 1835	
Original Use	Coal hole	
Description	Coal hole	
Significance Rating	Regional Importance	
Categories of Special Interest	Historic, Technical, Social	
Sensitivity	Medium Sensitivity	
Sources	DCC 2022, DAHG 2015, Dublin Civic Trust 2004, OSI 1837 to 1843, OSI 1847, OSI 1864, OSI 1889-90, OSI 1908 to 1911, O'Connell 1975, Field Survey	
Photographs

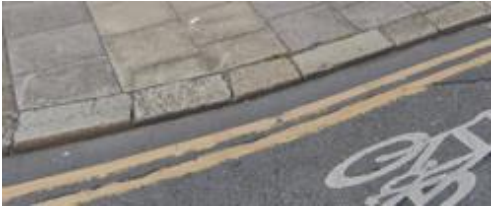
Identification No.	CBC0013BTH163
Location	West side of Fitzwilliam Place
Legal Status	Within a Conservation Area so protected under Policy BHA9 of the Dublin City Development Plan (DCC 2022)
Date of Construction	C 1830s
Original Use	Kerb
Description	Granite kerbing
Significance Rating	Regional Importance
Categories of Special Interest	Historic, Technical, Social
Sensitivity	Medium Sensitivity
Sources	DCC 2022, DAHG 2015, Dublin Civic Trust 2004, OSI 1837 to 1843, OSI 1847, OSI 1864, OSI 1889-90, OSI 1908 to 1911, O'Connell 1975, Field Survey
Photographs

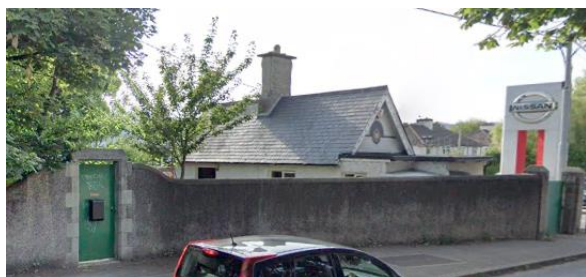
Photo 1: North and west elevations of Woodbrook Side Lodge as viewed from the Dublin Road

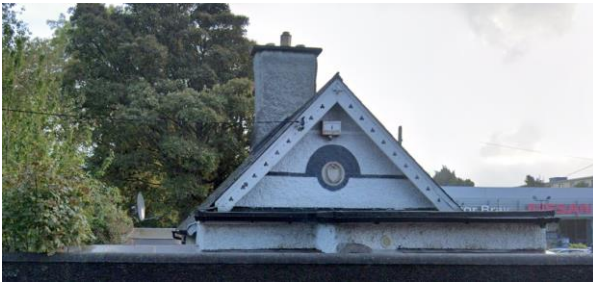
Photo 2: West gable of Woodbrook Side Lodge showing the, rendered and chamfered brick stack, decorative timber bargeboards, brick dressings which have been painted over, and limestone plaque

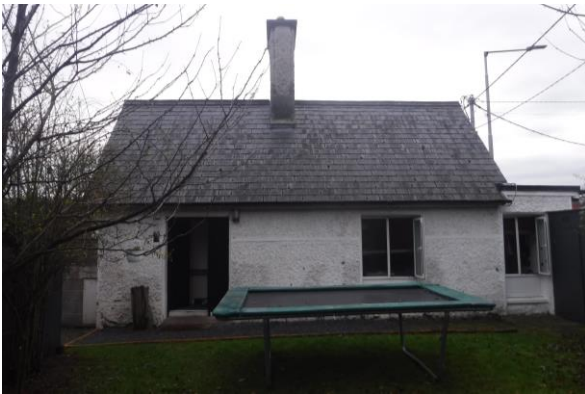
Photo 3: North elevation of Woodbrook Side Lodge showing the natural slate roof and rendered stack. The fenestration, cills and doors are all replacements

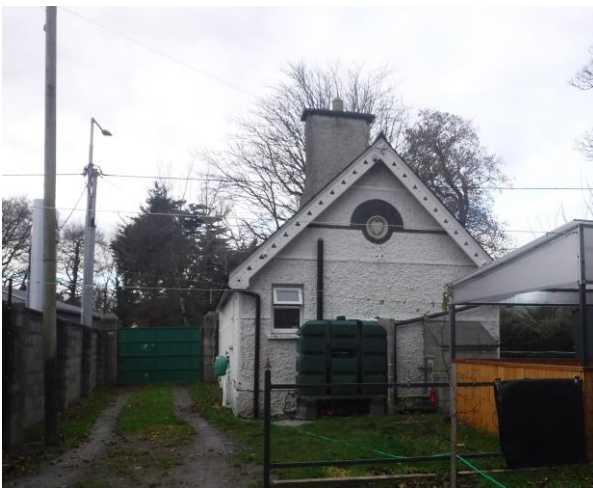
Photo 4: East gable of Woodbrook Side Lodge. The decorative timber bargeboards, brick dressings which have been painted over, and limestone plaque are original but the fenestration, cill and render are replacements

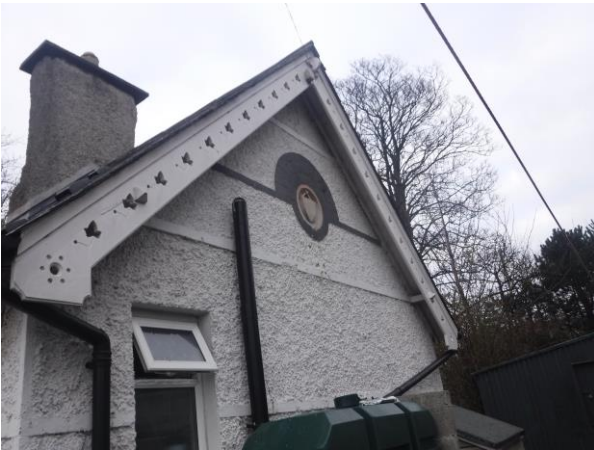
Photo 5: Detail of the east gable of Woodbrook Side Lodge showing the decorative bargeboards, brick dressings and plaque

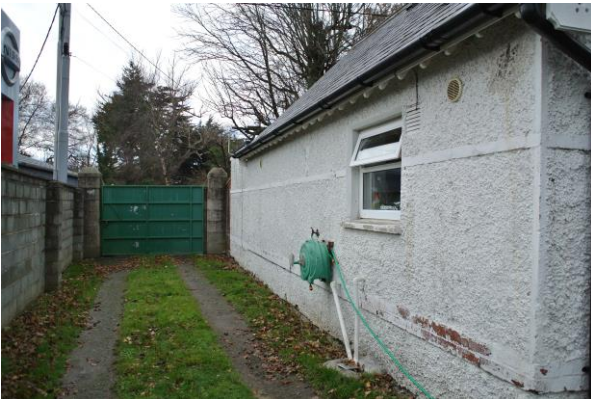
Photo 6: The south elevation of Woodbrook Side Lodge, showing the brick string courses which have been painted over. The rafters to the eaves are visible. The gutters have been replaced previously as has the fenestration and cills

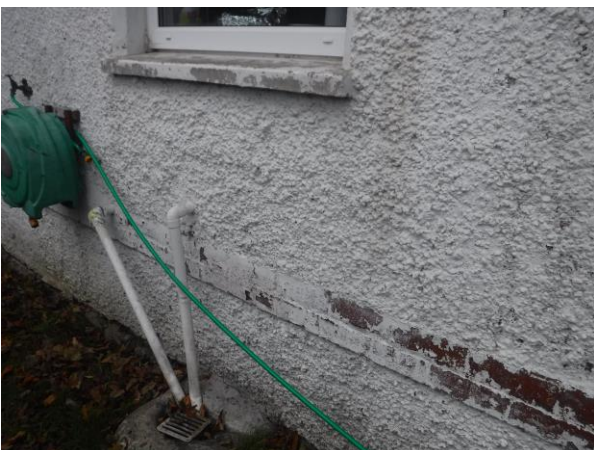
Photo 7: Detail of the south elevation of Woodbrook Side Lodge. The paint is spalling, revealing the brick string course. The cill is a concrete replacement as is the dash render

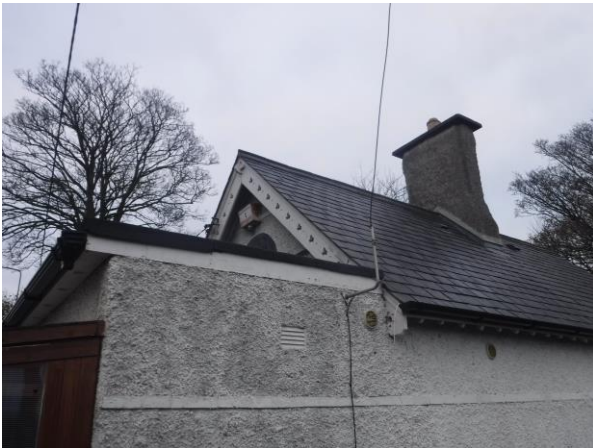
Photo 8: The flat roofed extension to the west gable of Woodbrook Side Lodge. The extension is a 20th century addition of no heritage value and obscures the west gable and barge boards

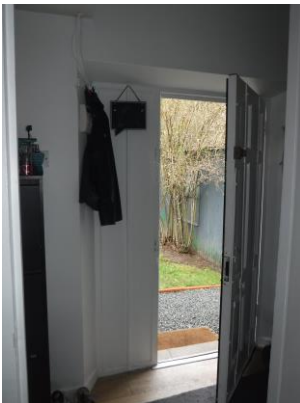
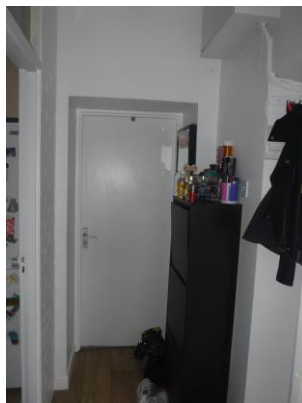
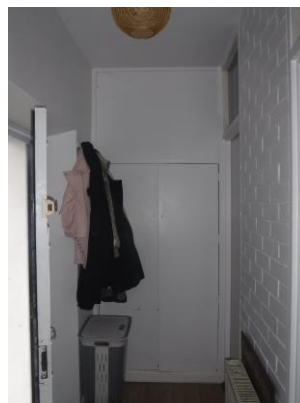
The interior has been subdivided and refurbished previously so that few original features remain other than the walls, chimney breast and stack, splayed reveals to the openings and roof structure.

Photo 9, 10 and 11: The hallway of Woodbrook Side Lodge. It forms part of a subdivided room at the east end of the present lodge. Other than the walls, there are no features of note

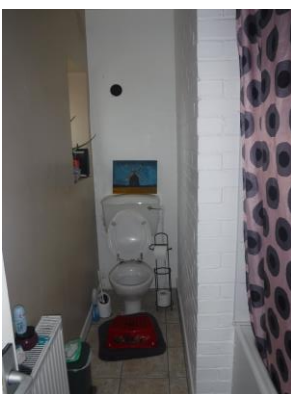
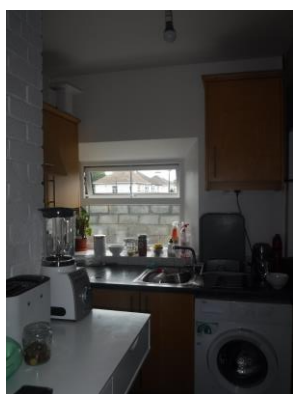
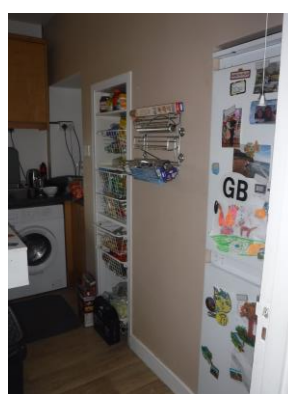
Photo 12, 13 and 14: The bathroom and kitchen of Woodbrook Side Lodge. Both form part of a subdivided room at the east end of the present lodge. Other than the walls, and the firebreast in the kitchen, there are no features of note

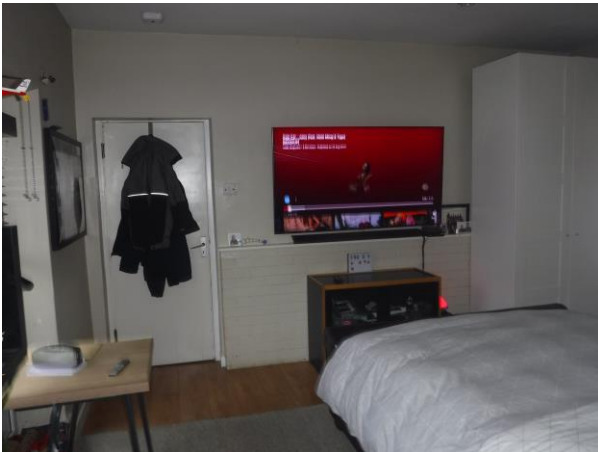
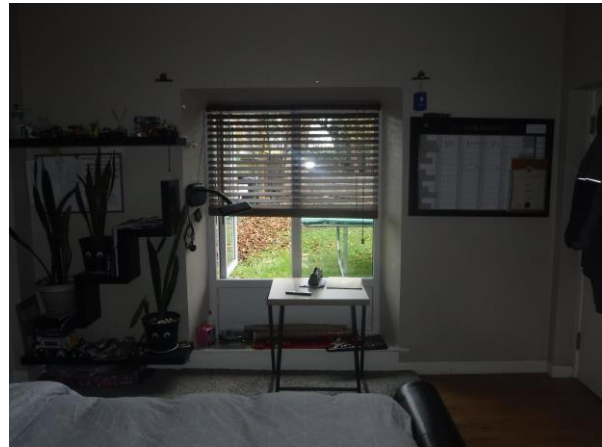
Photo 15 and 16: Bedroom 1 at the west end of Woodbrook Side Lodge. Other than the walls, and the firebreast, there are no features of note

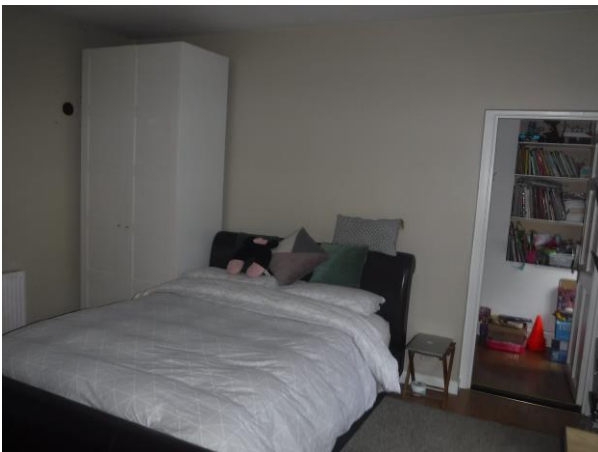
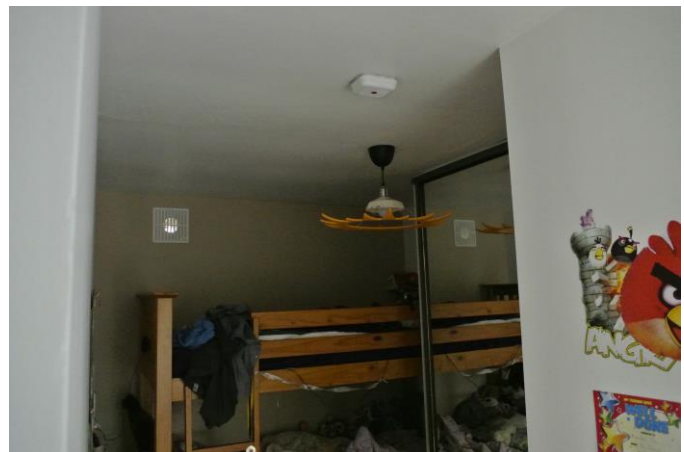
Photo 17 and 18: Bedroom 1 at the west end of Woodbrook Side Lodge. Bedroom 2 is located in the flat roofed extension and is not of heritage interest

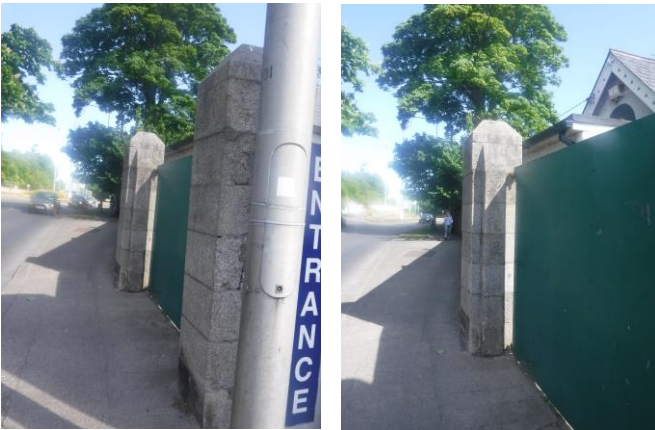
Photo 19 and 20: The vehicular gate as viewed from the west or Dublin Road side

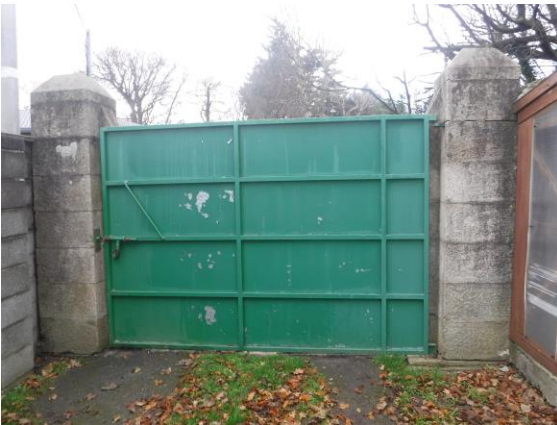
Photo 21: The vehicular gate as viewed from the east side

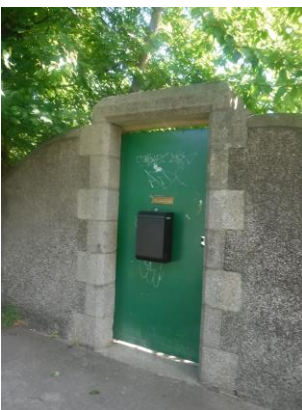
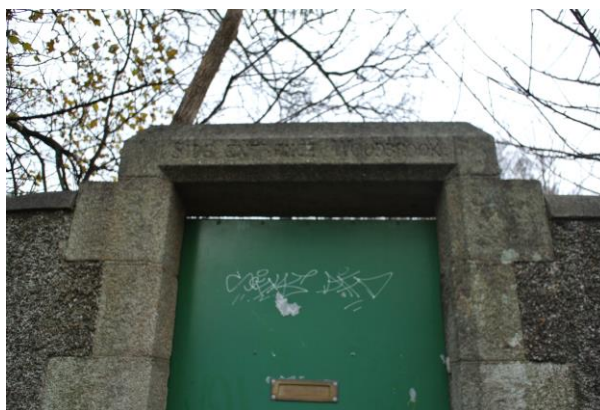
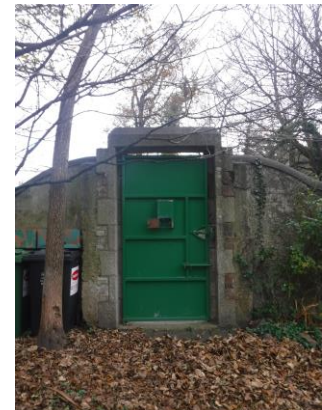
Photo 1, 23 and 24: The pedestrian gate as viewed from the west or Dublin Road side, the engraved lintel on the west elevation and the east elevation

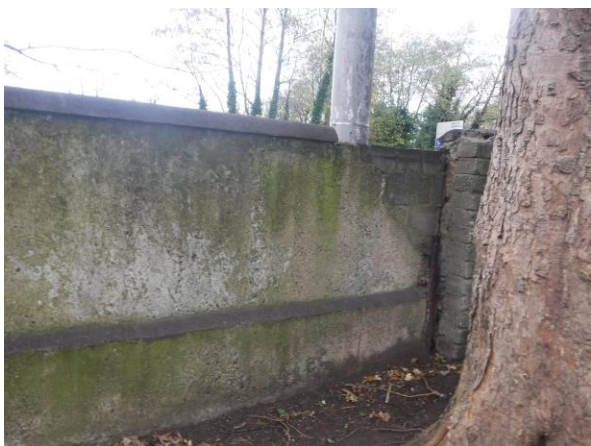
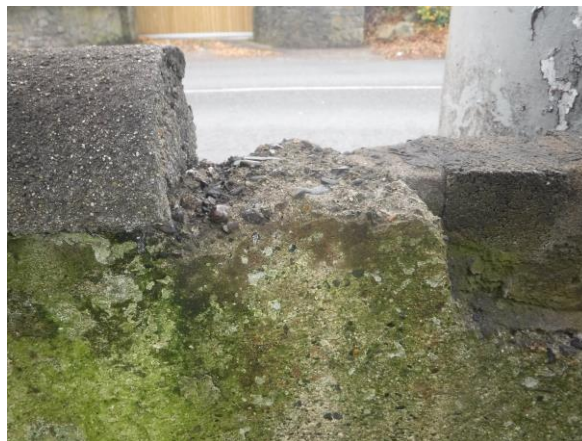
Photo 25 and 26: The east elevation of the boundary wall where the render and capping have fallen away, exposing the concrete block construction

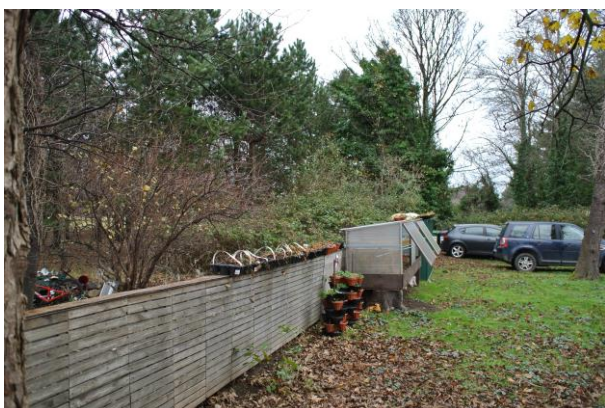
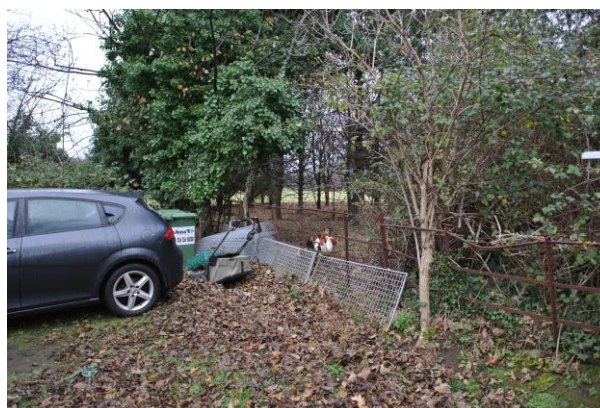
Photos 27 and 28: The north boundary is a timber fence. To the west, the Side Lodge is separated from the remainder of Woodbrook Demesne by a bank of trees

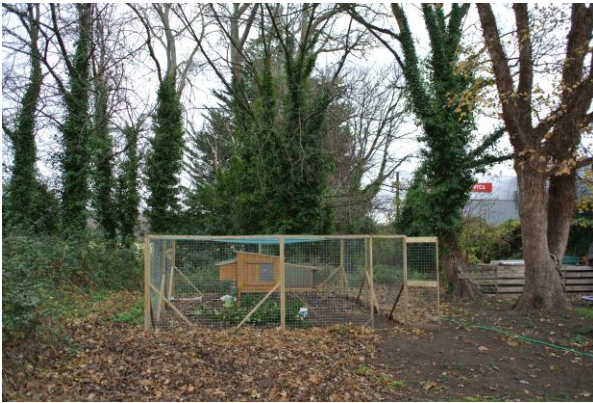
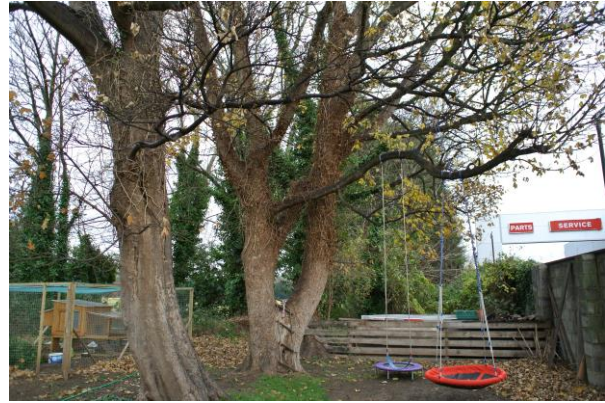
Photo 29 and 30: To the west, the Side Lodge is separated from the remainder of Woodbrook Demesne by a bank of trees. The south boundary is a concrete block wall. The secondary avenue leading up to the walled garden of Woodbrook House is just beyond the timber fencing visible beside the wall, though it has become overgrown.
