Appendix A17.1
Arboricultural Impact
Assessment

Arboricultural Impact
Assessment and
Method Statement

Client: Jacobs
Project: National Transport Authority
BusConnects Core Bus Corridor
Route 13
Bray to Dublin City Centre

Date: 02nd May 2023
Ref: 20-079-05
Revision: Version 9

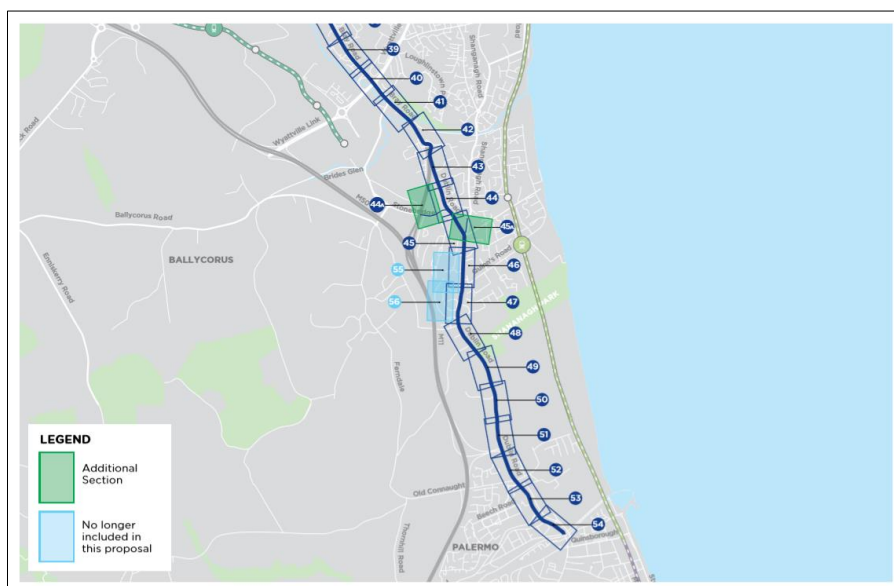
Figure 1c. Southern section of the Bray to Dublin City Centre Route (Source: BusConnects.ie).

2.9. The Bray to Dublin City Centre Route (hereinafter referred to as ‘the Route’) commences at the junction of Leeson Street Lower and St. Stephens Green. It extends along Leeson Street Lower and Upper including the existing one-way system on Sussex Road. It continues on Morehampton Road and Donnybrook Road through Donnybrook Village, and on to the Stillorgan Road. It intersects with the University College Dublin (UCD) to City Centre CBC at Nutley Lane and includes the Belfield Interchange at the entrance to UCD. It continues south on Stillorgan/Bray Road as far as the Loughlinstown Roundabout. The route then proceeds along the Dublin Road through Shankill and on to Bray through the Wilford Roundabout (M11 Access Roundabout) and Castle Street. The CBC terminates at the Dargle River Crossing where it ties into the proposed Bray Bridge Scheme (Figures 1a, 1b and 1c).

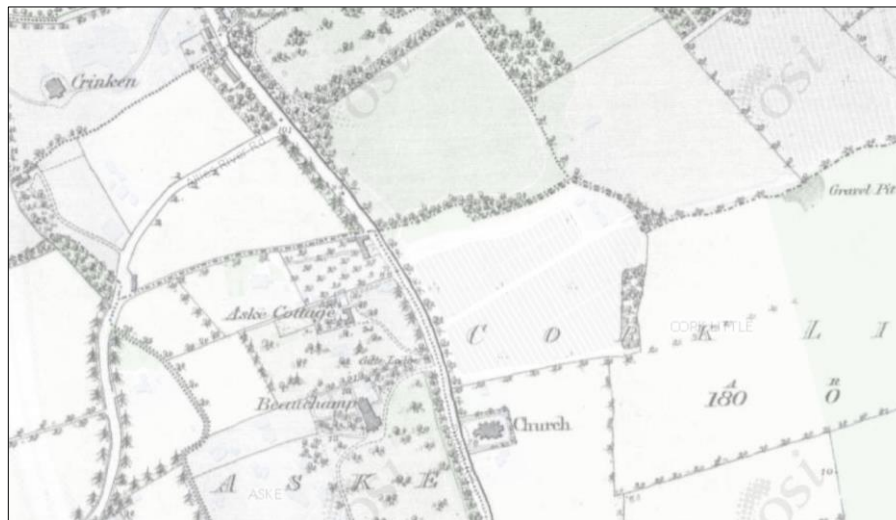
Figure 2b. Historic 6 Inch Ordnance Survey map (1837-1842) showing section of trees on Dublin Road between Crinken Church and Shankill (Source: GeoHive, 2021).

2.10. There is a large proportion of high and moderate quality trees located along the southern section of the Route, particularly as you leave Bray town centre and continue along the R119 Dublin Road. This area is lined by mature woodlands that are located beyond stone walls on private lands and estates. These trees provide mature canopy cover and a green corridor between Bray and Shankill, offer significant visual amenity and are intrinsic features of the local landscape. Many of the trees are at the peak of maturity and therefore at the peak of their ability to deliver significant environmental and social benefits, with many likely to hold historic and cultural significance in the local area due to their age and location. There are a number of locations where existing trees on Dublin Road between Bray and Shankill are likely to have direct links to those recorded on Historic 6 Inch Ordnance Survey maps of 1837-1842 (Figure 2a & 2b).

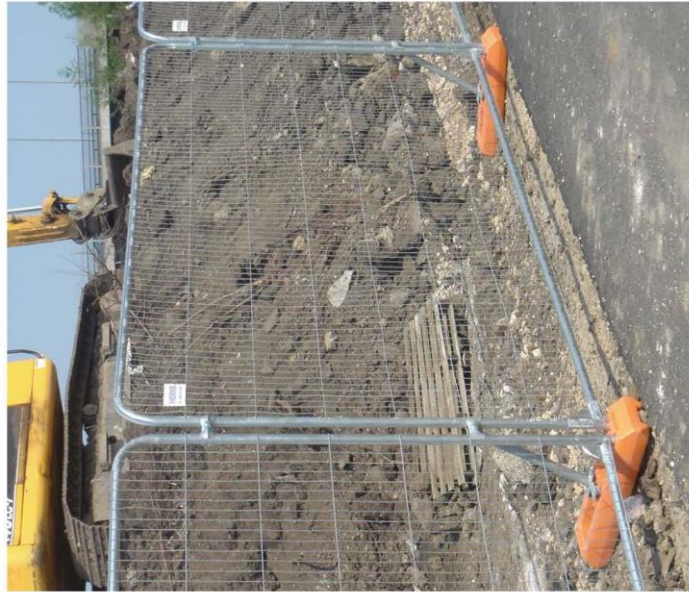
ROUND TOP PANELS WITH ANTI-CLIMB MESH

1. Front stabiliser
2. High visibility footblocks
3. Round top panel
4. Steadfast strut
5. Anti-tamper coupler
6. Optional steadfast safety strips
7. Anti-drib round top panel with steadfast struts to increase stability

- 1.1. A protective fence will be erected around retained trees, prior to the commencement of materials or machinery being brought onto site, removal of soil or any form of construction. The area within this fencing will form the construction exclusion zone (CEZ) and it will be afforded protection at all times. No works will be undertaken within this zone that causes compaction to the soil, severance of tree roots or damage to tree canopies.
- 6.9. The fence is to be sited in accordance with the Construction Stage Tree Protection Plan.
- 6.10. Details of the minimum distance for fencing from trees can be found in the Tree Schedule

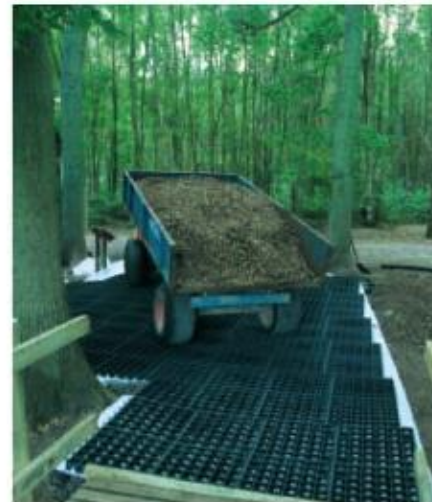
Glynebourne Wood.

Pedestrian path to recreational wand and built using a CellWeb™ foundation which was covered with Duollock and then filled with woodchip to create a porous surface.

The CellWeb™ system overcomes these issues and helps contractors to comply with tree health guidelines by creating a load-bearing base that is water-permeable, stable and durable.

With no need for excavation, the system is quick and easy to install, reducing construction time and saving costs and making it suitable for temporary and permanent solutions.

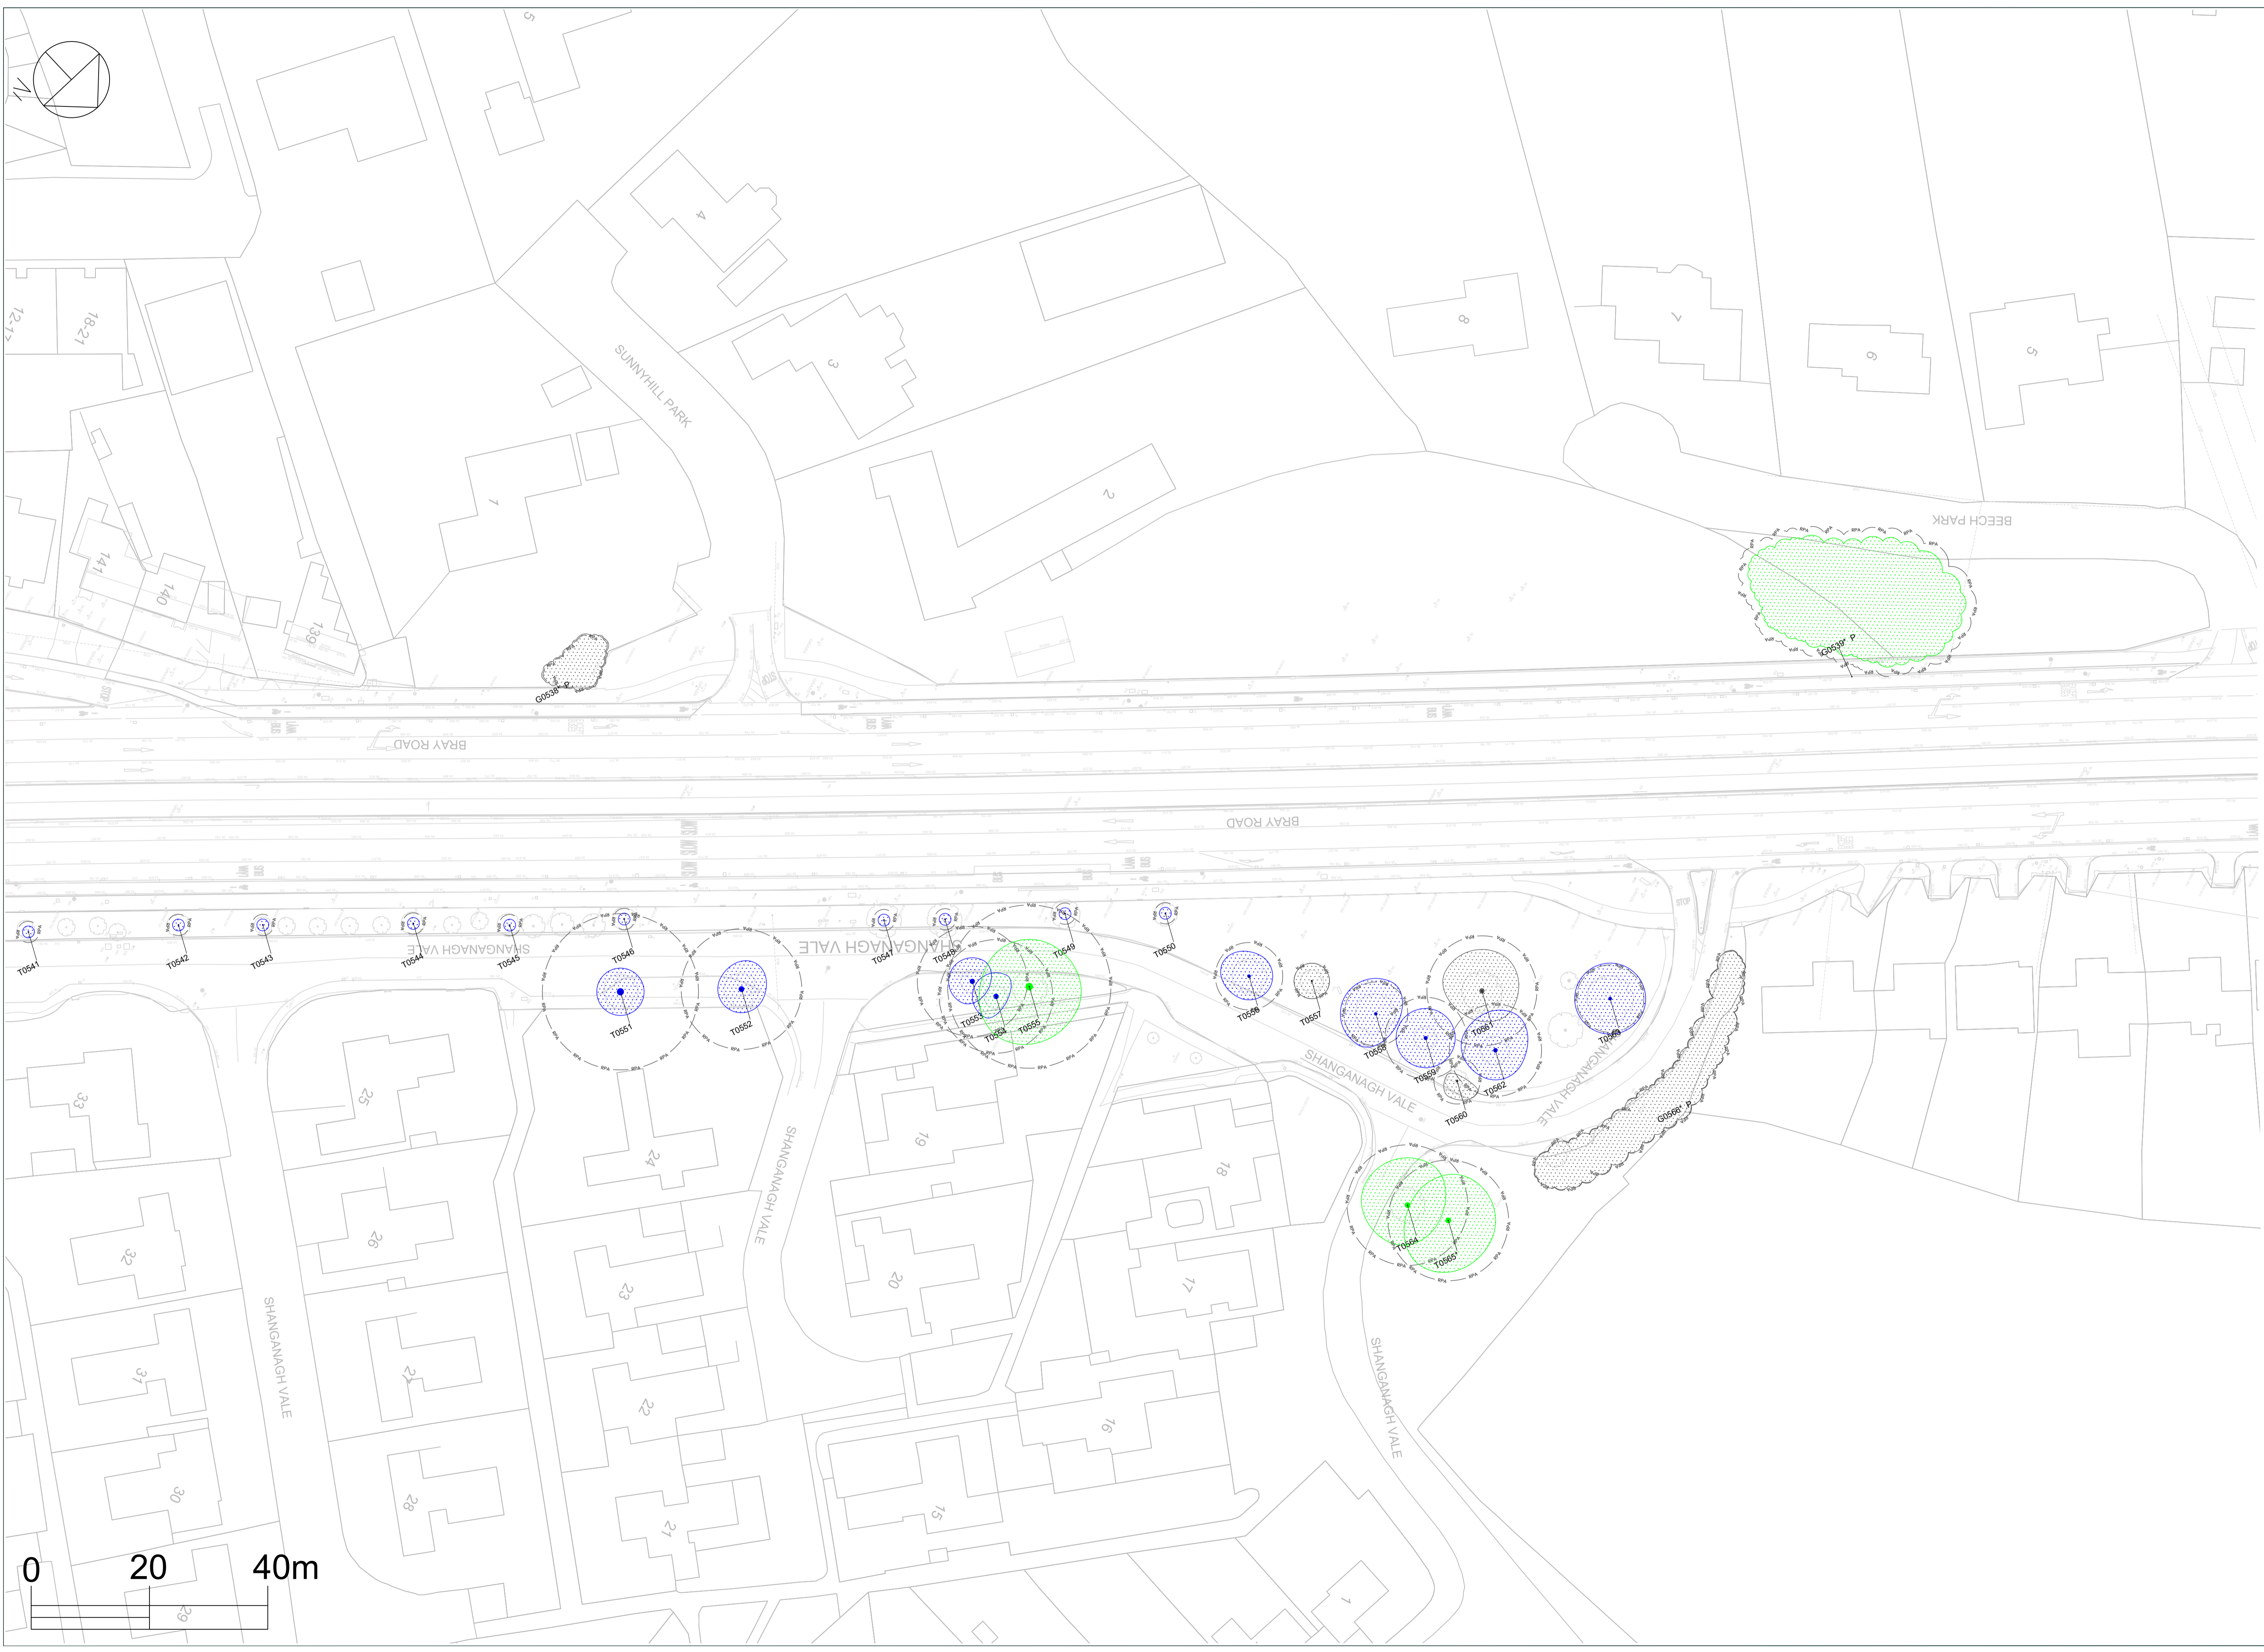
TITLE: Tree Constraints Plan - 19

Category C
Trees of low arboricultural quality and value currently in adequate condition and able to remain until new planting is established with a minimum useful life expectancy of 10 years, or trees with a stem diameter of <150mm.

Category U
Trees in poor physiological or structural condition that cannot realistically be retained in the context of current land use for longer than 10 years.

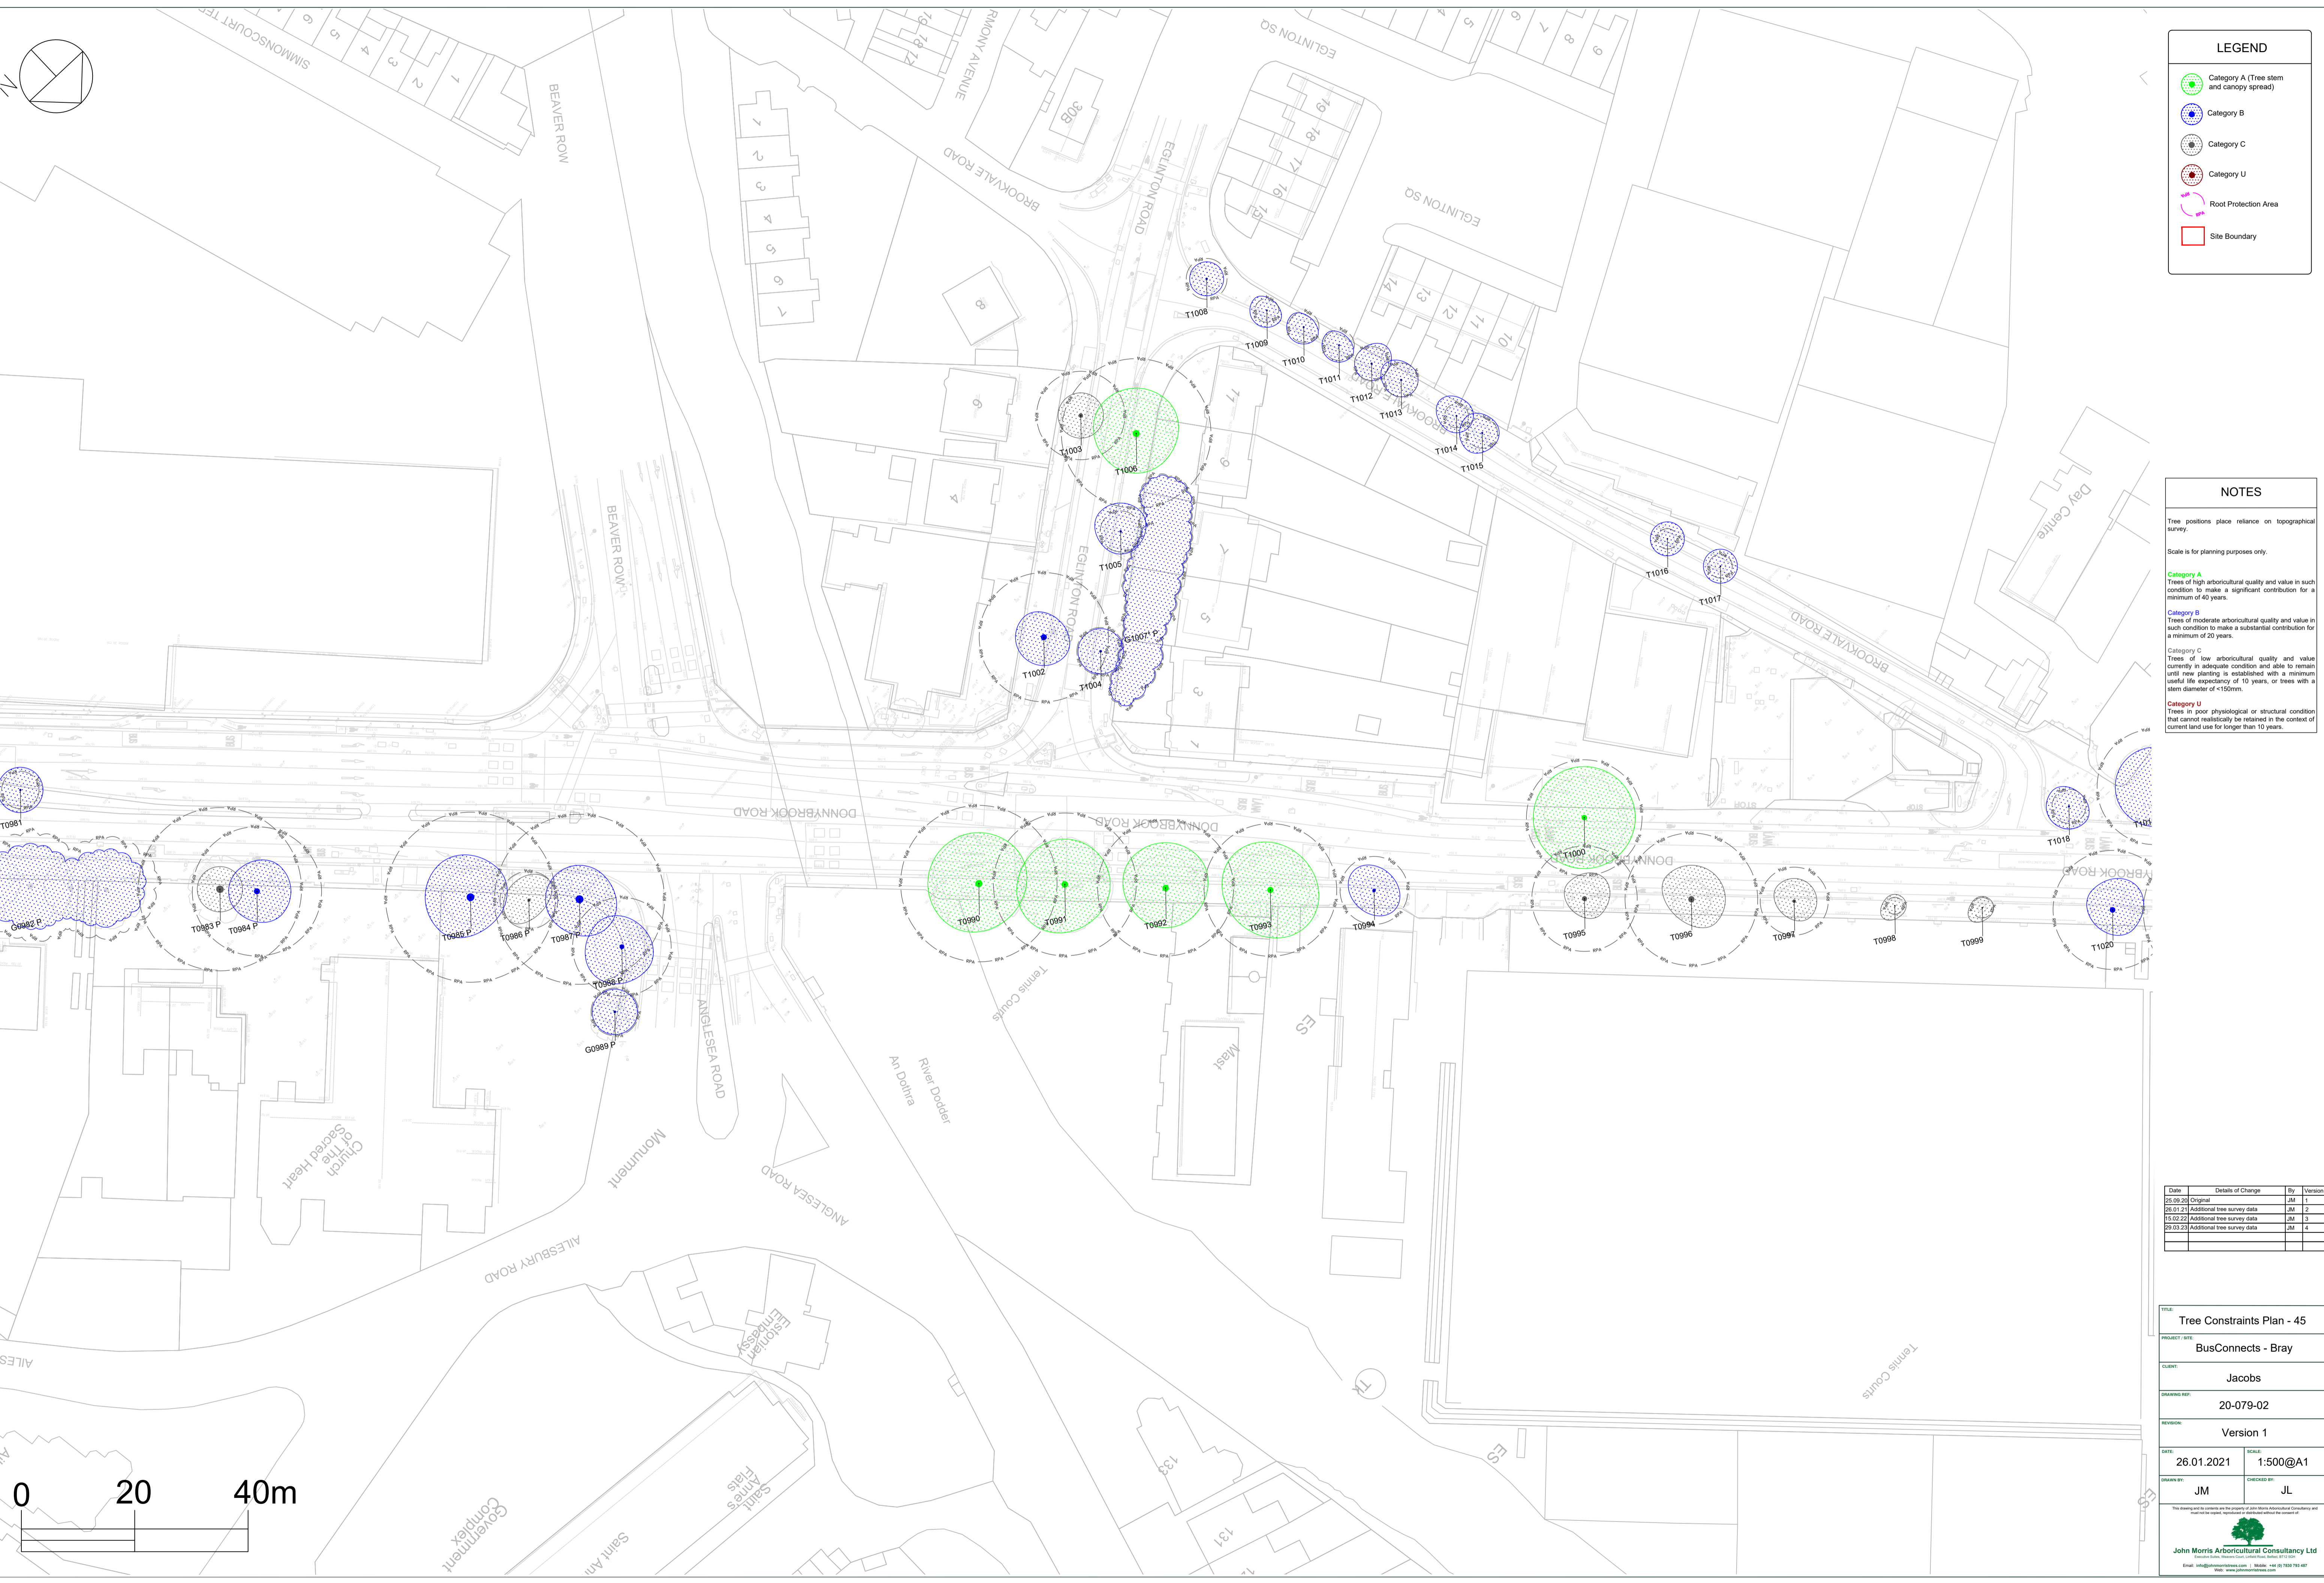
LEGEND	
	Category A (Tree stem and canopy spread)
	Category B
	Category C
	Category U
	Root Protection Area
	Site Boundary

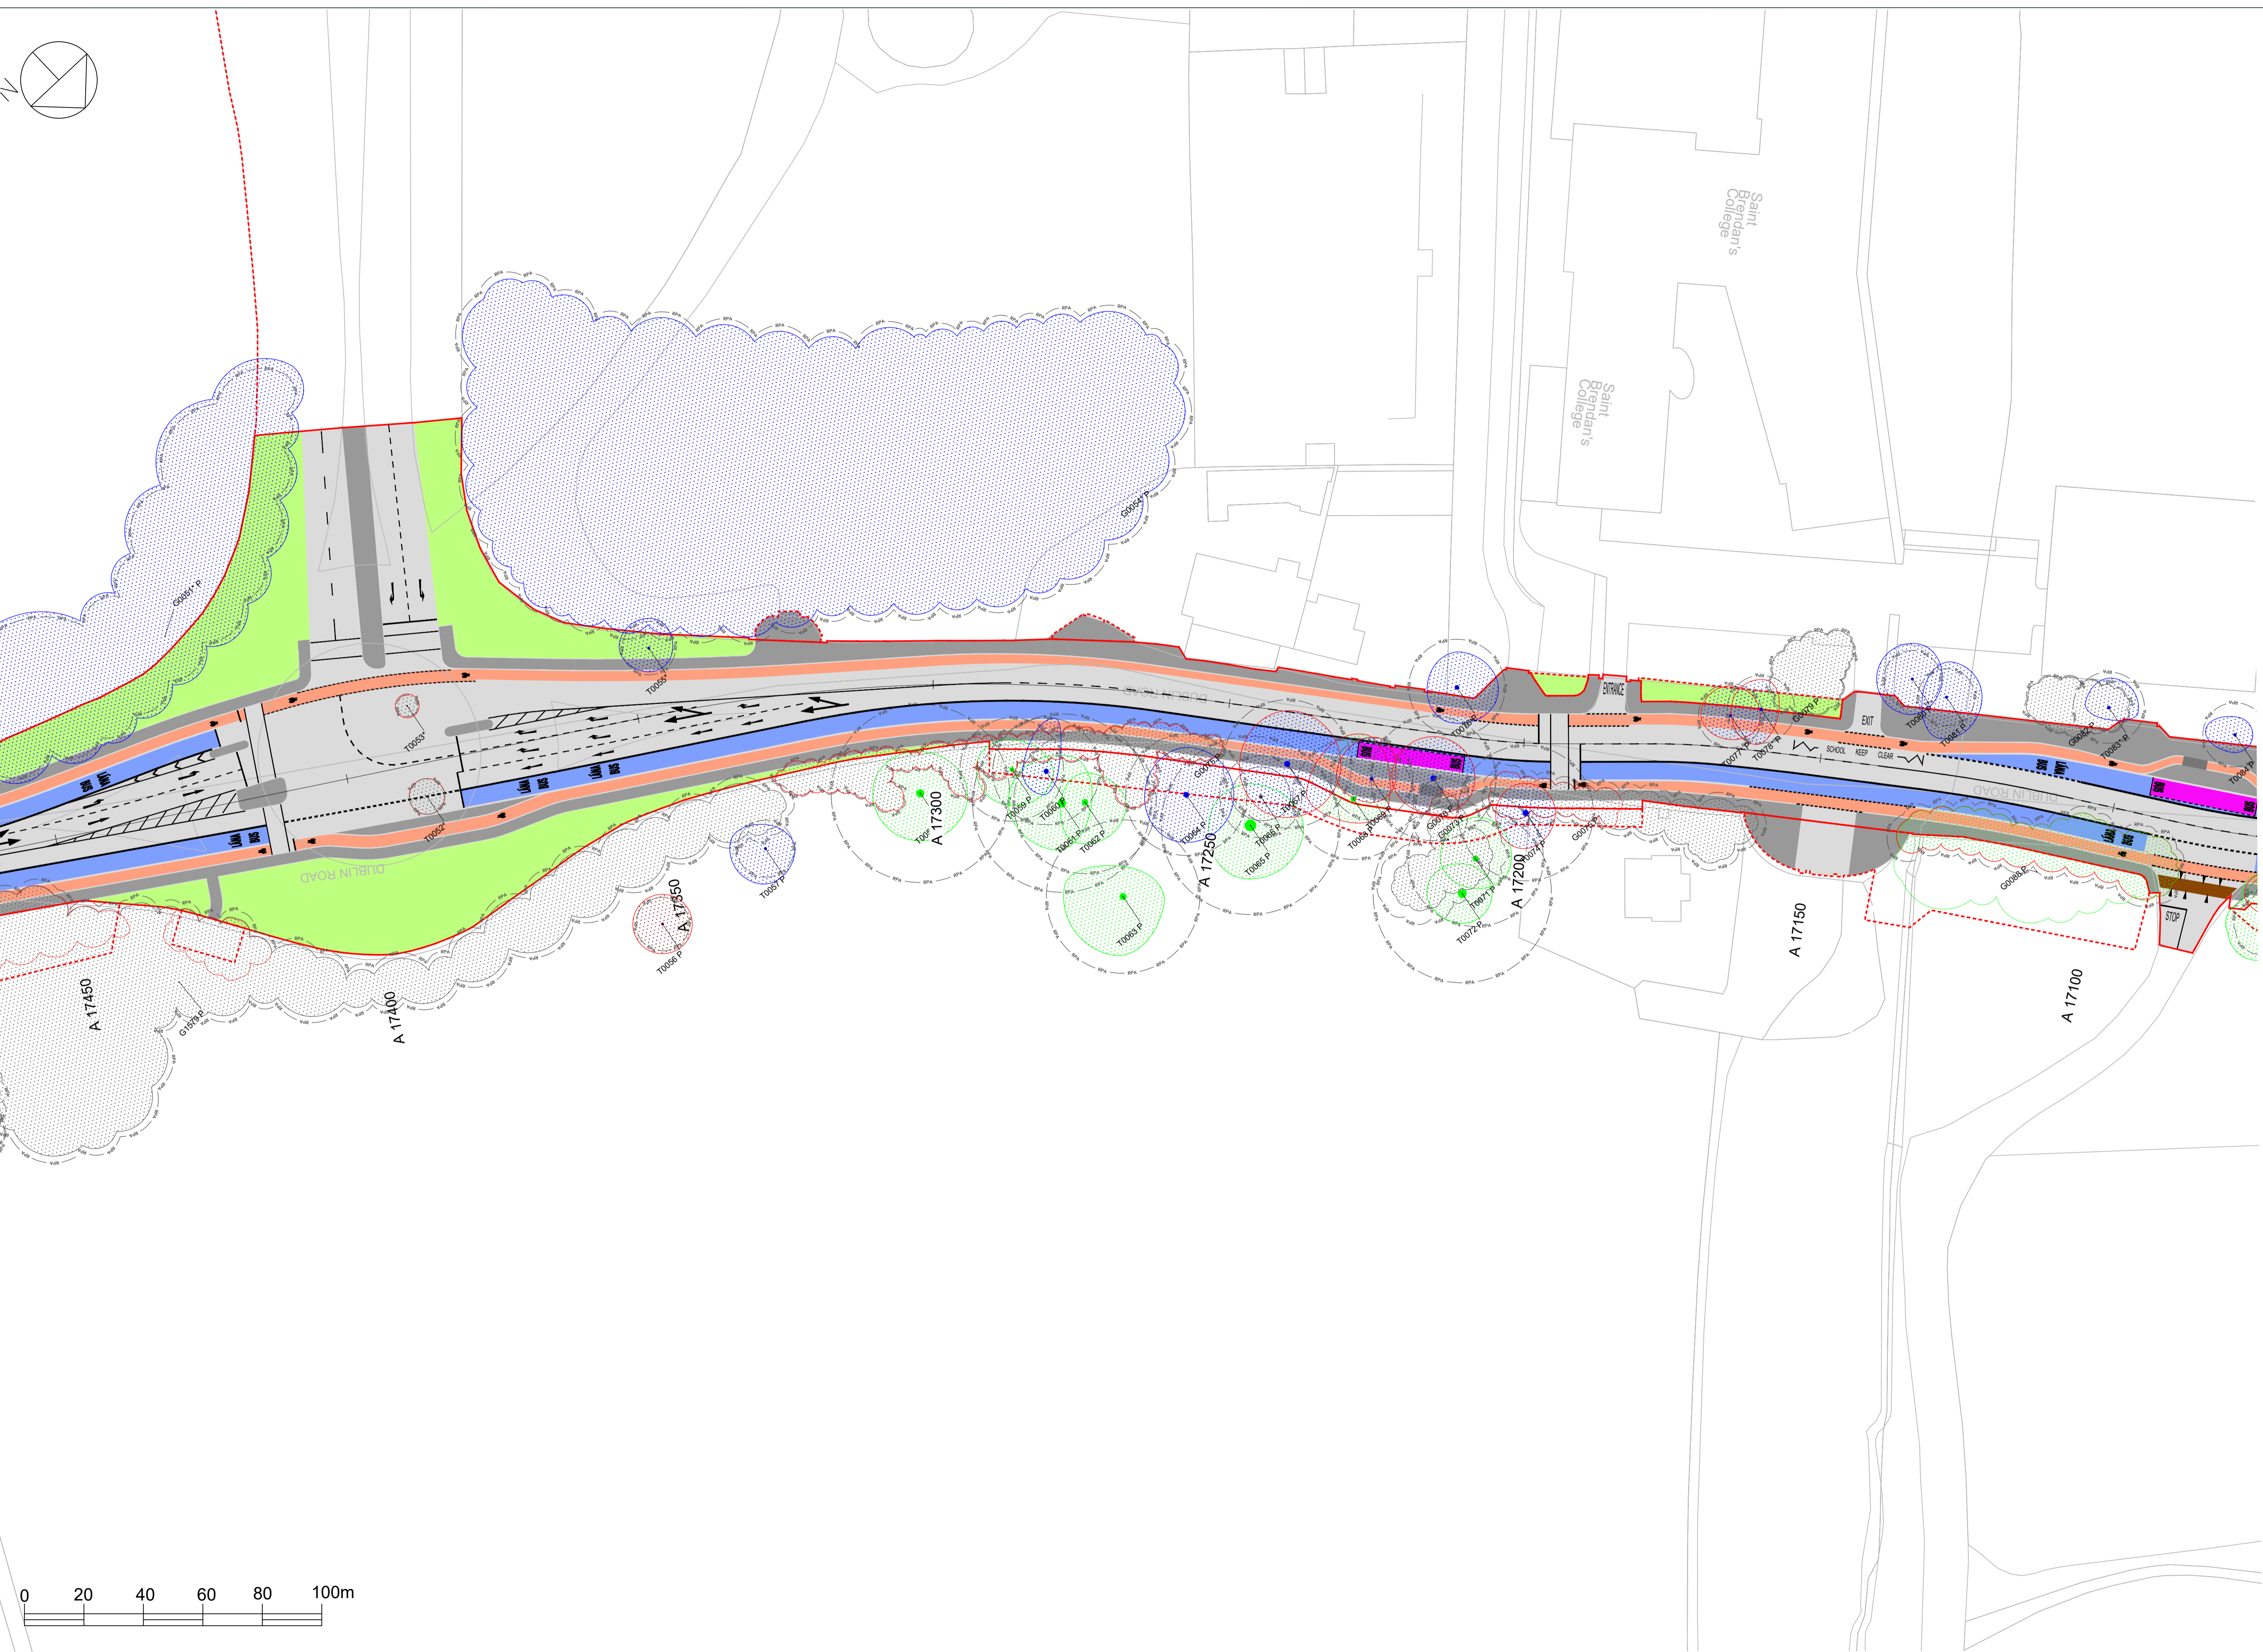
TITLE: Preliminary Design Tree Removal Plan - 4

Location of protective fencing/barriers, temporary and permanent ground protection and specialist construction methods to be illustrated on Construction Stage Tree Protection Plan in accordance with Arboricultural Method Statements.

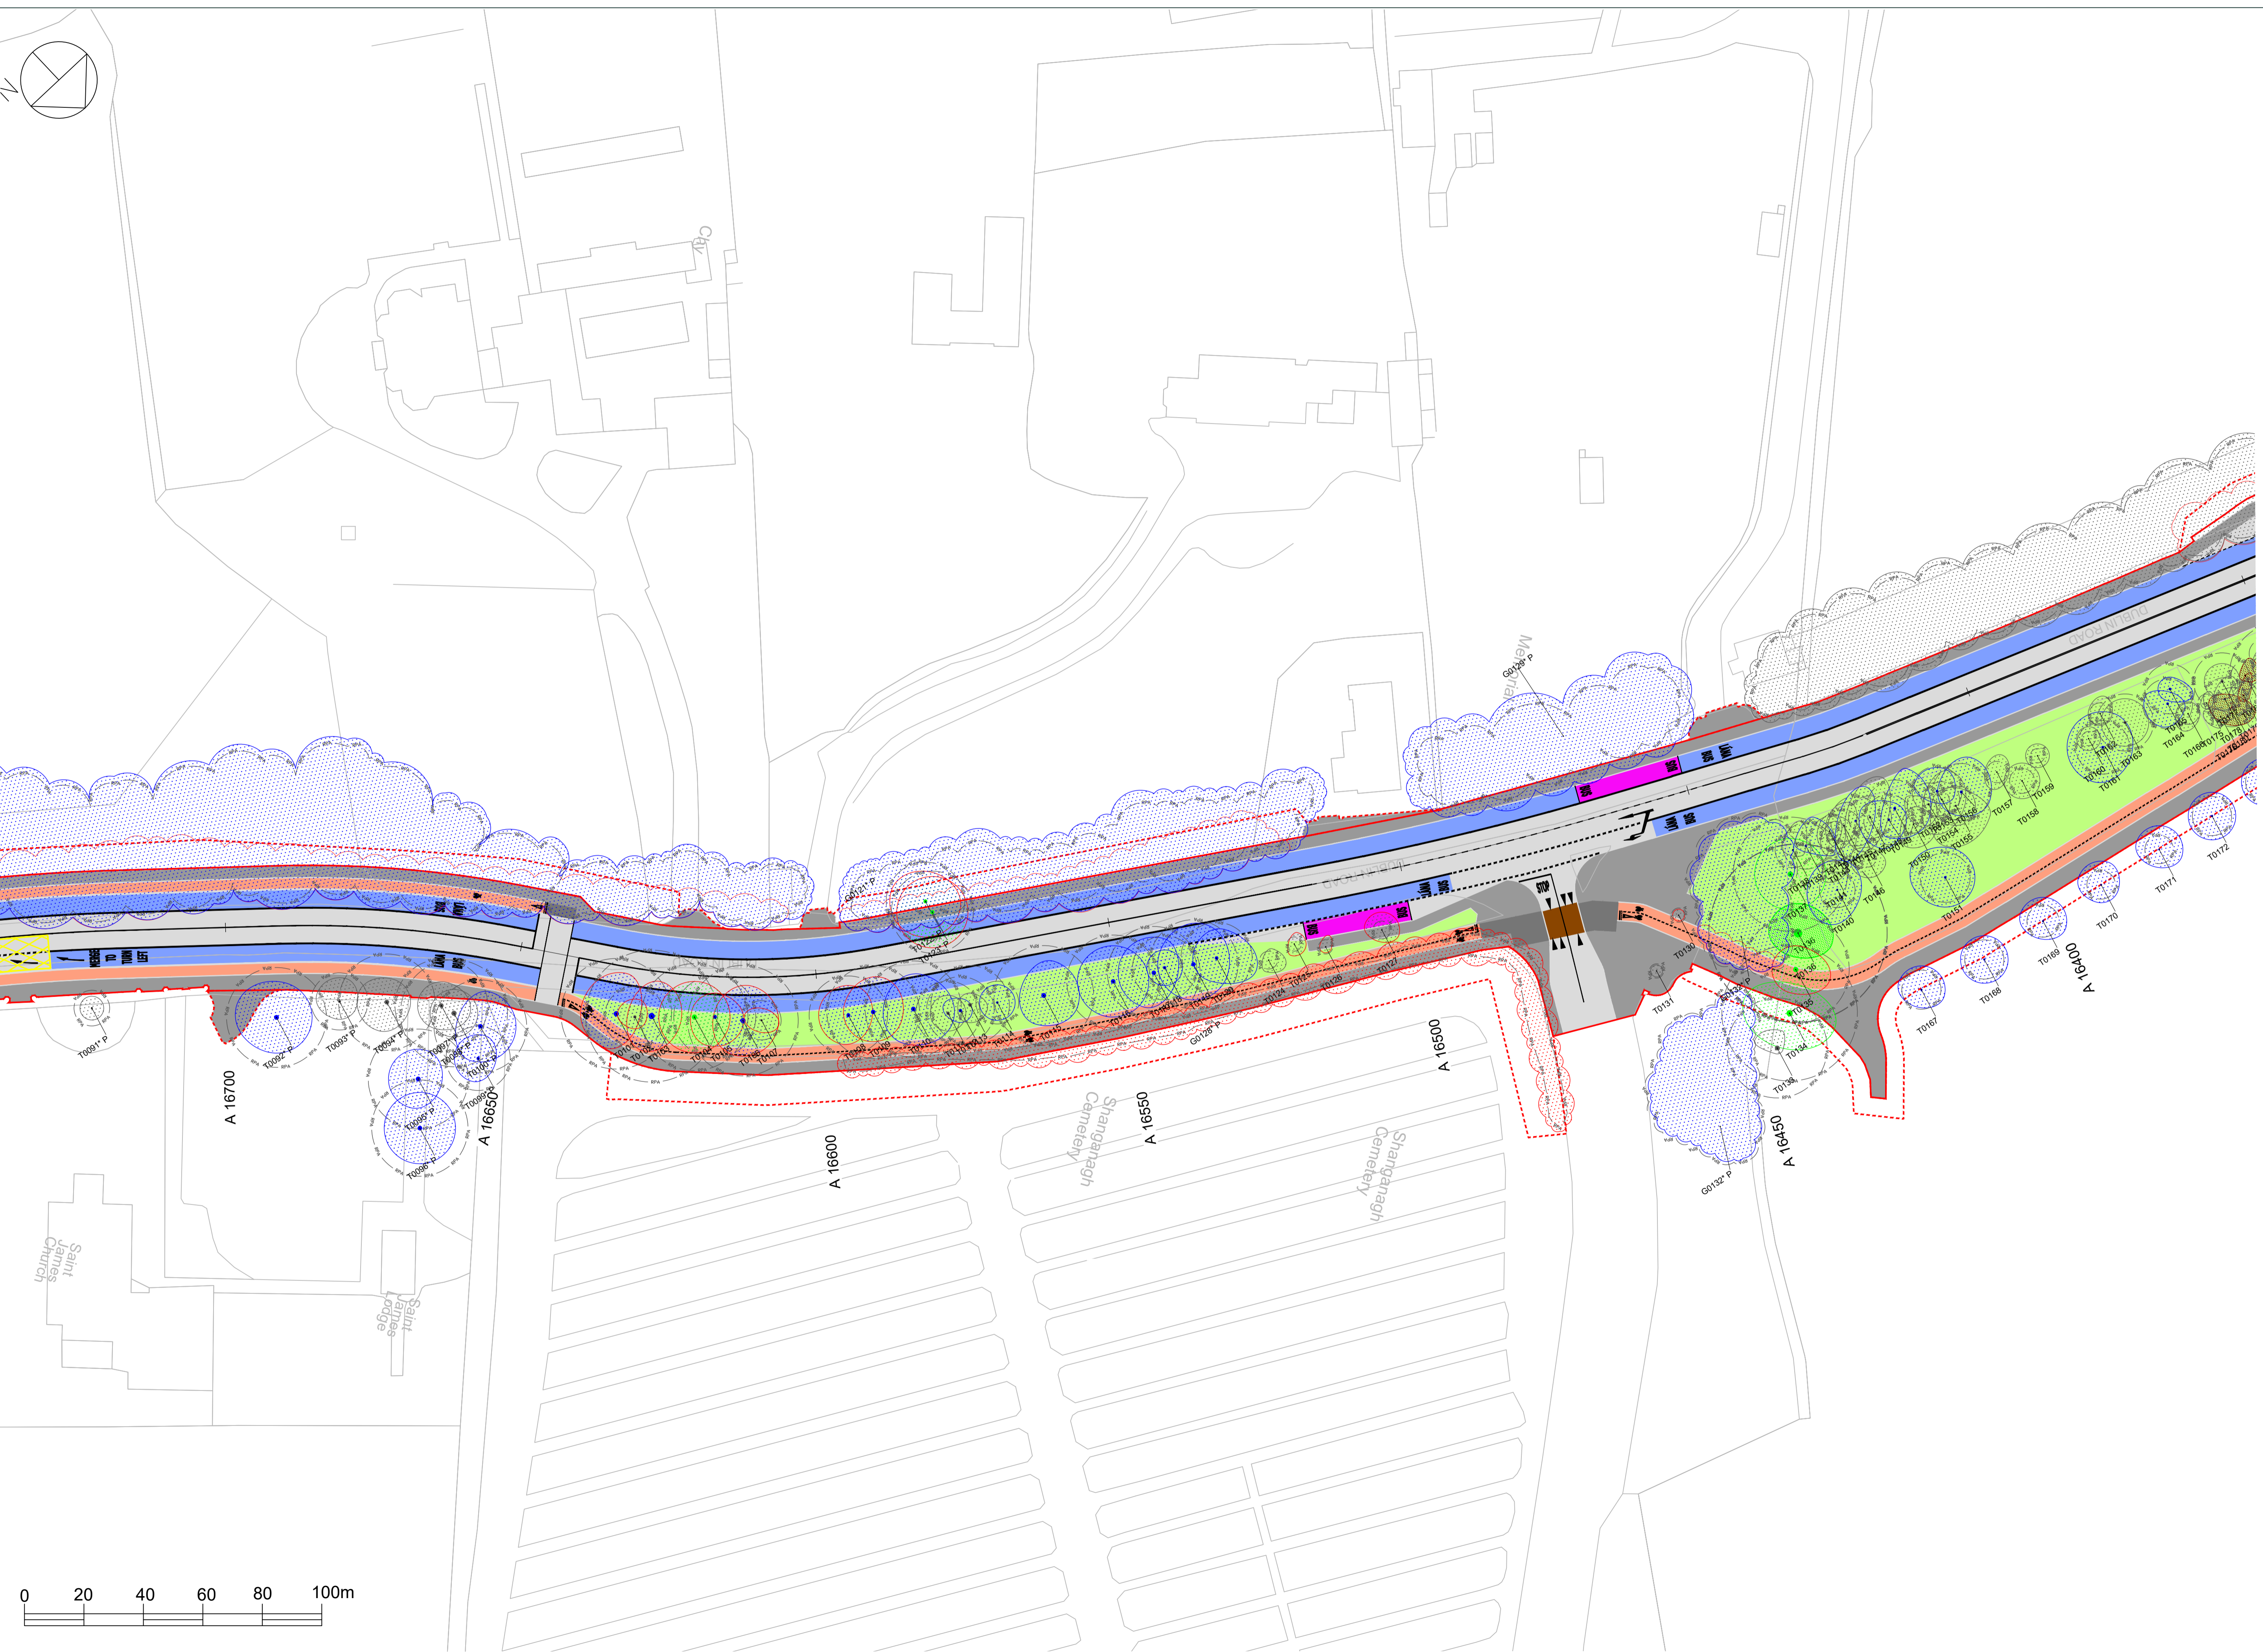
TITLE: Preliminary Design Tree Removal Plan - 6

Location of protective fencing/barriers, temporary and permanent ground protection and specialist construction methods to be illustrated on Construction Stage Tree Protection Plan in accordance with Arboricultural Method Statements.

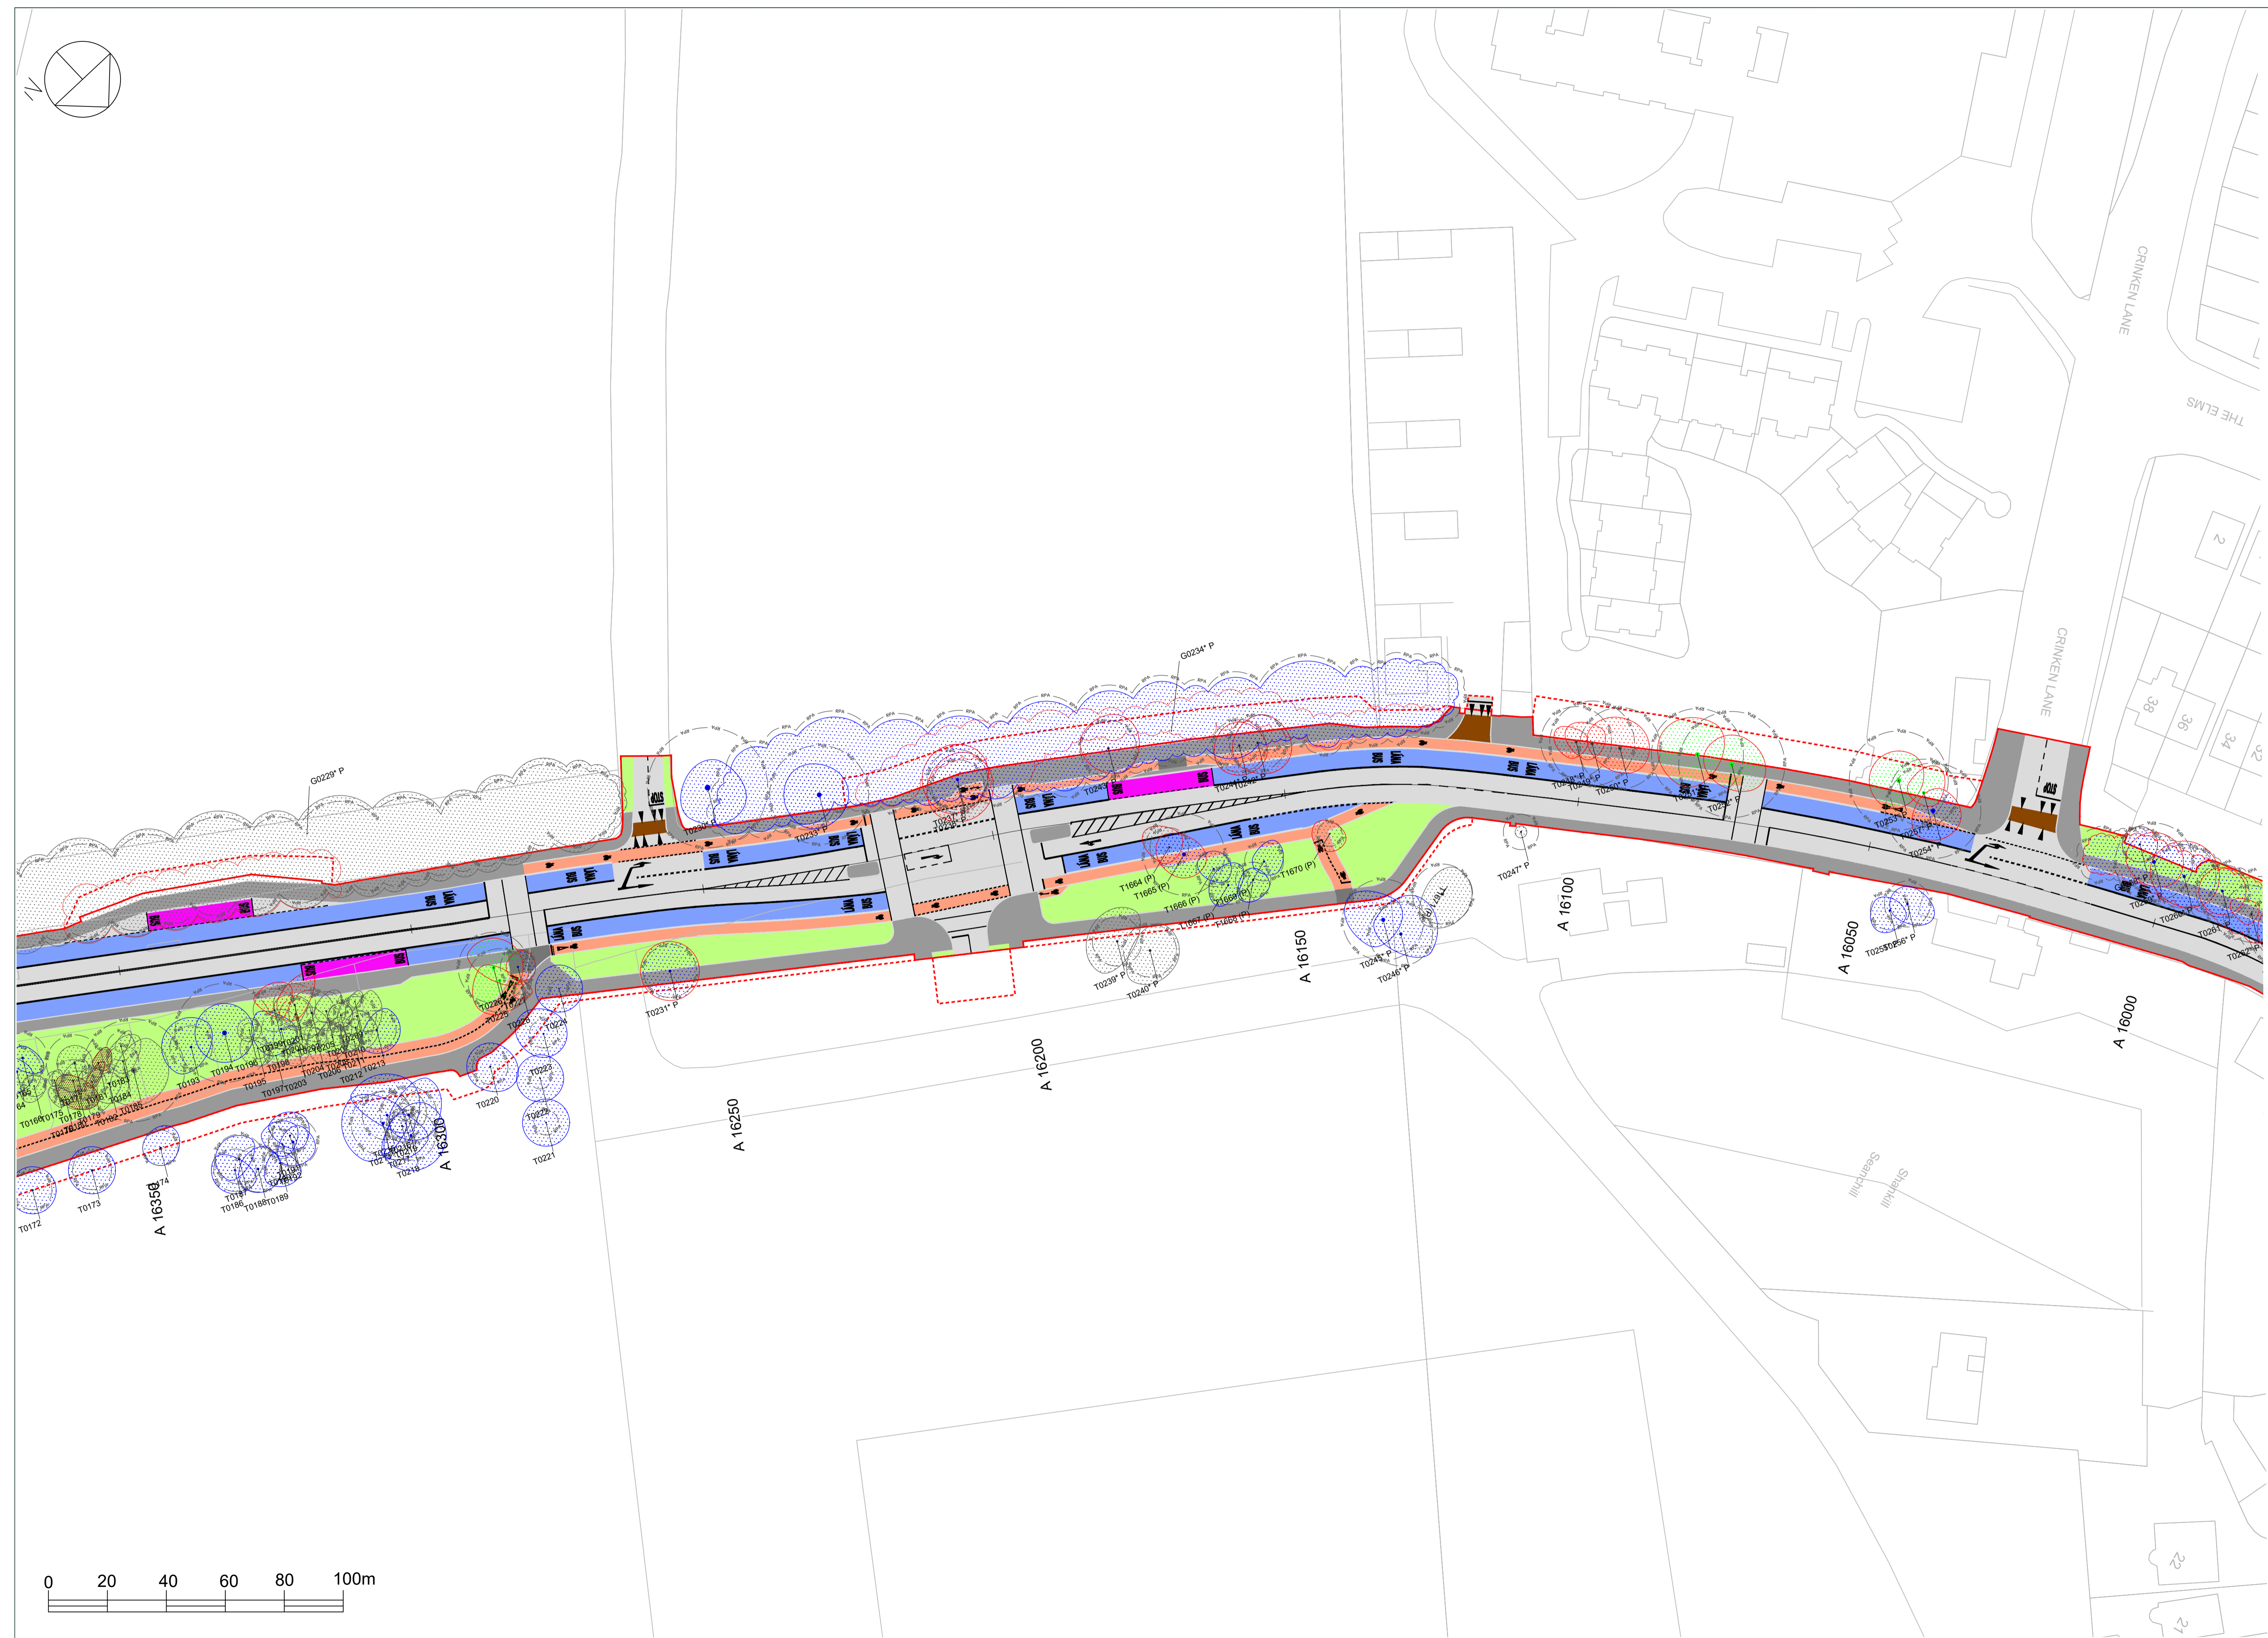
TITLE: Preliminary Design Tree Removal Plan - 7

Location of protective fencing/barriers, temporary and permanent ground protection and specialist construction methods to be illustrated on Construction Stage Tree Protection Plan in accordance with Arboricultural Method Statements.
