Appendix 13.4
Field Walkover Survey
Records Sheets

Project Name:
N2 Slane Bypass, Slane, Co Meath

EIAR FIELD SURVEY SHEET

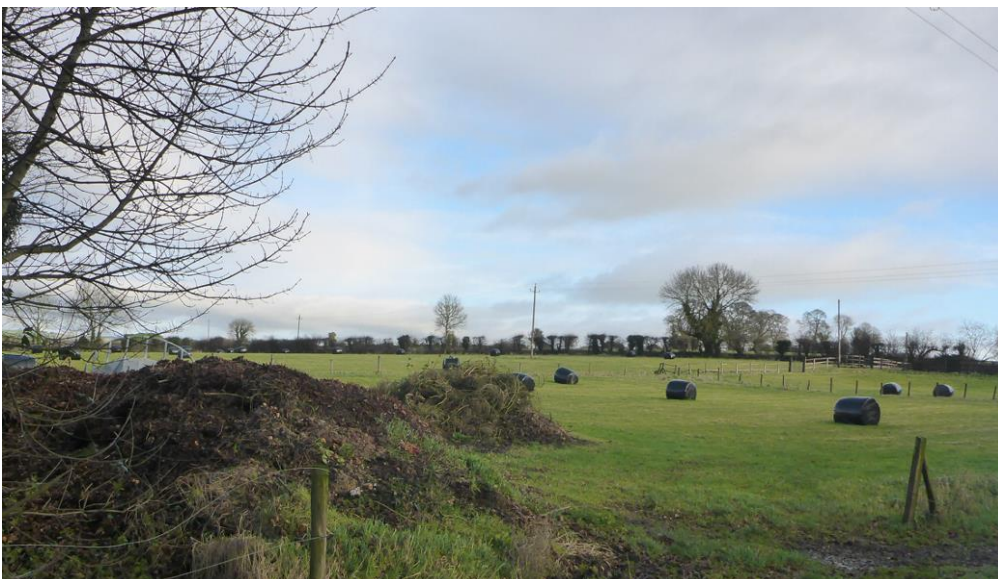
F1: Small pasture field, generally level, sloping very gently down to N2 road along W side. Dense hedgerow boundaries, deep drainage ditch along N2. Subdivided by wire fences. Bales of hay silage dotted throughout.

F1 facing SE

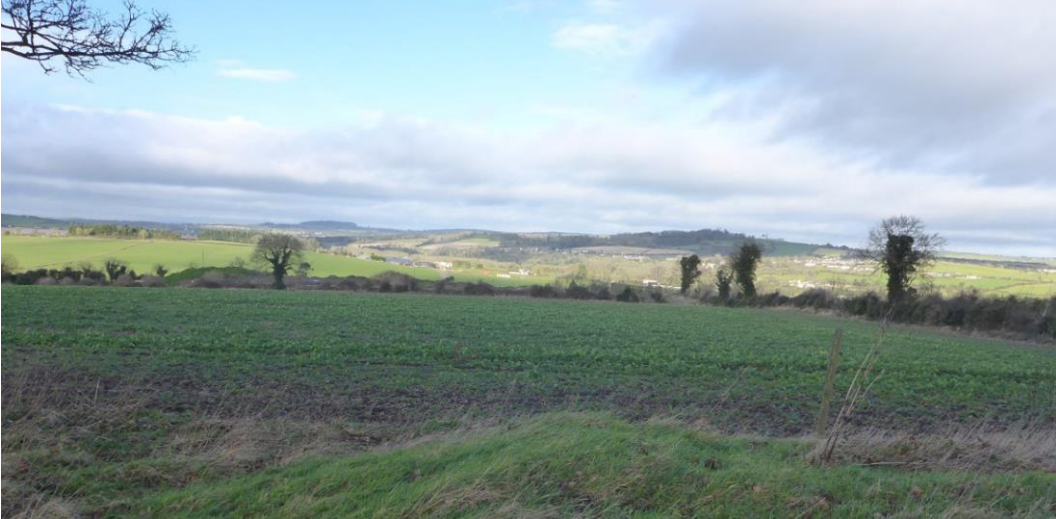
F2: Large, undulating arable field under young winter crop. Relatively level at S and sloping gently to N. Bounded by old Dublin road to E. Mature hedgerow boundaries with drainage ditches.

F2 facing W

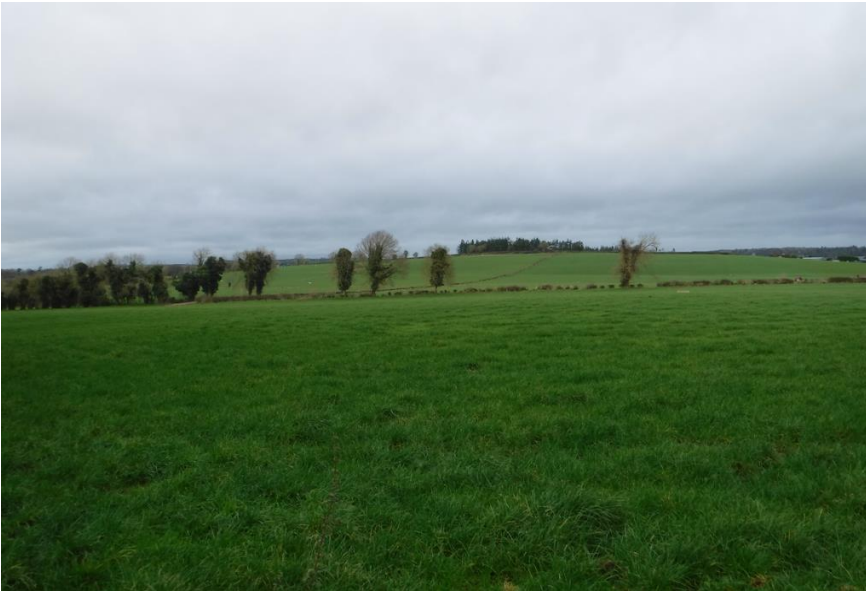
F3: Large, irregular-shaped field, relatively level pasture field. Good views of Hill of Slane. High earthen bank and hedgerow along roadside (N2), with the existing road at a height above the ground level within the field. Johnstown / Fennor townland boundary along NW, ditch in SW corner (where stream terminates on historic OS mapping), remainder is low hedgerow. Johnstown / Cullen townland boundary along NE corner, now a modern property boundary.

F3 facing N

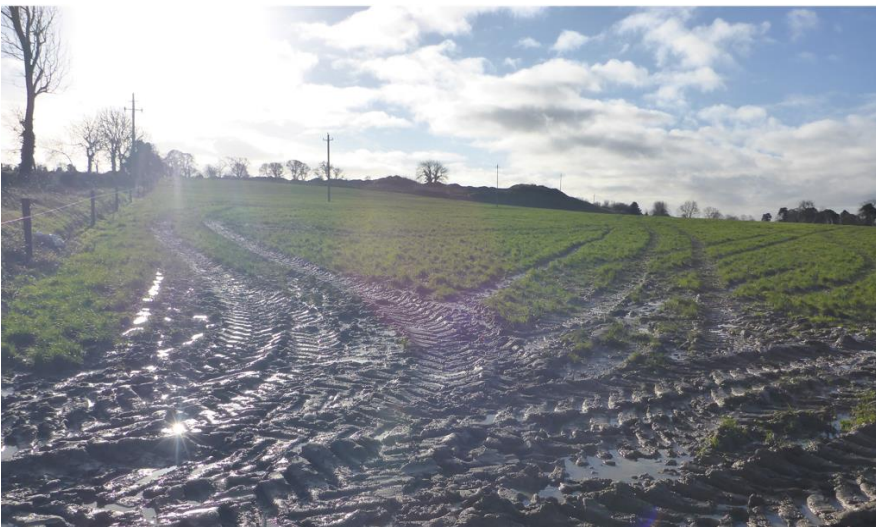
F4: Large former arable field, now under pasture, rises to SE. High mounds of dumped material in SE corner and 20th century properties along the SW side and at N end. Very restricted views except at highest point, in SE corner of field, which provides clear views of Knowth, which forms a prominent landscape feature to the E. The long defunct section of the Dublin to Slane road survives as a farm access track running between F4 & F5. Bounded by N2 road along W side. A well is marked at the side of the old roadway on the 25-inch OS map, at the boundary with F4; not depicted on the earlier first edition map or the later 1958 OS revision. There was no visible surface trace during field survey. The location is approximately where the field entrance is now.

F4 facing south

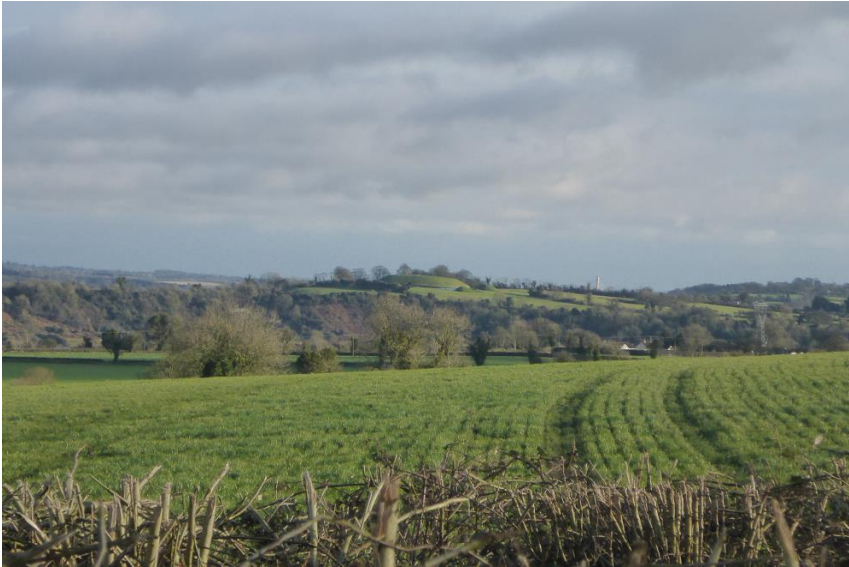
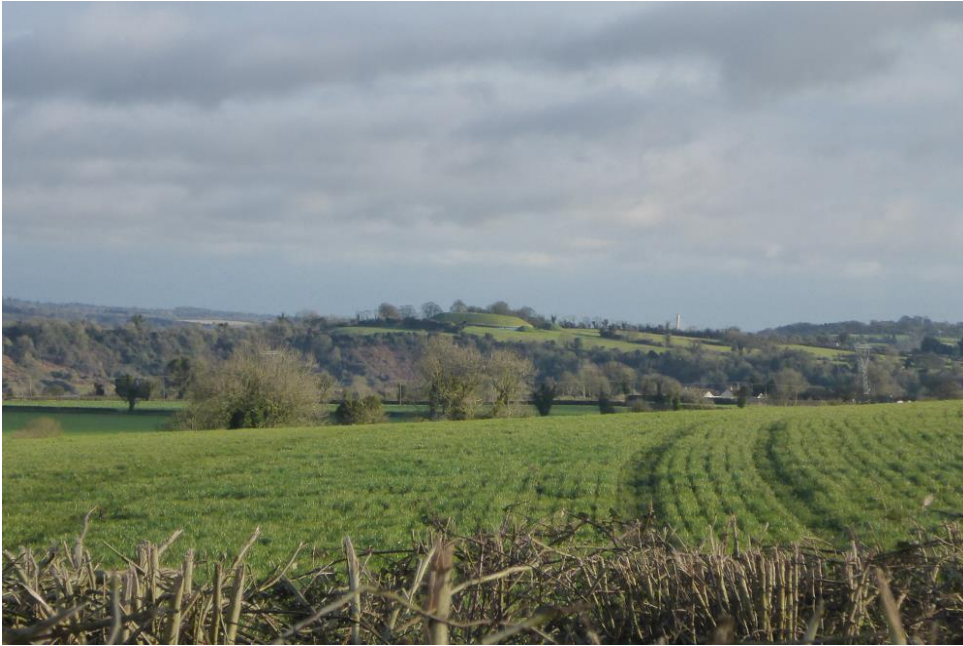
View of Knowth from boundary of F5

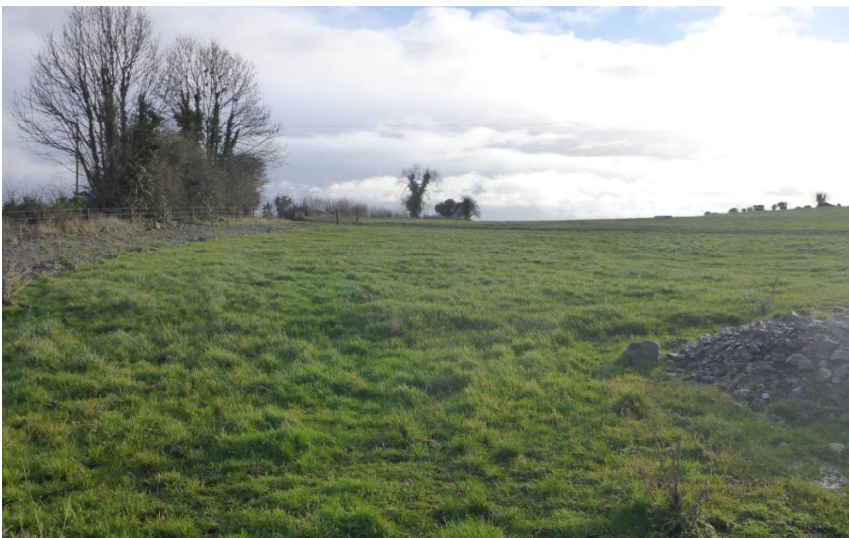
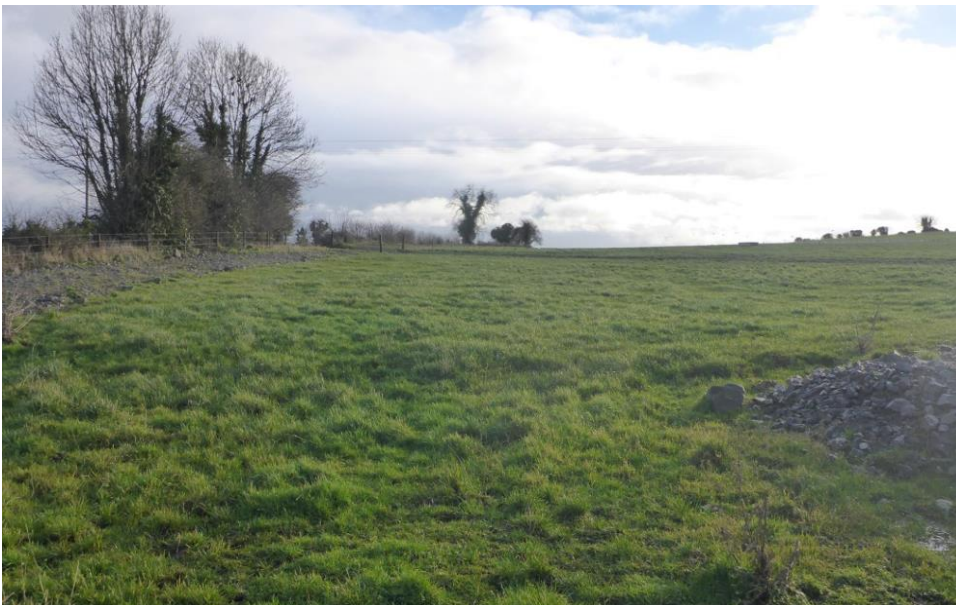
F5: Large former arable field, now under pasture, gently undulating and rising steadily to SSW. Hedgerow boundaries. Fennor / Cullen townland boundary runs along N side, formed by mature hedgerow and ditch, with large gaps along its length where the boundary is more sparse and has been supplemented with fencing. The long defunct section of the Dublin to Slane road survives as a farm access track running between F4 & F5 (described below under Cultural Landscape). View of Knowth from E side of field.

F5 facing south

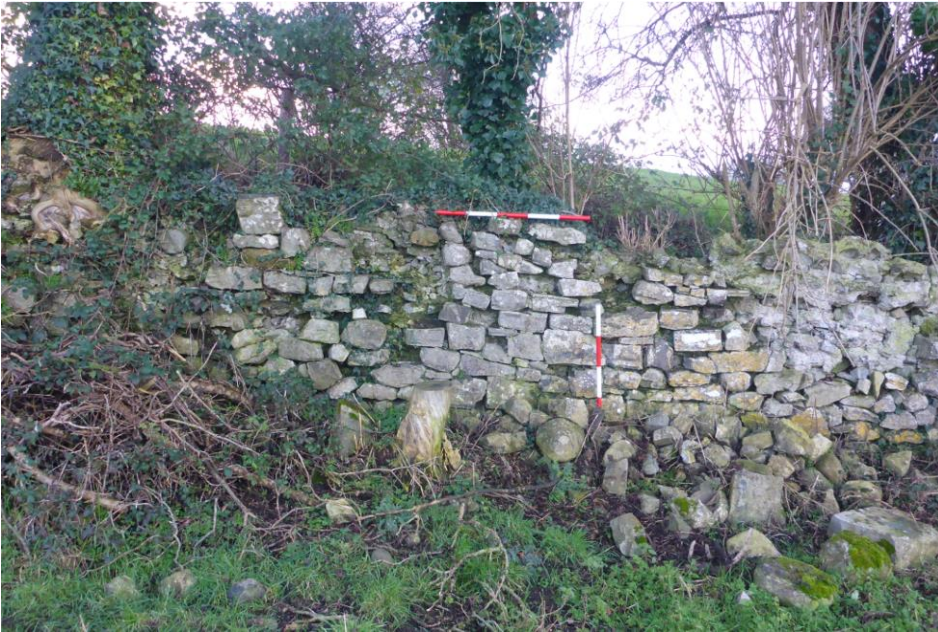
Retaining stone field boundary wall between F11 and F12

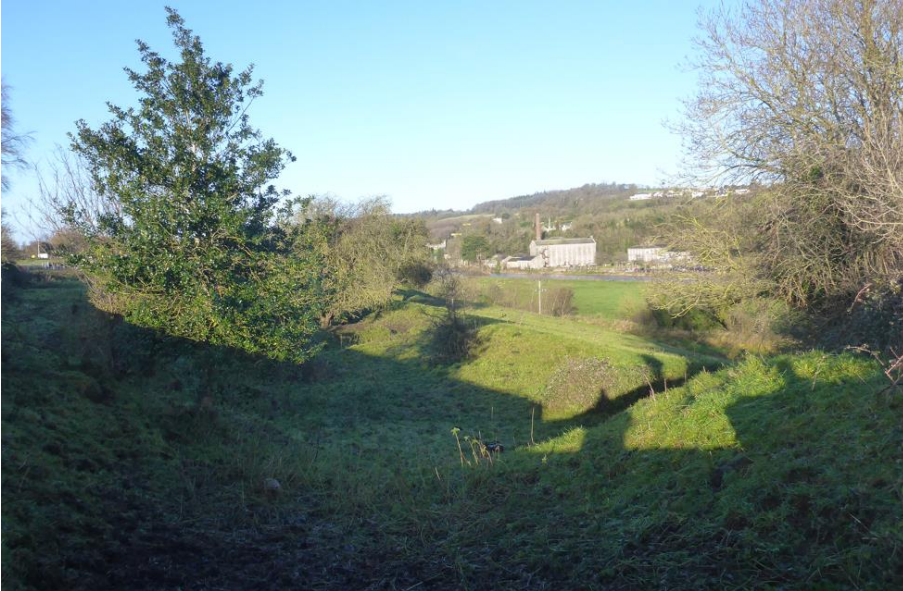
Large quarry pit at E end of F12, overlooking Slane Mill to NW

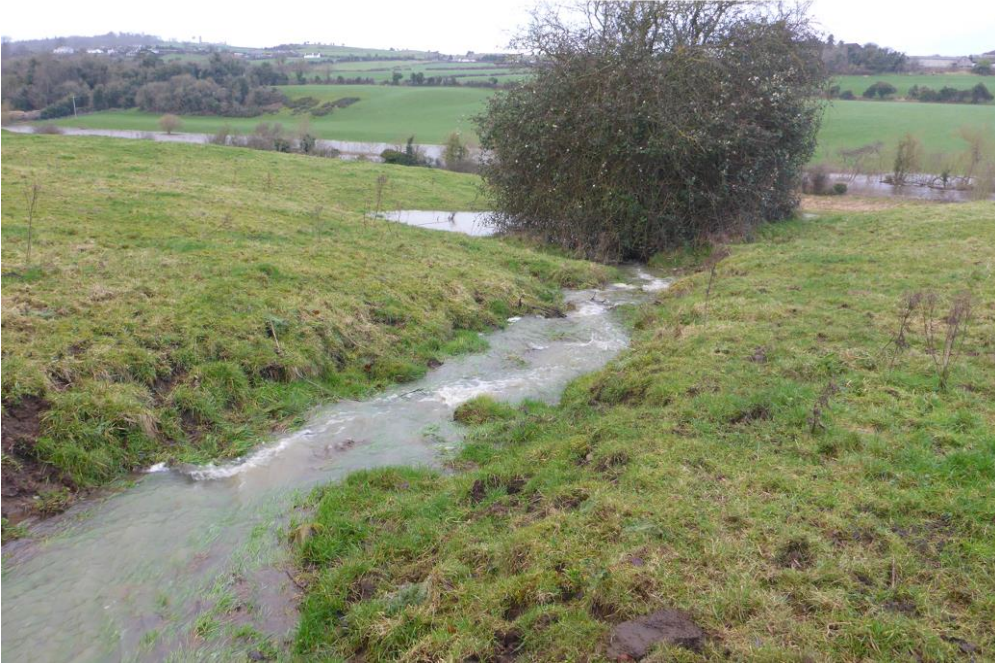
Recorded watercourse (SMR ME019-082). Described above. Initially identified as a possibly late medieval culvert, but cartographic evidence suggests 19th century.

Stream (SMR watercourse ME019-082) flowing through F11, facing NNW

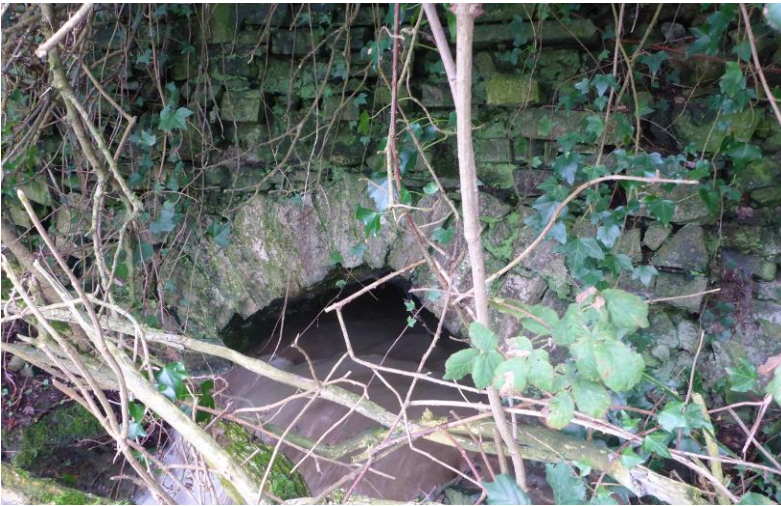
Culvert in F11

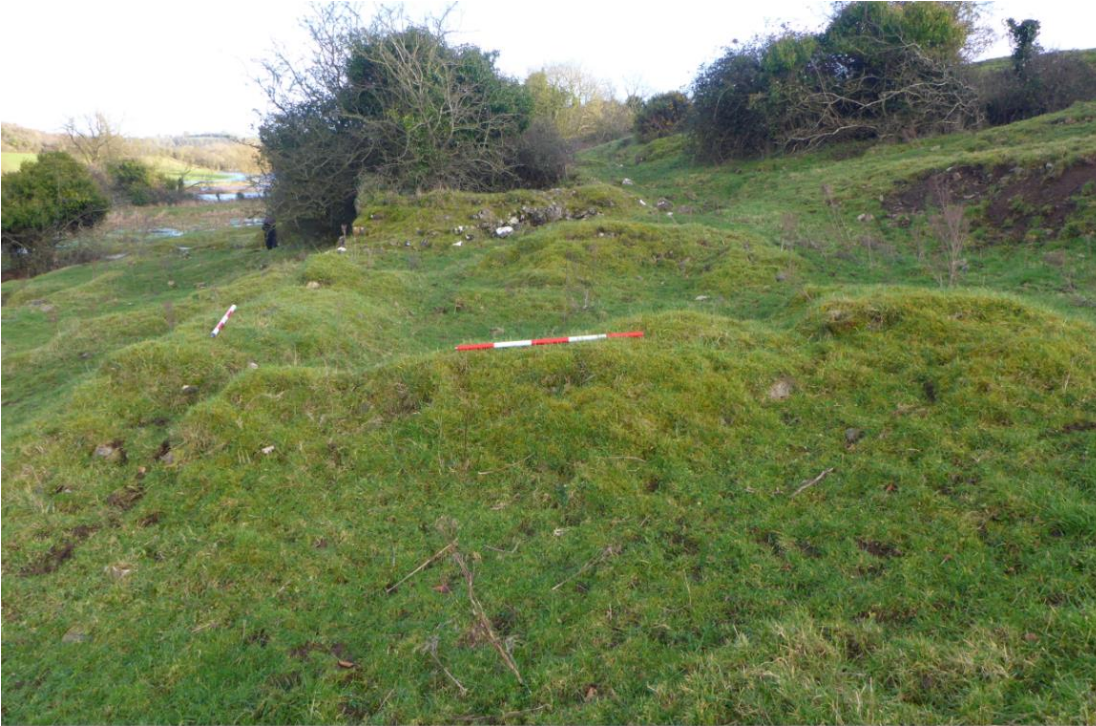
The remains two small structures depicted on the first edition OS map were identified in the NE corner of the field, with traces of an old lane running along the field boundary from the public road down to the structures. The degraded laneway runs north-south, marked by sections of collapsed stone wall and occasional hedgerow on the west side and a slight bank on the east. The laneway leads down to the site of two buildings and on towards the canal, with an entrance to the structures created by a gap in the bank (the S terminal is faced with neatly finished stonework). The structures are located on a terrace immediately to the south of the canal. The eastern building represents the remains of a small house. The north wall survives to a height of c. 1.7m and is constructed of squared rubble limestone. The other walls survive as grassed over foundations. Immediately to the west of the house are the grassed over wall footings of a smaller structure, possibly an associated outbuilding. The structures measure 3.6m internally from north to south. External measurements for both structures were also similar, c. 7m by c. 5m. A terraced area on the N side of the eastern structure is delineated by very low and eroded earthen banks and measures c. 13m by c. 4m. While it is possible that these represent a house and outbuilding, they are small structures of equal size and may instead be two separate dwellings. Given their proximity to the canal – and the laneway that provides access to it – it is possible that they were buildings constructed and utilised during the canal construction in the late 18th century, either as dwellings, for storage, or other works (or a combination thereof).

Foundation remains of house sites at E end of F11

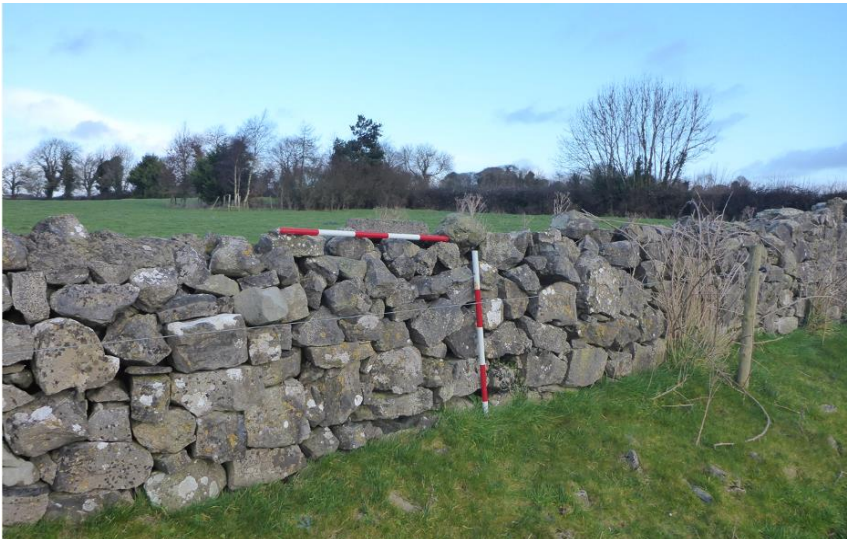
F19: Large triangular-shaped pasture field, relatively level, undulating slightly. Hedgerow boundaries, with N51 road at northern end and dry-stone wall boundary along S side. The wall is constructed of uncoursed rubble stone, with no coping or distinctive features, and stands c. 1m high.

Stone wall field boundary at S end of F19

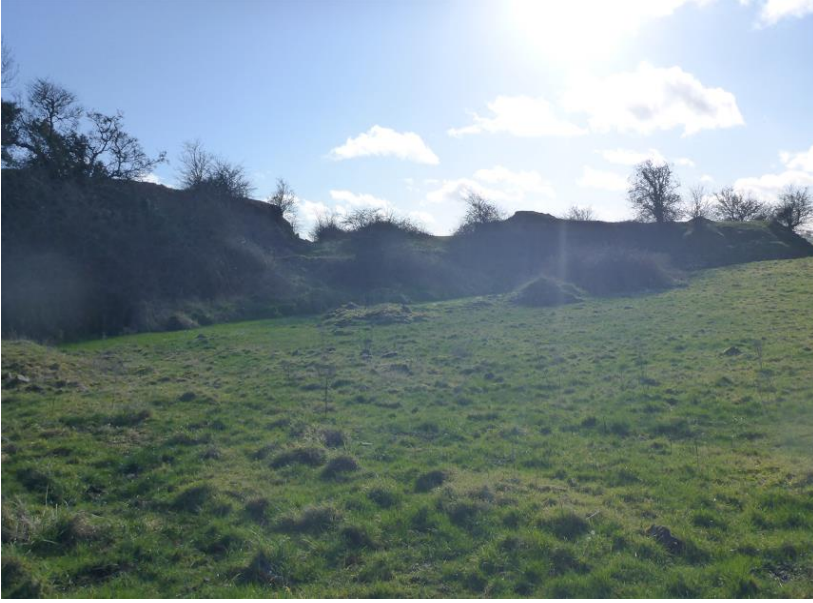
Quarried out knoll of Limekiln Hill, F22

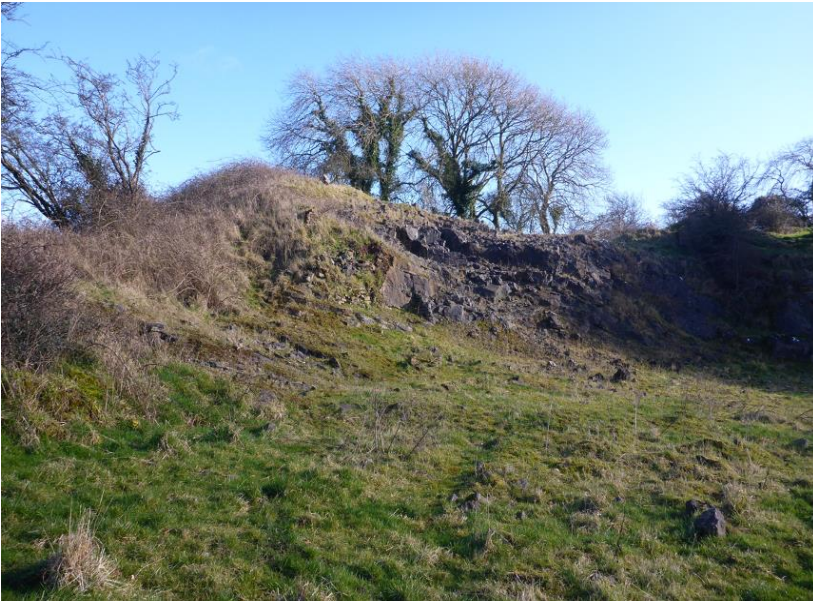
Quarry at Limekiln Hill, F22

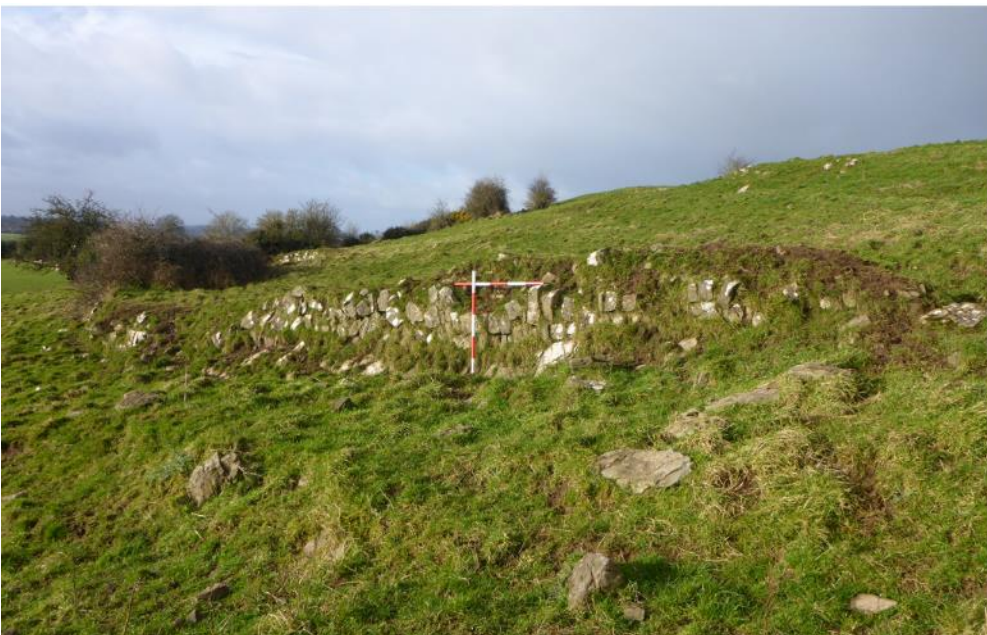
RMP / SMR sites on or near the proposed scheme are predominantly sub-surface (as described above), with the exception of two cashels located outside the proposed scheme. Of the two cashels, RMP ME019-062 on Stanley Hill is the best preserved, with the enclosing low dry-stone wall surviving almost the entire

Drystone enclosure boundary around hill top at Stanley Hill / Gallows Hill
