# Environmental Impact Assessment Report (EIAR)

## Volume 2 Appendices

Large Scale Residential Development at Ruanbeg, Kildare Town, Co. Kildare

May 2023

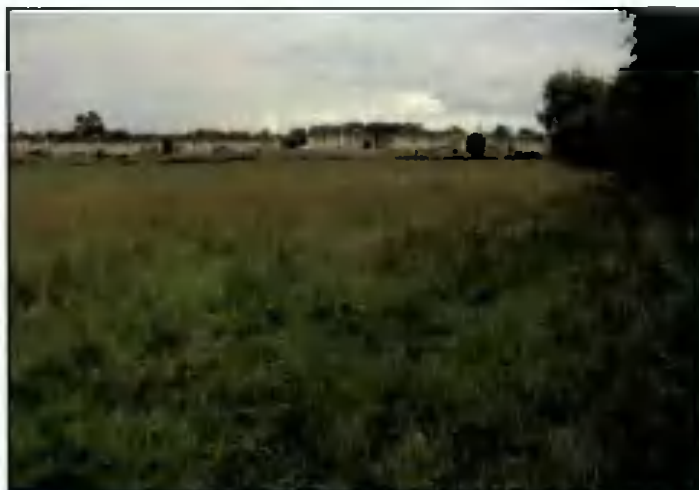
Plate 1: Hedge 1 to the northwest with existing estate to west

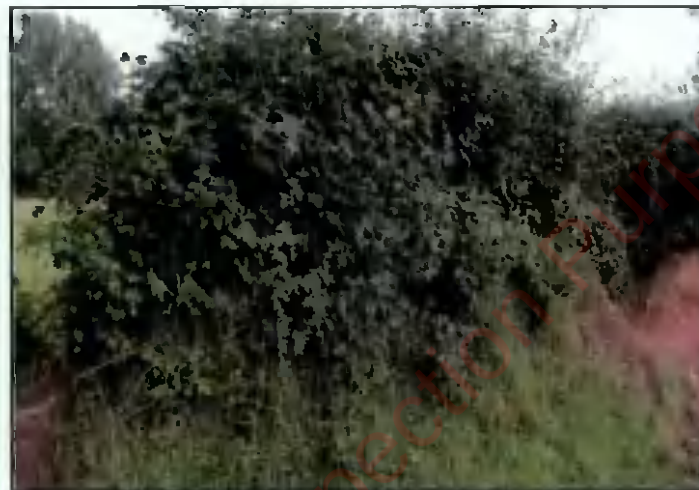
Plate 2: Section of hedgerow with livestock disturbance

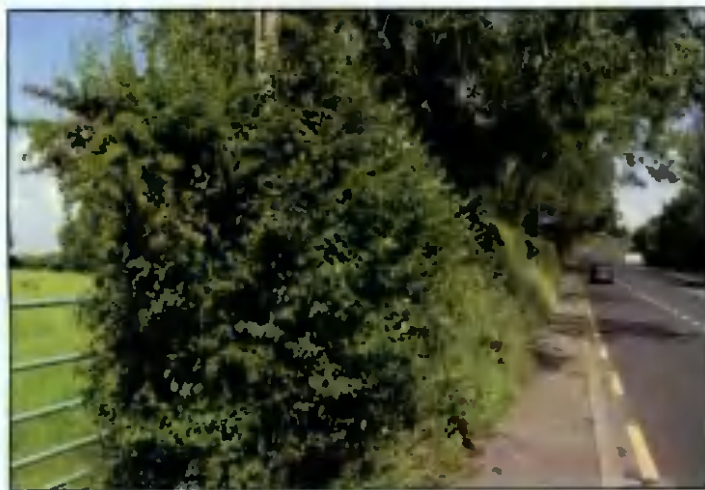
**Plate 5:** Hedgerow (WL1) along R445 (outside site boundary)

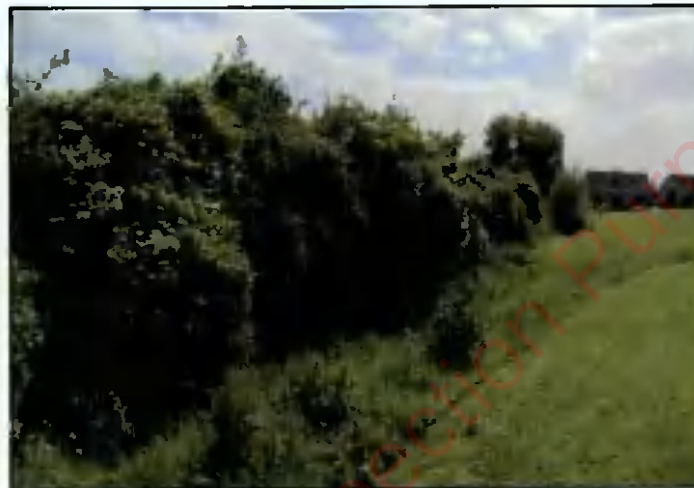
**Plate 6:** Hedge 1 from other side (outside site boundary)

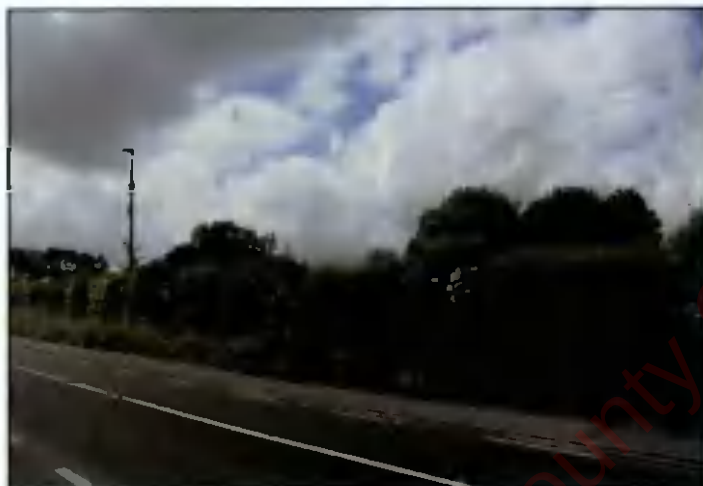
**Plate 7:** Hedgerow and with negligible potential for bat roosting

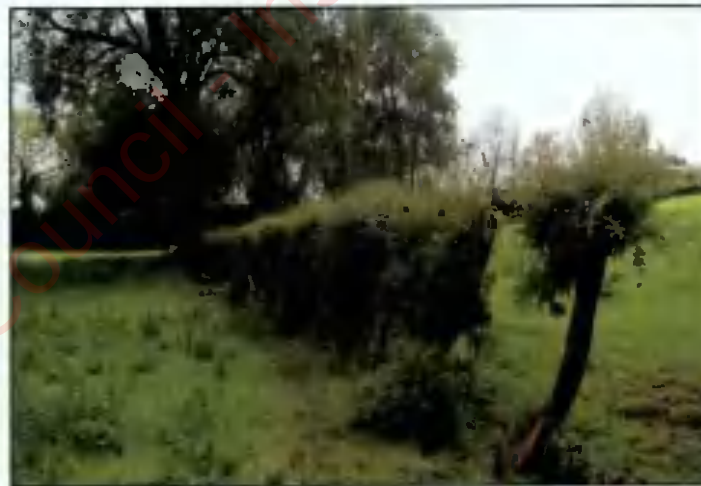
**Plate 8:** Hedgerow and with negligible potential for bat roosting

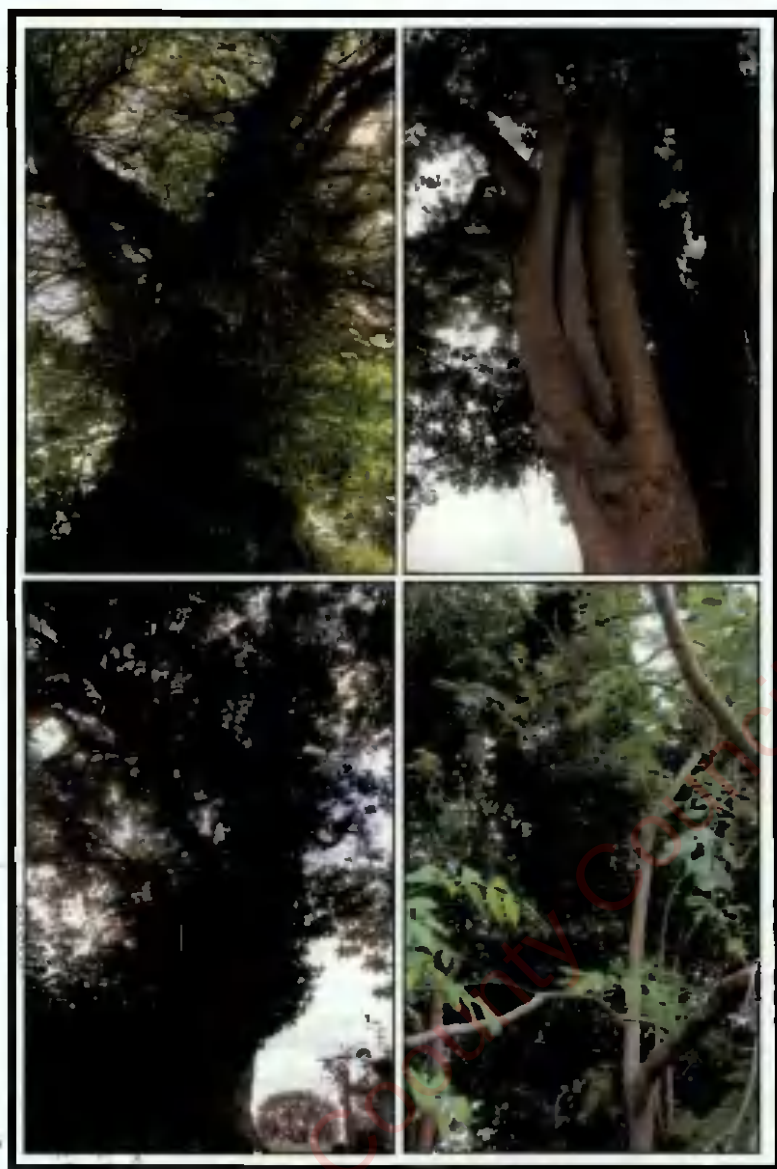
Plate 9: Trees with moderate potential for bat roosts

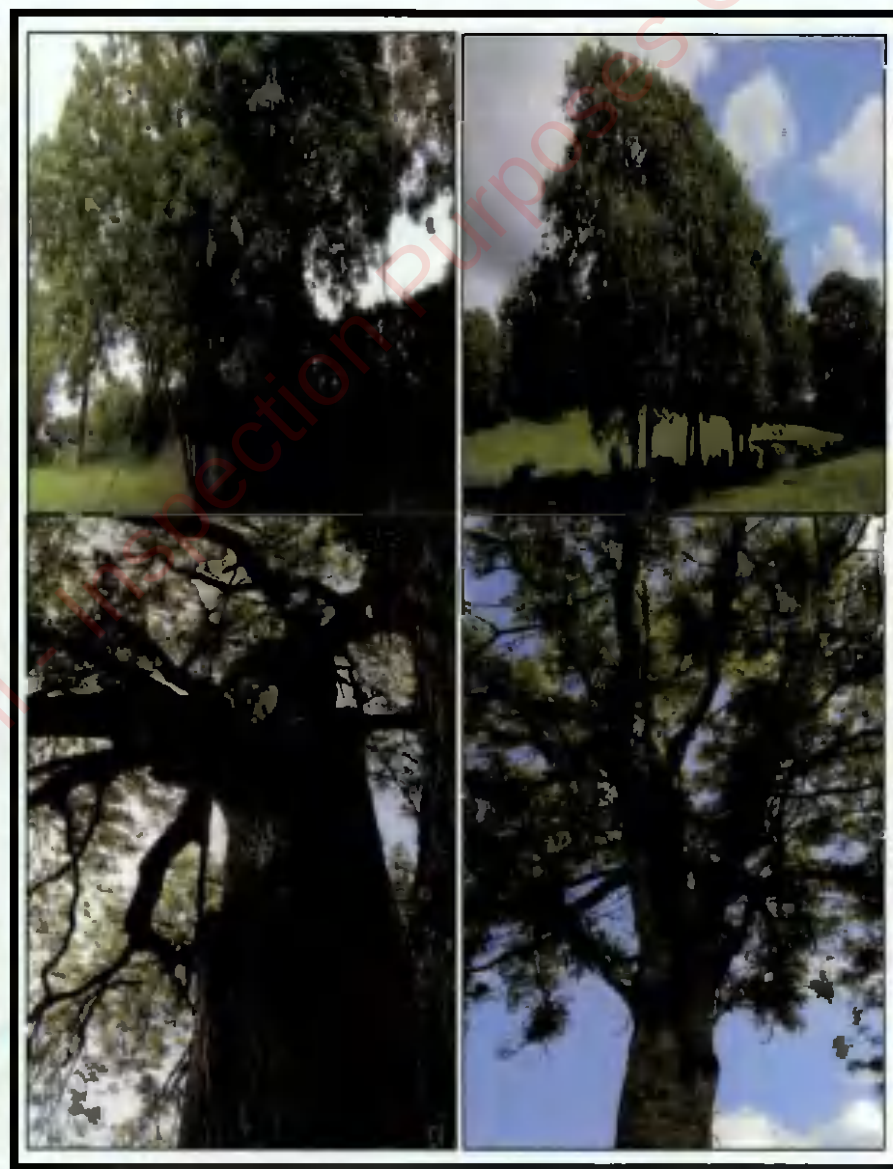
Plate 10: Ash and Sycamore Trees with low / negligible potential for bat roosts

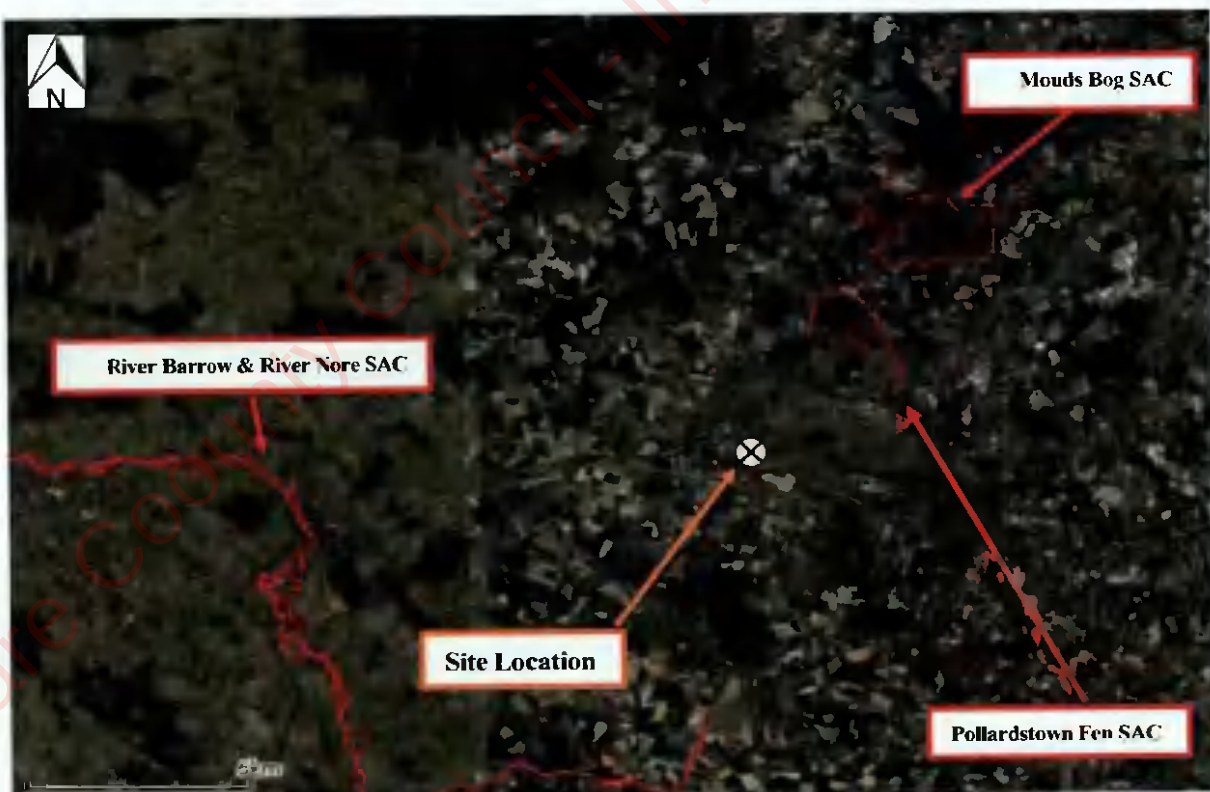
**Figure 4.2:** Location of Proposed Development and Natura 2000 Sites

The proposed development will consist of a Large-scale Residential Development of 295 no. units. The development will include one, two, three and four bed units in the form of two storey detached, semi-detached / terraced houses, along with 3 no. three storey duplexes/apartments and a single storey age friendly accommodation block. The development also includes a creche along with associated car parking, bicycle parking, landscaping, and open spaces. Vehicular and pedestrian access will be provided from the Dublin Road (R445) and via Ruanbeg Avenue. Additional pedestrian access will be provided via Ruanbeg Park. All other site works including boundary treatments and site services to facilitate development at Ruanbeg, Kildare Town, Co. Kildare [ITM Coordinates 674386, 712374], as shown in Figure 4.1 below. The total site area is approximately 10.3ha. The closest Natura 2000 sites are the Pollardstown Fen SAC (Site Code: 000396) located approximately 3.9km and Mouds Bog SAC (Site Code: 002331) located approximately 6.5km from the proposed development as shown in Figure 4.2 below.

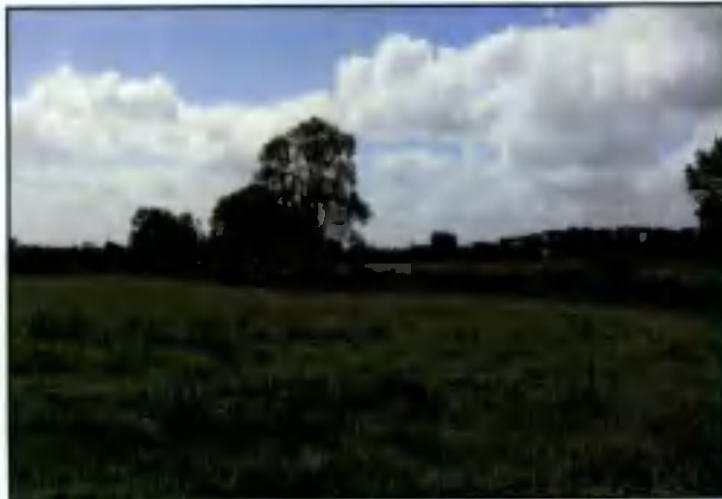
Plate 1: Improved agricultural grassland (GA1) habitat

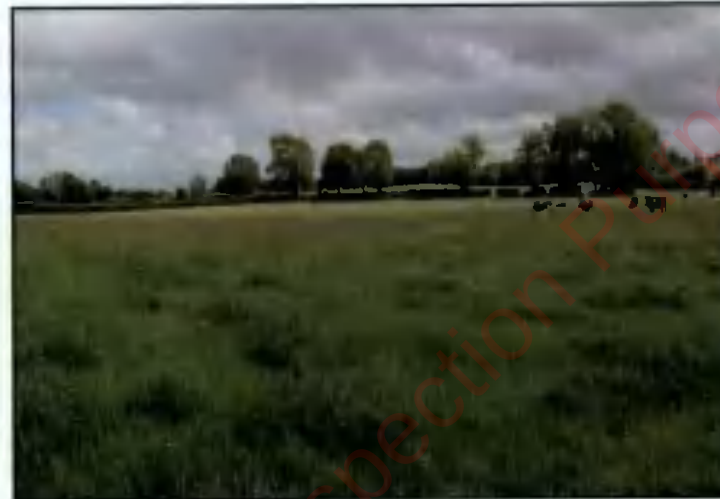
Plate 2: Improved agricultural grassland (GA1) habitat

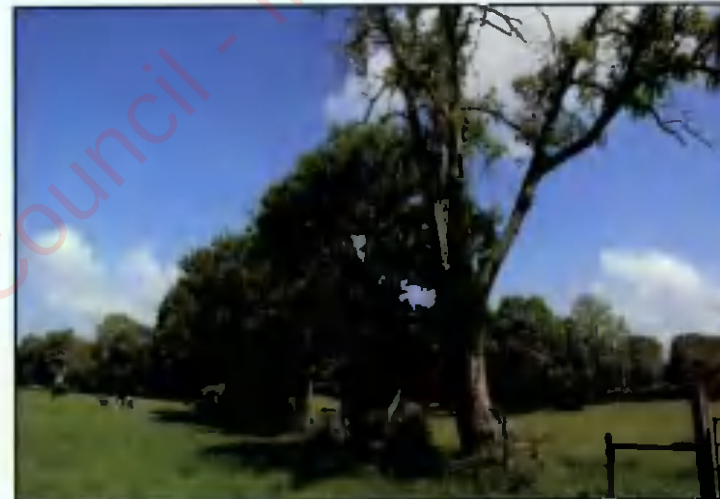
Plate 4: Treeline (WL2) habitat along field boundaries

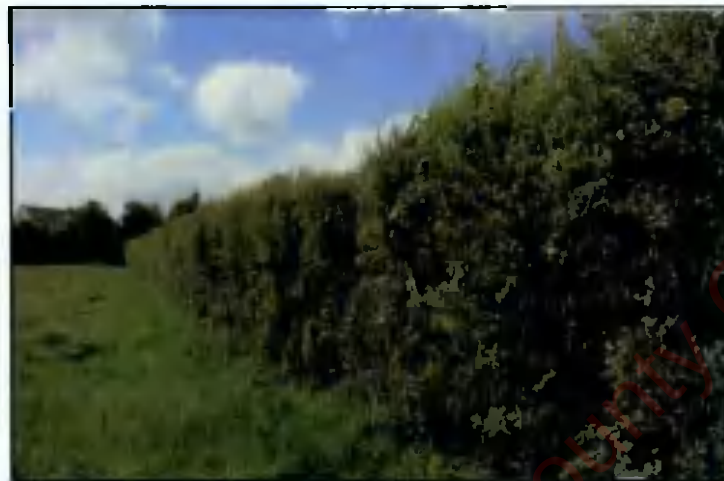
Plate 7: Hedgerow (WLI) habitat along field boundaries

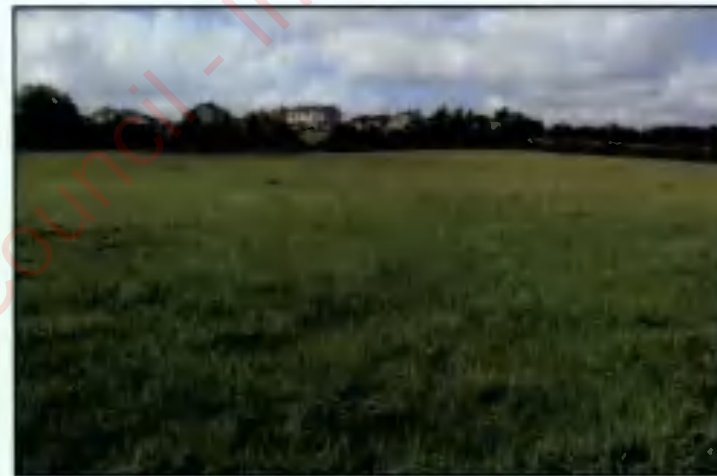
Plate 8: View of site facing north west

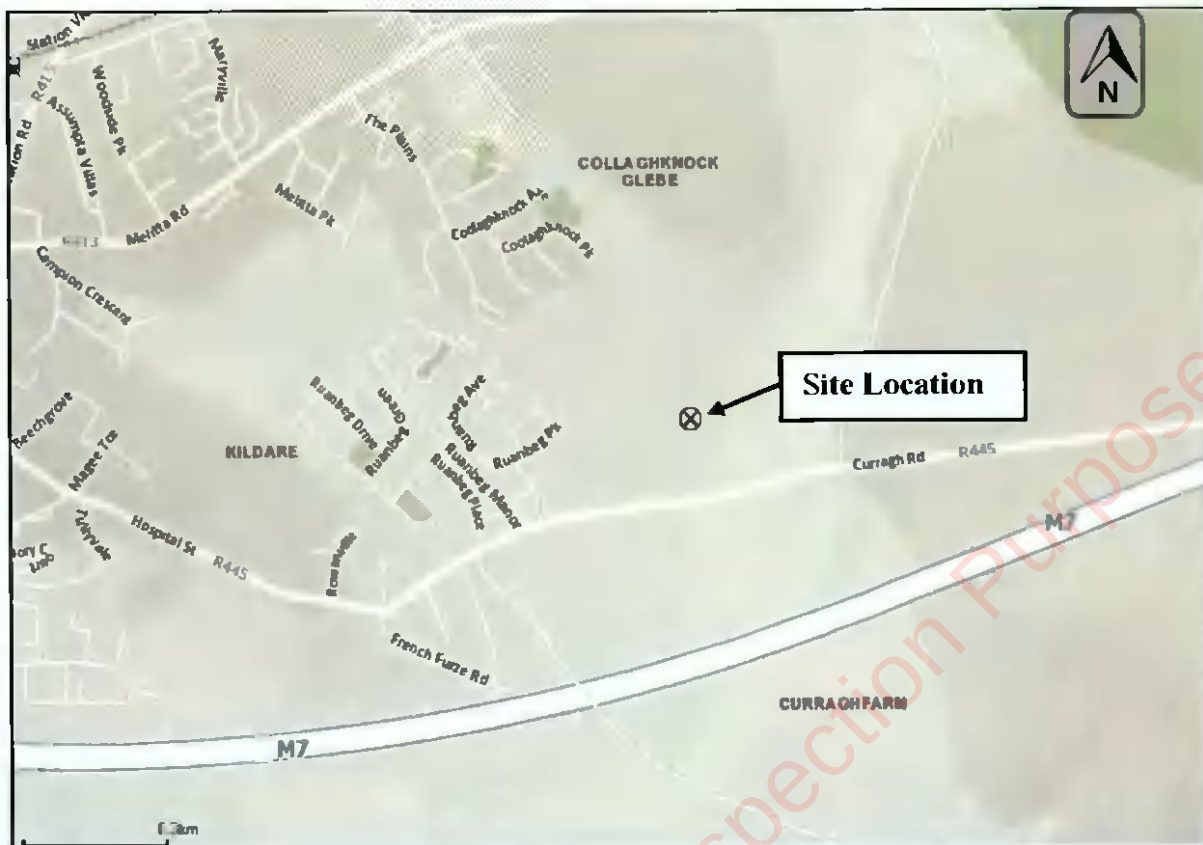
Figure 2.1: Location of Proposed Site at Ruanbeg, Kildare Town, Co. Kildare

The proposed development is located within at Ruanbeg, Kildare, Co. Kildare [ITM Coordinates 674386, 712374] as shown in Figure 2.1. The site is accessed via main entrance along the regional road R445. The development will include one, two, three and four bed units in the form of two storey detached, semi-detached / terraced houses, along with 3 no. three storey duplexes/apartments and a single storey age friendly accommodation block. The development also includes a creche along with associated car parking, bicycle parking, landscaping, and open spaces. Vehicular and pedestrian access will be provided from the Dublin Road (R445) and via Ruanbeg Avenue. Additional pedestrian access will be provided via Ruanbeg Park. All other site works including boundary treatments and site services to facilitate development.

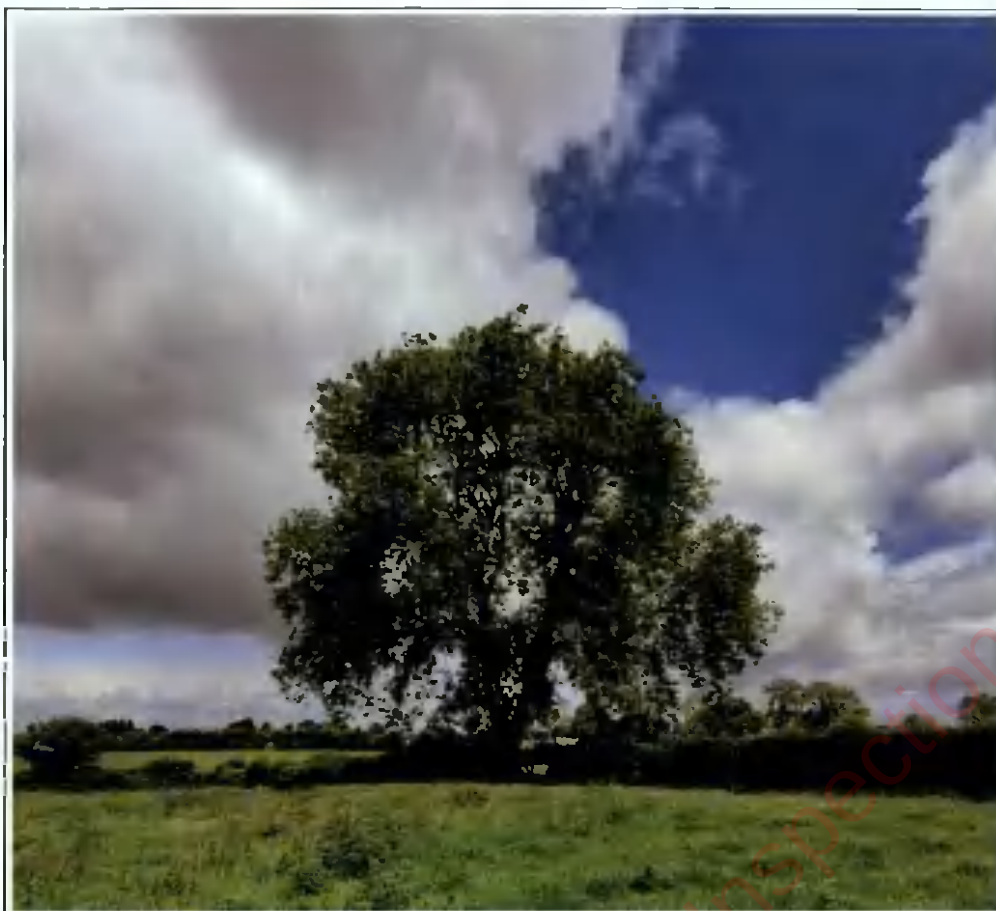
An example of the high quality ash trees on site

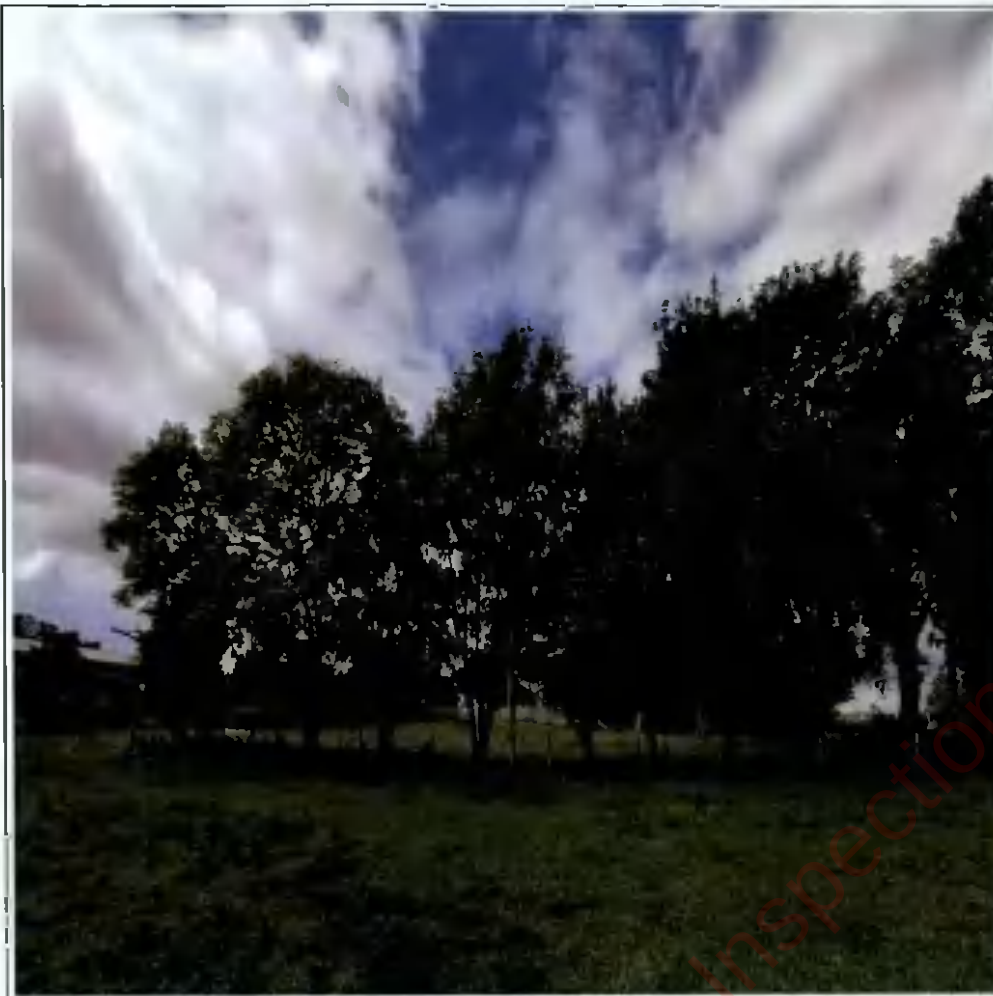
Group 1 , mixed  
deciduous trees located  
just off site

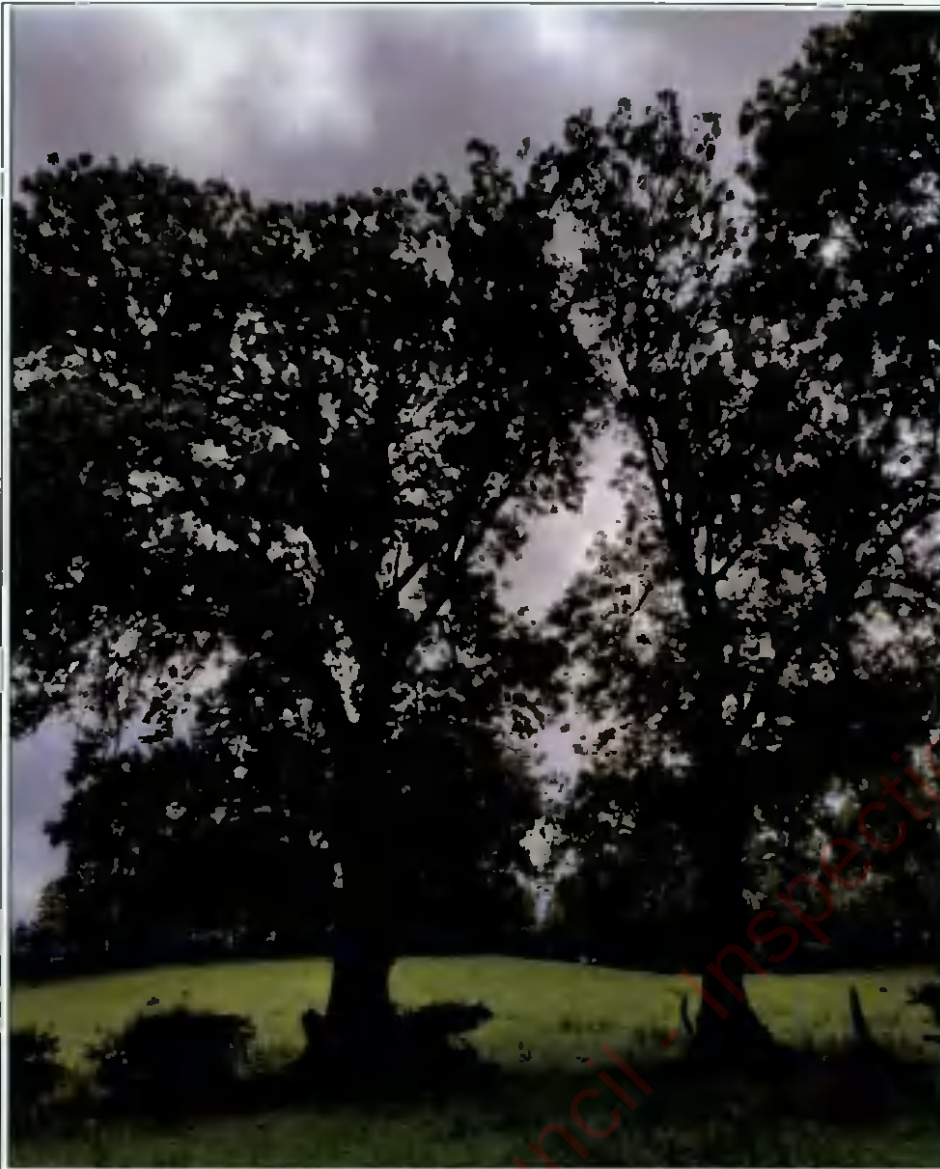
Two large mature trees

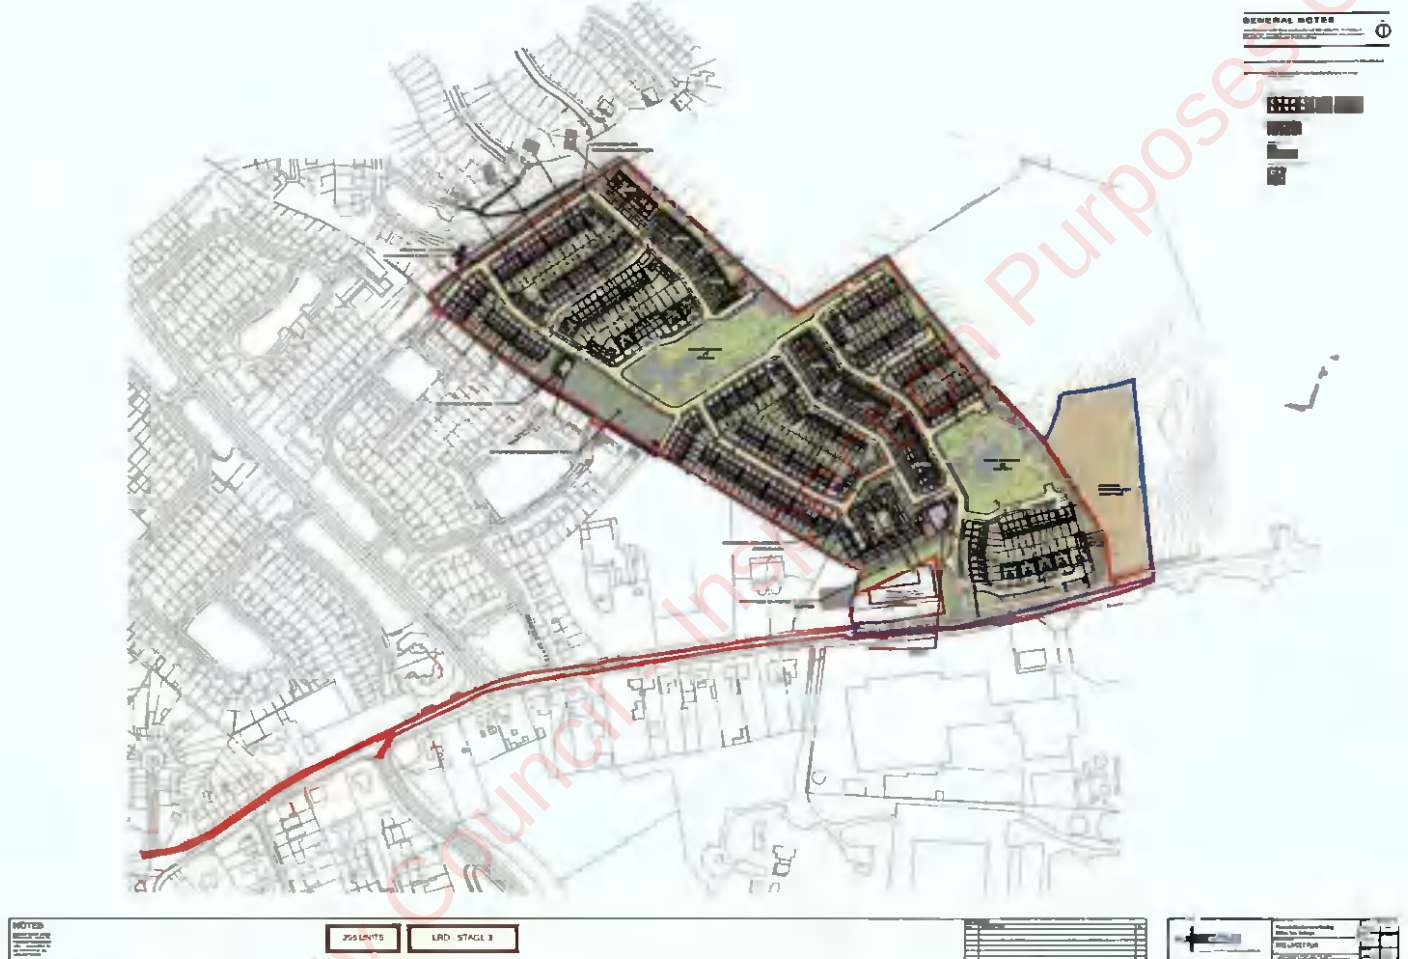
Figure 2. Proposed site layout.

The proposed development will consist of a Large-scale Residential Development of 295 no. units. The development will include one, two, three and four bed units in the form of two storey detached, semi-detached / terraced houses, along with 3 no. three storey duplexes/apartments and a single storey age friendly accommodation block. The development also includes a creche along with associated car parking, bicycle parking, landscaping, and open spaces. Vehicular and pedestrian access will be provided from the Dublin Road (R445) and via Ruanbeg Avenue. Additional pedestrian access will be provided via Ruanbeg Park. All other site works including boundary treatments and site services to facilitate development.

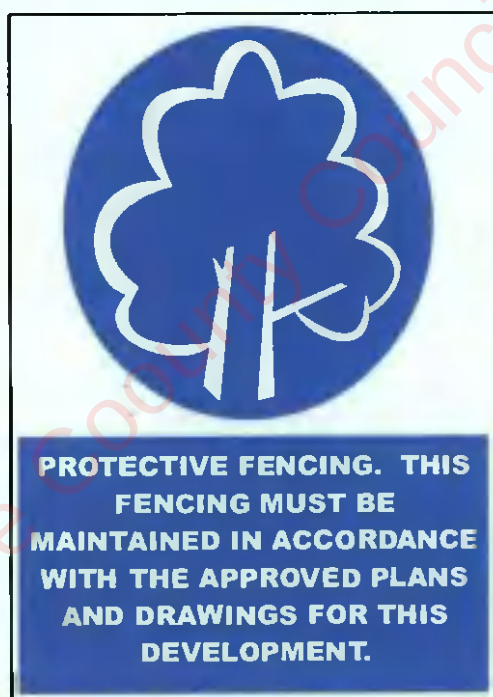
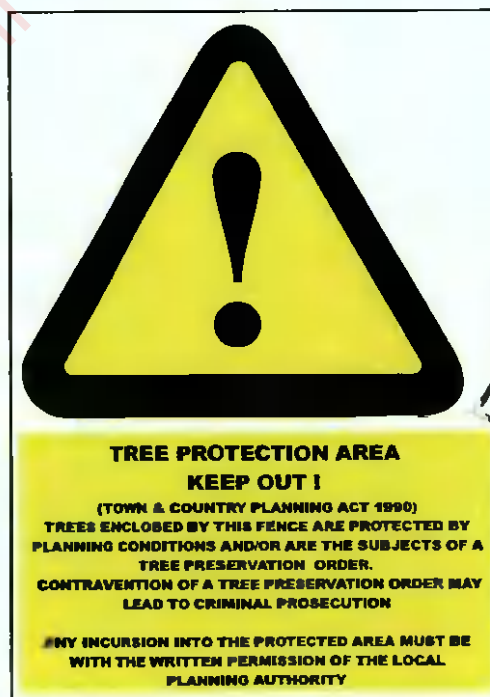
Figure 3 Default specification for tree protection barrier in accordance with BS5837:2012

| <b>Installation of fencing within RPAs</b> | <p>The installation of fencing within the RPAs of retained trees will be carried out using the following methodology:</p> <p>Post holes will be carefully positioned as far away from the stem of trees as possible (minimum 50 cm) to minimise contact with tree stems and significant tree roots.</p> <p>Holes will be manually excavated with the use of hand tools only and where roots greater than 25mm in diameter or large fibrous roots are present, the position of the hole will be slightly altered to avoid potential root damage.</p> <p>If the position of the hole cannot be altered, roots greater than 25mm in diameter or large fibrous roots will be protected with flexible plastic pipes and retained within the pit.</p> <p>In some cases, individual roots less than 25mm in diameter may be pruned, making a clean cut with a suitable sharp sterile tool (e.g. secateurs or hand saw).</p> <p>Once the required depth has been excavated, the hole will be lined using 1000-gauge polythene and filled with the appropriate concrete mix.</p> |

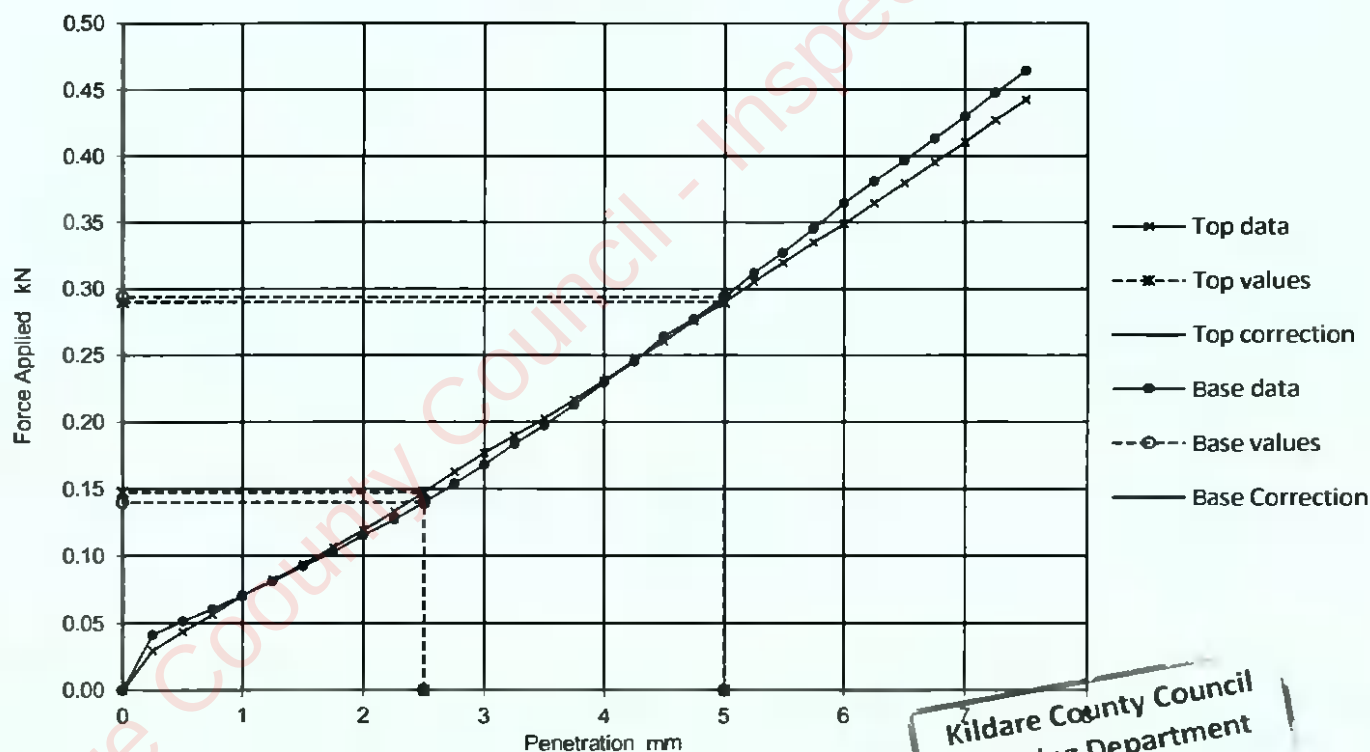
Force v Penetration Plots

| | Moisture content | 12 | % | | | | |

Tested at natural moisture content.

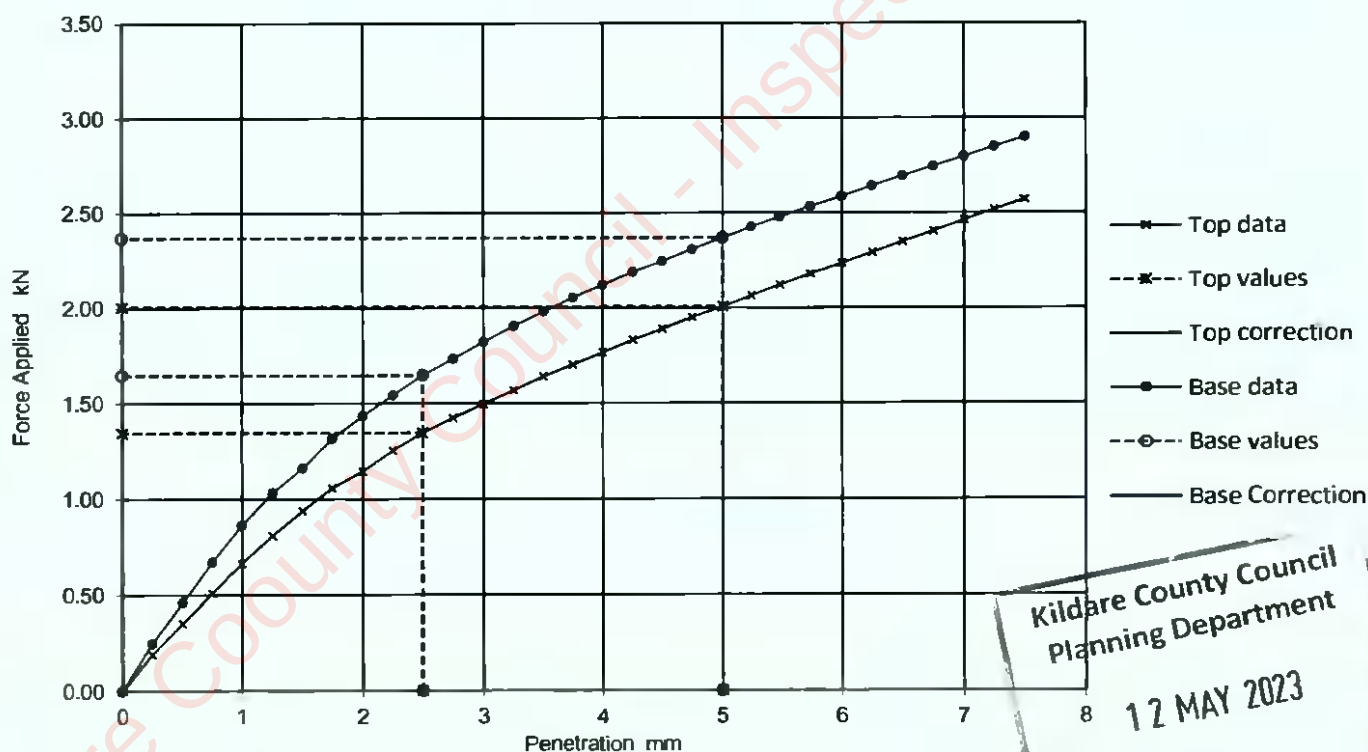
### Force v Penetration Plots

Moisture content 17 %

Tested at natural moisture content.

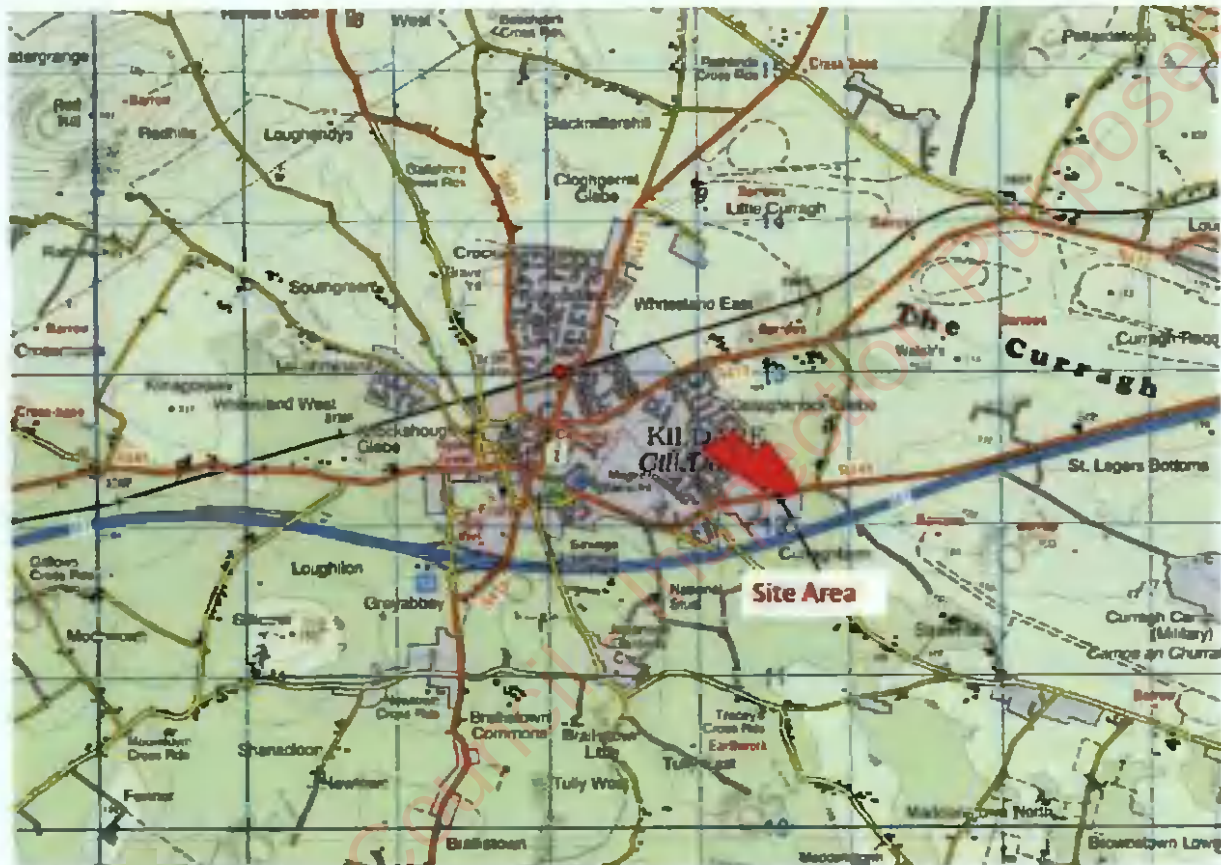
Figure 2.1 Site Location

The proposed residential development site comprises a landholding of 10.3 hectares immediately east of Kildare town. The site is located approximately 1.6km to the east of the centre of Kildare town, 450m north of the M7 motorway - see Figure 2.1.

The proposed site currently consists of a number of agricultural fields. The site is accessed by the regional road (R445) and the surrounding area is characterised by residential estates to the west and north and the Curragh Racetrack and associated surrounding Curragh plains to the east. The R445 bounds the southern boundary of the site.

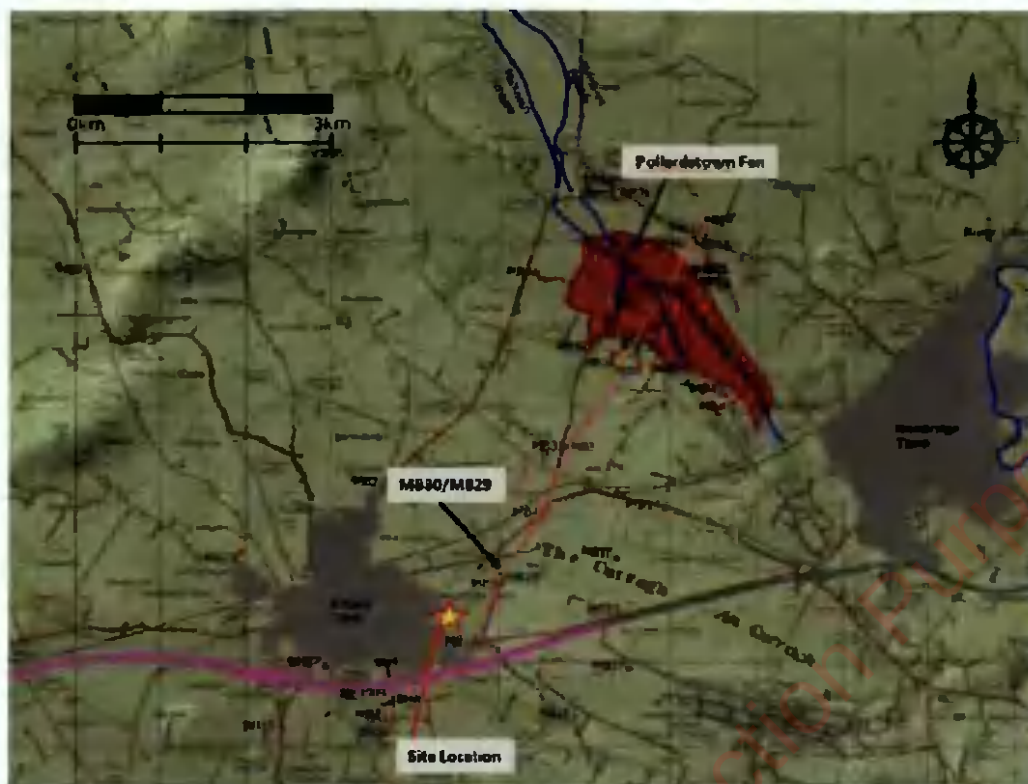
Figure 4.4 Transect through Curragh Aquifer & Pollardstown Fen

The monitoring borehole locations utilised by Langford, 2011 are presented in Figure 4.4 and Figure 4.6 with a cross section of the aquifer and interpreted ground flow directions provided in Figure 4.5 and Figure 4.6.

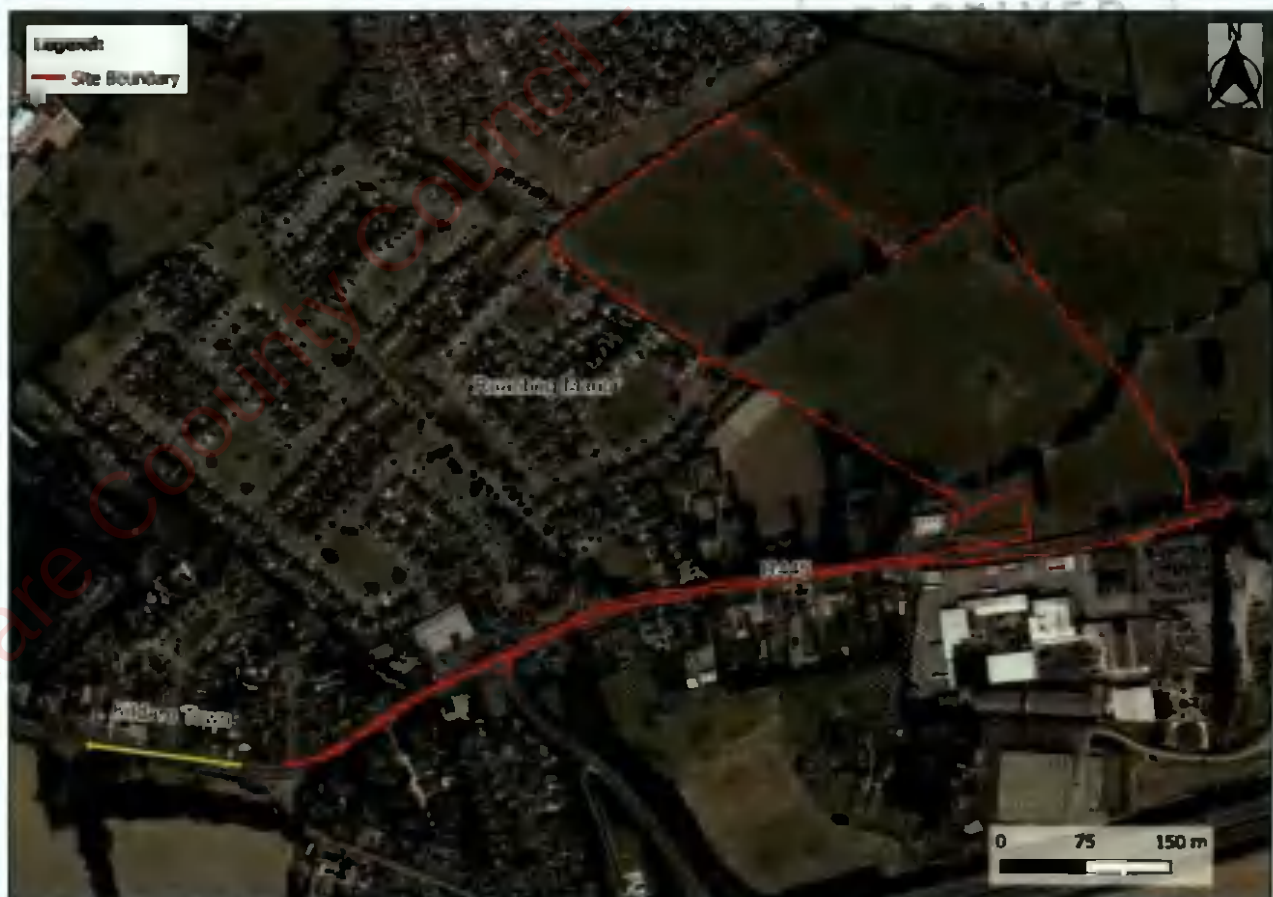
Figure 1-1: Site Location.

The proposed development is located on the northern side of R445 and the M7 (Kildare Bypass). The site is within the Kildare Council Development Plan (2023-2029) boundary and included within the Draft Kildare Local Area Plan (2023-2029).

The site location is shown in Figure 1-1 below.

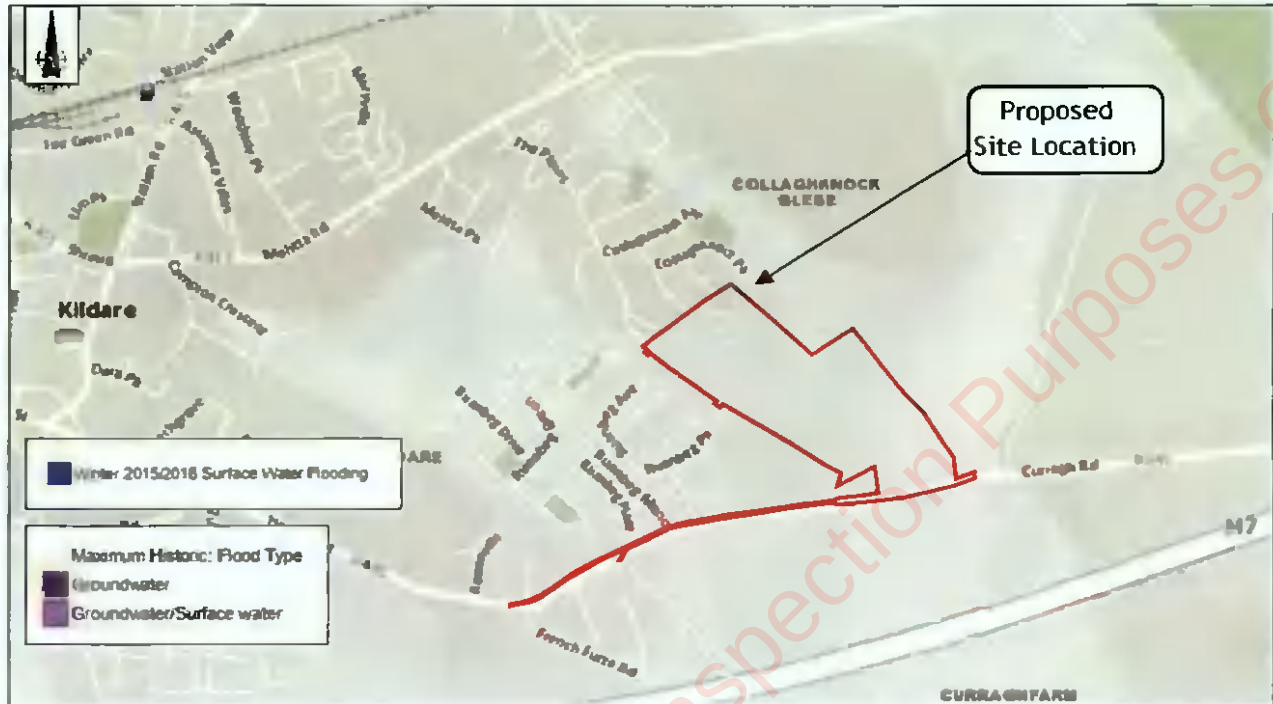
Figure 3-3: Winter 2015/2016 Surface Water Flooding and Maximum Historic Groundwater Flooding (source: Geological Survey of Ireland ([www.gsi.ie](http://www.gsi.ie)))

There is no identifiable flood risk associated with the site as shown in Figure 3-3.

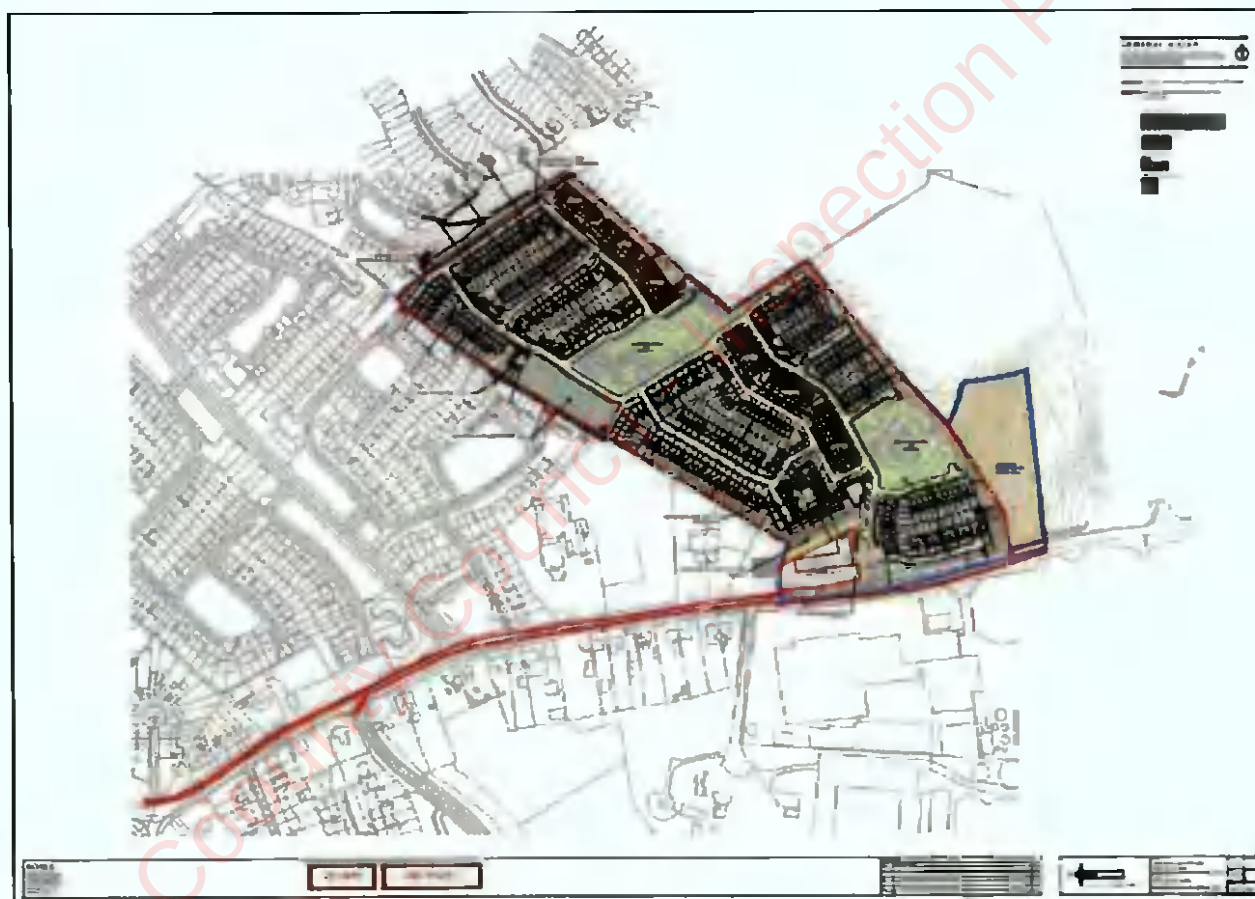
Figure 1 – Site Layout Plan

The proposed development will consist of a Large-scale Residential Development of 295 no. units. The development will include one, two, three and four bed units in the form of two storey detached, semi-detached / terraced houses, along with 3 no. three storey duplexes/apartments and a single storey age friendly accommodation block. The development also includes a creche along with associated car parking, bicycle parking, landscaping, and open spaces. Vehicular and pedestrian access will be provided from the Dublin Road (R445) and via Ruanbeg Avenue. Additional pedestrian access will be provided via Ruanbeg Park. All other site works including boundary treatments and site services to facilitate development.

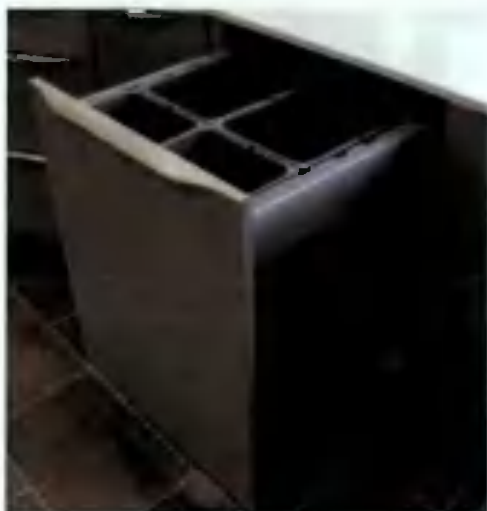
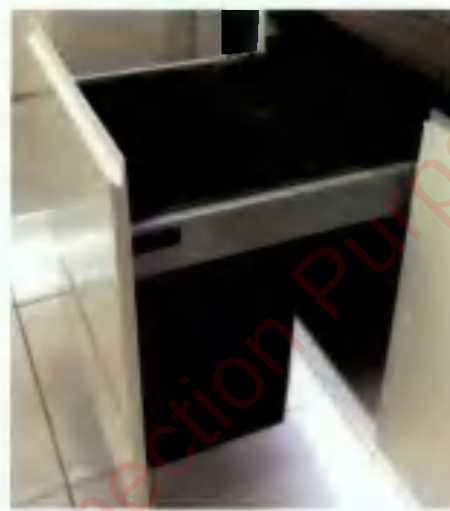
Provision is made for the segregation and storage of domestic waste within each unit. Each unit is provided with bins in the kitchen area to enable the separation of waste into different waste streams – 1.) glass, 2.) food, 3.) DMR (Dry Mixed Recycling) and 4.) general waste (MNR). Sample images of bin types in each unit below.

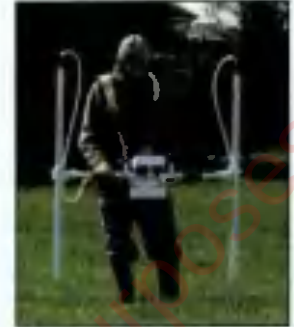
#### **Bartington GRAD 601-2**

The Bartington Grad 601-2 instrument is a specifically designed gradiometer for use in archaeological prospection. The gradiometer operates with a dual sensor capacity making survey very fast and effective. The sensors have a separation of 1m allowing greater sensitivity.
