# Environmental Impact Assessment Report (EIAR)

## Volume 2 Appendices

Large Scale Residential Development at Ruanbeg, Kildare Town, Co. Kildare

May 2023

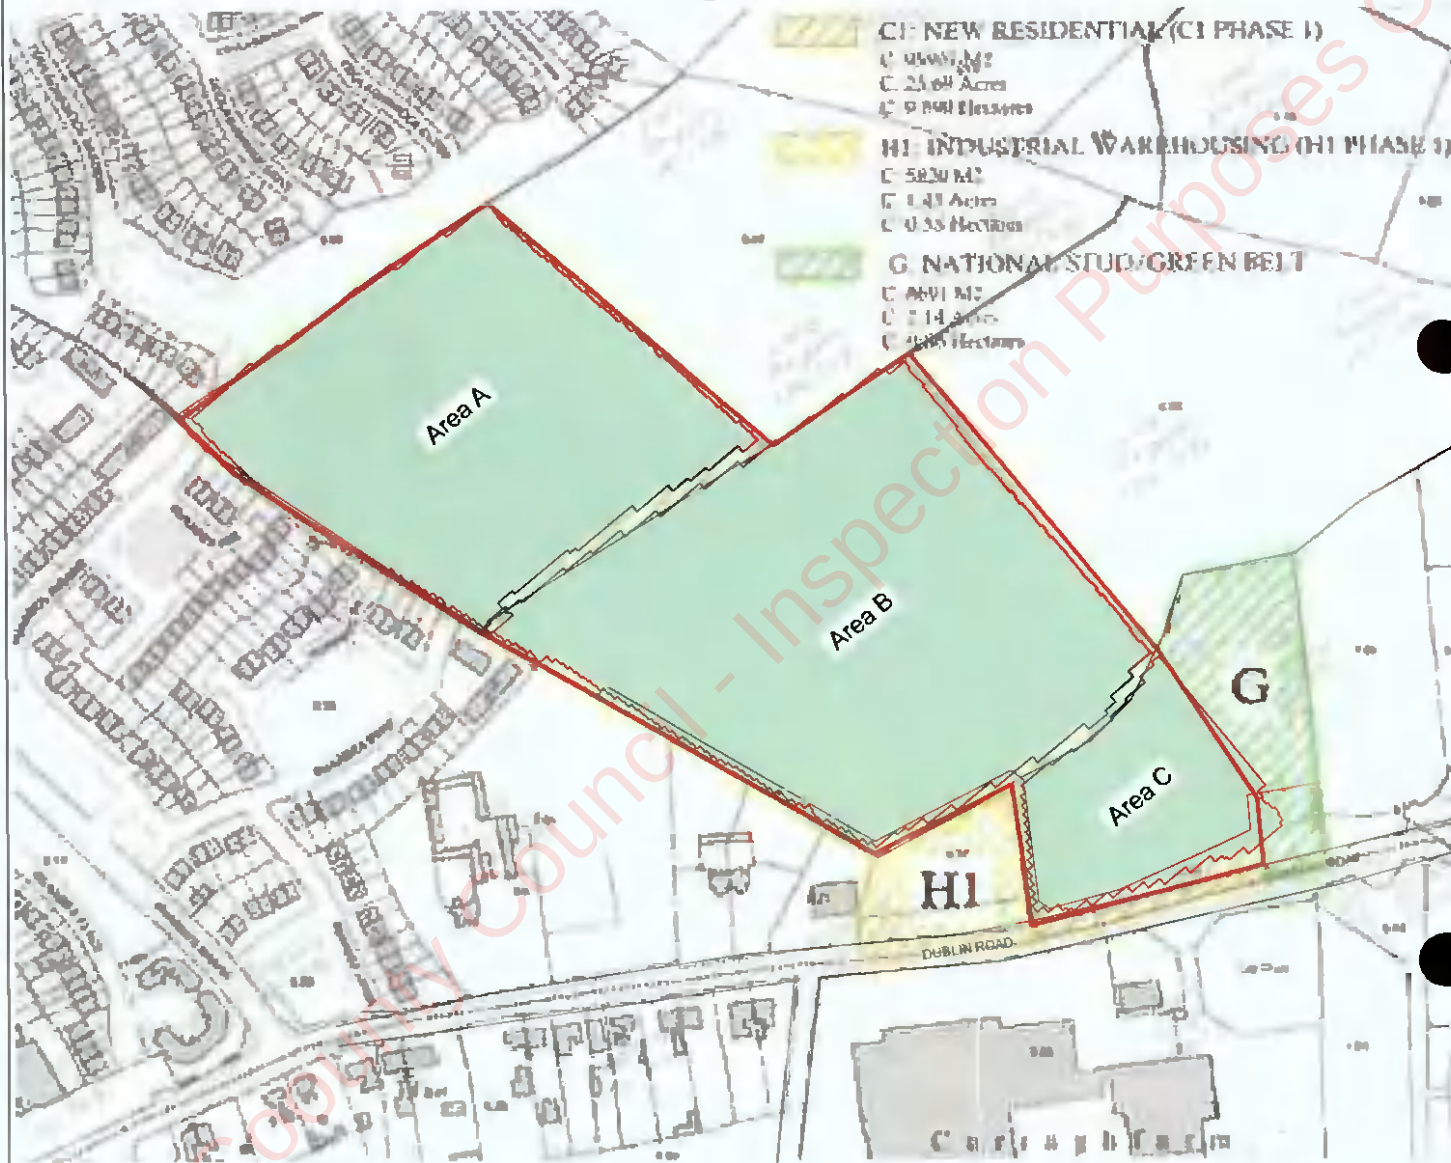
Scale @ A3 1:1,500  
Figure 2  
Licence No 22R0168  
Issue Date 30.06.2022

- 5.1 Detailed survey Area A is dominated by modern ferrous responses and magnetic disturbance. The ferrous responses result from modern litter and debris both on the surface of the field and buried. Broad ferrous responses (1) suggest the presence of large ferrous objects. These are considered to be modern in origin and not of archaeological interest.
- 5.2 In the south of Area A there is an area of increased magnetic response (2). It is possible that this represent further modern material. However, an archaeological interpretation can also be considered. It is possible that a spread of burnt archaeological material is represented here. This is speculative and, given the abundance of modern ferrous material in this field, the increased response (2) is most likely modern in origin.

- 5.3 In Area B, further modern magnetic disturbance is noted along the western extent of survey.
- 5.4 In the south of the field, a large ferrous response (3) and associated magnetic disturbance has been recorded. Adjacent to this is a distinct spread of increased magnetic response (4) and ill-formed curvilinear trends. The possible origin of these responses is unclear. The ground appeared disturbed here, with a small depression and clump of nettle vegetation. An archaeological interpretation is unclear and it is considered more likely that these responses represent more recent ground disturbance and activity.

| <b>Figure</b> | <b>Description</b> | <b>Scale</b> |
|---|---|---|
| Figure 2 | Summary greyscale image | 1:1,500 |

- 4.1 A summary greyscale image of the gradiometer survey data, with an accompanying interpretation diagram are presented in Figures 2 and 3, at a scale of 1:1,500.

- 5.7 Area C comprises of several linear responses and trends, indicative of agricultural activity. Linear responses (7) in the south of Area C have some correlation with a

former farm building as depicted in the historic OS 6inch mapping. It is speculated that the linear trends (8) represent associated agricultural activity and a possible former field system.

- 5.8 Ferrous responses (9) appear to be orientate with (7) and (8) and may represent an associated former boundary feature.
