Moyvannan Electricity Substation

Annex 6.1: Geophysical Investigation Report

**REPORT
ON THE
GEOPHYSICAL INVESTIGATION
AT
SEVEN HILLS WIND FARM
SUBSTATION
Co. ROSCOMMON
FOR
ENERGIA**

PROJECT NUMBER	AGP23061		
AUTHOR	CHECKED	REPORT STATUS	DATE
TONY LOMBARD M.SC (GEOPHYSICS)	EURGEOL PETER O'CONNOR P.GEO., M.Sc (GEOPHYSICS), DIP. EIA MGT.	V.01	19 TH JUNE 2023
TONY LOMBARD M.SC (GEOPHYSICS)		V.02	09 TH NOVEMBER 2023

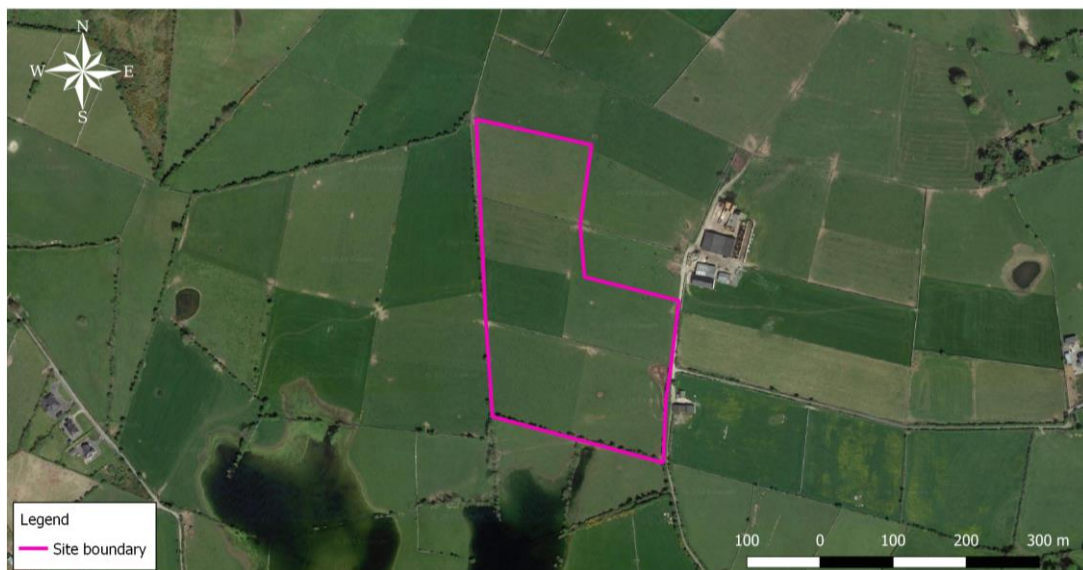
Fig 2.1: Site location shown in magenta.

The Seven Hills Wind Farm substation site (Fig. 2.1) is located approximately 12.5 km northwest of Athlone. The site is c. 8.2 ha in extents and consists of open agricultural land and topography is undulating and varies between 66.6 – 80.3 m OD.

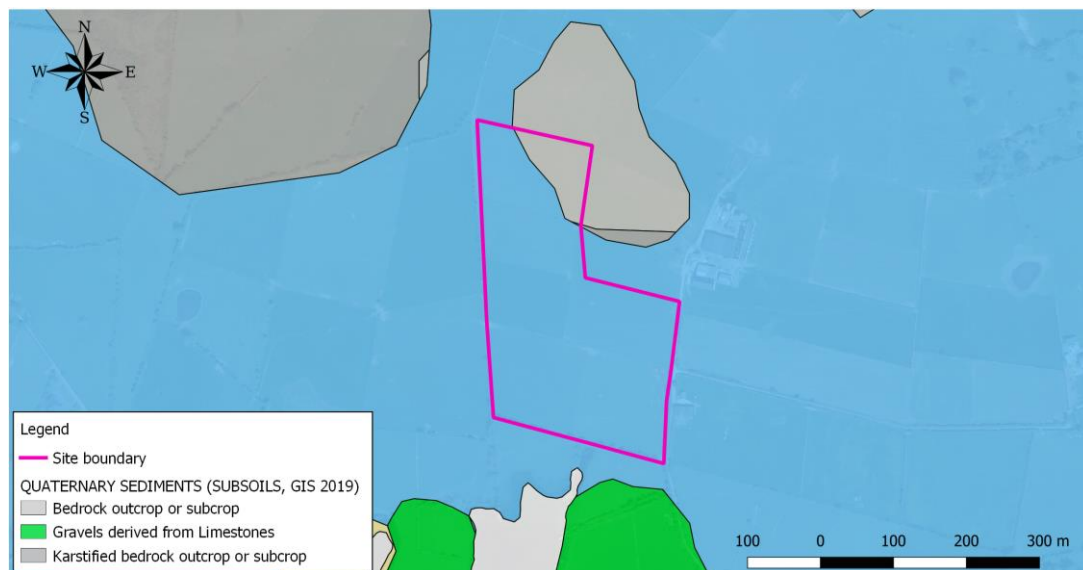
Fig 2.2: Quaternary sediments map.

The Geological Survey of Ireland (GSI) Quaternary Sediments map for the area (Fig. 2.2) indicates the site is in an area of till derived from limestone with bedrock outcrop or subcrop/Karstified rock in the northeast of the site.

While the GSI Quaternary Sediments map (Fig 2.2) shows bedrock/outcrop in the far northeast of the site the depth to top of interpreted dolomitic limestone/limestone map indicates a localised increase to > 8 m bgl just to the south. Boreholes BH01/RC01, BH02/RC02 and BH03/RC03 in the north of the site encountered rock at 12.2 m, 6.35 m and 10.9 m bgl respectively and this information was used in compilation of the depth to rock map.

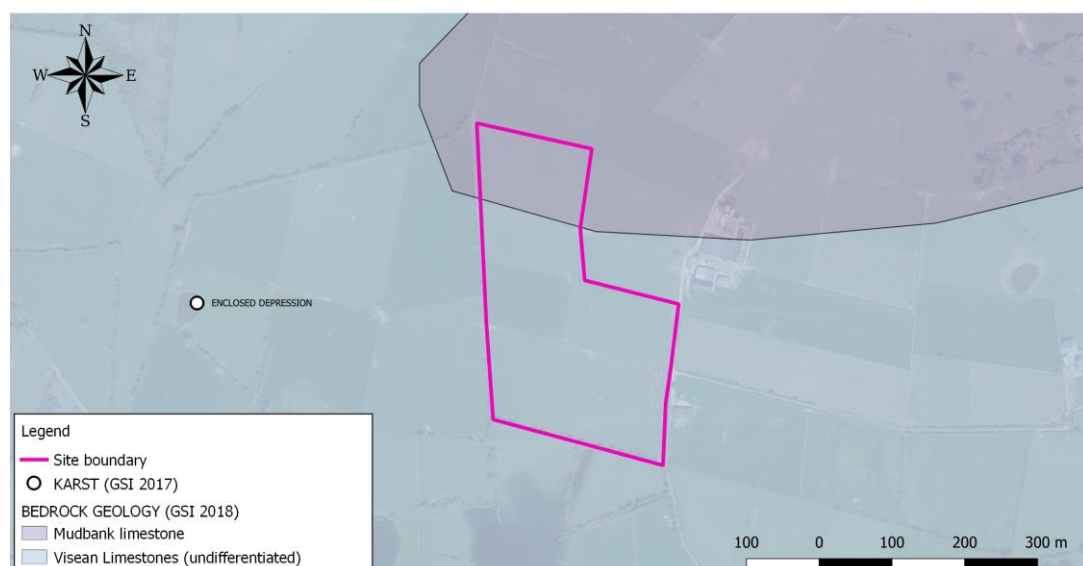
Fig 2.3: Bedrock geology map.

The GSI 1:100k Bedrock Geology map for the area (Fig. 2.3) indicates that the site is predominantly underlain by undifferentiated Visean Limestones with Mudbank limestone in the north of the site.

Several karst features, including springs, swallow holes and enclosed depressions are shown on the GSI karst database in the vicinity of the site with the closest karst feature, an enclosed depression, c. 400 m to the west of the site.

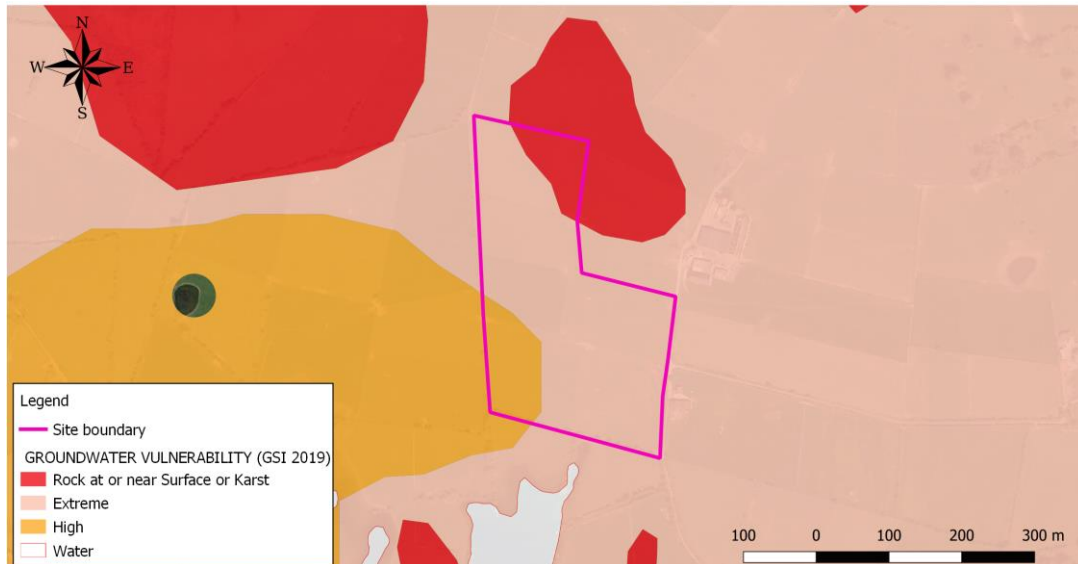
Fig 2.4: Groundwater vulnerability map.

The groundwater vulnerability rating for the site (Fig. 2.4) varies from high in the southwest to extreme across most of the site and rock at or near surface or karst in the northeast of the site.

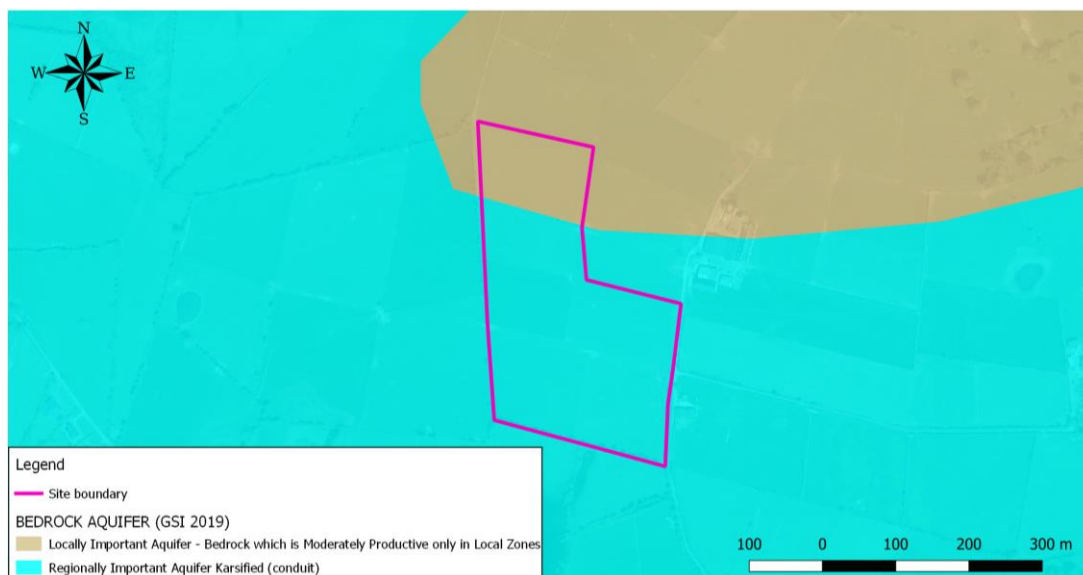
Fig 2.5: Groundwater vulnerability map.

The Visean limestone is classified as a 'Regionally Important aquifer – karstified (conduit)' (GSI) and the Mudbank limestone is classified as 'Locally Important aquifer – bedrock which is moderately productive only in local zones' (Fig. 2.5).

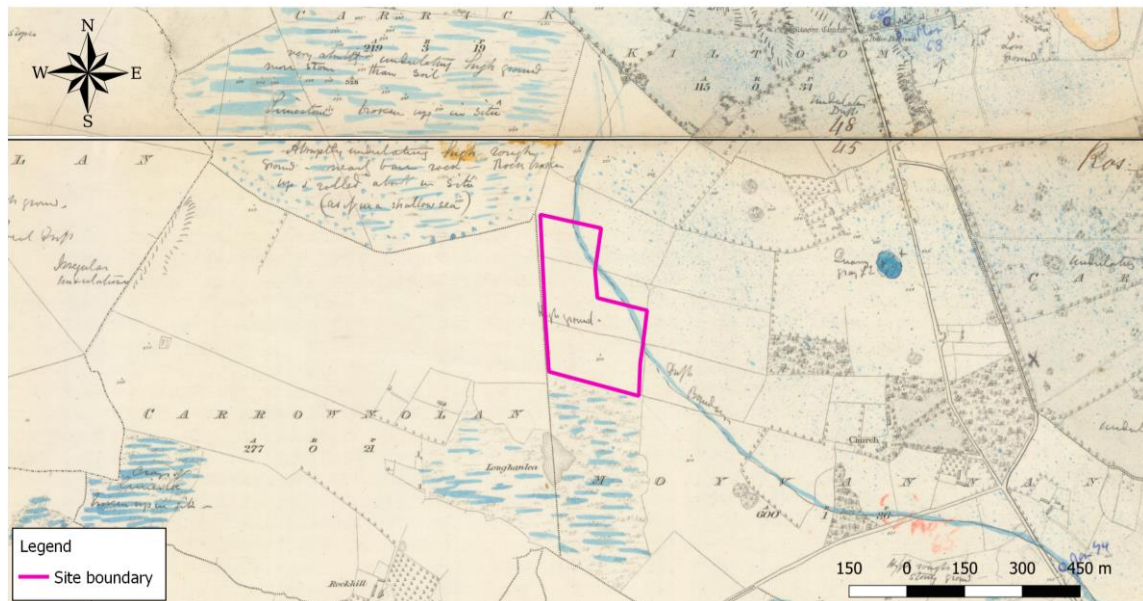
Fig 2.6: The historical 6inch map.

The historical 6-inch sheet for the area (Fig. 2.6) shows 'high ground' across the site with a 'grey limestone quarry' c. 900 m to the east of the site. Areas of 'very abruptly undulating high ground, more stone than soil, limestone broken up in situ' is shown to the northwest and south of the site.

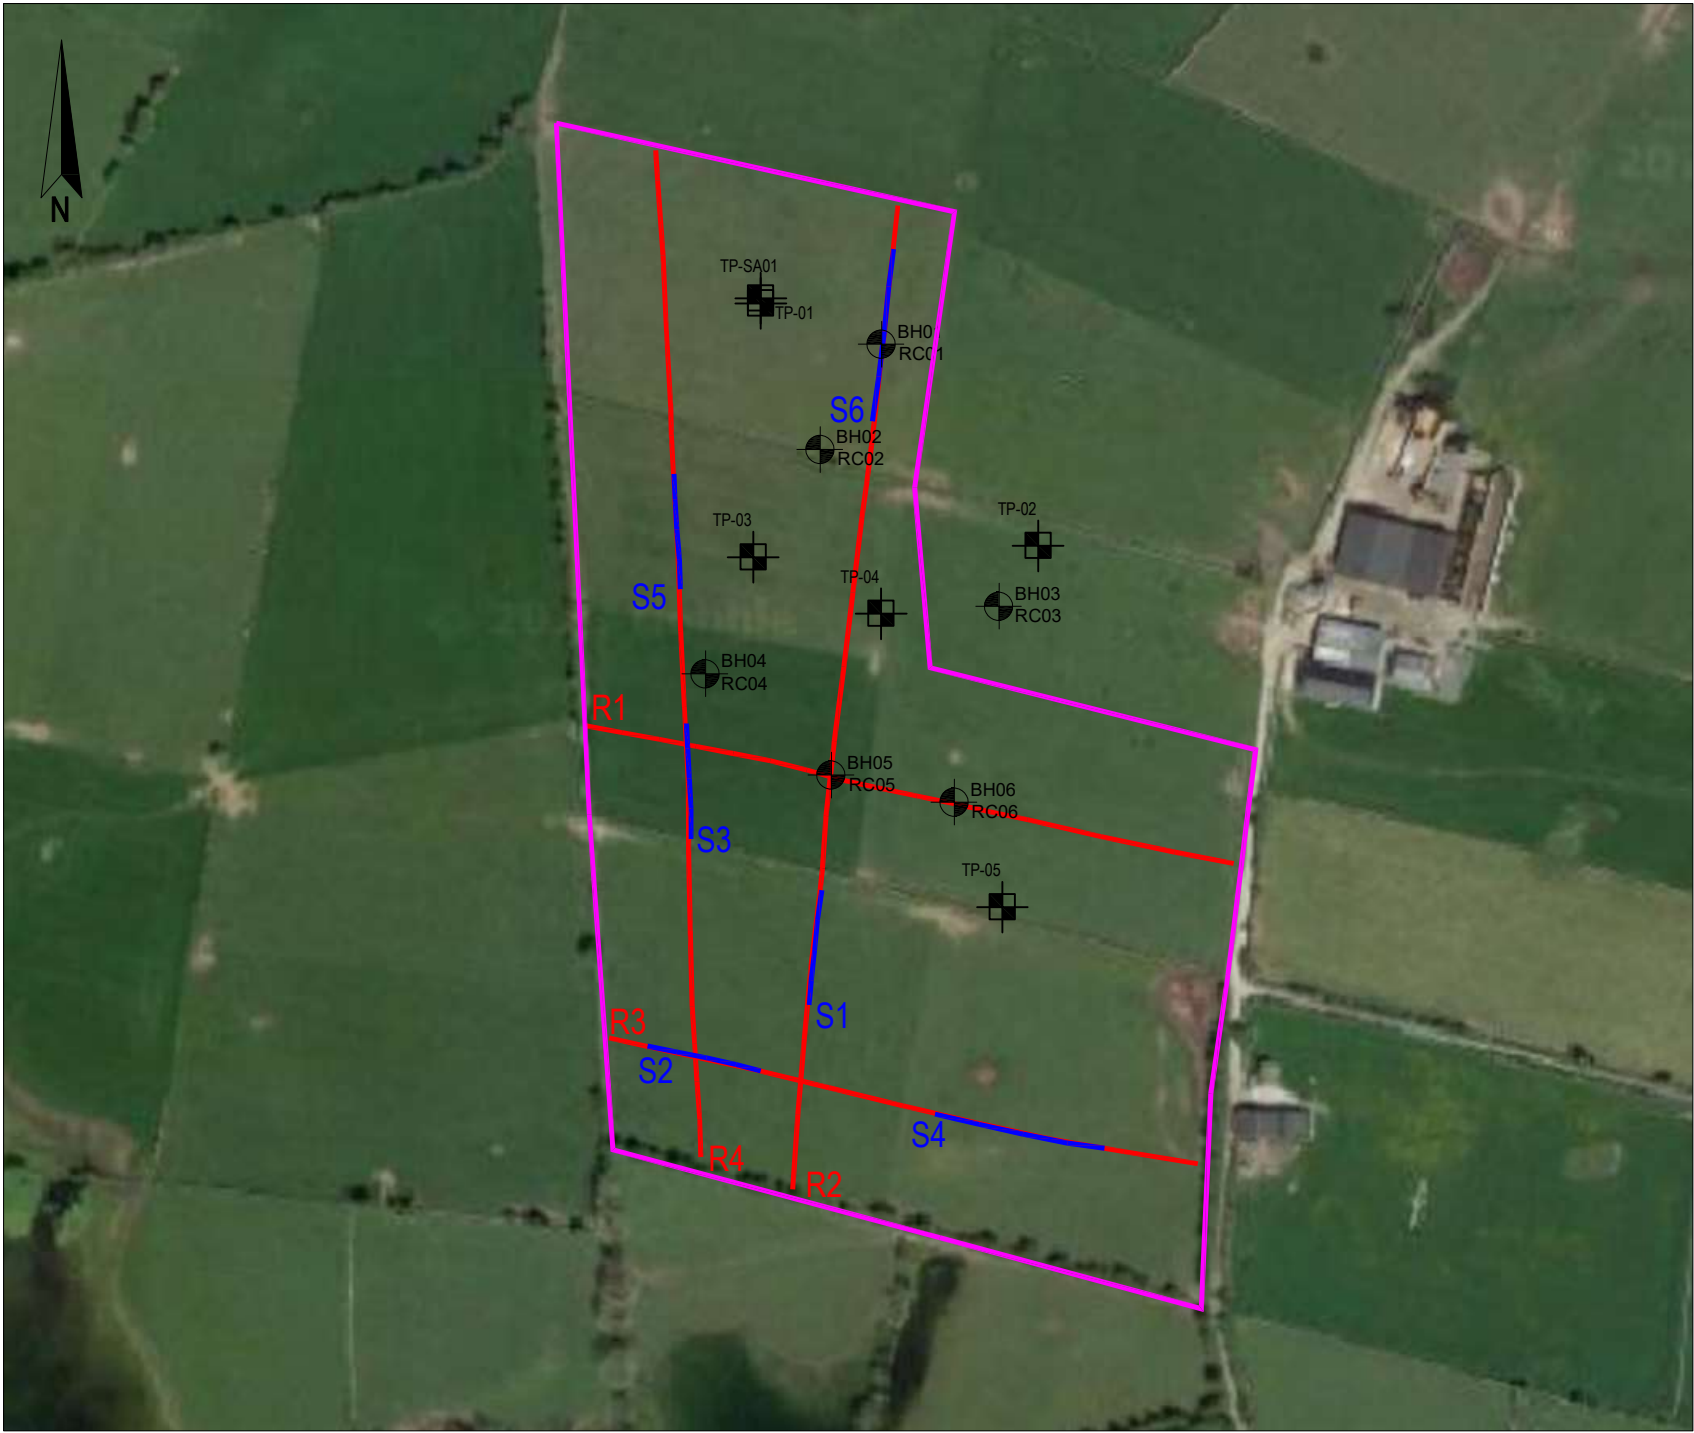
- Site
- R1 2D resistivity profile
- S1 Seismic refraction profile
- TP-01 Trial Pit
- BH01/RC01 Borehole/Rotary Core

The survey was carried out between the 24th and 26th of April 2023. The geophysical survey locations are indicated on Drawing AGP23061_01 (Appendix D). Direct investigation data was provided in October 2023 to assist in the compilation of this updated report.

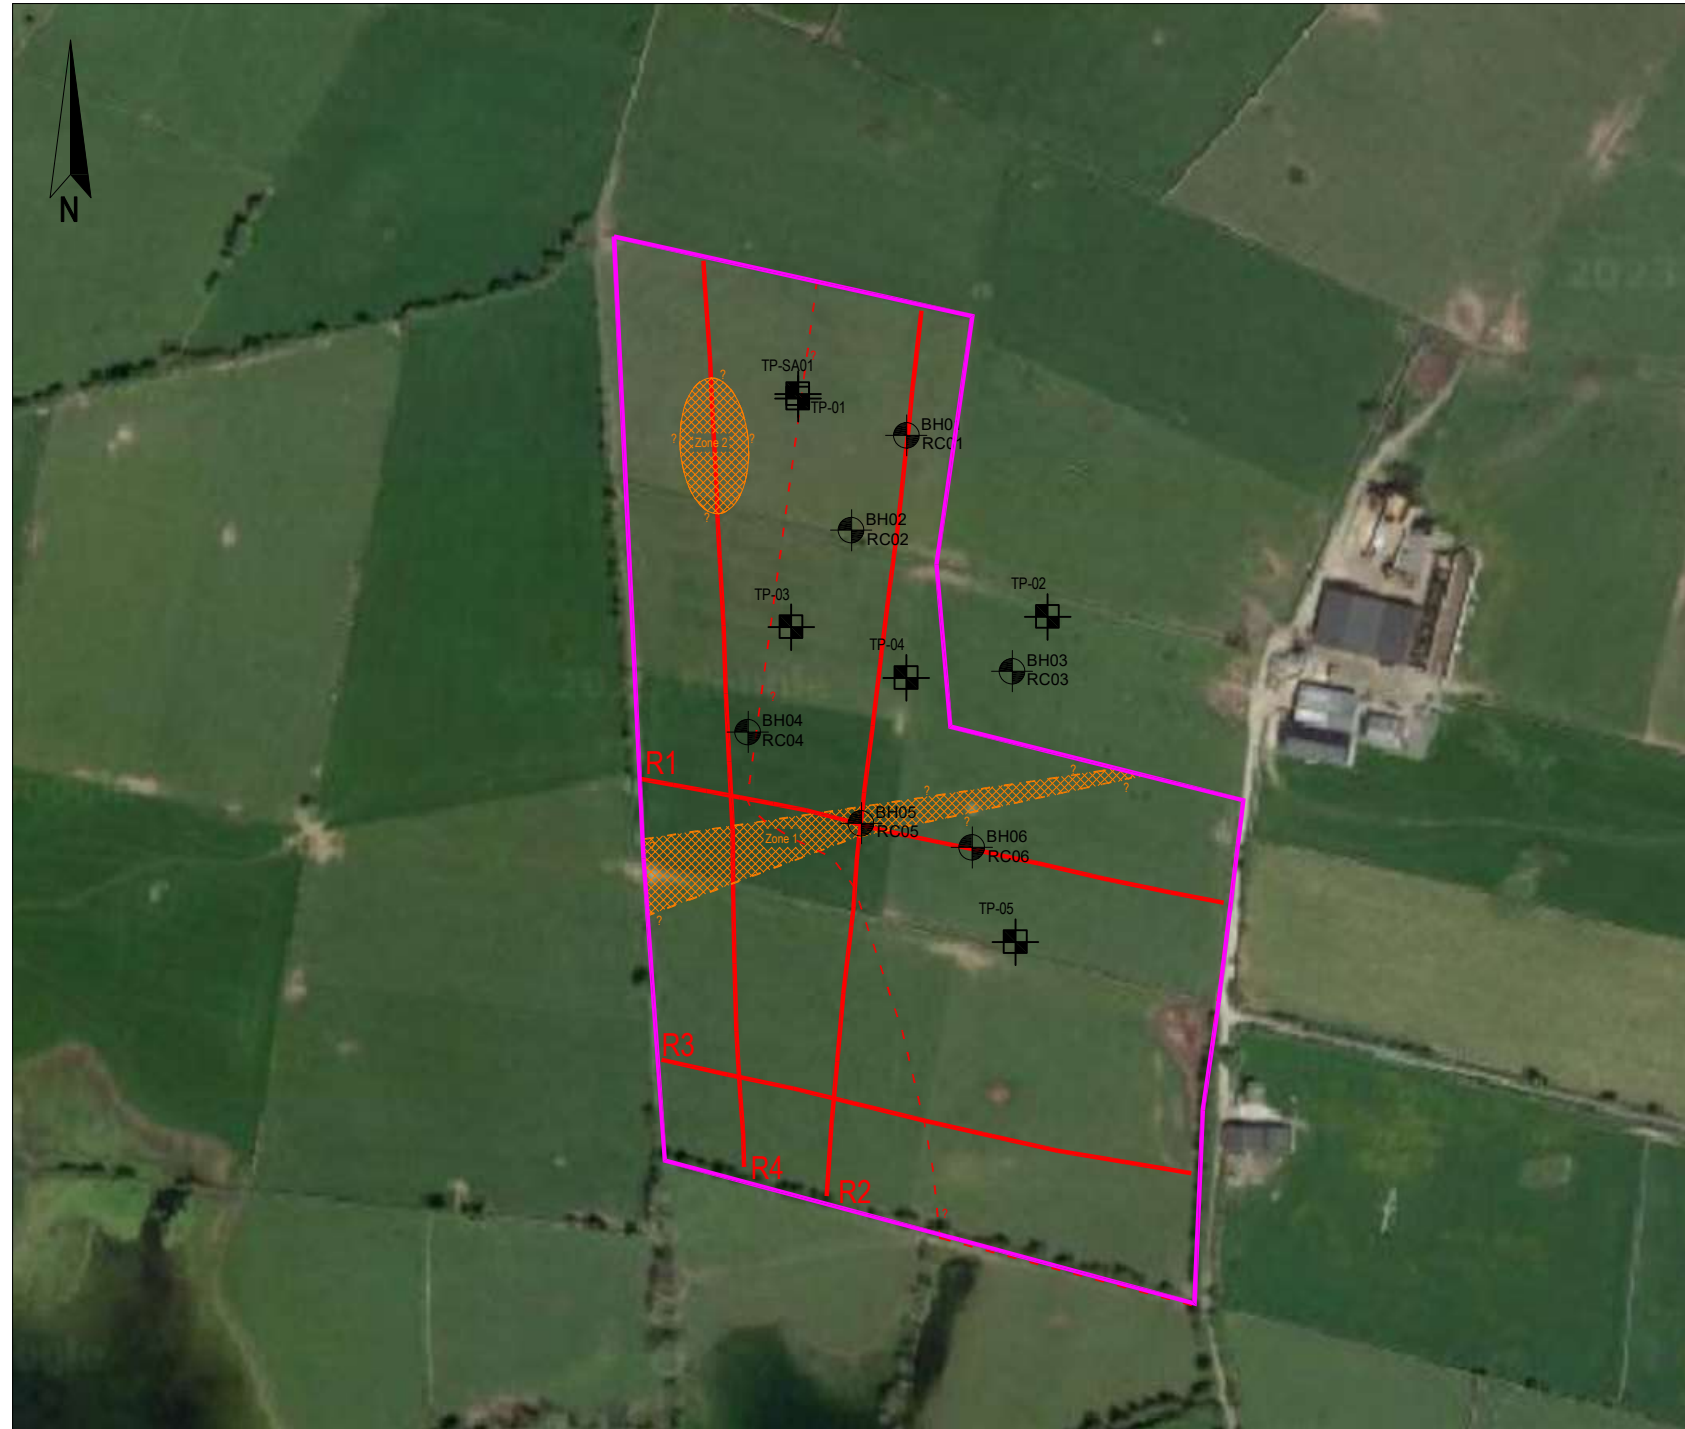
SUMMARY MAP
SCALE 1:3000

- Site
- TP-01 Trial Pit
- BH01/RC01 Borehole/Rotary Core
- Interpreted karst zones Z1 & Z2
- Main area of sandy gravelly Clay/
clayey sandy GRAVEL over rock
- Extension unclear

The stiff to very stiff sandy gravelly clay layer may act as a founding layer and an aquitard. This material is mainly present in the east and northeast of the site and is summarised on Drawing AGP23061_04.

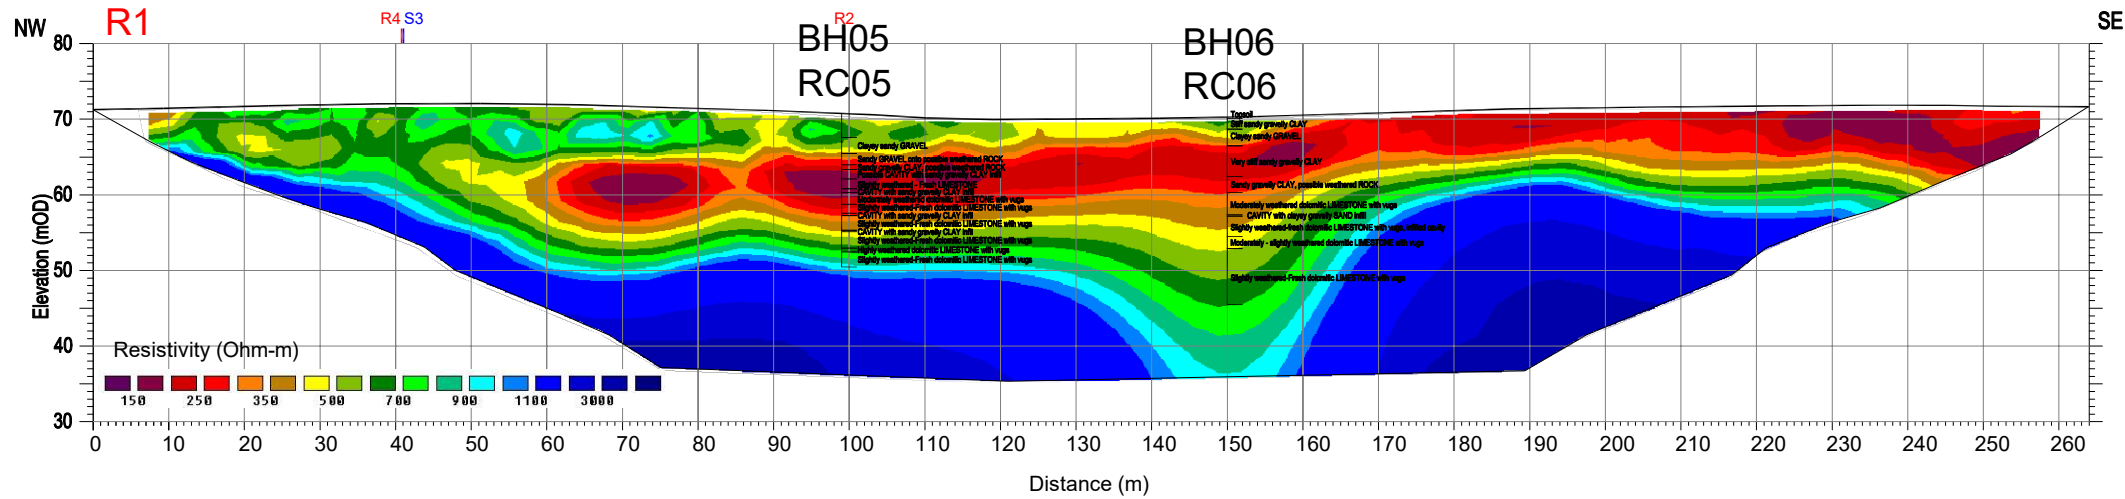
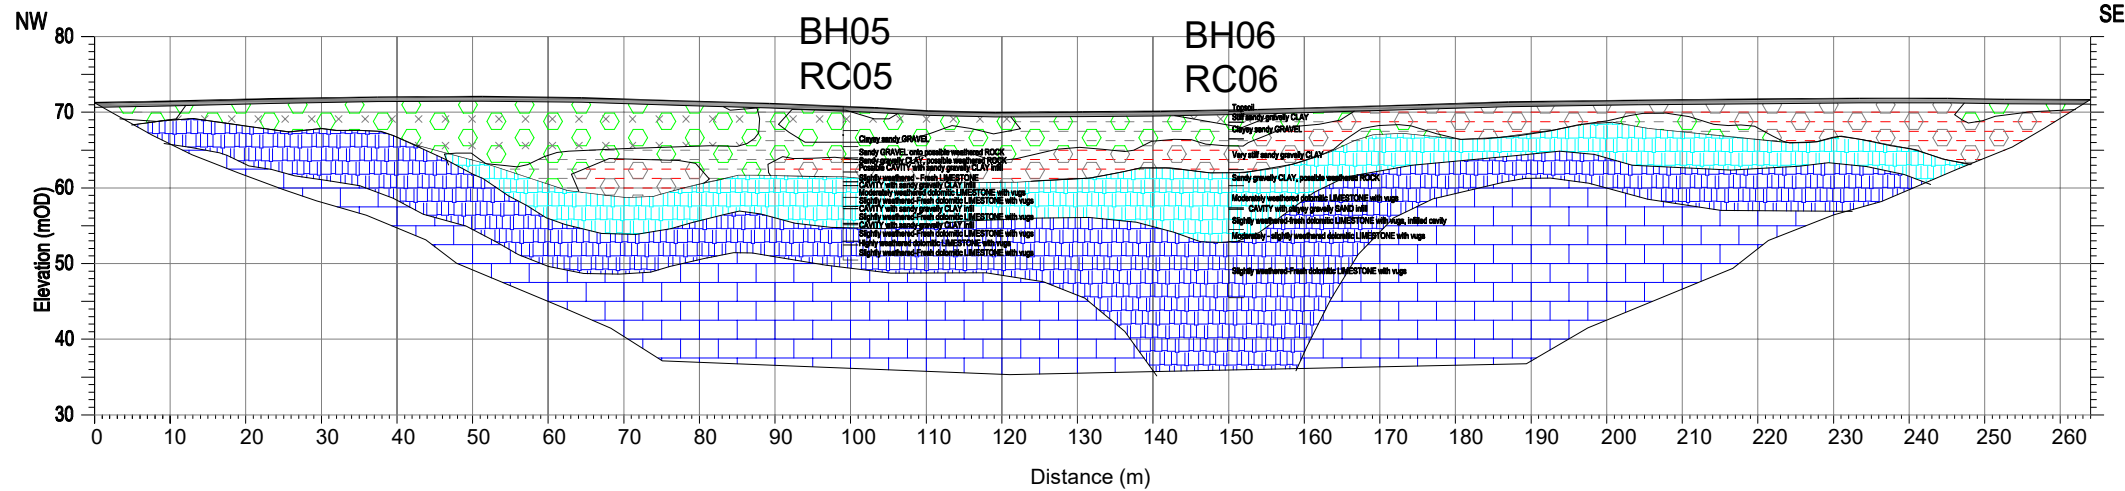
FIG.1. RESULTS ERT R1
SCALE 1:1000

FIG.2.INTERPRETATION ERT R1
SCALE 1:1000

Four resistivity profiles were recorded across the site (R1 to R4). The results are presented on Drawings AGP23061_R1 to R4.

On all four ERT profiles areas of slightly decreased resistivity values (< 1,100 Ohm) within the bedrock indicate areas of increased thickness of the moderately to slightly weathered limestone (see Drawings AGP23061_R1 to AGP23061_R4).

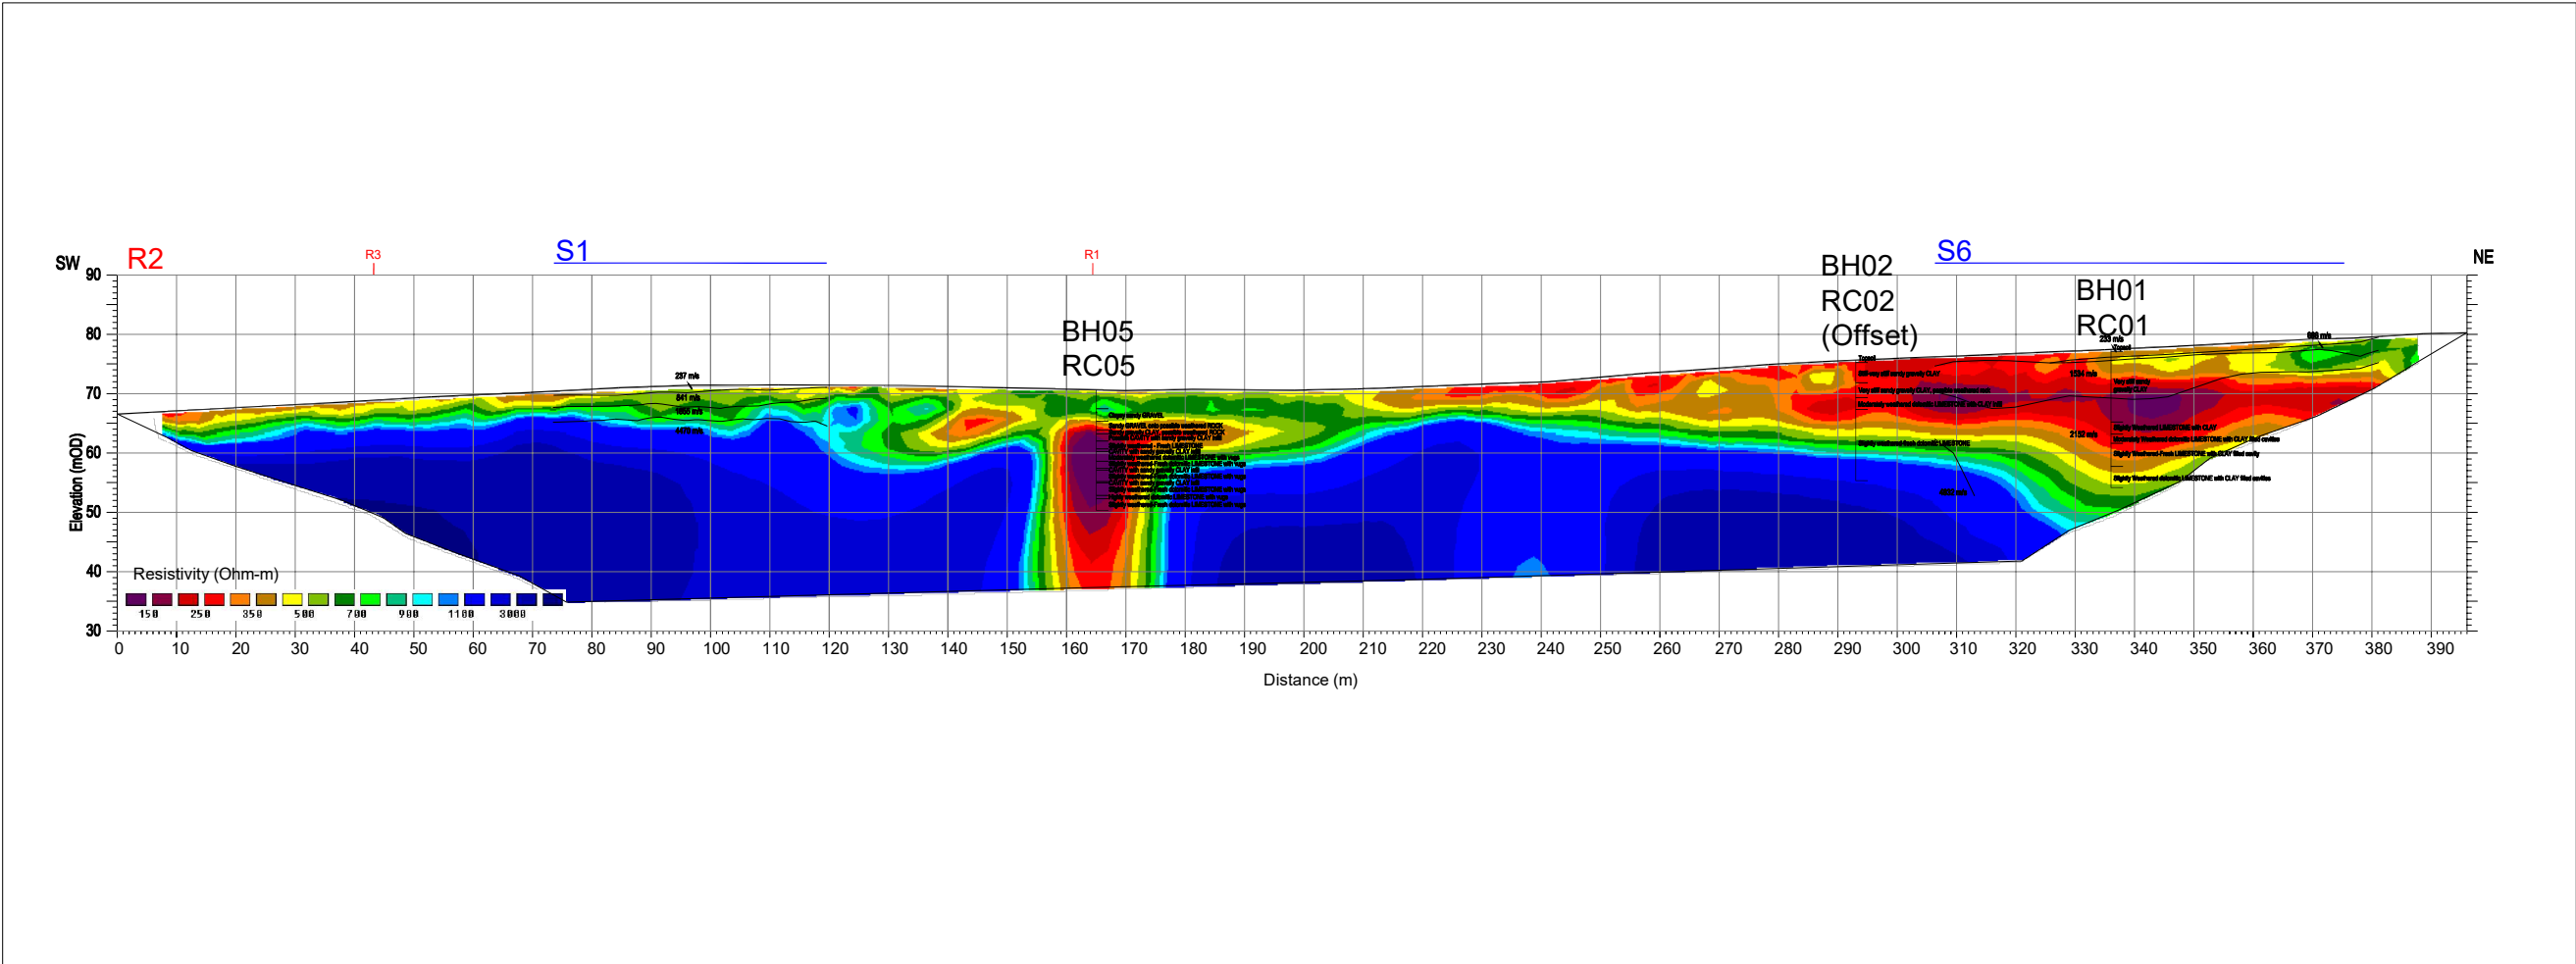
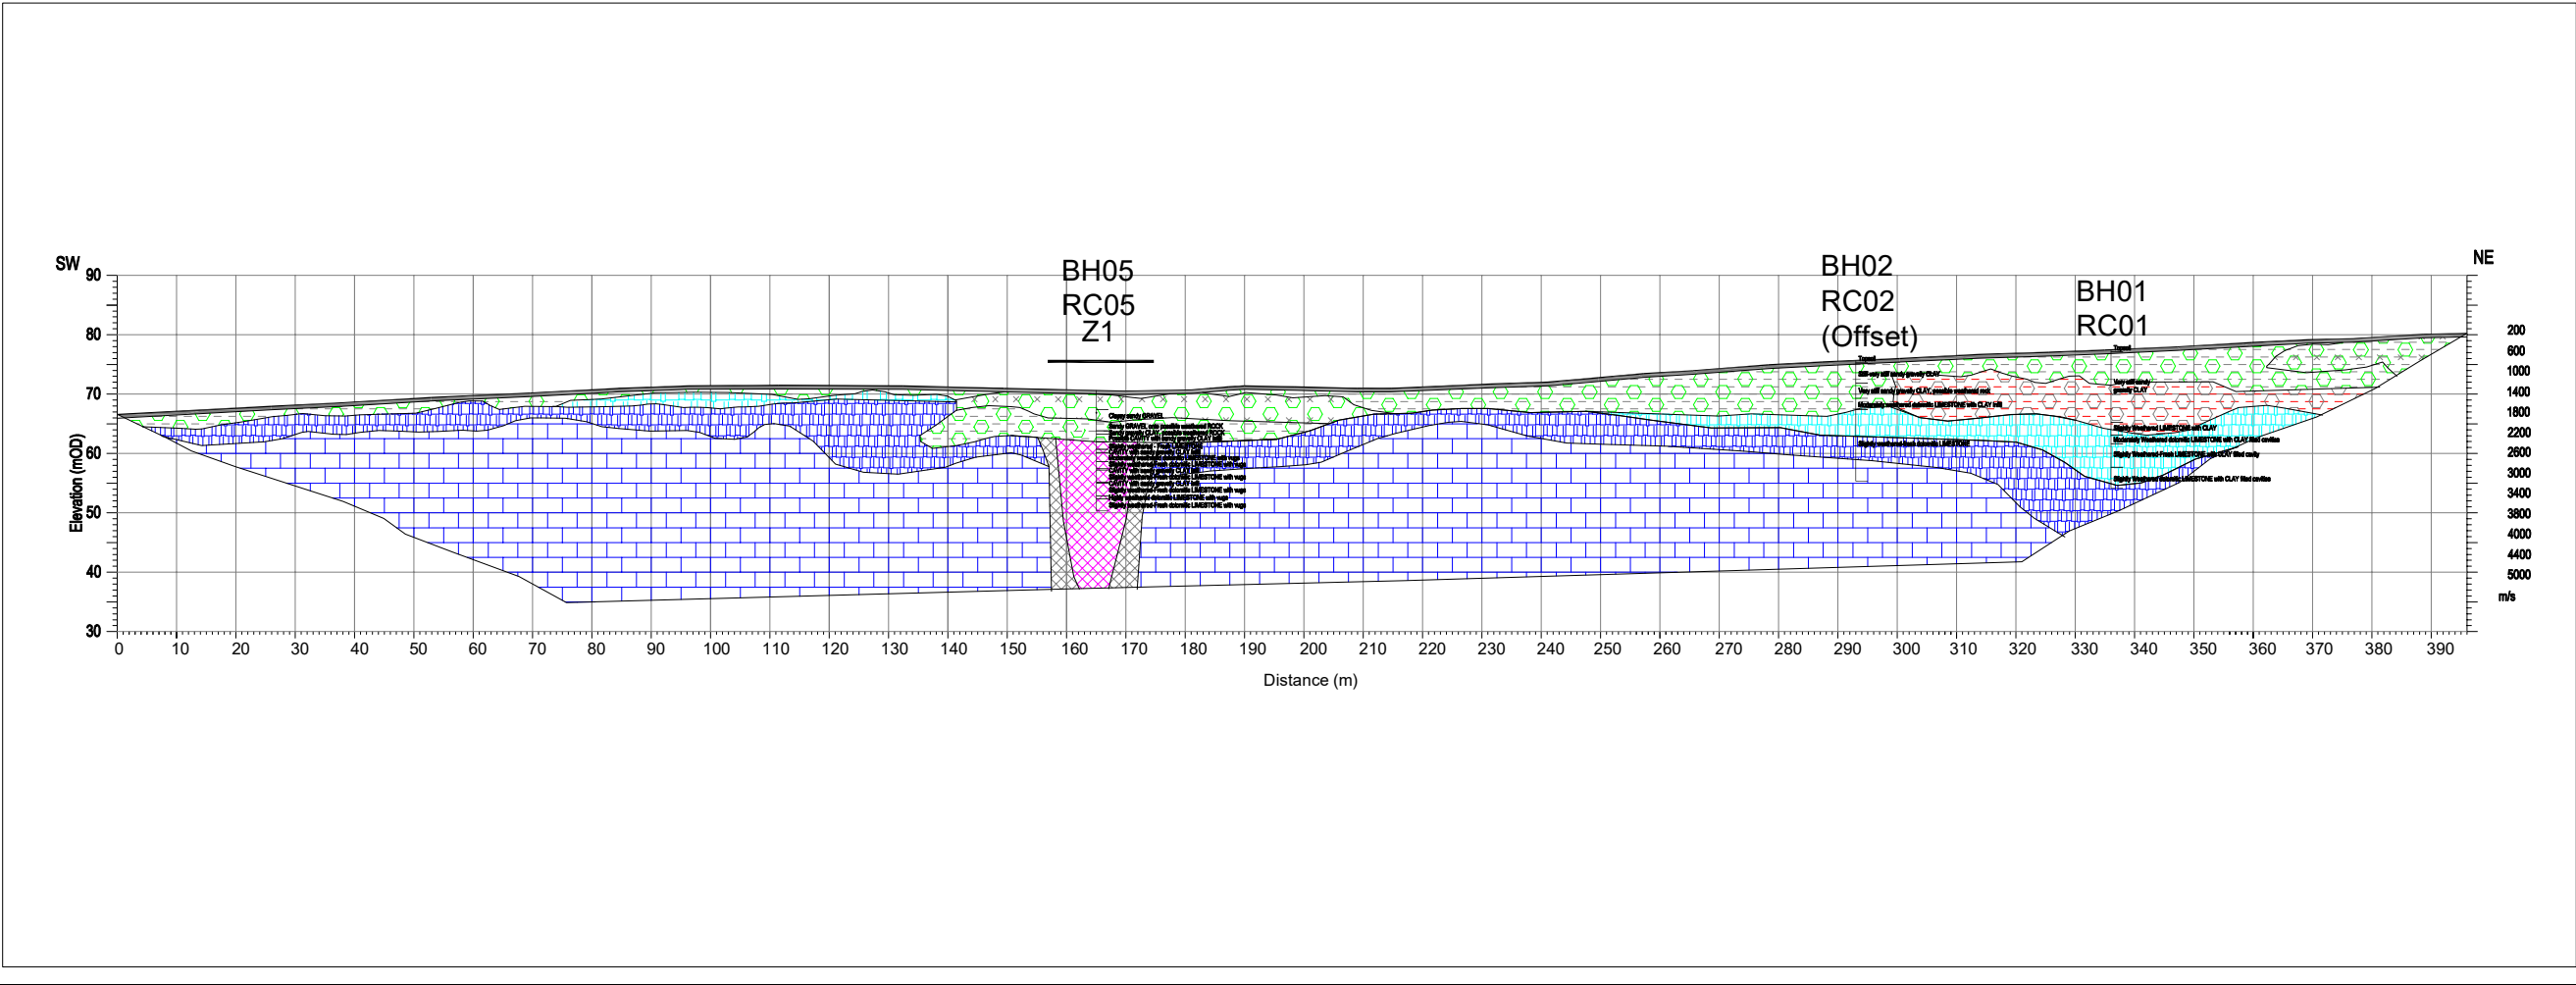
FIG.1. RESULTS ERT R2 AND SEISMIC REFRACTION S1 & S6
SCALE 1:1250

FIG.2.INTERPRETATION ERT R2 AND SEISMIC REFRACTION S1 & S6
SCALE 1:1250

- LEGEND: interpreted P-wave velocity
- Seismic refraction layer with interpreted P-wave velocity
 - Soft/Loose TOPSOIL
 - Stiff-very stiff Sandy Gravelly CLAY (possible weathered rock towards base)
 - Medium Dense-Dense Clayey Sandy GRAVEL (possible weathered rock towards base)
 - Medium Dense-Dense Silty Sandy GRAVEL/BOULDERS (possible weathered rock towards base)
 - Rock with high degree of Karstification with clay infill
 - Rock with some degree of karstification/fracturing/fissuring
 - Highly - moderately weathered Dolomitic LIMESTONE/LIMESTONE
 - Highly - moderately weathered Dolomitic LIMESTONE /LIMESTONE some cavities and clay infill
 - Moderately - Slightly Weathered Dolomitic LIMESTONE /LIMESTONE
 - Slightly weathered - fresh Dolomitic LIMESTONE /LIMESTONE

Two main zones of rock with a potential high degree of karstification with clay infill are interpreted across the site. One deeply penetrating zone (Z1) is present in the central part of the site and is characterised by an area of low resistivity values ($< 300 \text{ Ohm-m}$) in the bedrock at a distance of 165 m on profile R2 and 145 m on profile R4 (see Drawings AGP23061_02 and AGP23061_03). This zone is interpreted as a WSW – ENE feature shown on Drawing AGP23061_04 summary map. Borehole BH05/RC05 targeted this zone and encountered fractures with clay smearing, infilled cavities with sandy gravelly clay within highly weathered to slightly weathered to fresh rock over a depth range of 8.65 to 20.3 m bgl (see Drawing AGP23061_R2).

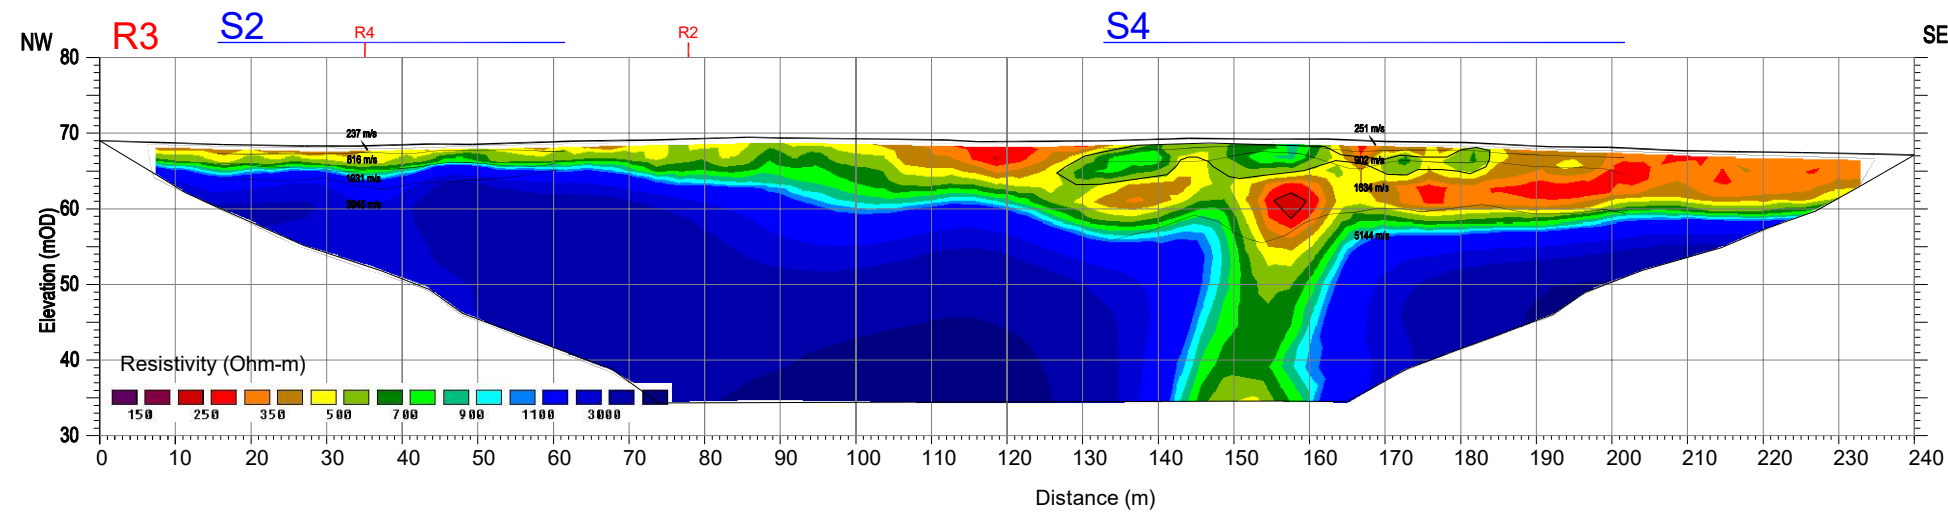
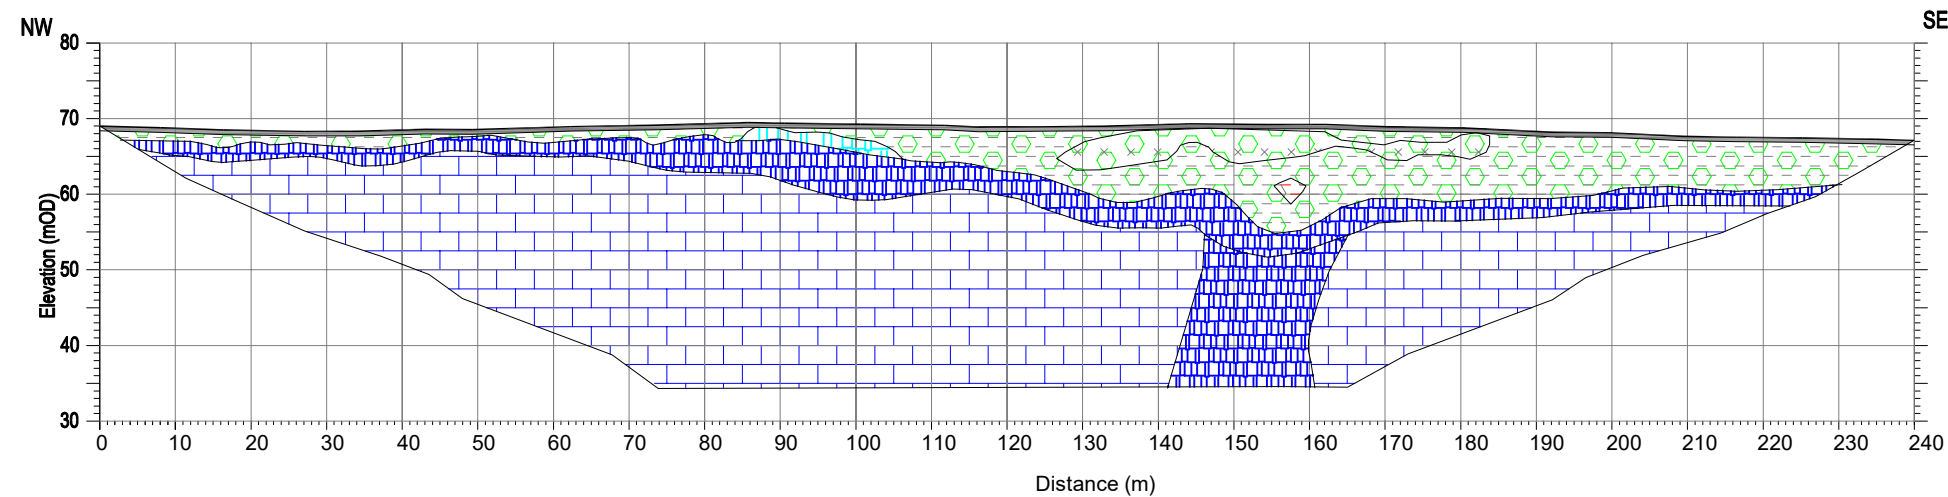
FIG.1. RESULTS ERT R3 AND SEISMIC REFRACTION S2 & S4
SCALE 1:1000

- LEGEND:**interpreted P-wave velocity
- Seismic refraction layer with interpreted P-wave velocity
 - Soft/Loose TOPSOIL
 - Stiff-very stiff Sandy Gravelly CLAY (possible weathered rock towards base)
 - Medium Dense-Dense Clayey Sandy GRAVEL (possible weathered rock towards base)
 - Medium Dense-Dense Silty Sandy GRAVEL/BOULDERS (possible weathered rock towards base)
 - Rock with high degree of Karstification with clay infill
 - Rock with some degree of karstification/fracturing/fissuring
 - Highly - moderately weathered Dolomitic LIMESTONE/LIMESTONE
 - Highly - moderately weathered Dolomitic LIMESTONE /LIMESTONE some cavities and clay infill
 - Moderately - Slightly Weathered Dolomitic LIMESTONE /LIMESTONE
 - Slightly weathered - fresh Dolomitic LIMESTONE /LIMESTONE

FIG.2.INTERPRETATION ERT R3 AND SEISMIC REFRACTION S2 & S4
SCALE 1:1000
