Moyvannan Electricity Substation

Annex 6.1: Geophysical Investigation Report

**REPORT
ON THE
GEOPHYSICAL INVESTIGATION
AT
SEVEN HILLS WIND FARM
SUBSTATION
Co. ROSCOMMON
FOR
ENERGIA**

PROJECT NUMBER	AGP23061		
AUTHOR	CHECKED	REPORT STATUS	DATE
TONY LOMBARD M.SC (GEOPHYSICS)	EURGEOL PETER O'CONNOR P.GEO., M.Sc (GEOPHYSICS), DIP. EIA MGT.	V.01	19 TH JUNE 2023
TONY LOMBARD M.SC (GEOPHYSICS)		V.02	09 TH NOVEMBER 2023

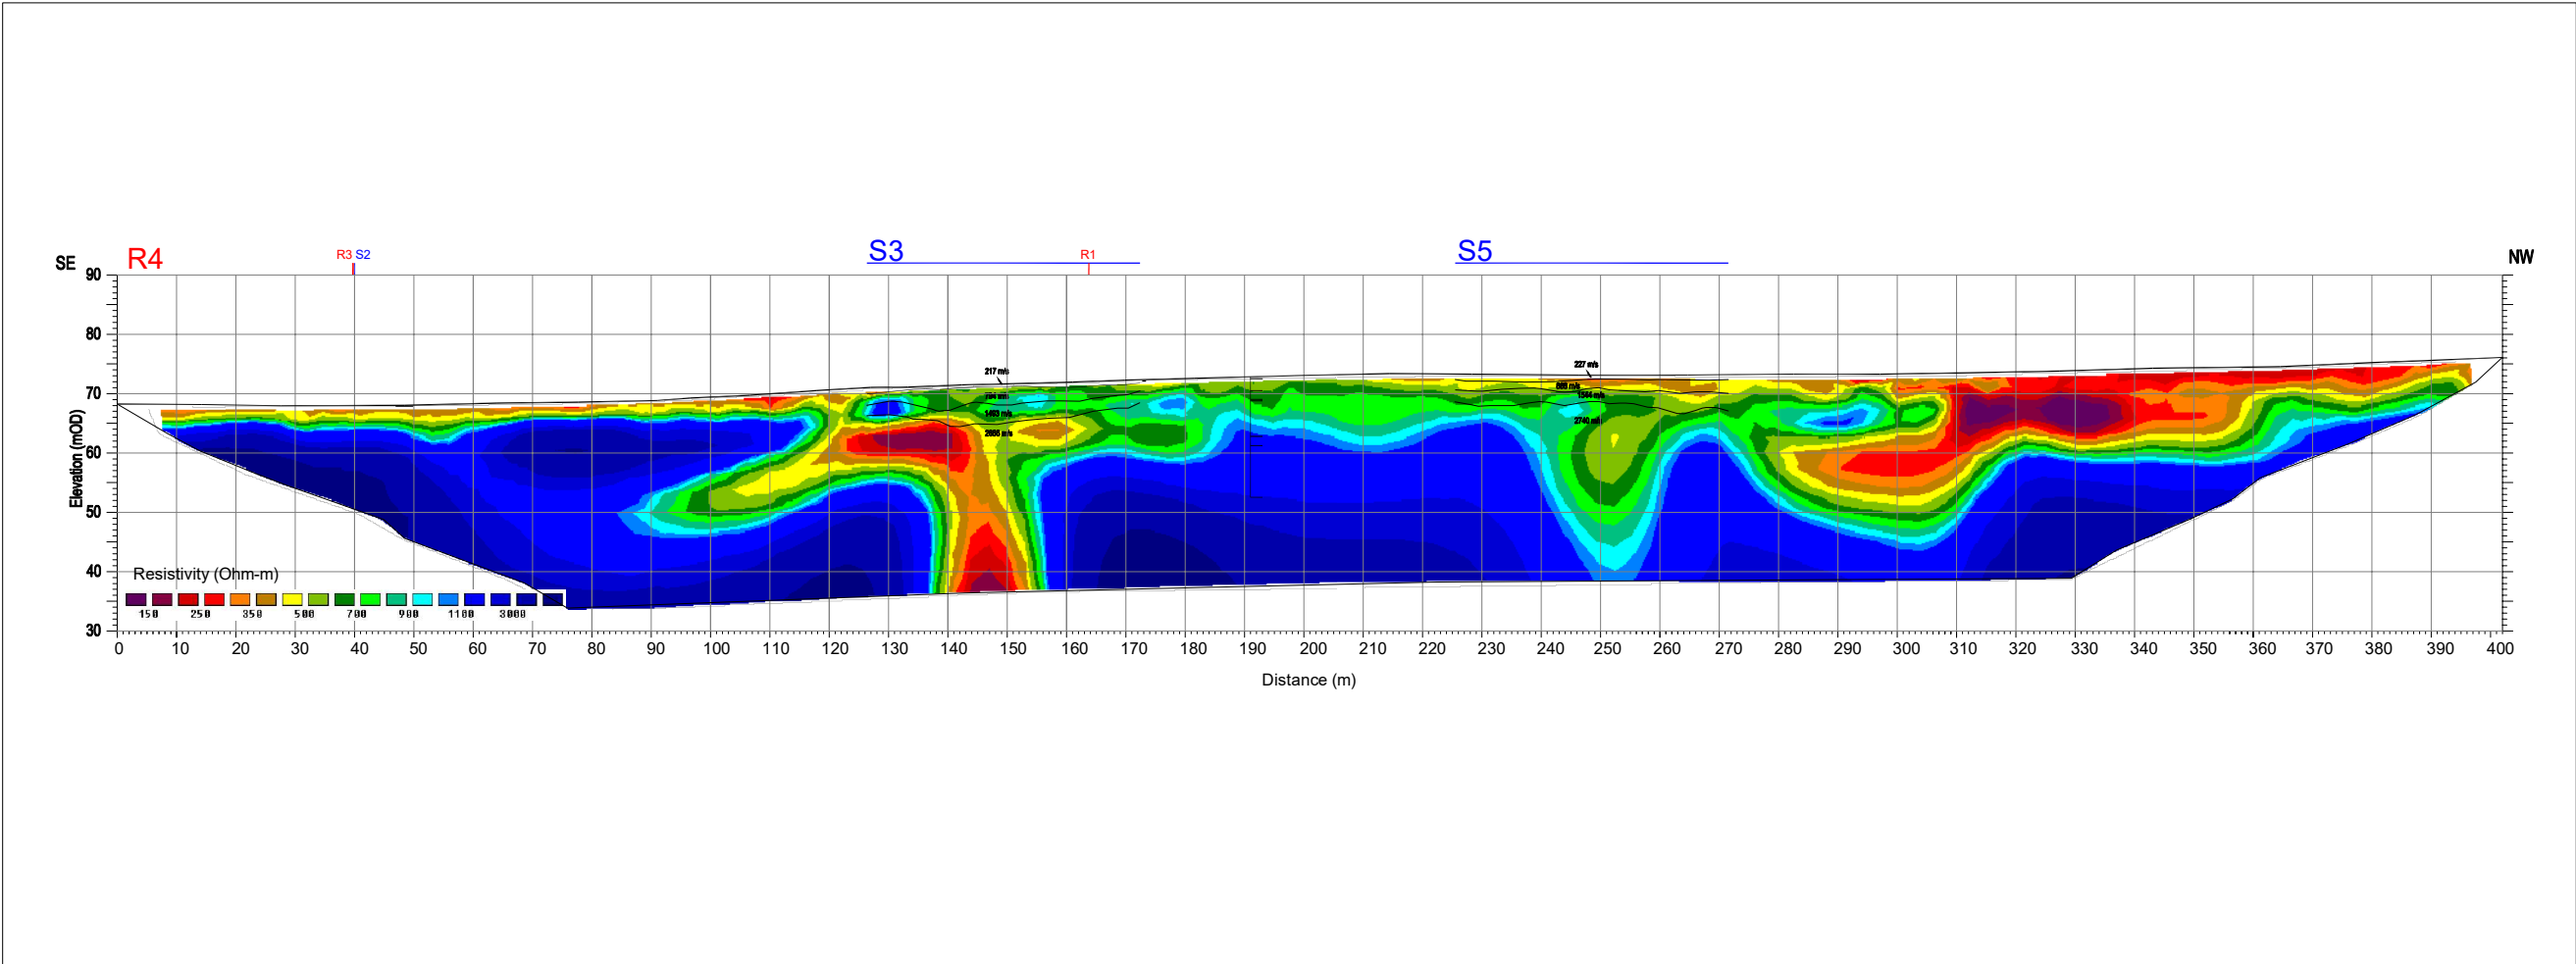
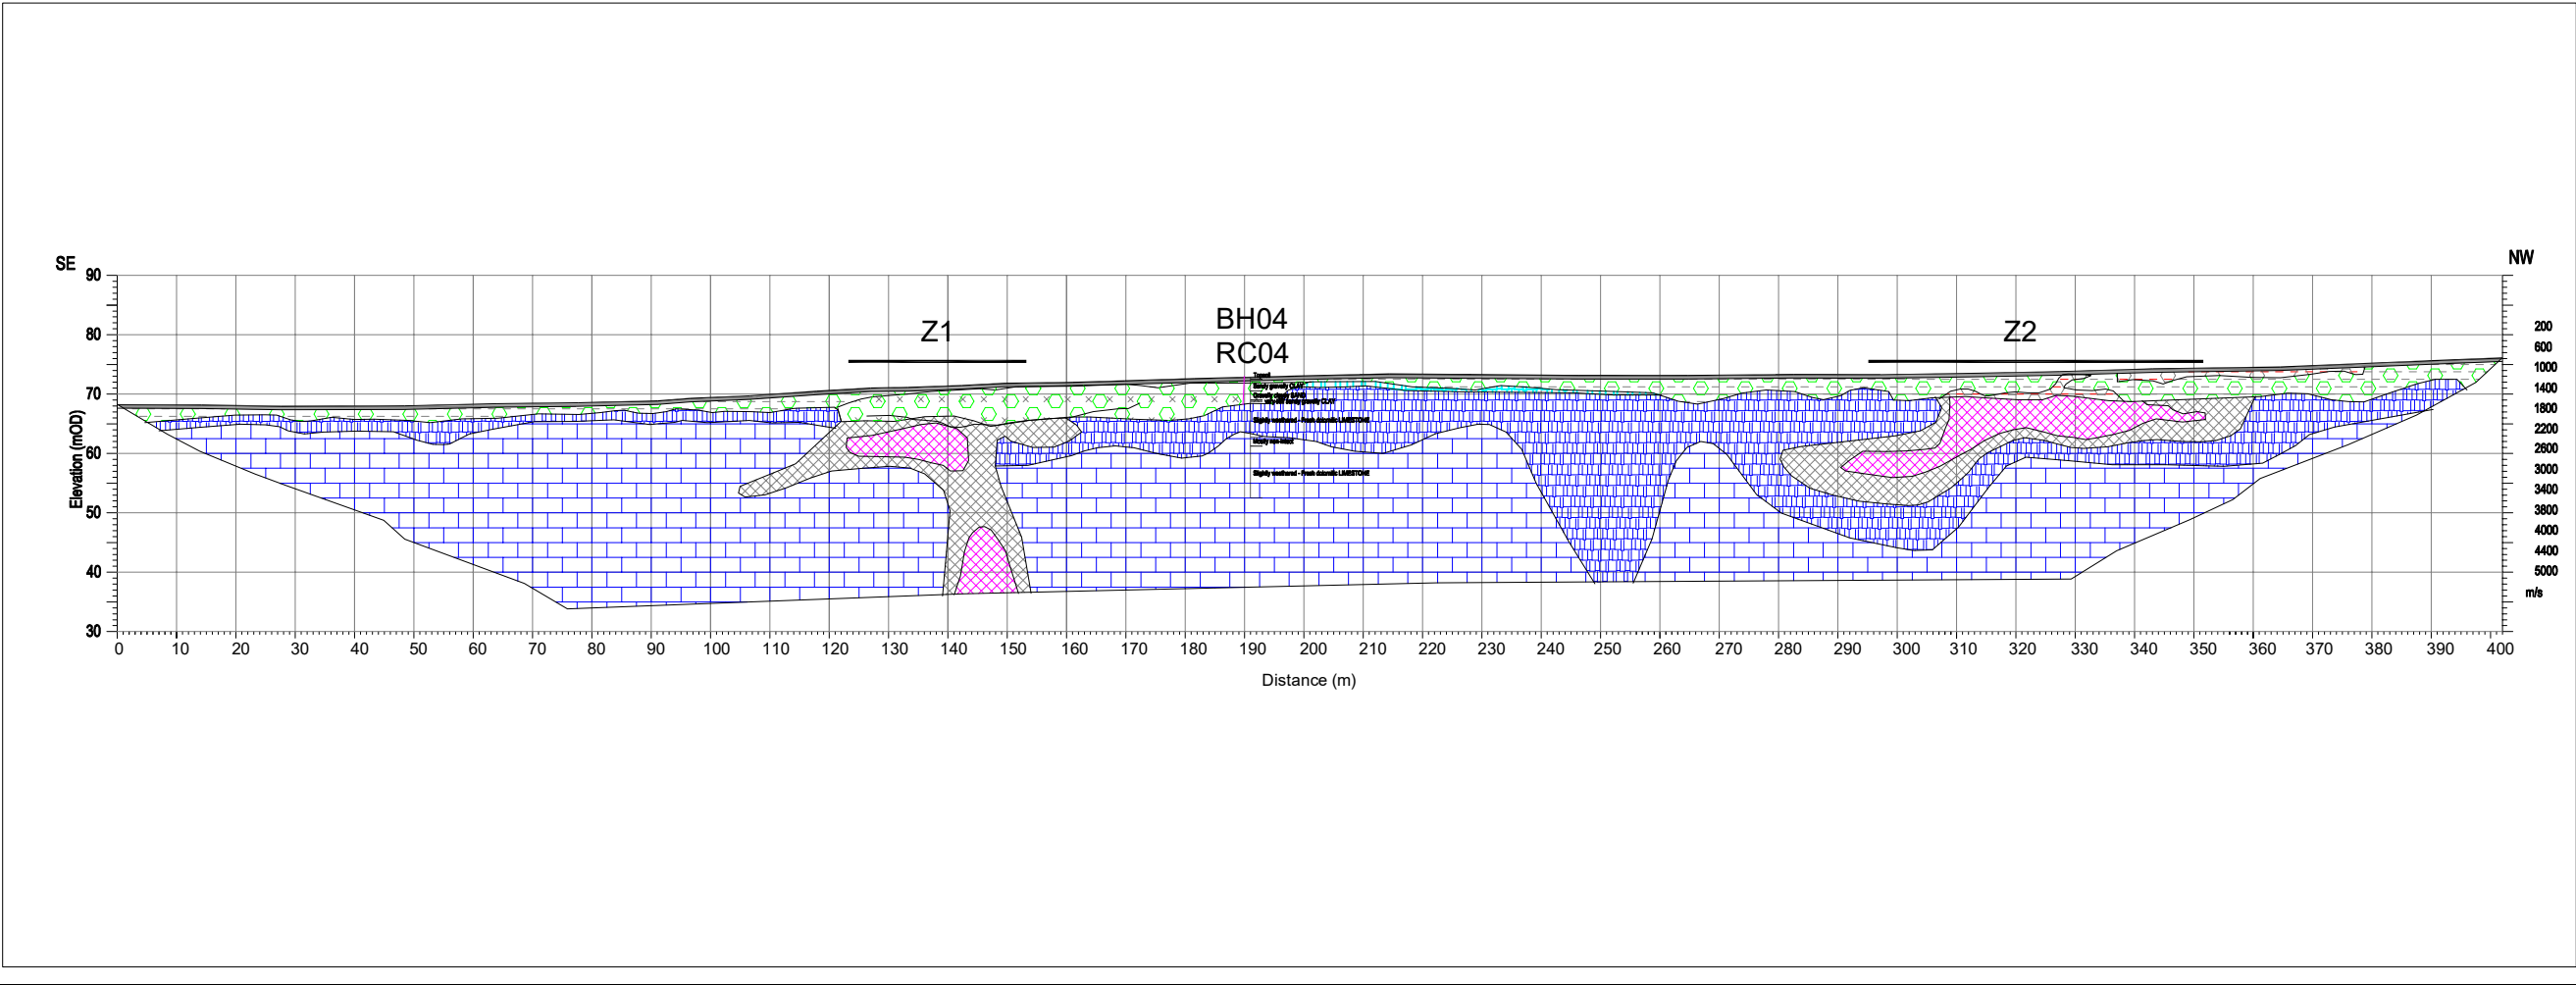
FIG.1. RESULTS ERT R4 AND SEISMIC REFRACTION S3 & S5
SCALE 1:1250

FIG.2.INTERPRETATION ERT R4 AND SEISMIC REFRACTION S3 & S5
SCALE 1:1250

- LEGEND:**interpreted P-wave velocity
- Seismic refraction layer with interpreted P-wave velocity
 - Soft/Loose TOPSOIL
 - Stiff-very stiff Sandy Gravelly CLAY (possible weathered rock towards base)
 - Medium Dense-Dense Clayey Sandy GRAVEL (possible weathered rock towards base)
 - Medium Dense-Dense Silty Sandy GRAVEL/BOULDERS (possible weathered rock towards base)
 - Rock with high degree of Karstification with clay infill
 - Rock with some degree of karstification/fracturing/fissuring
 - Highly - moderately weathered Dolomitic LIMESTONE/LIMESTONE
 - Highly - moderately weathered Dolomitic LIMESTONE /LIMESTONE some cavities and clay infill
 - Moderately - Slightly Weathered Dolomitic LIMESTONE /LIMESTONE
 - Slightly weathered - fresh Dolomitic LIMESTONE /LIMESTONE

On all four ERT profiles areas of slightly decreased resistivity values (< 1,100 Ohm) within the bedrock indicate areas of increased thickness of the moderately to slightly weathered limestone (see Drawings AGP23061_R1 to AGP23061_R4).

A second area of low resistivity values in the bedrock is present as a broader feature at the top of the rock at the NE of profile R4. This feature (Z2) penetrates to 22 m bgl.
