EIAR Volume 4: Offshore Infrastructure Technical Appendices Appendix 4.3.3-5 Underwater Image Analysis

Kish Offshore Wind Ltd

Dublin Array Offshore Wind Farm - Underwater Image Analysis

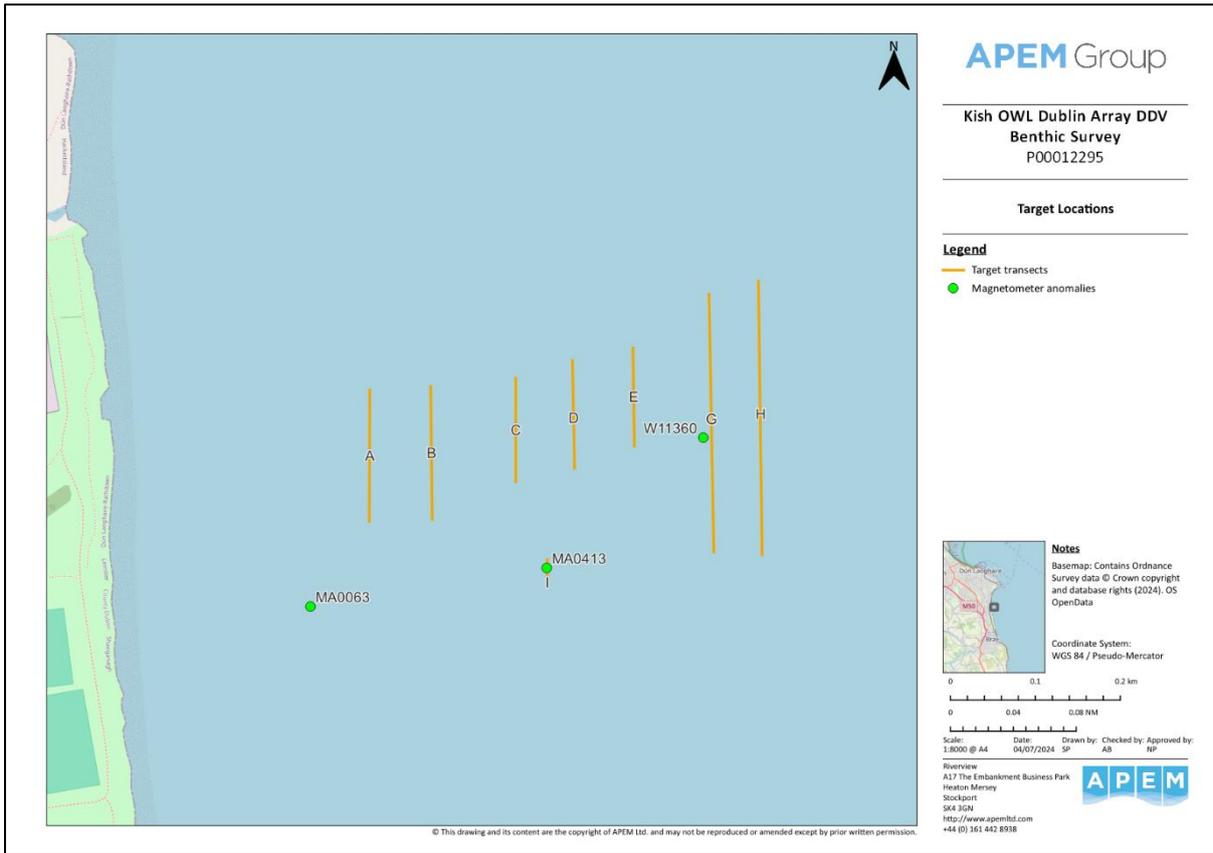
Figure 2 Locations of target transects and magnetometer anomalies

The DDV survey comprised capturing high definition (HD) video and still imagery of the seabed at eight predetermined locations. Seven of these locations were transects running parallel to the shore (see Figure 2) labelled A through H (Transect F was descope prior to the survey) and ranged between 40 and 325 m in length. Three anomalies identified during magnetometer survey were also included in the survey. One of these anomalies overlapped with transect G and another was designated as target location I. For the sake of consistency, location I is also referred to as a transect throughout this report. Figure 2 shows the target transect lines and areas that required archaeological investigation.

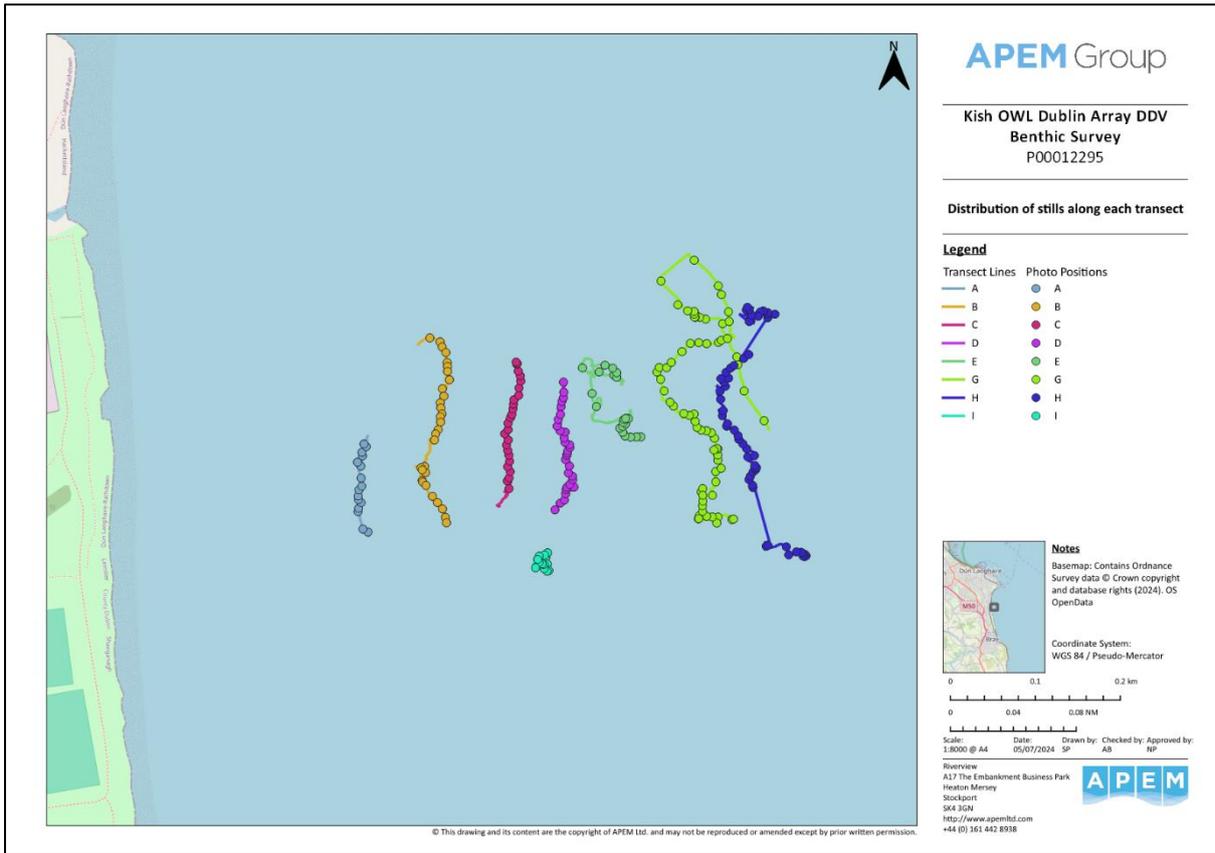
Figure 3 Distribution of analysed still images in relation to ROV flight paths for each transect

The sampling log with coordinates for the images analysed for each transect is presented in Appendix 1 and their distribution in relation to the ROV flight paths is mapped in Figure 3.

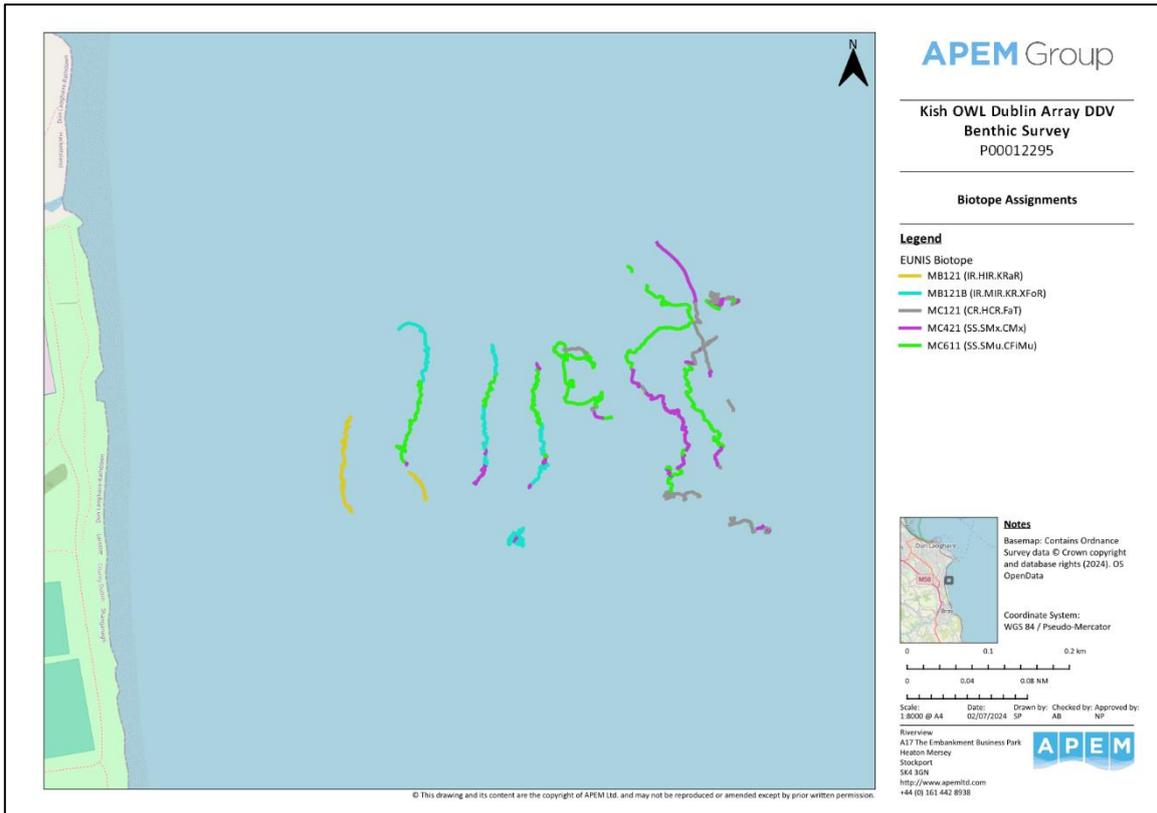
Figure 4 Distribution of extrapolated EUNIS habitat classifications for each transect

Notes on substrata and conspicuous fauna, biotope assignments and cobble reef assessments for each still image are presented in Appendix 2 . The distribution of extrapolated biotopes for each transect is mapped in Figure 4 and extrapolated stony reef assessments for each transect are mapped in Figure 5.

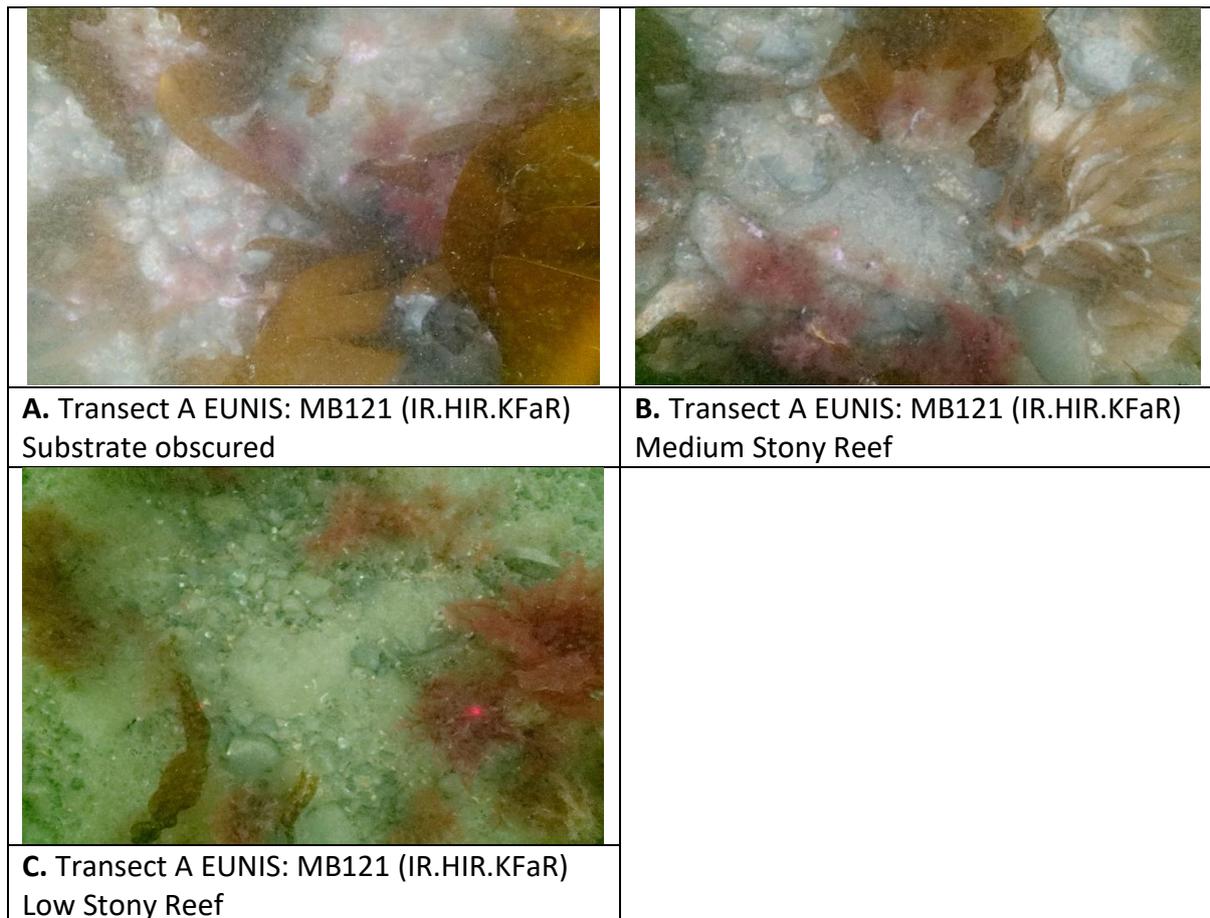
Figure 6. Representative seabed images of the biotopes identified at Transect A

Transect A had a consistent substrate and faunal composition although in some stills the substrate was obscured by large epibiota (Figure 6A). Where visible, the substrate was infralittoral rock formed from a mix of cobbles, boulders and pebbles with *Laminaria* spp. and filamentous red algae. The transect was assigned to the biotope complex ‘Kelp and seaweed communities on Atlantic infralittoral rock’ (EUNIS: MB121; JNCC: IR.HIR.KFaR), Figure 6A-C.

No mussels or *Sabellaria* spp. were observed on Transect A. The substrate in the first segment of the transect was obscured by fronds of the kelp *Laminaria* spp. so a stony reef assessment was not possible (Figure 6A). The remainder of the transect comprised medium sized cobbles (64 mm – 5 m) with over 40% coverage and >80% epifaunal species present (Figure 6B) so medium stony reef was assigned for all stills except P1021503.JPG. This still had cobbles with elevation <64 mm and a coverage of 10-40% so low resemblance reef was assigned (Figure 6C).

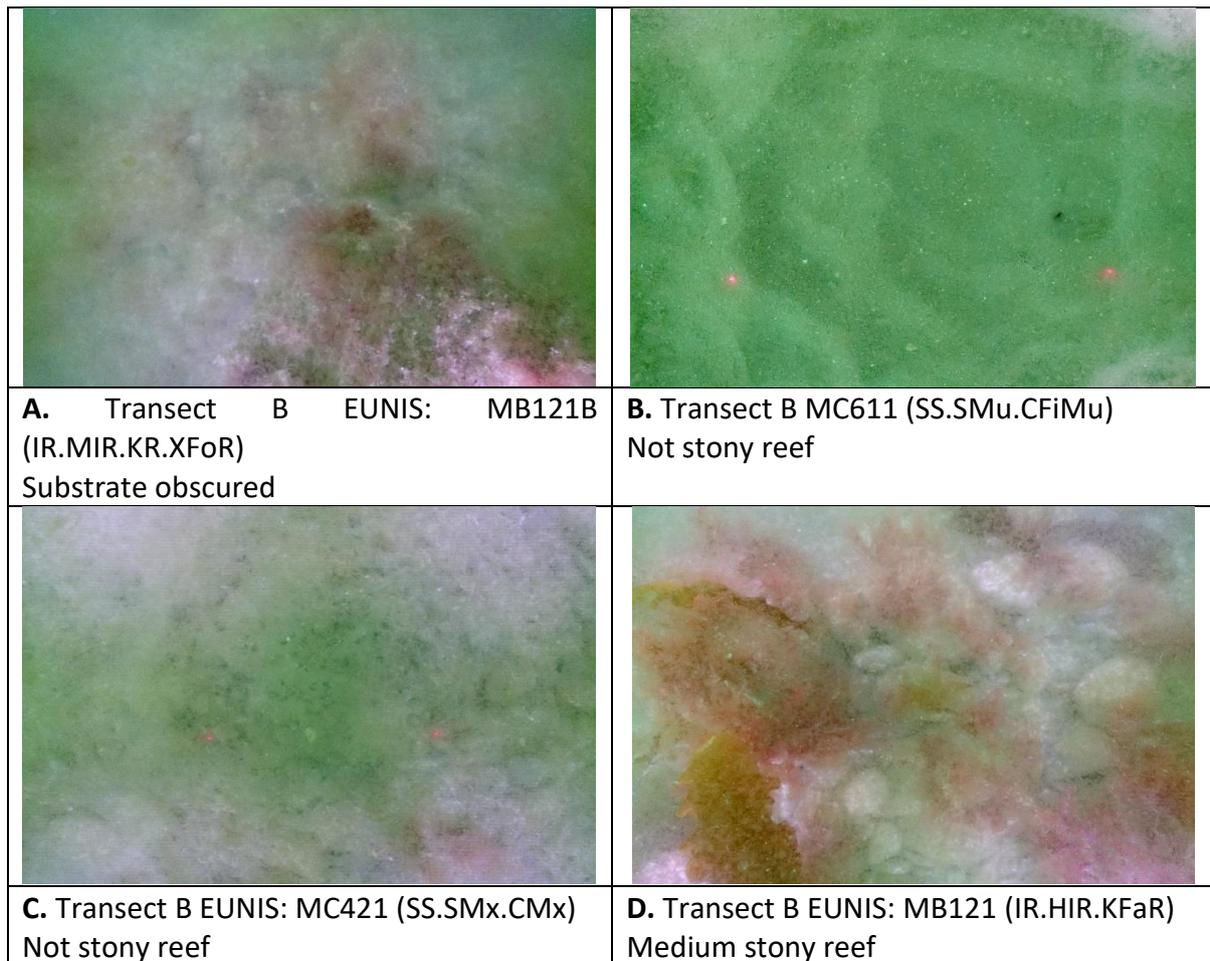
Figure 7. Representative seabed images of the biotopes identified at Transect B

Transect B comprised four distinct biotopes with varying sediment and faunal composition. The northern end of the transect was composed of large boulders and cobbles with filamentous red algae. This section of the transect was assigned to the biotope complex 'Dense foliose red seaweeds on moderately exposed Atlantic infralittoral silty rock' (EUNIS: MB121B; JNCC: IR.MIR.KR.XFoR), Figure 7A.

The middle section of Transect B comprised fine mud with some small burrows and no conspicuous fauna. This section was assigned to the biotope complex 'Circalittoral fine mud' (EUNIS code: MC611; JNCC: SS.SMu.CFiMu), Figure 7B.

A single still from Transect B was assigned to the biotope complex 'Faunal communities of Atlantic circalittoral mixed sediment' (EUNIS code: MC421; JNCC: SS.SMx.CMx), due to the presence of mud, shell fragments and pebbles but absence of cobbles, Figure 7C.

The substrata of southern section of Transect B consisted of cobbles and pebbles with *Laminaria* spp. and red filamentous algae. This section was assigned to the biotope complex 'Kelp and seaweed communities on Atlantic infralittoral rock' (EUNIS code: MB121; JNCC: IR.HIR.KFaR), Figure 7D.

No mussels or *Sabellaria* spp. were observed on Transect B. A stony reef assessment could not be completed for many of the stills on Transect B as the substrata were obscured by suspended sediment. In the northern extent of Transect B three stills were assigned to medium resemblance stony reef, comprised of medium sized cobbles (64 mm – 5 m) with over 40% coverage and >80% epifaunal species present (Figure 7D). A single still was assigned to low resemblance stony reef, comprising cobbles with elevation <64 mm and a coverage of 10-40%.

A stony reef assessment was possible for two stills from the southern biotope of Transect B. Both comprised medium sized cobbles (64 mm – 5 m) with over 40% coverage and >80% epifaunal species so medium resemblance stony reef was assigned.

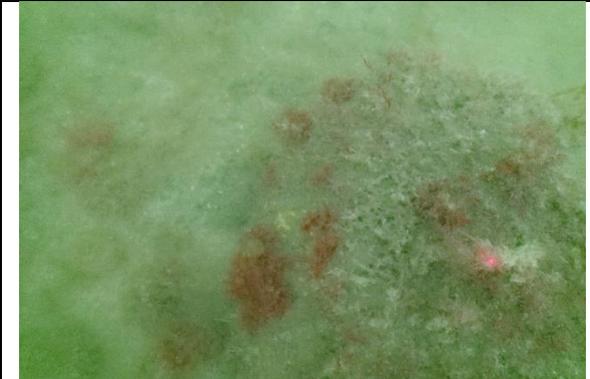
Figure 8. Representative seabed images of the biotopes identified at Transect C

Transect C consisted of three distinct biotopes with varying sediment and faunal composition. The northern and southern ends of the transect were composed of large boulders and cobbles with filaments red algae. These sections of the transect were assigned to the biotope complex ‘Dense foliose red seaweeds on moderately exposed Atlantic infralittoral silty rock’ (EUNIS: MB121B; JNCC: IR.MIR.KR.XFoR), Figure 8A & B. Conspicuous fauna observed in this biotope included the edible urchin *Echinus esculentus*.

No mussels or *Sabellaria* spp. were observed on Transect C. Stony reef assessment was not possible for some stills on Transect C as the substrata were obscured by suspended sediment. The northern and southern biotopes of this transect were mostly assigned to medium resemblance stony reef, comprised of medium sized cobbles (64 mm – 5 m) with over 40% coverage and >80% epifaunal species present (Figure 8A). Two stills from the southern section of the MB121B (IR.MIR.KR.XFoR) biotope complex were assigned to low resemblance stony reef, comprised of cobbles with elevation <64 mm and a coverage of 10-40% (Figure 8B).

<p>A. Transect C EUNIS: MB121B (IR.MIR.KR.XFoR) Medium stony reef</p>	<p>B. Transect C EUNIS: MB121B (IR.MIR.KR.XFoR) Low stony reef</p>

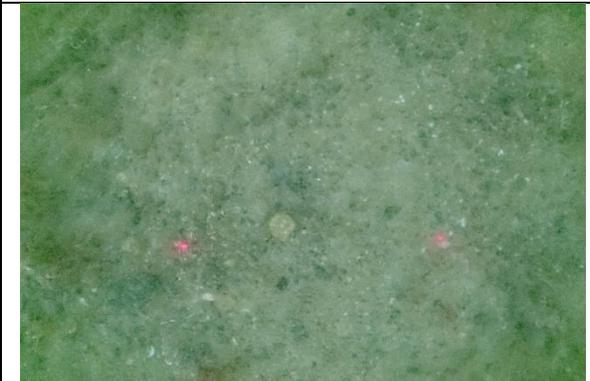
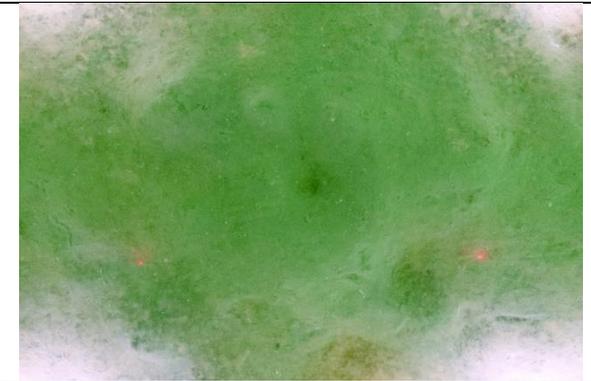
Two stills at the southern end of Transect C had substrata composed of mixtures of mud, gravel, pebbles and cobbles. These stills were assigned to the biotope complex ‘Faunal communities of Atlantic circalittoral mixed sediment’ (EUNIS code: MC421; JNCC: SS.SMx.CMx), Figure 8C. No conspicuous fauna was observed in this biotope.

The middle section of Transect C comprised of fine mud with some small burrows with no conspicuous fauna. This section was assigned to the biotope complex ‘Circalittoral fine mud’ (EUNIS code: MC611; JNCC: SS.SMu.CFiMu), Figure 8D.

<p>C. Transect C EUNIS: MC421 (SS.SMx.CMx) Not stony reef</p>	<p>D. Transect C EUNIS: MC611 (SS.SMu.CFiMu) Not stony reef</p>

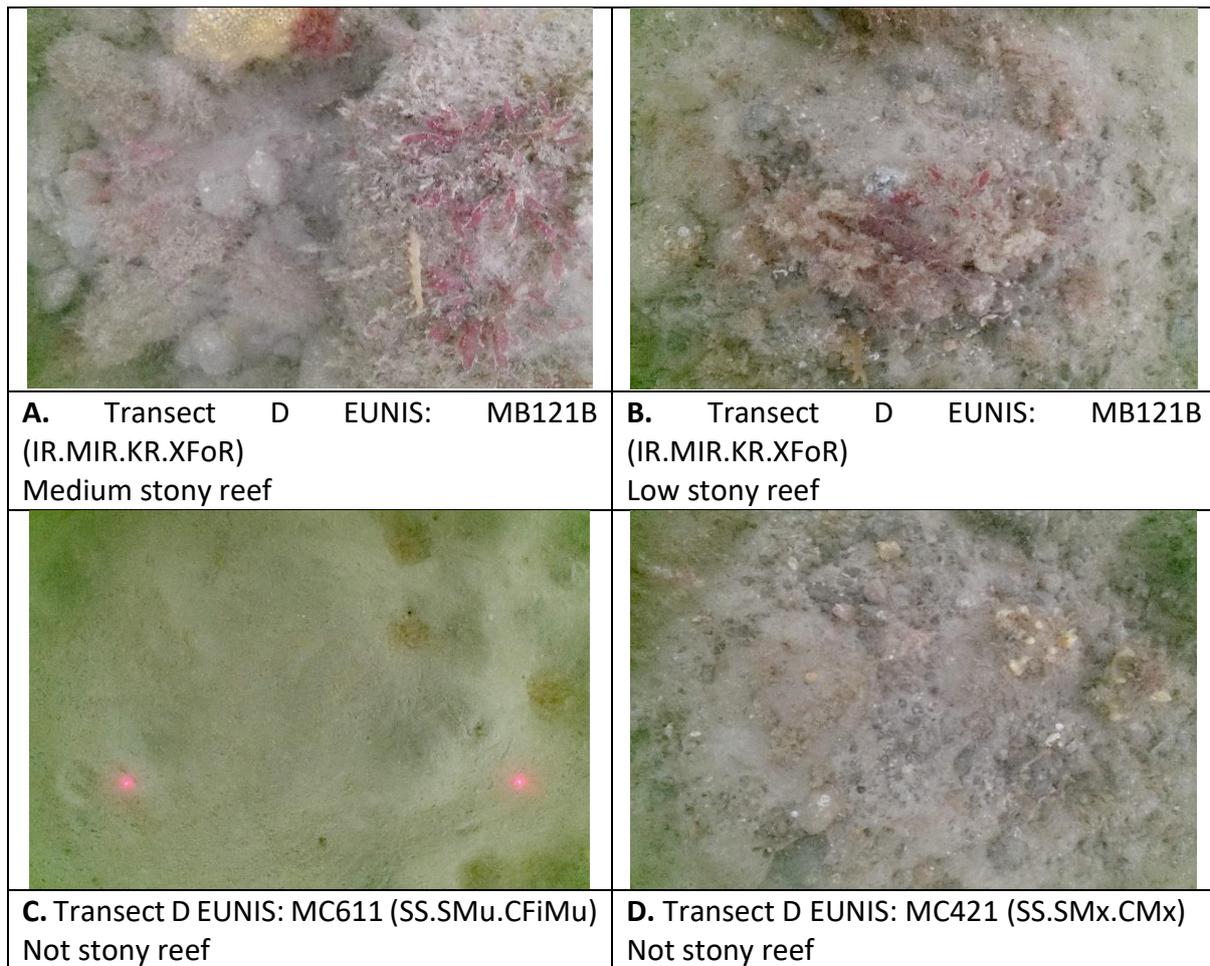
Figure 9. Representative seabed images of the biotopes identified at Transect D

Transect D consisted of three distinct biotopes with varying sediment and fauna composition. The southern end of the transect was composed of large boulders and cobbles with filamentous red algae. This section of the transect was assigned to the biotope complex 'Dense foliose red seaweeds on moderately exposed Atlantic infralittoral silty rock' (EUNIS: MB121B; JNCC: IR.MIR.KR.XFoR), Figure 9A & B. Conspicuous fauna found in this biotope included colonial Ascidiacea and *Alcyonidium diaphanum*.

The middle section of Transect D comprised of fine mud with some small burrows. Conspicuous fauna found in this biotope included *Cerianthus lloydii* and *Virgularia mirabilis*. This section was assigned to the biotope complex 'Circalittoral fine mud' (EUNIS code: MC611; JNCC: SS.SMu.CFiMu), Figure 9C.

Four stills (three at the southern end along with the northernmost still) along transect D had sediment composed of a mixture of mud, gravel, pebbles and cobbles. These stills were assigned to the biotope complex 'Faunal communities of Atlantic circalittoral mixed sediment' (EUNIS code: MC421; JNCC: SS.SMx.CMx), Figure 9D. Conspicuous fauna found in this biotope included filamentous red algae.

The southern biotope of Transect D was mostly assigned to medium resemblance stony reef, comprising medium sized cobbles (64 mm – 5 m) with over 40% coverage and >80% epifaunal species present (Figure 9A). Three stills from the southern section of the MB121B (IR.MIR.KR.XFoR) biotope complex were assigned to low resemblance stony reef, composed of cobbles with elevation <64 mm and a coverage of 10-40% (Figure 9B).

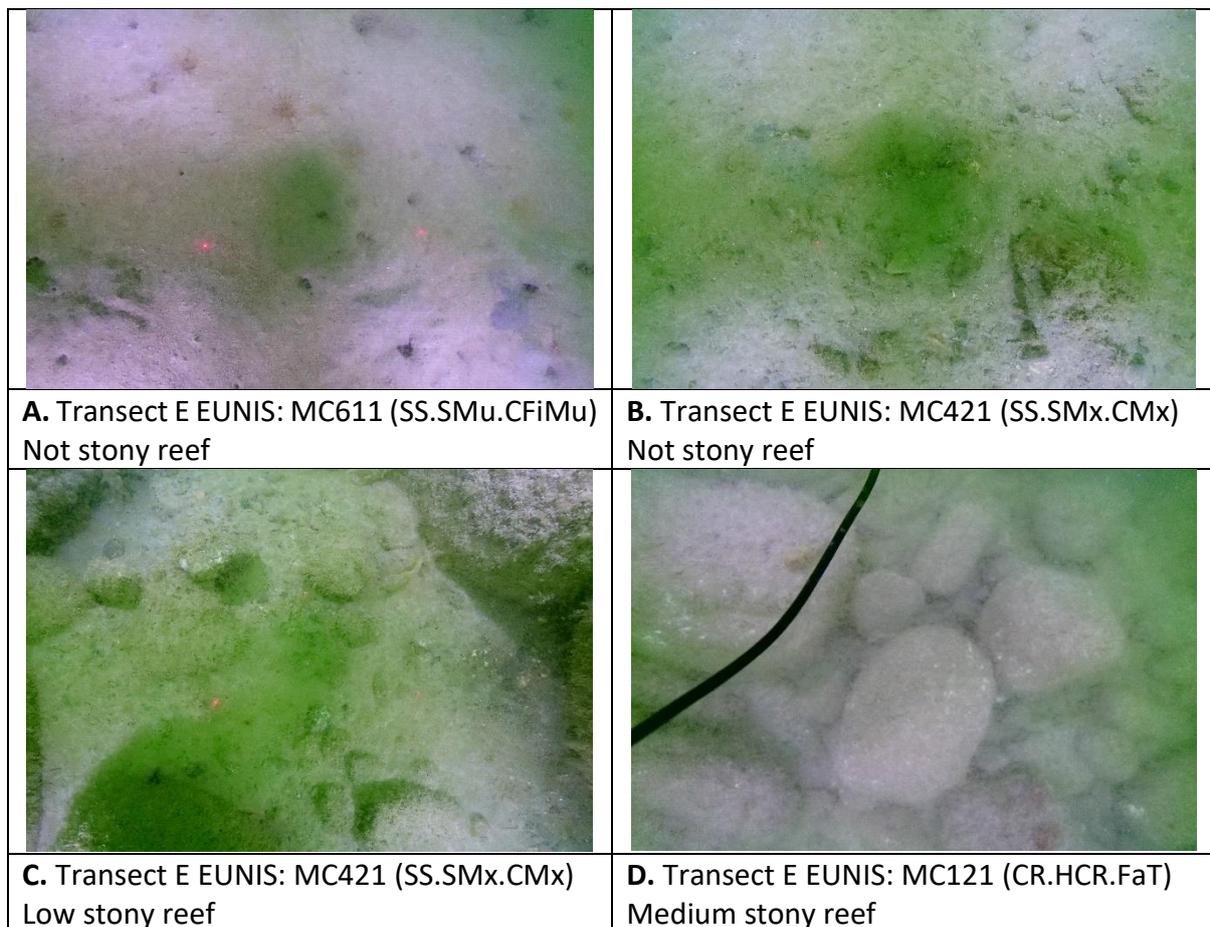
Figure 10. Representative seabed images of the biotopes identified at Transect E

Transect E consisted of three distinct biotopes with varying sediment and fauna composition. The majority of the transect comprised fine mud with burrows. Conspicuous fauna observed included *Cerianthus lloydii*. This section of the transect was assigned to the biotope complex ‘Circalittoral fine mud’ (EUNIS code: MC611; JNCC: SS.SMu.CFiMu), Figure 10A.

The areas of Transect E assigned to the 'MC121 (CR.HCR.FaT) biotope complex were assessed for stony reef. All were assigned to medium resemblance stony reef, comprising medium sized cobbles (64 mm – 5 m) with over 40% coverage and >80% epifaunal species present (Figure 10D).

One still from Transect E assigned to the biotope complex 'Circalittoral mixed sediment', was found to exhibit low resemblance stony reef, composed of cobbles with elevation <64 mm and a coverage of 10-40% (Figure 10C).

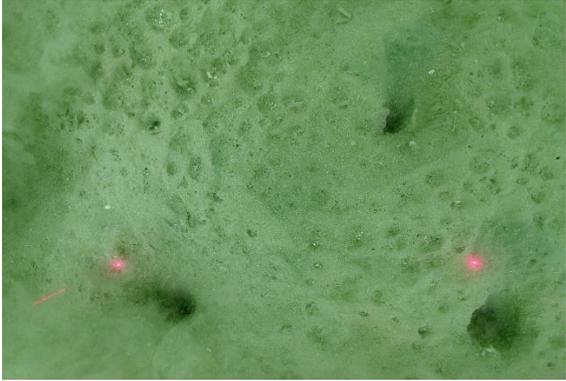
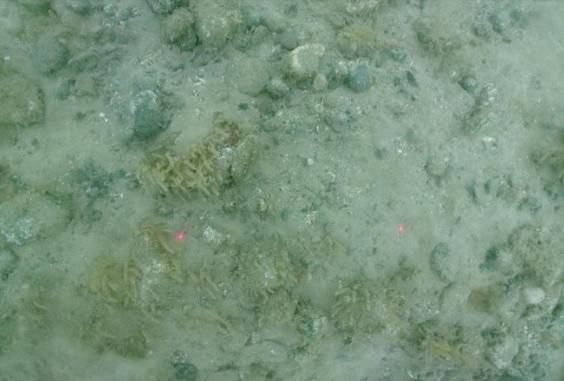
Figure 11. Representative seabed images of the biotopes identified at Transect G

The middle and north-western part of the transect were composed of a mixture of mud, gravel, pebbles and cobbles. Conspicuous fauna observed included *Cerianthus lloydii*, *Pecten maximus*, *Asterias rubens* and *Alcyonidium diaphanum*. These stills were assigned to the biotope complex ‘Faunal communities of Atlantic circalittoral mixed sediment’ (EUNIS code: MC421; JNCC: SS.SMx.CMx), Figure 11B & C.

<p>A. Transect G EUNIS: MC611 (SS.SMu.CFiMu) Not stony reef</p>	<p>B. Transect G EUNIS: MC421 (SS.SMx.CMx) Low stony reef</p>

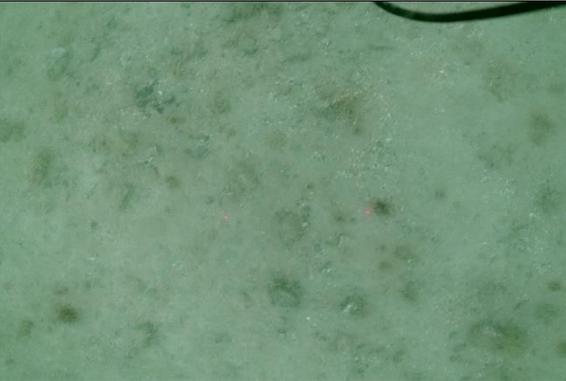
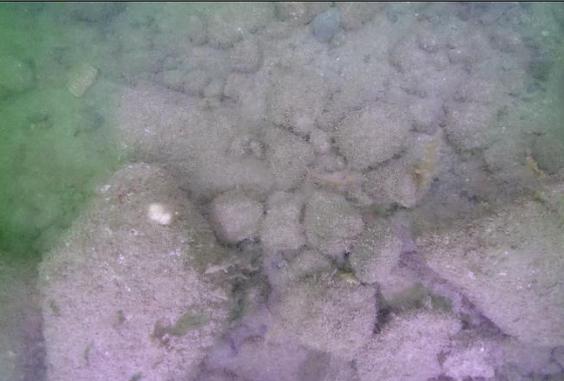
The remaining stills from Transect G comprised large boulders and cobbles covered in faunal turf. Conspicuous fauna observed included *Alcyonium digitatum*, *Asterias rubens* and *Alcyonidium diaphanum*. These stills were assigned to the biotope complex ‘Faunal turf communities on Atlantic circalittoral rock’ (EUNIS code: MC121; JNCC code: CR.HCR.FaT), Figure 11D.

<p>C. Transect G EUNIS: MC421 (SS.SMx.CMx) Not stony reef</p>	<p>D. Transect G EUNIS: MC121 (CR.HCR.FaT) Medium stony reef</p>

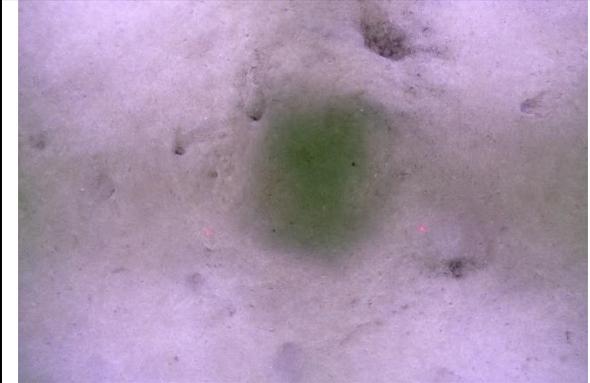
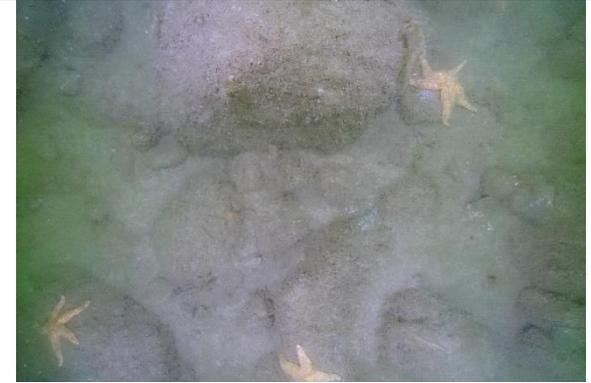
Figure 12. Representative seabed images of the biotopes identified at Transect H

Transect H consisted of three distinct biotopes with varying sediment and fauna composition. The middle section of Transect H was composed of fine mud with some small burrows. Conspicuous fauna found in this biotope included *Cerianthus lloydii* and the brown crab *Cancer pagurus*. This section was assigned to the biotope complex 'Circalittoral fine mud' (EUNIS code: MC611; JNCC: SS.SMu.CFiMu), Figure 12A.

The northern most and southern most extremes of Transect H comprised of large boulders and cobbles covered with faunal turf. Conspicuous fauna observed included *Necora puber*, *Alcyonium digitatum*, *Asterias rubens* and *Alcyonidium diaphanum*. These stills were assigned to the biotope complex 'Faunal turf communities on Atlantic circalittoral rock' (EUNIS code: MC121; JNCC code: CR.HCR.FaT) Figure 12B.

The areas of Transect H assigned to the MC121 (CR.HCR.FaT) biotope complex were assessed for stony reef. All were assigned to medium resemblance stony reef, composed of medium sized cobbles (64 mm – 5 m) with over 40% coverage and >80% epifaunal species present (Figure 12B).

<p>A. Transect H EUNIS: MC611 (SS.SMu.CFiMu) Not stony reef</p>	<p>B. Transect H EUNIS: MC121 (CR.HCR.FaT) Medium stony reef</p>

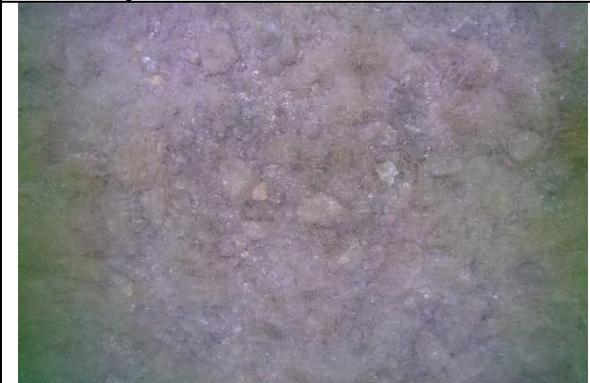
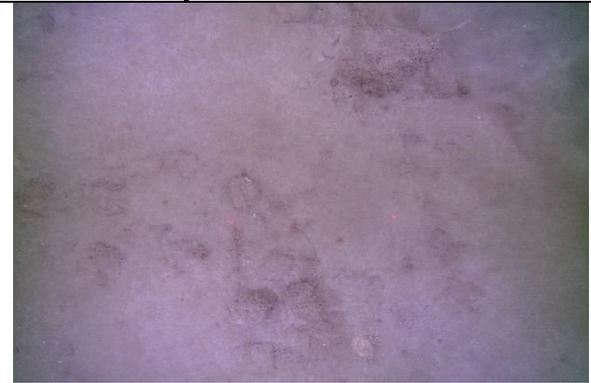
A few stills scattered along Transect H comprised mixtures of mud, gravel, pebbles and cobbles. Conspicuous fauna observed included *Cerianthus lloydii*, *Nemertesia* spp. and *Alcyonidium diaphanum*. These stills were assigned to the biotope complex 'Faunal communities of Atlantic circalittoral mixed sediment' (EUNIS code: MC421; JNCC: SS.SMx.CMx) Figure 12C & D.

A few stills from Transect H assigned to the biotope complex ‘Circalittoral mixed sediment’, were considered to be low resemblance stony reef, comprising cobbles with elevation <64 mm and a coverage of 10-40% (Figure 12C).

<p>C. Transect H EUNIS: MC421 (SS.SMx.CMx) Low stony reef</p>	<p>D. Transect H EUNIS: MC421 (SS.SMx.CMx) Not stony reef</p>

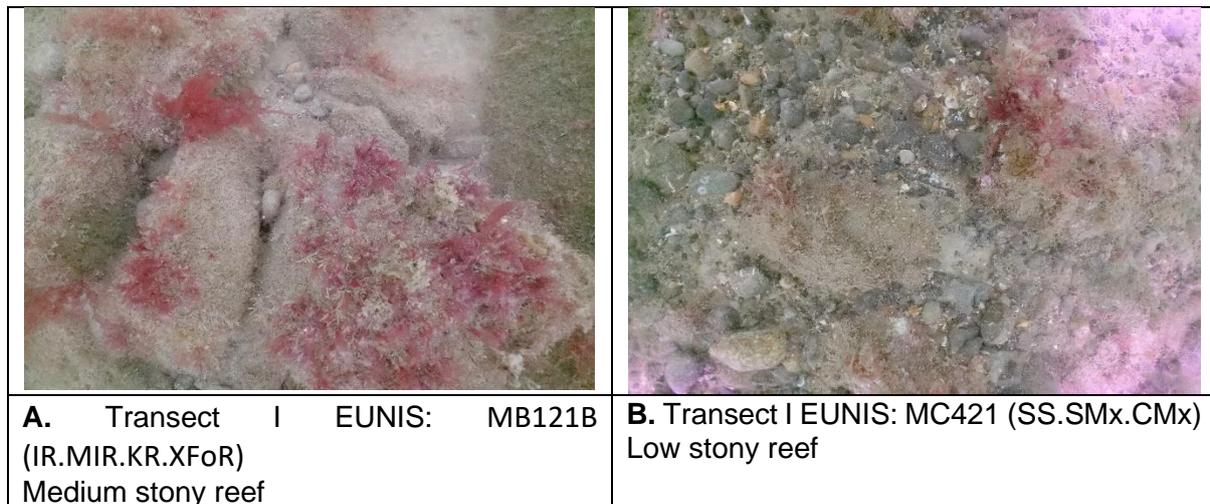
Figure 13. Representative seabed images of the biotopes identified at Transect I

Transect I consisted of two distinct biotopes with varying sediment and fauna composition. All but one of the stills on this transect included large boulders and cobbles with filamentous red algae. This section of the transect was assigned to the biotope complex ‘Dense foliose red seaweeds on moderately exposed Atlantic infralittoral silty rock’ (EUNIS: MB121B; JNCC: IR.MIR.KR.XFoR), Figure 13A. Conspicuous fauna found in this biotope included *Asterias rubens*.

A single still on Transect I was composed of mud, gravel, pebbles and cobbles. No conspicuous fauna was observed. This still was assigned to the biotope complex ‘Faunal communities of Atlantic circalittoral mixed sediment’ (EUNIS code: MC421; JNCC: SS.SMx.CMx), Figure 13B.

The areas of Transect I assigned to the MB121B (IR.MIR.KR.XFoR) biotope complex were assessed for stony reef. All were considered to represent medium resemblance stony reef, composed of medium sized cobbles (64 mm – 5 m) with over 40% coverage and >80% epifaunal species present (Figure 13A).

The still from Transect I assigned to the MC421 (SS.SMx.CMx) biotope complex was considered to be low resemblance stony reef, comprising cobbles with elevation <64 mm and a coverage of 10-40% (Figure 13B).

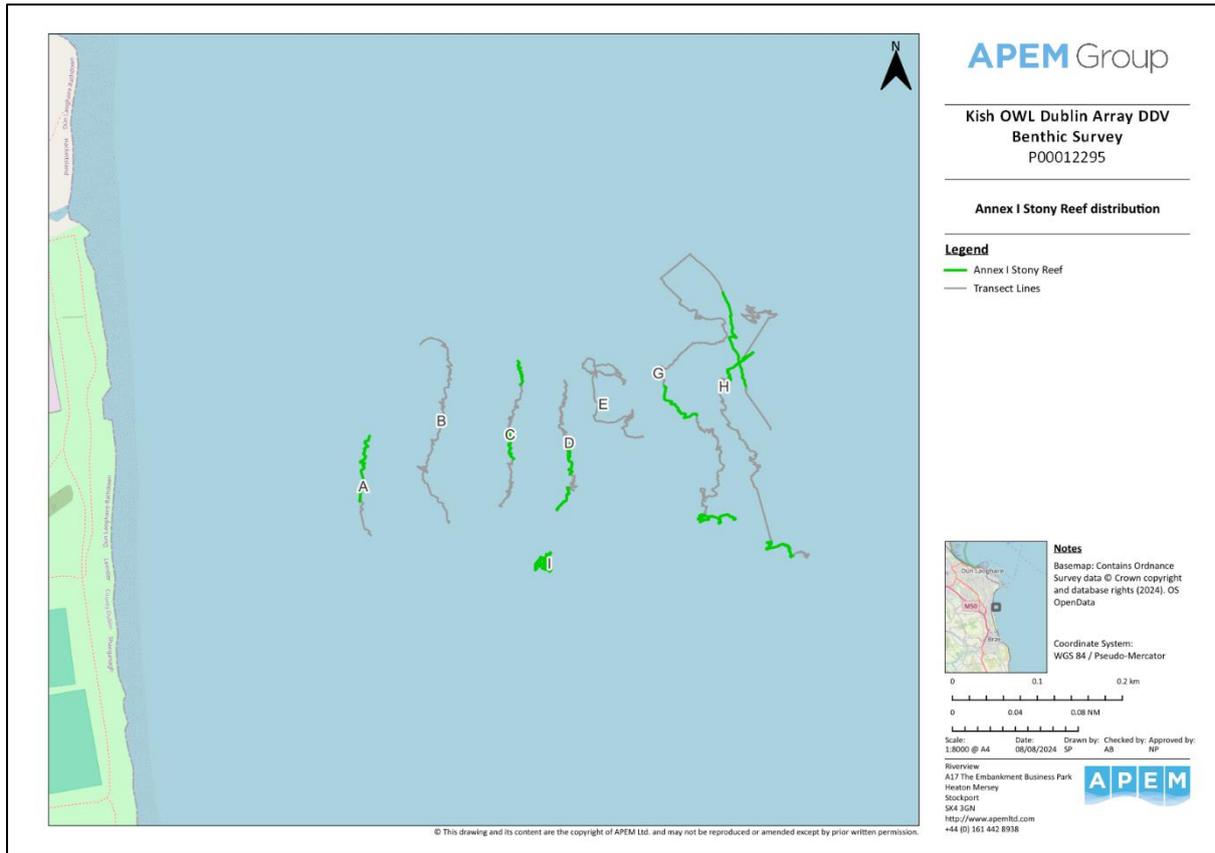
Figure 14. Distribution of Annex I stony reef habitat

The images classified as medium resemblance stony reef needed to fulfil the minimum extent criteria of >25 m² to qualify as Annex I reef habitat (Irving, 2009). The habitat extent, and in particular patchiness, is impossible to assess based on a single still image. Therefore, to provide a conservative estimate of the minimum extent of potential Annex I stony reef habitat the distances between consecutive images classified as including medium resemblance stony reef habitat were measured in GIS. Where consecutive images covered a minimum transect distance of 25 m, these were considered to represent Annex I stony reef habitat. The distribution of Annex I stony reef habitat identified is mapped in Figure 14.

Transects A, C, D, G, H and I all included at least one area that met the minimum extent criteria for Annex I stony reef (see Figure 14). The areas of potential stony reef identified on Transects B and E were only present in isolated images or consecutive images that were less than 25 m apart and were therefore did not represent Annex I habitat.
