PEAT AND SPOIL MANAGEMENT PLAN

Seskin Wind Farm
Peat and Spoil Management Plan

02 May 2024

AFRY Ireland Ltd
The Hyde Building
The Park
Carrickmines
Dublin
Ireland

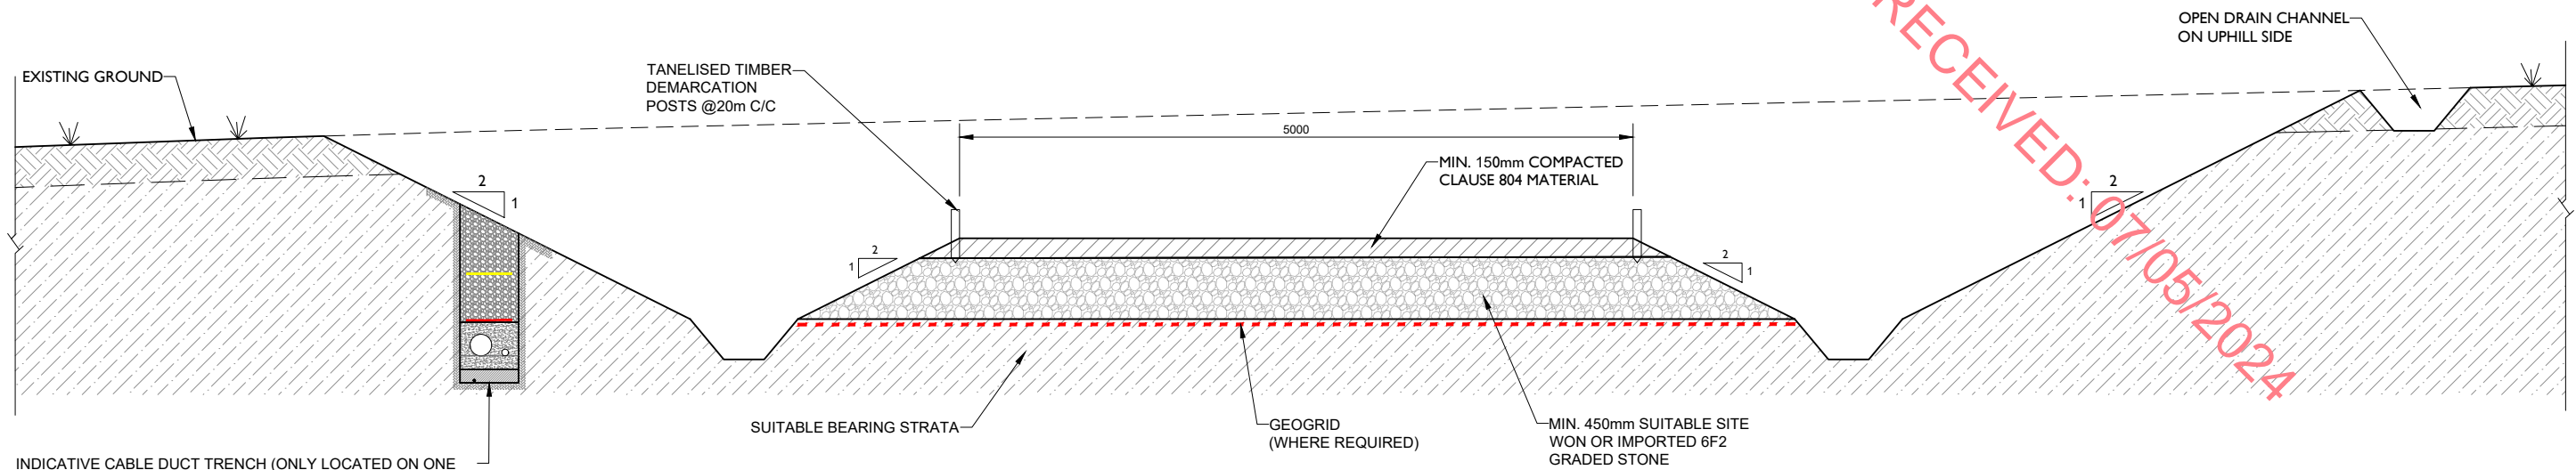
TYPE 'A' - NEW EXCAVATE & REPLACE ACCESS ROAD SECTION
(SHOWN IN CUT SCENARIO)
Scale 1:50

The finished road width will have a running width of 5m, with wider sections on bends and passing bays. Access road construction will be to the line and level requirements as per design/planning conditions.

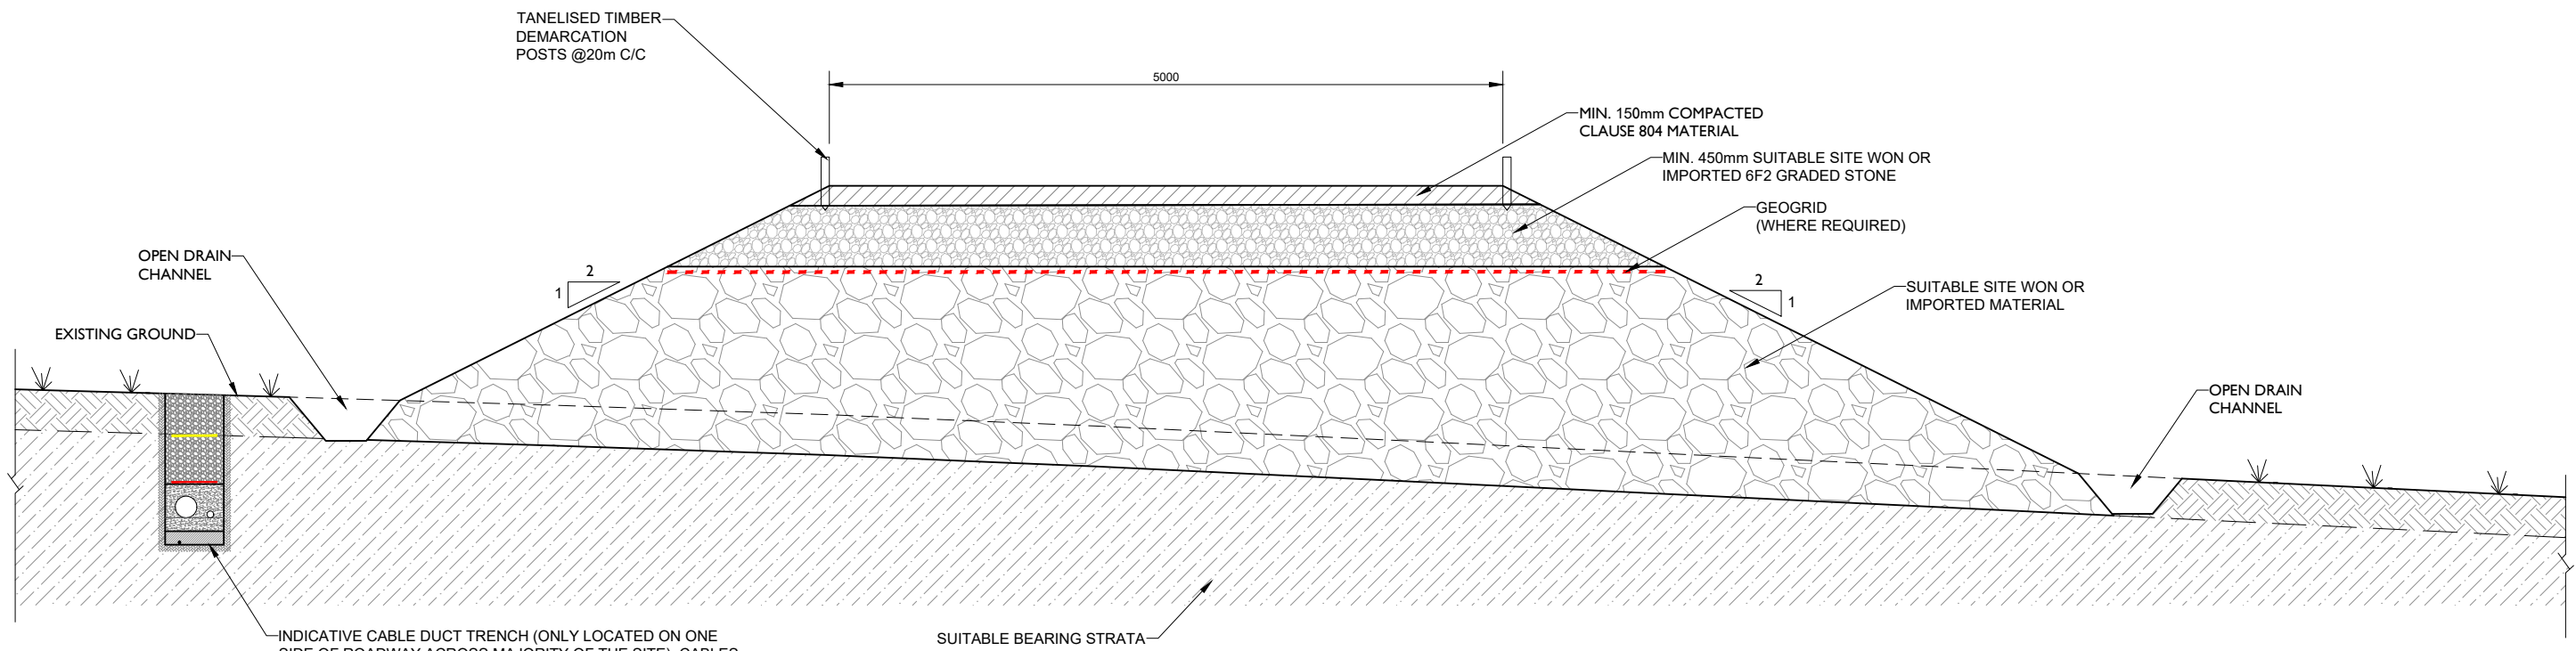
TYPE 'A' - NEW EXCAVATE & REPLACE ACCESS ROAD SECTION
(SHOWN IN FILL SCENARIO)
Scale 1:50

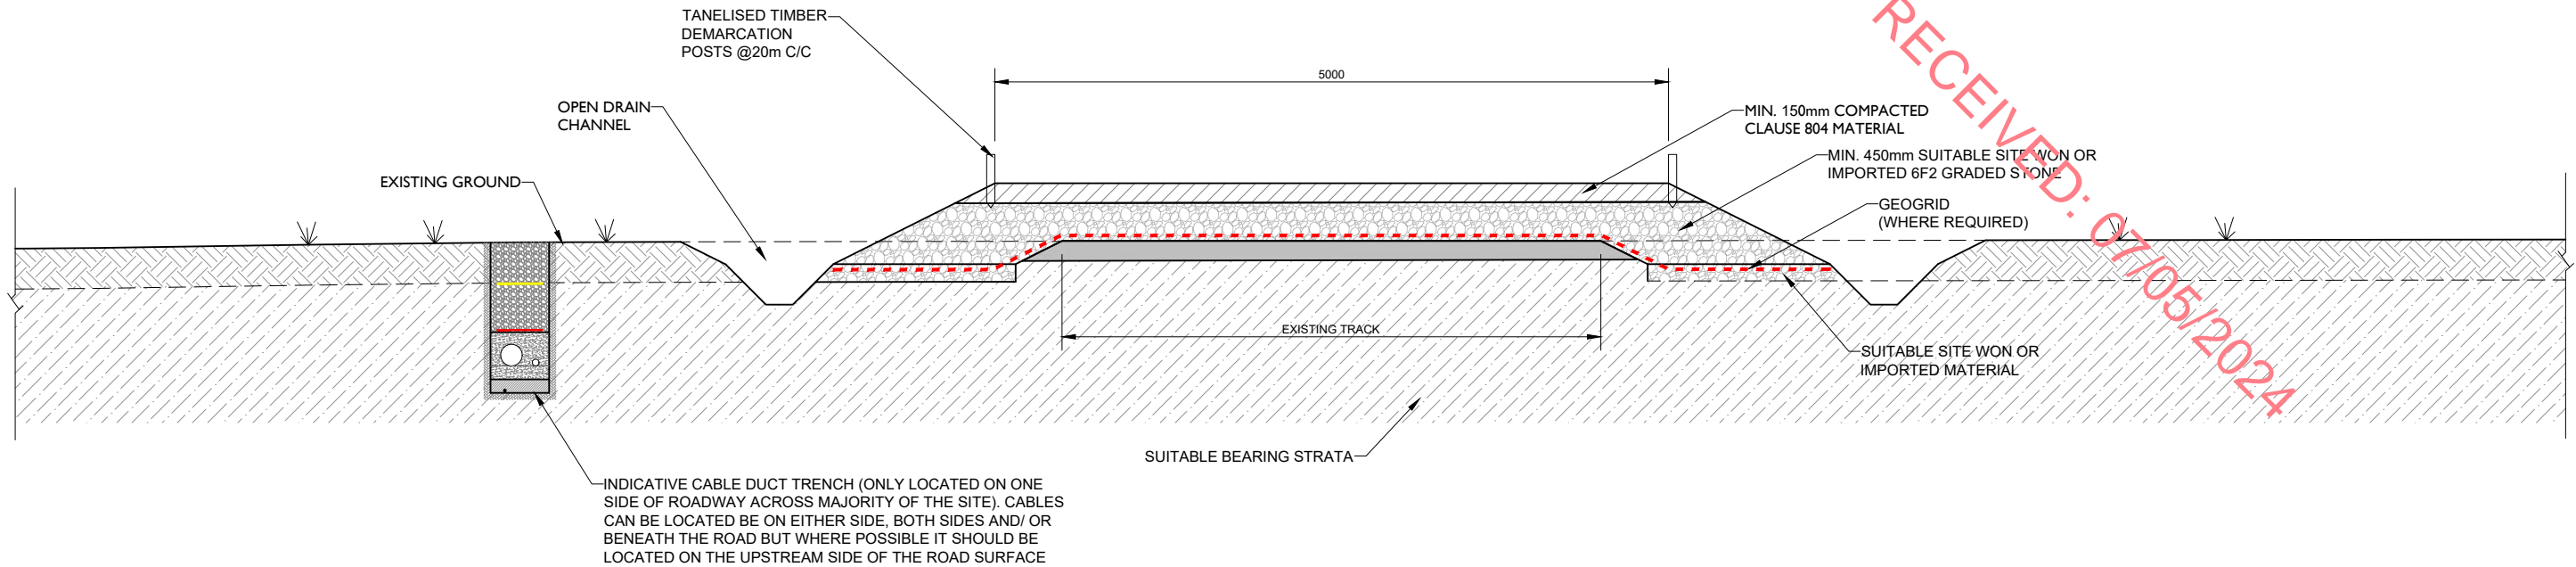
TYPE 'B' - UPGRADE OF EXISTING EXCAVATED ACCESS ROAD
(WIDENING ON BOTH SIDES)
Scale 1:50

The existing roads will be widened through excavation and the removal of organic material and soft subsoil to achieve a suitable formation level. The new section of the road will be constructed by placing a minimum of 450mm of granular fill material, such as Class 6F2 stone, and compacting it in layers on top of a layer of geogrid or geotextile, depending on site conditions and as specified by the detailed designer. This road construction will be similar in build up to the construction of excavate and replace type access road. The increased road width and the existing road surface, where necessary, will be capped with a 150mm layer of Clause 804 similar material.

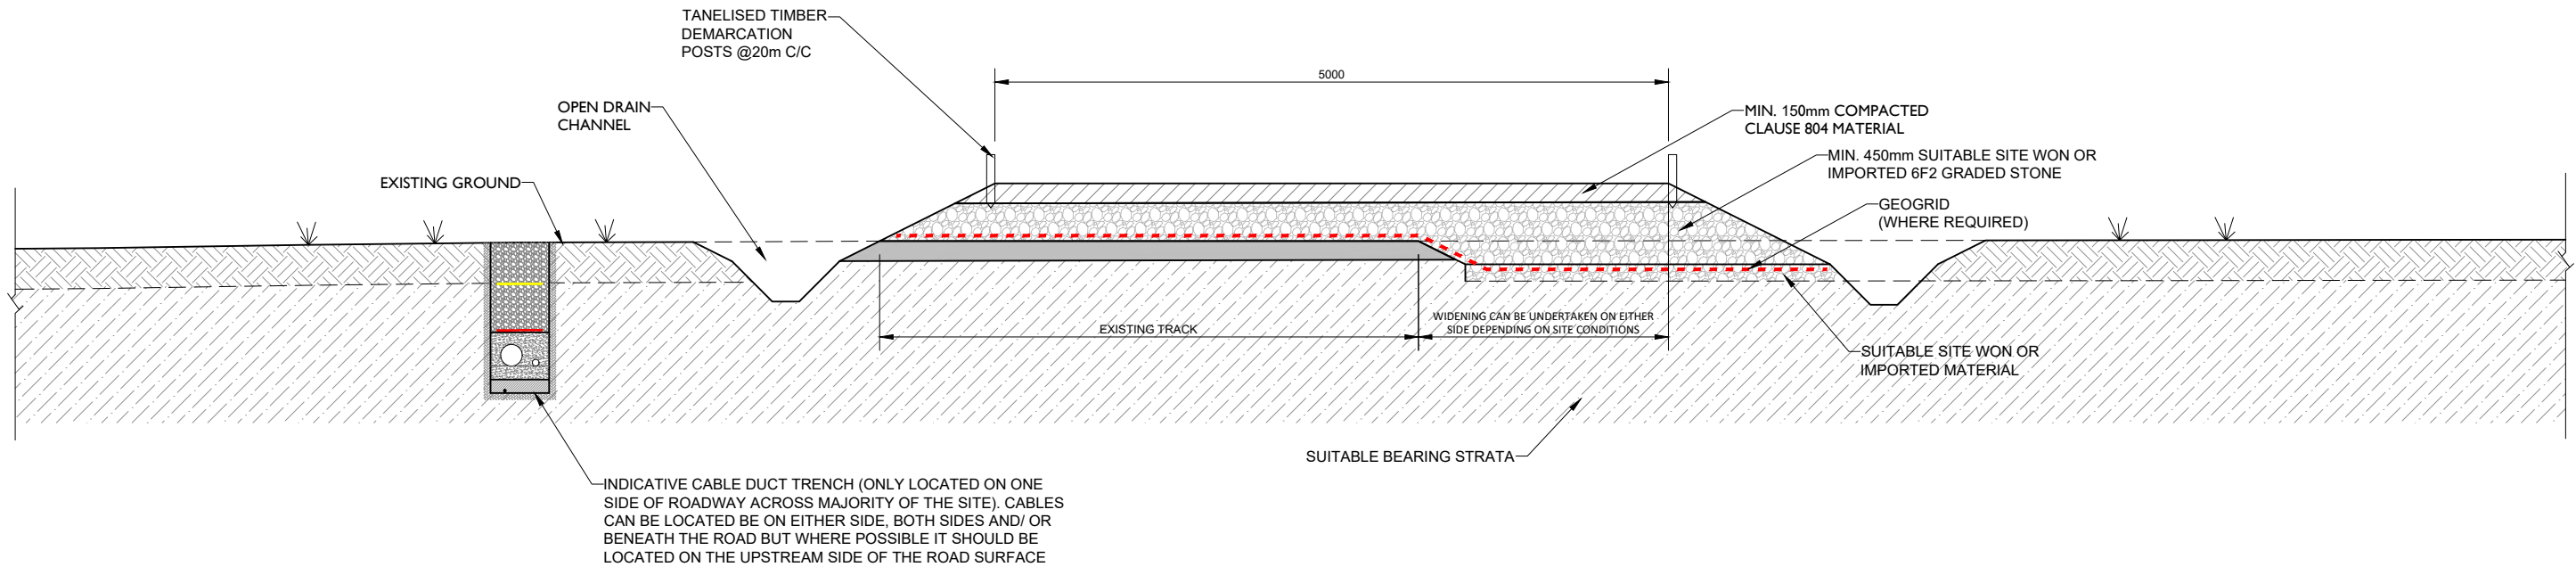
TYPE 'B' - UPGRADE OF EXISTING EXCAVATED ACCESS ROAD
(WIDENING ON ONE SIDE)
Scale 1:50

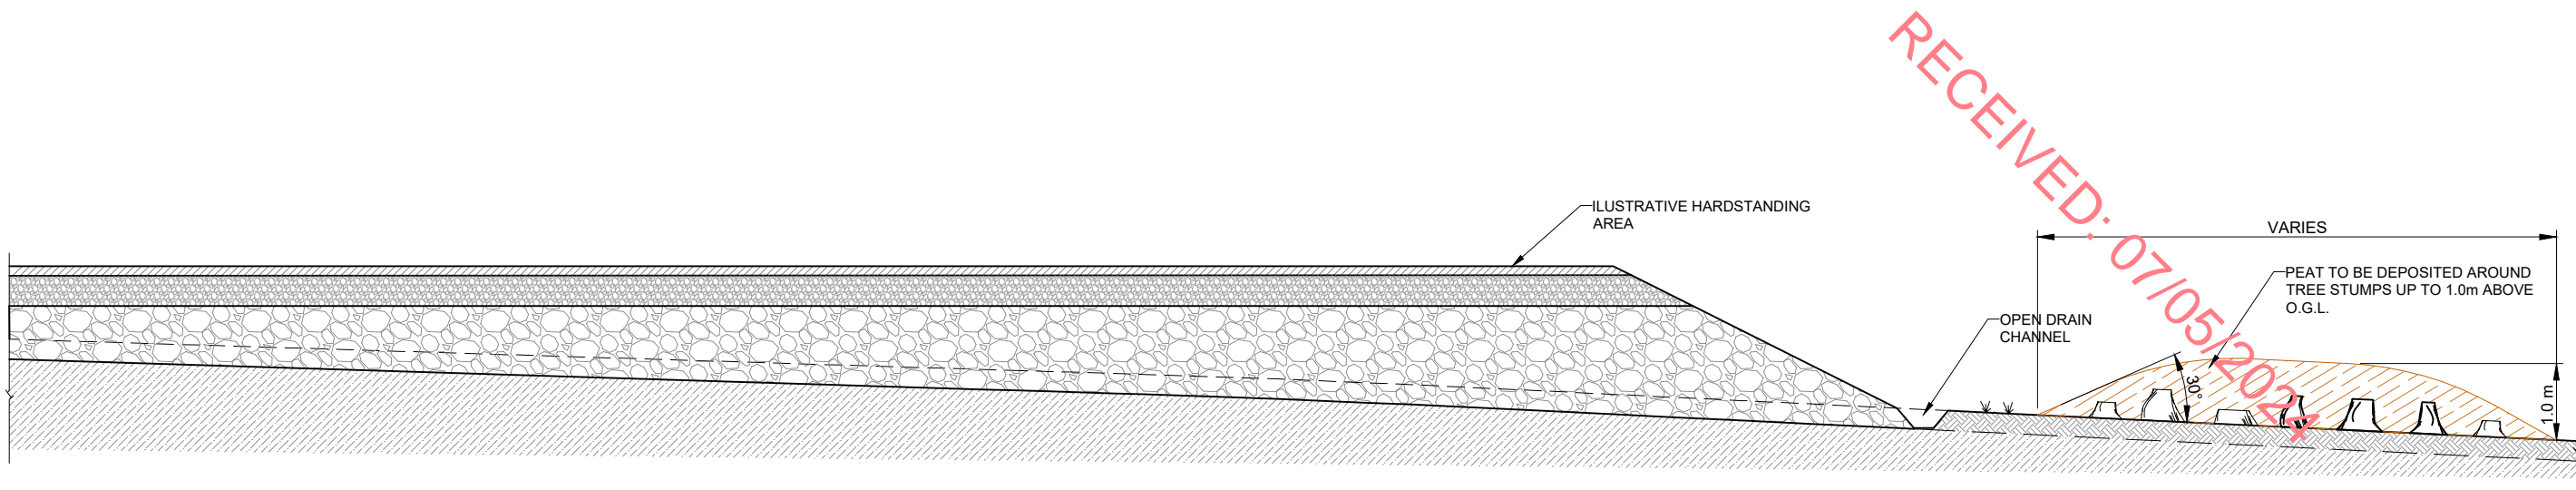
ILLUSTRATIVE PEAT REPOSITORY IN TREE FELLED AREA
Scale 1:50

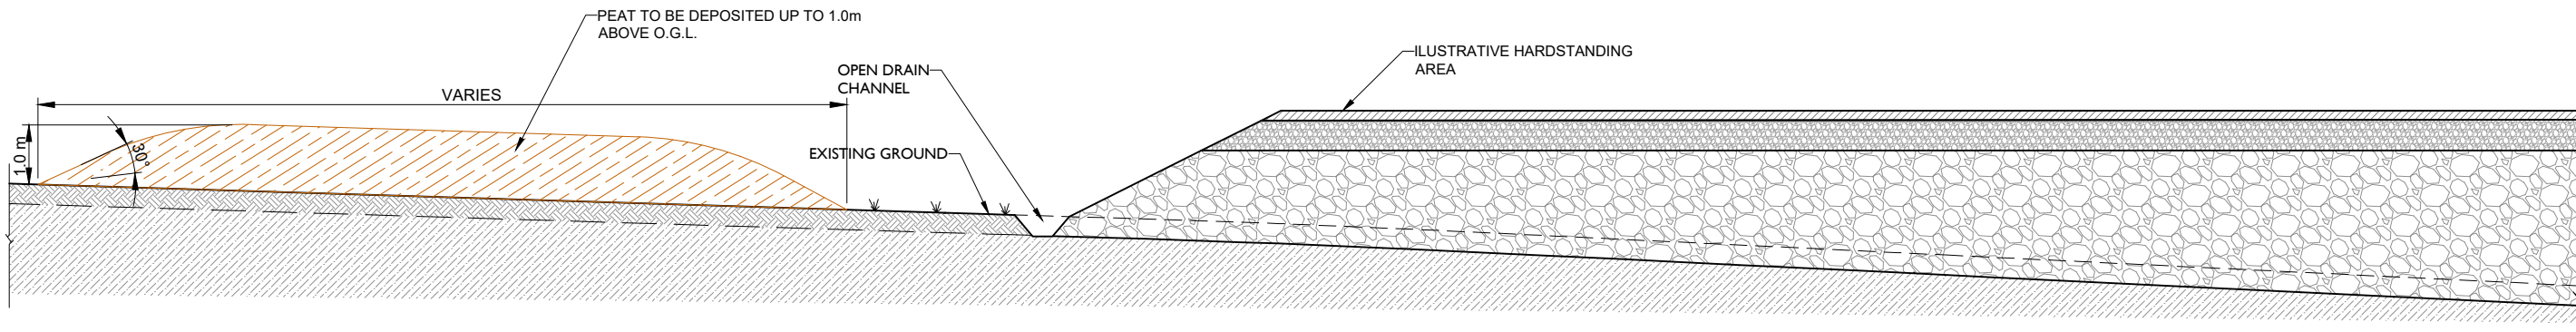
ILLUSTRATIVE PEAT REPOSITORY AREA
Scale 1:50

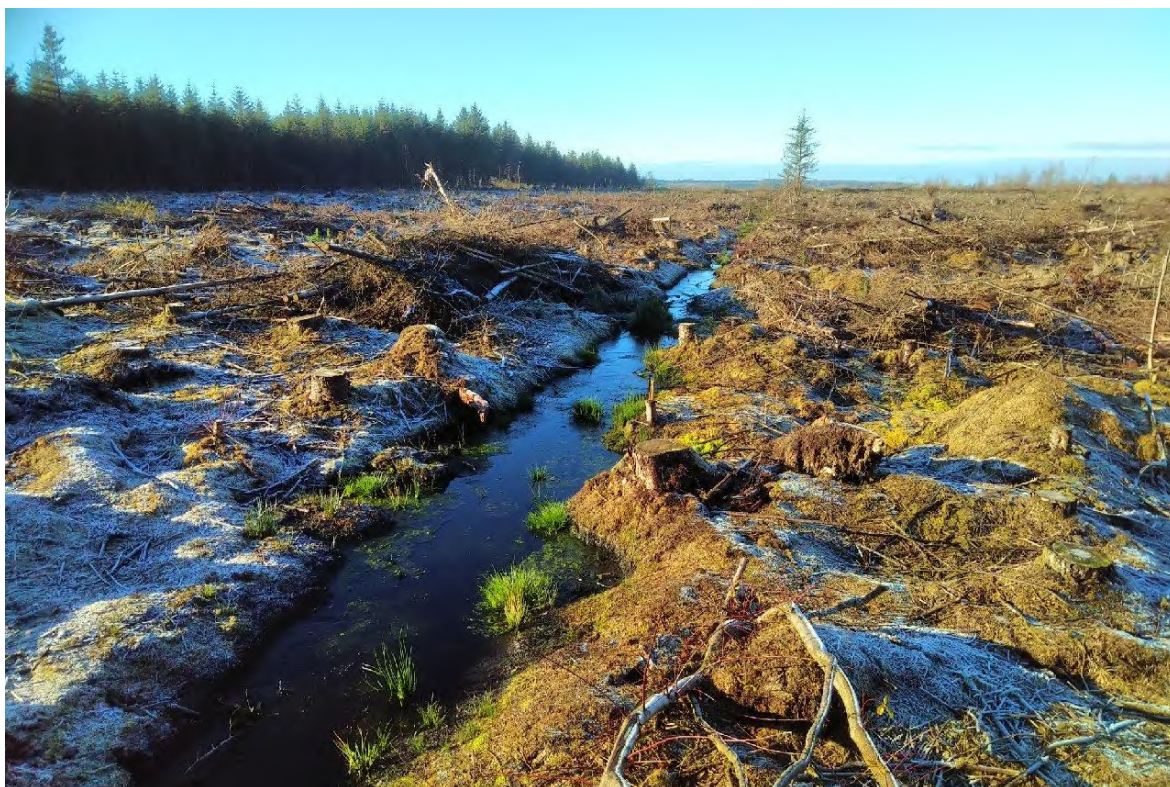
Photo 4: Access to T5 showing soft and wet ground conditions

During a subsequent site walkover in November 2023, it was noted that the areas adjacent to T4, T5, and T7 displayed an irregular and notably soft to very soft ground composition. The peat in these areas was observed to be saturated, considering the time of the year. For detailed information on ground conditions and stability of peat, please refer to the Geotechnical and Peat Stability Assessment included within Chapter 8 of this EIAR: Land, Soils and Geology.

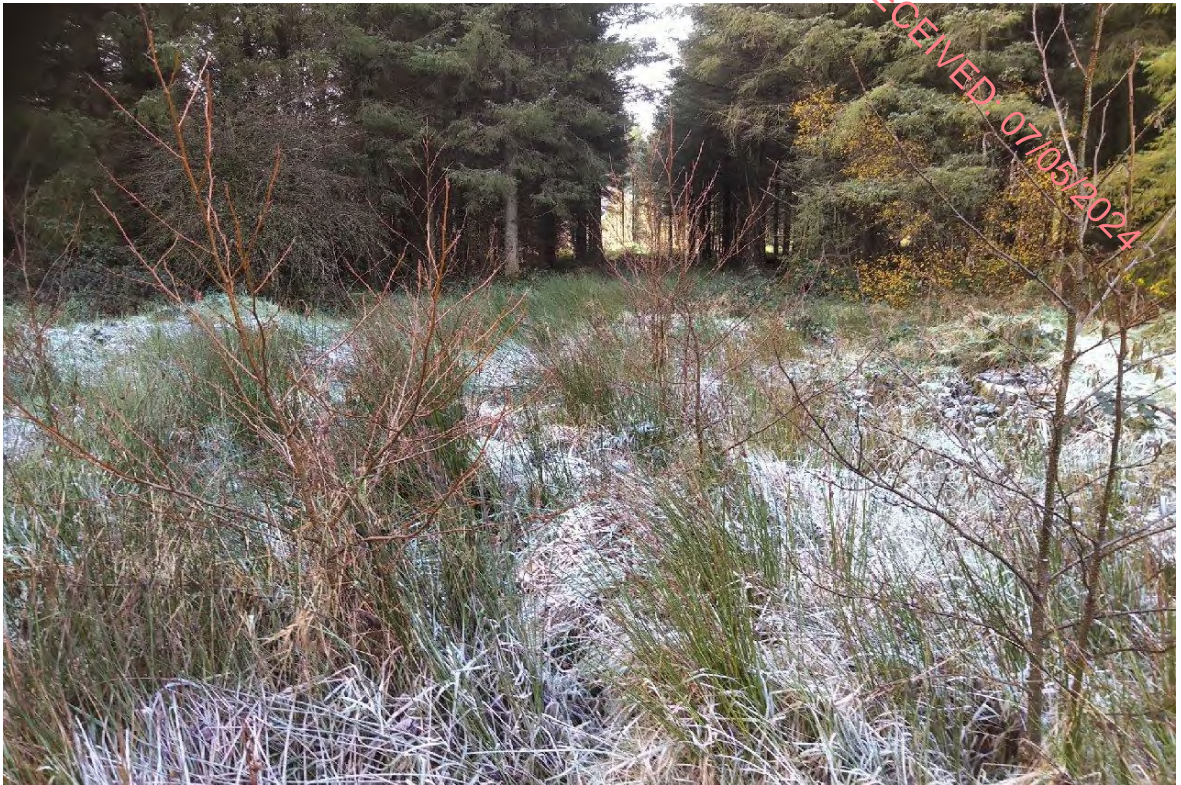
Photo 5: Area around T7 shows replanted fir and hardwood trees, with soft, uneven ground and tree stumps
