**DRAFT BORD NA MÓNA  
CUTAWAY BOG  
DECOMISSIONING AND  
REHABILITATION PLAN**

**Lemanaghan Bog (Kilnagoolny)**

**Draft Cutaway Bog Decommissioning  
and Rehabilitation Plan  
2025**

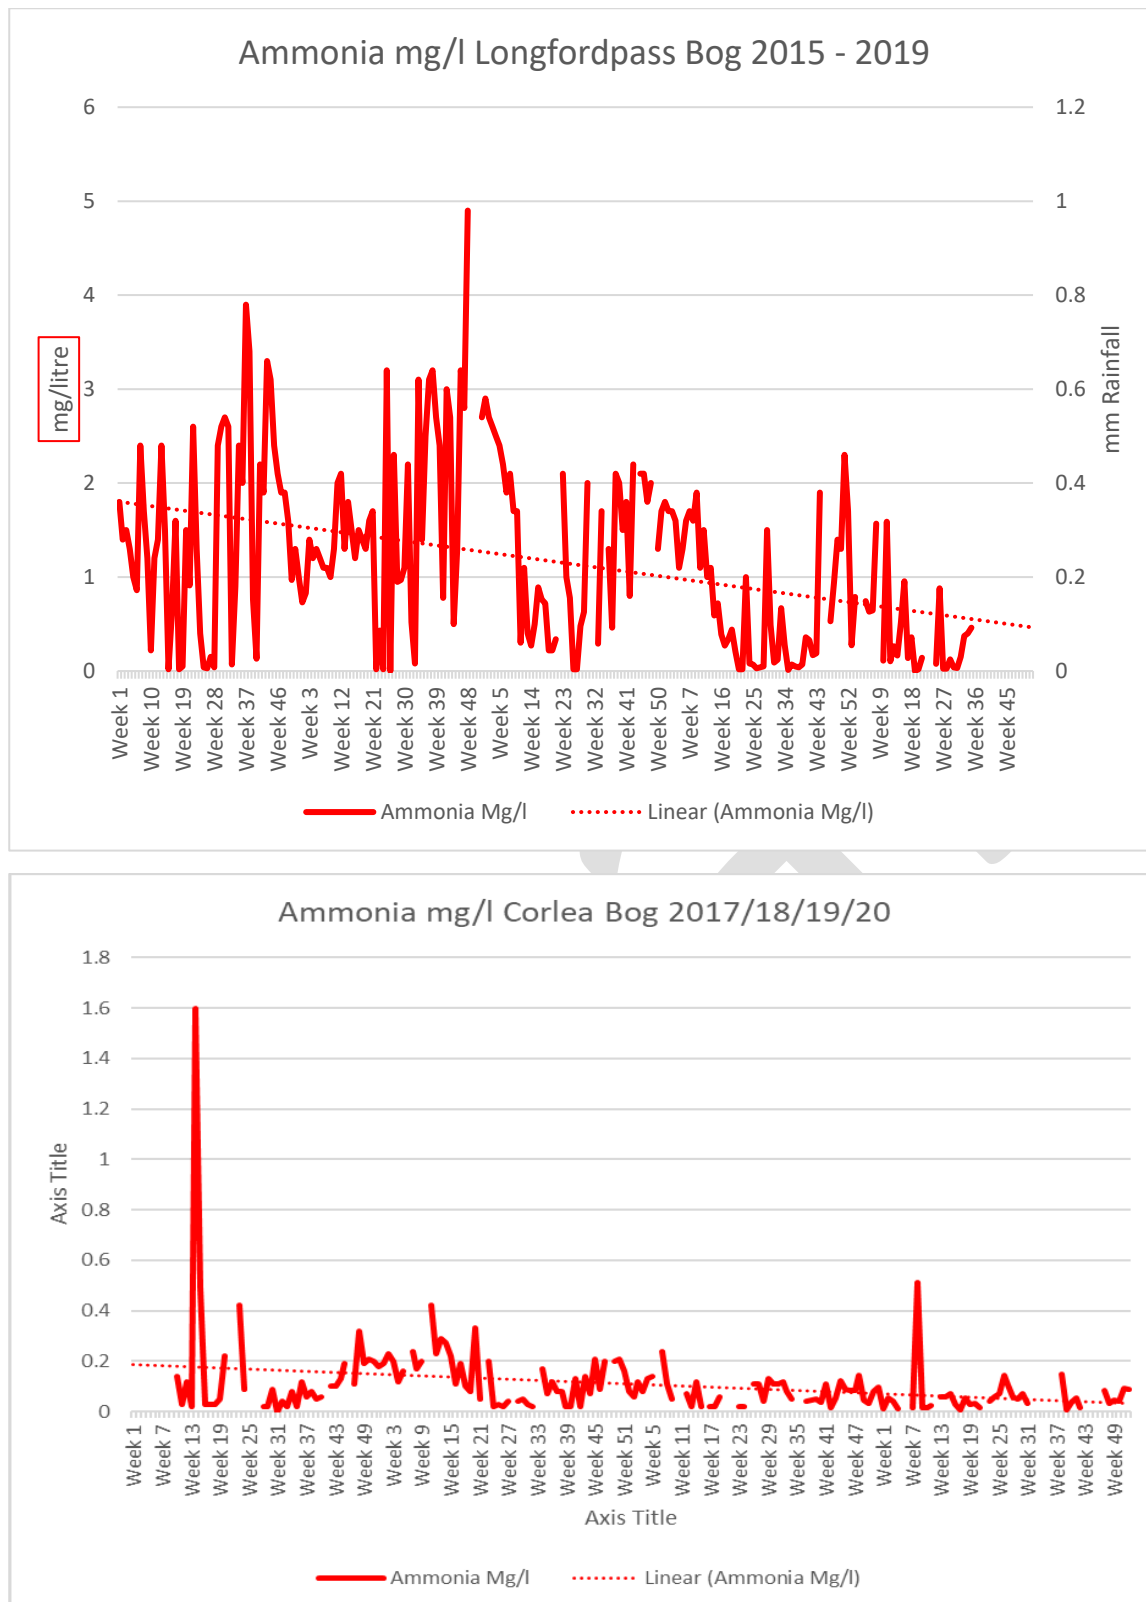
**Figure 7.1.** Ammonia levels over the period 2015-2019/2020 at Longfordpass and Corlea.

With regard to predicting and estimating likely trends that might materialize or could be considered as a target, the results of monitoring of surface water ammonia emissions from Longfordpass bog in Littleton over 4 years, post cessation of peat extraction with ongoing rehabilitation, were considered. These are indicating a downward trend in Ammonia concentrations (Figure 7.1).

Similarly monitoring of surface water ammonia emissions from a Corlea bog in Mountdillon over the past 4 years post cessation of peat extraction with ongoing rehabilitation indicate downward trends.
