Project No: P1653-1
Site: Seskin, Co. Laois
Client: MKO

Trial Pit Log

Trial Pit No: TP25-BP-01
Easting: 128662.276
Northing: 278106.563
Elevation: 145.071mOD

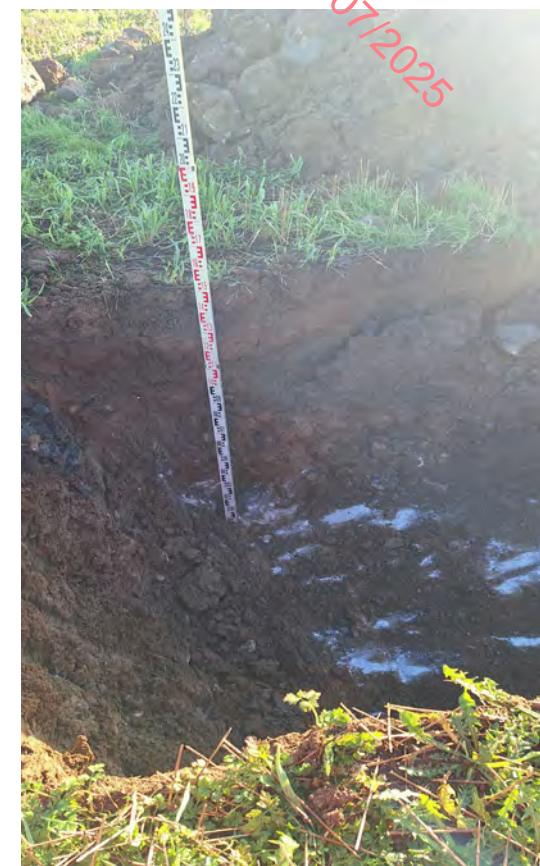
Depth	Symbol	Depth/Elev.	Description	Water Strikes	Sample Type	Comments
0.00		145.07	Ground Surface			
		0.00	Topsoil with grass rootlets			
		144.77				
		0.30	Light greyish brown, silty sandy Subsoil			
		144.57				
		0.50	Light greyish brown, silty SAND with frequent limestone cobbles and boulders. Boulders are angular.			
1.00						
		143.57				
		1.50	Limestone bedrock met, medium dark grey Limestone, medium hard, medium-large grain size with some crinoid ossicles present. No evidence of weatehring/clay - competent Limestone

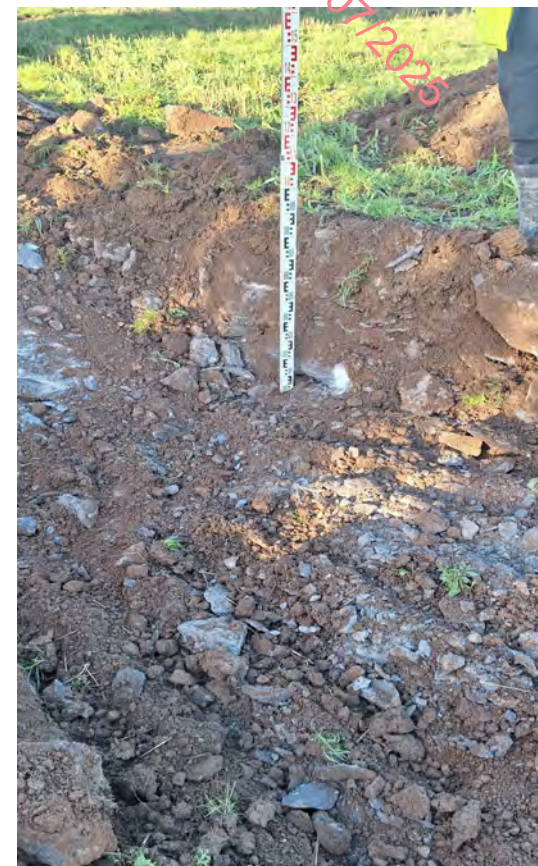
Trial Pit No: TP25-BP02
Easting: 242238
Northing: 174254
Elevation: 146.263mOD

Depth	Symbol	Depth/Elev.	Description	Water Strikes	Sample Type	Comments
0.00		146.26	Ground Surface			
		0.00	Topsoil with grass rootlets			
		146.16				
		0.10	Light greyish brown, silty sandy Subsoil			
		146.01				
		0.25	Limestone bedrock met, medium dark grey Limestone, medium-soft, medium-large grain size with some crinoid ossicles present. No evidence of weatehring/clay - competent Limestone			
		145.36				
		0.90				
1.00

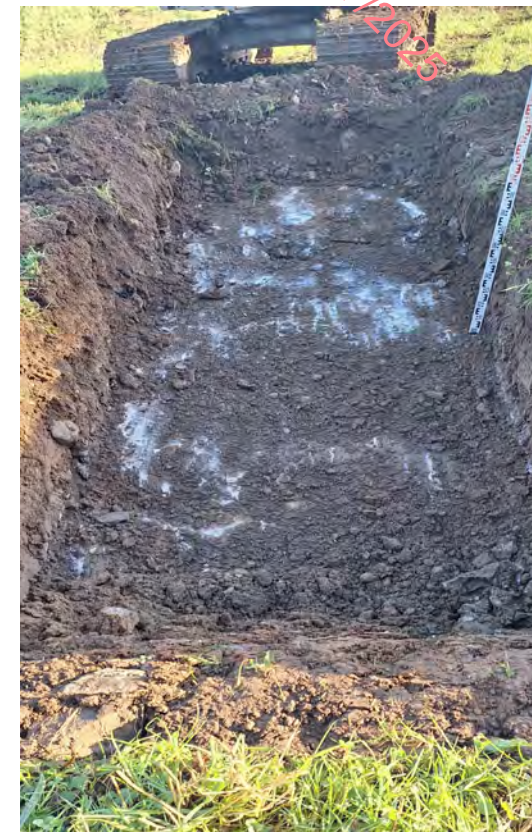
Trial Pit No: TP25-BP04
Easting: 242079
Northing: 174243
Elevation: 152.748mOD

Depth	Symbol	Depth/Elev.	Description	Water Strikes	Sample Type	Comments
0.00		0.75	Ground Surface			
		0.00	Topsoil with grass rootlets			
		0.45				
		0.30	Light greyish brown, silty sandy Subsoil			
		-0.15				
1.00		0.90	Limestone bedrock met, medium dark grey Limestone, soft, medium-large grain size with some crinoid ossicles present. No evidence of weatehring/clay - competent Limestone

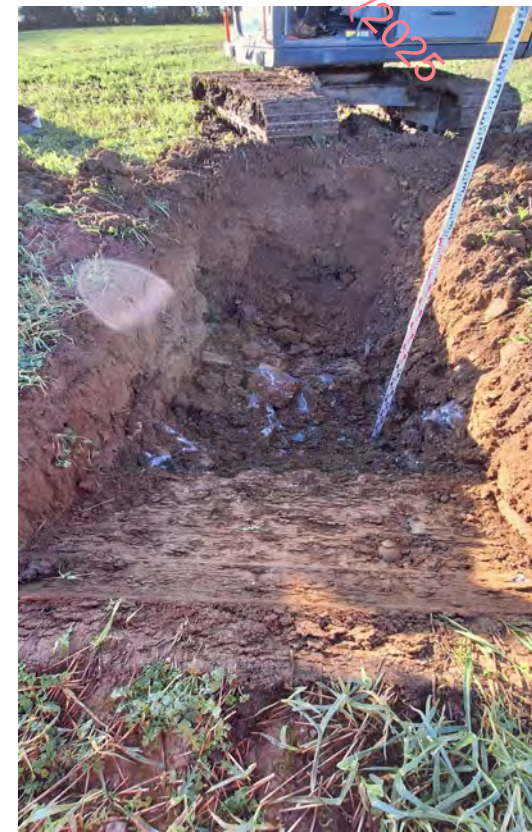
Trial Pit No: TP25-BP05
Easting: 242106
Northing: 174281
Elevation: 147.907mOD

Depth	Symbol	Depth/Elev.	Description	Water Strikes	Sample Type	Comments
0.00		147.91	Ground Surface			
		0.00	Topsoil with grass rootlets			
		147.61				
		0.30	Light greyish brown, silty sandy Subsoil			
		147.21				
		0.70	Broken, slightly weathered Limestone bedrock			
1.00						
		146.21				
		1.70	Limestone, medium dark grey Limestone, Hard, medium grain size. Evidence of minor weathering at surface but overall a competent hard Limestone			
2.00
