**Project No:** P1653-1  
**Site:** Seskin, Co. Laois  
**Client:** MKO

## Trial Pit Log

**Trial Pit No:** TP25-BP-01  
**Easting:** 128662.276  
**Northing:** 278106.563  
**Elevation:** 145.071mOD

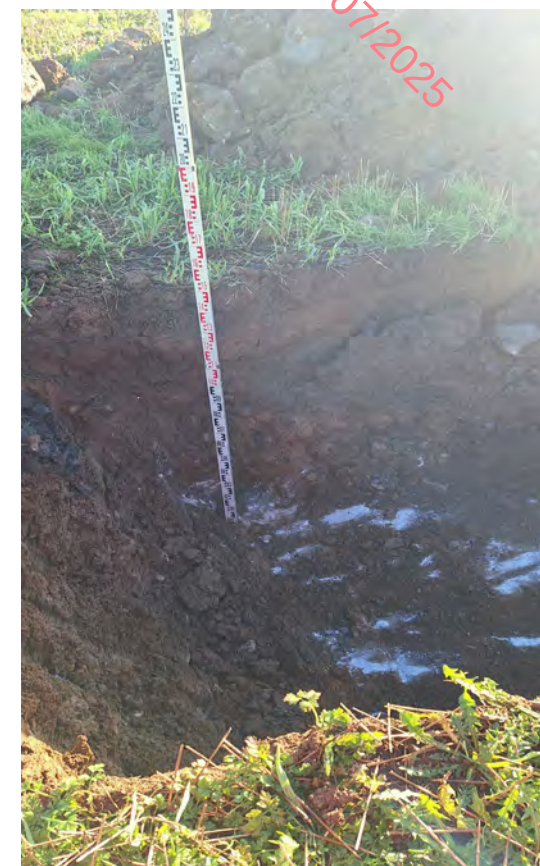
| Depth | Symbol | Depth/Elev. | Description | Water Strikes | Sample Type | Comments |
|---|---|---|---|---|---|---|
| | | 0.00 | Topsoil with grass rootlets | | | |
| | | 0.30 | Light greyish brown, silty sandy Subsoil | | | |
| | | 0.50 | Light greyish brown, silty SAND with frequent limestone cobbles and boulders. Boulders are angular. | | | |
| | | 1.50 | Limestone bedrock met, medium dark grey Limestone, medium hard, medium-large grain size with some crinoid ossicles present. No evidence of weatehring/clay - competent Limestone | | | |

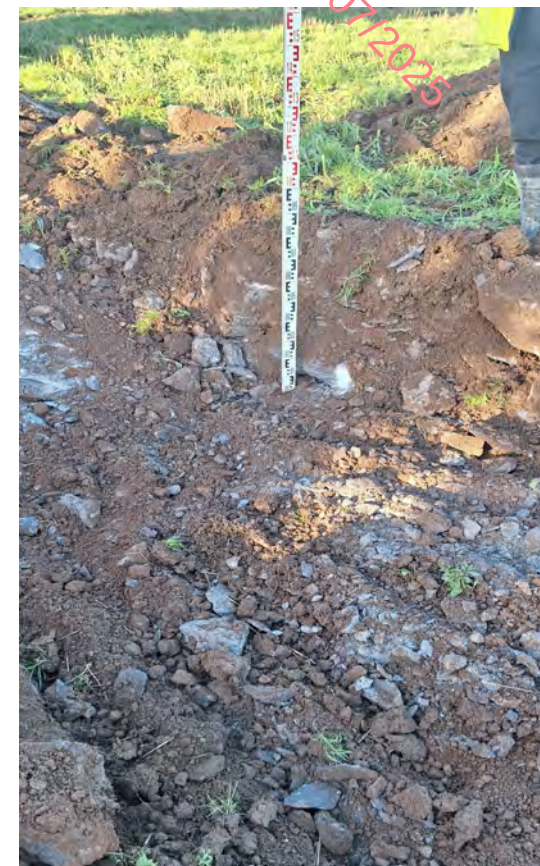
**Trial Pit No:** TP25-BP02  
**Easting:** 242238  
**Northing:** 174254  
**Elevation:** 146.263mOD

| Depth | Symbol | Depth/Elev. | Description | Water Strikes | Sample Type | Comments |
|---|---|---|---|---|---|---|
| | | 0.00 | Topsoil with grass rootlets | | | |
| | | 0.10 | Light greyish brown, silty sandy Subsoil | | | |
| | | 0.25 | Limestone bedrock met, medium dark grey Limestone, medium-soft, medium-large grain size with some crinoid ossicles present. No evidence of weatehring/clay - competent Limestone | | | |

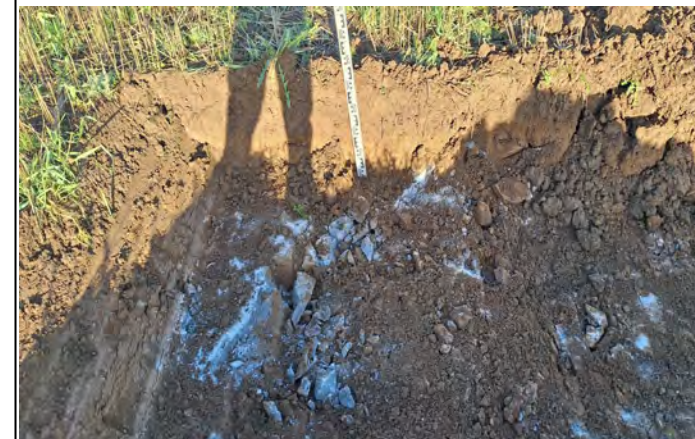
**Trial Pit No:** TP25-BP03  
**Easting:** 242170  
**Northing:** 174257  
**Elevation:** 150.152mOD

| Depth | Symbol | Depth/Elev. | Description | Water Strikes | Sample Type | Comments |
|---|---|---|---|---|---|---|
| | | 0.00 | Topsoil with grass rootlets | | | |
| | | 149.85 | Light greyish brown, silty sandy Subsoil | | | |
| | | 149.65 | Limestone bedrock met, medium dark grey Limestone, soft, medium-large grain size. No evidence of weathering/clay - competent Limestone | | | |

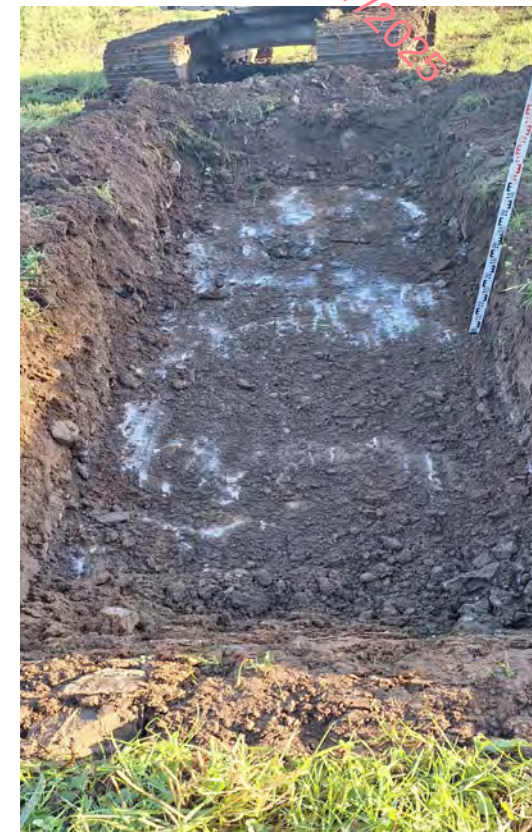
**Trial Pit No:** TP25-BP04  
**Easting:** 242079  
**Northing:** 174243  
**Elevation:** 152.748mOD

| Depth | Symbol | Depth/Elev. | Description | Water Strikes | Sample Type | Comments |
|---|---|---|---|---|---|---|
| | | 0.00 | Topsoil with grass rootlets | | | |
| | | 0.30 | Light greyish brown, silty sandy Subsoil | | | |
| 1.00 | | 0.90 | Limestone bedrock met, medium dark grey Limestone, soft, medium-large grain size with some crinoid ossicles present. No evidence of weatehring/clay - competent Limestone | | | |

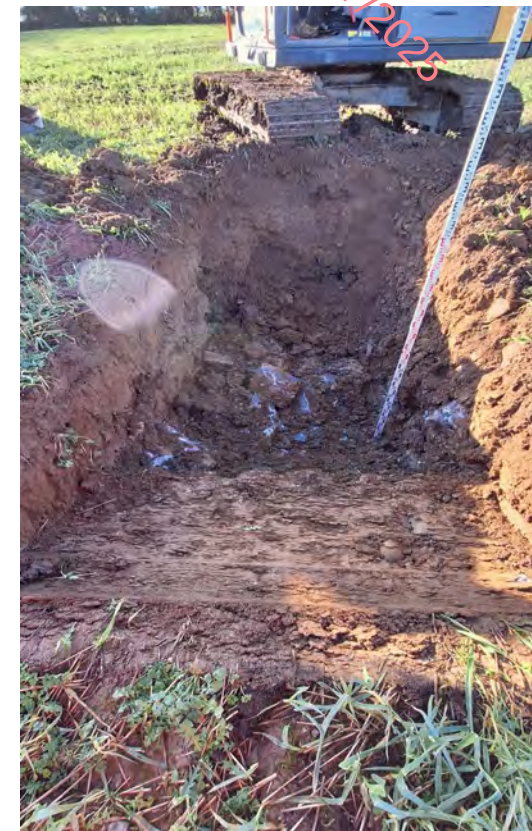
**Trial Pit No:** TP25-BP05  
**Easting:** 242106  
**Northing:** 174281  
**Elevation:** 147.907mOD

| Depth | Symbol | Depth/Elev. | Description | Water Strikes | Sample Type | Comments |
|---|---|---|---|---|---|---|
| | | 0.00 | Topsoil with grass rootlets | | | |
| | | 0.30 | Light greyish brown, silty sandy Subsoil | | | |
| | | 0.70 | Broken, slightly weathered Limestone bedrock | | | |
| | | 1.70 | Limestone, medium dark grey Limestone, Hard, medium grain size. Evidence of minor weathering at surface but overall a competent hard Limestone | | | |
