| MKO | MAP TITLE: <b>Subsoil Map</b> | | MAP NO.: <b>Figure 4.1</b> | SCALE: <b>1:25,000</b> |
| | PROJECT TITLE: <b>Phase 1 - Galway Inner Harbour, Galway</b> | | | DATE: <b>03-10-2019</b> |

| | MAP TITLE: <b>Groundwater Vulnerability Map</b> | | MAP NO.: <b>Figure 4.3</b> | SCALE: <b>1:25,000</b> |

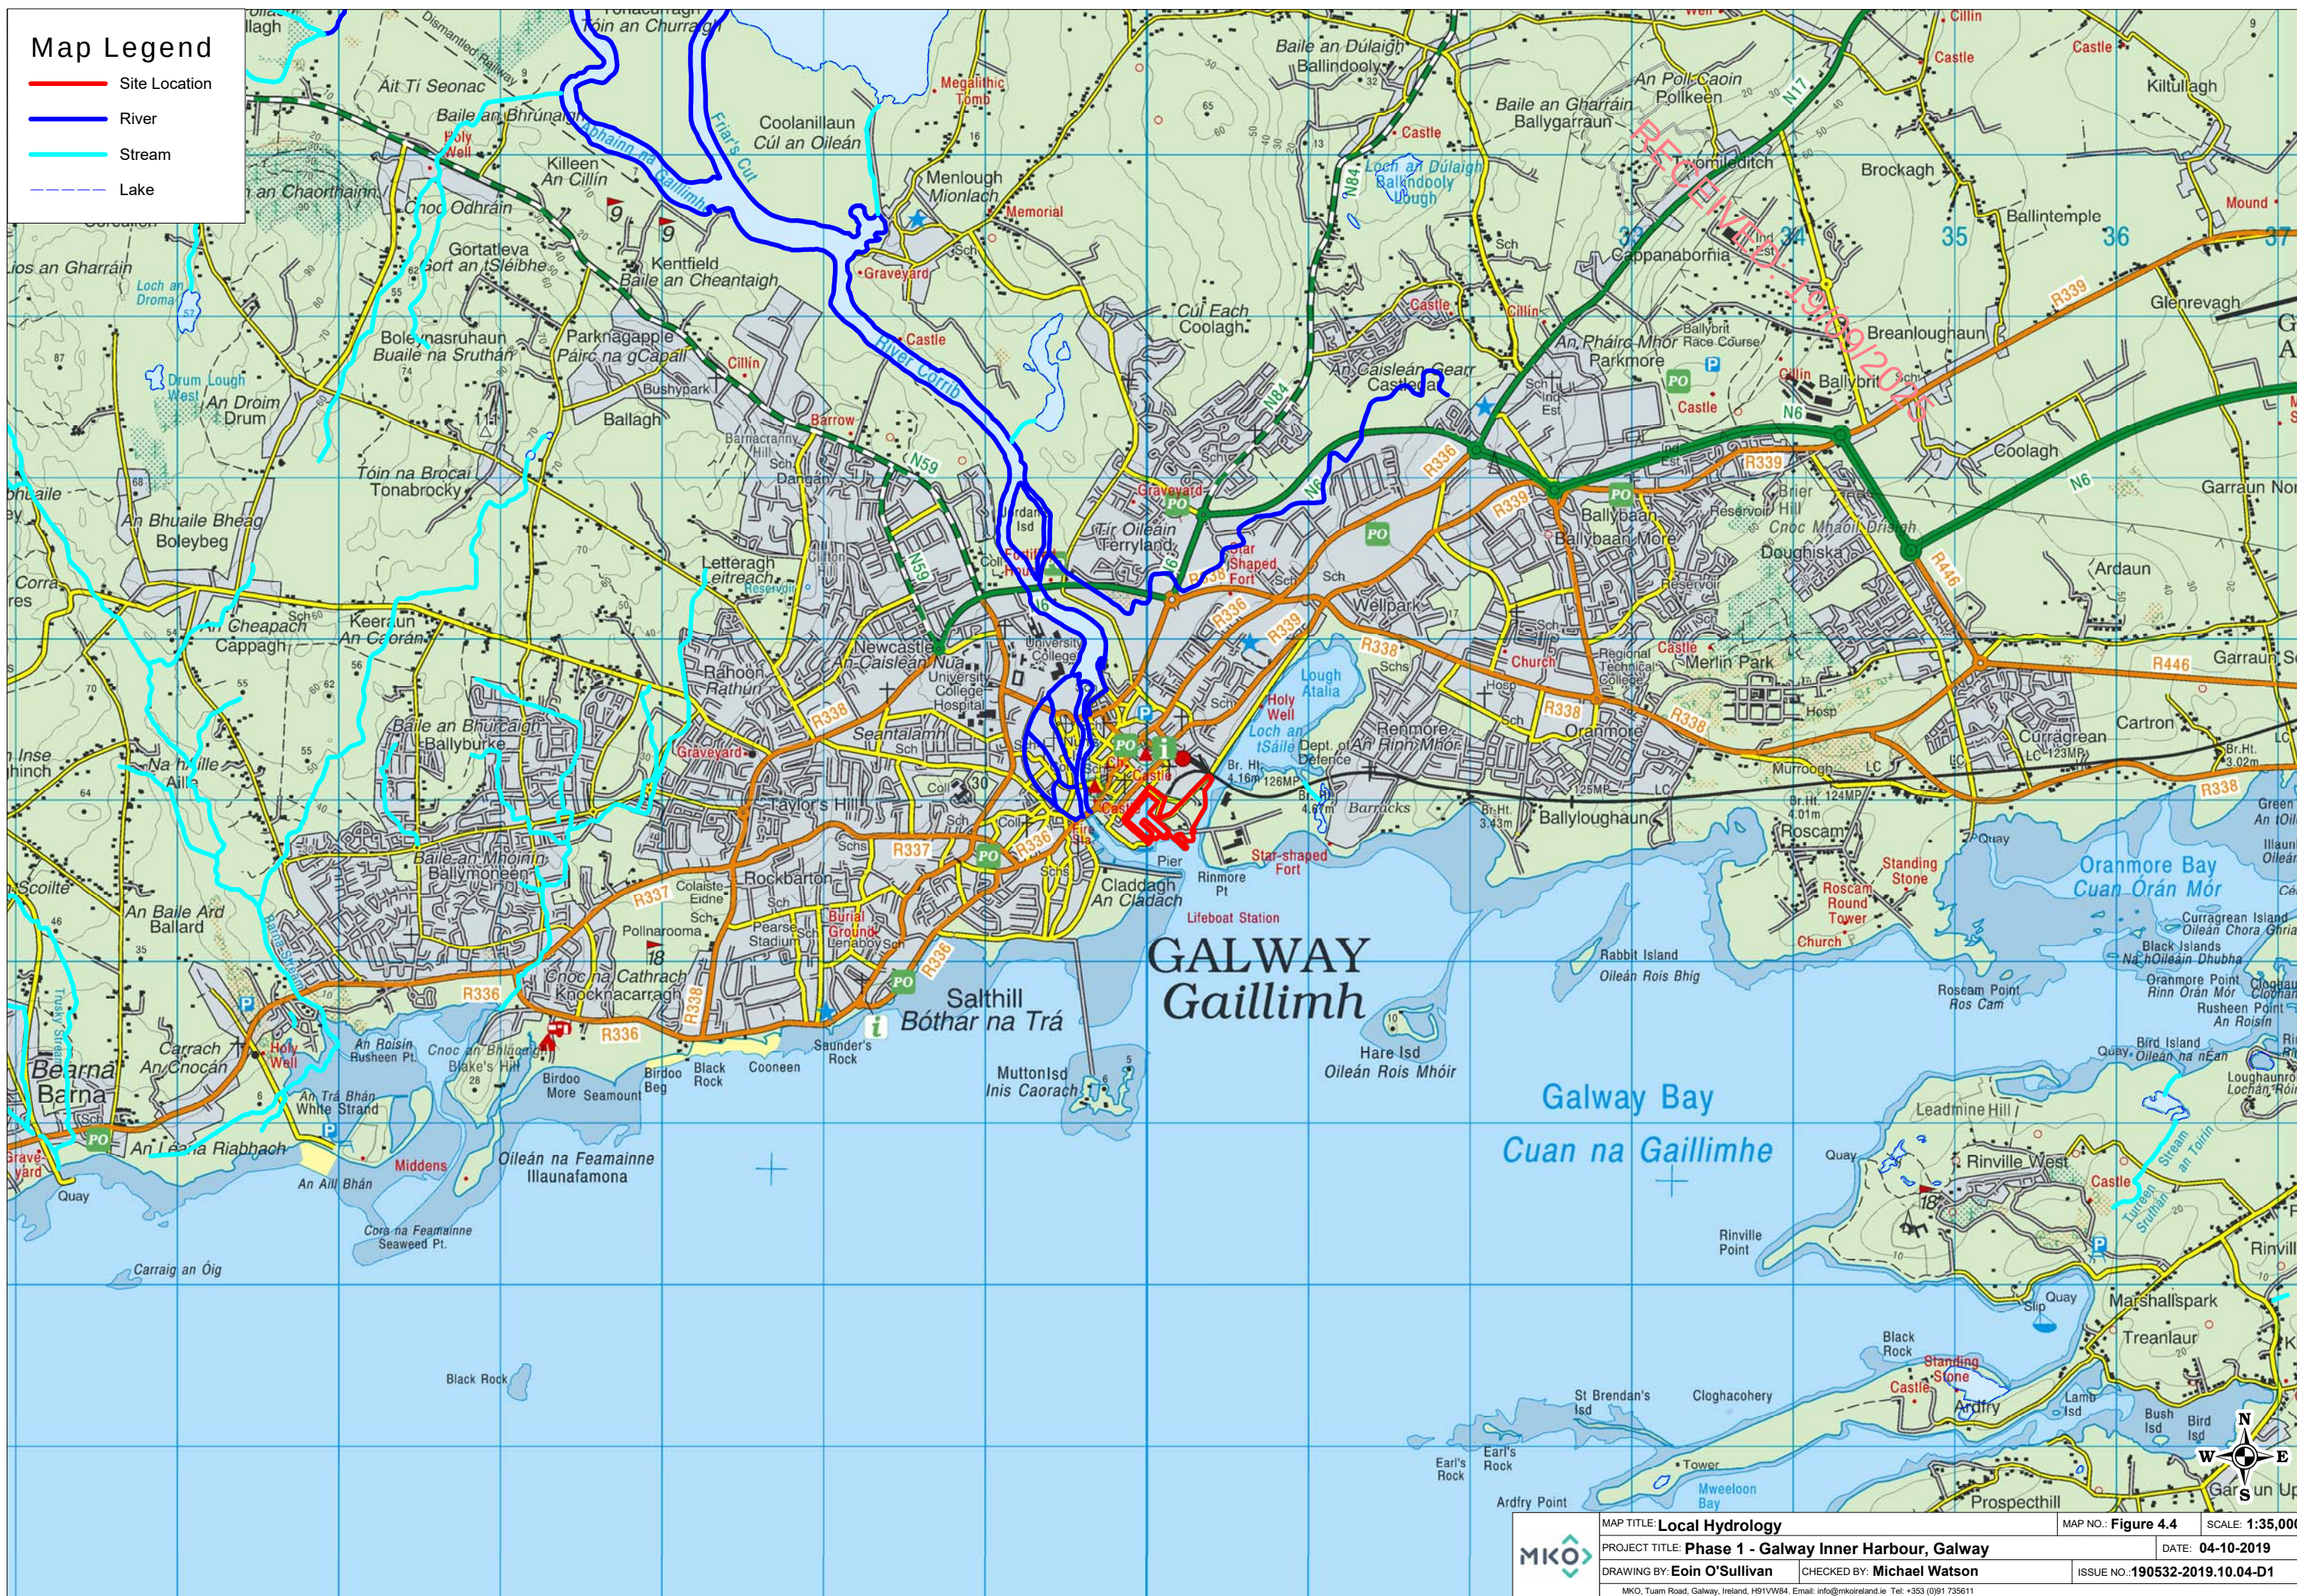
The nearest surface water bodies to the site are the Corrib Estuary which is adjacent to the site and the River Corrib which is located approximately 230 metres to the west of the site. The Corrib Estuary is classed as a transitional waterbody by the EPA.

Site Location  
 River  
 Stream  
 Lake

The local hydrology is presented on Figure 4-4.
