**Bord na Móna Cutaway Bog  
Decommissioning and Rehabilitation  
Plans**

## Ballivor Bog

### Cutaway Bog Decommissioning and Rehabilitation Plan

2024

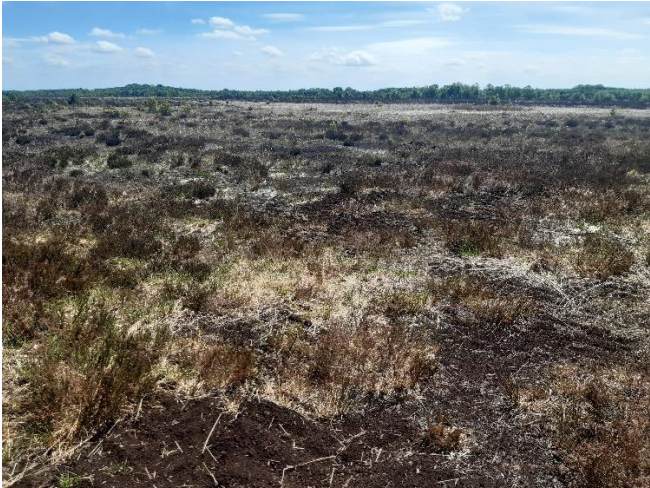
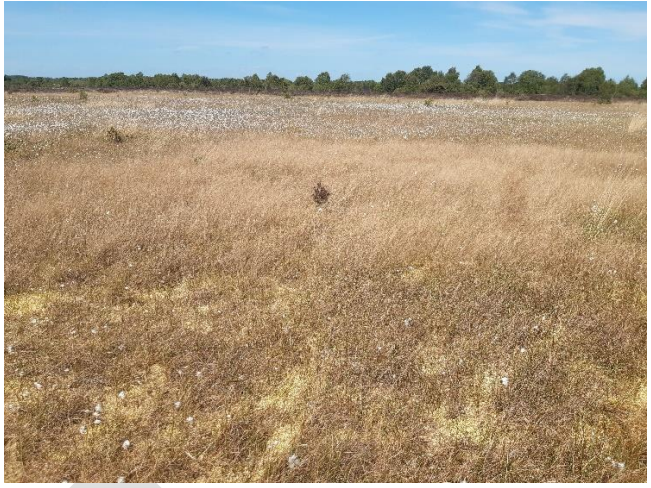
<p><i>Bare peat and degraded bog habitat at Ballivor (May, 2020)</i></p>	<p><i>Bog cotton at Ballivor (May, 2020)</i></p>

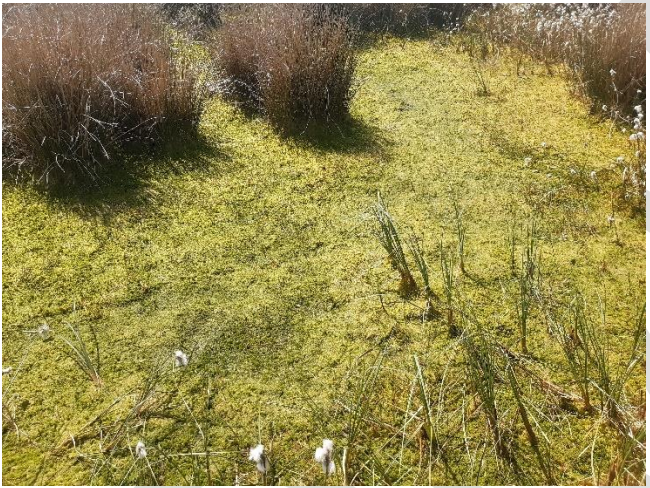
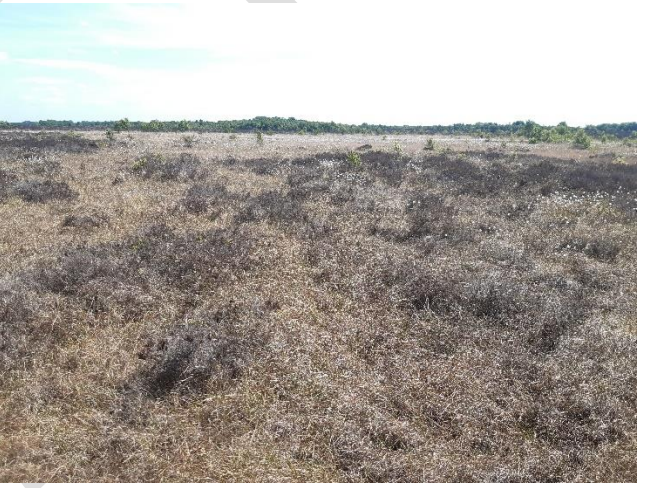
*Table 1: Photos of Habitats at Ballivor Bog*

<p><i>Sphagnum at Ballivor bog (May, 2020)</i></p>	<p><i>Raised bog remnant at Ballivor Bog (May, 2020)</i></p>

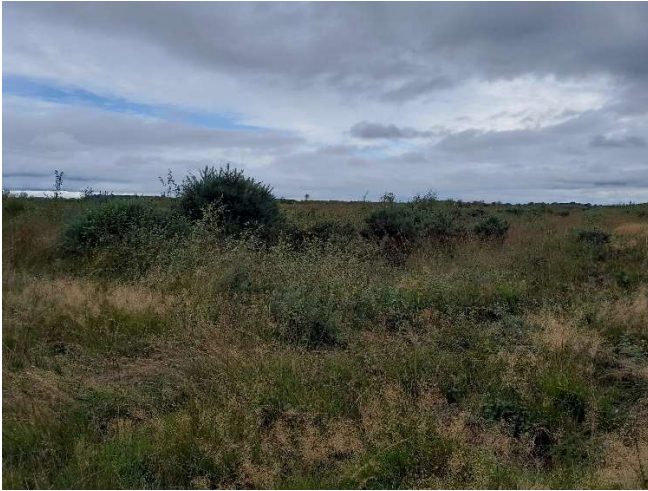
*Pioneering vegetation on cutaway including Scrub and Soft Rush dominated Poor fen (Sept 2021)*

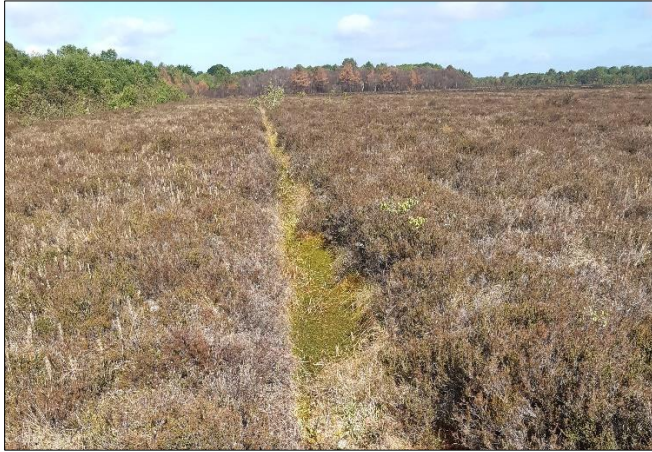
*Plate 3.1 Example of drainage ditches occurring within Lisclogher West, supporting Sphagnum mosses (May 2020).*

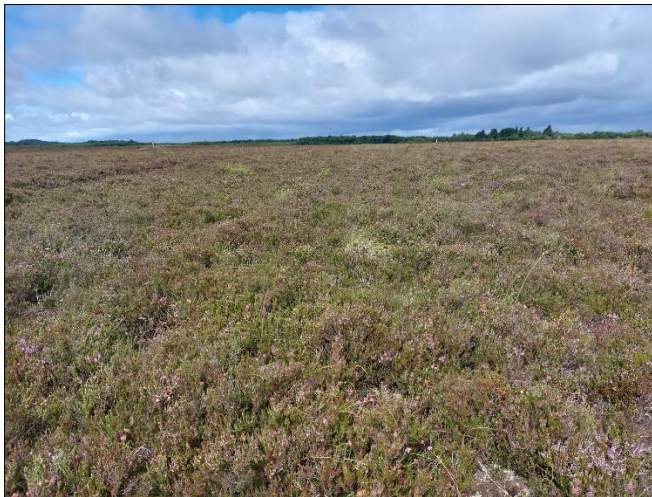
*Plate 3.3 Example of degraded/dry heather Lisclogher West bog (August 2022).*

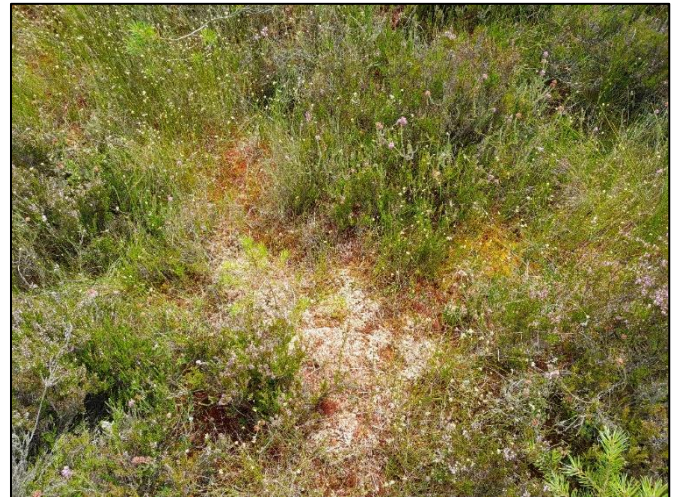
*Plate 3.4 Sub-central ecotope located in the active flush in the western section of the bog, formed in the basin of a former lake. (August 2022).*
