TECHNICAL REPORT

**Patton Brothers
Gortletteragh
Stranolar
Co.Donegal**

Item: Dust deposition results for monitoring period December 2010 using Dust deposit gauges as per VDI 2119 Part 2, at the Patton Brothers operation located at Gortletteragh, Stranolar, Co.Donegal.

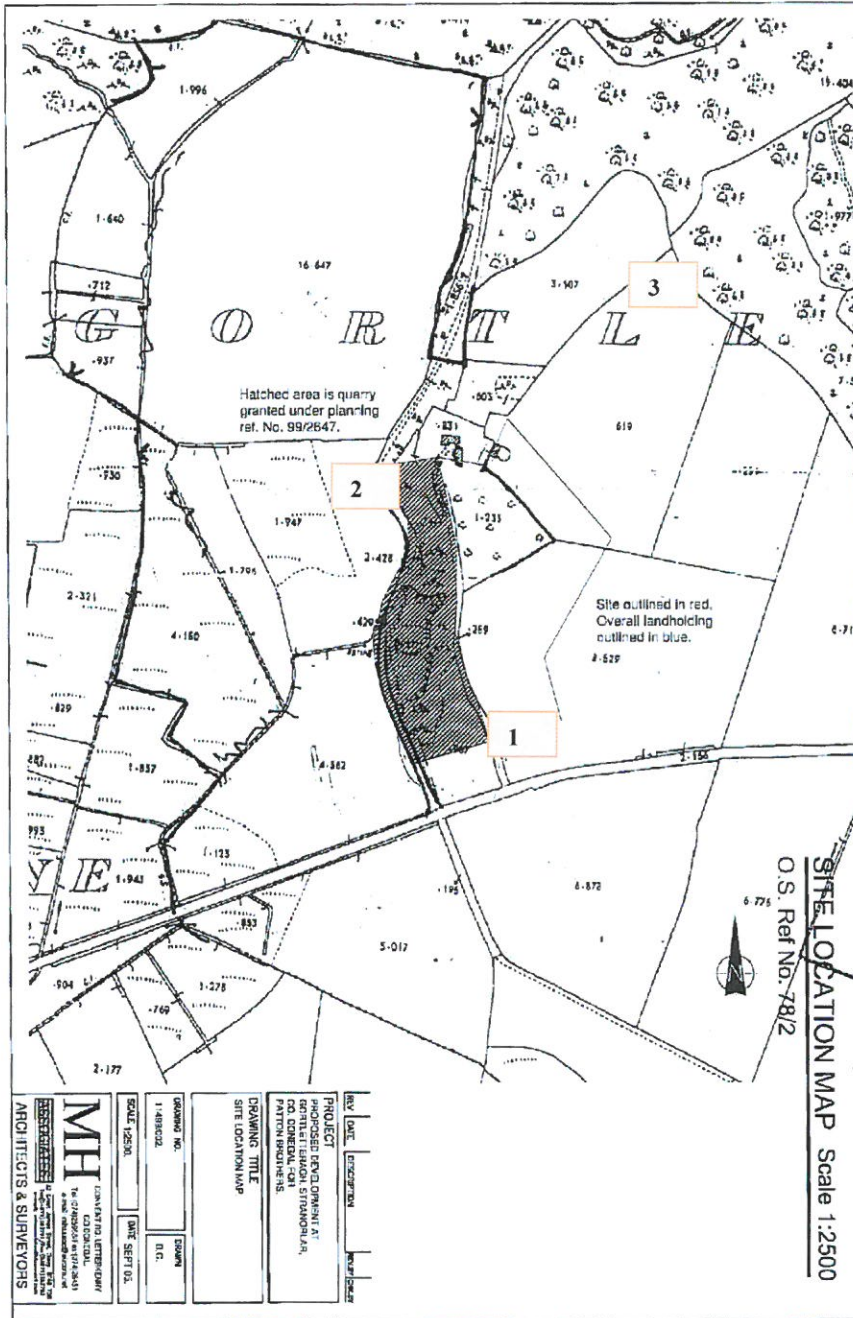
Appendix 1

The gauges were all placed at ground level. The locations of the sampling sites are presented in appendix 1.

Site Map showing Dust Monitoring Locations
