### **Aquafact Marine Survey Report 2025**

## Benthic Survey

## Ros an Mhíl Harbour 2025

AQUAFACT Ref: P-18569

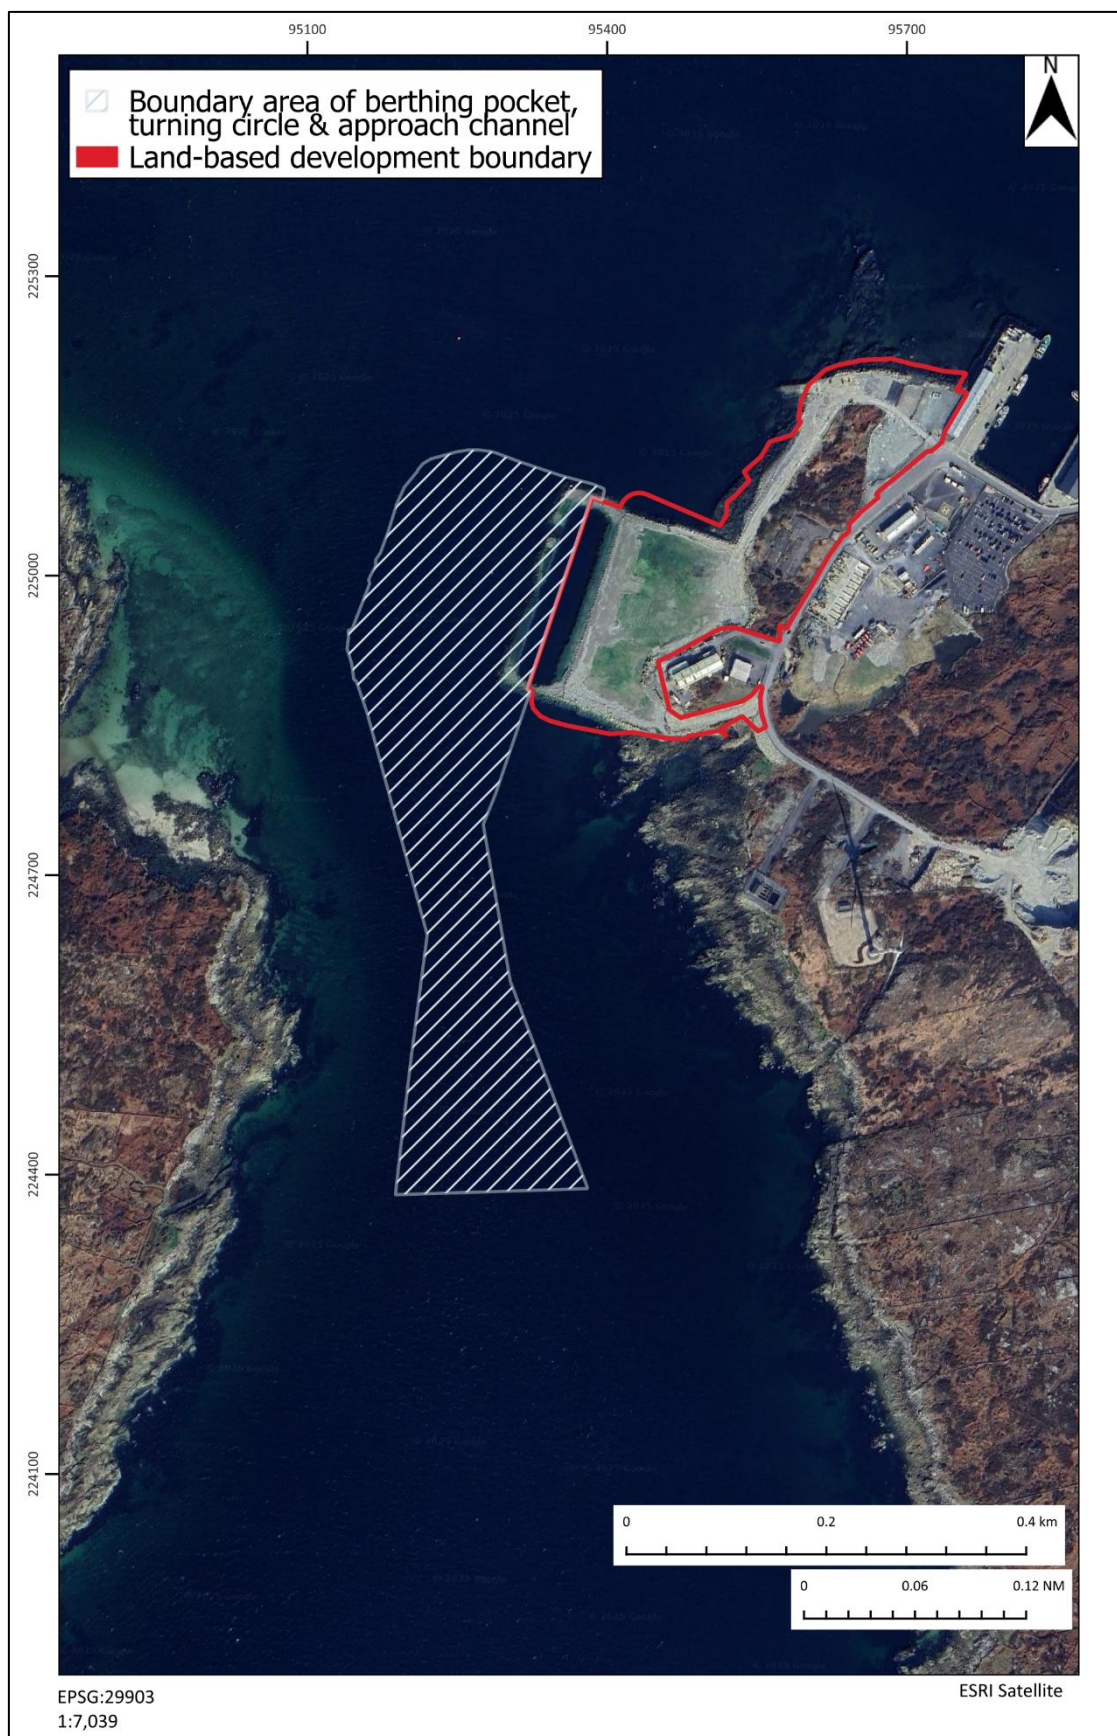
Figure 1.2: Development carried out in Ros an Mhíl Harbour as of 2025. Dredging in boundary area of berthing pocket, turning circle and approach channel remain to be completed (shaded area).

A map of the development site as of 2025 is shown in **Figure 1.2**.

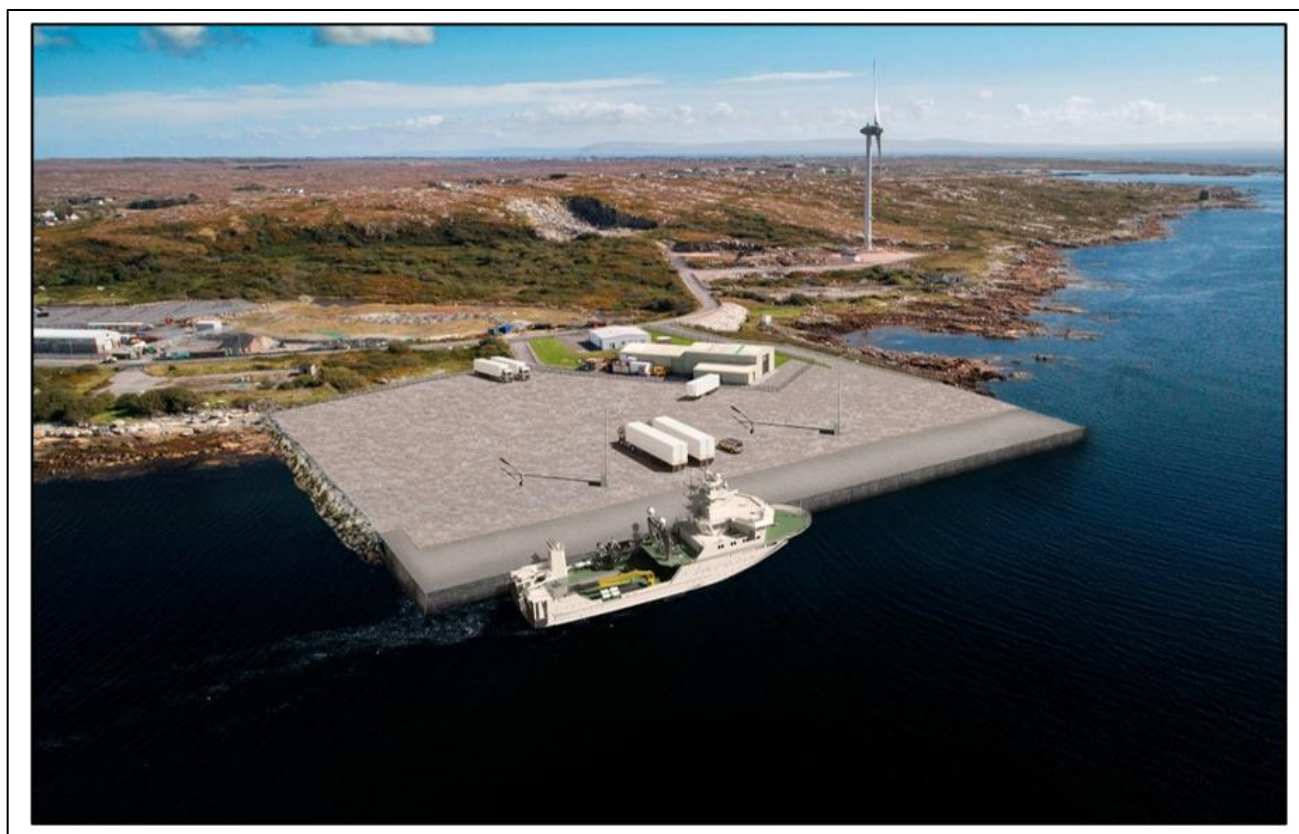
**Figure 1.3: Digital interpretation of the proposed deep-water quay development in Ros an Mhíl Harbour upon completion of works (Photo credit: MWP).**

A digital representation of the deep-water quay development when the works are completed is illustrated in **Figure 1.3**.

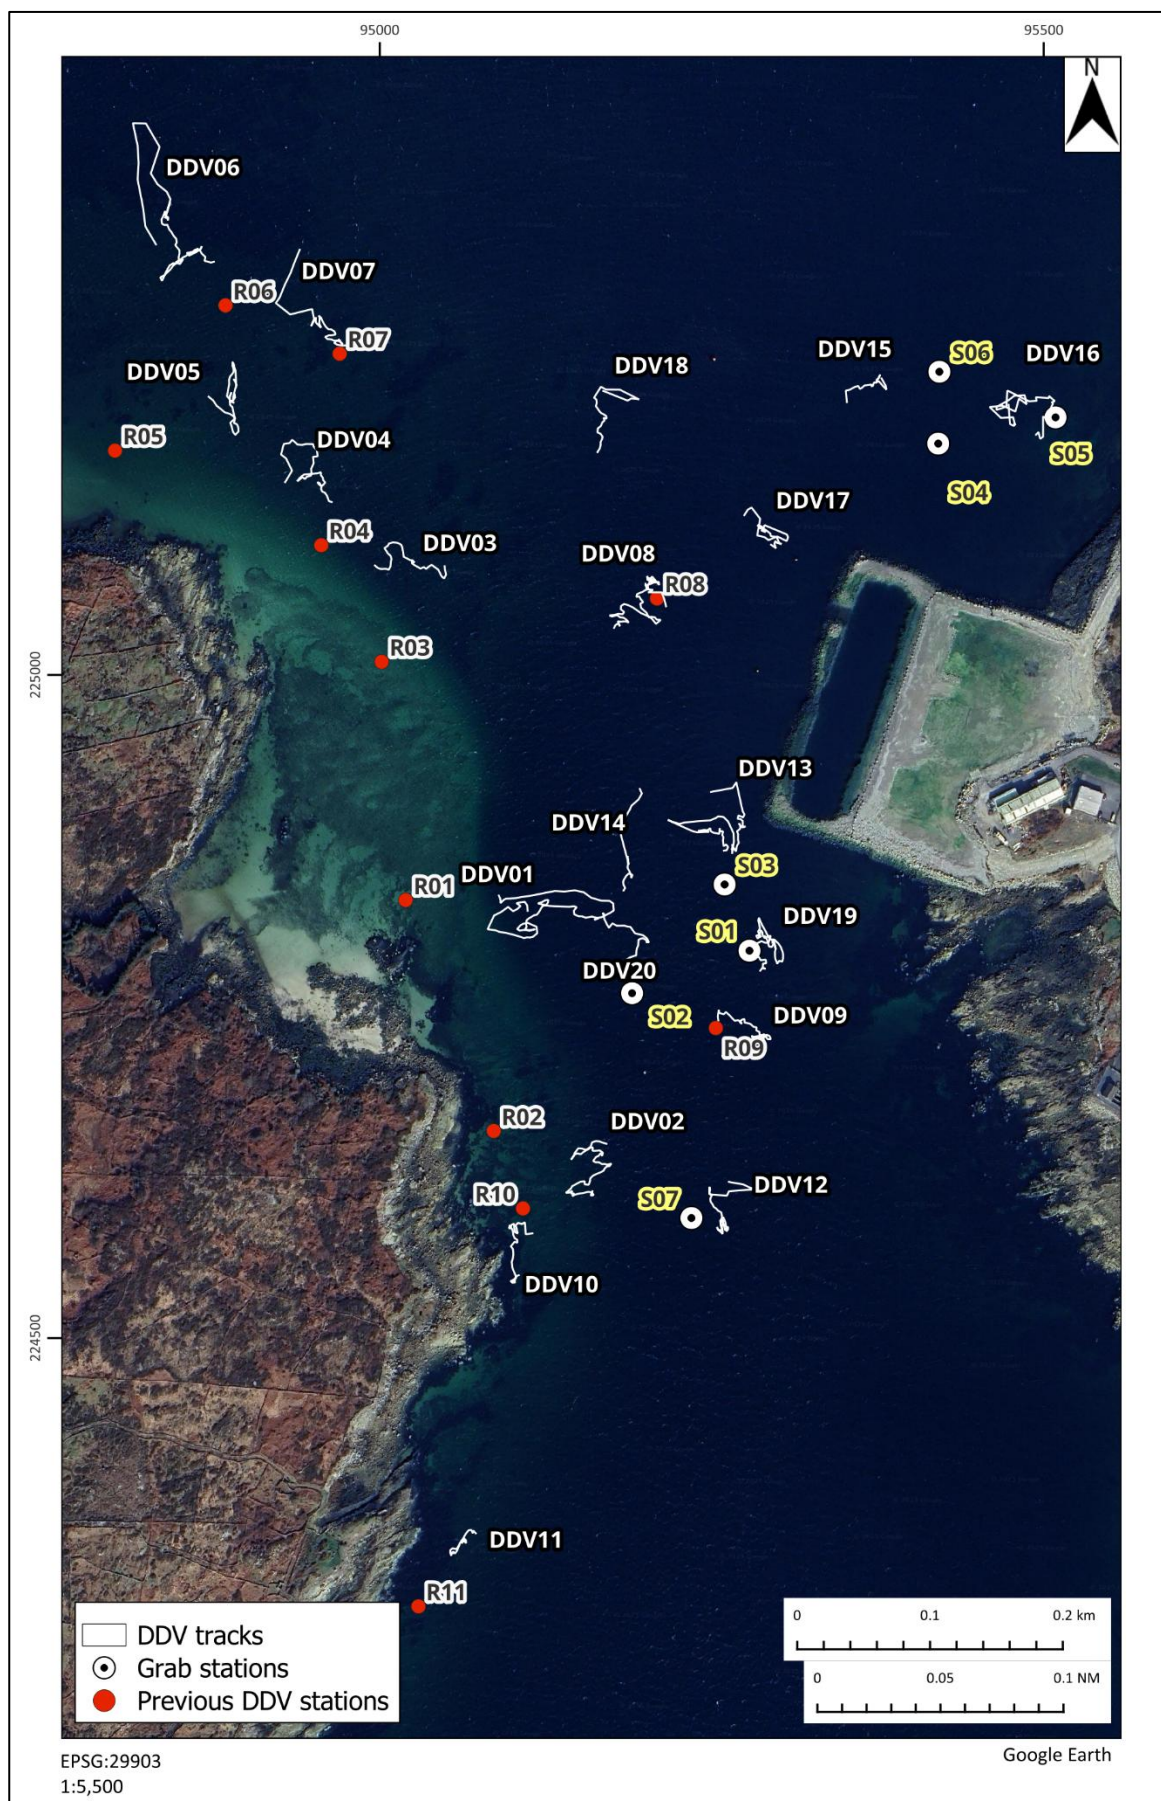
Figure 2.1: Drop-down video tracks conducted as part of the survey in Ros an Mhíl Harbour, Connemara, Co. Galway.

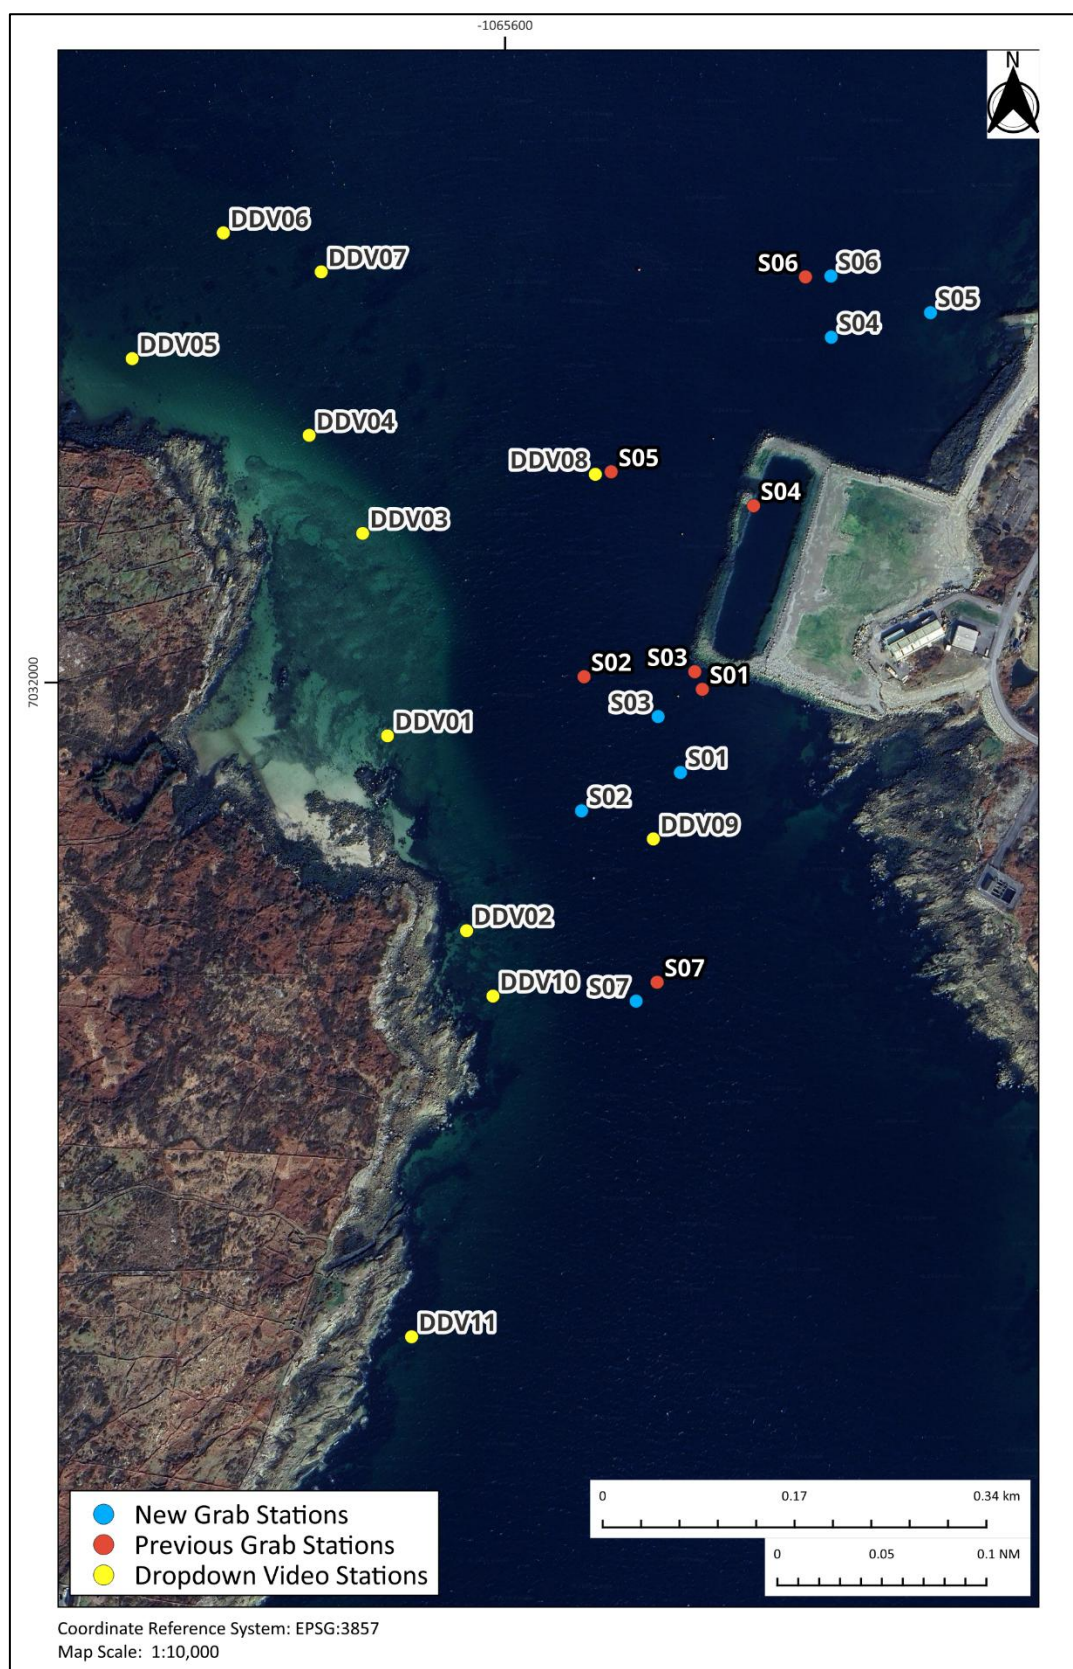
Figure 2.2: Map showing DDV stations, previous grab locations and new grab stations at Ros an Mhíl Harbour, Connemara, Co. Galway.

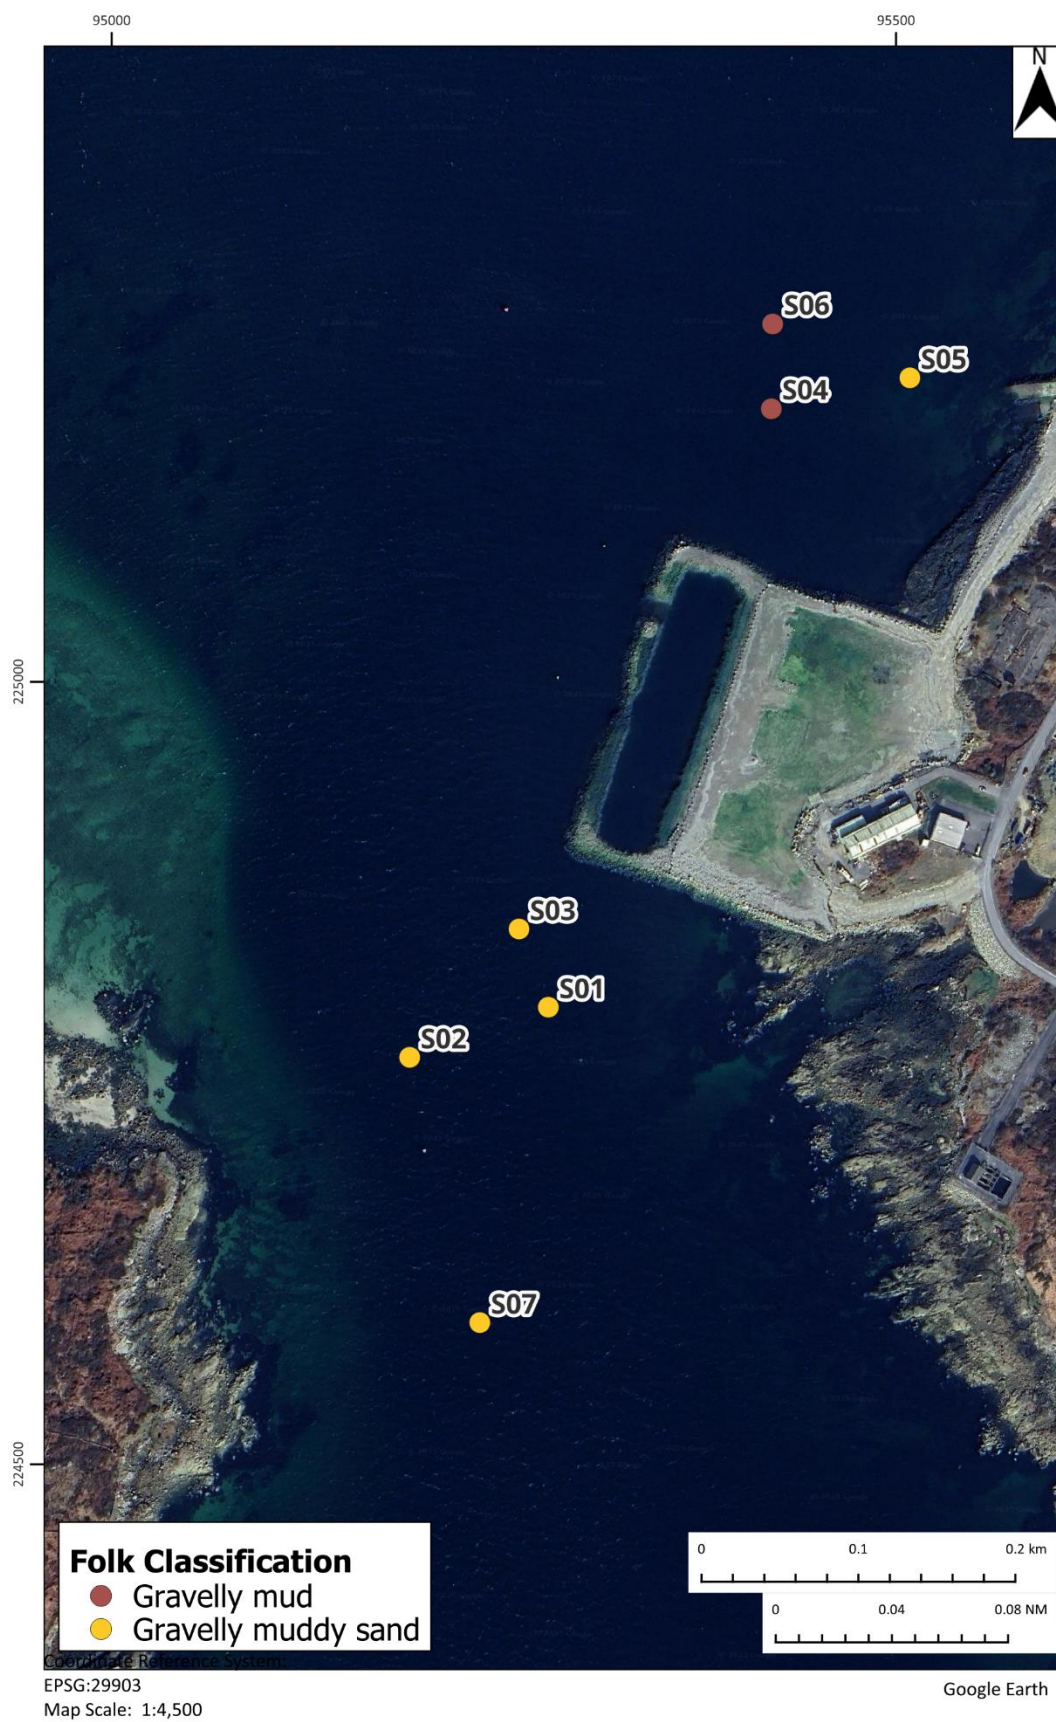
Figure 3.84: Sediment Classification (Folk, 1954).

**Table 3.4** displays the physico-chemical parameters analysed by SOCOTEC. The moisture content of the sediment analysed ranged from 39.7 % (Station 7) to 68.6 % (Station 6). Sediment density ranged from 2.54 mg/m<sup>3</sup> (Station 6) to 2.75 mg/m<sup>3</sup> (Station 3). The Total Organic Carbon (TOC) results ranged from 1.08 % m/m (Station 3) to 4.47% m/m (Station 6). Carbonate results ranged from 22.3 % m/m (Station 6) to 42.0 % m/m (Station 7). Granulometry results for the sediment composition in percentages for gravel (>2 mm), sand (63-2000 µm), and silt (<63 µm) are shown in **Figure 3.83**. Gravel percentage composition ranged from 5.50 % (Station 6) to 21.71 % (Station 3). Sand percentage composition ranged from 27.49 % (Station 6) to 69.70 % (Station 3). Silt percentage composition ranged from 8.59 % (Station 3) to 67.0 % (Station 6). Sediment particles varied between gravelly muddy sand to gravelly mud (see **Table 3.5** and **Figure 3.84**). The comprehensive laboratory results are available in **Appendix 3**.
