## **APPENDIX A**

**CHAPTER 4: PROJECT  
DESCRIPTION, rEiAR**

## 4. PROJECT DESCRIPTION

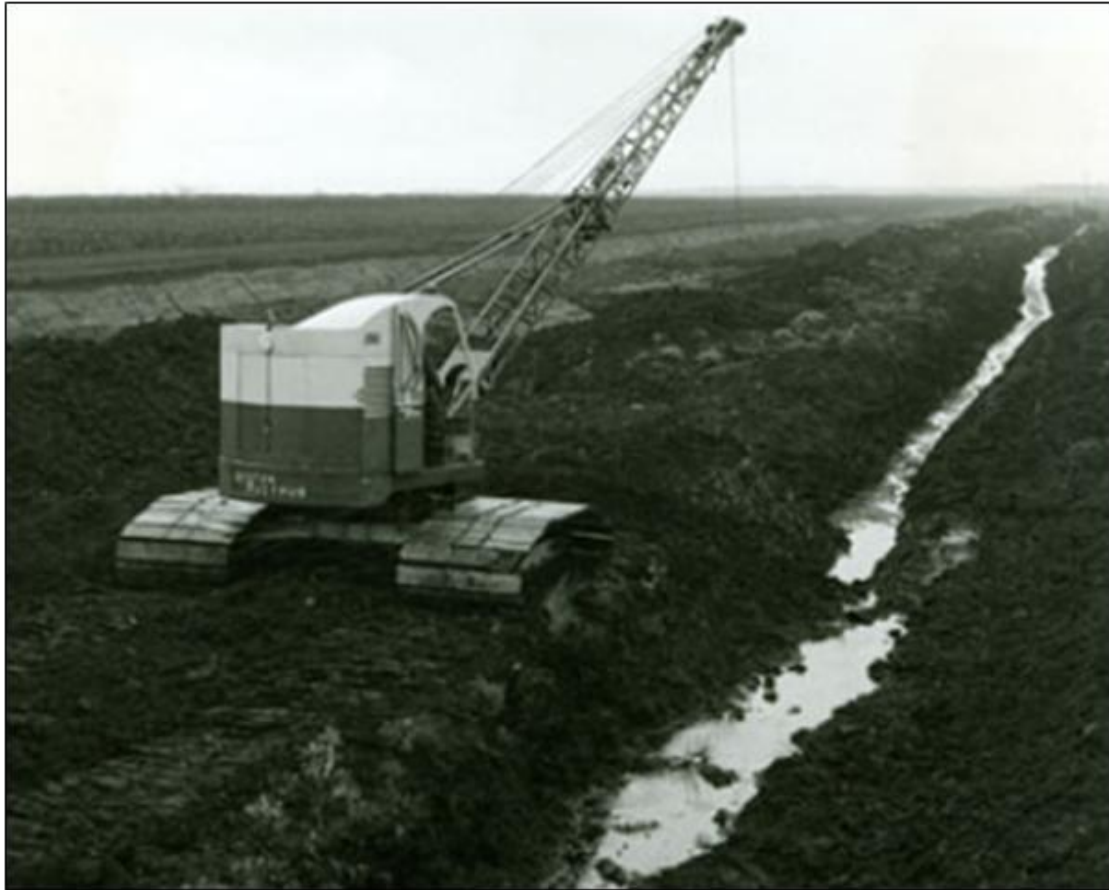
Plate 4-1 Dragline/Shovel excavator (Source: Living History)

In 1958, a new underframe for the dragline was designed to minimise surface pressure and eat compaction, thereby eliminating the need for the use of timber mats. The increased mobility and reliability of the machine resulting from the new underframe allowed the machines to move rapidly over the bog to do relatively small jobs which would earlier have been done by hand owing to the slowness and difficulty of moving the dragline over timber mats. Additionally, the elimination of the timber mats meant that groundsmen were no longer required to move the timber mats. This meant that draglines could be operated by the driver only, with no support staff required. The 287-model excavator had caterpillar-type tracks with timber sleepers, which provide the necessary bearing area for operation on bog, without using mats. The 478-model excavator, while equipped with caterpillar track chains, was not fitted with track sleepers but was supported on timber mats where necessary. When excavating bog these machines were fitted with a special dragline bucket of light design with a capacity of 750L. Plate 4-1 below is an image of this type of machinery operating on a BnM bog.

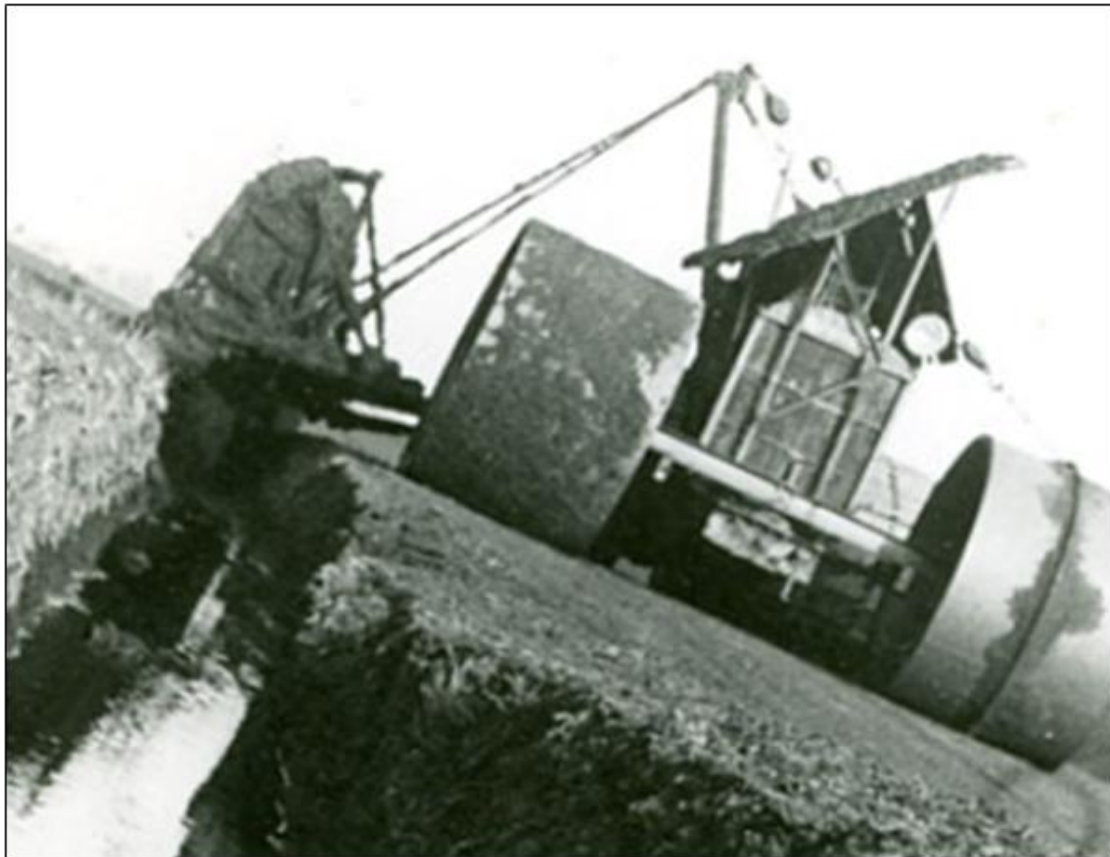
Plate 4-2 Drainage Machine Type – M.P. Field Slitter (Source: Living History)

This machine was developed to cut slit drains in milled peat fields to accelerate drainage in the poorer quality areas. The drains cut to a definite pattern comprising three longitudinal slits, one central and one on either side, with cross drains giving exit to the ditches at regular intervals. The machine comprised a tractor on full tracks with a chain saw cutting attachment similar to the chain saw machine. The tractor had a special transmission to give the correct forward travel speeds in second, and third gear. The modification involved the replacement of the gearbox primary gear train and the differential crown wheel and pinion, in addition to the insertion of a special reduction gearbox. The tracks comprised flat metal cleats carried on two chains and run on the standard tractor tyre wheels with an additional jockey wheel. The attachment was carried at the rear of the tractor, pivoted on the centre of a standard power-take-off bevel box output shaft and is raised and lowered about this pivot by a hydraulic ram operated from the driving position. The cutting element was a standard transmission chain with cutting teeth secured to it by welding, running over top driving sprocket and a bottom driven sprocket, whose shaft carries a cutting impeller on either side outside the support bearings. These impellers, in conjunction with the cutting chain, excavated a tunnel of rectangular section at the bottom of the slit drain cut by the chain only. The machine had a cab with toughened glass windows, allowing good vision for manoeuvring and observing the behaviour of the attachment. Plate 4-2 below is an image of this type of machinery operating on a BnM bog.

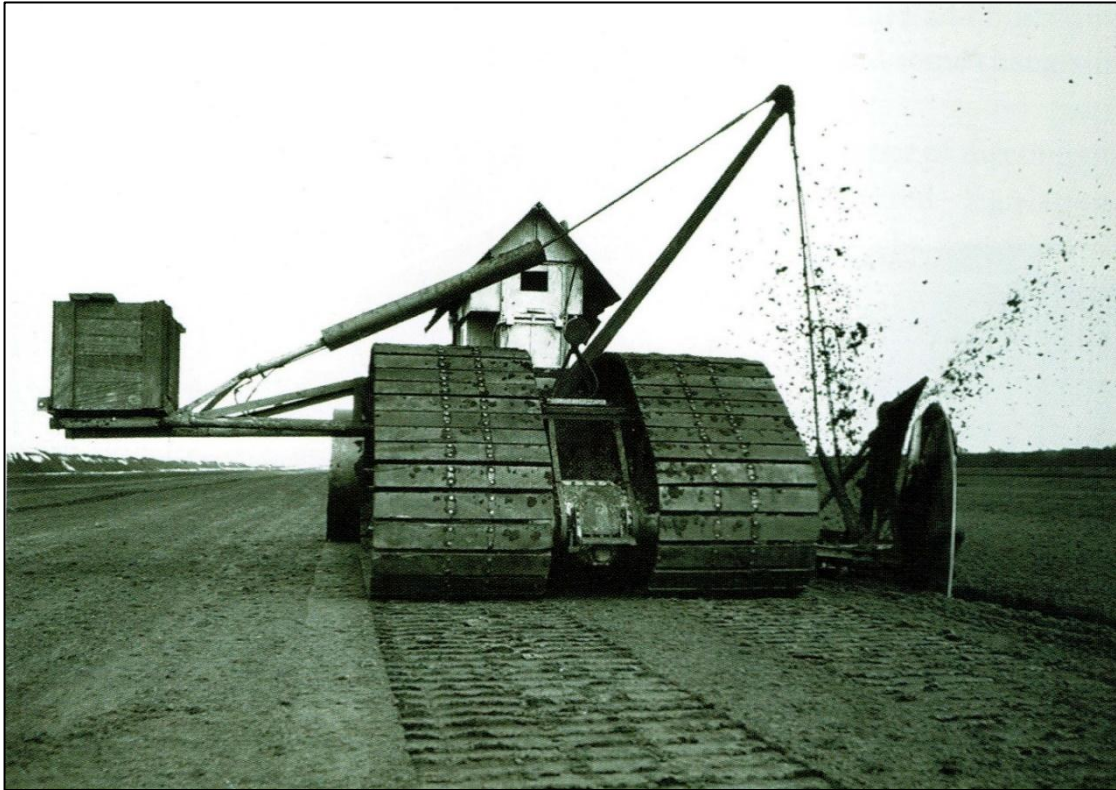
Plate 4-3 Ditching Attachment/Ditcher

the tractor main gearbox PTO shaft via a bevel gear reduction box and universal propeller shaft. On other machines, a chain drive reduction was inserted between the bevel gearbox and universal propeller shaft to achieve a slower disc speed. The disc had cutting blades and a stationary shield which deflected the flying spoil away from the machine and spread it evenly over the adjacent field. Plate 4-3 below is an image of this type of machinery.

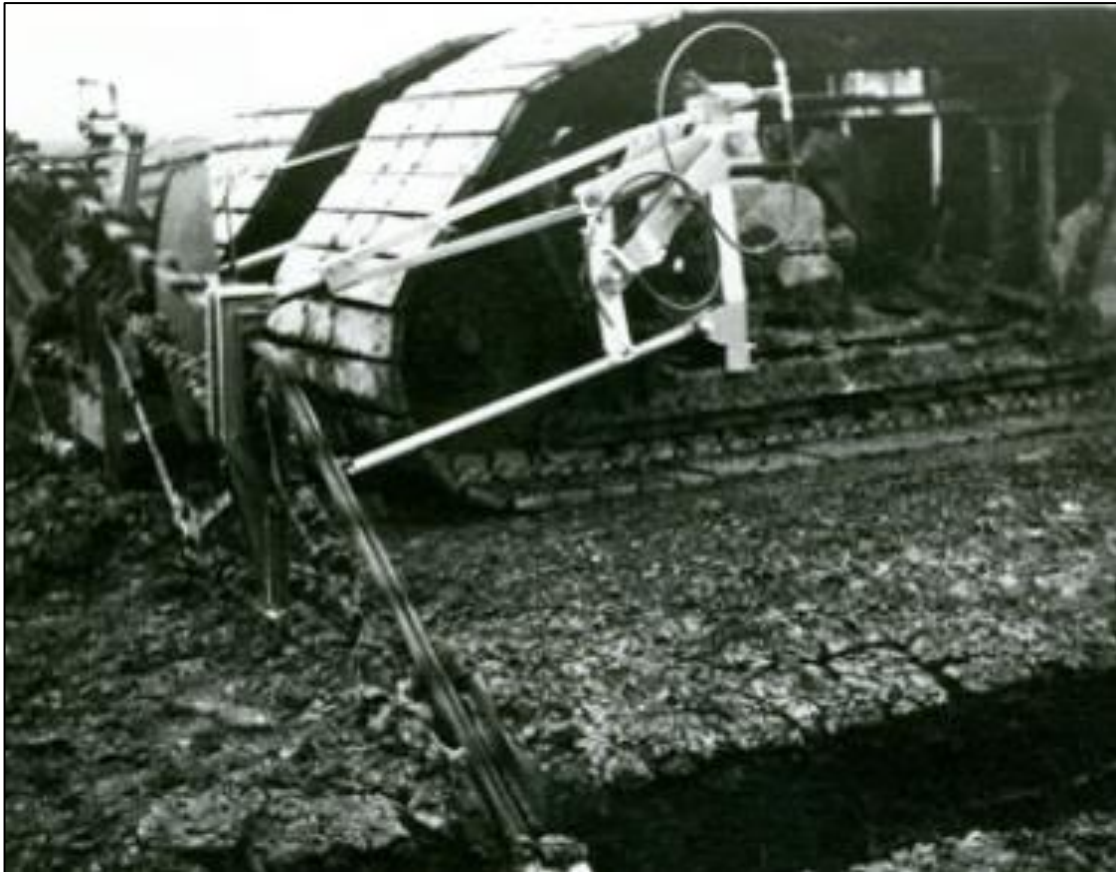
Plate 4-4 Drain Cutting Attachment - Cross Drain (Source: Living History)

The purpose of this attachment was to cut small drains in milled peat fields from the centre of the field to the ditches separating the fields. The attachment consisted of a cutting boom which was mounted on the rear of the H.D. Tractor Type II on radius arms, controlled for height and level by hydraulic rams. To cut the drain, the tractor stopped, and the cutting boom started, trimmed for level if necessary and lowered into the bog, discharging the spoil to the centre of the field. The boom was of light construction using standard steel sections. The chain was carried on sprockets at the ends of the boom while it ran in a guide with the aid of welded-on cleats along the bottom horizontal portion of the boom. The drive is taken from the P.T.O. shaft of the tractor main gearbox via chain drivers and universal jointed propeller shaft. Plate 4-4 below is an image of this type of machinery operating on a BnM bog.

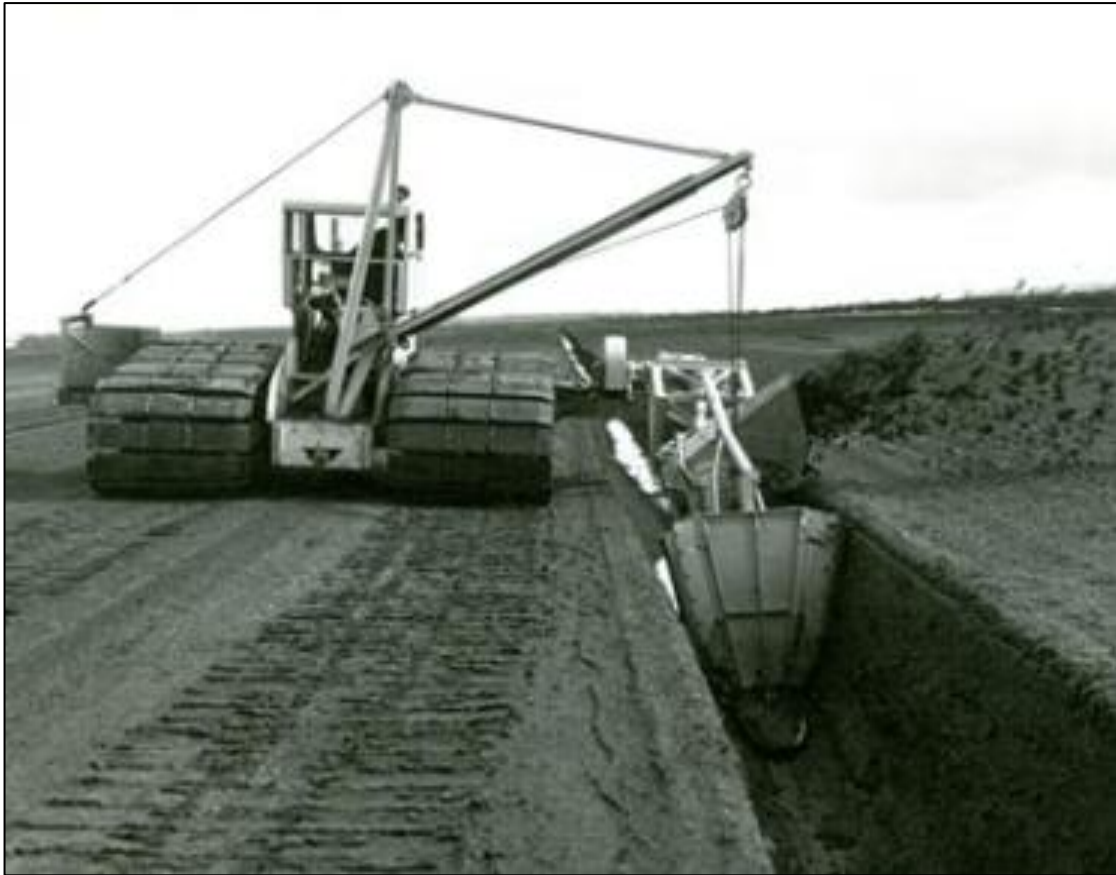
Plate 4-5 Drain Cleaner Screw (Source: Living History)

This attachment was used to remove slurry from the bottom of milled peat field ditches and dispose of it by spreading it on the adjacent field. The attachment was a screw elevator with radial blades fitted at the top to eject the spoil through an outlet in the casing in a predetermined direction. The attachment was mounted on a cantilevered bracket from the tractor on a pivot arrangement so that the screw casing could be lifted and lowered as required by winch rope. In the working position the screw elevator is lowered into the ditch and scooped the slurry from the bottom of the ditch as the tractor advances. As the tractor progresses along the ditch or drain it accumulates the slurry; the screw elevated it into the discharge chamber and the radial blades ejected it through the outlet onto the peat field. Plate 4-5 below is an image of this type of machinery operating on a BnM bog.

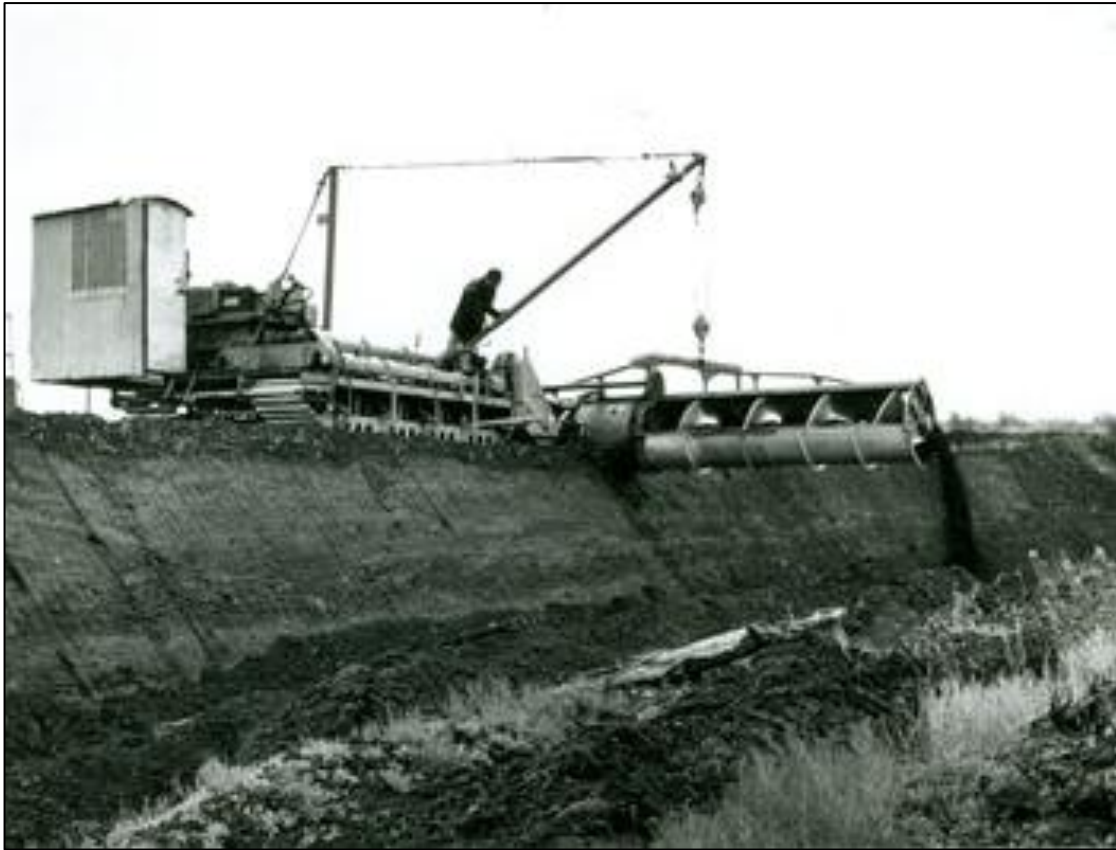
Plate 4-6 Stripping Machine (Source: Living History)

The Type II machine was powered by a diesel engine driving through an over-centre type clutch, a 'V' rope drive special worm and spur gear reduction box, and chain drives. The machine was steered by coil clutches on the track's final drives. There were 6 forward speeds available using change sprockets. Plate 4-6 below is an image of this type of machinery operating on a BnM bog.

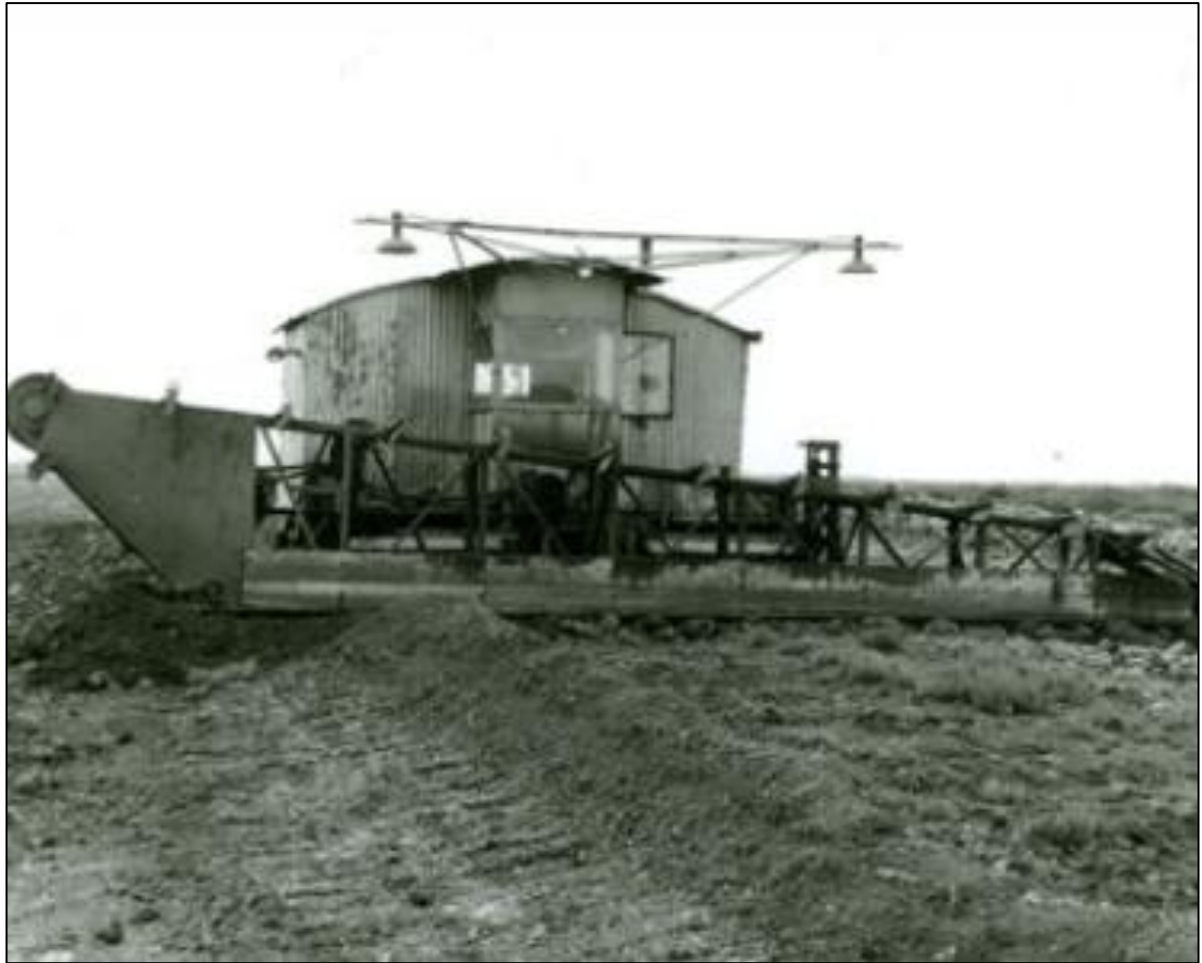
Plate 4-7 Levelling Machine Type - Scraper (Source: Living History)

The purpose of this machine was to prepare the surface of the high bog and cutaway for the efficient operation of all other machines, by levelling it. The machine consisted of a large tractor unit carrying a leveller boom in front. As the machine advanced on its long tracks, the boom cut away the high areas, losing the spoil in the hollows. The tractor unit had a rigid main frame supported on caterpillar type power driven tracks and was powered by diesel engine and gear transmission of standard manufacture. The boom had a light framework made up of standard steel sections, around which was driven two conveyor-type chains running on sprockets at each end and in guides along the bottom and top. Across these two chains, arms were fitted, projecting beyond the front of the boom. The projecting portion of the arm had a cutting knife and scraper palm. The boom was controlled for height and level by hydraulic rams. Plate 4-7 below is an image of this type of machinery operating on a BnM bog.

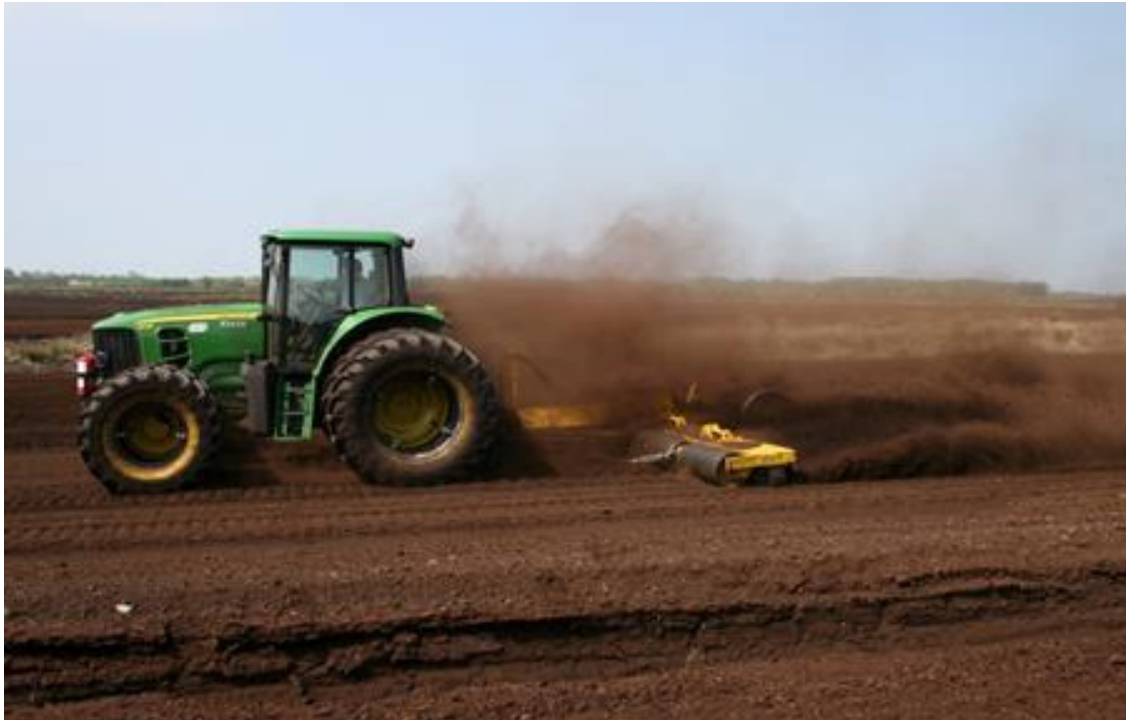
Plate 4-8 Milling process (source: BnM)

1. **Milling** - During the milling process, the top 10-15mm of the surface of each field was broken into peat crumbs by powered milling drums towed behind agricultural tractors (Plate 4-8). This layer of crumbed or milled peat/moss is called a crop and would have had a moisture content of about 80% when milled;

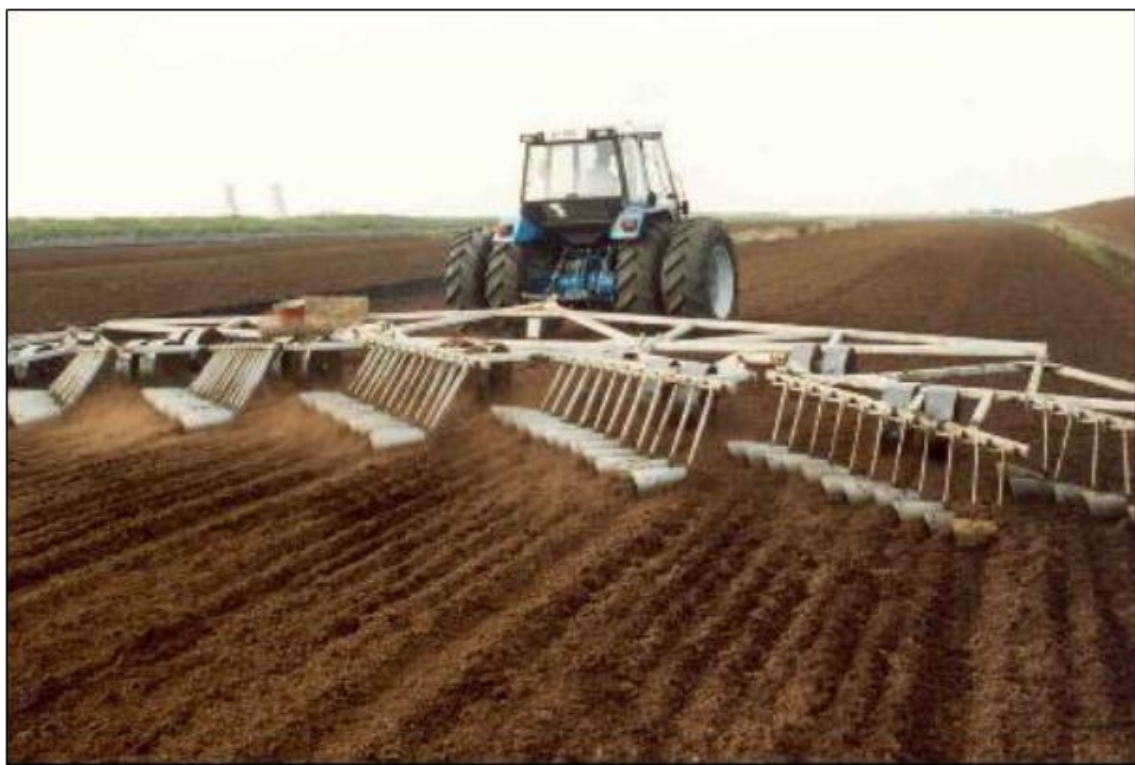
Plate 4-9 Harrowing process (source: BnM)

2. **Harrowing** - After milling, the peat crop was dried. To assist in this drying, the loose peat was harrowed or turned over. The harrow consisted of a series of spoons which were towed behind an agricultural tractor (Plate 4-9). The spoons on the harrow were fitted with special base plates which prevented the scraping of wet particles from below the milled peat layer. Harrowing was usually required 2 to 5 times per peat crop, depending drying conditions, the water table level in the peat extraction fields, the initial moisture content of the peat at milling, and peat quality. If rain interrupted the drying process, more harrowing may have been needed.

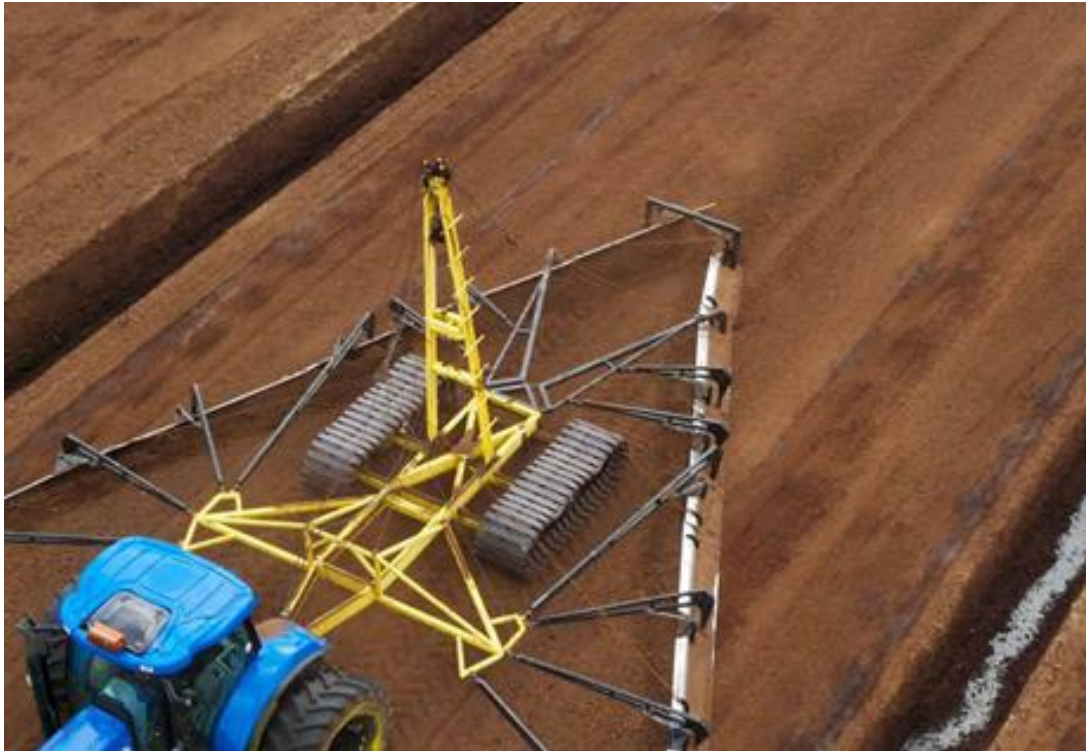
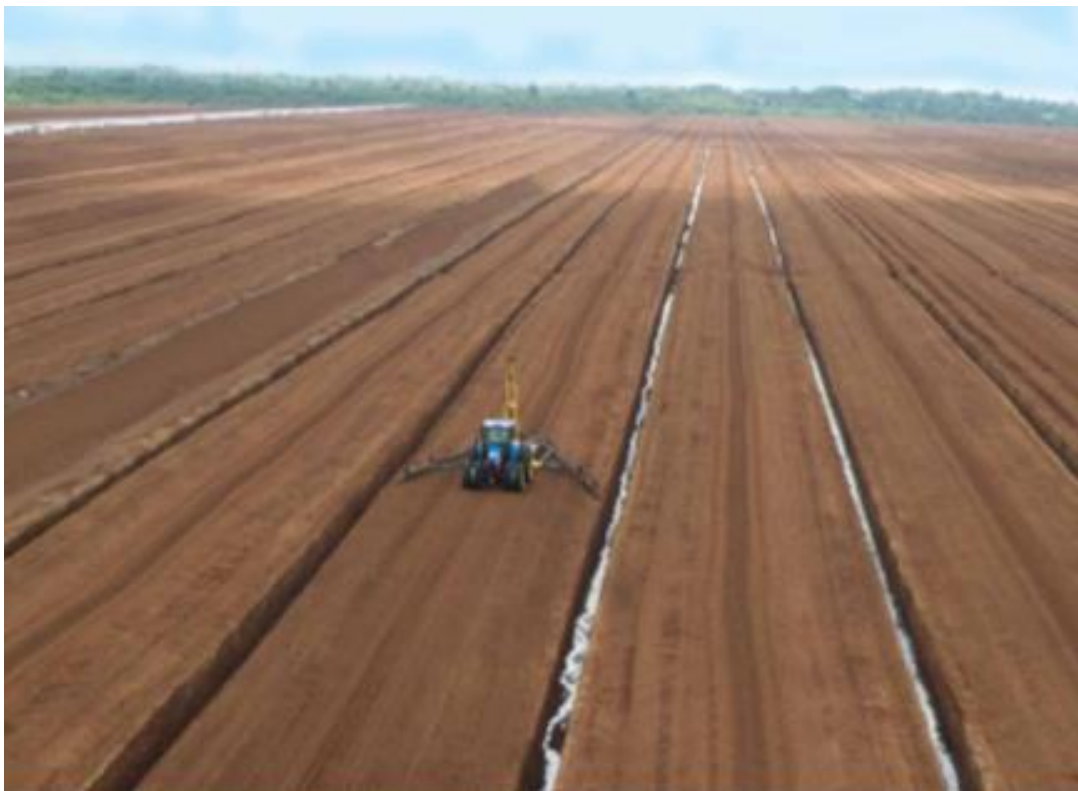
3. **Ridging** - When the milled material was dried to a moisture content of between 45% and 55%, it was gathered into ridges in the centre of each peat extraction field. The ridger consisted of a pair of blades towed in an open V behind an agricultural tractor fitted with balloon tyres which allowed the tractor to travel over wet peat without contaminating the dry peat crop. The open V blades rest on the bog and channel the loose crop into a triangular ridge in the centre of each peat extraction field. (Plate 4-10 and Plate 4-11);

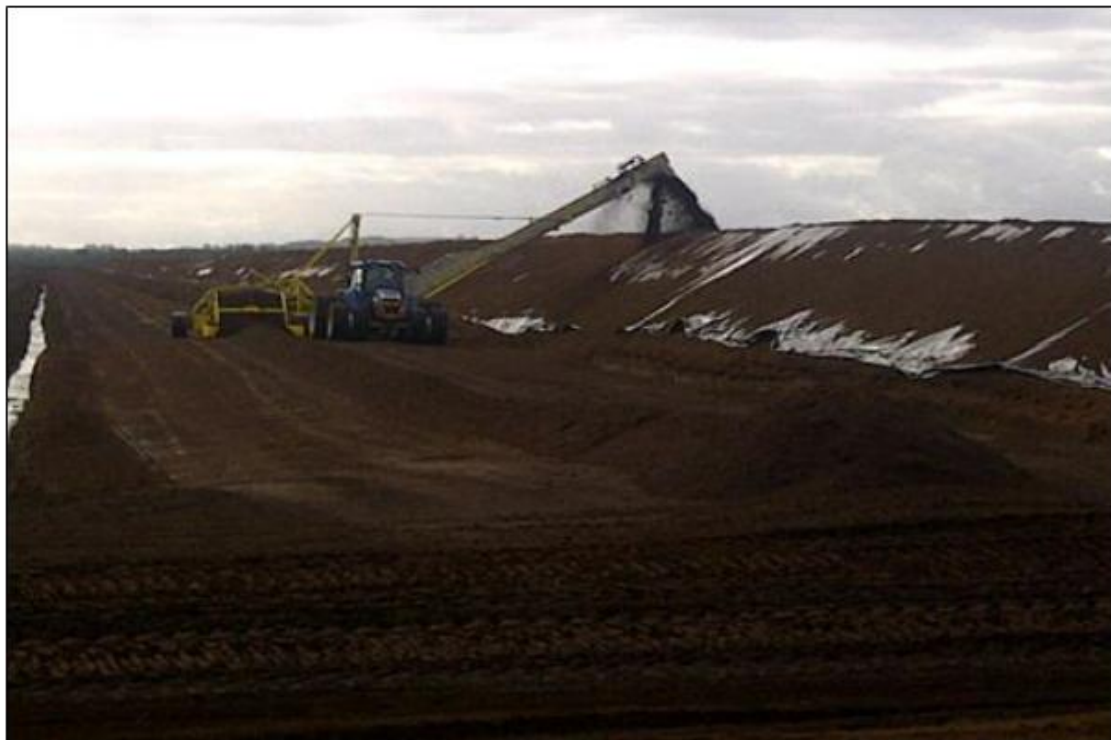
Plate 4-15 Process of Stock Protection, showing a layer of milled peat being spread over polythene sheeting to anchor the sheeting in place (source: BnM)

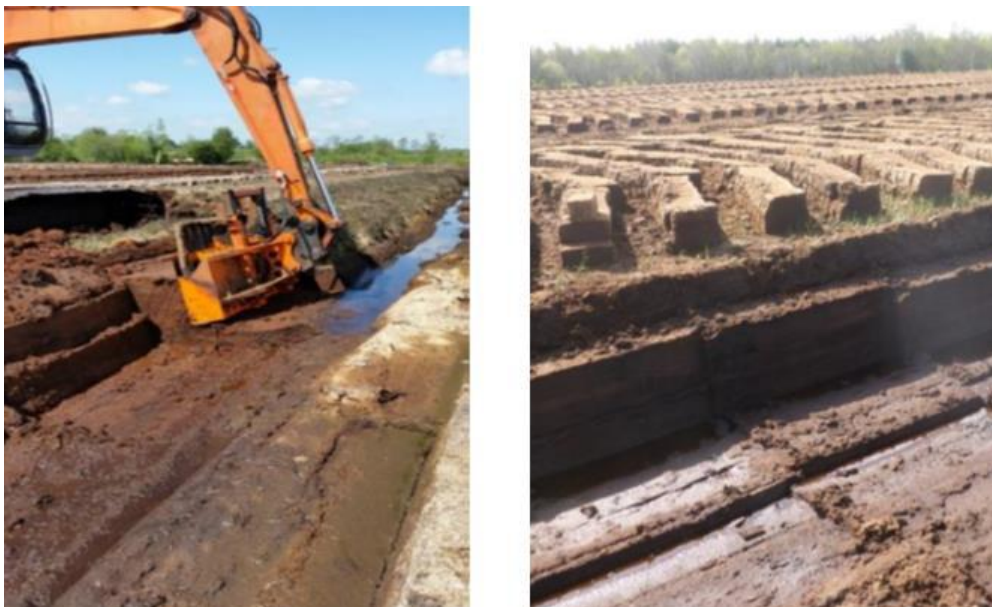
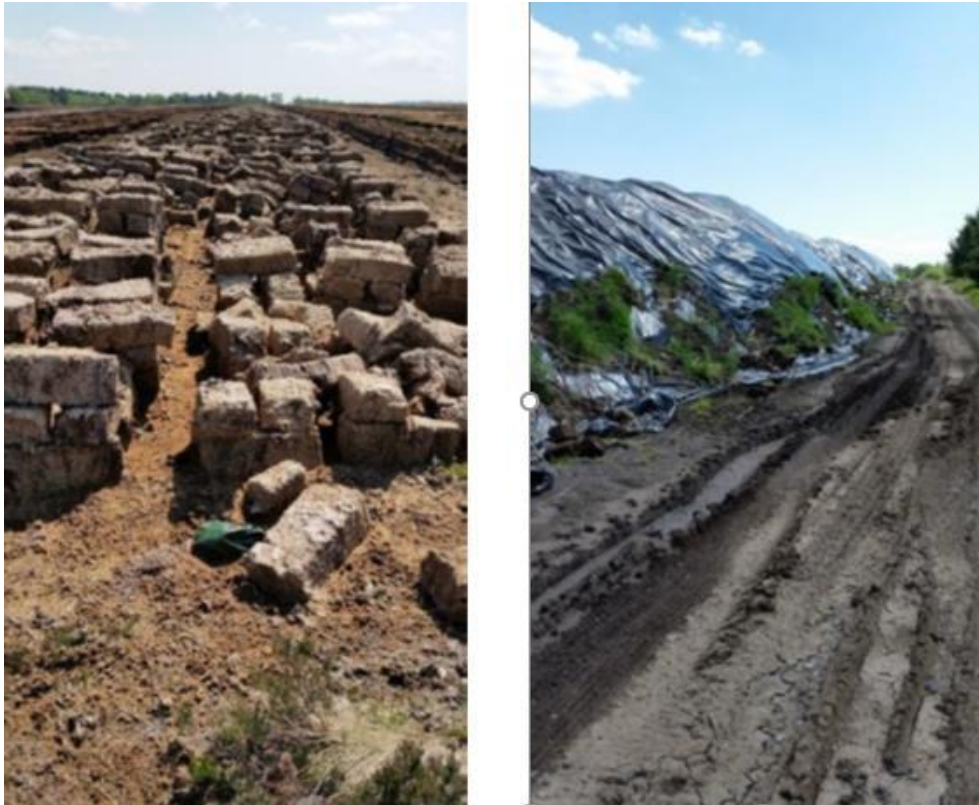
Following drainage, sod moss was extracted mechanically with specially equipped excavators. The sods were cut from mini face-banks or the margins of trenches that were gradually widened and left on the bog to dry for approx. 12 months, reducing moisture content from 90% to between 50% and 60%. Once the required moisture content was reached, the sod moss was stockpiled at the edge of the bog prior to transportation via rail for processing. One layer was typically cut at a time until the sod moss deposit was exhausted. Please see Plate 4-16 and Plate 4-17 for details.

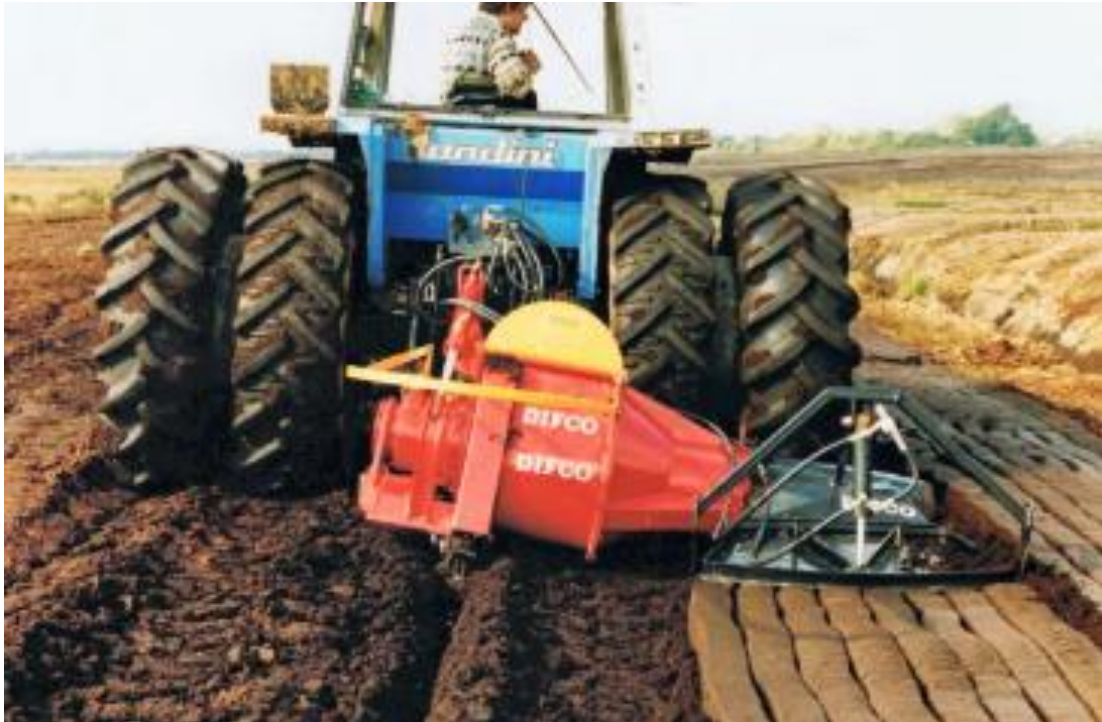
After about two weeks on the surface of the bog, the sods were turned by a sod turning machine to allow the other side of the sod to dry. When the sods were fully dried, the density and uniform texture resulting from the maceration process made them very impervious to rewetting. The maceration process created larger fractions in the sod to facilitate root structure as a result, bin sod is exclusively used for horticulture. Please see Plate 4-18 for details.

Plate 4-18 Process of extracting bin sod. The peat is macerated, extruded into sods and cut with trailing discs (source: BnM).

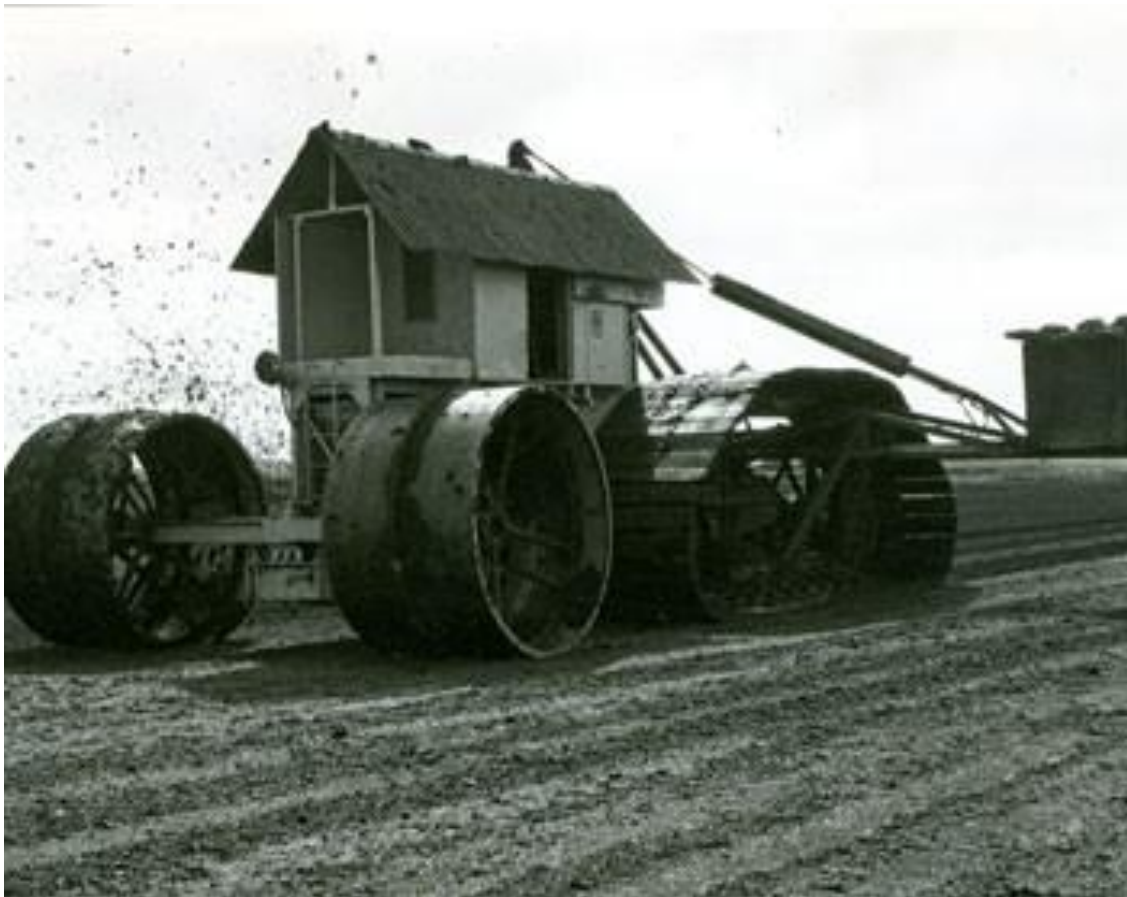
Plate 4-19 H.D. Tractor II (Source: Living History)

idler sprockets were fitted with wear resisting cast steel pads where the track link driving spuds make contact with the sprocket plates. The front rollers were steel rimmed with spokes from a central cast hub. A circumferential steel angle section was fitted to obtain steering adhesion. The rollers were mounted on a swinging axle. The steering was manual through a wormbox, operating winding drums with wire ropes to the axle. The driver's platform was spacious, located at a high level over the main gearbox. For ditching operations, a protective cab was fitted over this platform to protect the driver from ditching spray and the elements. On some tractors on ditching operation, a simple hydraulic steering system was fitted. Plate 4-19 is an image of this type of machinery operating on a BnM bog.

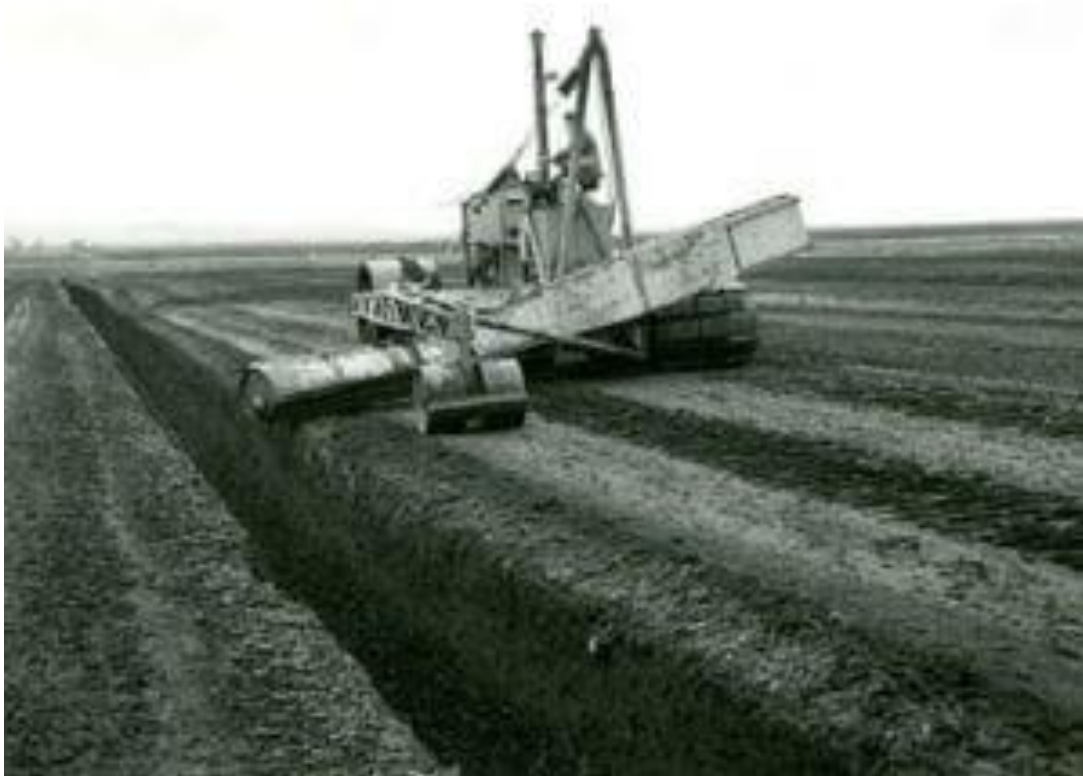
Plate 4-20 LHT Tractor II (source: Living History)

The main frame accommodated either of two engines, the size depending on the attachment to be used with the tractor. Steering was manual by hand wheel through a worm reduction gearbox, draglink and track rod. The front axle swung in the vertical plane to avoid undue distortion of the tractor frame. The front rollers were fitted with a circumferential ring of steel angle section to obtain steering adhesion. Plate 4-20 is an image of this type of machinery operating on a BnM bog.

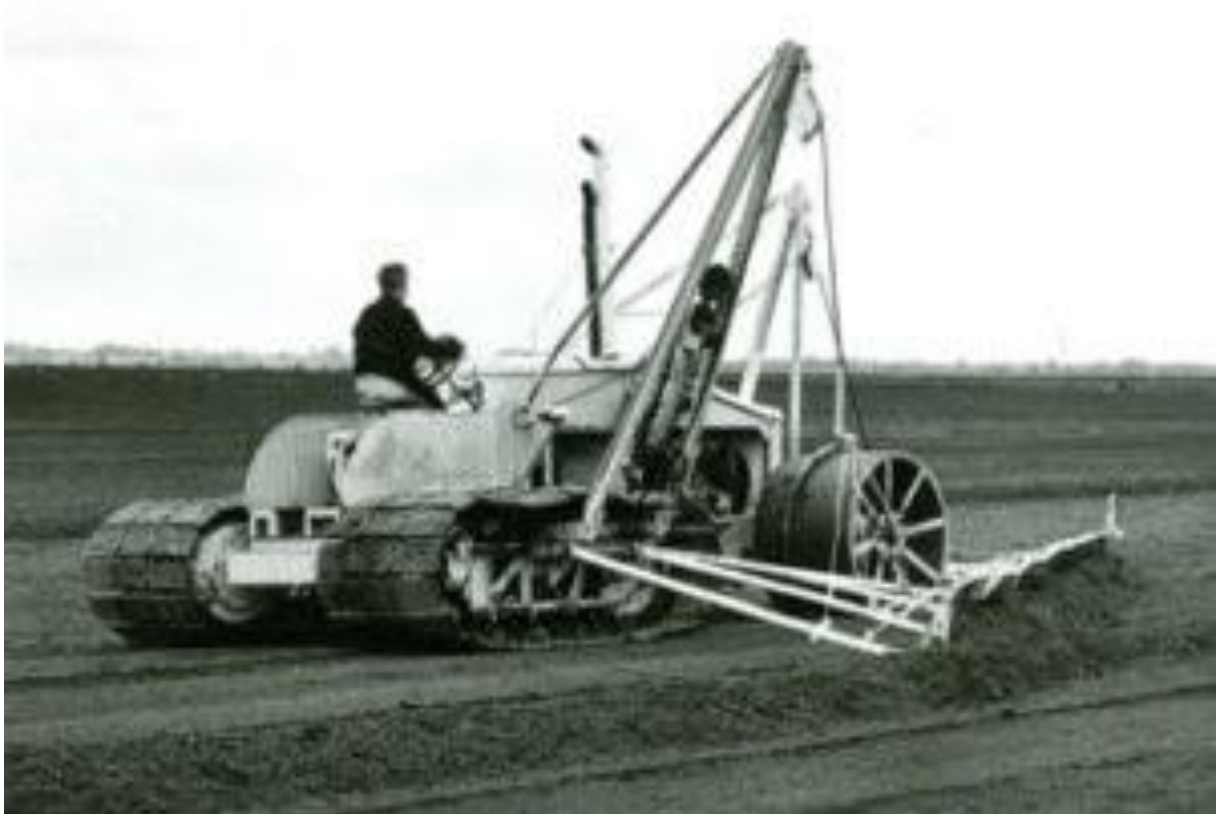
Plate 4-21 Ridger Tractor (source: Living History)

directly to the axle hubs. The tractor was carried on front rollers of generous proportions carried on stub axles and steering is powered by hydraulics. The engine was fitted with two hydraulic pumps, one for power steering and the other for the attachment hydraulic system. The attachment consisted of double blades similar to the single ridger attachment, one blade on either side of the tractor converging at the rear. The blades were supported by sturdy spars which radiated from the tractor chassis. Adjustment of the sole-plate of the blade relative to these spars was provided. The attachment was lifted and lowered hydraulically through a multi-guy rope system over the top of a central mast on the tractor. Plate 4-21 is an image of this type of machinery operating on a BnM bog.

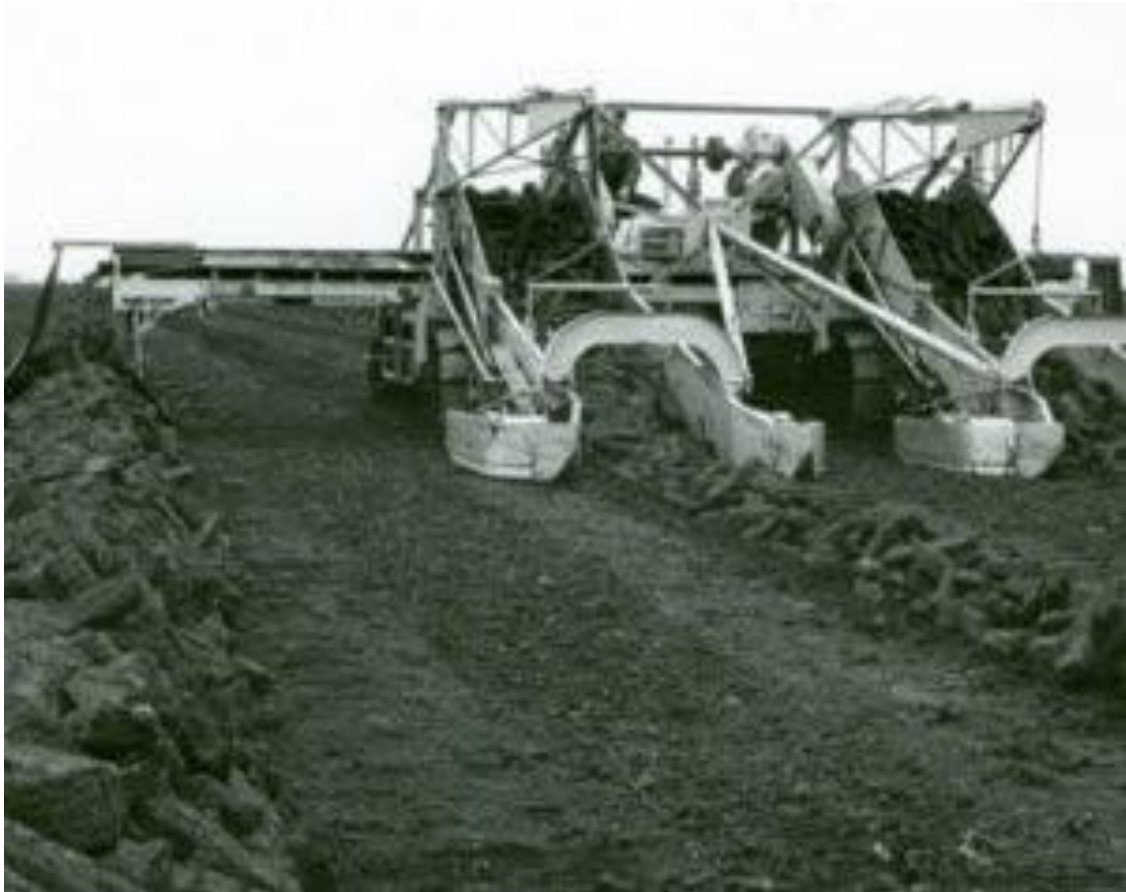
Plate 4-22 Sod turning machine (source: Living History)

This machine does the same work as the Single Turning Machine but had greater output. The elevator mechanism was the same as the single machine and the components were interchangeable. These elevator units were located in front of the tractor tracks, and they discharged either into a cross conveyor, rubber belt type, or two return conveyors, rubber belt type, positioned over the tracks. The cross conveyor was reversible and moveable to either side of the machine. The tractor unit consisted of a strong main frame mounted on caterpillar-type tracks suitable for high idle travel speeds. It was powered by a standard diesel engine and transmission gearbox which is fitted with a proprietary clutch and brake steering equipment. A standard hydraulic pump was also built into this transmission and is used to operate the hydraulic lift of the elevators for idle travel. A special chain reduction drive was inserted between the half shaft of the standard tractor transmission and the track drive sprocket. The drive to the elevators and conveyors were taken off from the standard power take-off shaft of the transmission unit. Plate 4-22 is an image of this type of machinery operating on a BnM bog.
