## **APPENDIX A**

**CHAPTER 4: PROJECT  
DESCRIPTION, rEiAR**

## 4. PROJECT DESCRIPTION

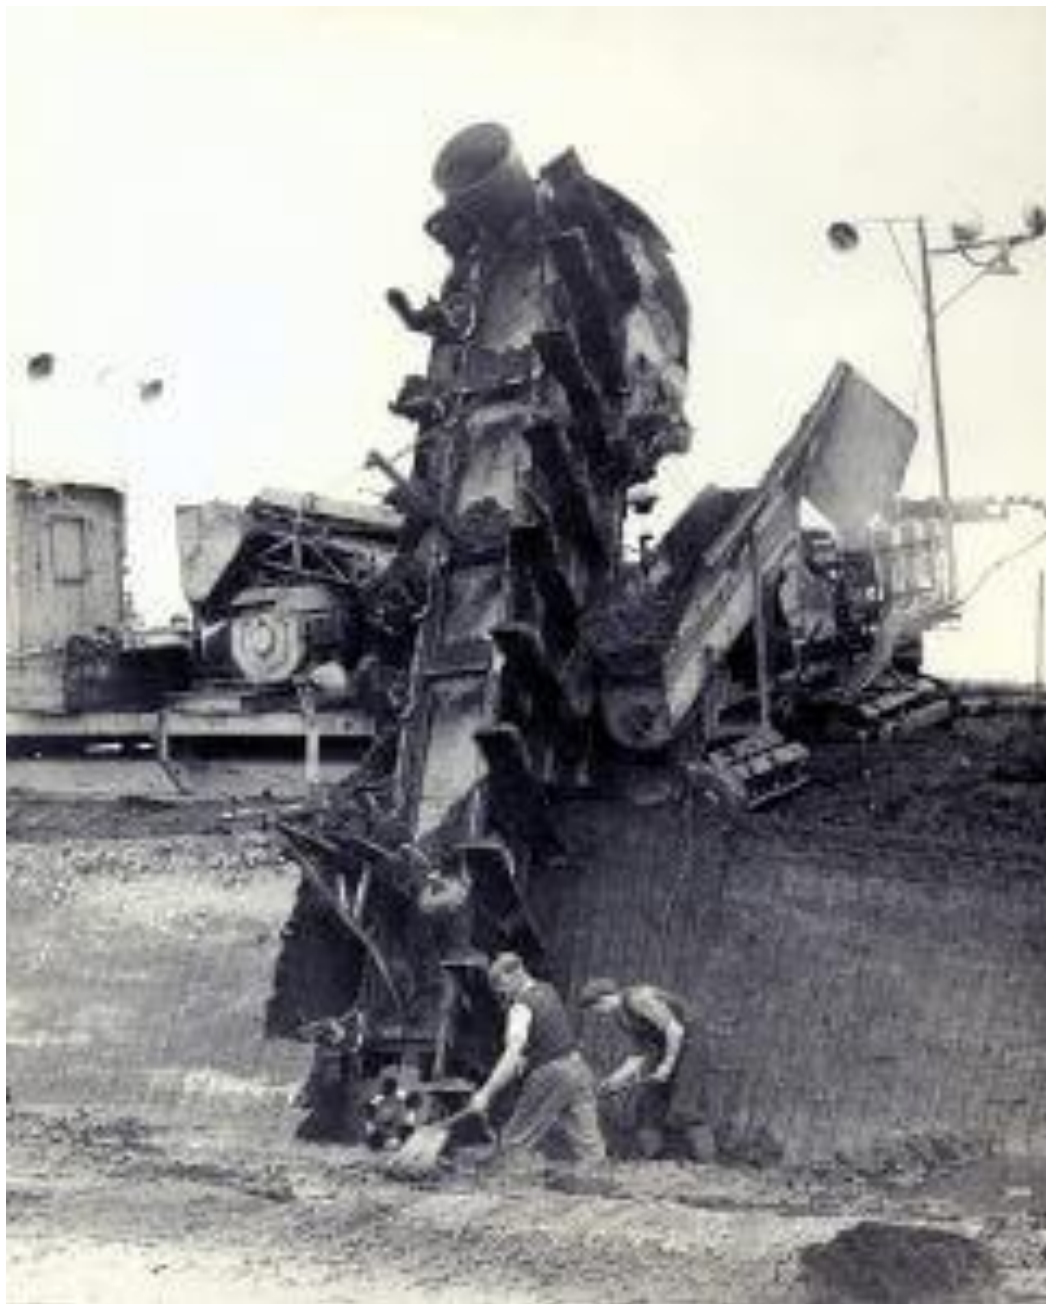
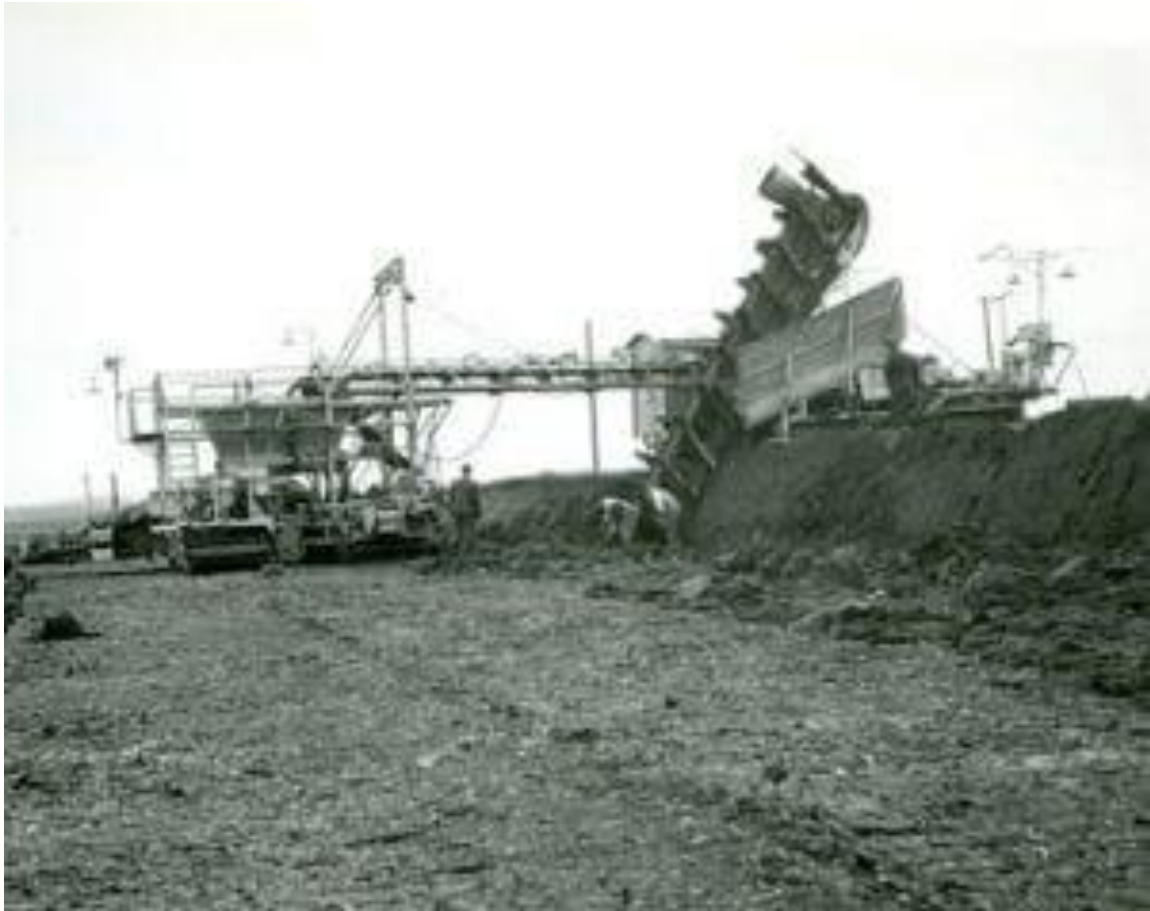
Plate 4-23 Sod Peat Bagger/Excavator (source: Living History)

The purpose of the machine, and the various versions of it, was to excavate, macerate and spread turf for the extraction of sod peat. This is necessary as the high spread ground area diminishes to the point where it will not take a full spread. The machine consists of a sturdy main frame, supported on power driven caterpillar tracks, which carries the various units and their transmission drives, and to which is attached a spreader arm. The turf is excavated by a multi-bucket type digger boom which is retractable to facilitate operation at varying depths and is pivoted on the main machine so that it can be stowed for idle travel. The boom cuts a face bank at 60° to the horizontal. The turf is discharged from boom buckets into a scraper conveyor, and in turn, into a screw conveyor and twin-screw macerator. The macerator extrudes the turf onto the spreader plate chain which carries the extrusion for a distance of 54 metres, when it is discharged to the bog surface. Cutting discs trailing behind the spreader arm, marks the extrusion into sods as the machine advances. The machine is powered by electricity, and friction clutches are fitted to all motor drives for starting up. All unit drives are protected by shear pins. The machine is fitted with lights for night work and equipped with a short-wave radio transmitting/receiving set. Plate 4-23 and Plate 4-24 is an image of this type of machinery operating on a BnM bog.

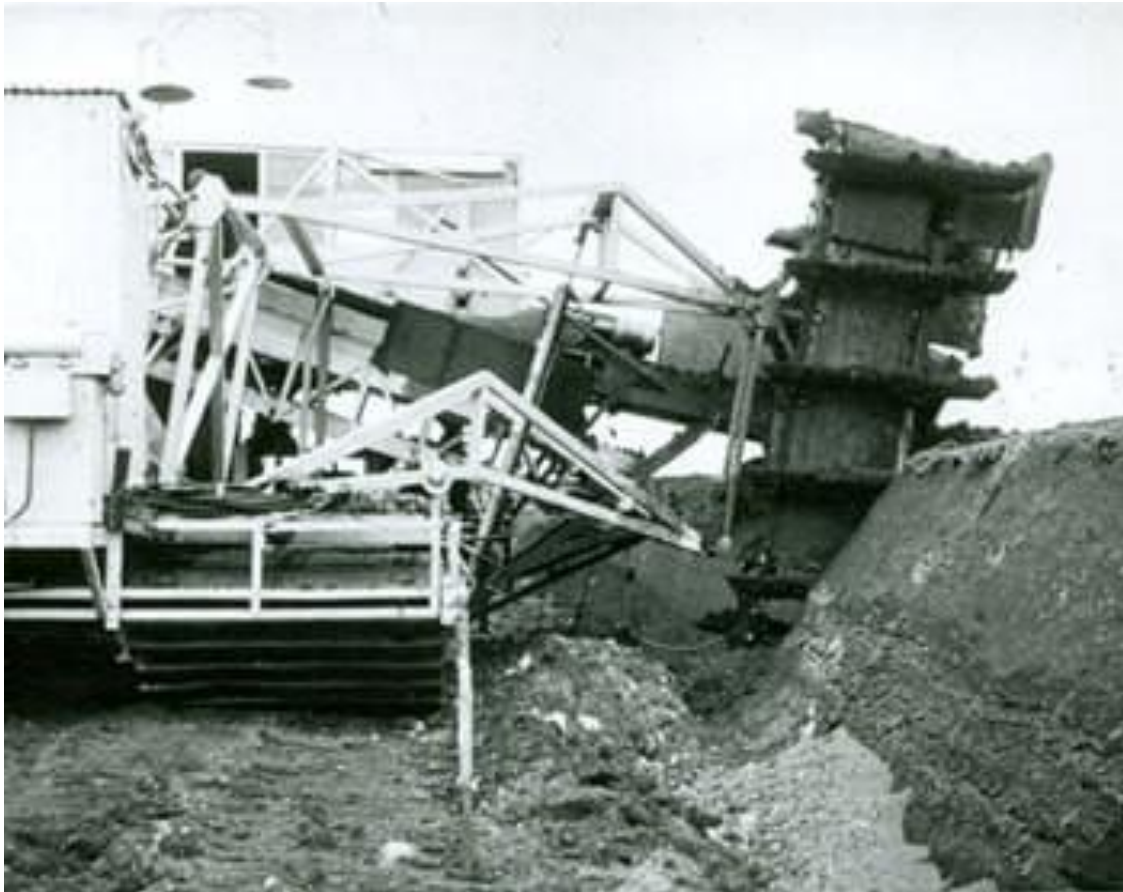
Plate 4-25 Cutaway Boom Attachment (source: Living History)

The catchment conveyor, supported by the boom frame, was a rubber/canvas conveyor belt running on a conventional driver, end roller, and troughing idlers. The section of the belt receiving the turf from the buckets was supported on a series of slides of self-lubricating nylon to prevent deflection of the belt and ensure more efficient sealing. The conveyor had an independent motor/gearbox drive. The catchment conveyor discharged into the original scraper conveyor of the main machine. The attachment could be readily fitted to or removed from the machine by five pins. Plate 4-25 is an image of this type of machinery operating on a BnM bog.

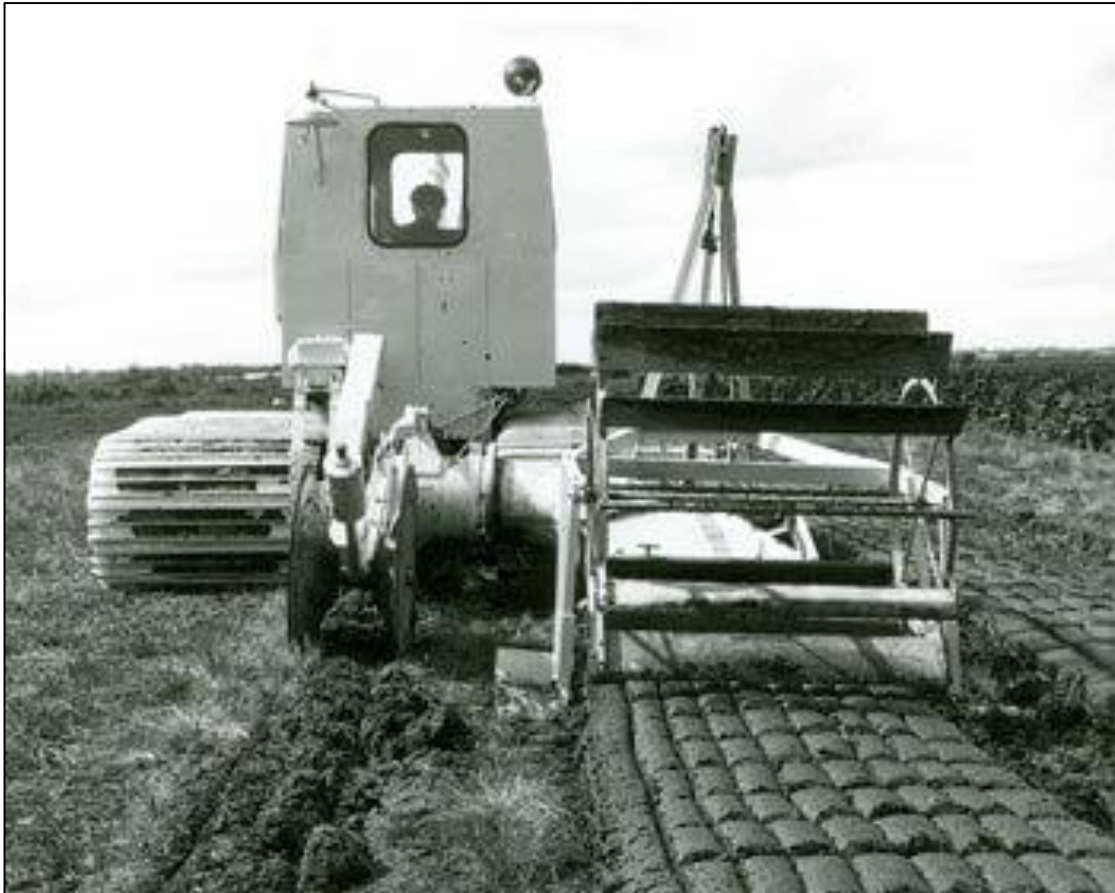
Plate 4-26 Chain Saw Excavator (source: Living History)

The excavator, macerator, and spreading equipment were carried on the rear of the tractor unit, while a guide roller was carried on the front. All this equipment was lifted and lowered by hydraulics. The turf was excavated by a high-speed chain sword carrying cast steel teeth and discharged by centrifugal force at the upper sprocket into a screw/conveyor/macerator unit. This unit extruded the turf through a fan-tail spout, with an adjustable outlet, onto the spread ground. A series of cutting discs and a marking frame divided the layer of turf into the required sod size.

A pair of loaded rollers were trailed behind the cutting sword to close the top of the excavation just made, preparing the spread ground for the next run of the machine. In this way, all available bog could be covered with spread turf, leaving only nominal spaces between the extrusions. Plate 4-26 is an image of this type of machinery operating on a BnM bog.

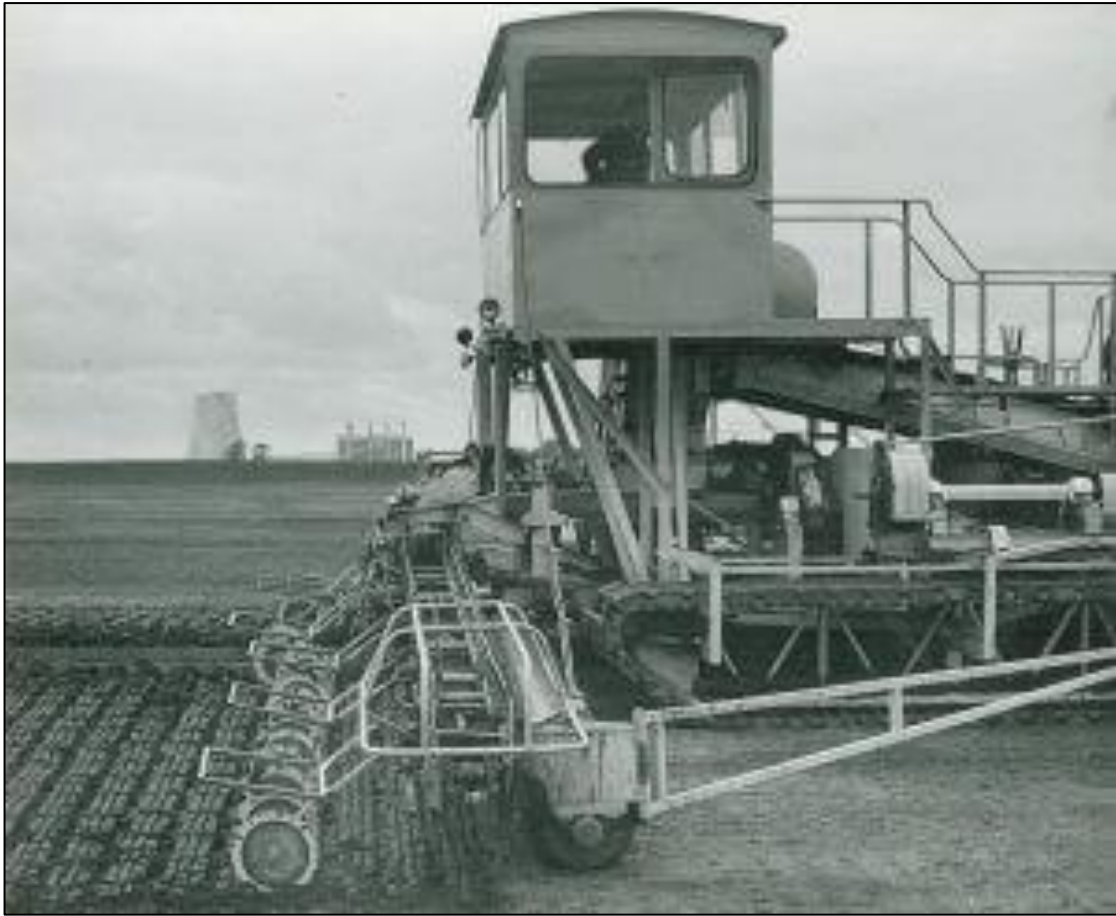
Plate 4-27 Földin Machine (source: Living History)

The fóidín machine originated from an experiment, the 'short cycle harvesting project' conducted at Oweninny bog Co. Mayo in 1965. The aim of the experiment was to produce fast drying peat sods from the surface of milled peat fields that were easy to crush in power stations, this led to the development of the fóidín machine in 1966. It came in two sections: the towing unit, which cut the peat, and the towed unit, which would macerate, extrude and spread the sods. Each of these sections was powered by its own diesel engine. It was steered by coil clutch and all other controls were operable from a cab which overlooked the working parts of the machine. The collection and stockpiling of the sods could be carried out with a combination of existing sod and milled peat machinery, modified in some cases. Fóidín extraction was suspended in most areas in 1972 and was abruptly terminated in 1973 due to several reasons, mainly that the yield from the fóidín system was small and insignificant compared to that of milled peat, complications arose burning crushed sods at ESB stations due to the higher calorific content of fóidín peat, and the cost of extraction was high relative to other peat extraction methods. Out of the 25 fóidín machines owned by BnM, one was sold to the Finnish State Fuel Supply Department, four were retained, and 20 were sold as scrap. Plate 4-27 is an image of this type of machinery operating on a BnM bog.

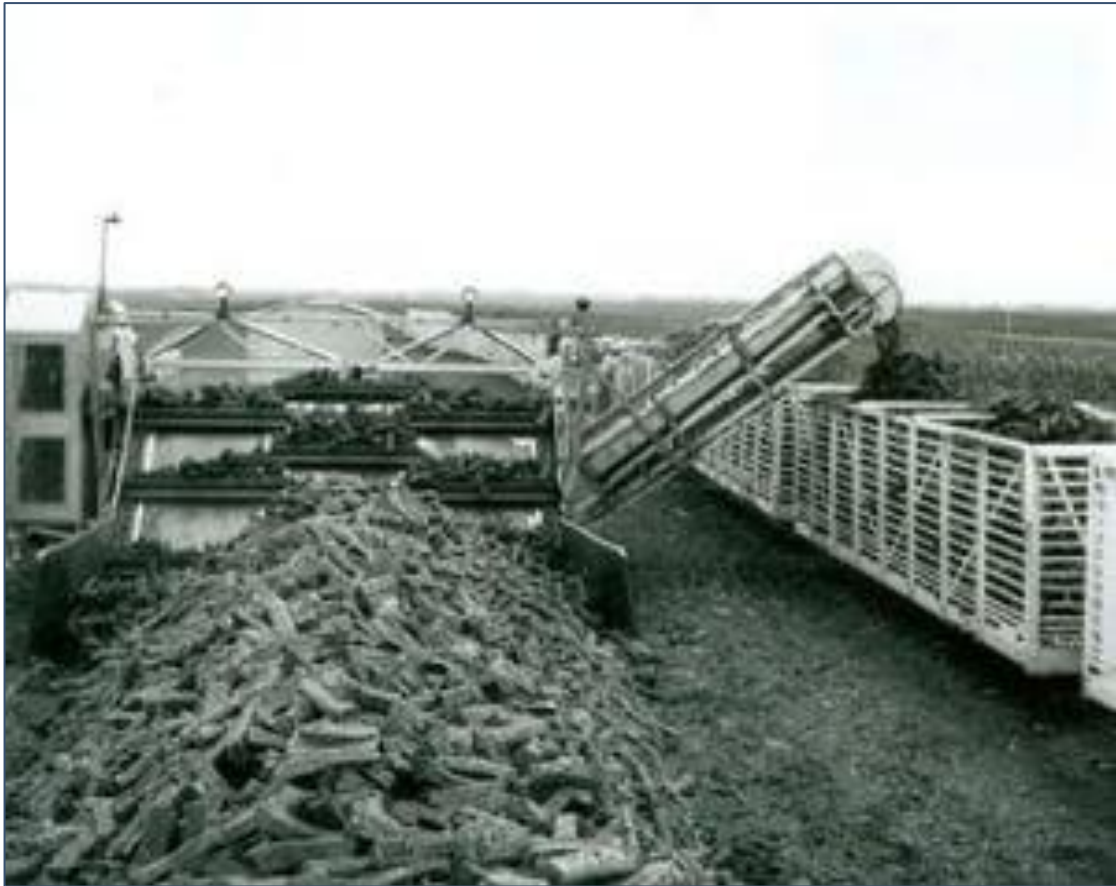
Plate 4-28 Sod Peat Loading Machine (source: Living History)

The purpose of this machine was to load sod peat from bog ricks into railway wagons on one side of the rick only. The machine consisted of a lightly constructed mainframe mounted on caterpillar-type power driven tracks and carried a short scraper elevator in front, extending over the width of the tracks, and a low-level cross conveyor which elevated as it projected from the side of the machine. These loading machines were either diesel- or electric-powered and would be fitted with either a diesel engine or electric motor as required. Plate 4-28 is an image of this type of machinery operating on a BnM bog.

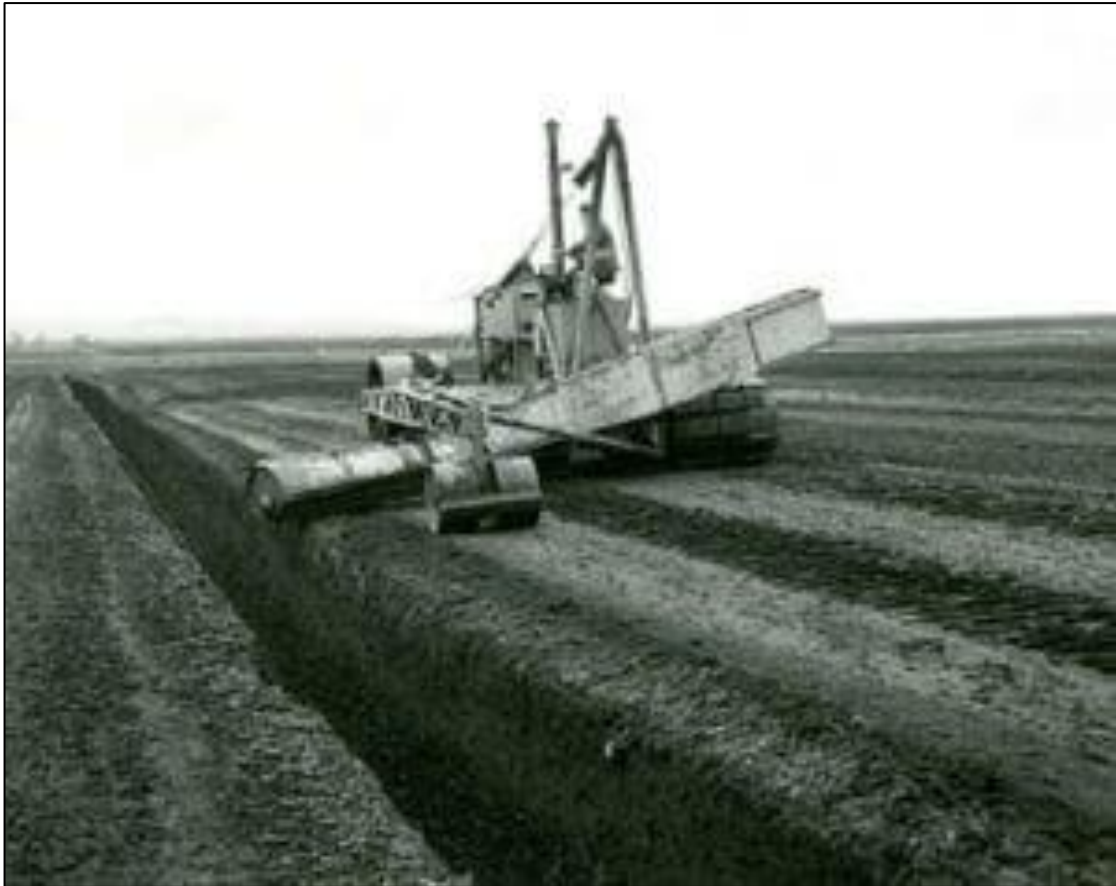
Plate 4-29 Single miller attachment (source: *Living History*)

Single miller attachments consisted of a simple but strong tubular steel frame, the main members of which extended to, and were pivoted, at the mid-position of the tractor tracks. Rigidly mounted on the underside of the frame was a pin-type milling drum which was driven from the tractor PTO shaft through a bevel gearbox and chain drive. The single miller attachment was supported by a ground roller, through springs, located immediately in front of the milling drum and by a depth control castor a few feet behind the milling drum. For idle travel, the single miller attachment was lifted by a hydraulic ram so that the pin milling drum is clear of the bog surface. This attachment, by virtue of the sprung main supporting roller, caused the milling drum to cut deeper on the hills and shallower in the hollows, thus having a levelling effect on the bog surface. The drive to the milling drum is protected by a tension bolt safety device. Plate 4-29 is an image of this type of machinery operating on a BnM bog.

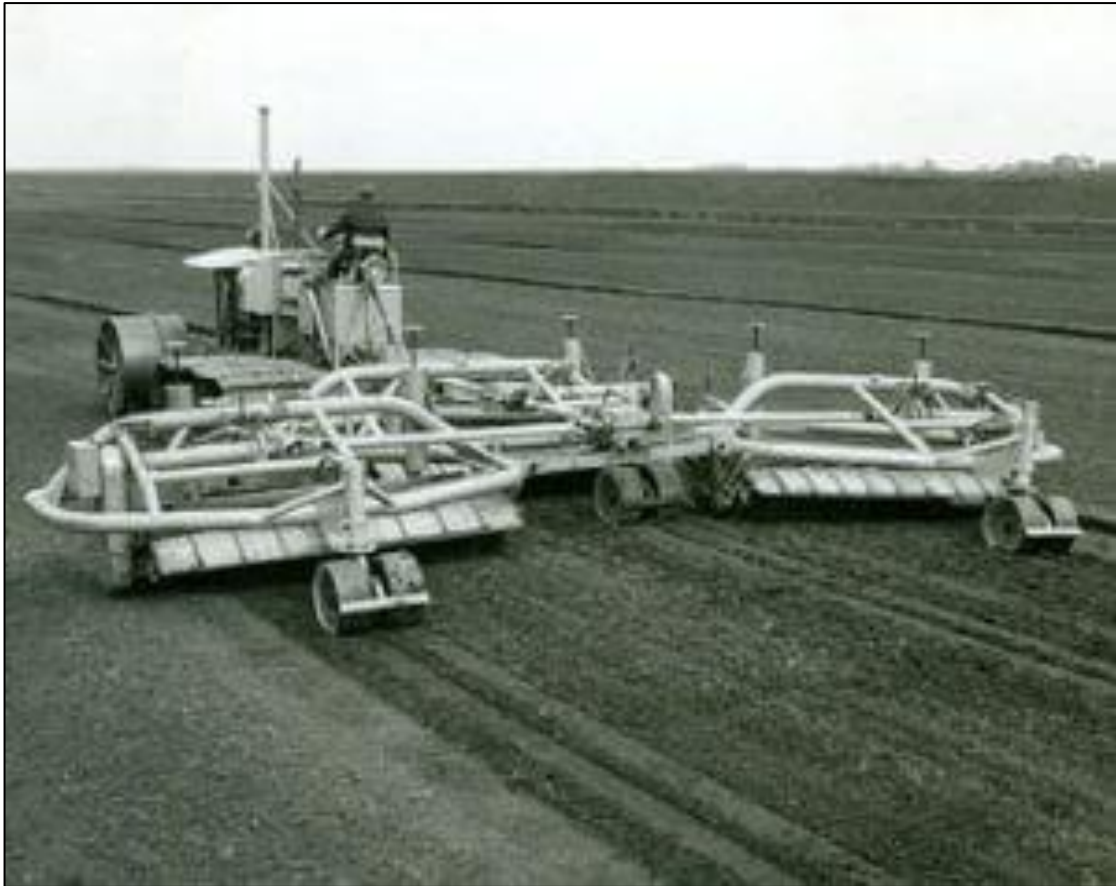
Plate 4-30 Boom Attachment (source: Living History) Triple miller attachment (source: Living History)

The triple miller attachment consisted of units similar to the single attachment, ganged together. The front centre unit was attached to the tractor drawbar, while the two side rear units were drawn by brackets from the side of the front centre unit frame. These brackets were pivoted, and the level of the front of the side unit frame was controlled by roller castors running on the bog surface. The drives to the three milling drums were by universal jointed propeller shafts with splined slip sleeves, two bevel gearboxes and final chain drives. The milling drum speed was lower than the single unit, but in all other respects, the behaviour of the individual units is the same as the single miller attachment. For idle travel, the units were lifted on hydraulic rams incorporated in the rear castor roller assemblies. Depth of cut was also adjusted by these rams from the driving seat. The drive to each of the three units was protected by a tension bolt safety device. Plate 4-30 is an image of this type of machinery operating on a BnM bog.

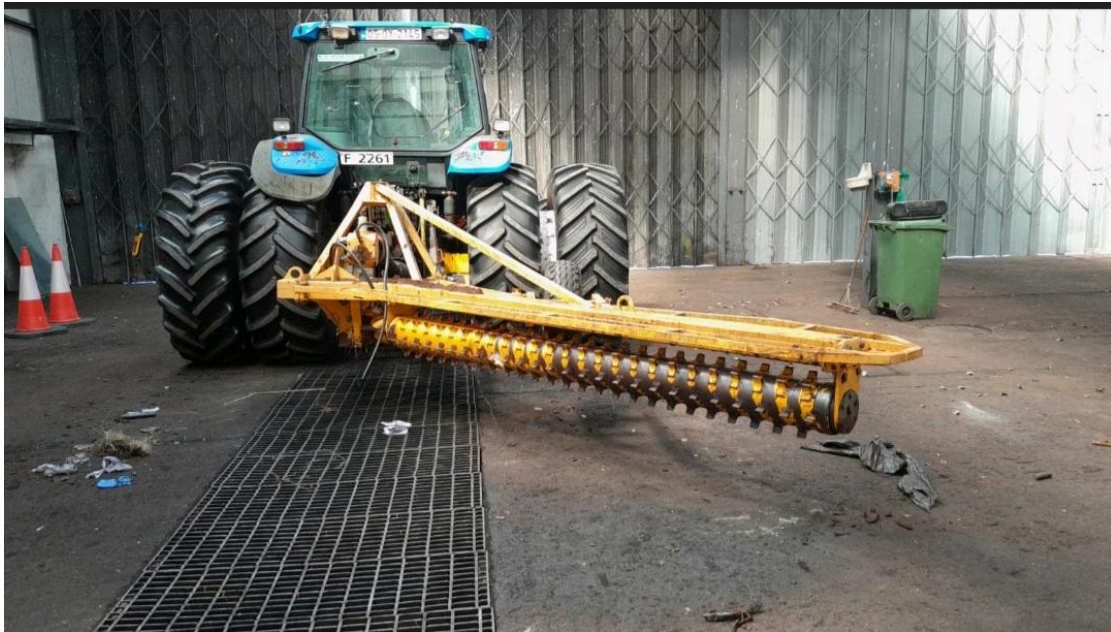
Plate 4-31 Offset Miller Attachment (source: BnM)

This attachment was used to form a bevel on the edges of milled peat fields, to assist surface drainage. It maintained the camber of the production field and was only used after every 3 to 4 harvests. The attachment was a miller drum, projecting from the rear of the tractor unit on a casing arm which is pivoted at a central position on the rear of the tractor main frame and extended to carry a ballast weight. The drive was taken from the tractor PTO shaft, through a bevel gearbox which formed the pivot assembly of the arm, and a universally jointed propeller shaft extended to the actual milling drum. The milling drum was set backwards as it extended from the tractor so that the spoil was thrown back towards the centre of the milled peat field, where it could be harvested. A supporting trolley fixed to a projecting bracket at the centre of the tractor track and supported on a roller behind the drum, carried the drum arm on an adjustable suspension. The trolley, complete with an extension arm and drum could be lifted by a winch rope passing over a mast frame mounted on the tractor. For bogs in early development, a bladed drum was used, while a pin drum was used on extraction bogs. Plate 4-31 is an image of this type of machinery.

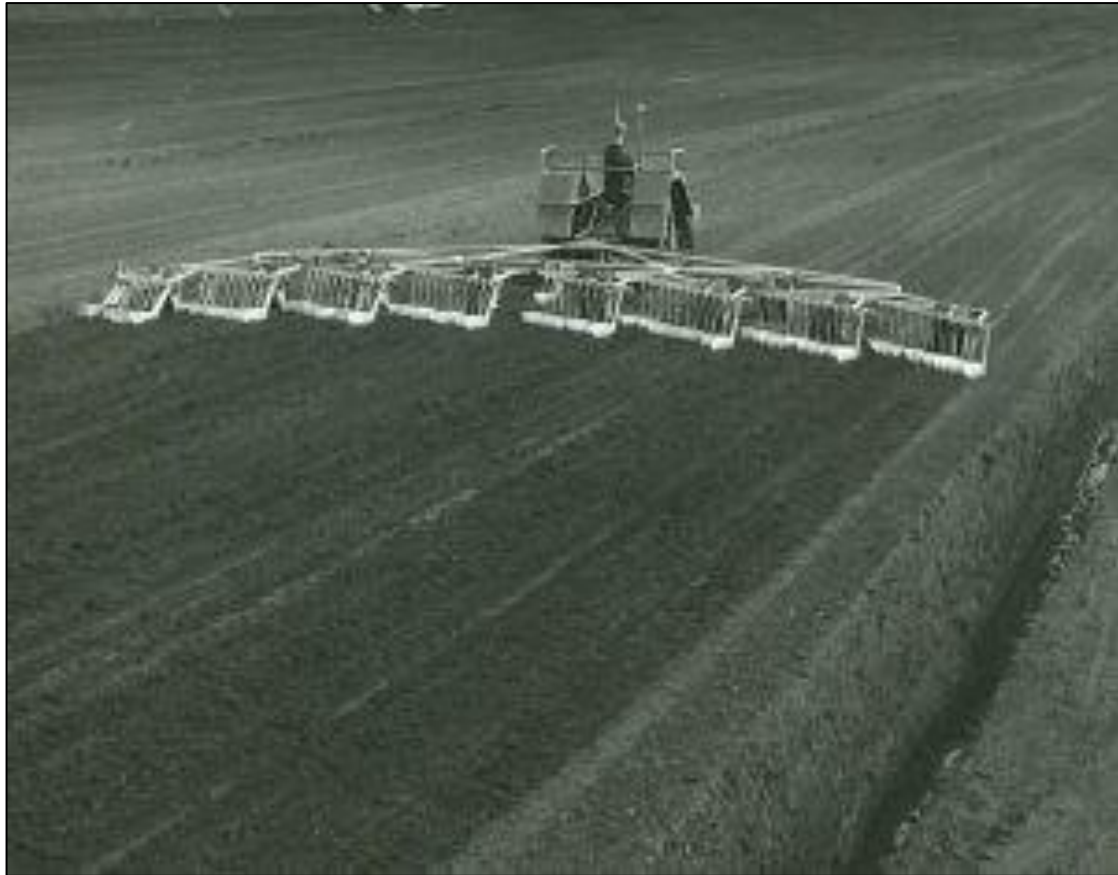
Plate 4-32 Harrow (source: Living History)

The harrow was fitted with a spoon lifting gear. Each spoon arm was connected to a miniature beam over each bank of spoons. A wire rope from the centre of this beam passed over a supported pulley and secured to a special frame on the rear of the tractor. The standard tractor hydraulics actuated this frame to lift or lower the spoons as required. Plate 4-32 is an image of this type of machinery operating on a BnM bog.

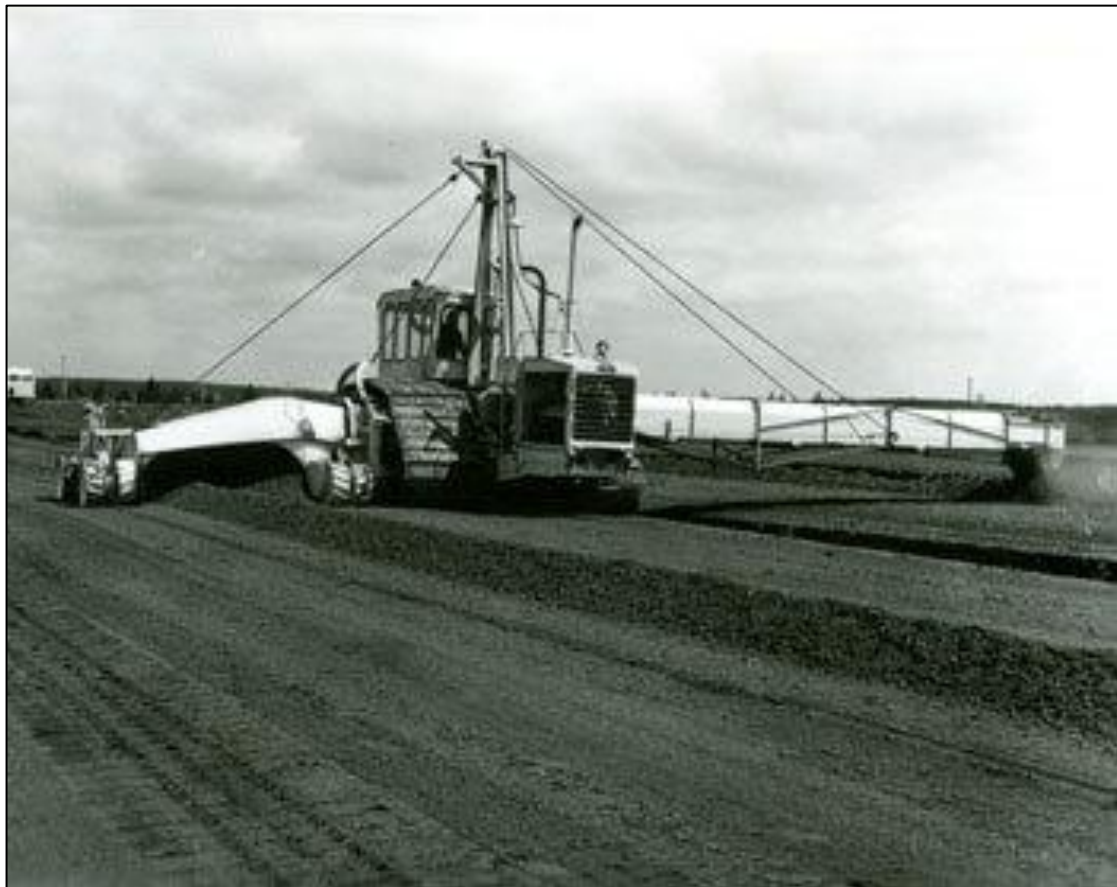
Plate 4-33 Harvester (source: Living History)

The driver of the machine could raise or lower the jib and the trailing boards, raise the spiral casing completely off the bog surface by hydraulics, and control the jib deflector by a simple rope winch. Plate 4-33 is an image of this type of machinery operating on a BnM bog.

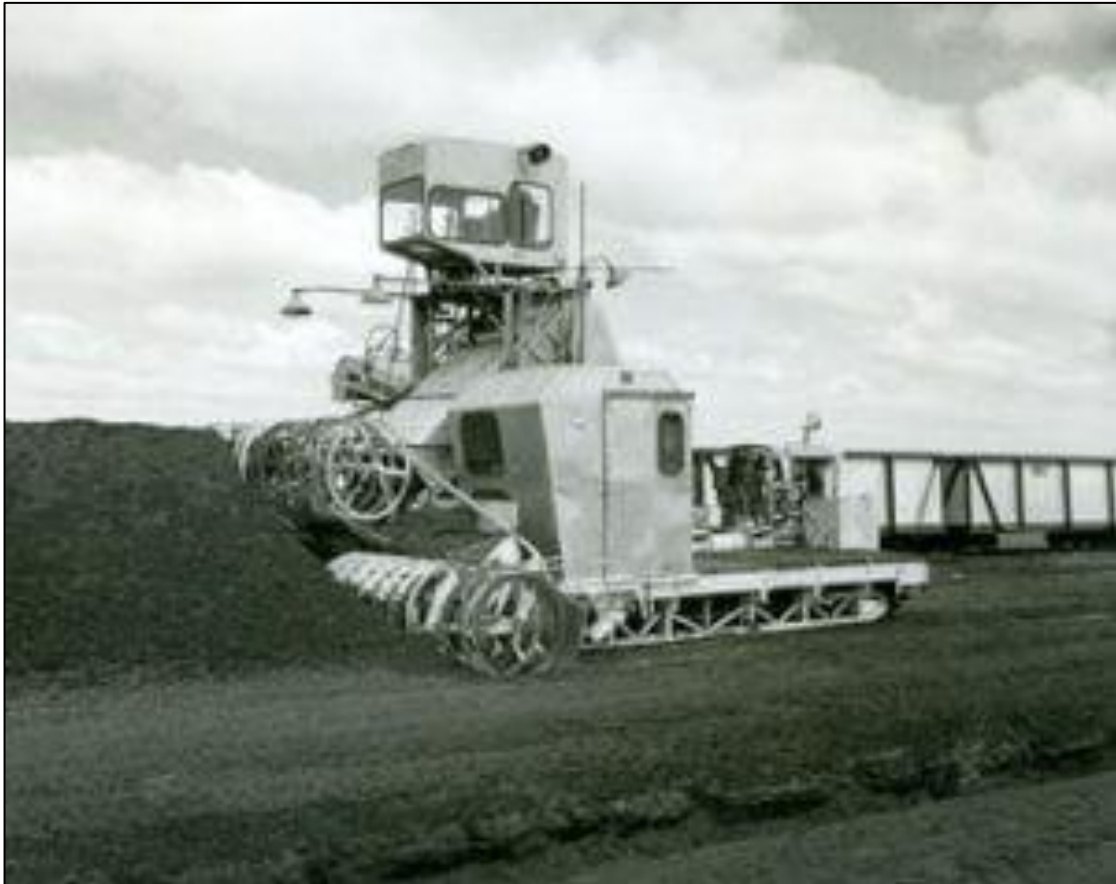
Plate 4-34 Milled Peat Loading Machine (source: Living History)

The purpose of this machine was to load milled peat from peat stockpiles into railway wagons. The machine consisted of a tractor unit carrying a ground spiral on the front, extending either side of the bottom shaft was a bucket elevator which sloped back over the tractor unit. As the buckets overtopped the top sprockets of the elevator, they discharged onto a rubber belt conveyor which discharged into the railway wagons. Plate 4-34 is an image of this type of machinery operating on a BnM bog.

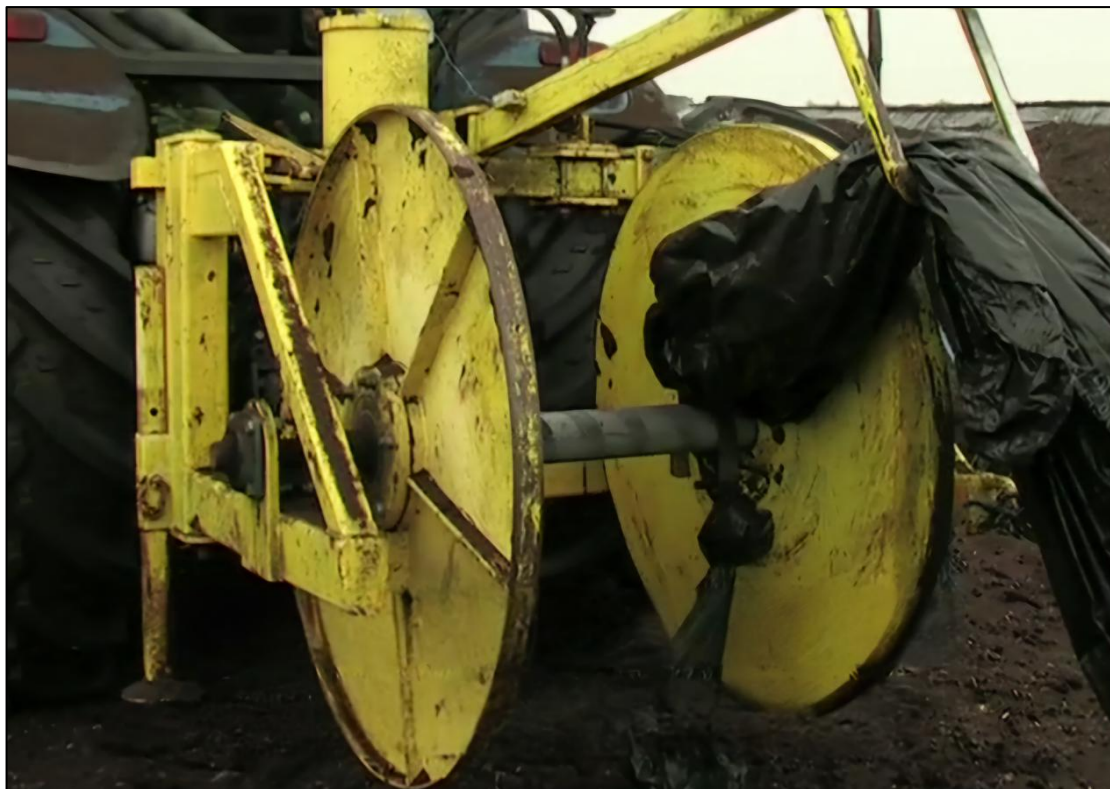
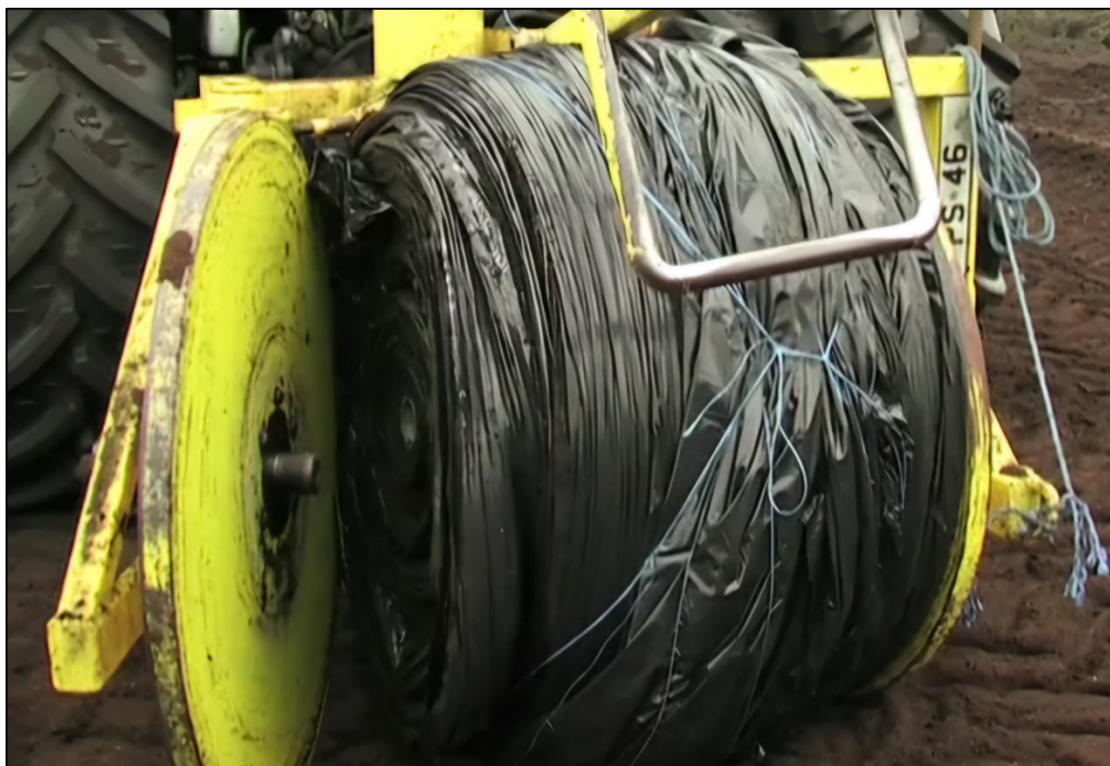
Plate 4-35 Polywrapper

As described in Section 4.4.3.2 above, a polywrapper was used in the uncovering of milled peat stockpiles. The polywrapper was mounted on the three-point linkage of a tractor (see Plate 4-35 and Plate 4-36 below). The eye of the polywrapper was attached to a pendulous swivel arm, which, as the tractor moved forward, oscillated from left to right to ensure that the polythene being collected was being dispensed evenly across a metal shaft on the polywrapper. This ensured an even spool of polythene was collected. Once the spool was at capacity, one side of the polywrapper was opened (see Plate 4-36 below), which allowed the metal shaft to be removed and replaced with a plastic one. The entire spool was then removed and sent for appropriate disposal/recycling. The metal shaft was reinserted into the polywrapper, the side closed, and the process began again until the stockpile was fully uncovered and all the polythene collected.

Plate 4-36 Polywrapper with the frame opened to allow access to the collected bale of polythene

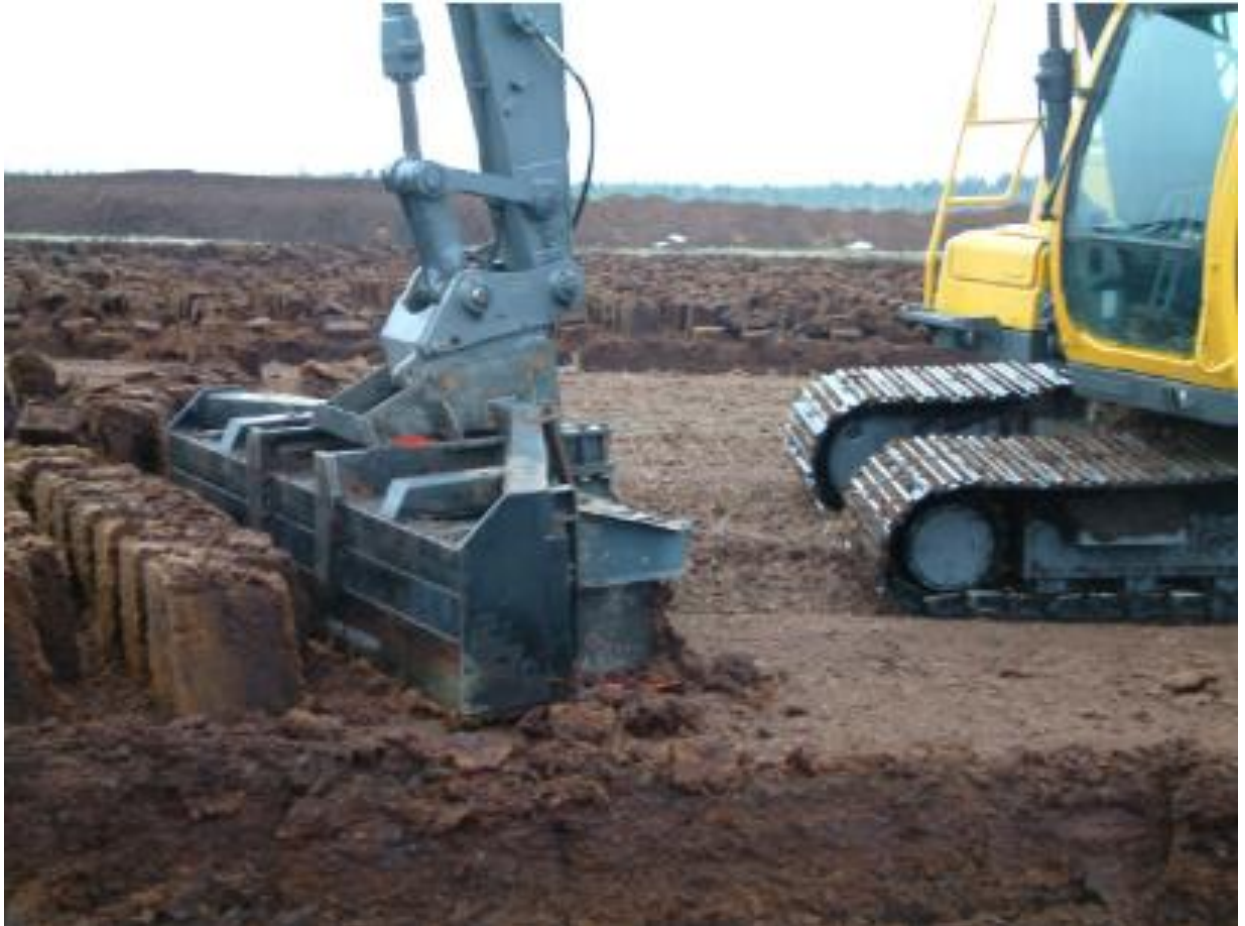
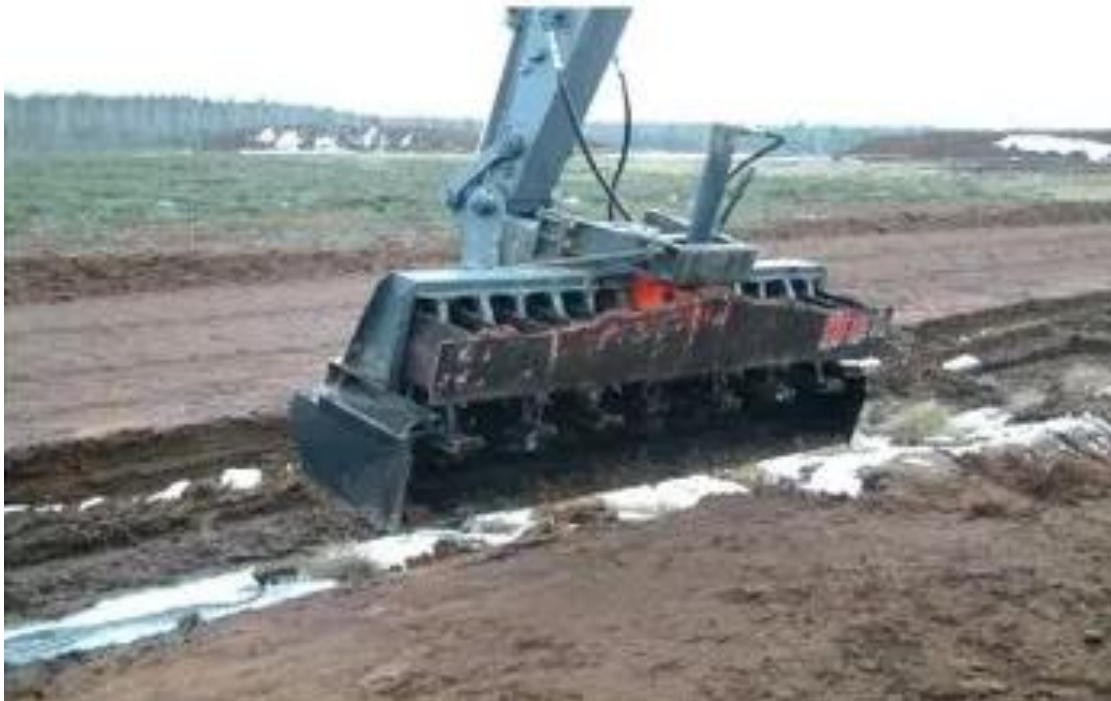
Plate 4-37 Sod Moss cutting attachment attached to a digger (source: BnM)

Sod moss was cut with a special bucket attachment on a digger. The bucket attachment collected peat from the face bank of the bog and deposited the peat as 8 separate sods on the surface of the bog. Plate 4-37 and Plate 4-38 show this type of attachment extracting sod moss.

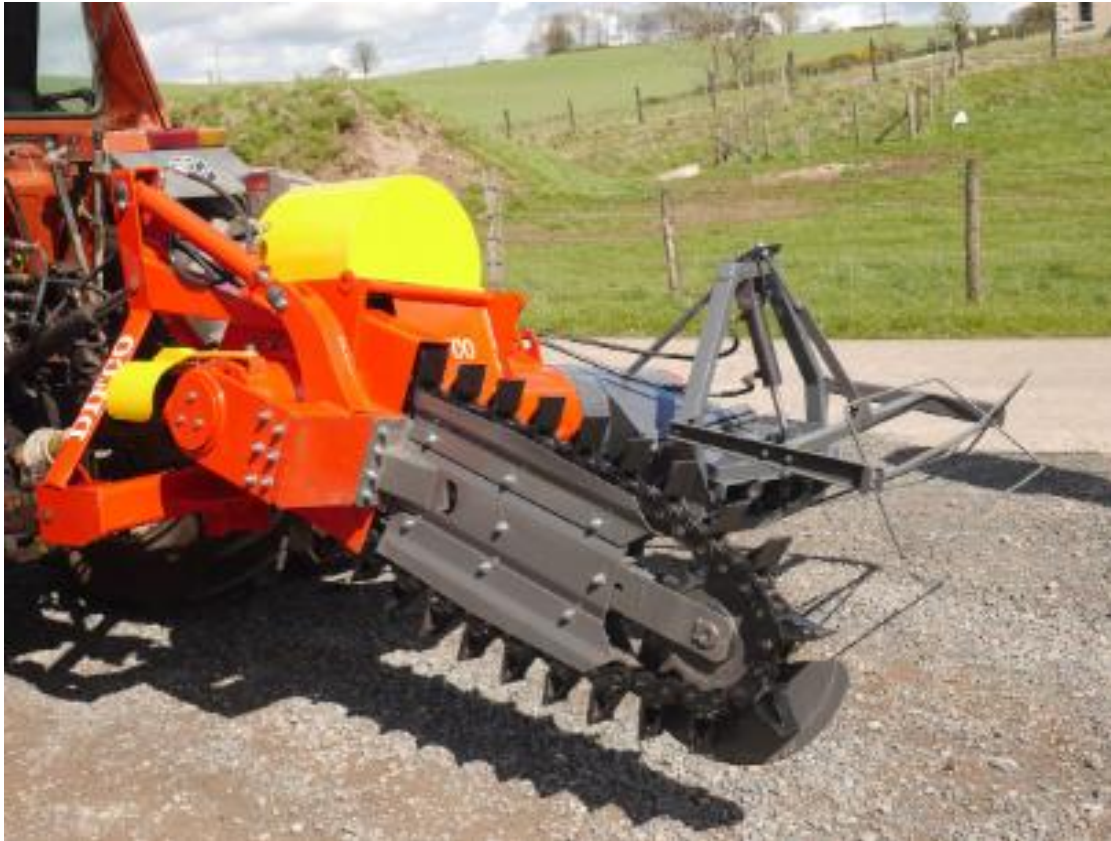
Plate 4-39 Bin sod tractor attachment (source: BnM)

The bin sod tractor attachment had a 5ft chainsaw type blade which extracted peat from the surface of the bog and deposited it into a macerator which pulped and mixed it. The macerated peat pulp was then extruded into rows of continuous bin sods. As they were extruded, trailing discs then cut the rows into 8 long sods. The bin sod was spread on the large area between the trenches which allowed sufficient room to dry the peat. Plate 4-39 show the bin sod attachment on a tractor.

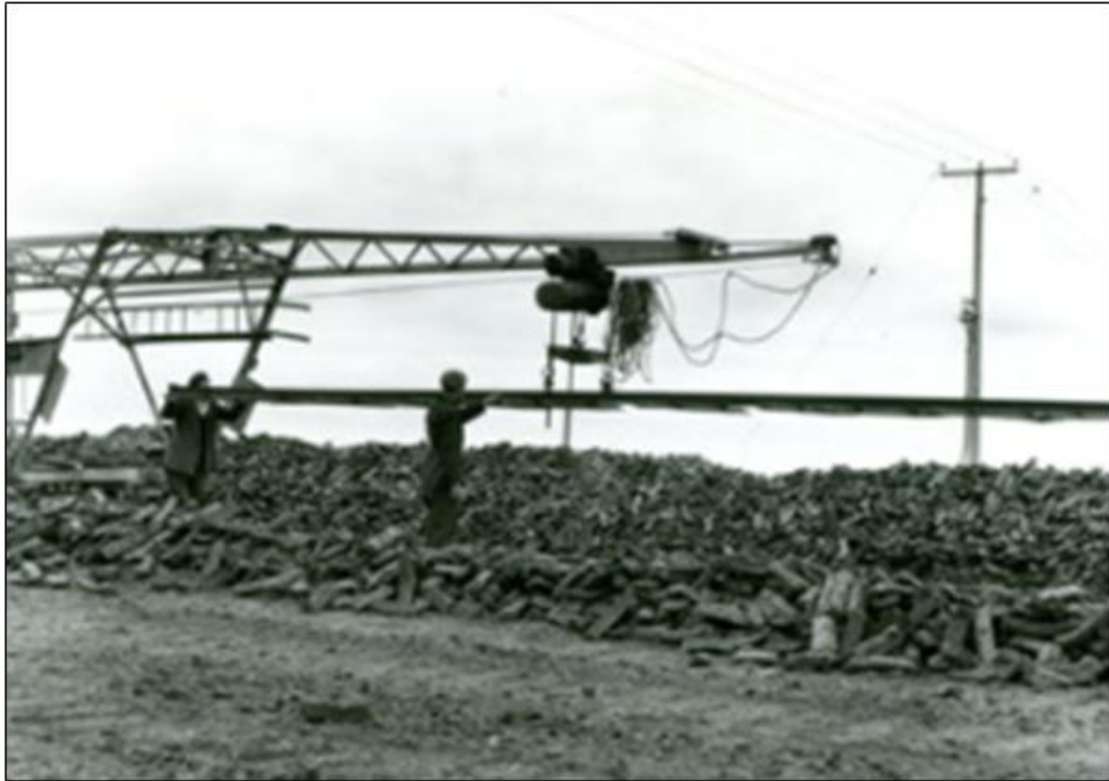
Plate 4-41 Rail Shifter (source: Living History)

A rail shifter was an attachment fitted onto tractors which was used to lift temporary railway tracks in sections and build them onto bolster bogies for transport to a new area. The rail lifter consisted of a lightly constructed main frame supported on two bogies and an overhead latticework beam supported from the main frame to allow the passage of the rail sections through the machine. When seven sections were built on the bolster bogies, they were hauled away by a locomotive. Plate 4-41 is an image of this type of machinery operating on a BnM bog.

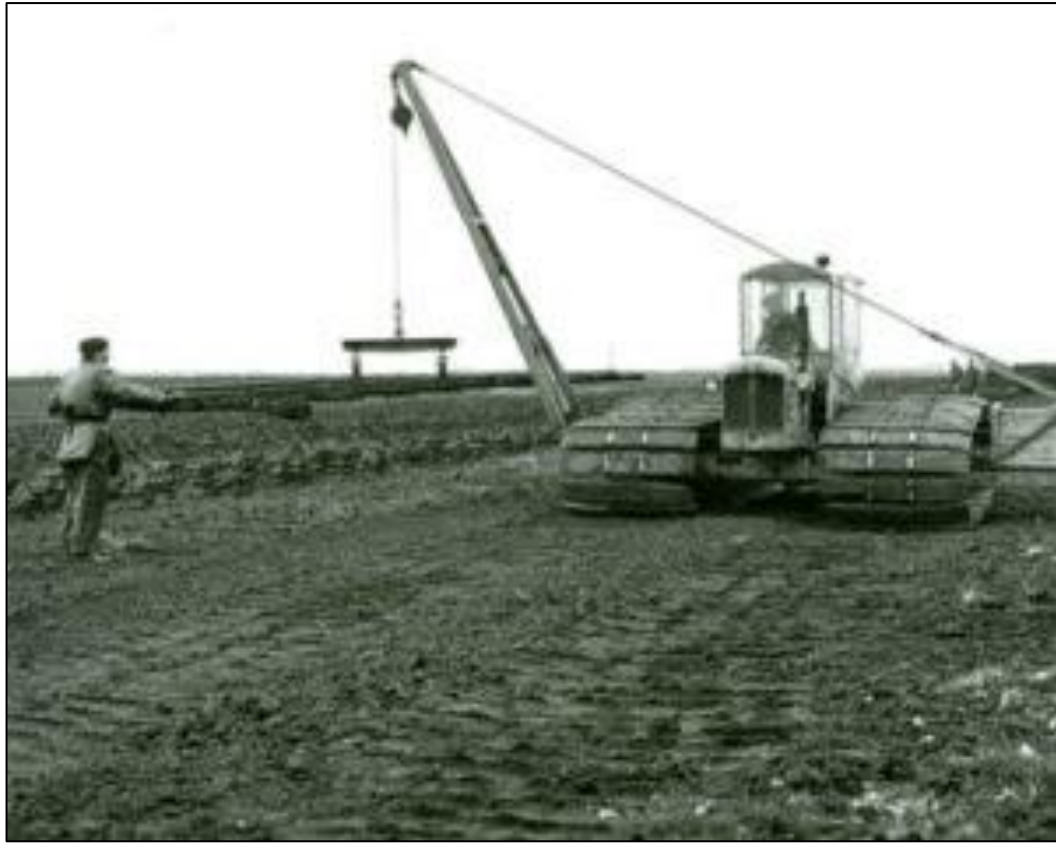
The purpose of the rail moving attachment was to lift and lay temporary railway tracks along sod peat ricks and milled peat piles. The attachment was fitted to a tractor and consisted of an A-frame jib pivoted on a bracket secured to the track frame of the tractor and braced back at the top by wire rope to a projected ballast box on the other side of the tractor. A short jib was used for sod peat operations while a longer jib was used for milled peat operations. Plate 4-42 is an image of this type of machinery operating on a BnM bog.

Plate 4-42 Rail Moving Attachment to lift and lay temporary track, along sod peat ricks and milled peat piles. (source: Living History)

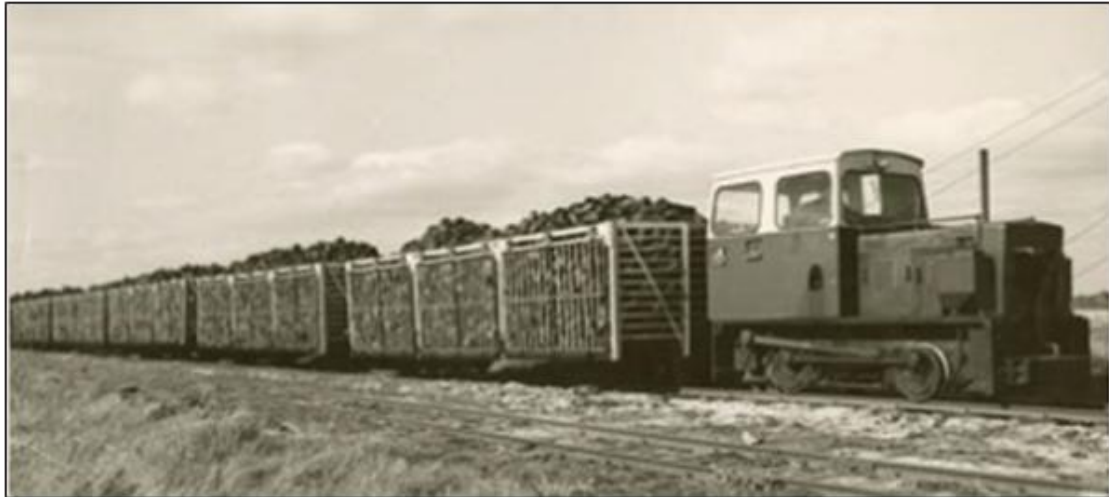
Plate 4-43 Locomotive with wagons (source: *Living History*)

The locomotive hauled peat from the stockpiles across the Application Site to Ballydermot Works for processing. The locomotive was powered by a water-cooled diesel engine driving through a fluid coupling, automotive type clutch, standard automobile change speed gearbox, a special reversing bevel/spur reduction gearbox and drive and coupling rods to the wheels. The main frame was fabricated steel plate. The axles ran in self-aligning double row roller bearings in cast steel housings sliding in horn guides with manganese steel wearing faces. A cab of generous size was included, with a tumbling-type seat to facilitate driving in both directions. The clutch control pedal was duplicated for the two driving positions. The braking system was mechanical hand operated. The locomotive was fitted with beam lighting, electric windscreen wipers and driving mirrors for both directions of travel. Plate 4-43 is an image of this type of machinery operating on a BnM bog.
