**Objection to the Derrybrien Windfarm Substitute Consent "Exceptional Circumstances" Application by the ESB PL07 308019-20**

In support to my objection please see enclosed a copy of a recently published *Technical Assessment of Derrybrien Windfarm and Ancillary Works by Arcadis Design & Consultancy July 2021* which identify very serious deficiencies with the rEIAR submitted with the substitute consent application.

JULY 2021

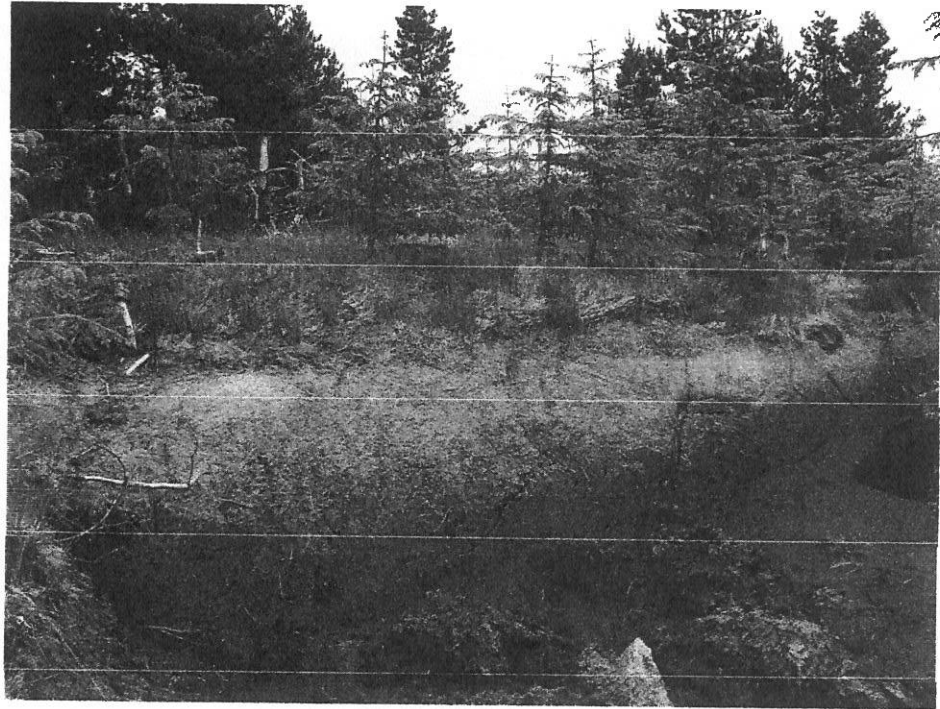
**Figure 1.** Smooth face of a peat crack, or fissure, resulting from peat shrinkage caused by water loss from the peat matrix as a result of drainage. The face is aligned along a former forestry ploughing furrow. Photograph taken during a 2004 field investigation of the Derrybrien windfarm site.

Such cracking is a well-known phenomenon of plantations on peat as a result of drying out and consequent peat shrinkage. The smooth faces of many peat blocks, as illustrated by Lindsay & Bragg (2005), show where the peat separated into long ribbons of peat along these cracks during the 2003 slide. Such smooth-faced ribbons contrast markedly with the jagged faces of blocks typical of many peatslides where the peat has simply been torn apart.

A key, indeed a critical, part of the Derrybrien rEIAS should therefore have been the mapping of all such cracks and fissure, but the rEIAS makes no mention of such cracking. As SGG-2017 observes: *“In preparing assessments of peat stability, developers should give afforested peatlands (which are often hydrologically disrupted and physically degraded) the same scrutiny as peatlands without forest, even if this may be more arduous in practice (due to concealment of the ground surface by tree cover and associated access difficulties).”*

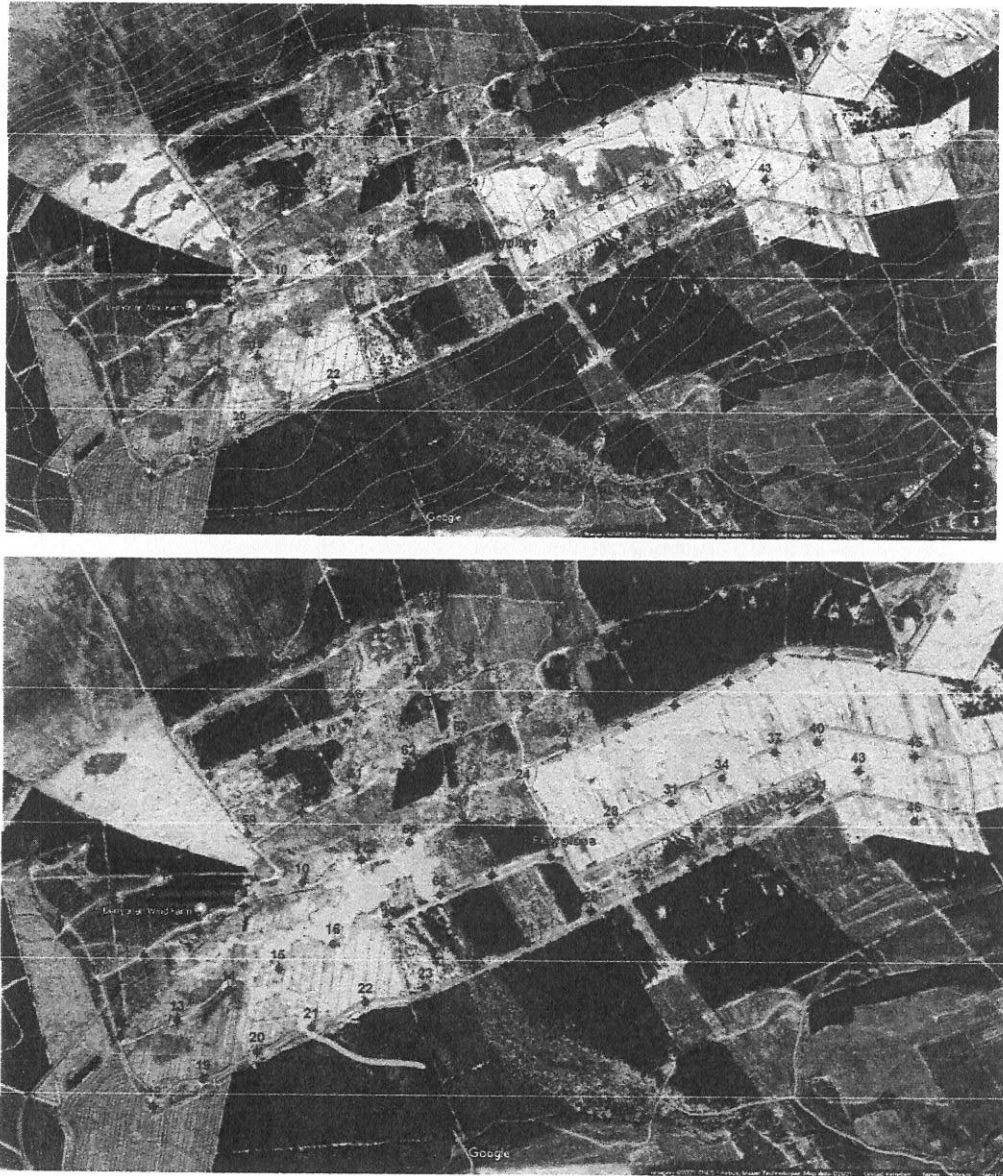
**Figure 2.** Aerial photograph of the Derrybrien windfarm site with (top) Google Maps aerial photo, contours and turbines; (bottom) Google Maps aerial photo with pale blue shading indicating possible zones of surface/sub-surface seepage. Dotted blue zones indicate areas of possible seepage obscured by tree cover or forest felling operations.

A similar band of sinuous shading which forms a huge crescentic shape leading down into the same ‘shallow valley’ which experienced the 2003 peatslide (see Figure 2) is merely identified (along with others) as an ‘*Area of deeper peat and high water table on flat terraces (Darker vegetation)*’ but with no mention of the (very likely) possibility that this, too, is an area of sub-surface piping and/or seepage. Furthermore, the dark zones identified in the NW corner of the aerial photograph and lying just outside the windfarm boundary actually point downslope and converge on a natural drainage line, so it is possible that these, too, are seepage zones or areas of sub-surface piping.

Further areas of dark ground can just be discerned vanishing into the forest blocks within the windfarm site, so it is possible that sub-surface seepage is widespread within the site. These may be natural zones of seepage, but published evidence from, for example, Holden *et al.* (2002) and Holden (2005) have identified a clear linkage between drying peatlands and prevalence of sub-surface piping.

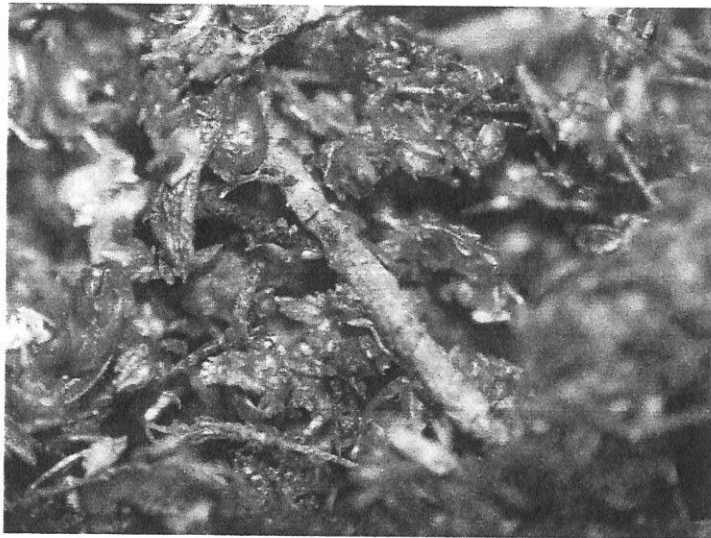
**Figure 3.** Close-up of largely undecomposed peat (von Post value of H1) showing the numerous lengths of moss stem and branch spindles set within the matrix of loose leaves.

While actual identification of fissures obviously gives a direct indication of ground state, the degree of humification as indicated by a von Post test gives an indication of the susceptibility of a given section of peat to shrink and crack under the stresses generated by drainage. Peat with a low von Post value of anywhere between H0 and H4 will shrink much less than a highly decomposed peat with a von Post value of H8 or H9. This is because little-decomposed peat contains many more long fibres which help to bind the peat matrix together and give it a high tensile strength. Figure 3 shows a close-up of peat with a von Post value of H1 (i.e. largely undecomposed). The mass of Sphagnum bog moss stems and branch spindles can be seen to interconnect somewhat like tangled scaffolding, preventing any significant degree of shrinkage.

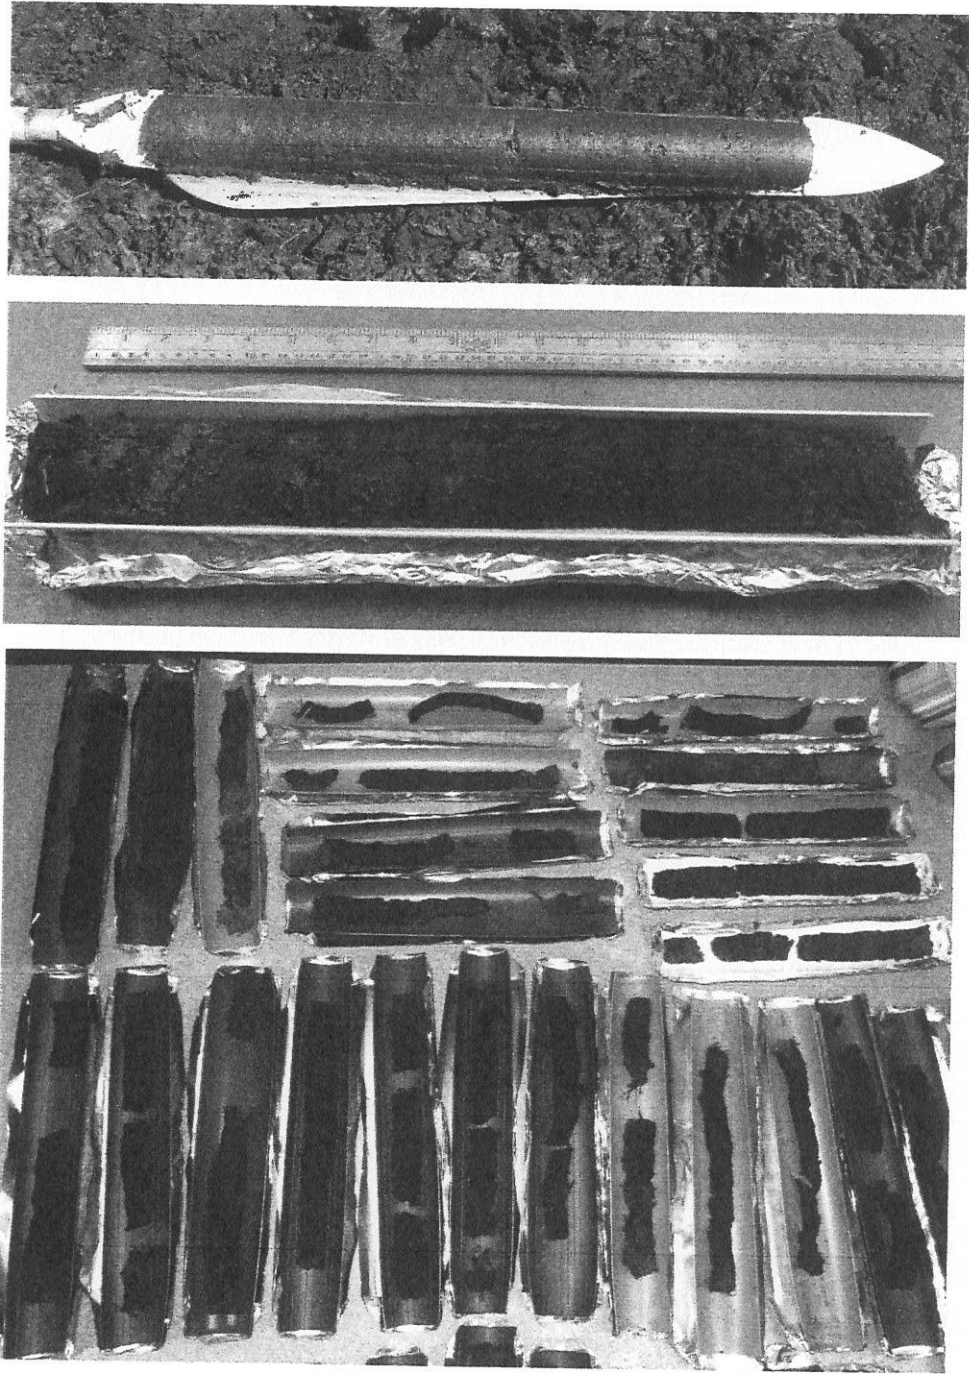
**Figure 4.** Variable shrinkage due to drying of peat cores, taken from a bog in northern England, having differing von Post values. (top) Core just after removal from the bog; (middle) Core unwrapped for drying; (bottom) Differential shrinkage and fragmentation of cores following drying, with greatest shrinkage occurring in cores with high von Post values.

Figure 4 shows the difference in shrinkage between peat cores having differing von Post values. The higher the von Post value (i.e. the more decomposed the peat) the greater the extent of shrinkage, cracking and fragmentation.

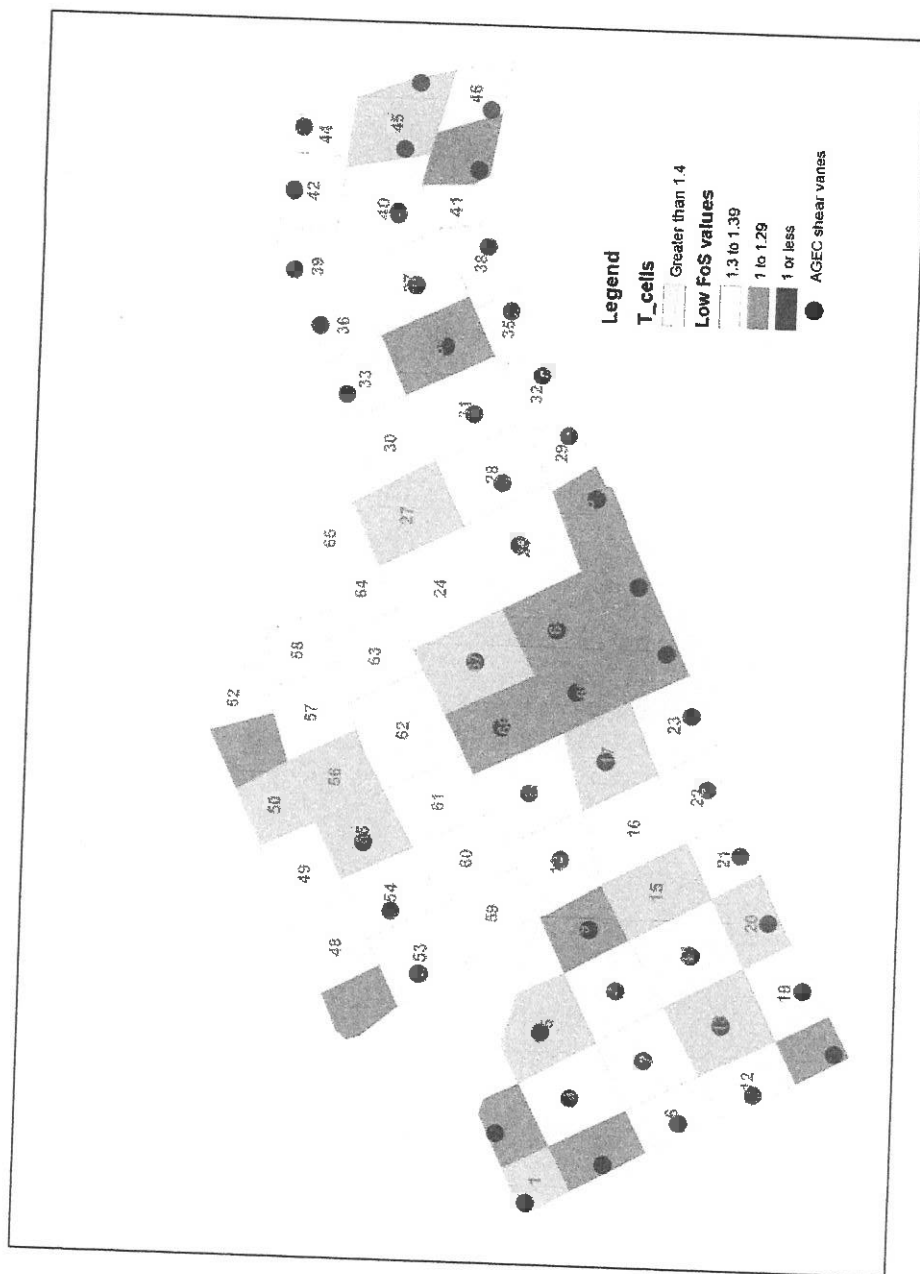
**Figure 6.** The 71 'T-cells' created by AGECC (2004). Each 200 m x 200 m cell is centred on a numbered turbine. Coloured shading indicates those cells with calculated Factor of Safety values less than 1.4, based on a hypothetical load of 10 kPa (equivalent to 1 m depth of excavated peat) and a weak layer within the peat (see Section 10.7, AGECC, 2004). Black circles indicate AGECC shear vane measurements. Note that the northern area of the windfarm in particular has few actual shear vane measurements yet parts are still indicated as at maximum risk under this scenario. The zone around T68 from where the 2003 failure flowed is clearly indicated as a high-risk region.

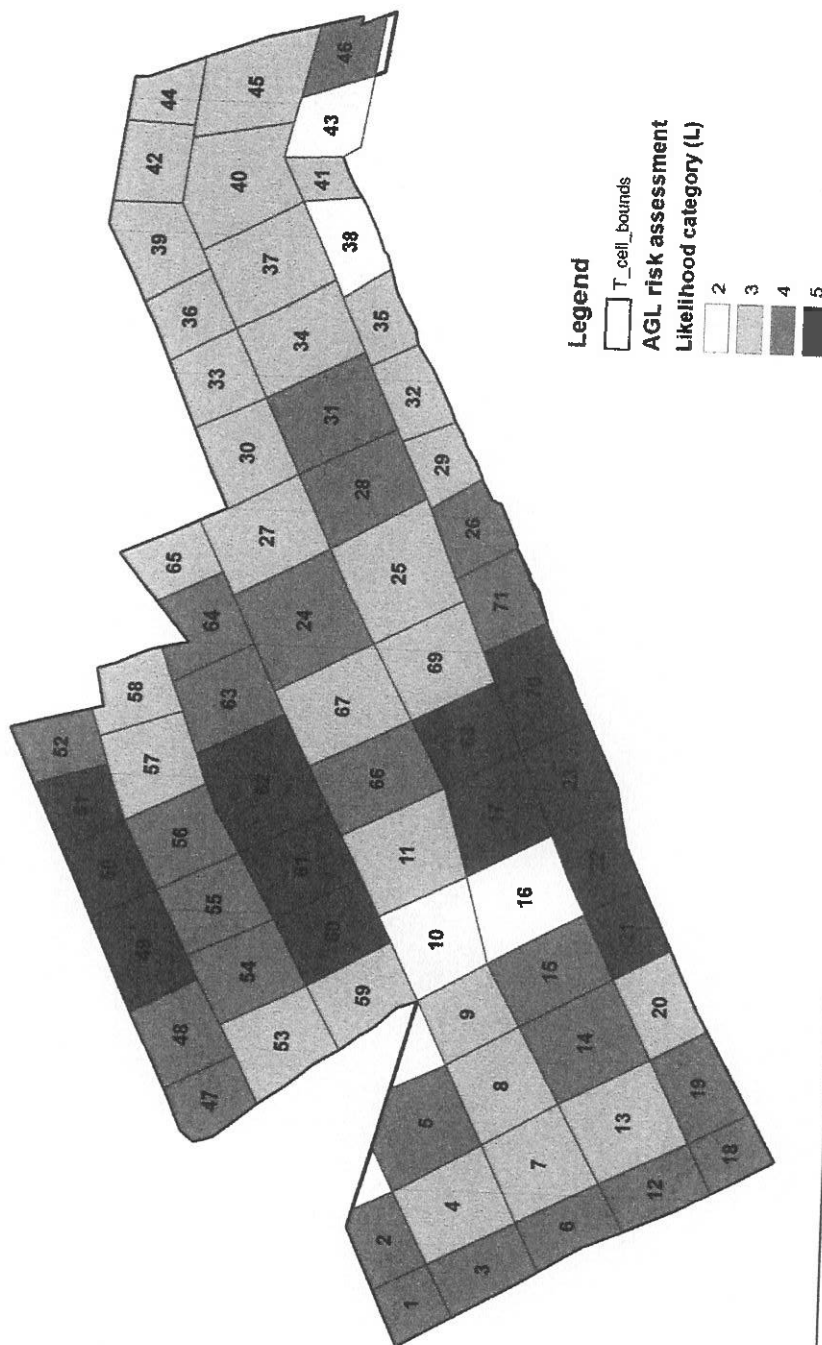
**Figure 8.** Peat Stability Assessment by AGL (2020) for baseline conditions in 1998 for each T-cell. Highest risk rating is '5'. Note the concentration of high risk cells in the northern section of the site, and also the high risk value along the western margin of the site.

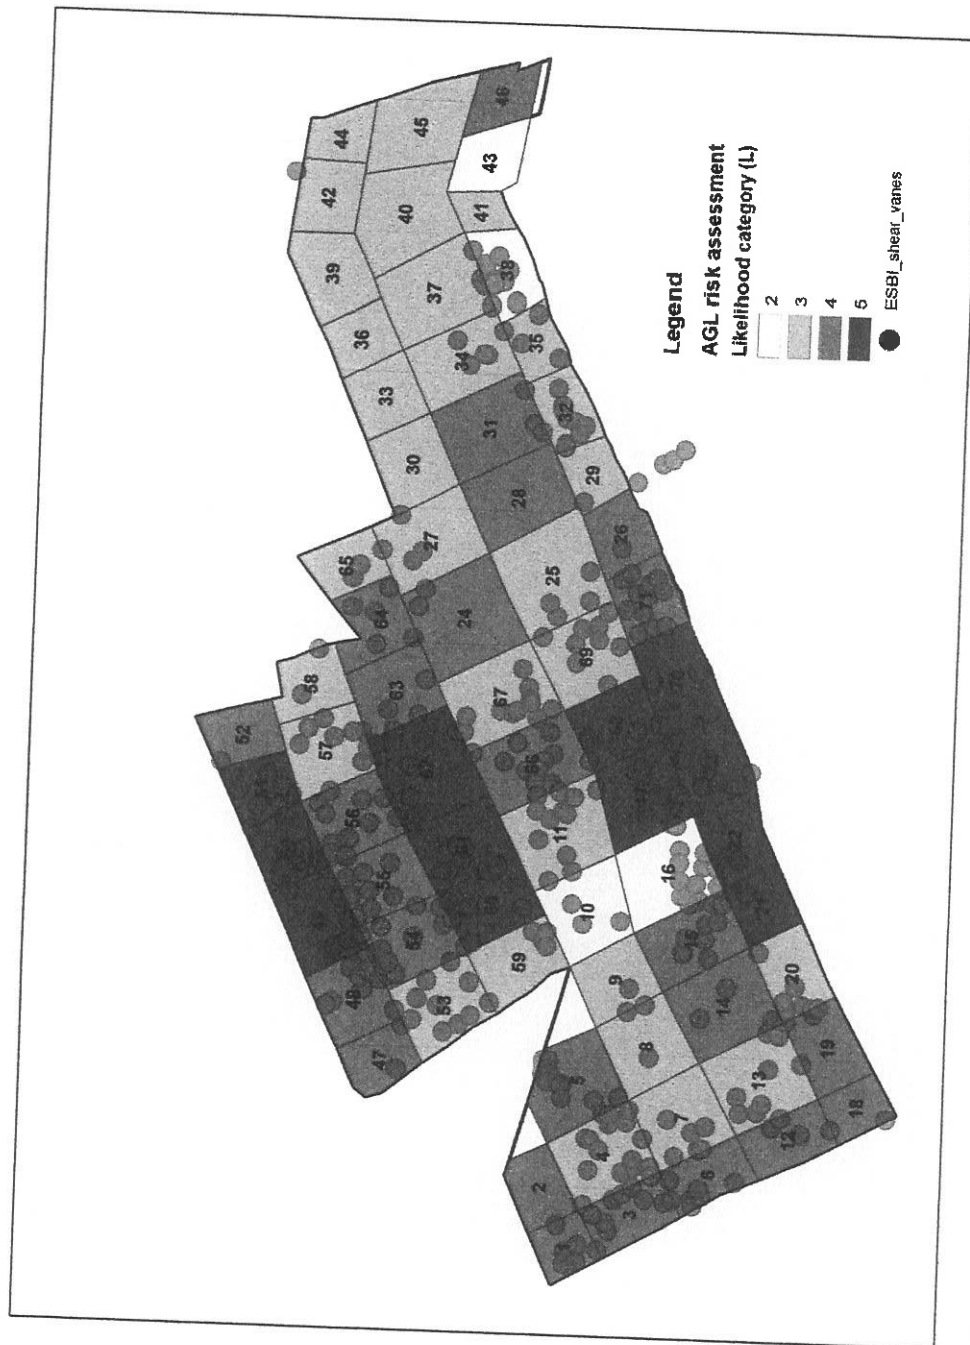
**Figure 9.** Peat Stability Assessment by AGL (2020) for baseline conditions in 1998 for each T-cell (highest risk rating is '5'), together with locations of shear vane sampling by ESBj in 2004/2005. Note the limited number of samples in high-risk cells 47 and 52, as well as the limited sampling in the SW corner of the site, and the absence of sampling for T-cell 46.

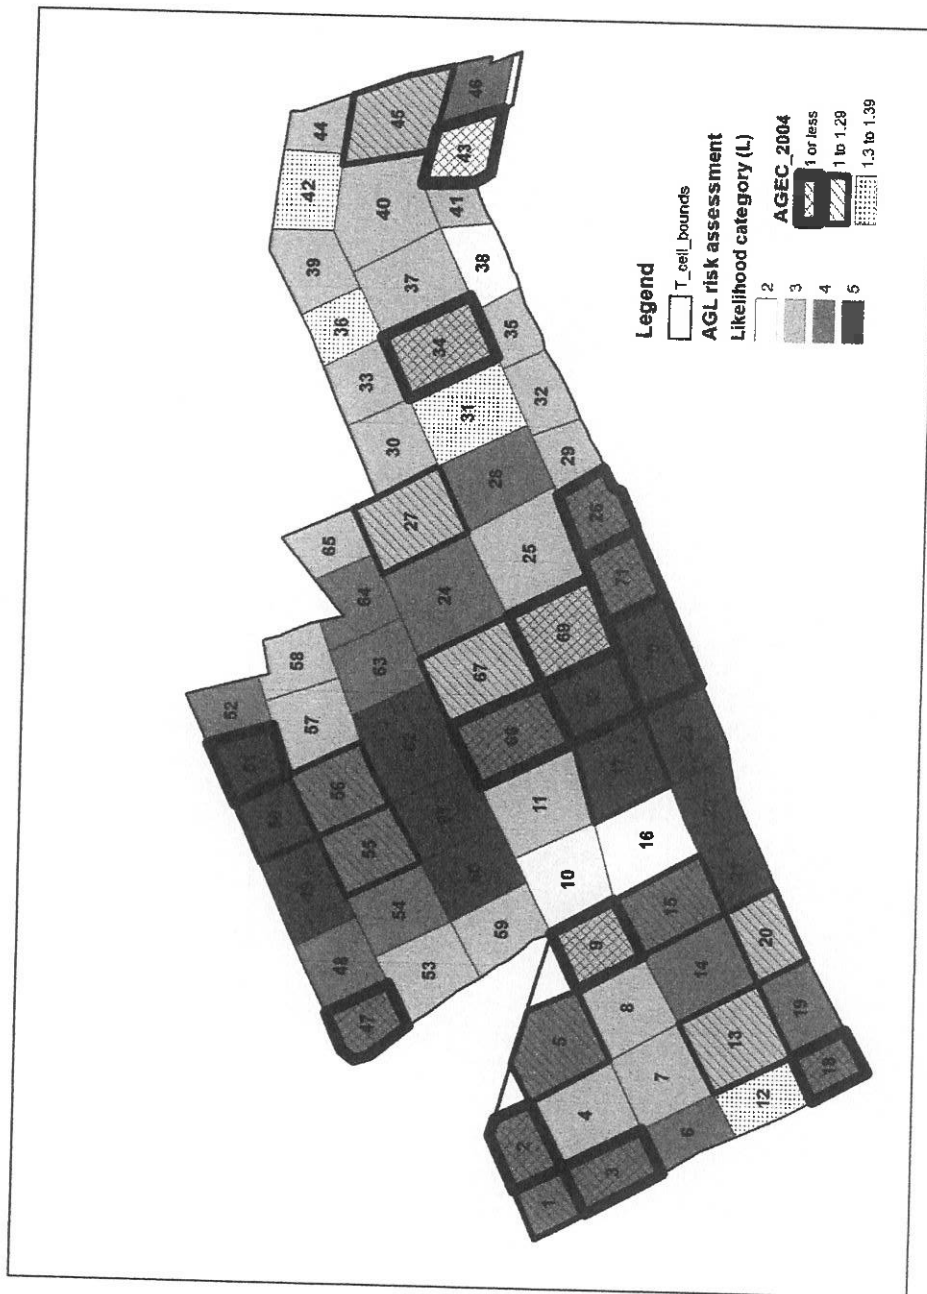
**Figure 10.** Peat Stability Assessment by AGL (2020) for baseline conditions in 1998 for each T-cell (highest risk rating is '5'), together with 'hypothetical' risk assessment by AGEC (2004). Note correspondence of the two assessments for western T-cells 2, 3 and 18, and northern T-cells 47, 50, 51, 55 and 56.

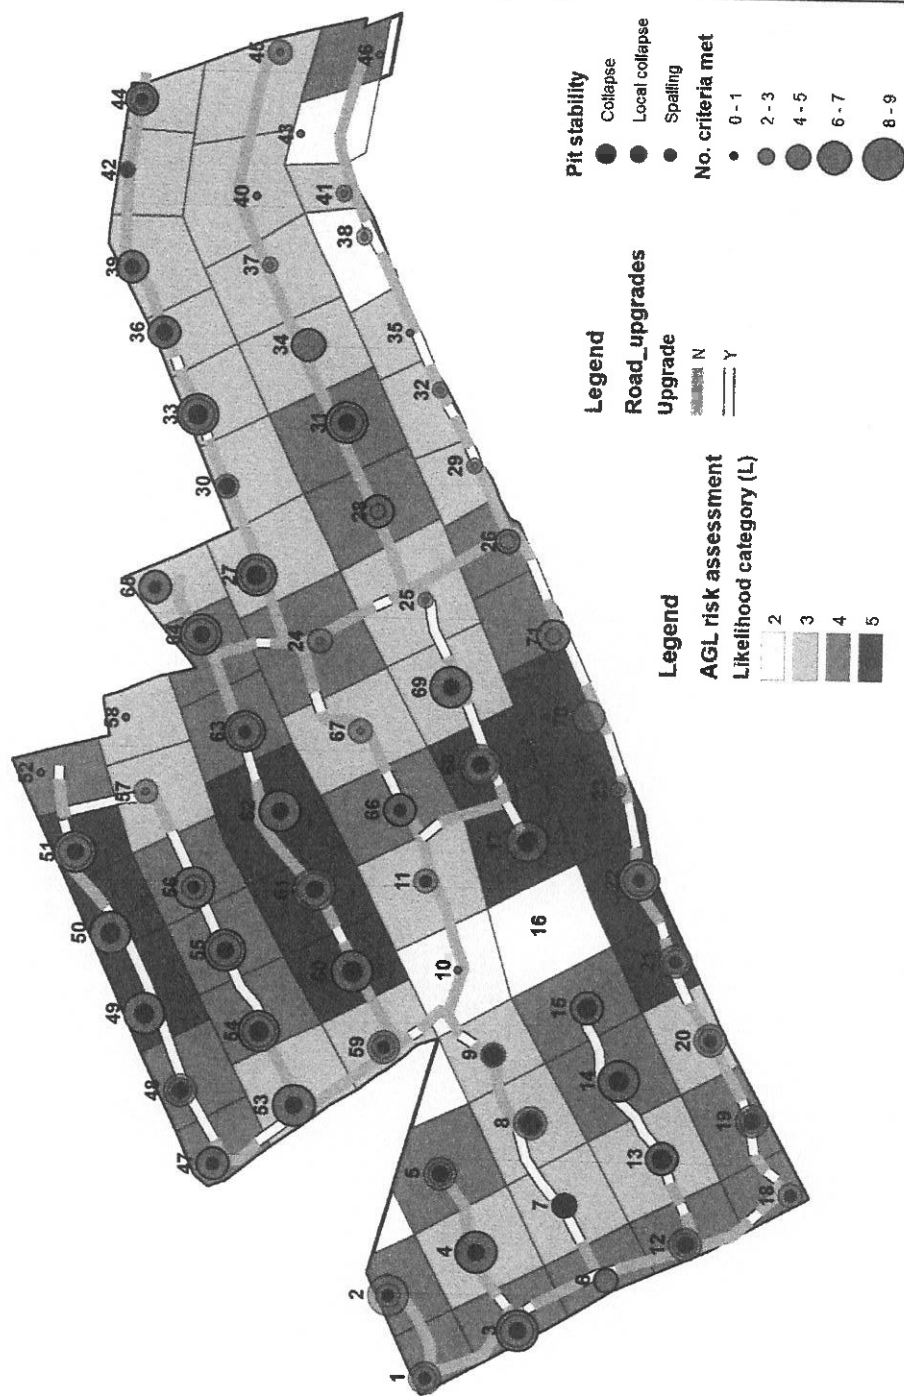
**Figure 12.** Map of road system indicating (in red) sections requiring remedial action in 2014. Correspondence between identified peat-slide risk. The need for remedial action (in addition to the zone of the 2003 peat-slide) is particularly marked in northern and western sections of the site. Road upgrade map from 'Drawing P378015-C-0003, Appendix A of Appendix B'.
