# Stage 2 Structural Assessment Report

Mayo County Council

Document title: MO-N58-001.00 Strade River Bridge Stage 2 Assessment

Client	Mayo County Council
Project	TASK ORDER NO.315 MAYO BRIDGE ASSESSMENTS & STRENGTHENING 2023
Job number	0088572
Client

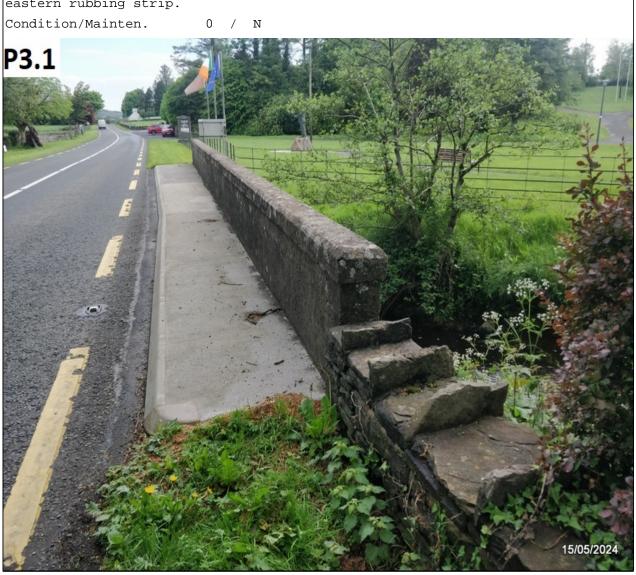
The rubbing strips are both in good condition, see P3.1 for a view of the eastern rubbing strip.

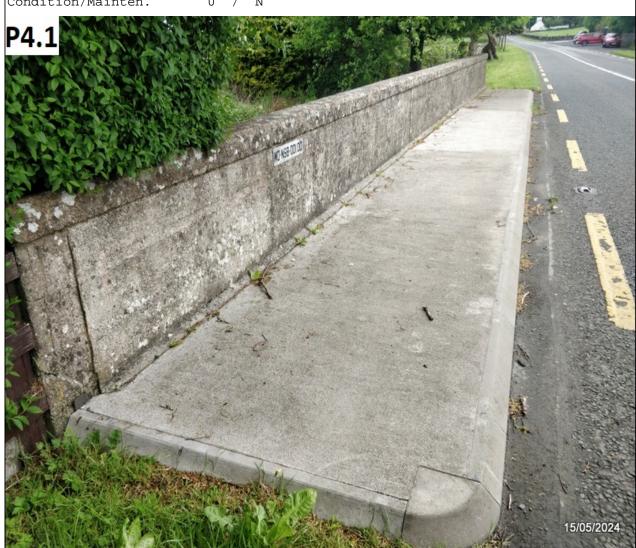
#### Parapets/Safety barrier Component No. The parapets are in good condition, see P4.1 for a view of the western parapet.

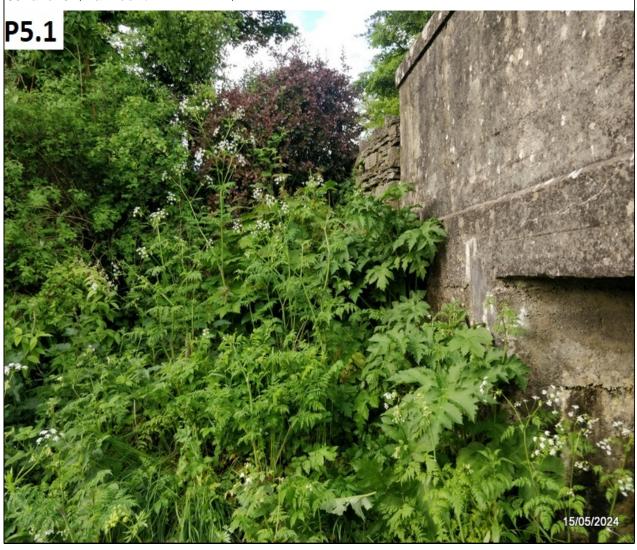
The embankments are in a good condition apart from vegetation growth that should be cut back from all the embankments during RM, see P5.1 for a view of the southeast embankment.

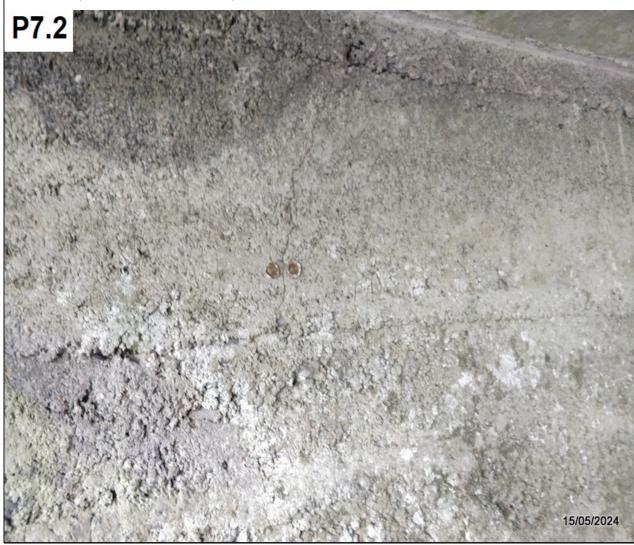
Both abutments are in a fair condition, see P7.1 for view of the southern abutment. The previously reported crack to the west side of the northern abutment remains 0.6mm wide, see P7.2. The previously installed crack pips have a measurement of 25.91mm (The previous base reading 23.1mm is confirmed to be incorrect with 25.91mm the new base reading). The crack should be injection repaired.

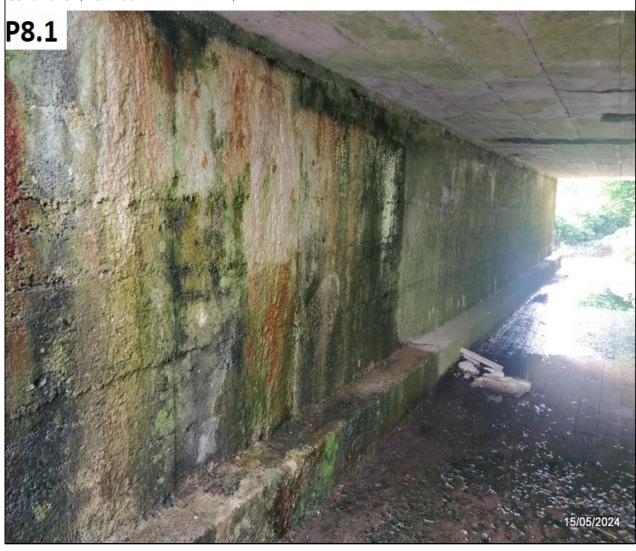
The pier is in a good overall condition, see P8.1 for view of the south face of the pier looking east. There is minor honeycombing to the east side upstream of the pier which requires no action, see P8.2. There is a crack sealed with calcite on the concrete protection to the north face of the pier, see P8.3.

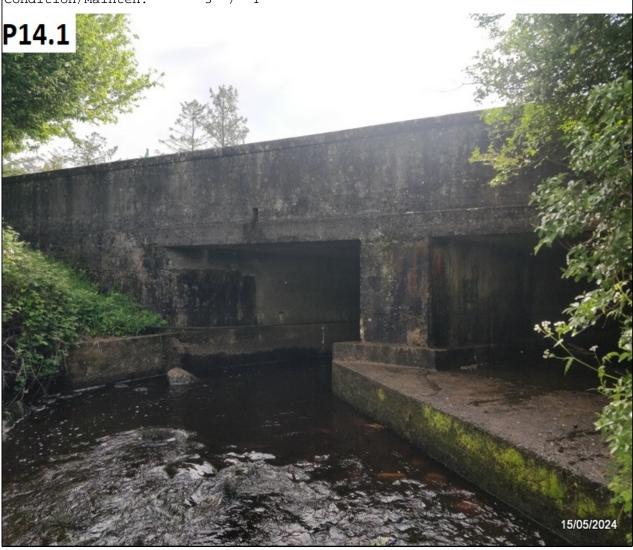
The structure is in a fair condition with cracking to the northern abutment and spalling and delamination to the southern and northern deck slabs with exposed beams evident. Routine Maintenance is also required. See P14.1 and P14.2 for views of the western and eastern elevations respectively. The inspection of the structure has been undertaken in accordance with the requirements of TII AM-STR-06039 (BD 79) outside of the normal PI schedule due to the 2012 Stage 1 Assessment Report finding the structure to have a reduced load capacity due to failure of the bond stress checks between the filler beams and surrounding concrete.

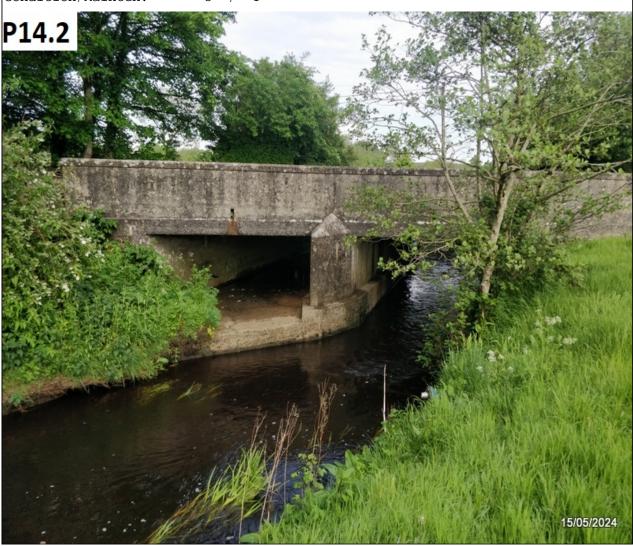
The structure is in a fair condition with cracking to the northern abutment and spalling and delamination to the southern and northern deck slabs with exposed beams evident. Routine Maintenance is also required. See P14.1 and P14.2 for views of the western and eastern elevations respectively. The inspection of the structure has been undertaken in accordance with the requirements of TII AM-STR-06039 (BD 79) outside of the normal PI schedule due to the 2012 Stage 1 Assessment Report finding the structure to have a reduced load capacity due to failure of the bond stress checks between the filler beams and surrounding concrete.

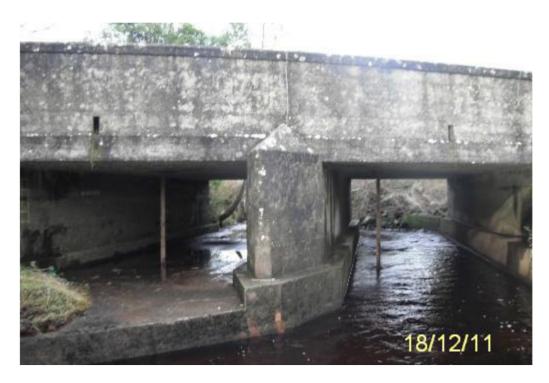
The visual inspection was carried out in dry weather from the river, inside the structure and from the carriageway over the bridge. Photos are given in Appendix B. Eastern and western elevations of the structure are shown in photos 1 & 2. The structure was on a straight alignment.

Photo 1. General view - Eastern elevation

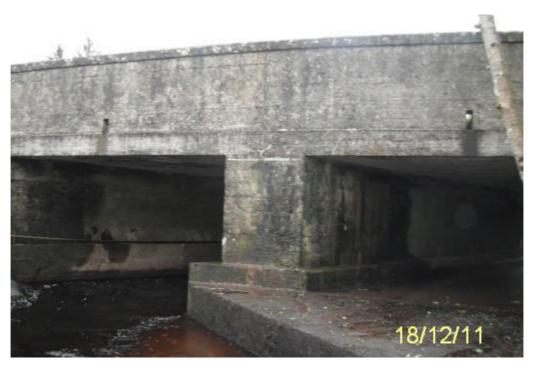
Photo 2. General view - Western elevation

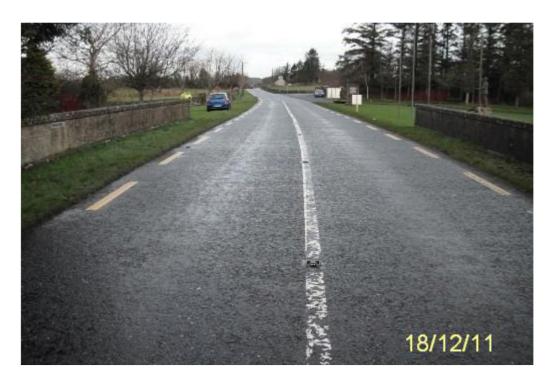
The surfacing of the 5.62m wide carriageway was noted to be in good condition, apart from minor wear. There were no obvious signs of rutting or ponding over the main carriageway. Road markings were showing signs of wear (Ref. photo 3, 4 & 5).

**Photo 3. Northern Departure (Increasing Chainage)**

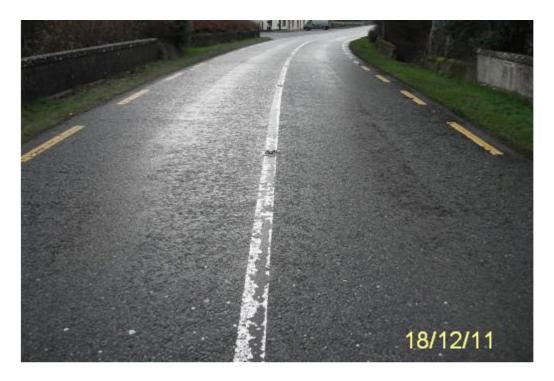
**Photo 4. Southern Departure (Decreasing Chainage)**

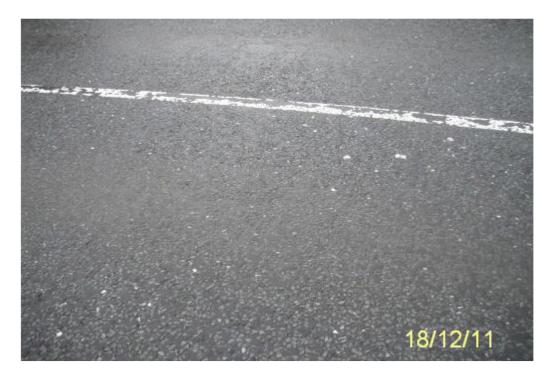
Photo 5. Road surface

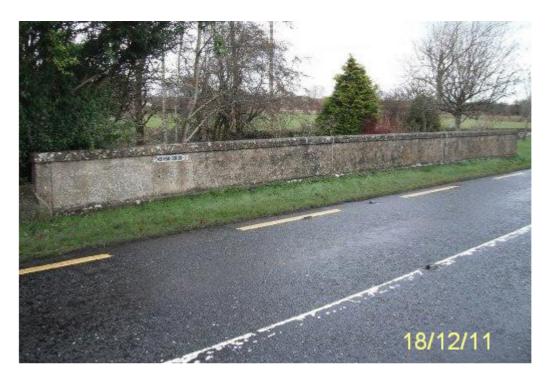
The western parapet was 980mm high and the eastern parapet was 930mm high. Both parapets were 230mm thick. Both parapets were in good condition. Cracks to both parapets as outlined in the previous Principal Inspection Report have been repaired and the ivy growth removed (Ref. photo 6 & 7).

Photo 6. Western parapet

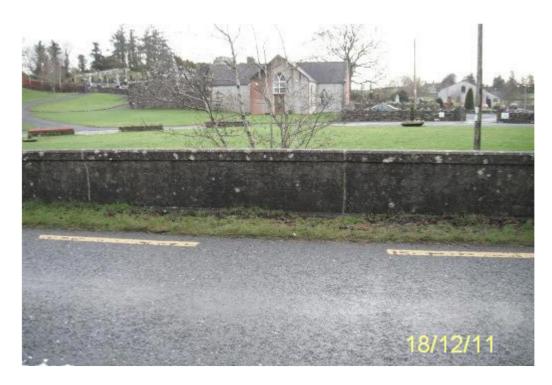
Photo 7. Eastern parapet

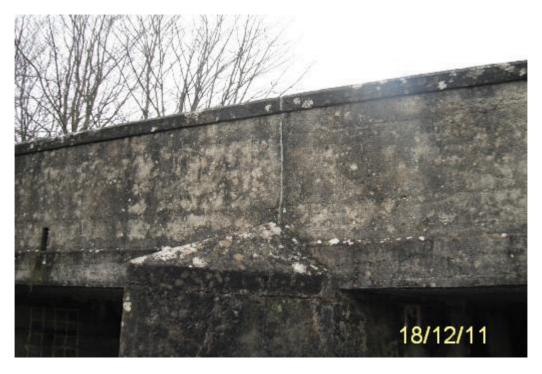
Both head walls were in good condition and there was no defects recorded (Ref. photo 8 & 9).

Photo 8. Eastern Headwall

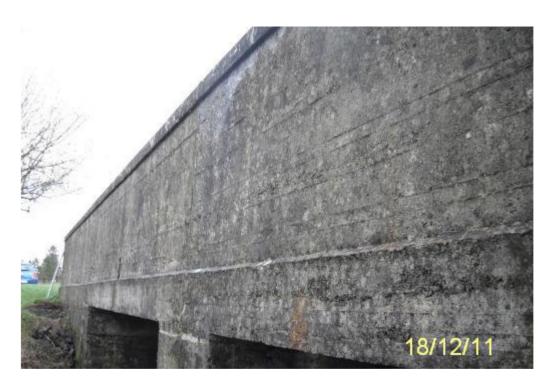
Photo 9. Western Headwall

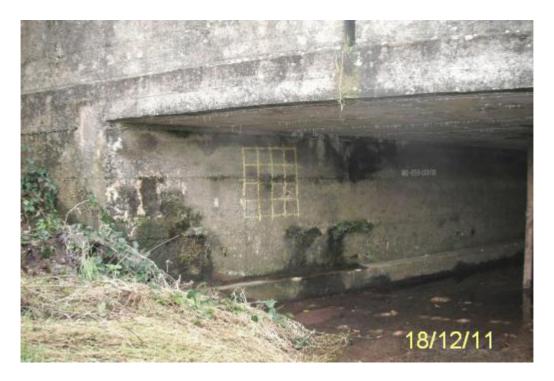
There were concrete abutments on both sides of the structure. The abutments were noted to be in good condition, apart from honeycombing noted to both components (Ref. photo 12 & 13). There was 210mm wide x 230mm high scour protection on the southern abutment and the south face of the pier. There was also 210mm wide x 770mm high scour protection on the abutment and north face of the pier. The pier was in good condition apart from honeycombing to the east cut water as outlined in the previous inspection. The ivy growth has been removed from the west face of the pier (Ref. photo 14).

Photo 12. Southern abutment

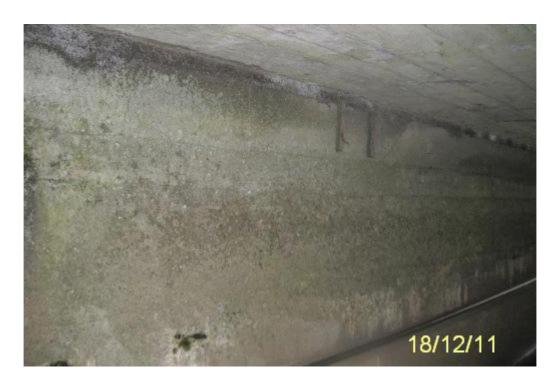
Photo 13. Northern abutment

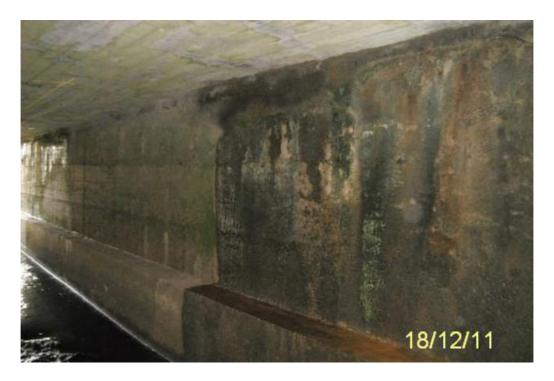
Photo 14. North face of pier

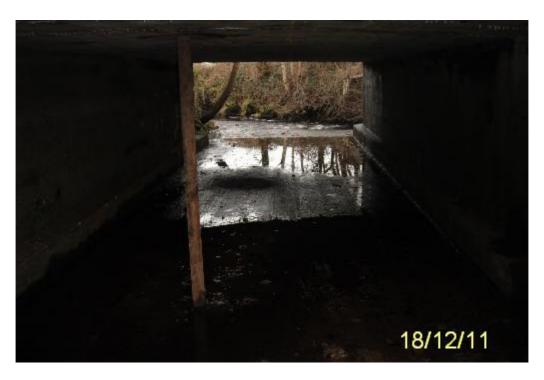
The riverbed was in good condition. The river bed in span 1 had a raised 540mm thick concrete apron and was dry at the time of inspection (Ref. photo 15 to 18).

Photo 15. View through span 1

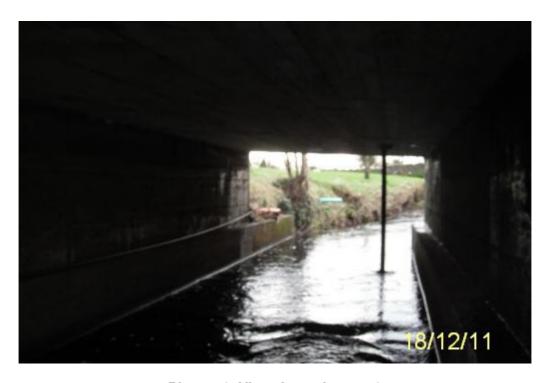
Photo 16. View through span 2

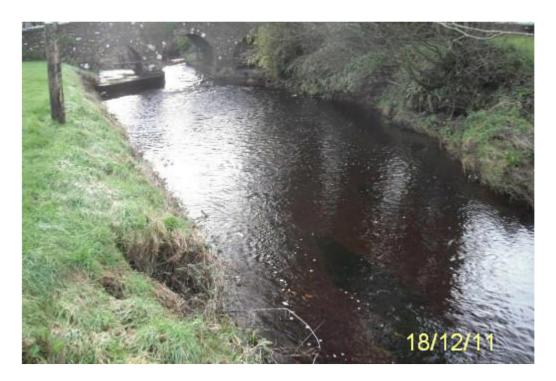
Photo 17. Upstream channel view

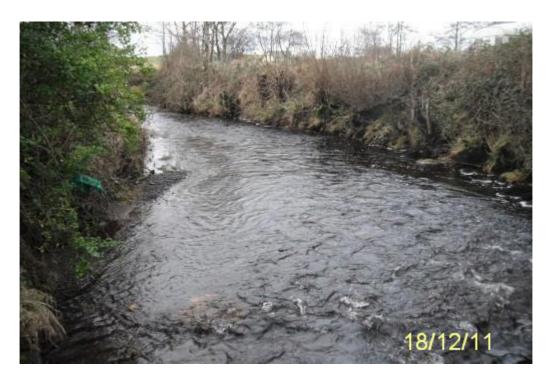
**Photo 18. Downstream Channel View**

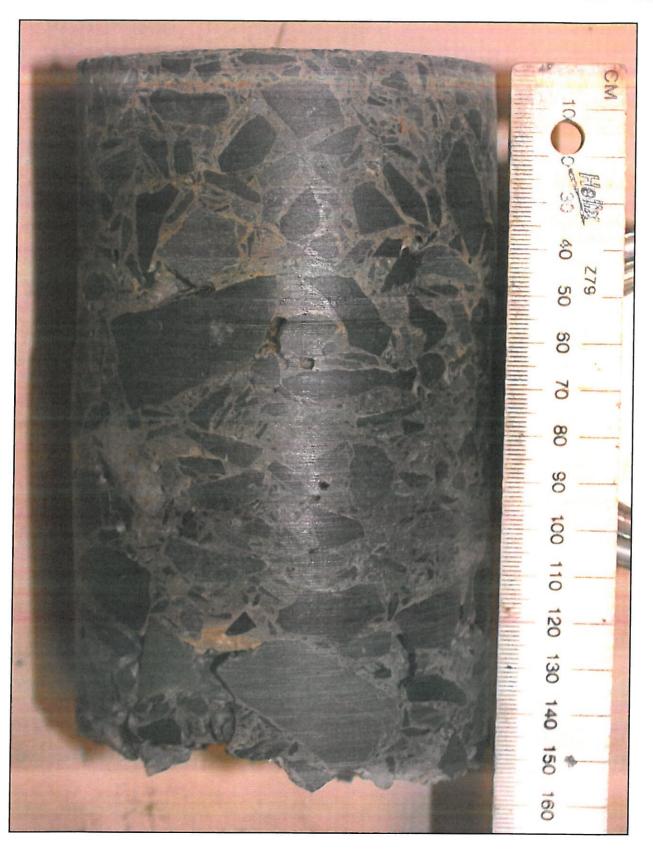
CORE MARK/No: C1 PHOTOGRAPH: Yes GRN: 23960

CLIENT:	W.S Atkins Ireland L	imited	FILE REF:	8623		
STRUCTURE:	Strade River Bridge		LOCATION:	Soffit S	pan 1	
DATE CORED:	01/12/2011	CORED BY: Stanger	DATE R	EC'D: <u>1</u>	12/12/20	11
CORE MARK/N	Vo: <u>C1</u>	PHOTOGRAPH: Yes	GRN:		23960	
0 20	40 60 80	100 120 140 160				
20						
40 —	Compressive					
60 —	Strength		Aggregate Distribu	ution	:	Even
80 —			Nominal Maximur	n Size	:	40mm
100—			Compaction Rema	rks:		
			Compaction Excess Voidage		:	Good 1.0%
120-			Honeycombing		ì	None
140			Cracks		:	None
160			No of pieces		:	1
100						
180			Type of Aggregate Shape of Aggregate		: :	Crushed Rock Angular
220—			Presence of Microc	cracking	:	N/A

-						
240			Max/Min Length (r Diameter (mm)	nm)	: :	150/160 92mm
260			Depth of Carbonati	on	:	<1mm
280—						
300			Render	:	:	None
320			Repairs	:	:	None
340			Reinforcing Bars	:		None
360			No: N/A D	iameter:		N/A
380			Orientation of core			
400			With respect to struc	cture :		Vertical Up
420						
440						
460			Checked by :	-	S.Lilley	<u> </u>
480			Date :		16/12/20	11

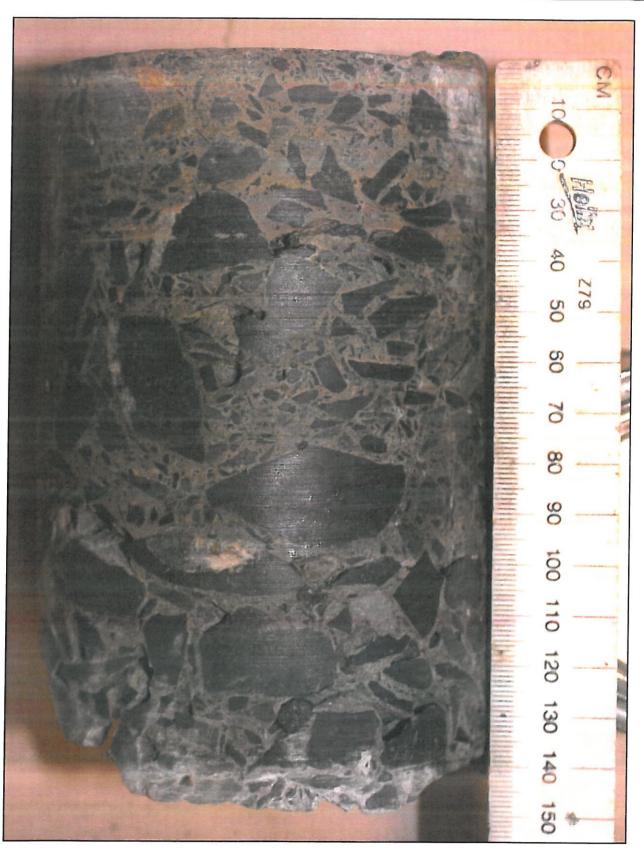
CORE MARK/No: C2 PHOTOGRAPH: Yes GRN: 23960

CLIENT: <u>W.S</u>	Atkins Ireland Limited		FILE REF:	8623		
STRUCTURE: Strade River Bridge			LOCATION: Soffit Span 1			
DATE CORED: 01/1	<u>2/2011</u> C	ORED BY: Stanger	DATE	REC'D: 1	2/12/20	11
CORE MARK/No: <u>C2</u>		PHOTOGRAPH: Yes	_ GRN:		23960	
0 20 40	60 80 100	120 140 160				
40 — Comp Stren	pressive ngth		Aggregate Distri	bution	:	Even
80 —			Nominal Maxim	um Size	:	20mm
120			Compaction Ren Compaction Excess Voidage Honeycombing Cracks	narks:	:	Fair 1.5% None None
160—			No of pieces		:	1
180			Type of Aggrega Shape of Aggreg		:	Crushed Rock Angular
200—			Presence of Micr	ocracking	:	N/A
240—			Max/Min Length Diameter (mm)		© :	140/120 92mm
280—			Depth of Carbona	ation	:	<1mm
300						
320—			Render		:	None
340			Repairs		:	None
360			Reinforcing Bars	1	: !	None
380			No: N/A	Diameter	:	N/A
400			Orientation of cor With respect to st		1	Vertical Up
420						
440						
460			Checked by	: _	S.Lilley	8

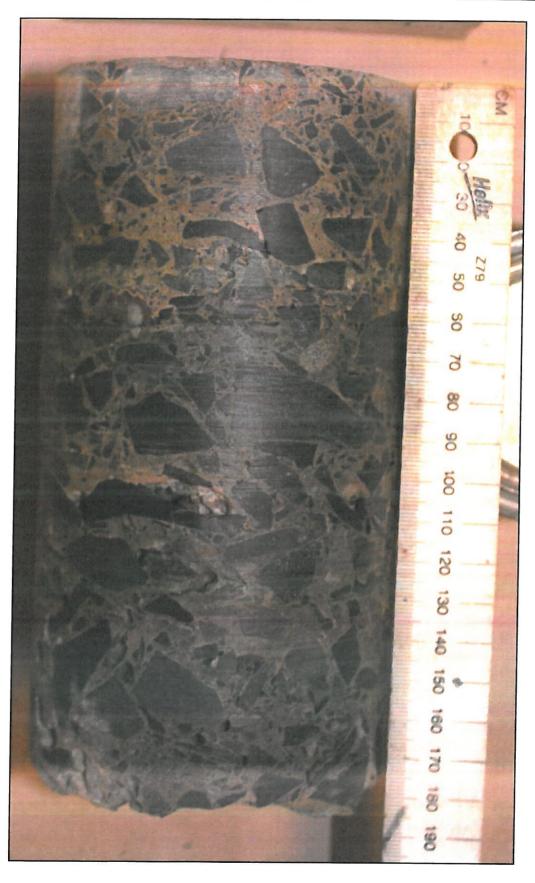
CORE MARK/No: C3 PHOTOGRAPH: Yes GRN: 23960

CLIENT:	W.S Atkins Ireland Lim	nited	FILE REF: 862	3	
STRUCTURE:	STRUCTURE: Strade River Bridge		LOCATION: Soffit Span 1		
DATE CORED:	01/12/2011	CORED BY: Stanger	DATE REC'I	D: 12/12/2	011
CORE MARK/N	o: <u>C3</u>	PHOTOGRAPH: Yes	GRN:	23960	100
0 20	40 60 80 1	00 120 140 160			
20					
40 —	Compressive				
60 —	Strength		Aggregate Distribution	:	Even
80 —			Nominal Maximum Siz	e :	20mm
			Compaction Remarks:		
100			Compaction	:	Fair
120			Excess Voidage Honeycombing	:	1.5% None
			Cracks	:	None
140			No of pieces	:	1
160—					
180-			Type of Aggregate	:	Crushed Rock
200—			Shape of Aggregate	:	Angular
220—			Presence of Microcrack	ing:	N/A
240—			Man /Mi - T 1 / N		100/170
			Max/Min Length (mm) Diameter (mm)	:	180/170 92mm
260—			Depth of Carbonation	:	<1mm
280—			- I	•	
300—					
320			Render	1	None
340			Repairs	:	None
360			Reinforcing Bars	:	None
380			No: N/A Diame	ter:	N/A
			Orientation of core		
400			With respect to structure	:	Vertical Up

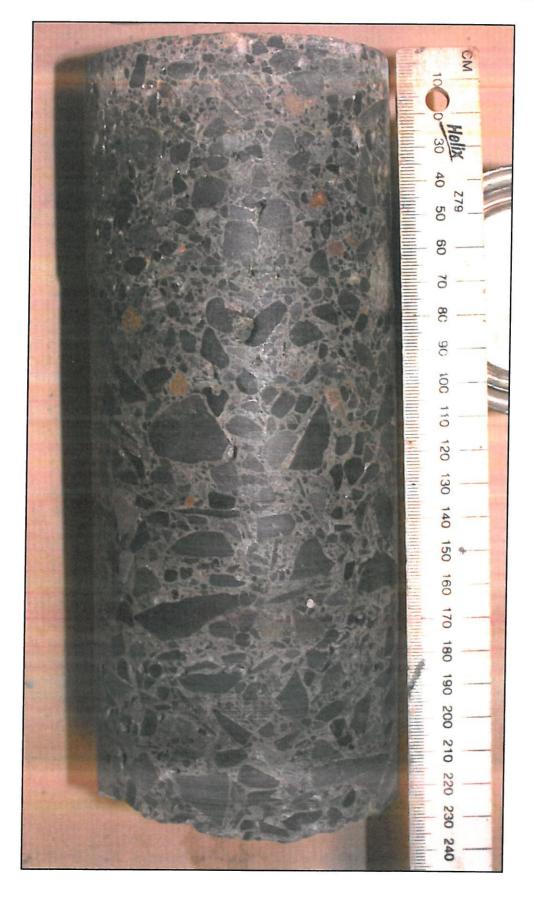
CORE MARK/No: C4 PHOTOGRAPH: Yes GRN: 23960

Excess Voidage						:	
Honeycombing   None	100						
Cracks	120—					:	
140	-					:	
Type of Aggregate	140—				No of nieces	•	
Shape of Aggregate : Angular  Presence of Microcracking: N/A  Max/Min Length (mm) : 225/225 Diameter (mm) : 92mm  Depth of Carbonation : <1mm  Render : None  Repairs : None  Reinforcing Bars : None  No: N/A Diameter: N/A  Orientation of core With respect to structure : Vertical Up  400  Checked by : S.Lilley  440  Checked by : S.Lilley  Date : 16/12/2011	160—				The of pieces	•	
200 220 240  Max/Min Length (mm) : 225/225 260  280  Depth of Carbonation : <imm 12="" 16="" 2011<="" 320="" 340="" 440="" 480="" :="" a="" bars="" by="" checked="" core="" date="" diameter:="" n="" no:="" none="" of="" orientation="" reinforcing="" render="" repairs="" respect="" s.lilley="" structure="" td="" to="" up="" vertical="" with=""><td>180</td><td></td><td></td><td></td><td></td><td>:</td><td>Crushed Rock</td></imm>	180					:	Crushed Rock

220 240  Max/Min Length (mm) : 225/225 Diameter (mm) : 92mm  Depth of Carbonation : <imm 12="" 16="" 2011<="" 400="" 480="" :="" a="" bars="" by="" checked="" core="" date="" diameter:="" n="" no:="" none="" of="" orientation="" reinforcing="" render="" repairs="" respect="" s.lilley="" structure="" td="" to="" up="" vertical="" with=""><td>200—</td><td></td><td></td><td></td><td>Shape of Aggregate</td><td>:</td><td>Angular</td></imm>	200—				Shape of Aggregate	:	Angular
Diameter (mm)	220—				Presence of Microcrac	king:	N/A
Diameter (mm)	240				Max/Min I ength (mm)	٠.	225/225
Depth of Carbonation							
Render	-				Depth of Carbonation	:	<1 mm
Render							
Repairs					Render	•	None
Reinforcing Bars : None    No: N/A   Diameter: N/A					Repairs	:	None
No: N/A Diameter: N/A  Orientation of core With respect to structure : Vertical Up  440  Checked by : S.Lilley  Date : 16/12/2011					Reinforcing Bars	:	None

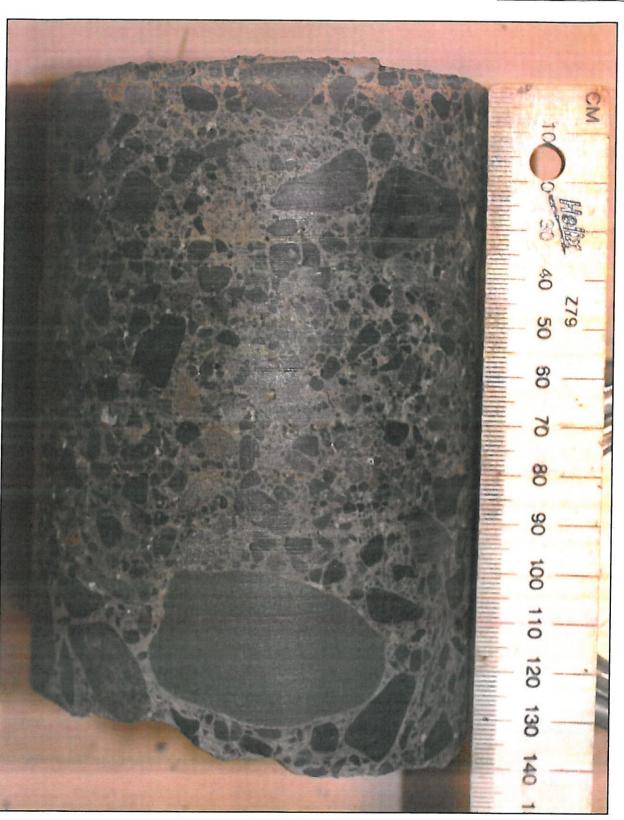
CLIENT: W.S Atkins Ireland Limited FILE REF: 8623 STRUCTURE: Strade River Bridge LOCATION: Soffit Span 2 DATE CORED: 01/12/2011 CORED BY: Stanger DATE REC'D: 12/12/2011 CORE MARK/No: C5 PHOTOGRAPH: Yes GRN: 23960 0 20 40 60 80 100 120 140 160 20 40 Compressive Strength Aggregate Distribution Even 60 Nominal Maximum Size : 40mm 80 Compaction Remarks: 100-Compaction Good Excess Voidage 1.0% 120-Honeycombing None Cracks None 140-No of pieces 1 160-180-Type of Aggregate Crushed Rock Shape of Aggregate Angular 200-Presence of Microcracking: N/A 220-240-Max/Min Length (mm) 125/135 Diameter (mm) 92mm 260-Depth of Carbonation <1mm 280-300-Render None : 320-Repairs None 340-Reinforcing Bars None 360-No: N/A Diameter: N/A 380-Orientation of core 400-With respect to structure: Vertical Up 420-440\_ 460\_ Checked by S.Lilley 480\_ Date 16/12/2011

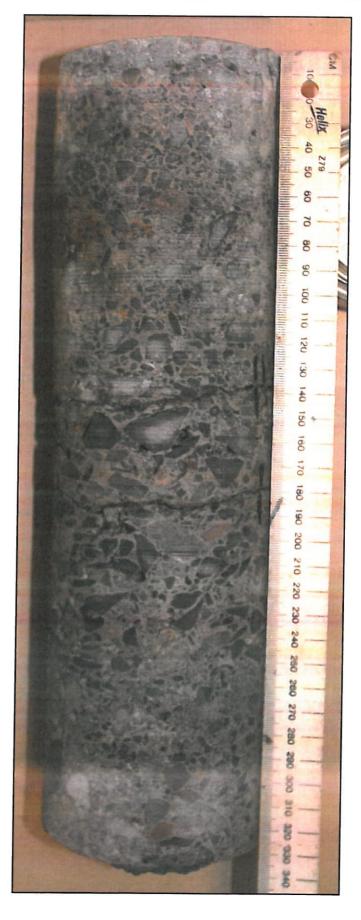
CORE MARK/No: <u>C6</u> PHOTOGRAPH: <u>Yes</u> GRN: <u>23960</u>

CLIENT: W.S Atkins Ireland Limited FILE REF: 8623 STRUCTURE: Strade River Bridge LOCATION: Soffit Span 2 DATE CORED: 01/12/2011 CORED BY: Stanger DATE REC'D: 12/12/2011 CORE MARK/No: C6 PHOTOGRAPH: Yes GRN: 23960 0 20 40 60 80 100 120 140 160 20 40 Compressive Strength Aggregate Distribution Even 60 Nominal Maximum Size : 20mm 80 Compaction Remarks: 100-Compaction Good Excess Voidage 1.5% . 120-Honeycombing None Cracks None 140 No of pieces 3 160 180-Type of Aggregate Crushed Rock Shape of Aggregate Angular 200-Presence of Microcracking: N/A 220-240-Max/Min Length (mm) 340/340 Compressive Diameter (mm) 92mm 260-Strength Depth of Carbonation <1mm 280-300-Render None 320-Repairs None 340 Reinforcing Bars None 360-No: N/A Diameter: N/A 380-Orientation of core 400-With respect to structure: Vertical Up 420 440 460\_ Checked by S.Lilley 480\_ Date 16/12/2011

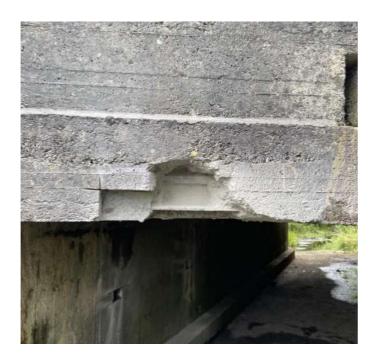
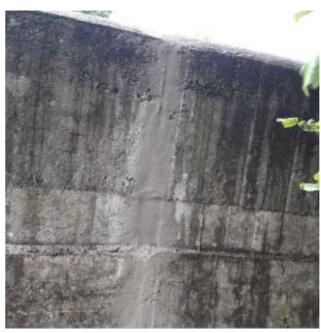
Fosroc Renderoc HB45 was used to carry out concrete repairs to breakouts.

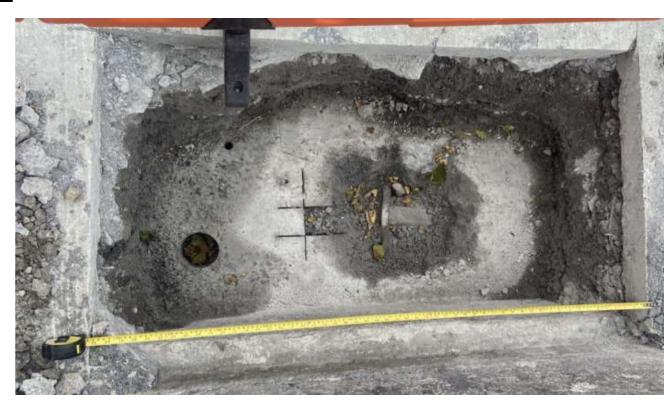
Figure 12: Test area 1 containing pilot hole, core sample hole and breakout.

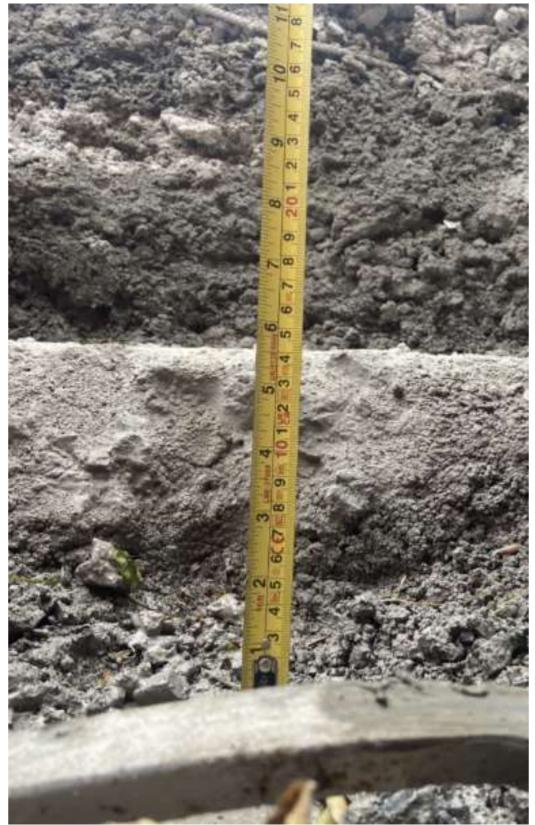
Figure 14: Deck cover on longitudinal steel

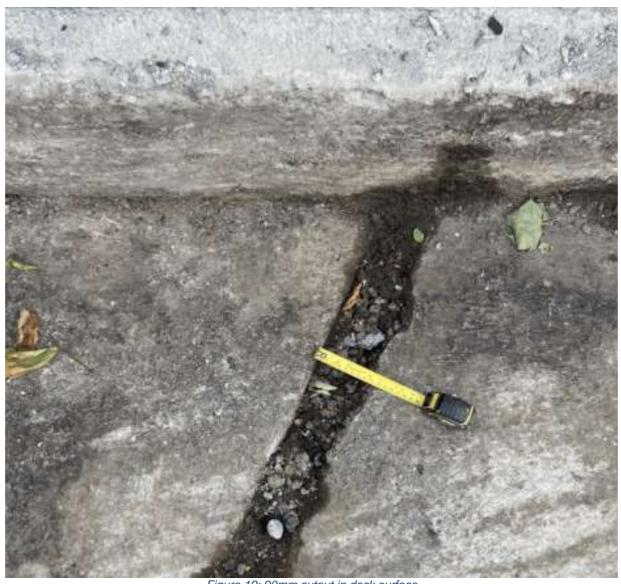
Figure 19: 90mm cutout in deck surface

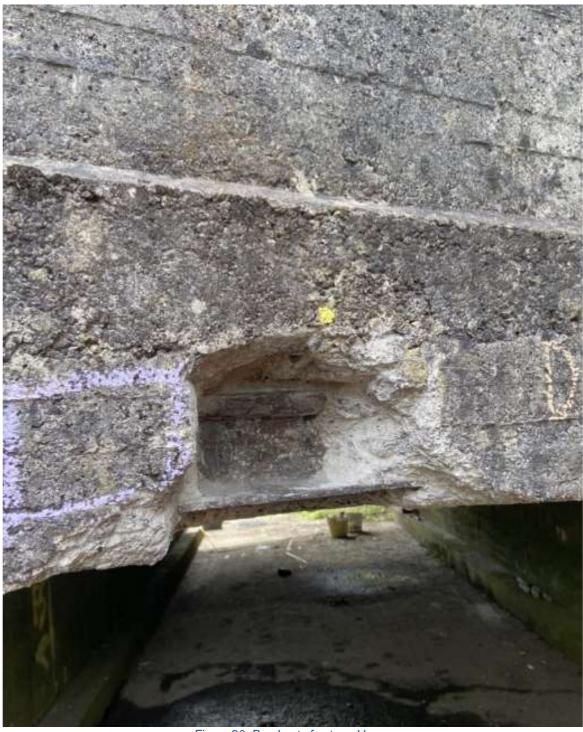
Figure 20: Breakout of external beam

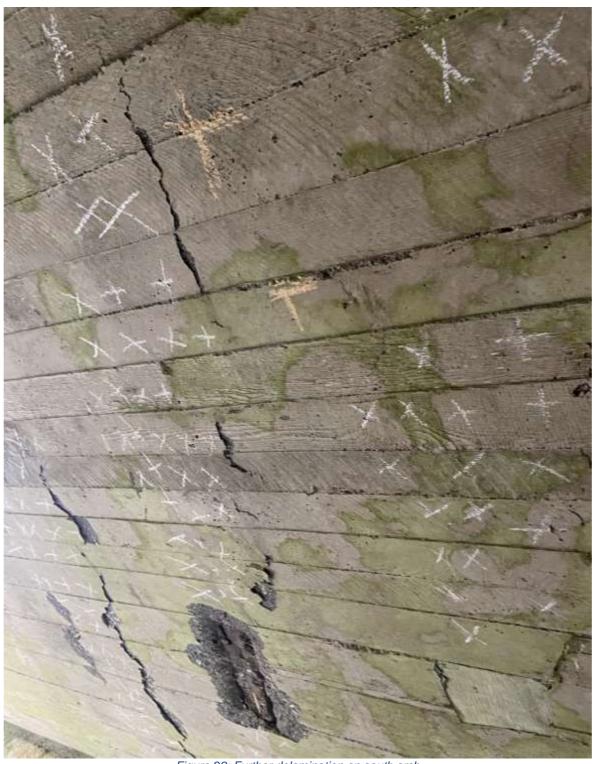
Figure 29: Further delamination on south arch

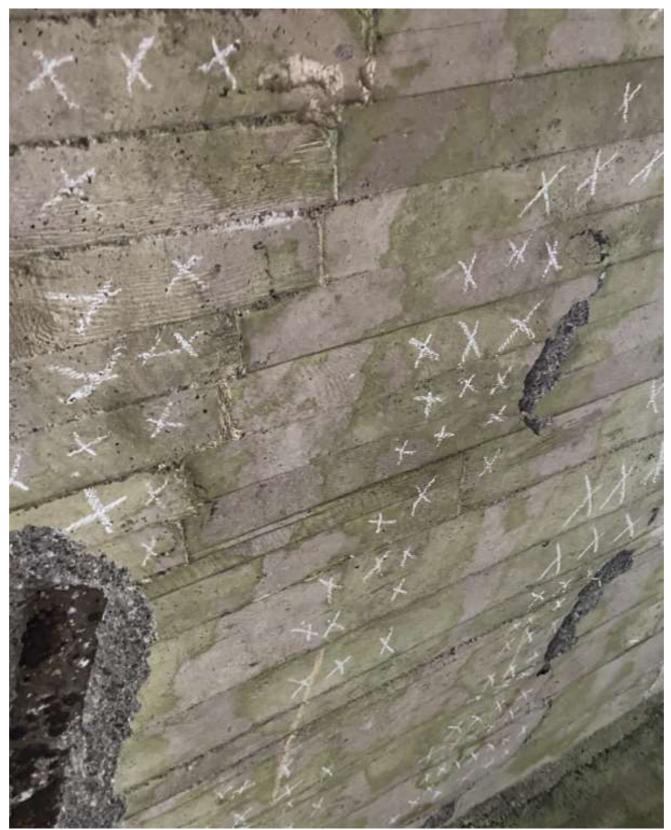
Figure 30: Exposed beams due to delamination of concrete cover

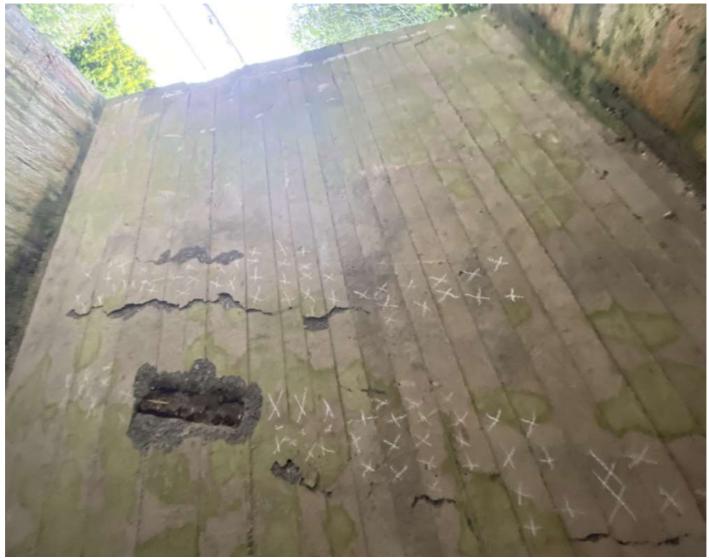
Figure 31: Delamination denoted by white x chalk marks

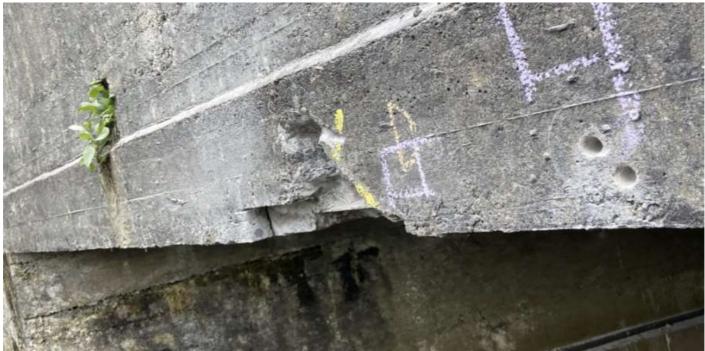
Figure 34: Breakout at test area 4 exposing external beam

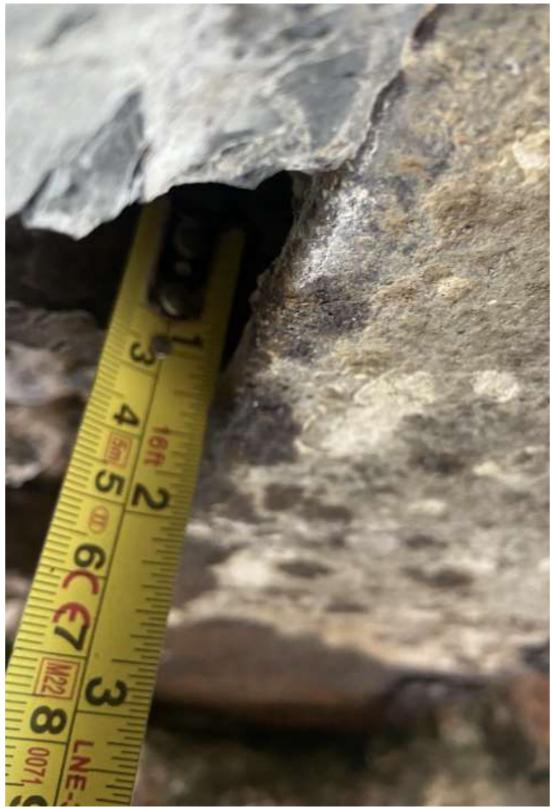
Figure 41: Cover of Transverse steel

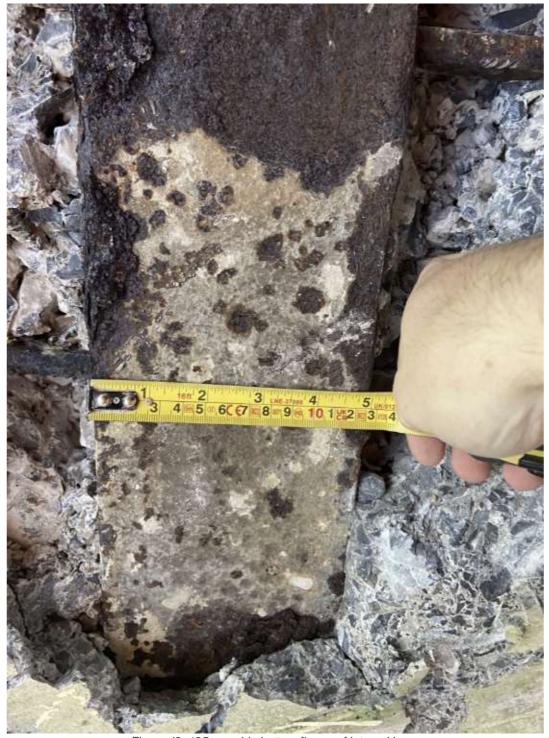
Figure 42: 125mm wide bottom flange of internal beam

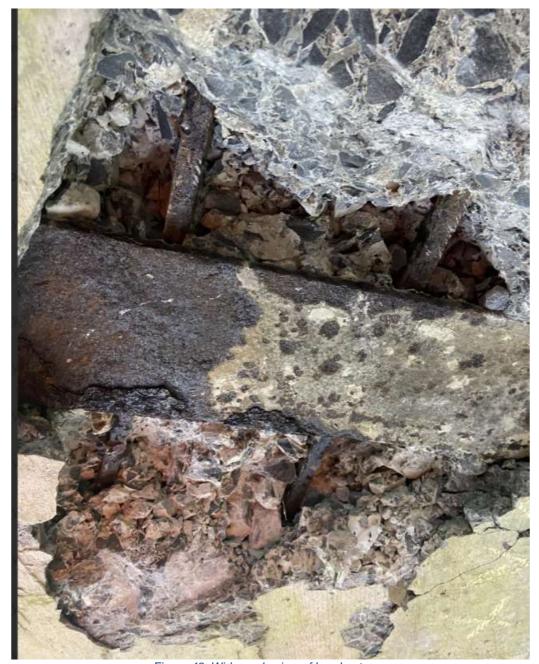
Figure 43: Wide angle view of breakout area

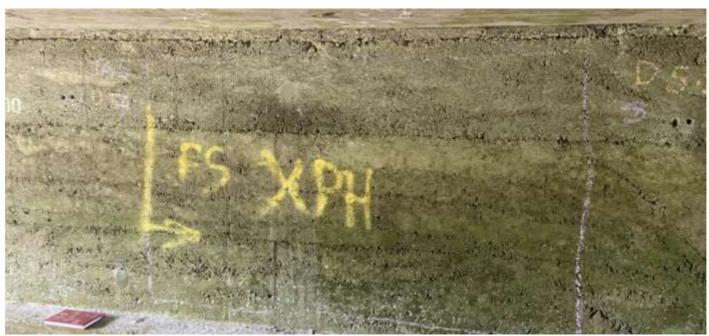
Figure 44: Pilot hole reinstatement along with dust sample holes

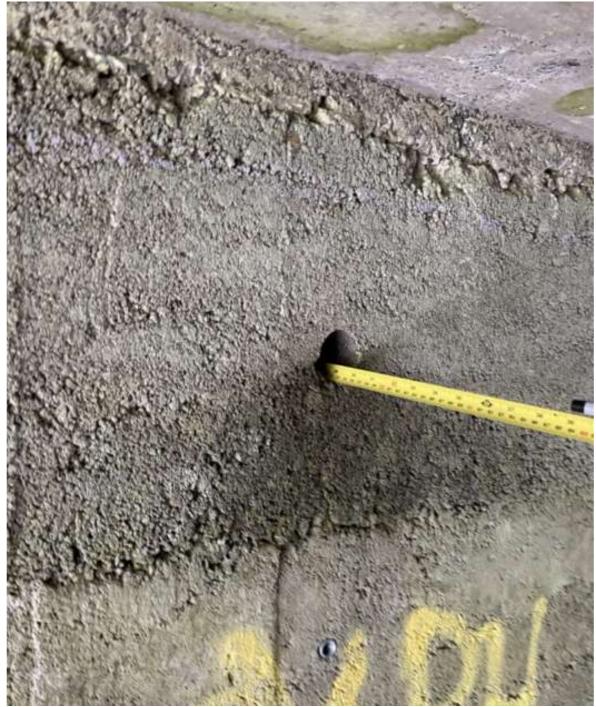
Figure 45: Pilot hole depth measurement

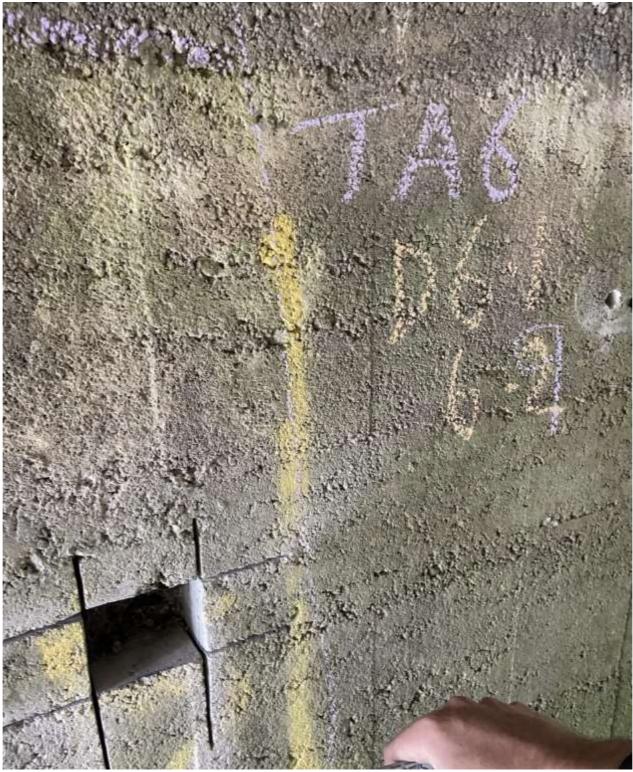
Figure 47: Outline of scanned area with carbonation sample removed

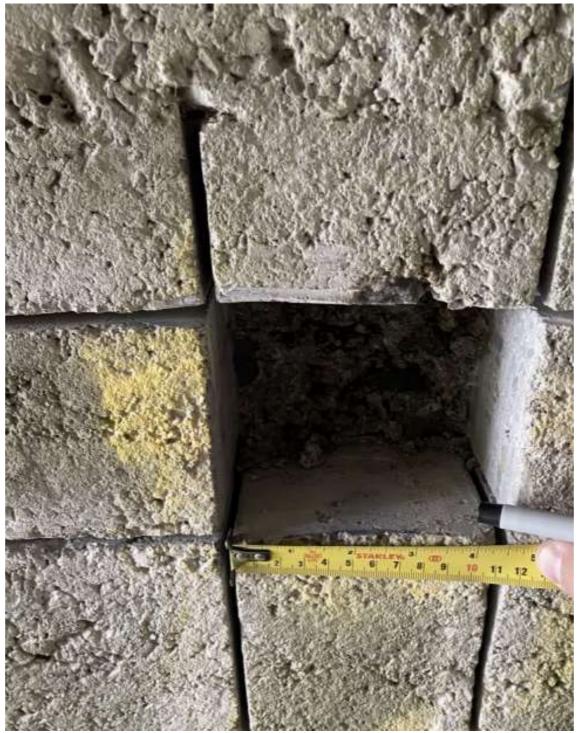
Figure 48: Carbonation sample consisted of 100mm x 100mm x 80mm cuboid

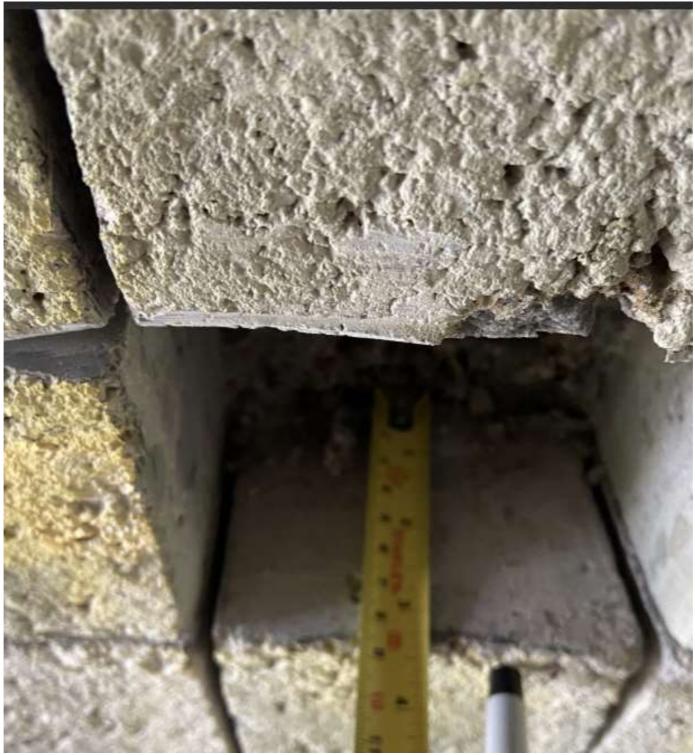
Figure 49: TA6 carbonation sample depth into pier

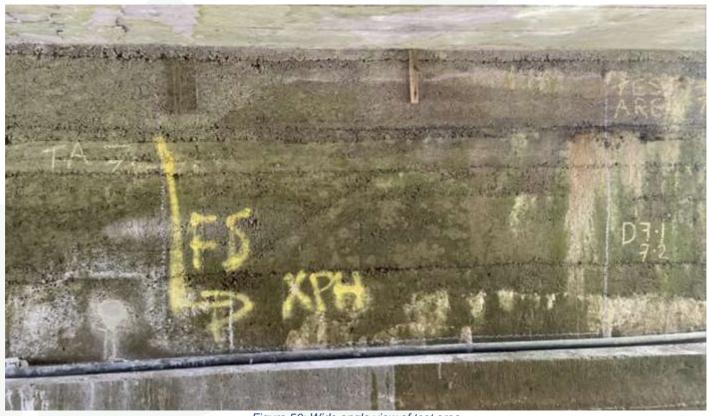
Figure 50: Wide angle view of test area

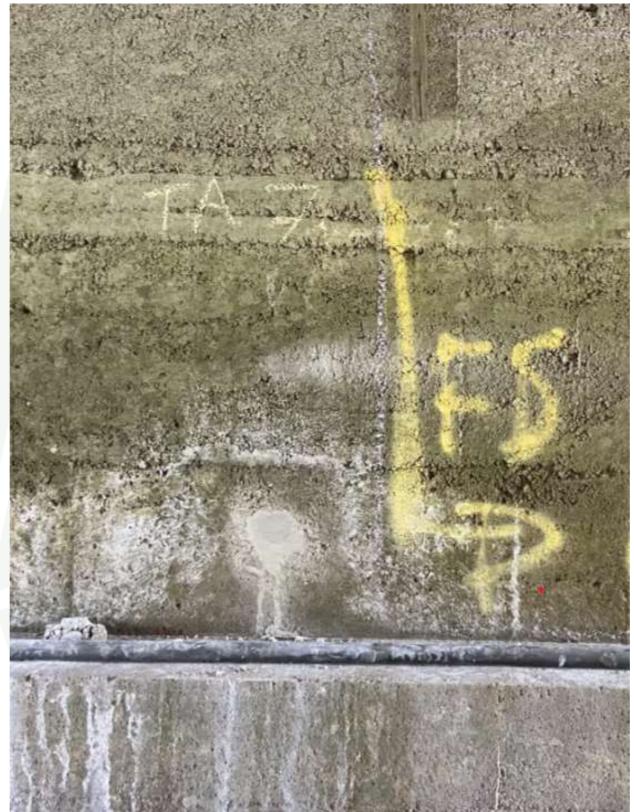
Figure 51: Pilot hole reinstatement

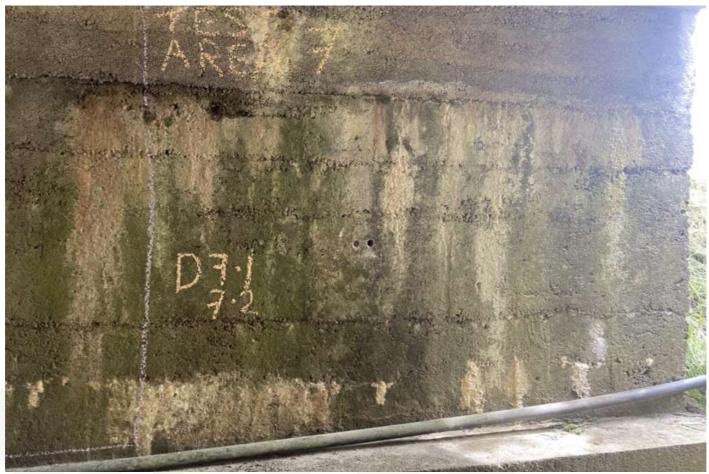
Figure 52:Drill holes used for dust collection located on the northesatern end of the abutment

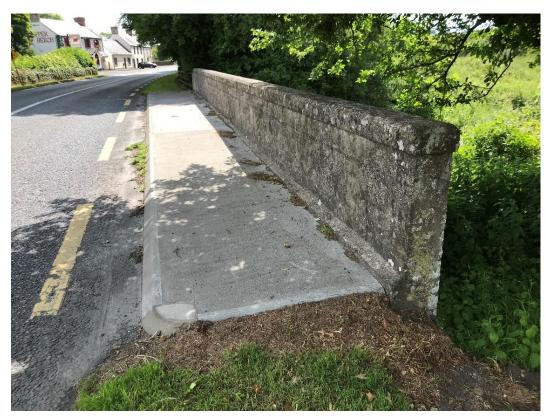
Figure H-4 - View of the western footway

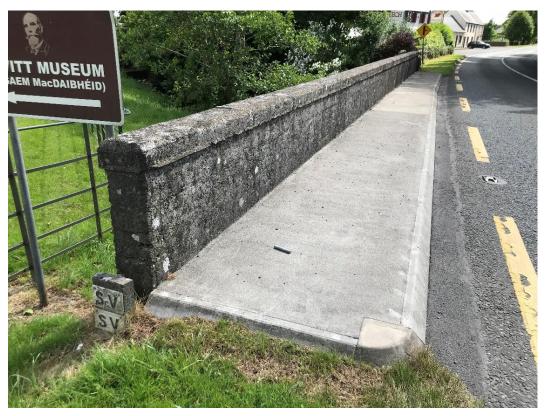
Figure H-5 - View of the eastern parapet

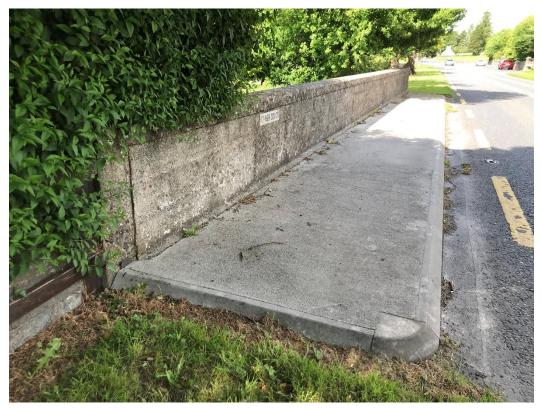
Figure H-6 - View of the western parapet

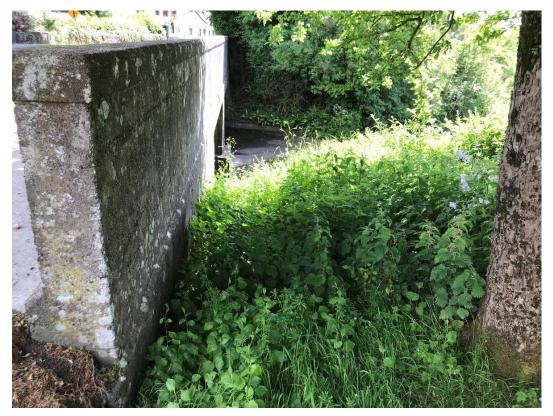
Figure H-7 - View of the northwest embankment

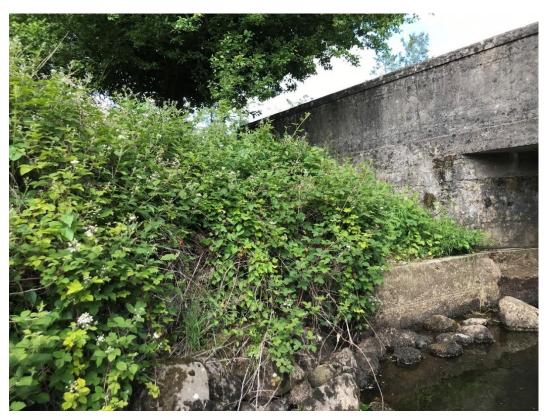
Figure H-8 - View of the southeast embankment

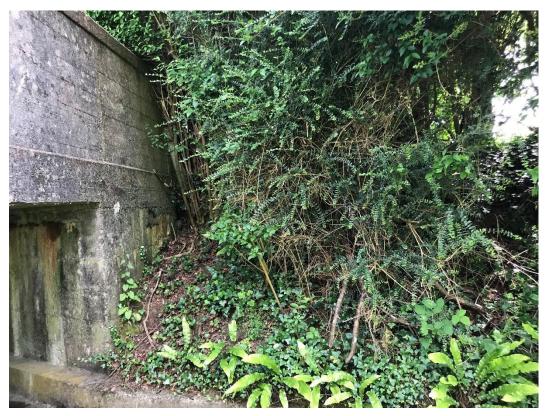
Figure H-9 - View of the southwest wing wall

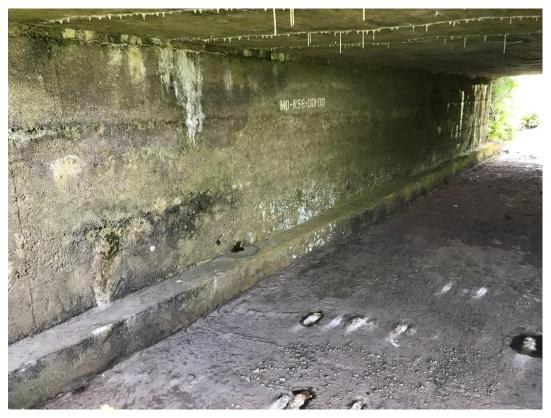
Figure H-10 - View of the south abutment

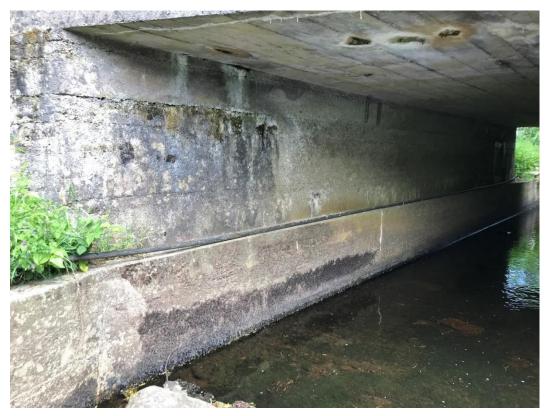
Figure H-11 - View of the north abutment

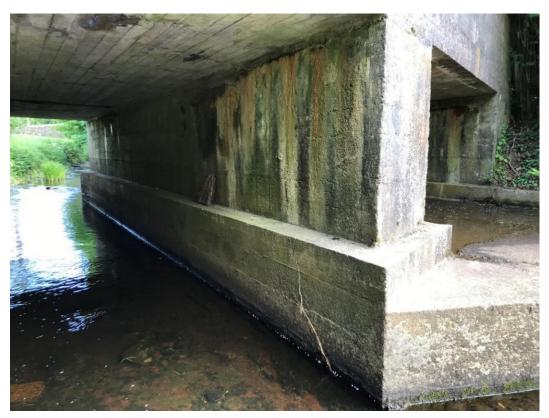
Figure H-12 - View of the northeast pier face

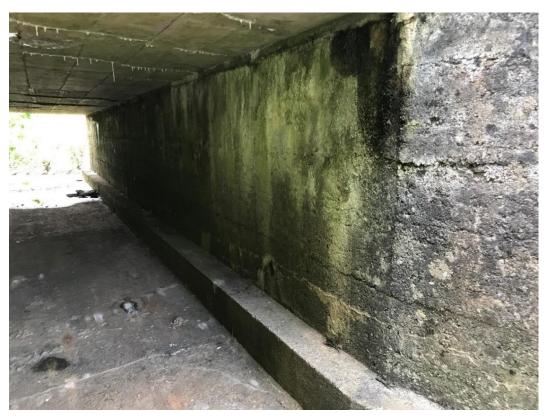
Figure H-13 – View of the south pier face

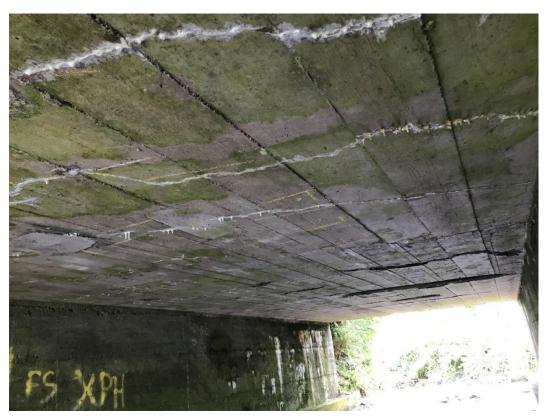
Figure H-16 – View of the south span deck slab

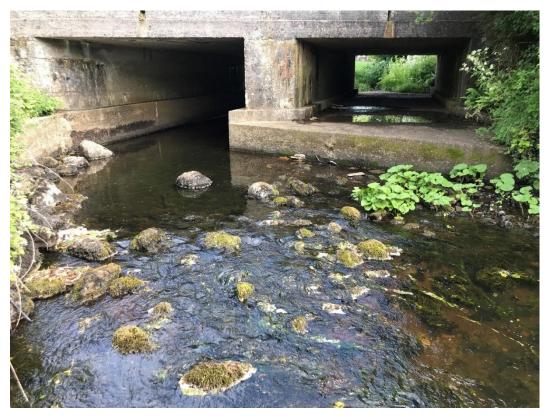
Figure H-21 – View of riverbed west of structure looking east
