# Stage 2 Structural Assessment Report

Mayo County Council

Document title: MO-N58-001.00 Strade River Bridge Stage 2 Assessment

Client	Mayo County Council
Project	TASK ORDER NO.315 MAYO BRIDGE ASSESSMENTS & STRENGTHENING 2023
Job number	0088572
Client

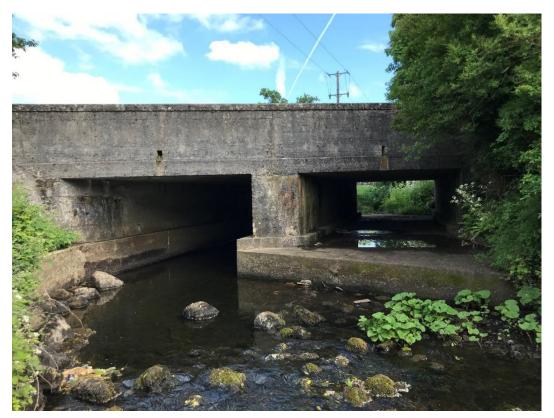
Figure H-22 - View of the west elevation

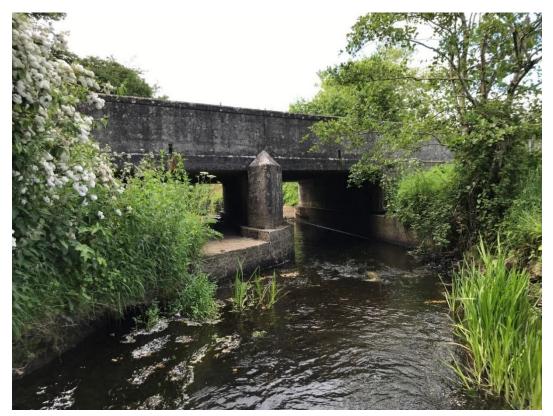
Figure H-23 - View of the east elevation
