Structure Options Report

Mayo County Council

N58 STRADE RIVER BRIDGE REHABILITATION WORKS

Name and nature of the Structure(s) Strade River Bridge

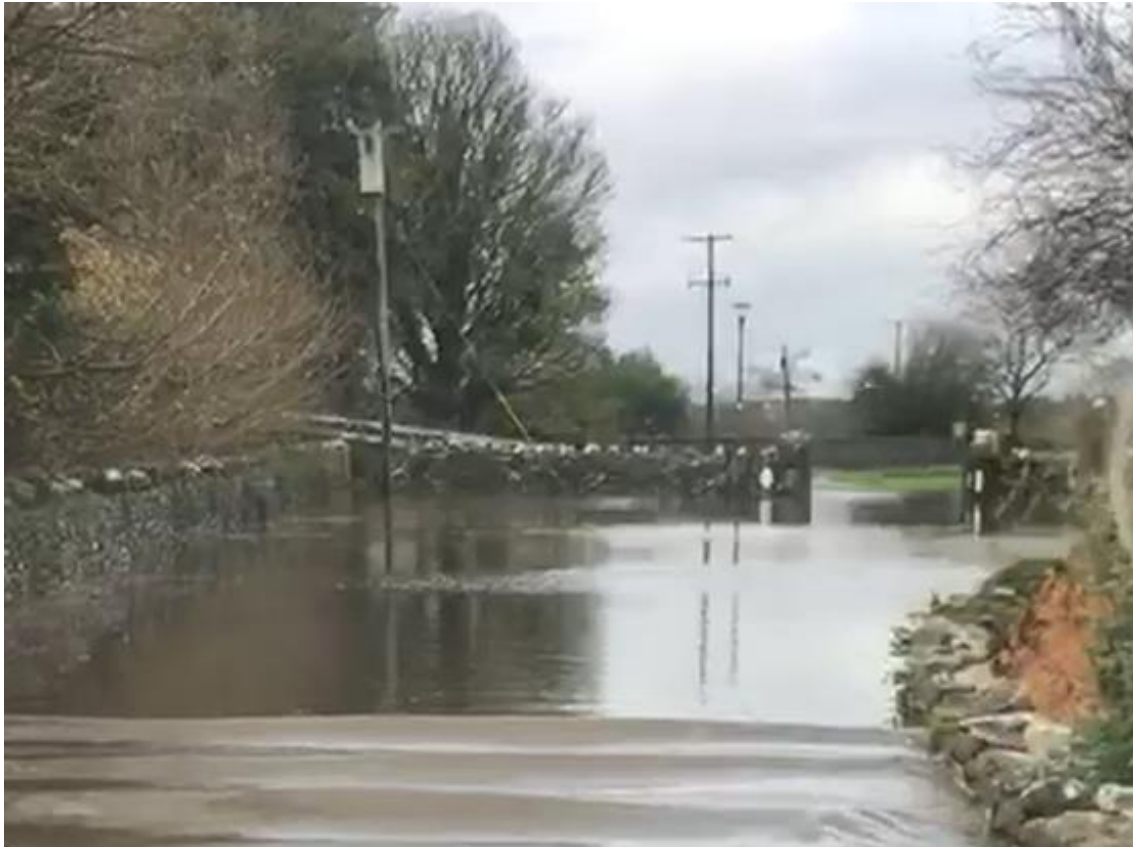
Figure 8-2 – Flooding upstream of Strade River Bridge on 23rd November 2024

The hydraulic assessment of the existing structure determined a design flood level of 18.38mOD at the existing bridge, with the bridge soffit level of 18.1mOD below the design flood level.

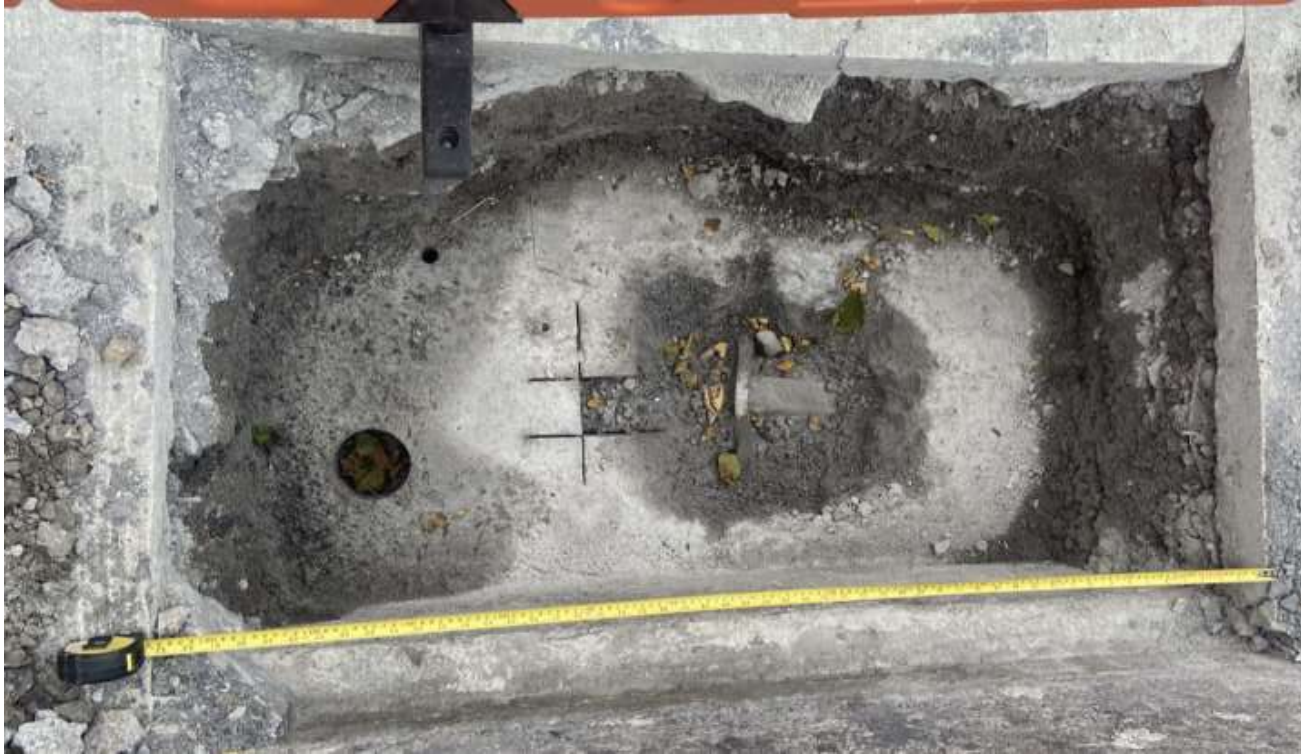
Figure 12: Test area 1 containing pilot hole, core sample hole and breakout.

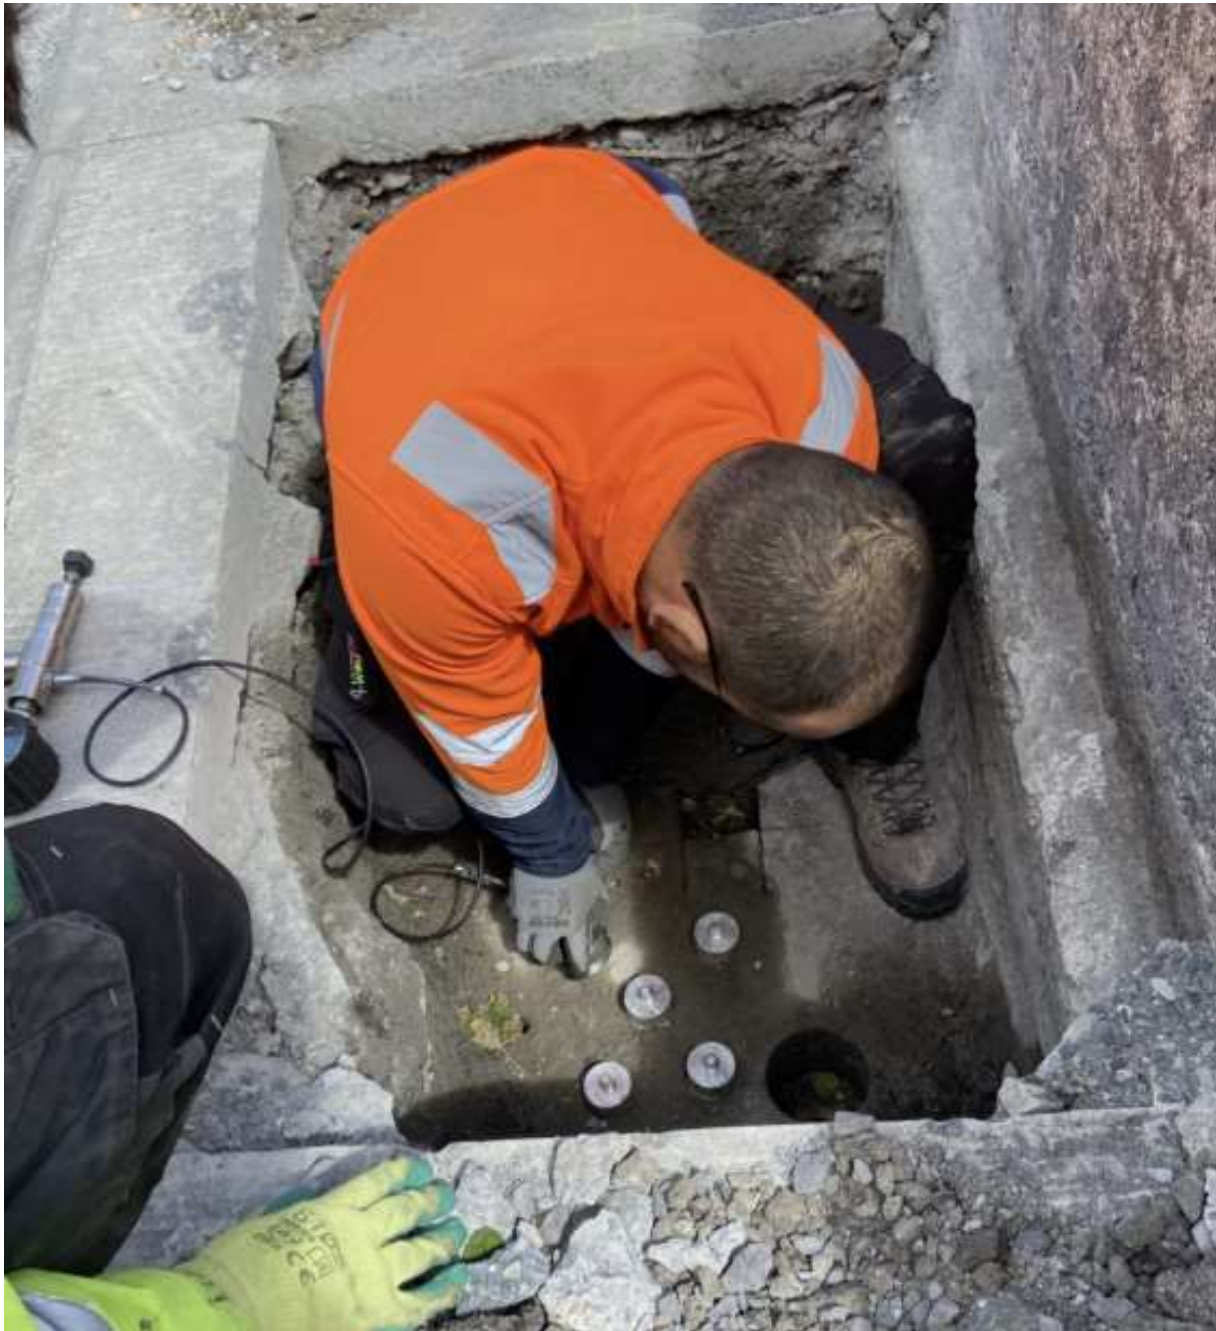
Figure 16: Adhesion testing

Test Reference	Max Applied Load (MPa)	Depth of failure (mm)	Failure occurred in
Area 1 top deck	1.4	3	Below adhesive in concrete substrate (cohesion failure)
Area 1 top deck	1.7	4	Below adhesive in concrete substrate (cohesion failure)
Area 1 top deck	2.3	5.0	Below adhesive in concrete substrate (cohesion failure)
Area 1 top deck	0.9	0	Below adhesive on top of concrete surface (adhesion failure)
Area 1 top deck	2.6	4.0	Below adhesive in concrete substrate (cohesion failure)
Mean	1.78

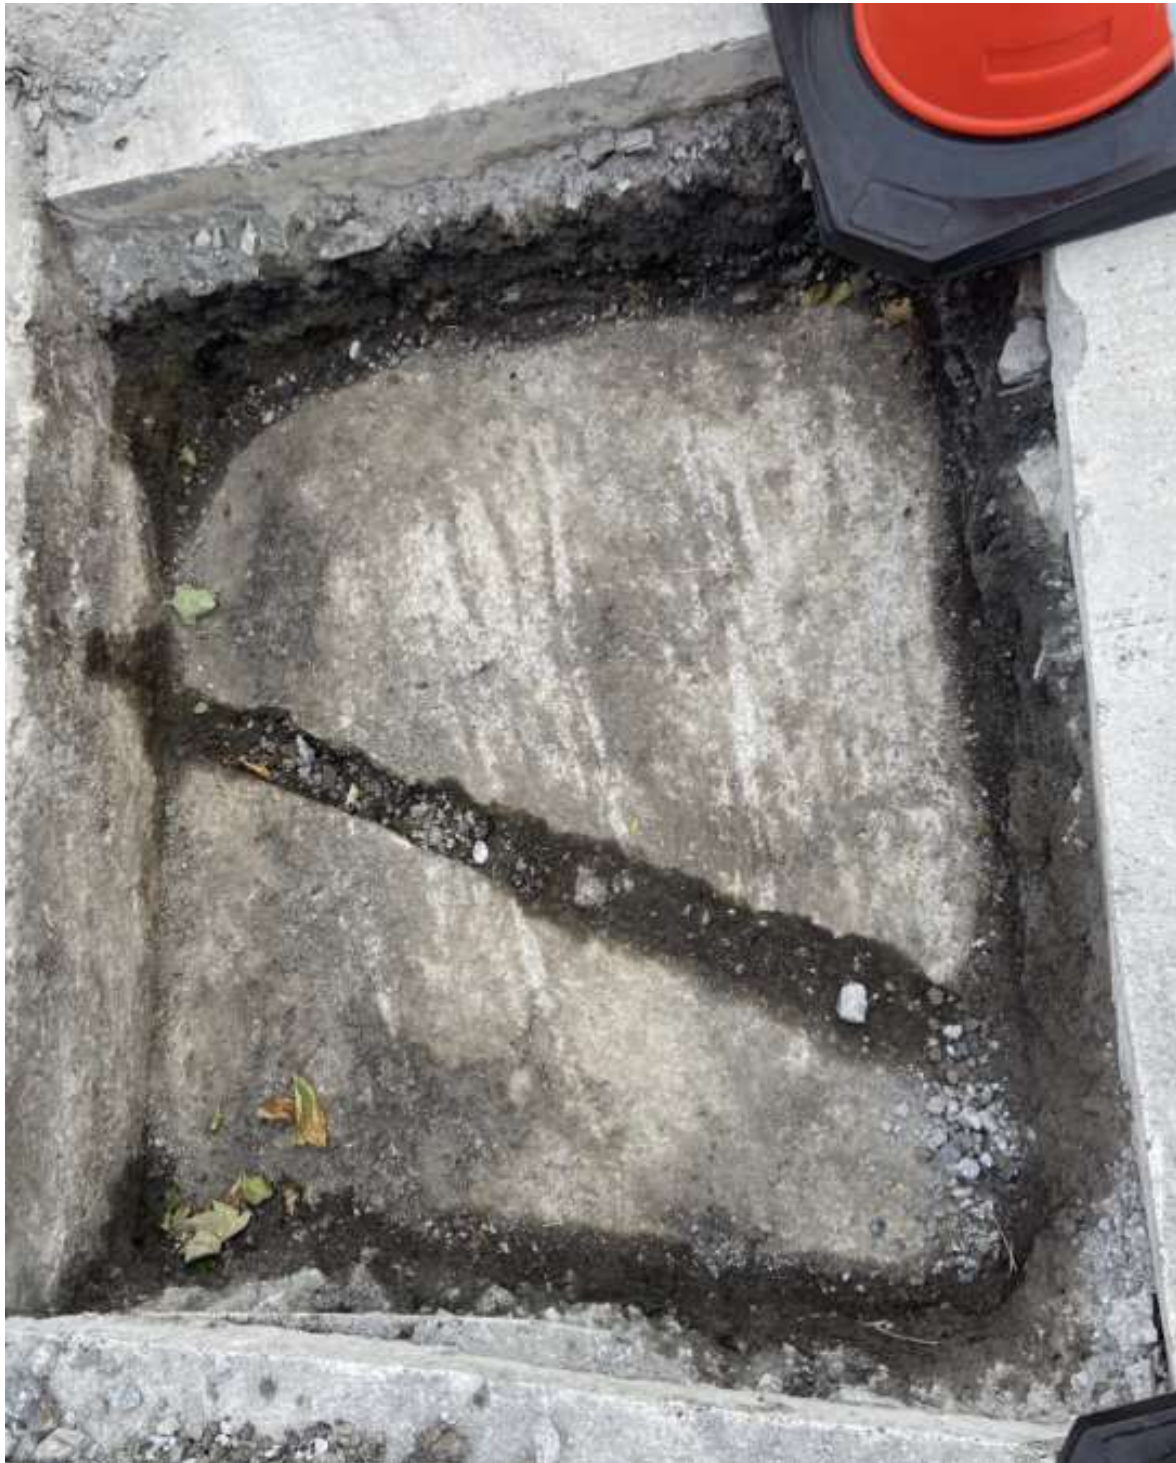
TEST AREA 2	mm
DeckTrial hole (west)	
cover of fill	315
cover on longitudinal bars	n/a
cover on transverse bars	n/a
Longitudinal bar sizing	n/a
Transverse bar sizing	n/a
<i>No reinforcement found above rail girders</i>

Figure 17: Trial pit on western edge

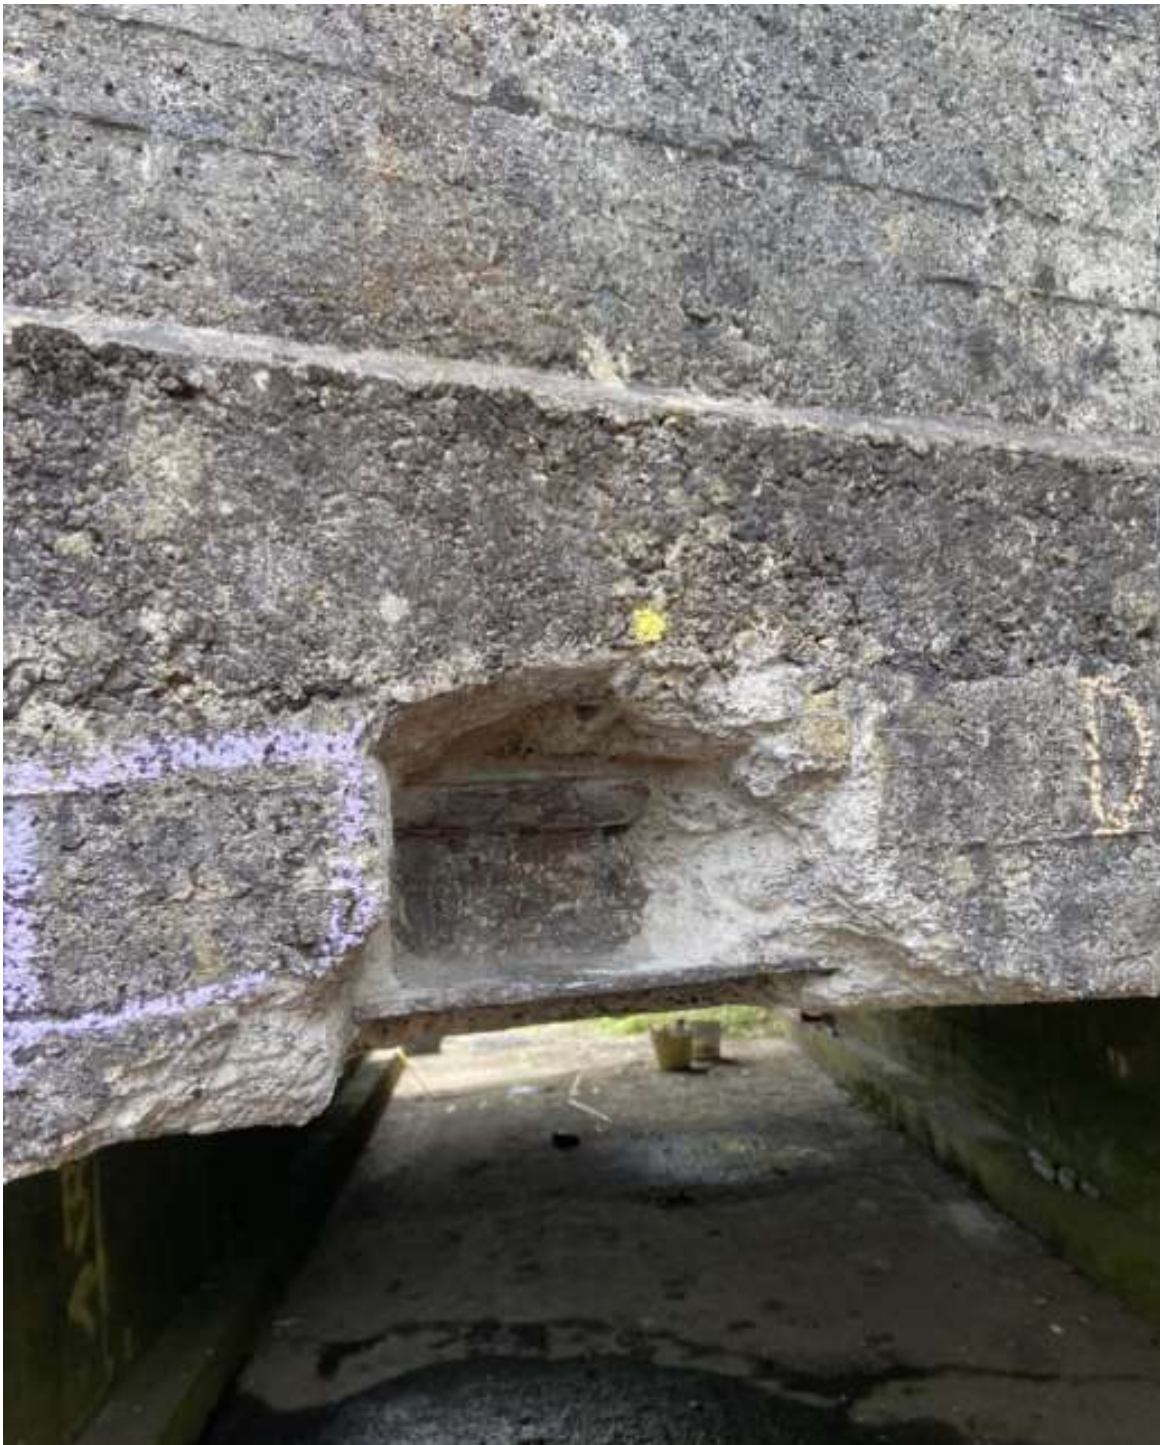
Figure 20: Breakout of external beam

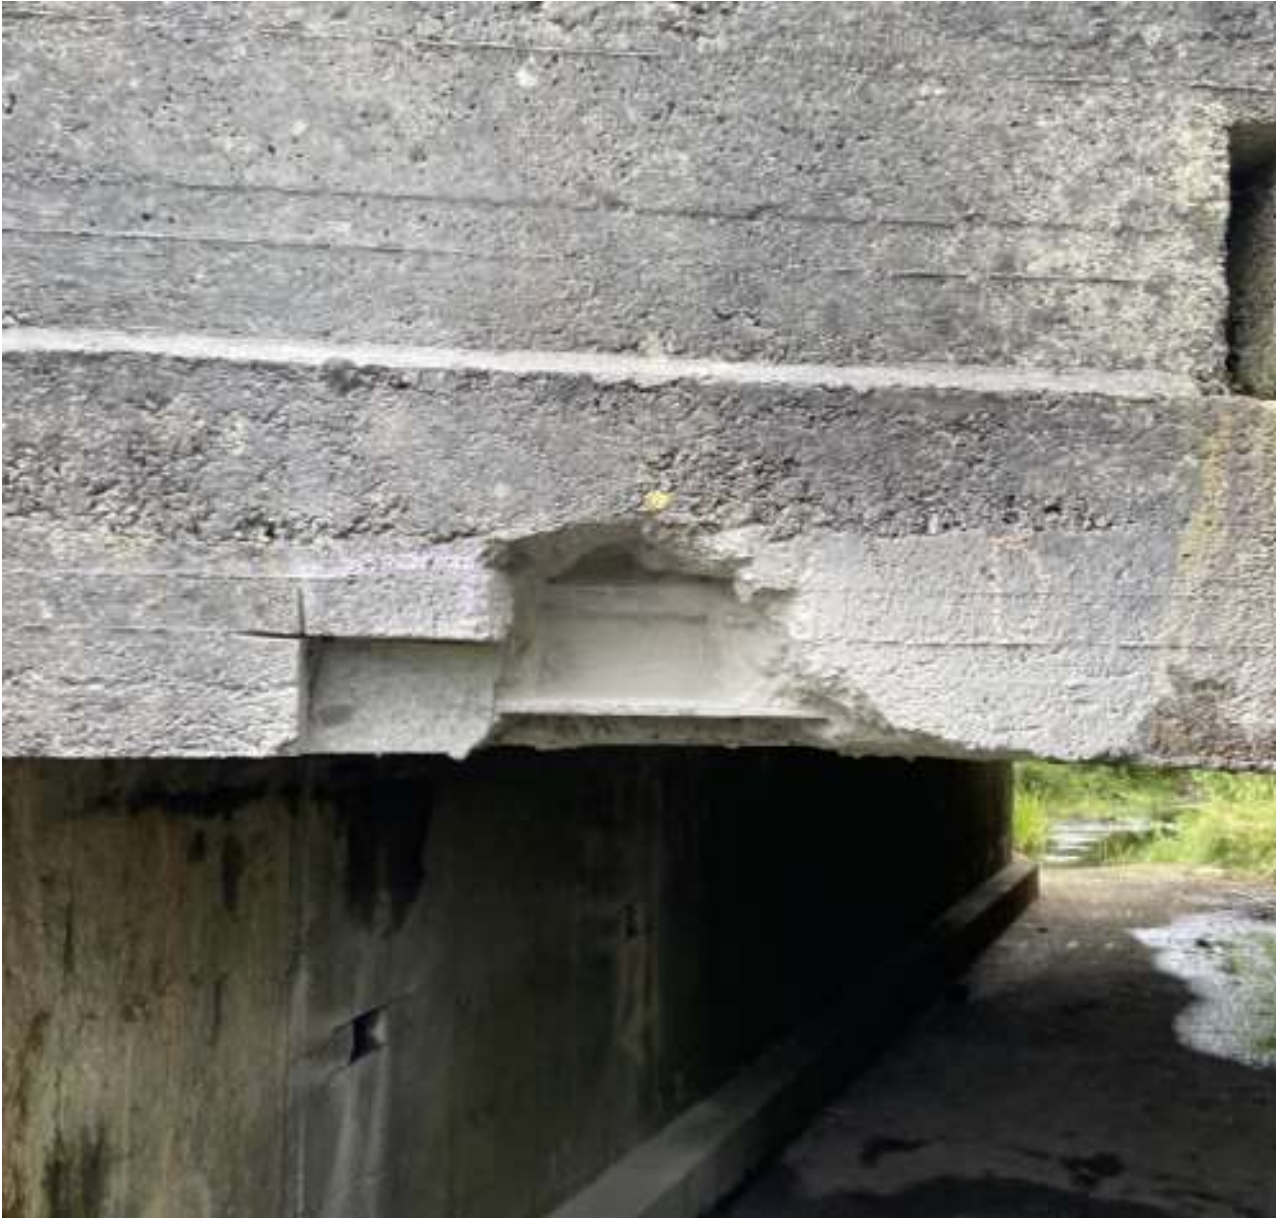
Figure 23: Carbonation test sample extracted to the left of breakout

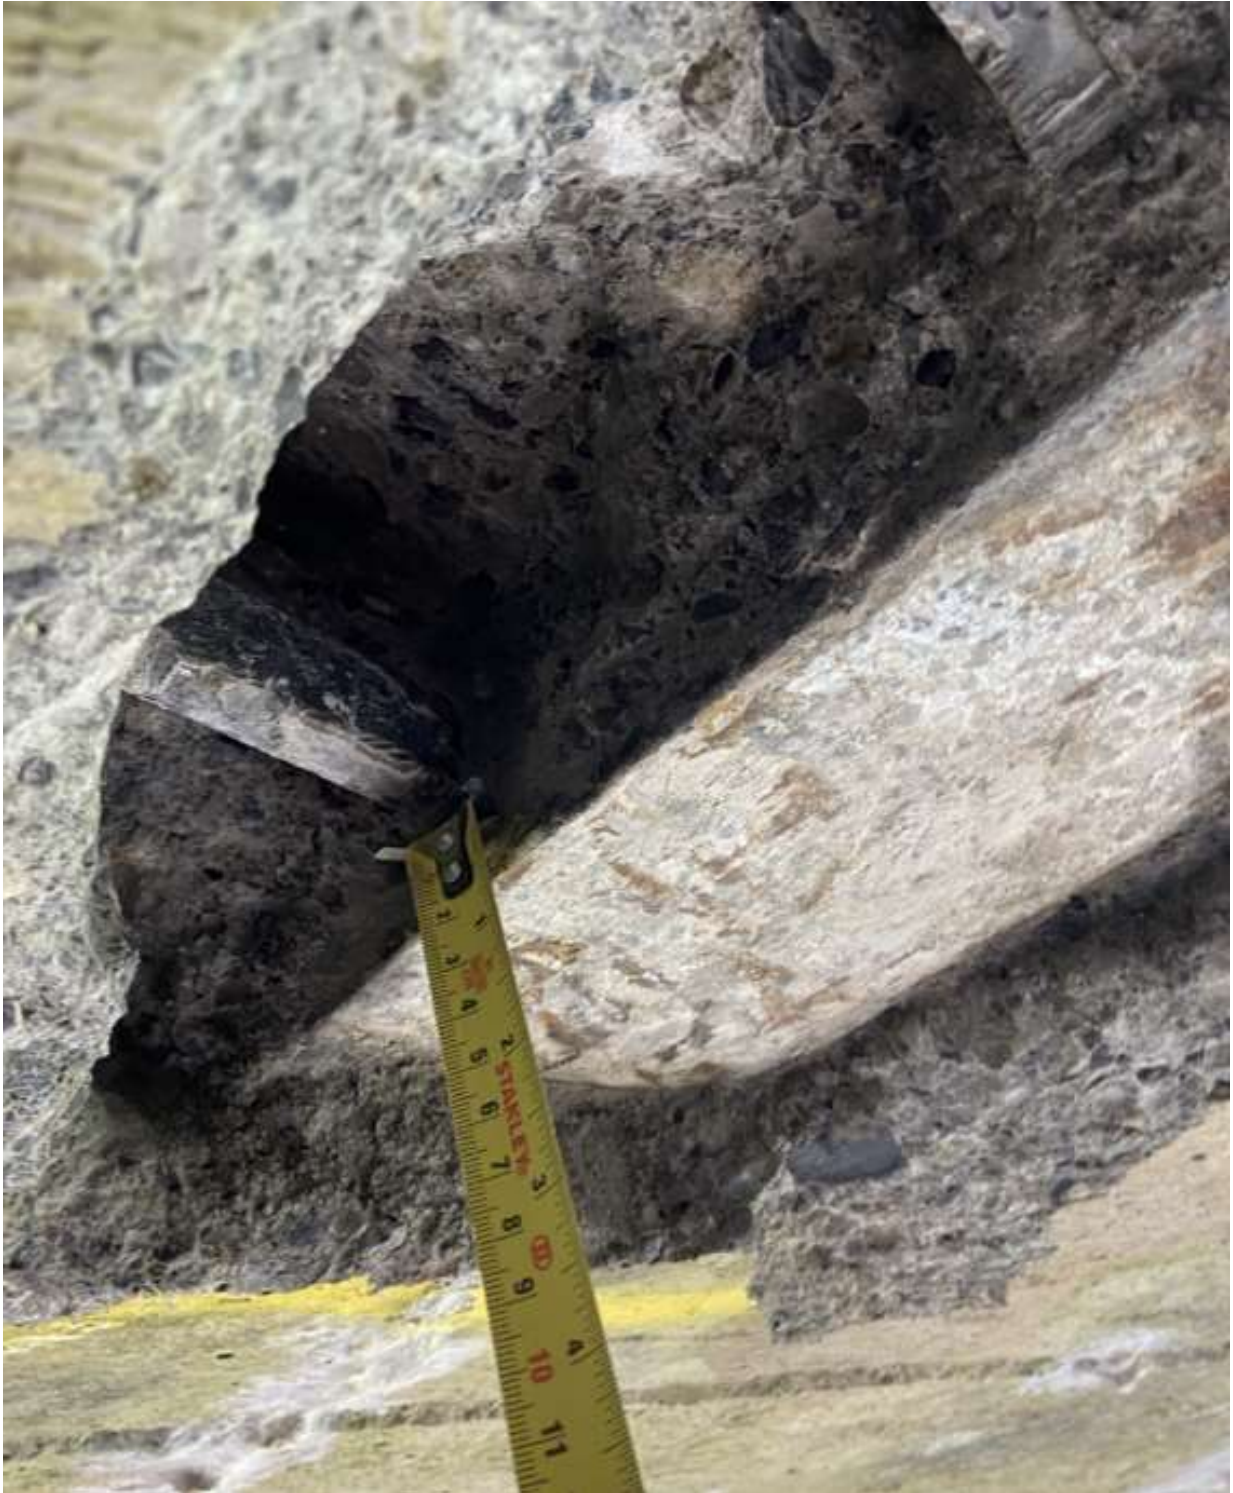
Figure 26: Transverse steel members running perpendicular to longitudinal members at 160mm spacing

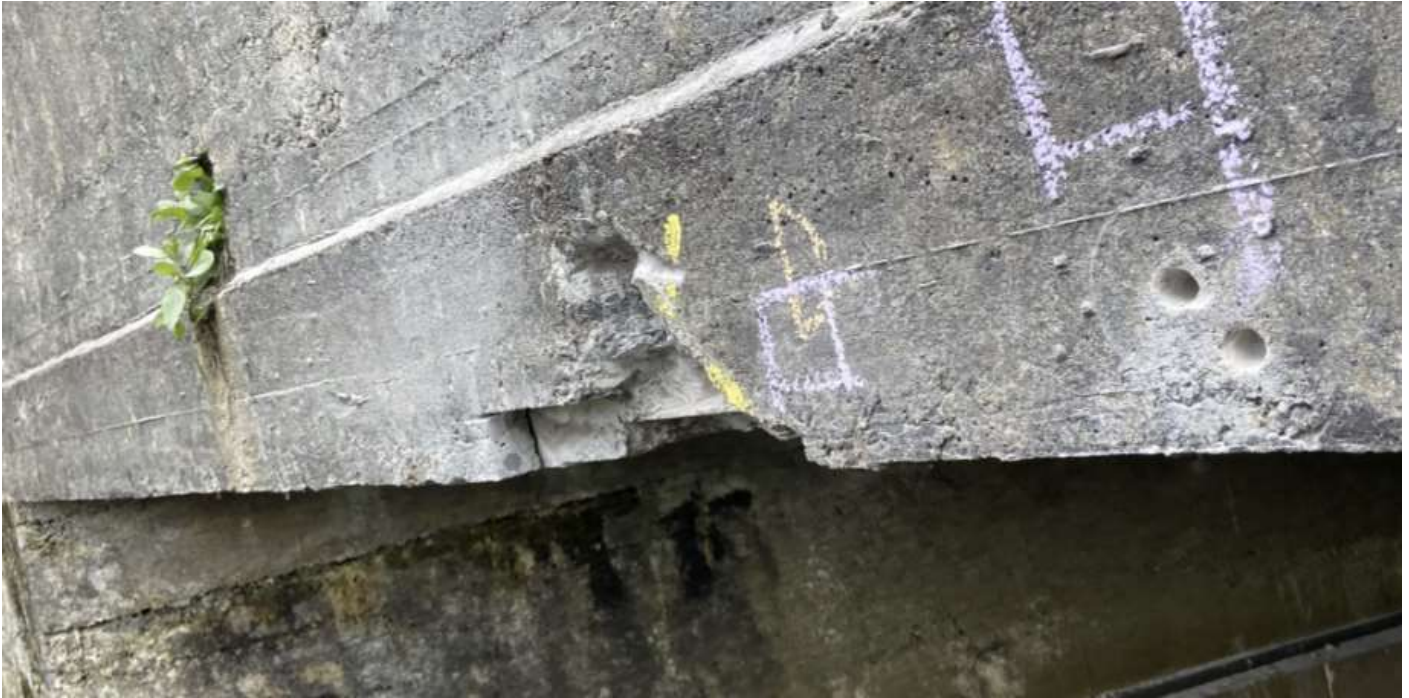
Figure 34: Breakout at test area 4 exposing external beam

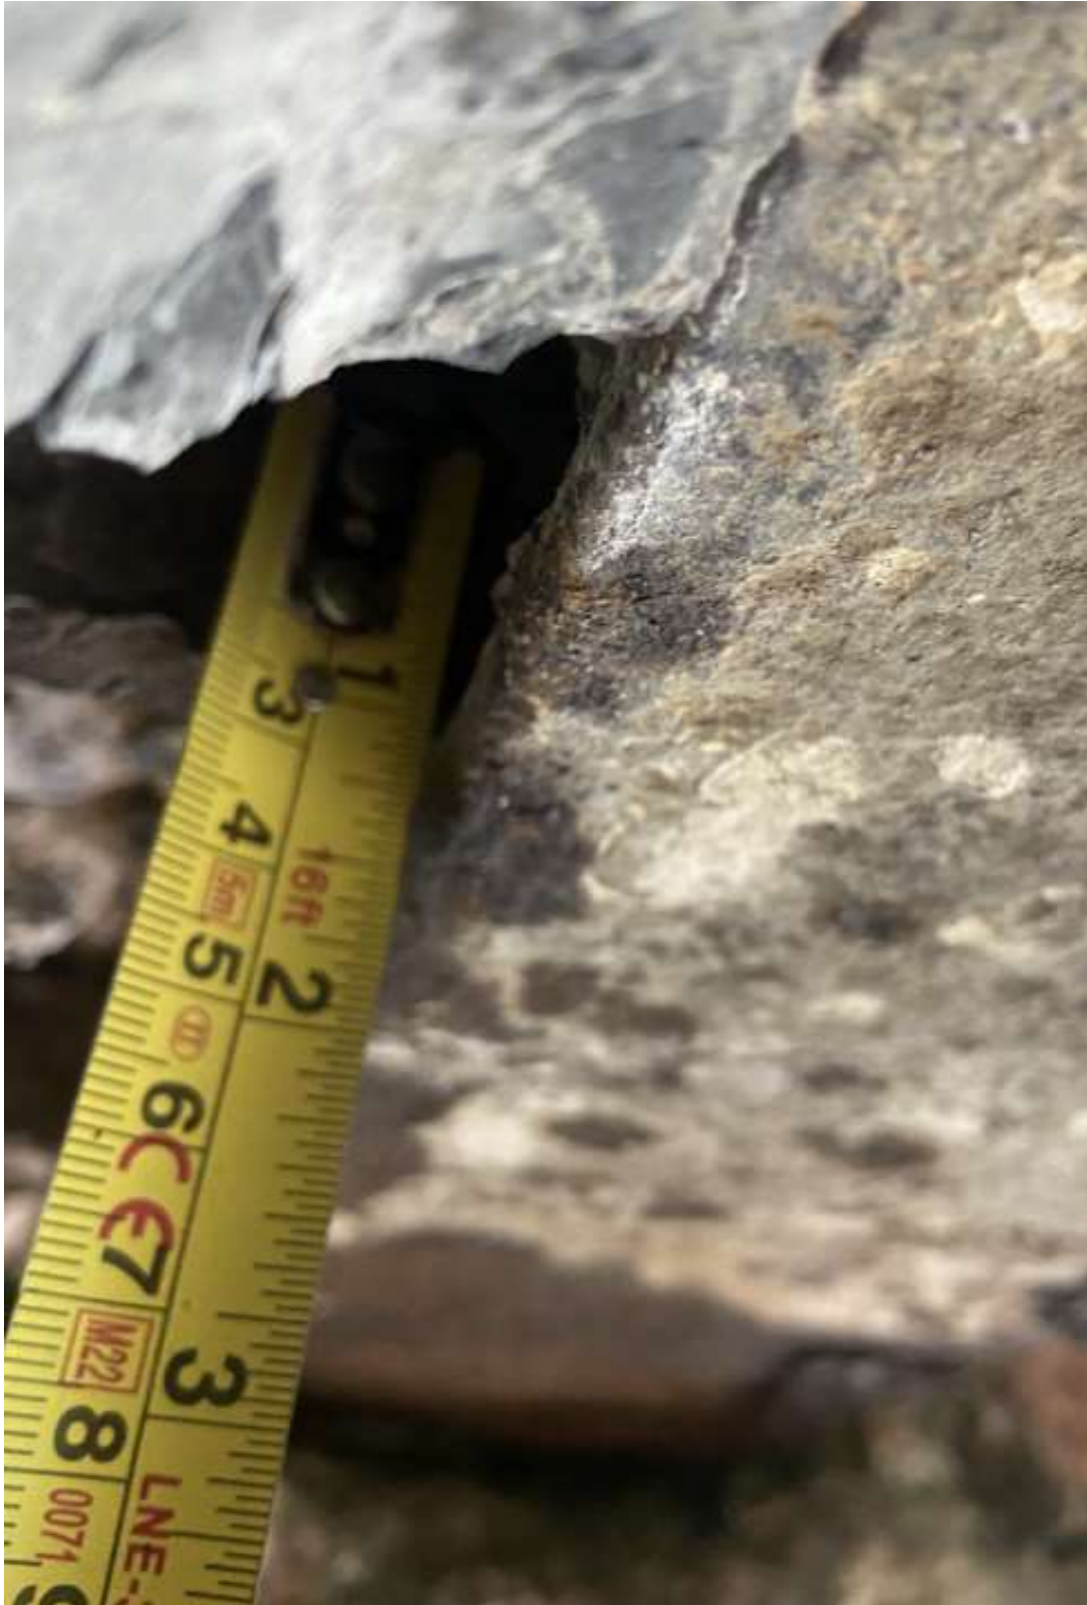
Figure 41: Cover of Transverse steel

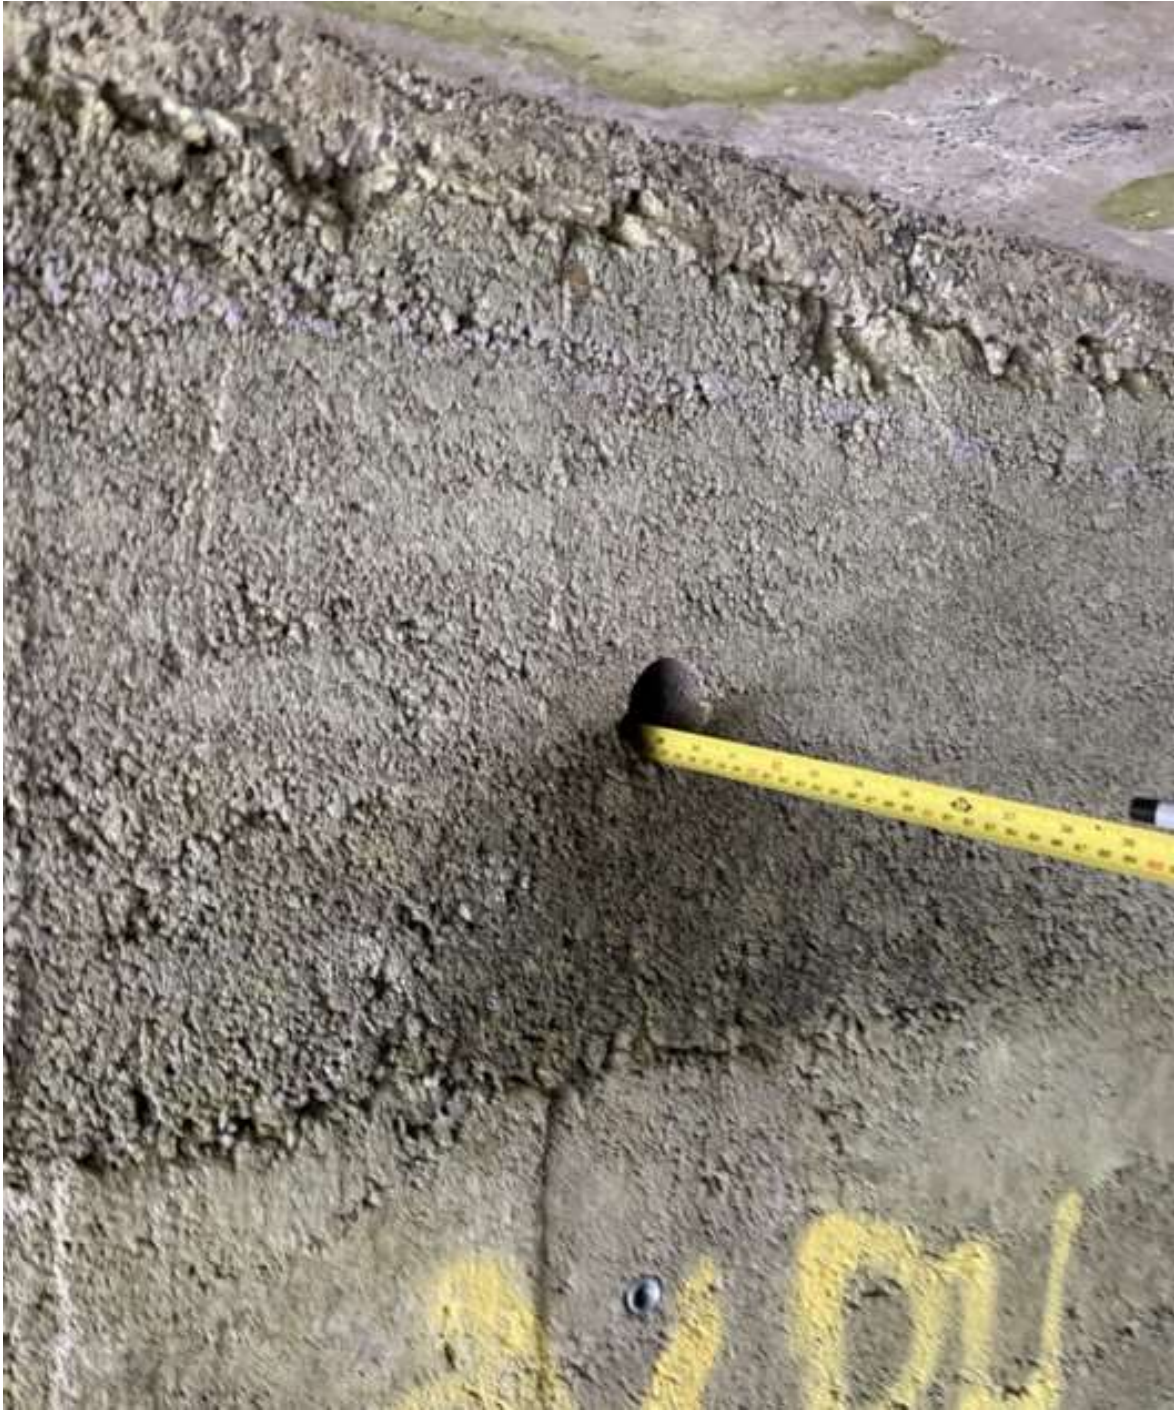
TEST AREA 5	mm
Southern Abutment	
pilot hole	740
cover on longitudinal bars	n/a
cover on transverse bars	n/a
Longitudinal bar sizing	n/a
Transverse bar sizing	n/a
<i>No reinforcement found</i>

Figure 45: Pilot hole depth measurement

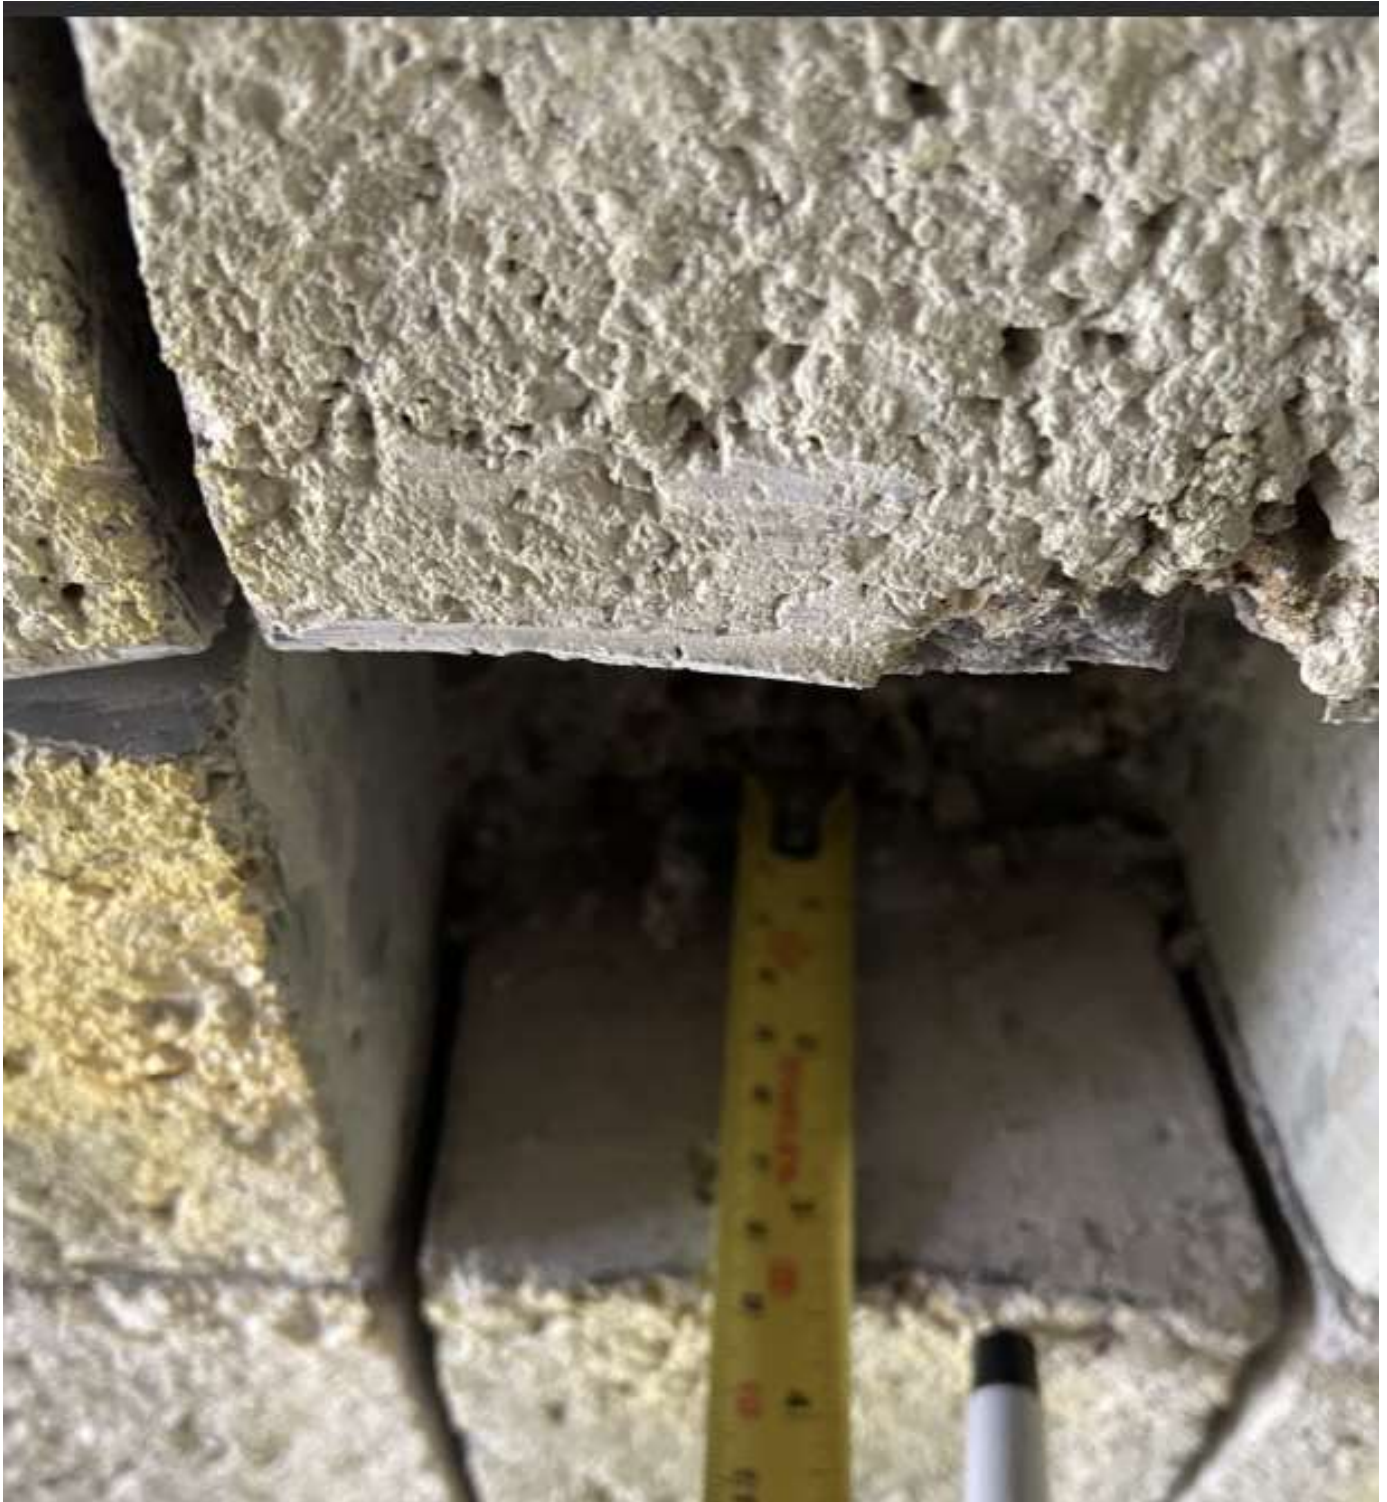
TEST AREA 6	mm
Pier mid support (south west side)	
pilot hole	n/a
cover on longitudinal bars	n/a
cover on transverse bars	n/a
Longitudinal bar sizing	n/a
Transverse bar sizing	n/a
<i>No reinforcement found</i>

Figure 49: TA6 carbonation sample depth into pier

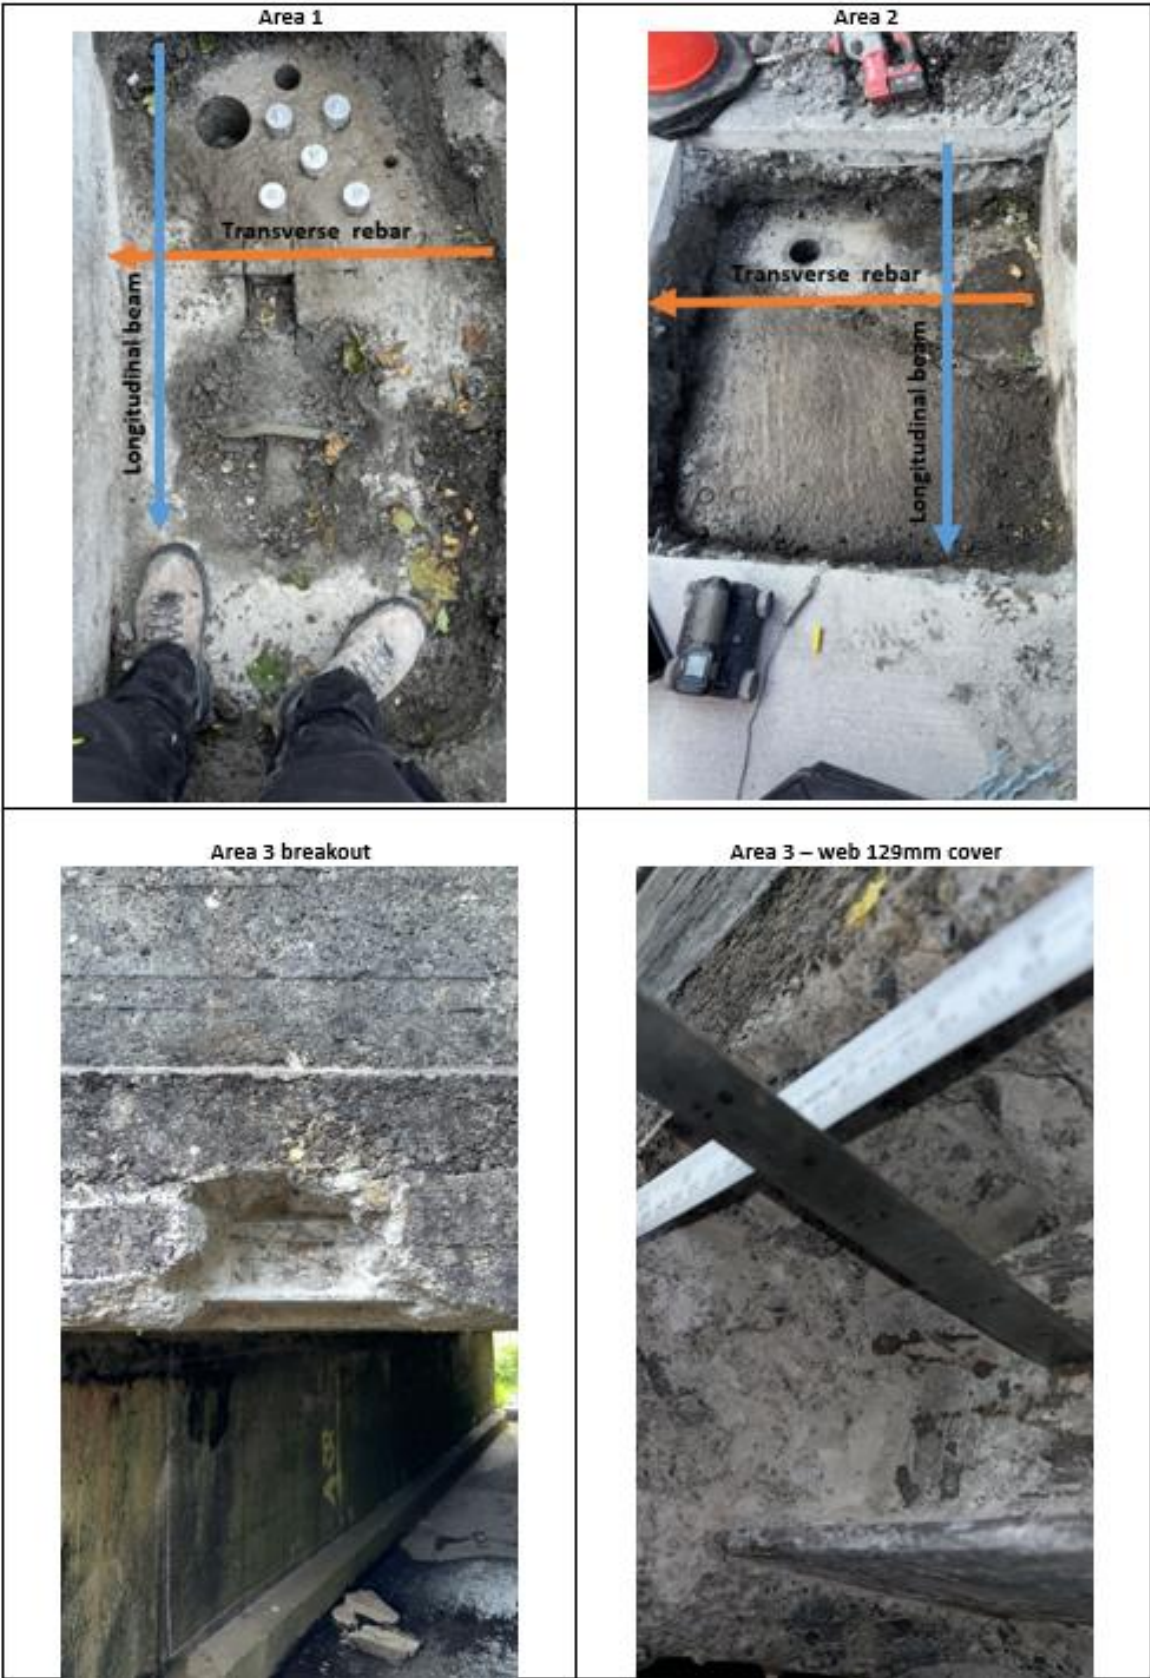
Area 3 - Bottom flange 32mm

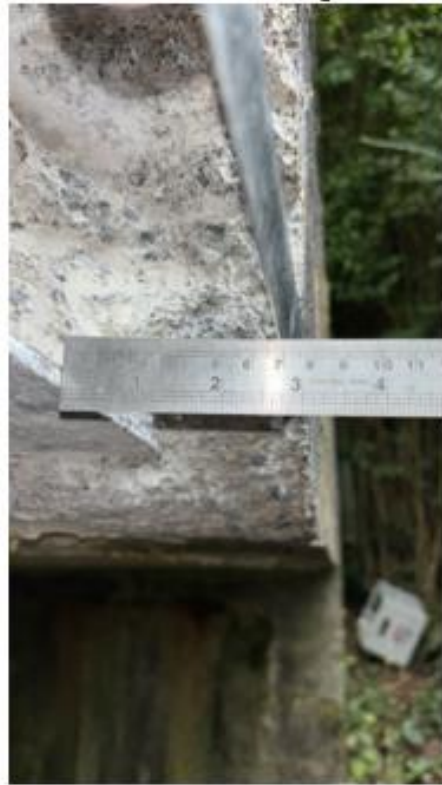
Area 3 - Bottom of side flange 68mm

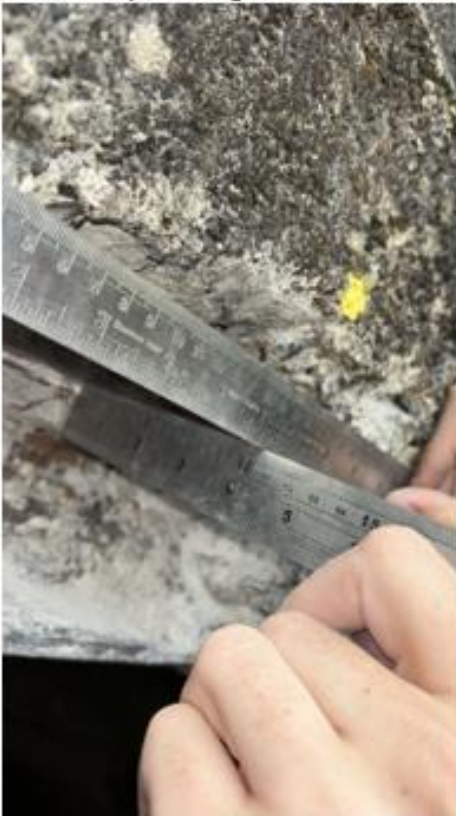
Area 3 - Top side flange 105mm cover side

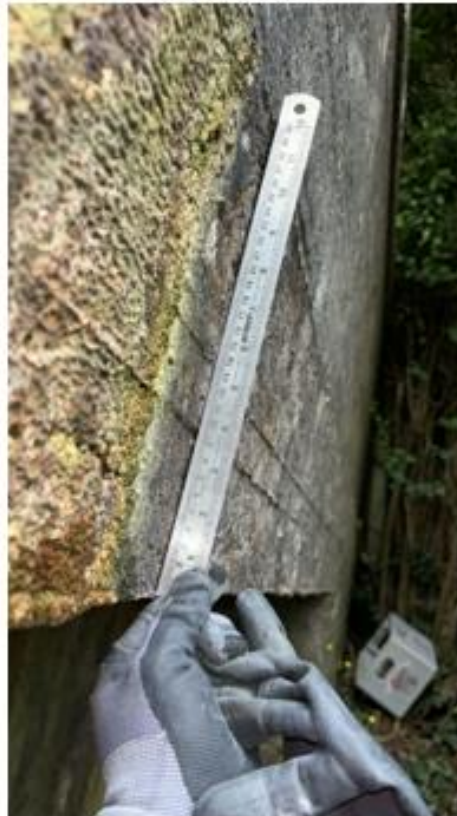
Area 3 - 300mm

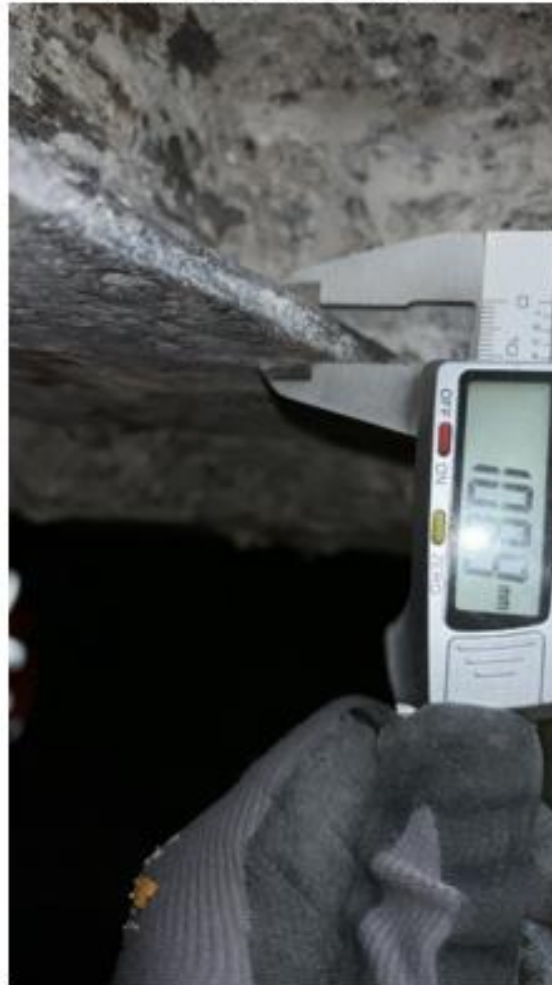
Area 3 - Bottom flange 10.89mm

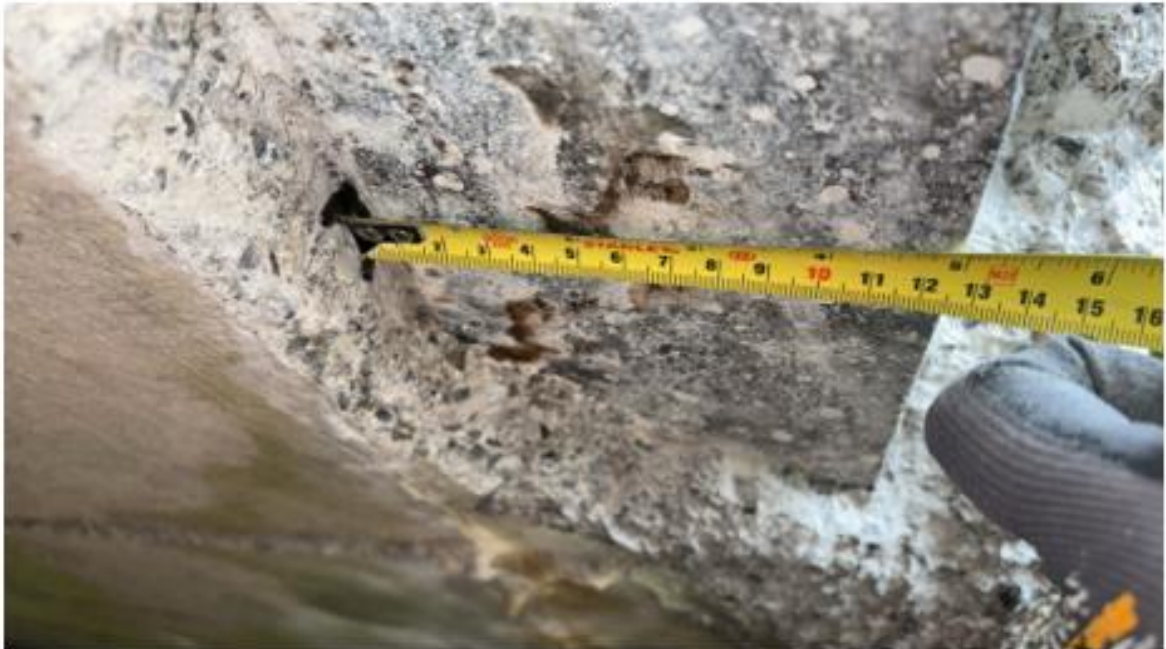
Area 3 - Bottom flange 124mm width

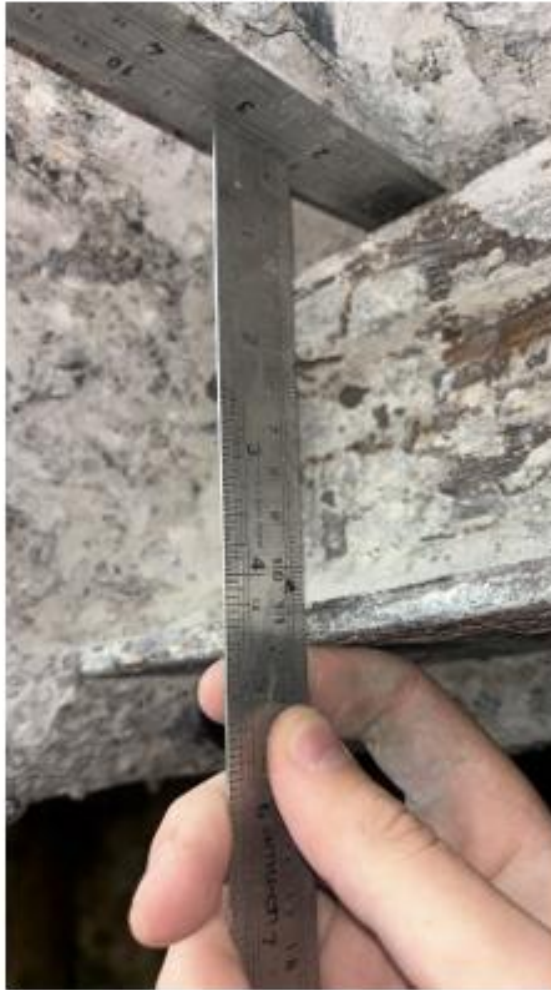
Area 3 - 117mm

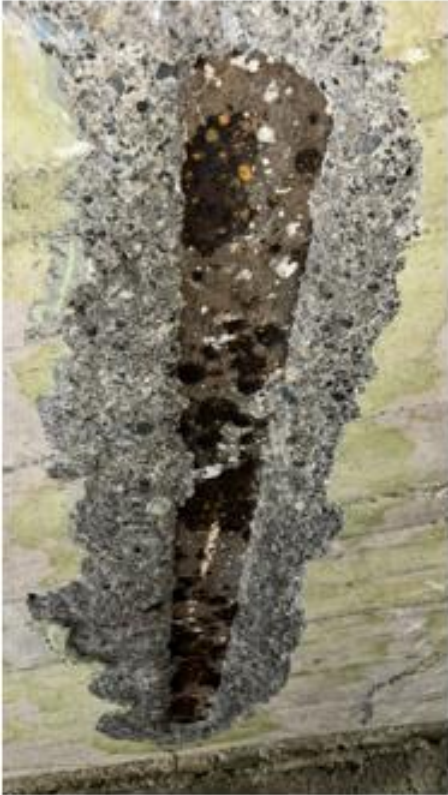
Area 3.1 uncovered area

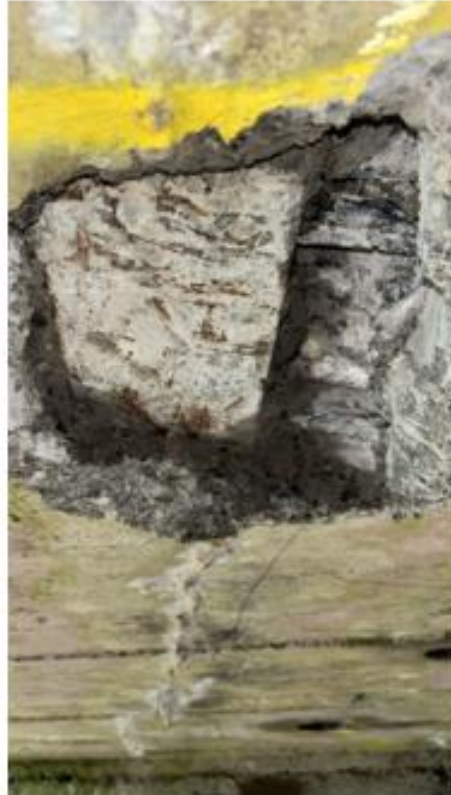
Area 3.1 Soffit breakout

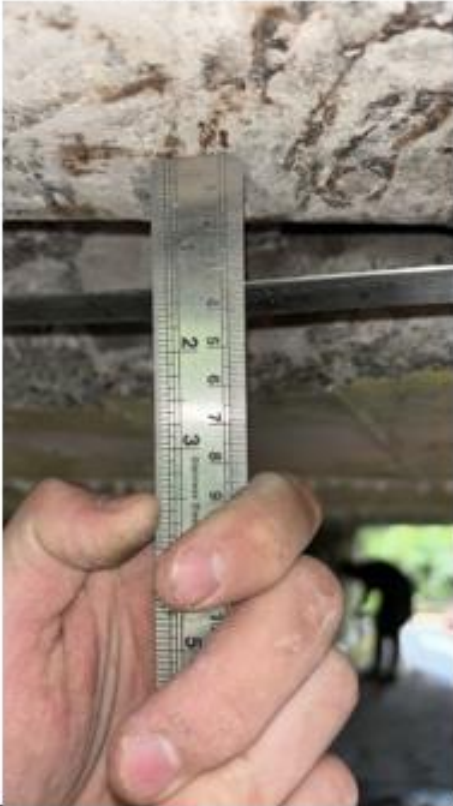
Cover bottom flange 34mm
