Structure Options Report

Mayo County Council

N58 STRADE RIVER BRIDGE REHABILITATION WORKS

Name and nature of the Structure(s) Strade River Bridge

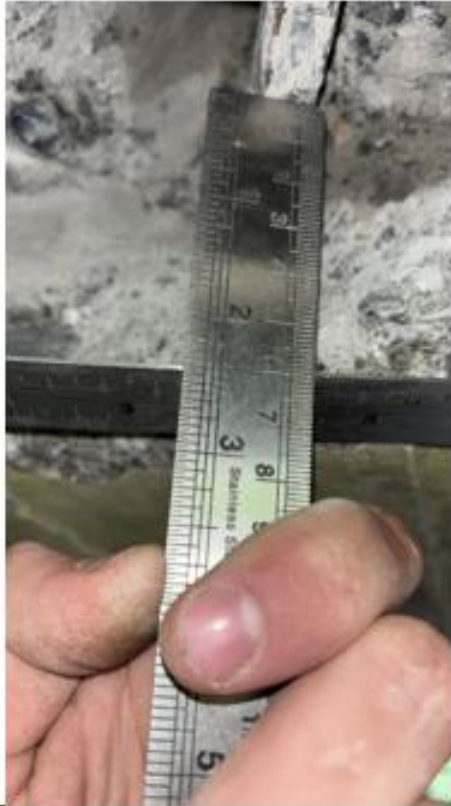
Cover transverse square rebar 59mm

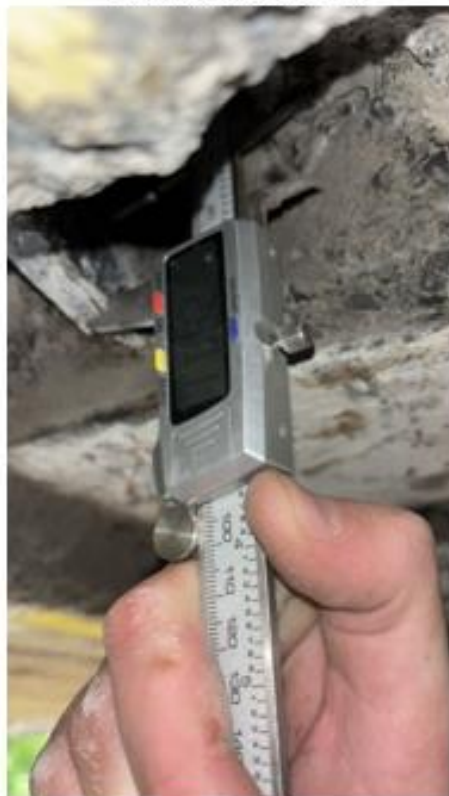
Transverse rebar 28.9mm

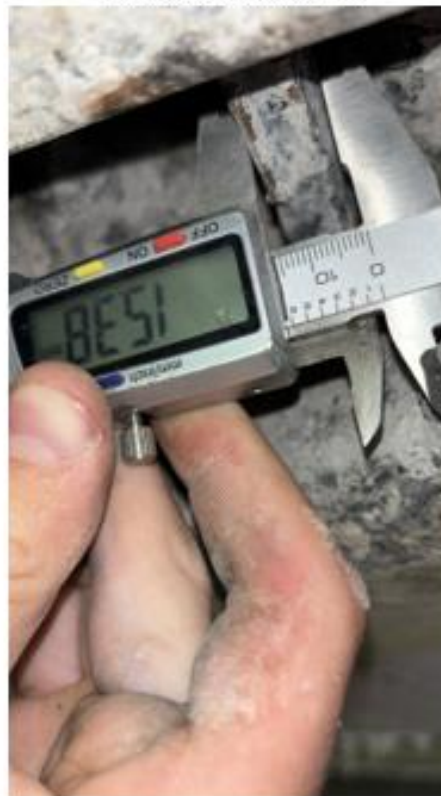
Transverse rebar 15.38mm

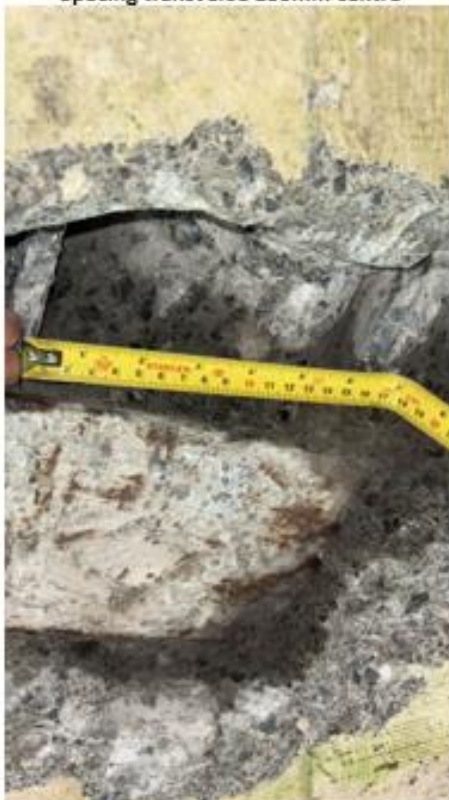
Spacing transverse 160mm centre

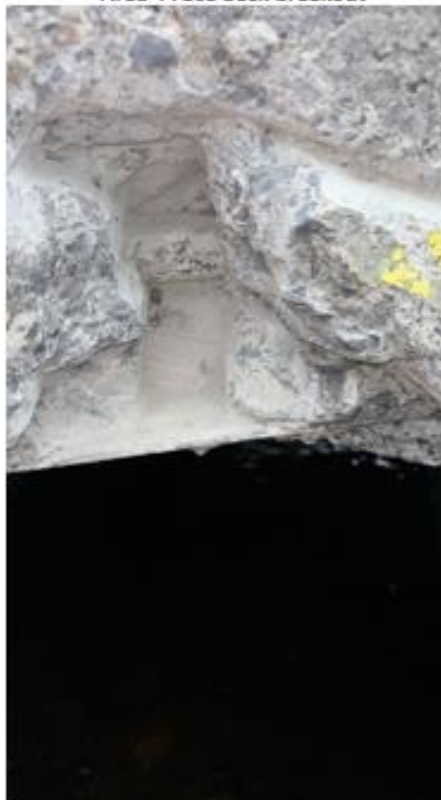
Area 4 Face deck breakout

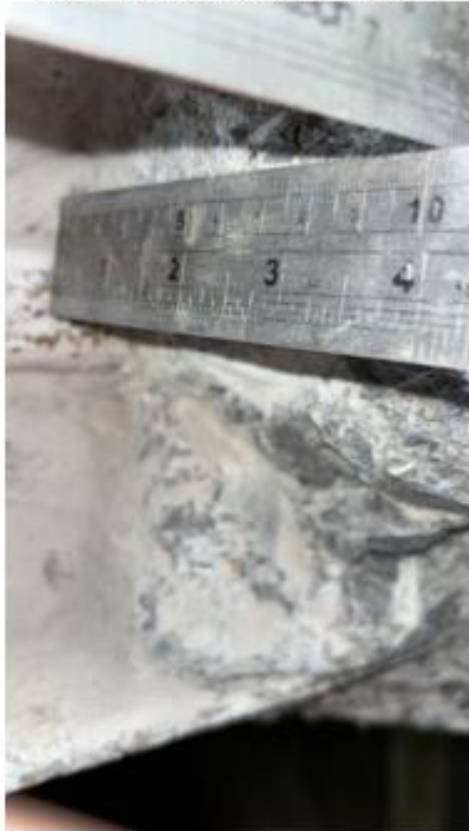
Area 4 –top side flange cover 104mm

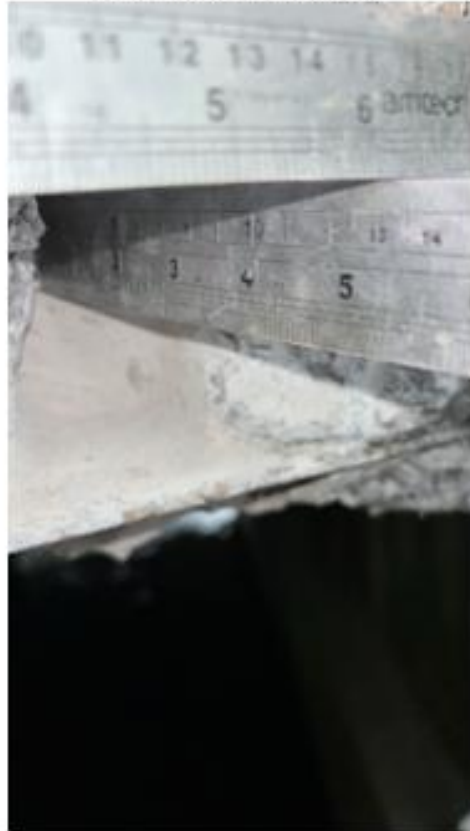
Area 4 - 132mm cover web

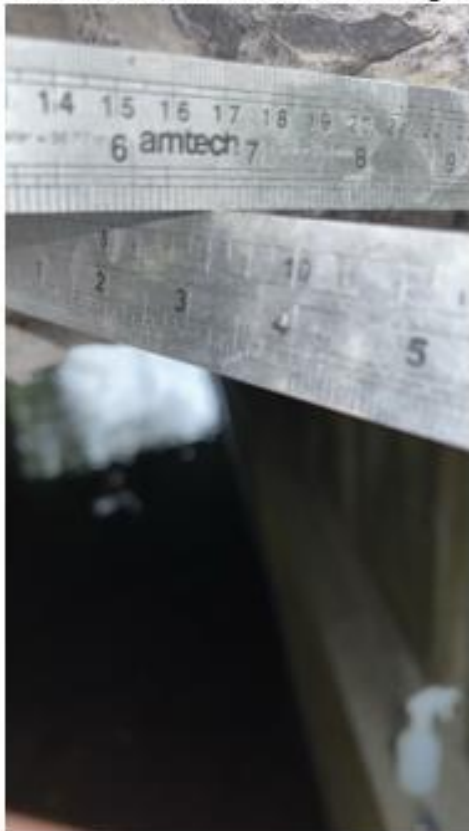
Area 4 - Cover 80mm side bottom flange

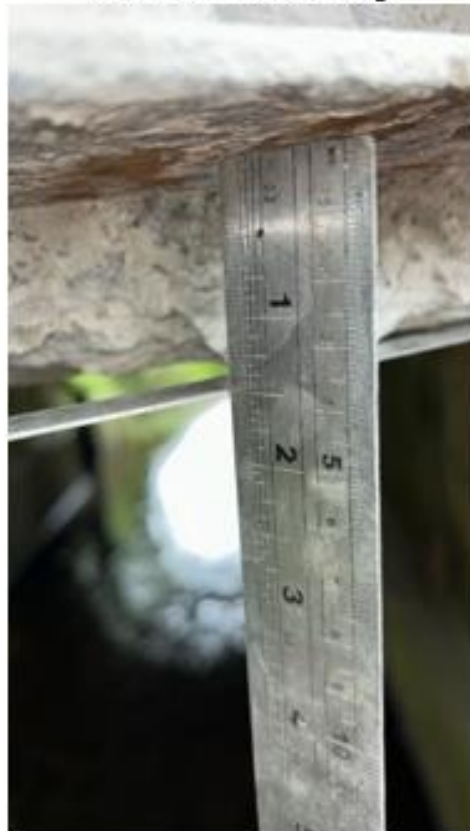
Area 4 – 37mm bottom flange

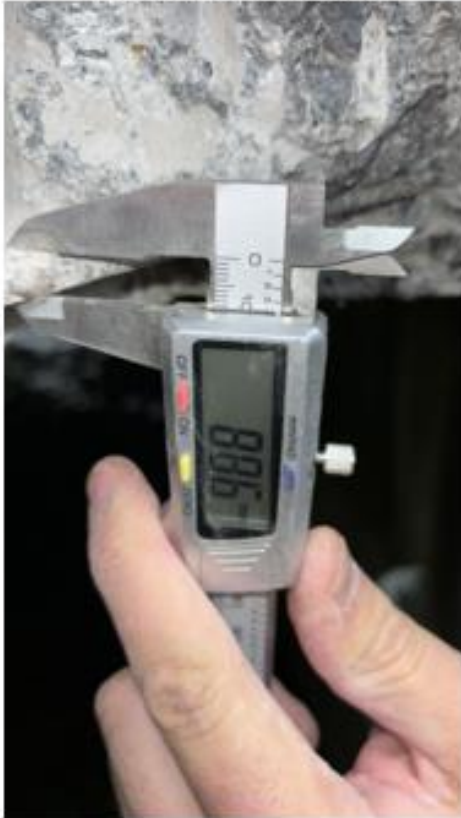
Area 4 – bottom flange 8.86

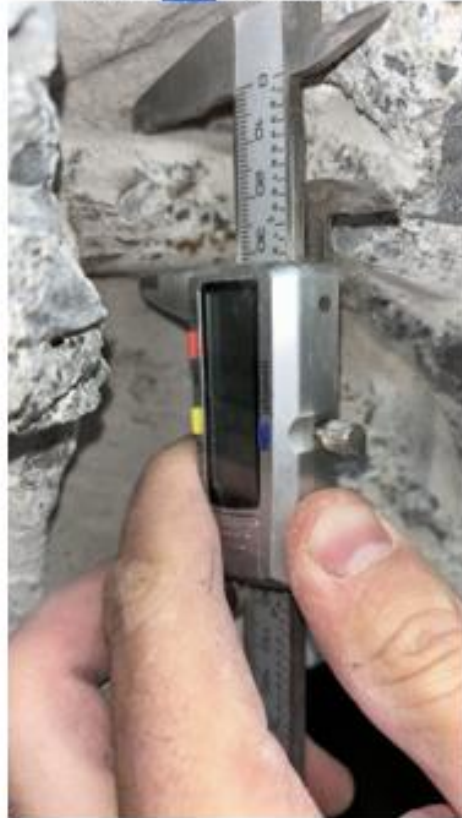
Area 4 - top flange 31.39mm

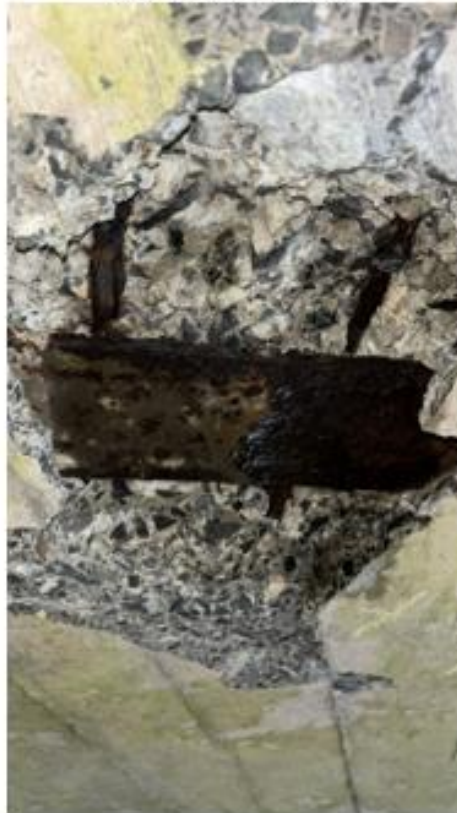
Area 4.1 soffit breakout

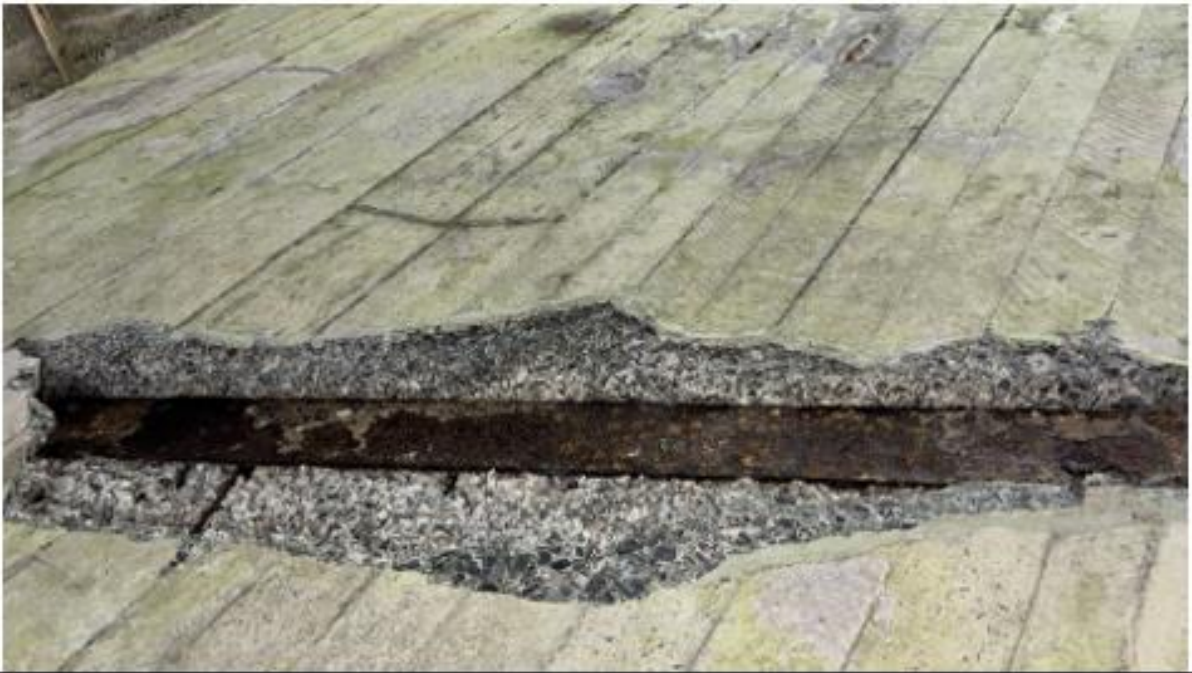
Area 4.1 uncovered area

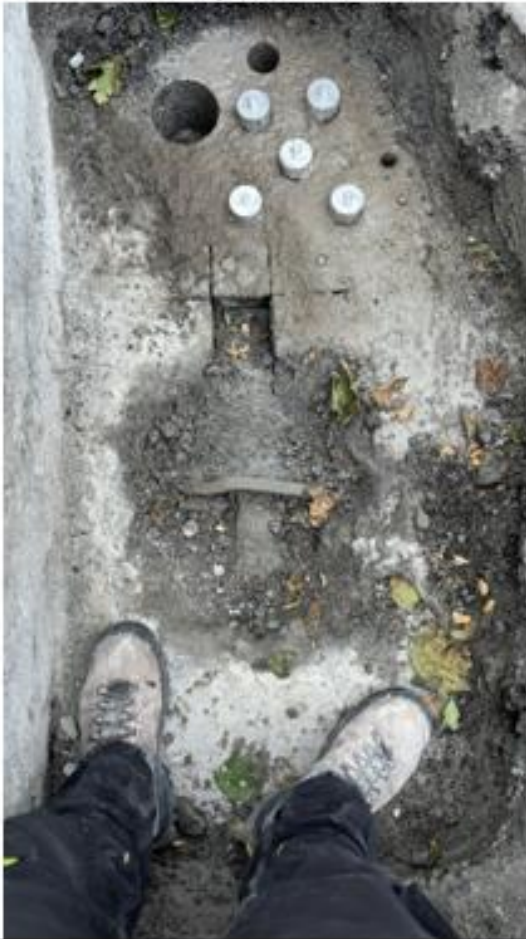
Area 1 Top of deck Breakout

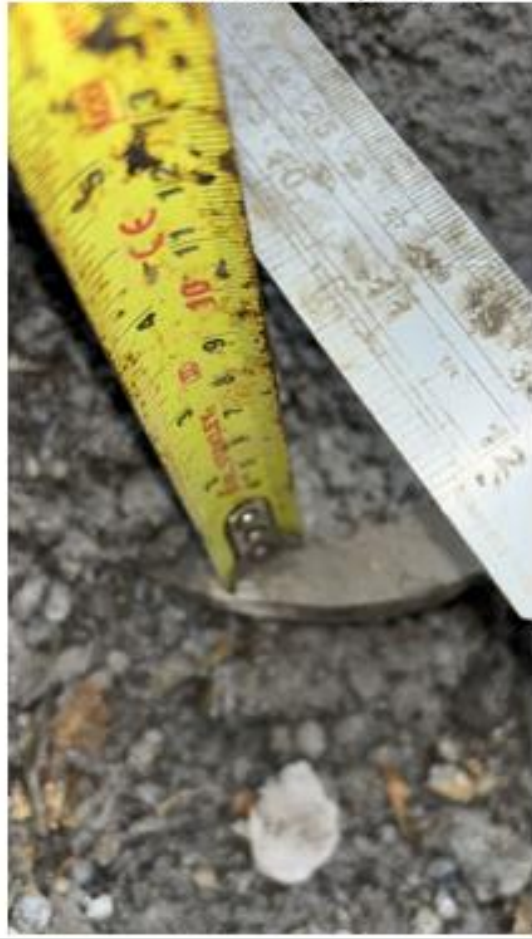
Cover 109mm Transverse square rebar

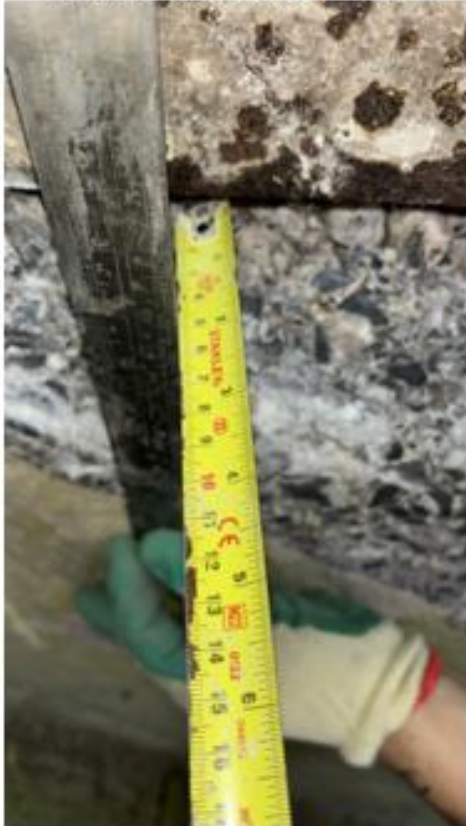
Transverse square rebar cover 51mm

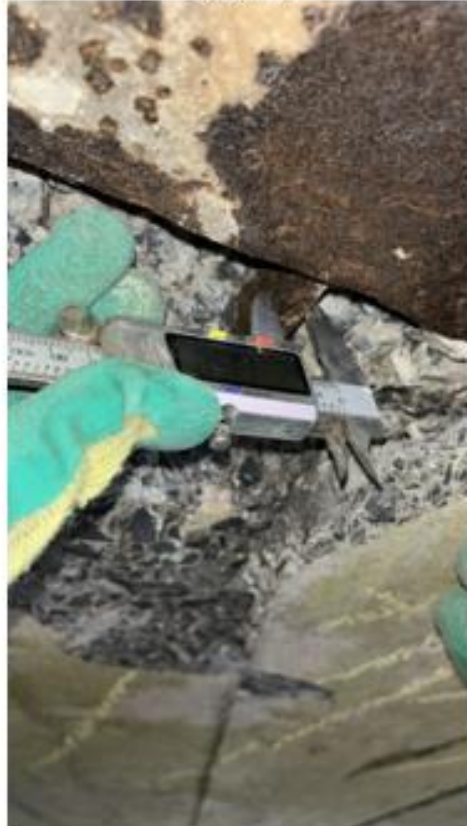
13,5mm

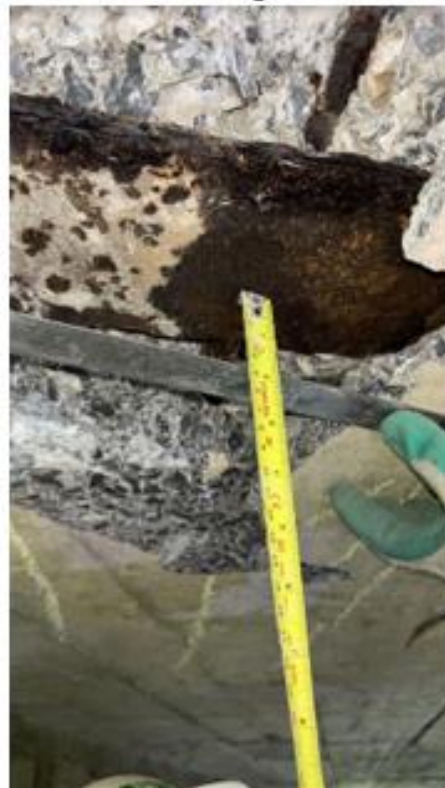
Area 4.1 bottom flange 47mm cover
